Sutton Place, Sutton Green Nr Guildford, Surrey

Archaeological Evaluation and Walkover Report

Ref: 84660.03 June 2012

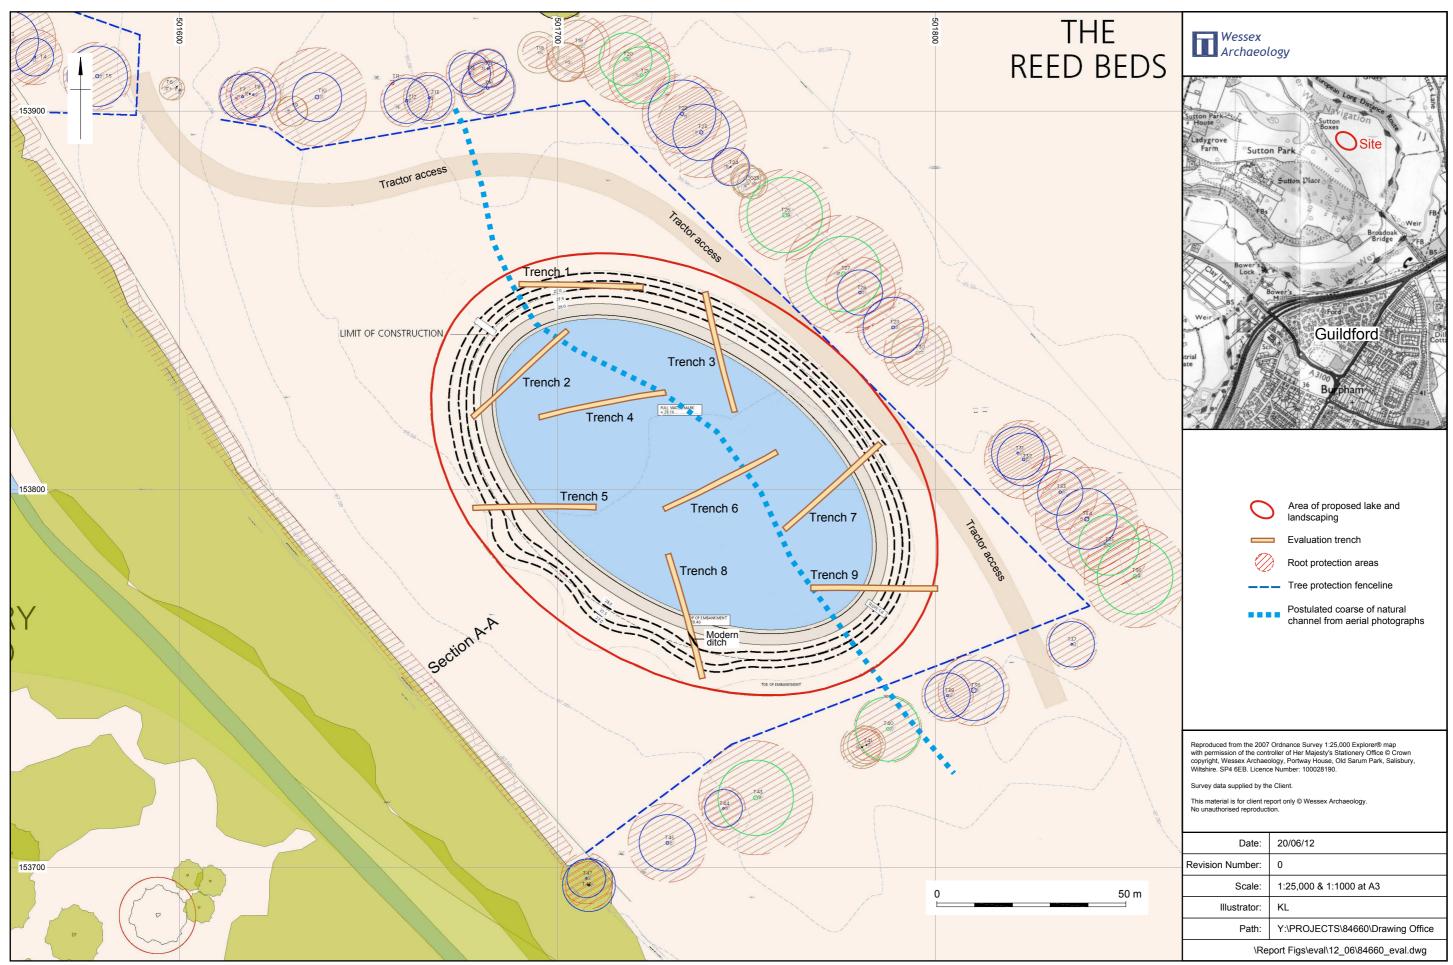
- 1 Site Location showing proposed irrigation lake and evaluation trenches.
- 2 Plates 1-6

2.4.1 During the preparation of the Project Design (WA 2012) Wessex Archaeology undertook a review of all available aerial photographs of the Site held at the National Monuments Record based in Swindon. Twenty two photographs from collections dating from 1945 to 1994 were studied. No crop/parchmarks indicating the presence of archaeological features were distinguishable from the photographs. However, a linear trend likely to be associated with natural water channels due to the proximity of the River Wey was noted on a north-west to south-east alignment through the centre of the Site (**Figure 1**).

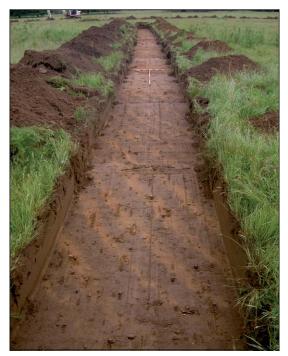
Plate 1: Trench 3 from the north showing plough scars (scale 1m, 2m)

- 6.4.1 No archaeological features of significance were observed within the trenches. Numerous plough scars of post-medieval or modern date were revealed aligned northwest to southeast and running with the long axis of the field; parallel to the eastern limit of the Site.
- 6.4.2 A single modern drainage ditch was observed in Trench 8, this also ran on a northwest to southeast alignment.

Trench	Dimensions :	33.12m by 1.40m by 0.43m	Gre	ound	26.41m
3	Coordinates (NGR):	501739.06, 153852.16 501746.89, 153820.43	sui lev	rface el:	aOD
Context	Category	Description		Depth	n (bgl)
301	Layer	Plough soil: Mid brown sandy loam wi frequent pieces of gravel <0.03m in sincluded throughout.	ze	0-0.34	4m
302	Natural	Mid orangish brown gravelly sand with frequent inclusions of <0.04m pieces of gravel throughout. Lightens to yellowish brown with frequent poorly sorted iron stain inclusions towards the South end of the trench. Softly compacted and heterogeneous.		0.34m	ì+
		N.B. Plough scars evident running N SE across N end of trench a sporadically towards the southern end	and

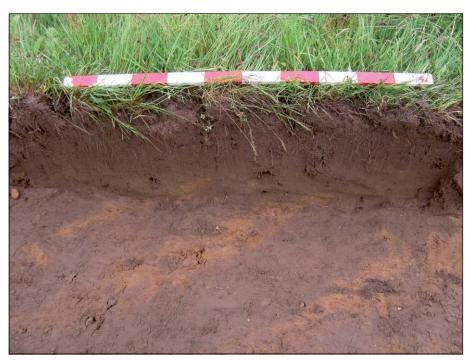
Plate 2: West facing representative section of Trench 3 (scale 1m)

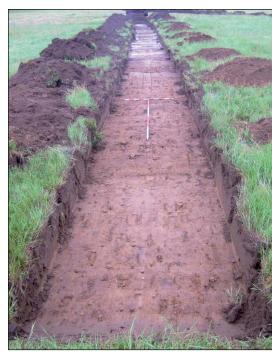
Plate 3: Trench 4 from the east (scale 1m, 2m)

Trench	Dimensions :	34.90m by 1.40m by 0.39m	Gro	ound	26.46m
4	Coordinates	501728.59, 153825.60		rface	aOD
•	(NGR):	501695.16153819.04	lev	el:	aob
Context	Category	Description		Depth	n (bgl)
401	Layer	Plough soil: Mid brown sandy loam. Friable and homogenous with frequent small to medium sized >0.10m pieces of gravel and sub-rounded stones included Single sherd of medieval pottery.		0-0.32	2m
402	Natural Mottled orange/brown gravelly sand with frequent inclusions of <0.10m sized pieces of gravel. Homogenous and softly compacted. Changes to a light greyish yellow sand to the western end of the trench.			0.32m	ì+

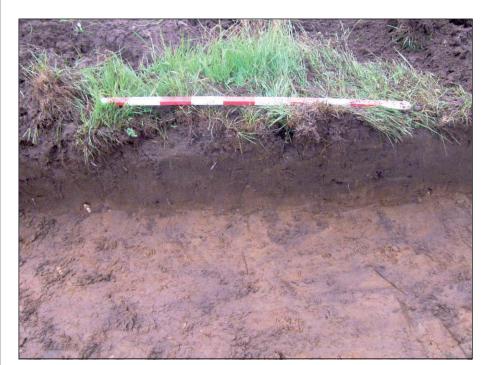
Plate 4: North facing representative section of Trench 4 (scale 1m)

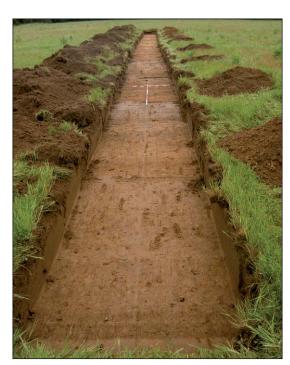
Plate 5: Trench 7 from the north-east

Trench	Dimensions :	34.90m by 1.40m by 0.40m	Gro	ound	26.55m
7	Coordinates (NGR):	501785.37, 153812.09 501760.05, 153789.38	sur lev	face el:	aOD
Context	Category	Description		Depth	ı (bgl)
701	Layer	Plough soil: Mid brown sandy loam with frequent inclusions of <0.05m gravel included throughout. Two sherds of medieval pottery.	l	0-0.40)m
702	Natural	Mid orangish brown gravelly sand with moderately frequent inclusions of <0.05 sized pieces of gravel. Lightens to a yellowish brown to the SW end of the trench with occasional gravel patches. N.B. Plough scars evident in the NE enof the trench. Running NESW on the same alignment as those in Trench 3.		0.40m	1+

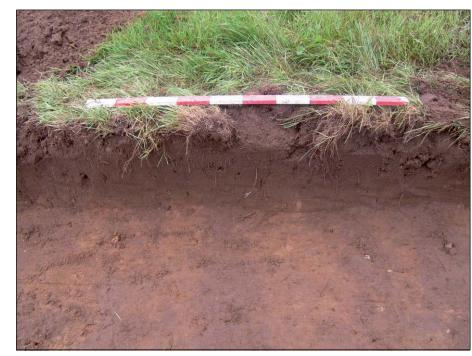
Plate 6: South-east facing representative section of Trench 7 (scale 1m)
