Cannington Court, Cannington Somerset

Archaeological Evaluation Report

Ref: 85500.03

June 2012

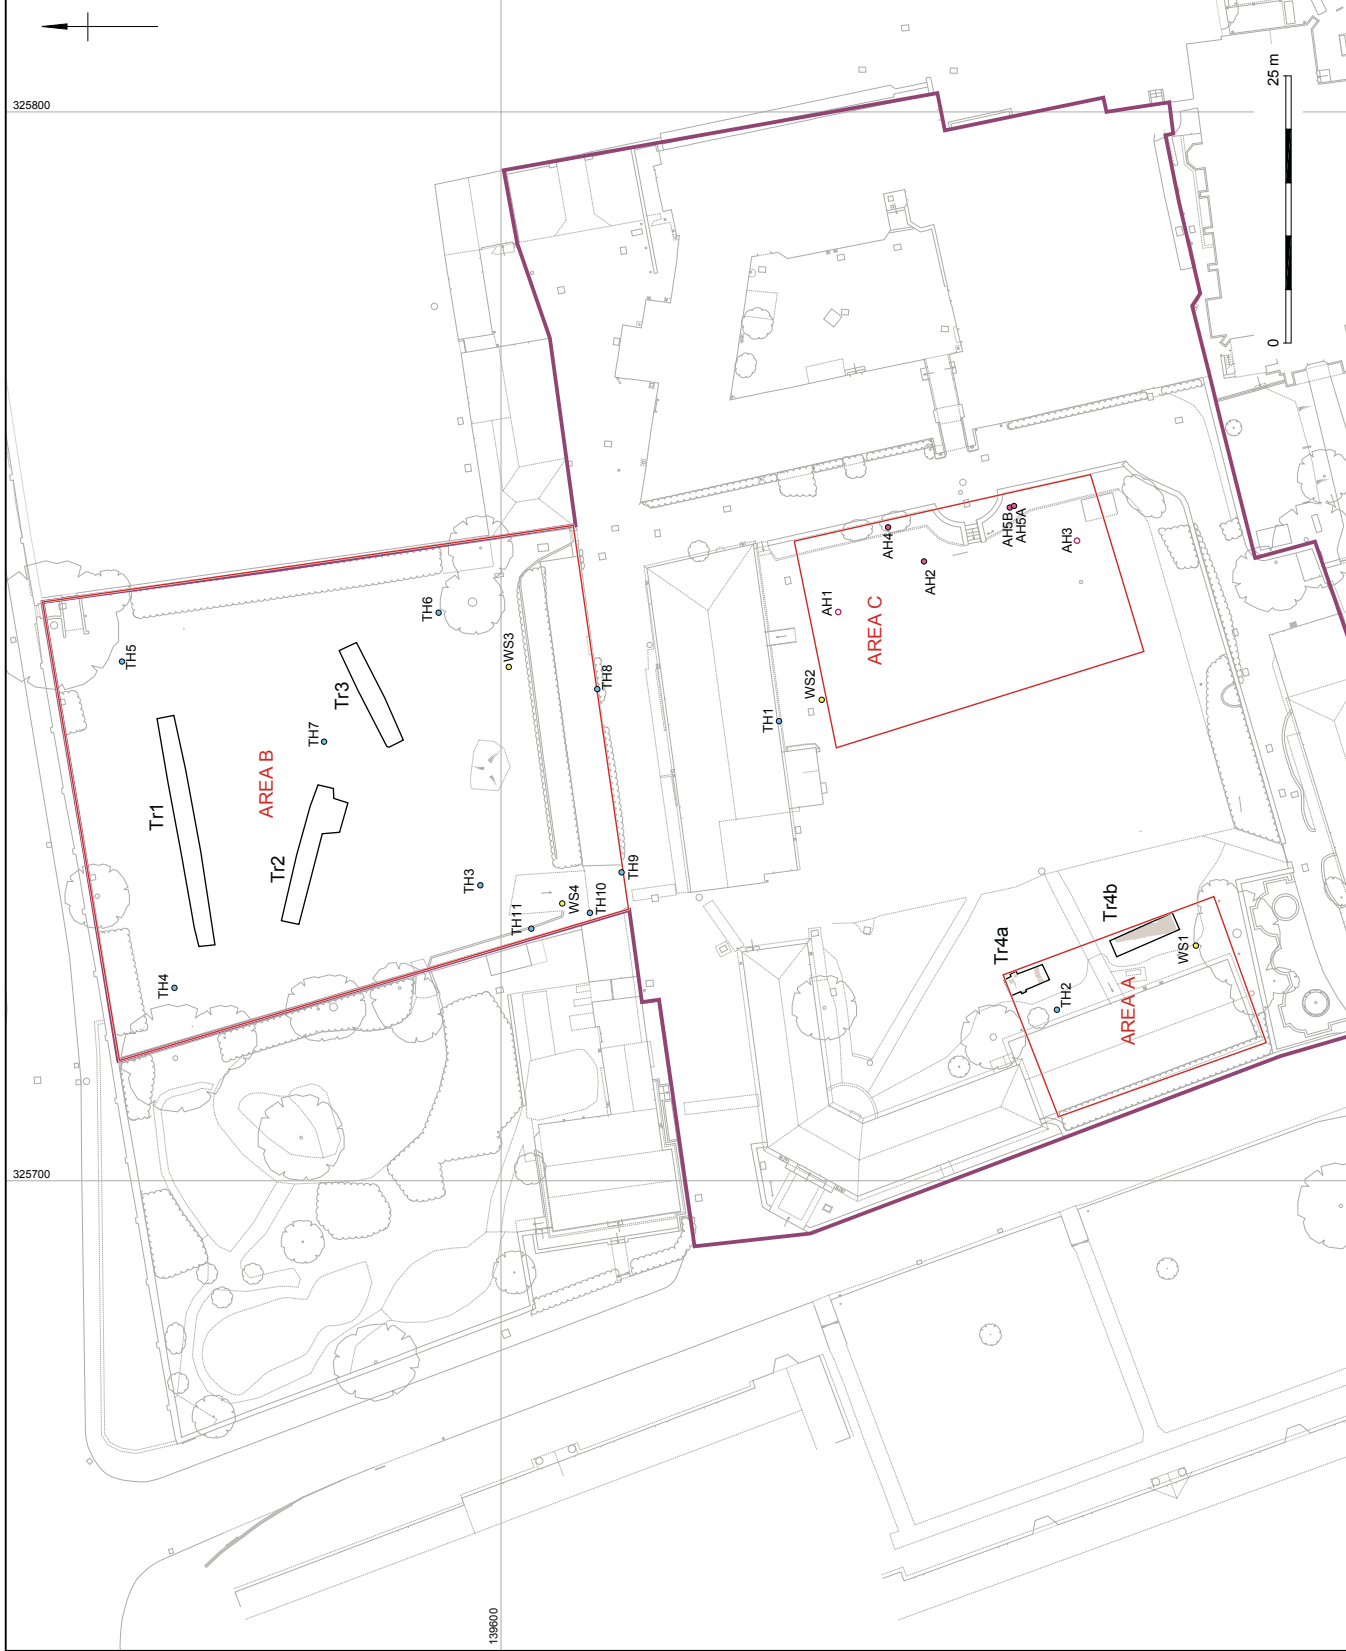
Figure 1

Site location plan showing archaeological works

- 4.4.2 Hand augers were used to define the depth of the modern overburden at three locations under and adjacent to the existing Courtyard Car Park (AH2, AH4 and AH5a/b). Auger holes AH1 and AH3 were not excavated due to difficult ground conditions (**Figure 1** and **Appendix 2**).

- 4.5.1 In addition to the archaeological evaluation a series of geotechnical test pits were conducted within Areas, A, B and C (located on **Figure 1**), these were all archaeologically monitored and the results, including the stratigraphic sequence, can be found in **Appendices 3** and **4**, and will not be repeated here.
- 4.5.2 No archaeological features or deposits were identified within any of the geotechnical test pits. The hand excavated test pits, including the CBR tests (TH1 to TH11) did not breach the made ground level anywhere within Areas, A, B or C.
- 4.5.3 The window sample tests (WS1 to WS4) reached natural deposits within Areas A, B and C.

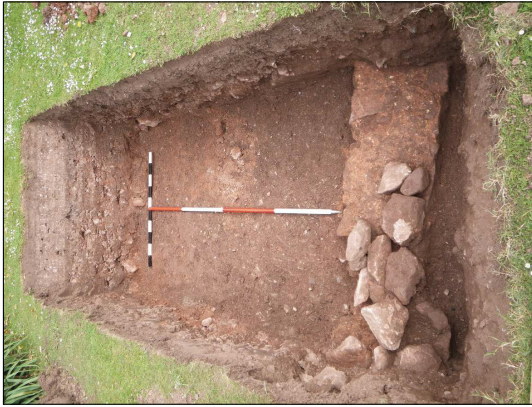
Plate 1: Overall shot of trench 4a from the southeast, showing wall 409 in the foreground, destruction debris layer 413 in the centre frame, and hints of walls 414, 415 and 416 around the northern end of the trench, these were later partially exposed by excavation

- 4.2.4 Structural remains were encountered within Trench TR4a at a depth of 0.60m Below Ground Level (BGL).
- 4.2.5 Trench TR4a (**Figure 2** and **Plate 1**) contained four walls (**409**, **414**, **415** and **416**), a possible remnant floor surface (**417**) and an underlying levelling layer (**418**) overlain by possible demolition deposits (**413**). These features were overlain by a sequence of made ground (**412**), modern topsoil (**411**) and turf line (**410**).
- 4.2.6 Wall **409** was situated in the southern end of the trench and was found to be 0.43m wide and extending in a broadly east-west direction. The wall appeared to be *in-situ*, but has mostly been 'robbed out' leaving only a few loose stone rubble elements of the upper structure and a fairly intact

- 4.2.7 The long eastern edge of northwest-southeast wall **414** was just visible in the western edge of the trench, as a possible line of loose sandstone rubble near the base of the excavated sequence. A small north-western extension of the trench revealed that the sandstone rubble was overlying a mortar foundation similar or identical in construction to wall **409**.

- 4.2.8 Walls **415** and **416** were identified in the north of the trench and extended beyond the defined trench area. Two further small trench extensions and a small sondage were excavated in the north-east corner of the trench to better characterise these features (**Figure 2** and **Plate 2**). Wall **415** was found to be extending in a parallel east-westerly direction to wall **409**, situated c.2.00m to the south. Wall **415** appears to turn through 90° to the south, or is joined by northwest-southeast wall **416** under the north-eastern bulk of the trench. Information retrieved from a small sondage excavated in the north-eastern corner of the trial trench would suggest that wall **415** and **416** are part of the same phase of construction, as no evidence of butting was observed, however this intervention was extremely limited and this relationship although considered likely is by no means proven.

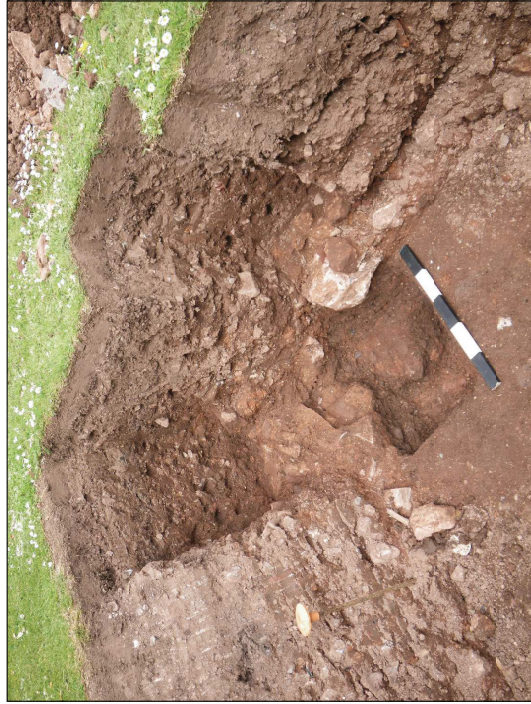
Plate 2: Wall 415 and 416 showing sondage containing possible remnant floor surface 417 and levelling layer 418, view from southwest

- 4.2.13 Within the north-eastern sondage a possible remnant floor surface (**417**) and an underlying levelling layer comprising sandstone rubble, and dark red clay (**418**) was found to be butting against the possible corner formed by walls

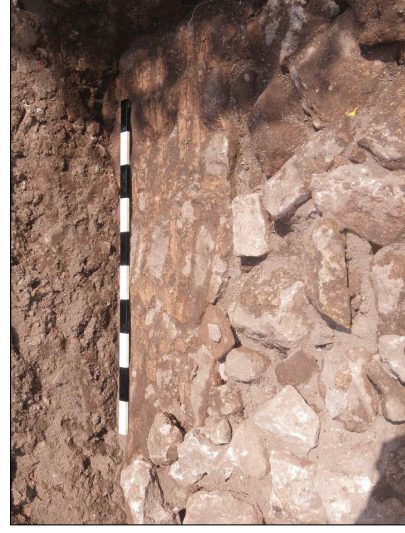
Plate 4: Floor surface 408 and wall 407 from the west - note tile fragment in the centre left of frame

| 408 | Mortar and Stone Surface – Pale yellow-grey mortar surface which was roughly ridged with a trowel or float, presumably a mortar and stone underlay for a possible tiled(?) floor surface, the deliberate ridging seemingly intended to allow the secure fixing of hard floor tiles, the mortar and stone surface appeared to soft to function as a floor surface alone. A single floor tile was also retrieved from wall 407 . Observed only in the south-eastern corner of the trench. Appears to be built up against wall 407 . | 0.56→ |

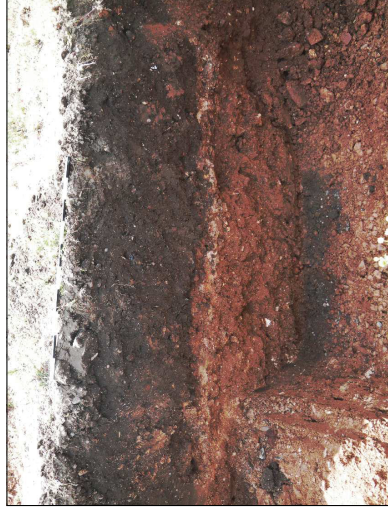
Plate 5: Trench 1 representative section

- 4.3.4 No significant archaeological features or deposits were observed within trench TR1. However, a considerable depth of made ground was identified up to a depth of 1.55m BGL, where natural geology, comprising angular red-brown sandstone gravels and cobbles was encountered. Three distinct layers of made ground were identified with the trench (**101, 102 and 103**), each contained quantities of fractured CBM rubble, slag and coal.

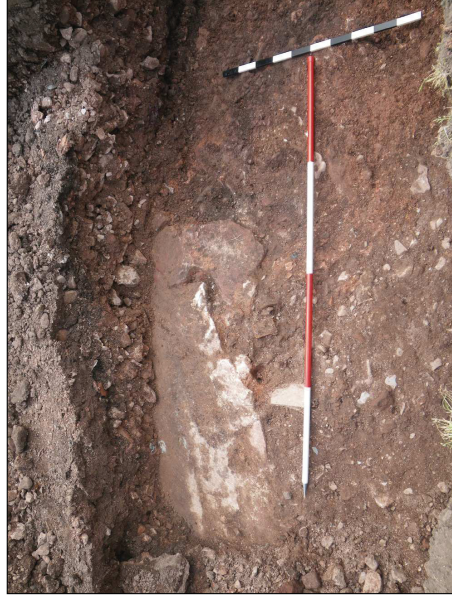
Plate 6: Modern features 201 and 202 in trench 2, showing overlying modern made ground

- 4.3.6 A compact mortar deposit (**201**) was identified in the north-west end of the trench at a depth of 0.94m BGL (**Figure 3, section** and **Plate 6**). Because of the loose and friable nature of the overlying made ground (**205**), trench TR2 was extended and stepped in this area to facilitate the safe investigation of this feature. Underlying mortar deposit **201** were a series of levelling layers (**202, 203** and **204**), and located securely with the middle levelling layer (**203**) was a modern factory made teapot spout, distinctively shaped like the heads and neck of a bird, possibly a peacock. The function of deposit **201** is not clear, the feature was observed in a previously damaged state which made positive identification difficult, this damage presumably occurred when the area was built up. In addition, nothing which would positively identify surface **201** is depicted on the historical mapping (see section 4.6 below), however, the 1st edition Ordnance Survey mapping of 1884 does depict a clearly defined pathway extending east-west across this area and the 1841 tithe map of Cannington depicts a well defined rectilinear pond (tithe number 756; Ross and Foyle, 2012), which appears to have been filled in before the 1884 survey. It would therefore seem feasible that deposit **201** may relate, to an element of this pond.

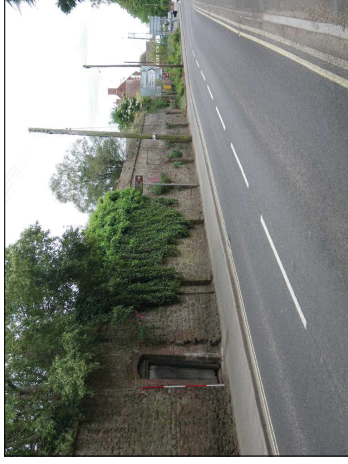
Plate 7: The northern (precinct) wall north of Area B (Former Tennis Court) showing the relative height of the present road/pavement surface of Fore Street, and the northeast gate leading into Area B from the road (note 2m scale).

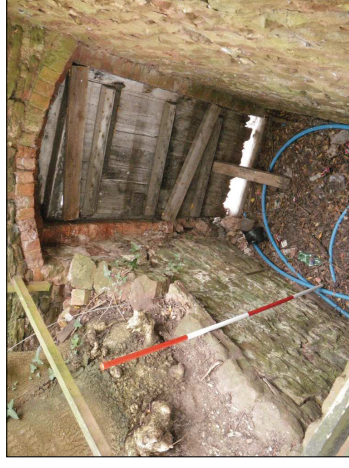
Plate 8: The internal side of the north-eastern gate depicted in Plate 7. Note the depth of made ground against the internal side of the precinct wall (note 2m scale).

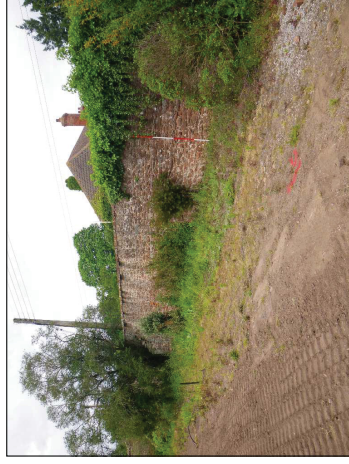
Plate 9: The internal side of the northern precinct wall from Area B, just to the west of the north-eastern gate depicted in Plate 8 (note 2m scale).
