Archaeological Watching Brief Statement of Results

Scheduled Monument No. 25655

LILLA HOWE, FYLINGDALES, NORTH YORK MOORS, SCHEDULED MONUMENT NO. 25655

Report reference: 78781.01

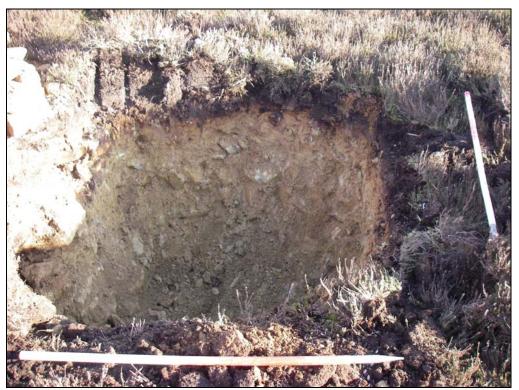
Plate 1: Borrow pit 3, view from northwest

Fourteen borrow pits were excavated outside the scheduled area, six to the south, one to the north, three to the west and one to the east of the monument (**Figure 1**). The pits averaged 1m x 1.2m and were on average 1m deep (**Plate 1**). The stratigraphy was largely consistent within all pits; the natural geology consisted of dark yellow sand with moderate medium to large stones and frequent small stones which lay below 0.1-0.2m of peat. In some pits grey clay was also revealed underlying the sand. No archaeological deposits or features were identified in any of the pits. The material recovered from the pits was used to create the path across the monument (**Front Cover, Back Cover, Plate 2-4**).

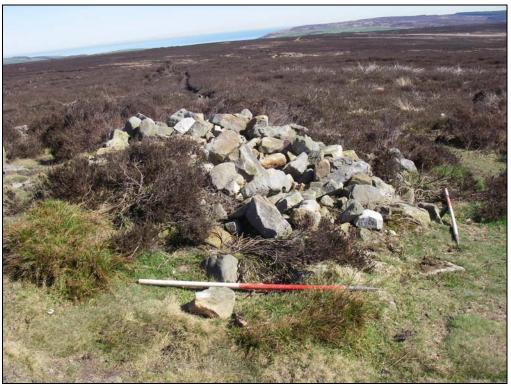
Plate 5: Southern cairn, view from north

Two walkers cairns, one at the south side of the monument (**Plate 5-6**), the other at the north (**Plate 7-8**) were both dismantled and the stones were reused in the path construction (**Back Cover**). Each stone was visually examined to check for the presence of prehistoric rock art. No rock art was identified on any on the stones.
