Project Allenby / Connaught, Bulford, Wiltshire

Archaeological Evaluation Report

Report reference: 56252. 04

June 2008

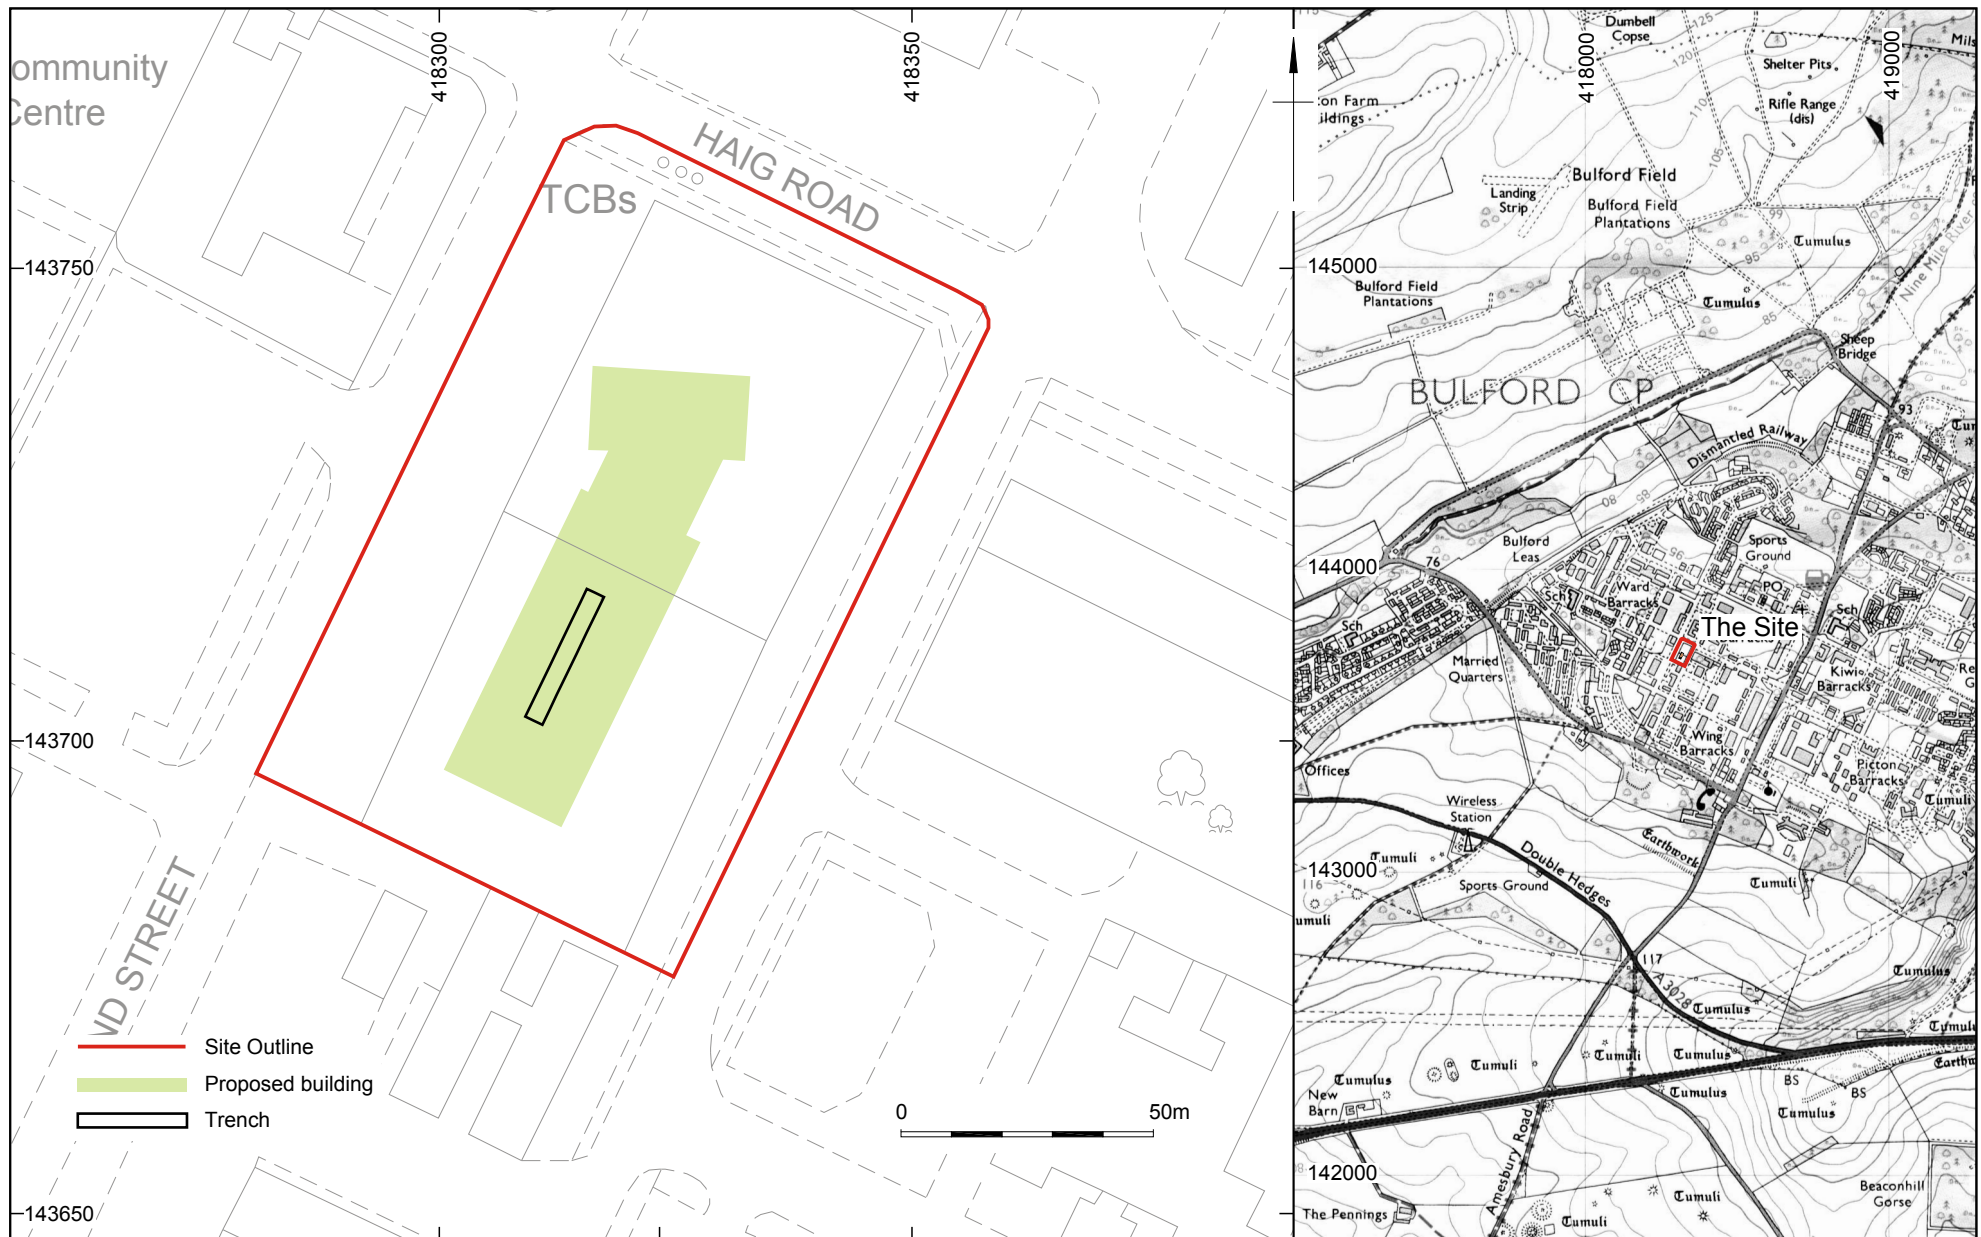
Figure 1

Site and trench location plan

1.1.1 Wessex Archaeology was commissioned by Aspire Defence Capital Works (the Client) to undertake an archaeological evaluation in support of an application for planning permission (S/2008/0725) for the construction of a new building comprising a two storey training classroom wing and a single storey lecture theatre (hereafter the Site, see **Figure 1**).

- 5.1.2 A single trial trench orientated north-east to south-west was excavated within the proposed development footprint by a JCB mechanical excavator using a toothless bucket and under constant archaeological supervision (**Figure 1**). Machine excavation proceeded to the top of the archaeological levels, or the top of natural deposits, whichever was the higher.

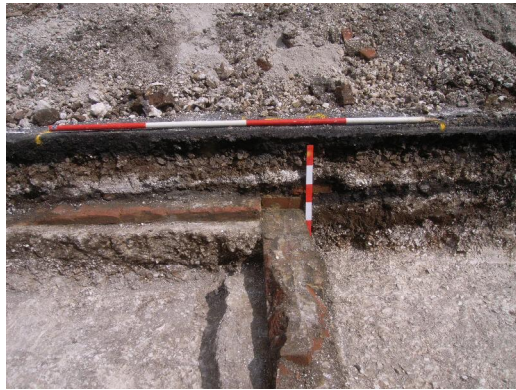
Walls 111 and 114 from north-west

- 6.1.4 Two modern walls were recorded in the north-eastern half of the trench which probably represent the south-eastern corner of a building. A single course of frogged bricks (111) bonded with a sandy mortar and set on a foundation of concrete (113) was recorded at the north-eastern end of the trench. The wall and foundation extended along the eastern side of the trench for c.7.50m. To the south-west wall (111) was observed to overlie (114), a modern wall oriented north-west to south-east comprising two rows of frogged bricks bonded with a sandy mortar and set on a foundation of concrete (115). Wall (111) was sealed by modern overburden deposits (110), (114) and (112).

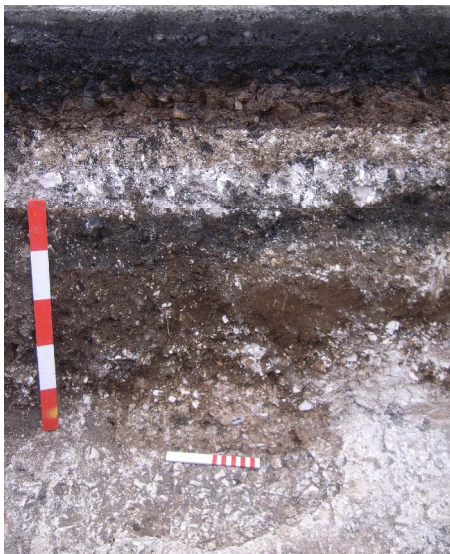
Pit 104 from south-east

- 6.1.6 Pit [104] protruded from the north-western edge of the trench and measured 0.57m wide and 0.13m deep with a flat base, its sides were steep to almost vertical on the north-eastern side and shallowed out to a gentle slope on the south-western side. The fill (101), a dark brown chalky silty, sand loam produced a single sherd of Late Bronze Age / Early Iron Age pottery.

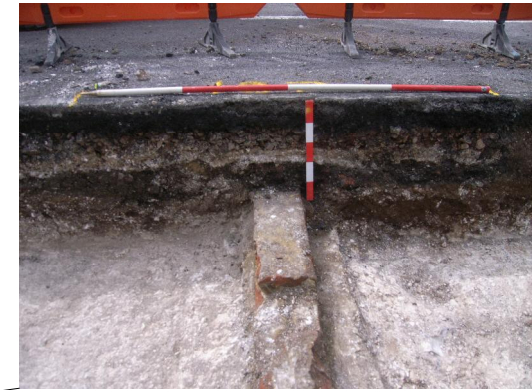
Wall 114 from south-east
