Project Allenby/Connaught Travers Barracks Aldershot Military Town, Hampshire

Archaeological Watching Brief Report

ASSET TRO 602 ARCHAEOLOGICAL WATCHING BRIEF REPORT

Report reference: 56255.07

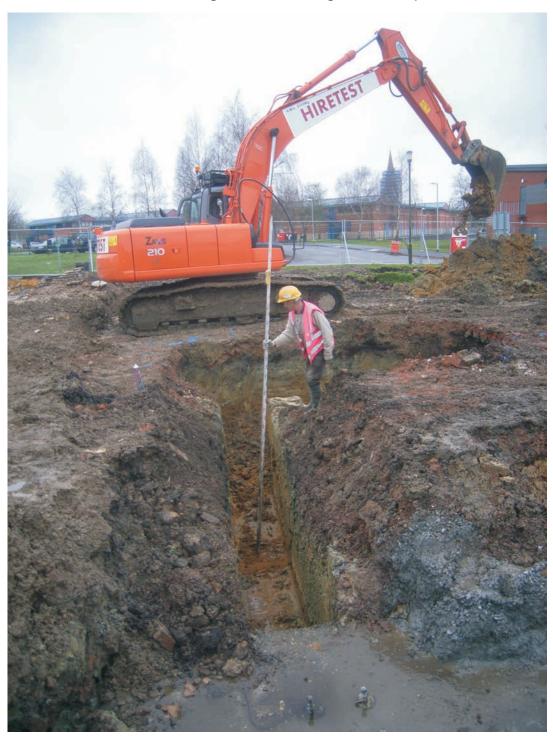
| 1 | INTRODUCTION1 | | | | | |
|---|---|---|---|--|--|--|
| Front cover | | er Excavation of southern strip footing | Excavation of southern strip footing | | | |

- 5.3.1 This area had suffered less truncation than the Southern Area from the former use of the Site, as the majority of it was a former car park. The strip footings in this area were excavated to over 2m deep, and a greater amount of the soil profile was observable in section (see **Plates 2 and 3**). A complete profile for the northern portion of the eastern footing was not observed, as the concrete had already been poured. The natural ground surface slopes from south to north, and the northern portion of the former car park had been made up to level off the area. The southern 9m of the strip footings had been subjected to a greater degree of truncation, as the former building had extended into this area (**Front Cover**).

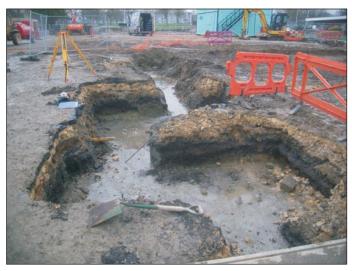
Plate 1: View of strip footings from the north

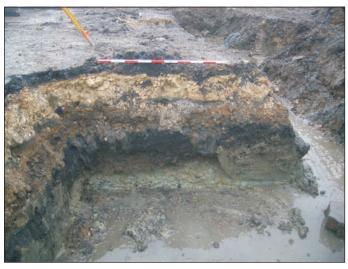
- 5.3.2 The upper 0.50m of the soil profile consisted of a tarmacadam surface **100**, which overlaid make up layer **101**, light brownish yellow sub-angular sandstone hardcore, within a coarse sand matrix, which in turn sealed make up layer **102**, a very mixed deposit of dark to mid brownish grey coarse sand with 40% well sorted rounded flint gravel, with occasional modern brick and ceramic building material inclusions.

- 5.3.3 The modern made ground overlaid a series of natural water lain deposits, including 103, a very dark greyish brown silty sand, with occasional bands of well rounded sorted flint gravel, with lighter grey laminations present towards the top of this deposit. This sealed 104, a mid reddish grey brown silty sand with occasional rounded flint gravel inclusions, which in turn sealed 105, a mottled light bluish green clayey sand. It is likely that these three deposits relate to either localised alluvial deposition within a low-lying boggy area, or alternatively alluvial deposition of the floodplain itself. The darker colours of 103 and 104, are probably due to decayed organic components within these deposits.

- 5.3.4 At the bottom of the sequence, and observable to a depth of over two metres was **106**, a heavy, mottled light green, changing to orangey brown deeper down, sandy clay, which is probably alluvial in origin, and relates to the formation of the floodplain.

Plate 2: North facing section of strip footing

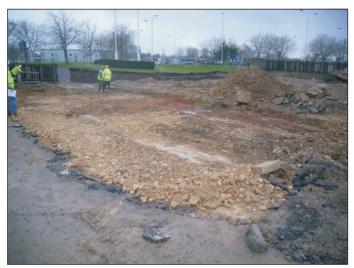
The natural geology was only revealed in a very small area in the south, in the terraced area immediately to the north of the existing roundabout. It consisted of well sorted, rounded flint gravel, pea grit and coarse sand, and is water lain in origin. This was overlain by modern made ground, which also indicates that the area had been landscaped in the past, as there was no buried topsoil or subsoil present. The formation level of the car park did not reach the natural geology over the majority of the area, with only made ground present (see **Plate 3**).

Plate 3: View of Southern Area from the north east
