St Michael's Church Heckfield, Hampshire

Archaeological Watching Brief Report

July 2012

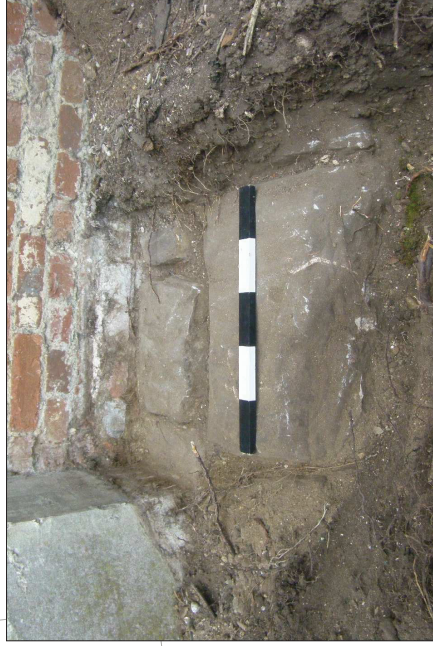
Plate 1: Threshold 103, view from west

- 3.2.2 The service trench (**Figure 2**) was excavated adjacent to the blocked west door. At this initial starting point, several stone blocks were found (**103**) which were interpreted as being the remnants of the original door threshold (**Figure 2, Plate 1**). Two stones were necessarily moved to allow access for the pipe but the rest were left *in situ*. Further stones could be seen beneath the excavated depth.

- 5.1.3 The stonework **103**, seen at the base of the now blocked west door is likely to be the original threshold. The use of roughly shaped stone suggest that this may relate to the construction of the tower in the early 16th century rather than to the 18th century when much of the tower was rebuilt using brick (Page 1911, 44-51). A brick structure (**6002**) seen in Test Pit 6 adjacent to the north wall of the tower is likely to be related to the Victorian boiler-house.

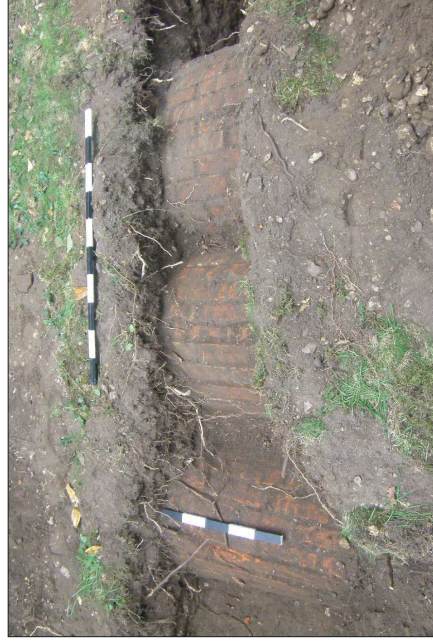
Plate 2: Brick capping 105, 106 and 107, view from east

- 3.2.5 Three further similar brick 'vaulted caps' were located approximately 2m to the south of **102**, comprising **105**, **106**, and **107** (**Figure 2, Plate 2**). These were similarly east – west aligned and were immediately adjacent to each other. The close proximity of these three, strongly suggests they are a family group. The style and dimension of the bricks used for all four 'vaulted caps' were closely comparable indicating that they are all 18th or early 19th century. Although no markers were *in situ* for **105**, **106**, and **107** there are a number of obviously relocated gravestones against the churchyard wall in this part of the graveyard. A section of all four 'vaulted caps' had to be removed to allow access for the pipe, this was done by hand with the intention of replacing the bricks during the backfilling and reinstatement.

105	<i>Structure</i>	Slightly arched brick cap for grave. Red brick arch (bricks 0.23x0.10x0.07, some arch bricks). 0.7m wide. Pale grey-white/yellow-white lime mortar. Rectangular, east – west aligned. Close proximity to 106 and 107 suggest family group.	0.25 high
106	<i>Structure</i>	Slightly arched brick cap for grave. Red brick arch (bricks 0.23x0.10x0.07, some arch bricks). 0.7m wide. Pale grey-white/yellow-white lime mortar. Rectangular, east – west aligned. Close proximity to 105 and 107 suggest family group.	0.25 high
107	<i>Structure</i>	Slightly arched brick cap for grave. Red brick arch (bricks 0.23x0.10x0.07, some arch bricks). 0.7m wide. Pale grey-white/yellow-white lime mortar. Rectangular, east – west aligned. Close proximity to 105 and 106 suggest family group.	0.25 high
108	<i>Bone group</i>	Skull situated face down, 2 or 3 disarticulated vertebrae and a ?tibia. Approximately 0.8m below structure 107. Bone group disturbed by grave diggers excavating later graves.	1.00+ bgl

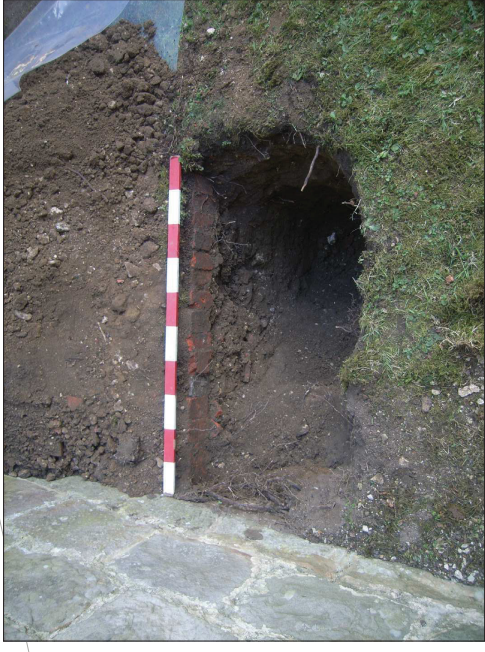
Plate 6: Structure 6002, view from east

- 3.2.15 Nothing structural was encountered within Test Pit 5, which lay just to the west of the path.
- 3.2.16 The final monitored test pit was situated adjacent to the north wall of the west tower. Beneath a very shallow depth of topsoil the edge of a brick floor or edging **6002** was visible in the east facing section of the test pit (**Figure 3, Plate 6**). This was thought to be related to a Victorian boiler-house that was once situated in this area.

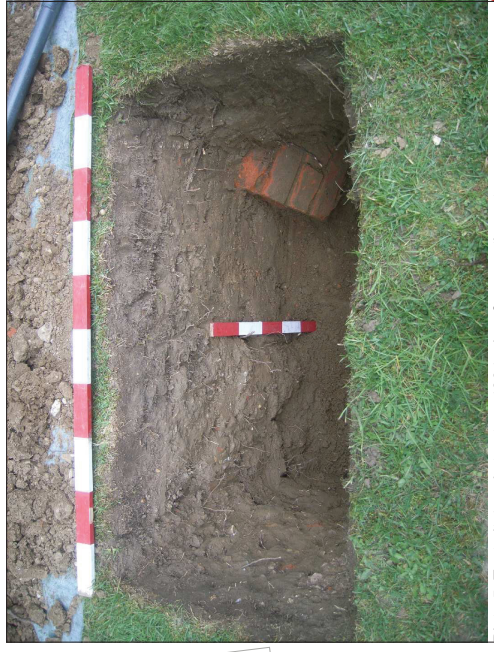
Plate 5: Test pit 4 and structure 4004, view from south-east

- 3.2.14 A small proportion of a brick built structure **4004** was visible in the north-east corner of Test Pit 4 (**Figure 3, Plate 5**). This structure is likely to be the south-east of corner of a 'vaulted cap' similar to **102**, **105**, **106** and **107**, seen on the south side of the church. A variation in the graveyard soil **4003** seen within the lower part of the test pit may indicate a less disturbed deposit and proximity to undisturbed natural geology.

TEST PIT 4			
Length: 0.90m		Width: 0.45m	Max. depth: 0.80m
Context	Description		Depth (m)
4001	<i>Topsoil</i>	Modern topsoil. Mid grey-black silty clay. 2% gravel, sub-angular, <1-4cm. Homogeneous. Bioturbated. Humic. Overlies 4002.	0.00-0.15 bgl
4002	<i>Layer</i>	Graveyard soil. Mid grey-brown sandy clay. 5% gravel, sub-rounded – sub-angular, <1-4cm. Fairly loose and friable. Humic. Overlies 4003.	0.15-0.50 bgl
4003	<i>Layer</i>	Mid orange-brown sandy clay loam. 5% gravel, sub-rounded – sub-angular, <1-8cm.	0.50-0.80+ bgl
4004	<i>Structure</i>	Likely part of arched brick cap for grave (red bricks 0.23x0.11x0.07). Pale yellow-white sandy lime mortar.	0.40-0.60 bgl

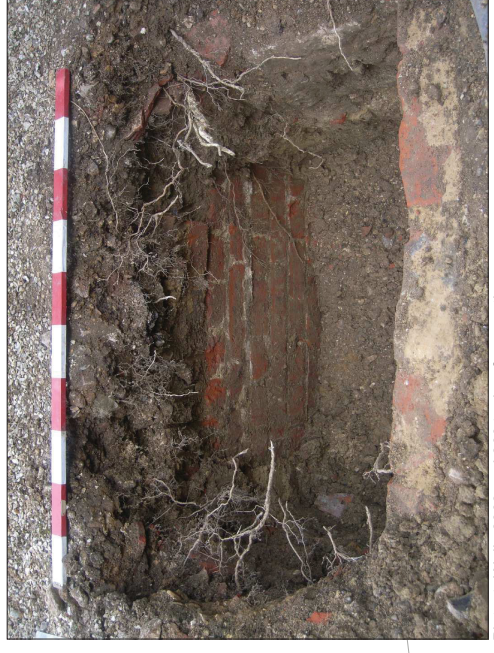
Plate 4: Walls 3003 and 3004, view from north

- 3.2.13 Test Pit 3, which was also through the path, encountered two brick built walls, **3003** and **3004**, either side of the test pit (**Figure 3, Plate 4**). These are mostly likely either side of a brick lined tomb (though they could conceivably be the walls of two adjacent tombs). The mortar and bricks are similar to those seen in the structures to the south of the church, suggesting a post-medieval date.

TEST PIT 3			
Length: 1.0m		Width: 0.6m	Max. depth: 0.80m
Context	Description		Depth (m)
3001	<i>Made ground</i>	Made ground/surfacing for path. Fine gravel underlain by CBM fragments and hardcore. Overlies 3002.	0.00-0.18 bgl
3002	<i>Layer</i>	Graveyard soil. Mid grey-brown sandy clay. 5% gravel, sub-rounded – sub-angular, <1-7cm. Fairly loose and friable. Humic.	0.18-0.80+ bgl
3003	<i>Structure</i>	Brick built wall, part of brick lined vault (red brick, 0.23x0.10x0.10). 6 courses exposed. Pale yellow sandy lime mortar. East – west aligned, possibly associated with 3004.	0.05-0.50+ bgl
3004	<i>Structure</i>	Brick built wall, part of brick lined vault (red brick, 0.23x0.10x0.10). 6 courses exposed. Pale yellow sandy lime mortar. East – west aligned, possibly associated with 3004.	0.30-0.80+ bgl
