44–50 Bedwin Street Salisbury, Wiltshire

Archaeological Trial Trench Evaluation Report

Report reference: 859701.03
Path: x:\projects\85970\report\85970_eval_report_v0.4.doc

October 2012

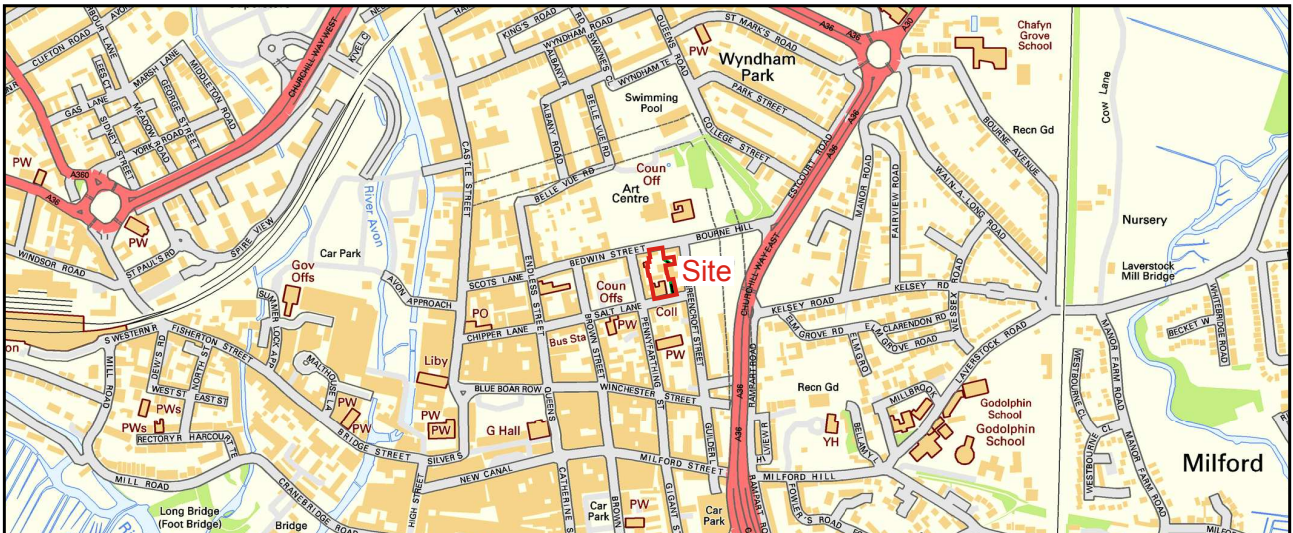
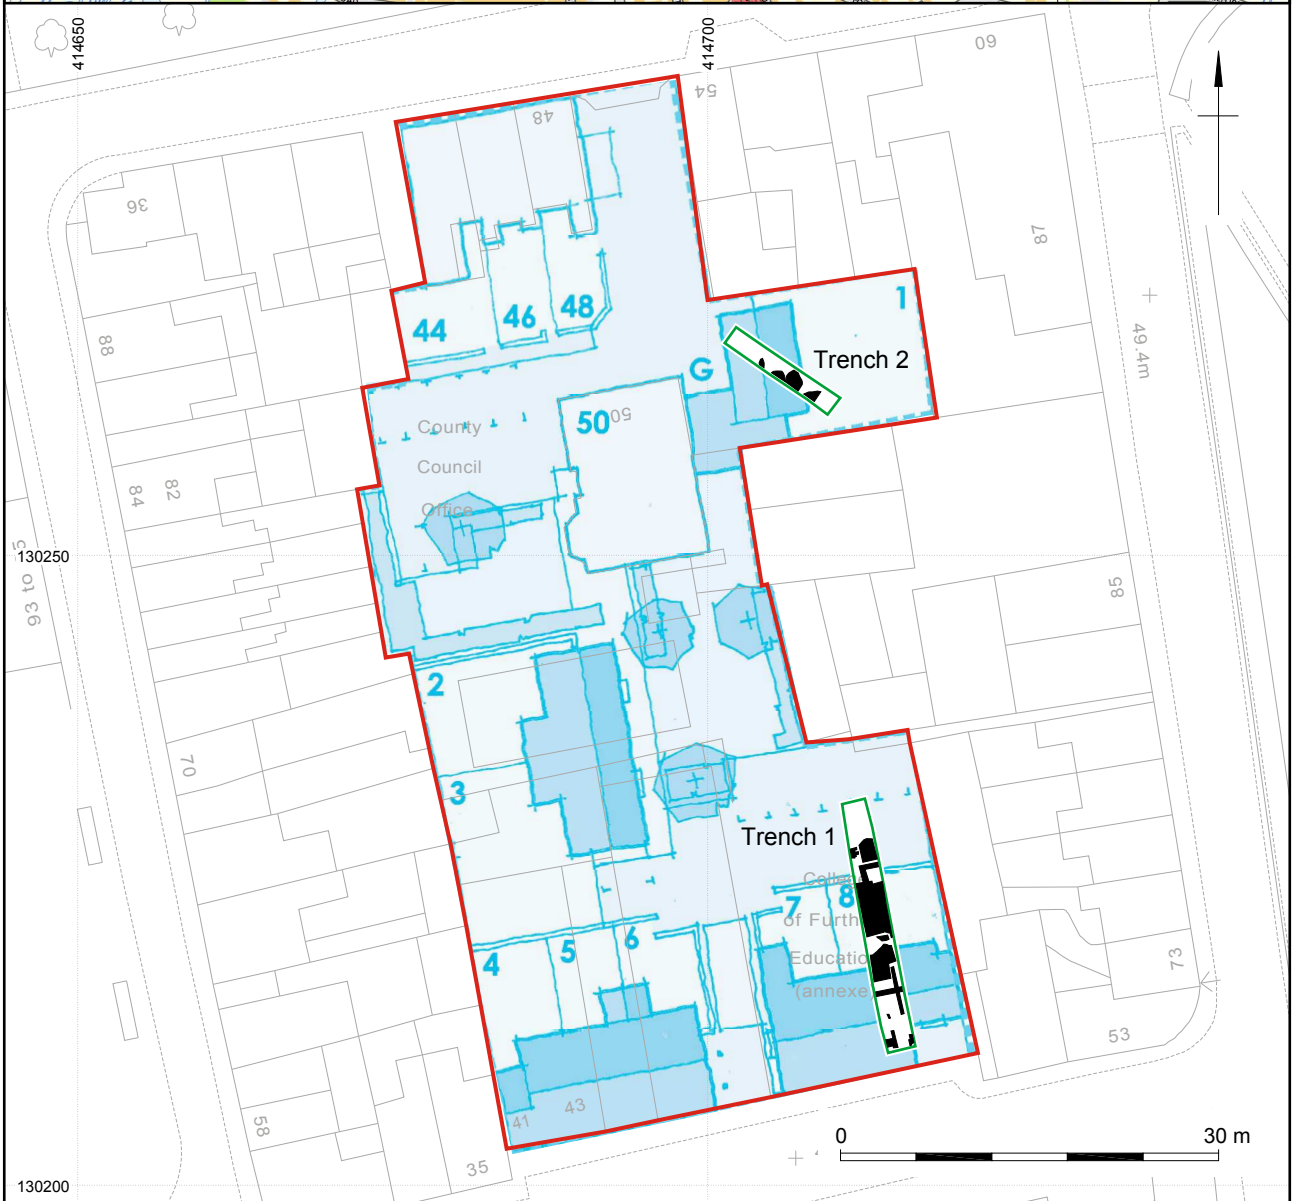
Figure 1

Site and trench location plan

3.1.1 The evaluation was carried out in accordance with the Written Scheme of Investigation (Wessex Archaeology 2012). The evaluation comprised the excavation of two evaluation trenches within the Site, measuring 20m by 2m and 10m by 1.50m (**Figure 1**).

4.1.2 In total, two trial trenches were excavated and recorded during the course of the field evaluation (**Figure 1**). Trench 1 was located towards the southern boundary of the Site and measured 20m by 2m. Trench 2, located in the north-eastern corner of the Site in an area of old car park, measured 10m by 1.5m.

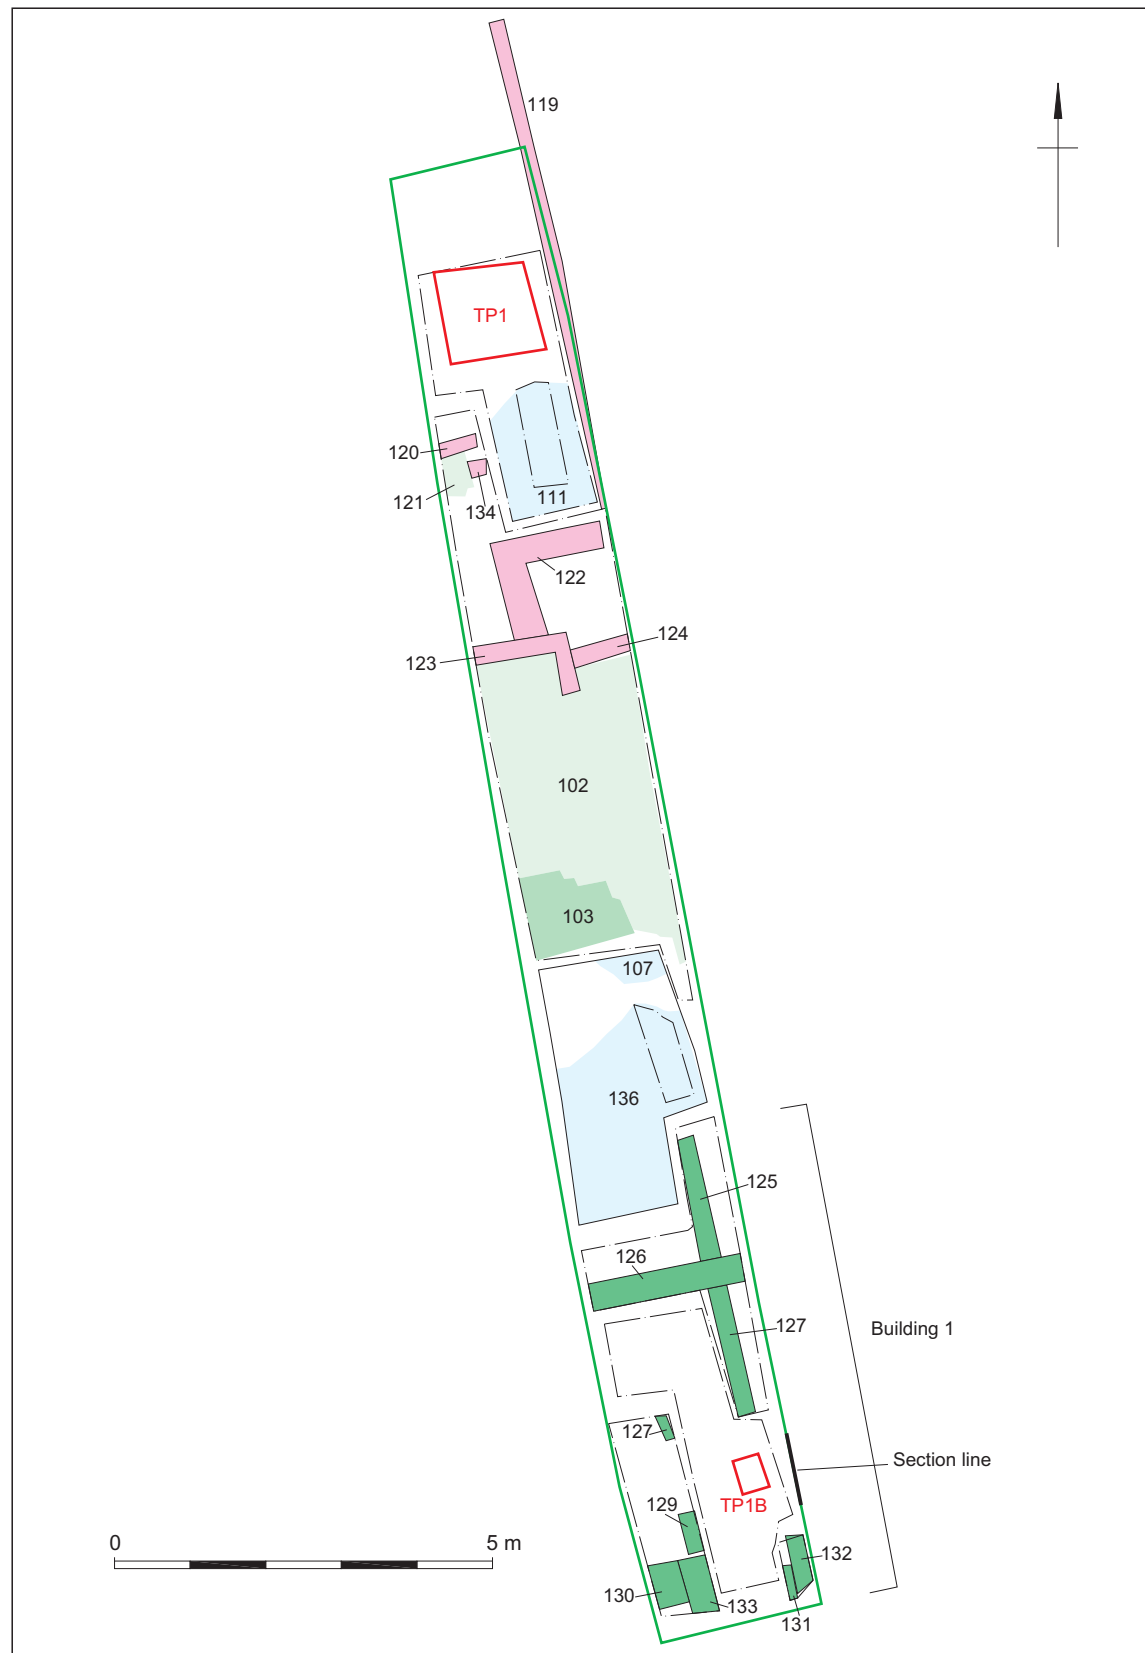
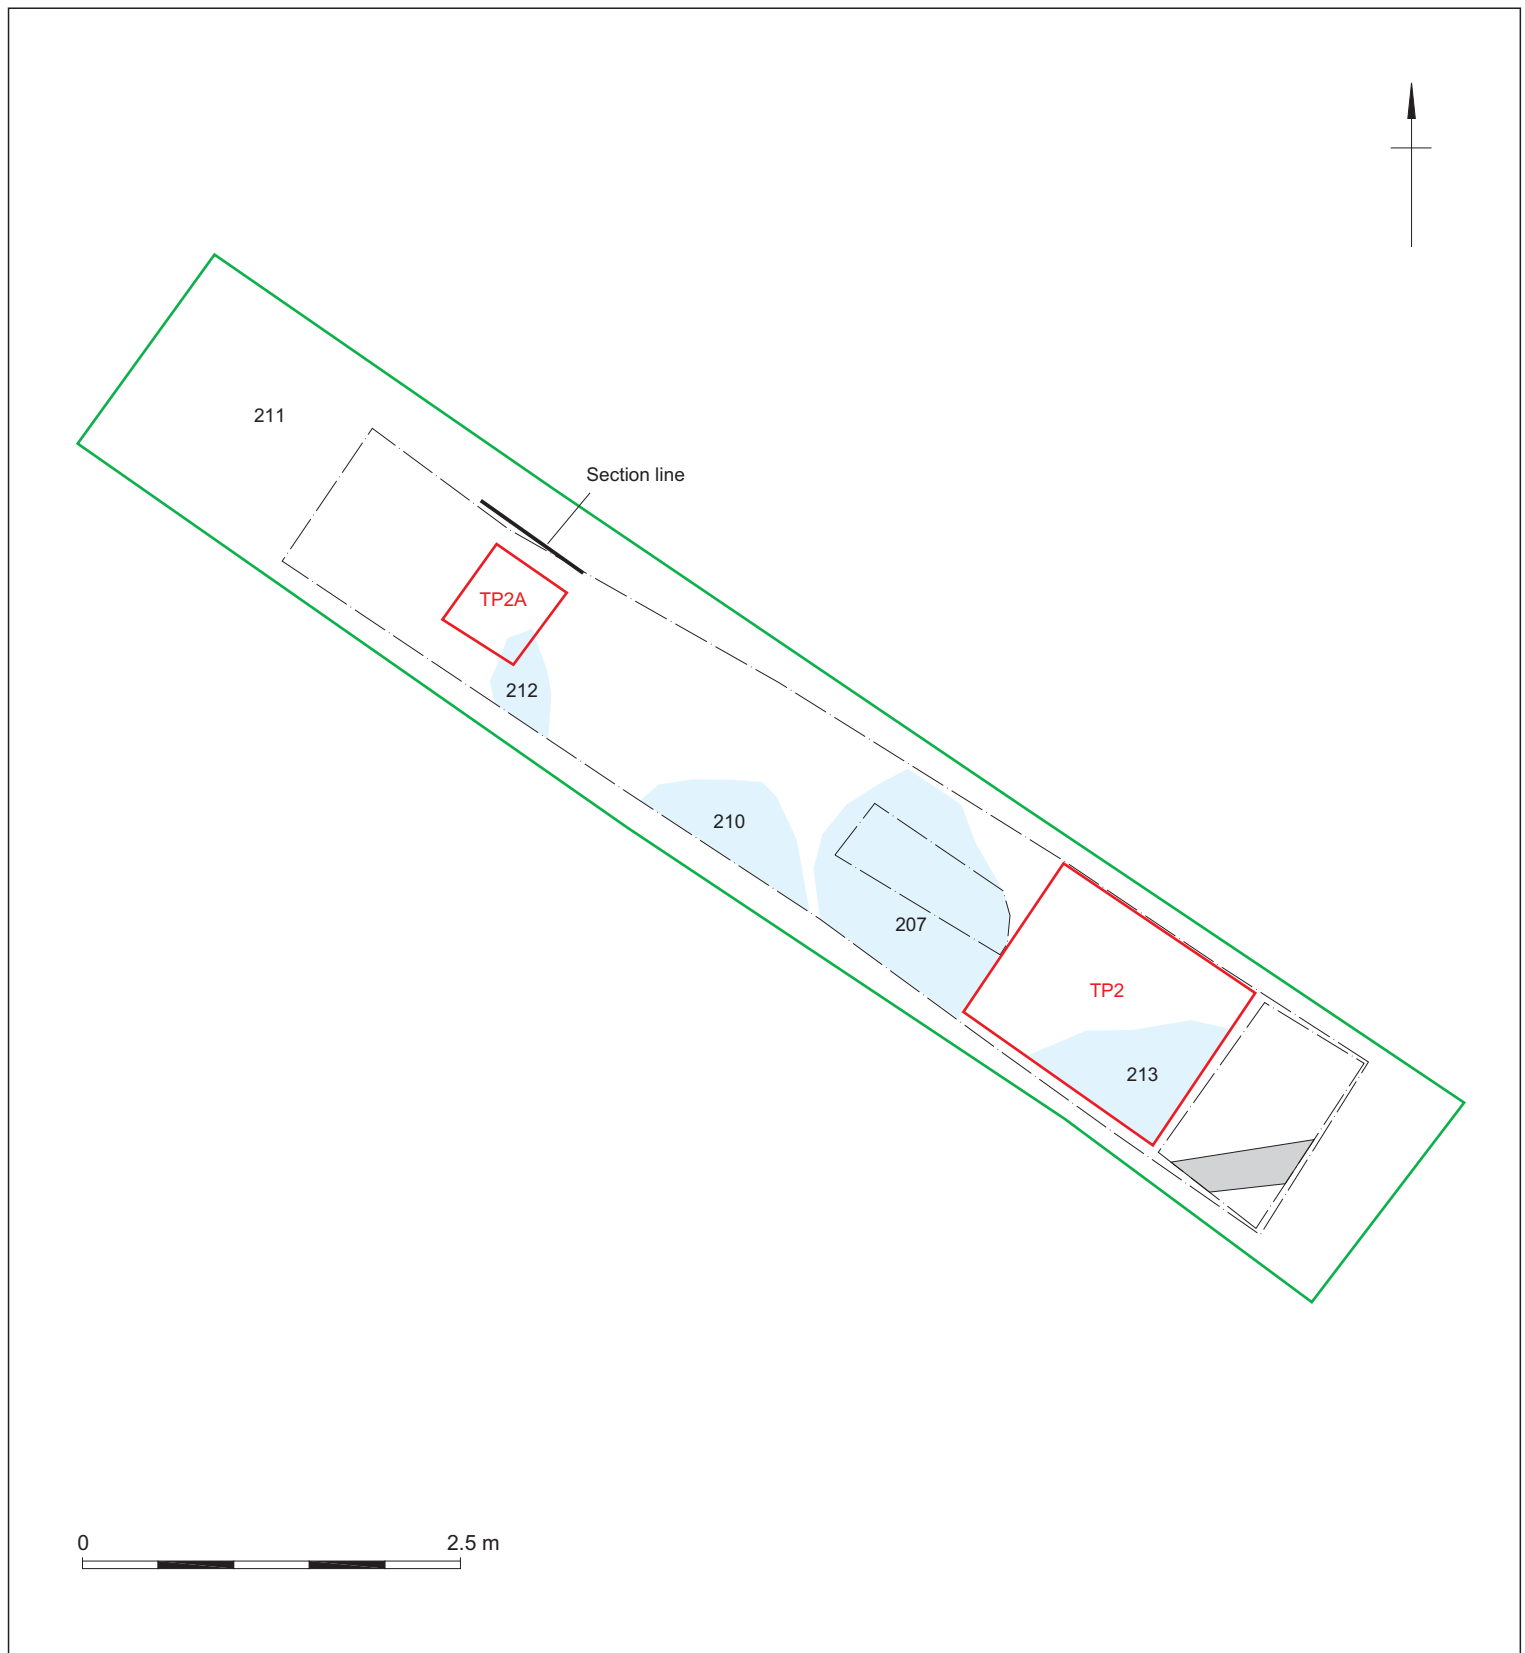
Figure 2

Trench 1

Trench 2

Detail of trenches 1 and 2

4.2.1 Trench 1 was located towards the southern boundary of the Site and was excavated in an area of hard-standing, which had previously formed a car park (**Figure 2; Figure 3, Plate 1**). The trench was aligned approximately north to south and measured 20m by 2m.

4.3.2 Due to the depth of the overlying garden soils and made ground, natural deposits were only observed within a machine excavated test pit and a hand dug test pit at either end of the trench (**Figure 2**). The underlying natural was mid reddish-brown clay loam with common flint gravel inclusions. The natural was recorded at a depth of 1.3m BGL at the north-western end of the trench and sloped down gradually to 1.4m BGL at the south-eastern end of the trench.

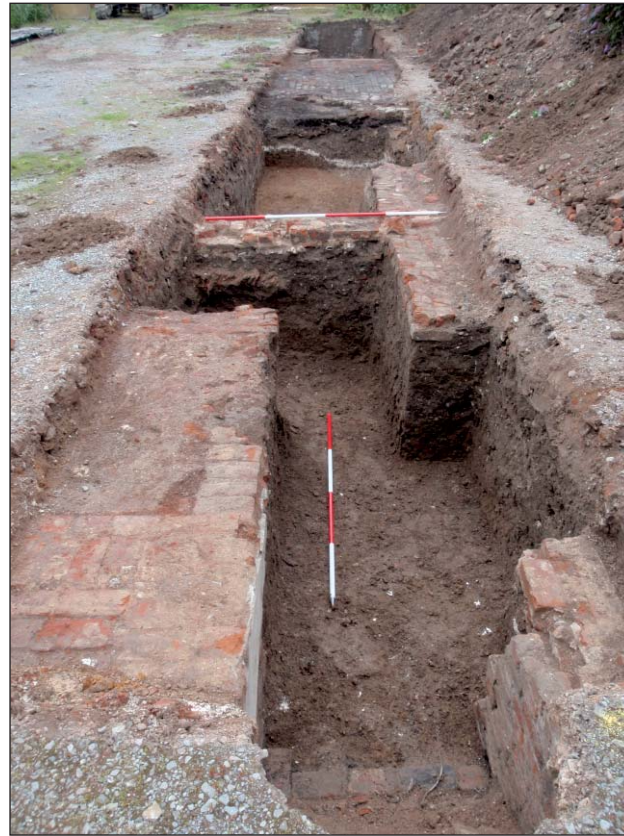
Plate 1: General view of Trench 1 from south

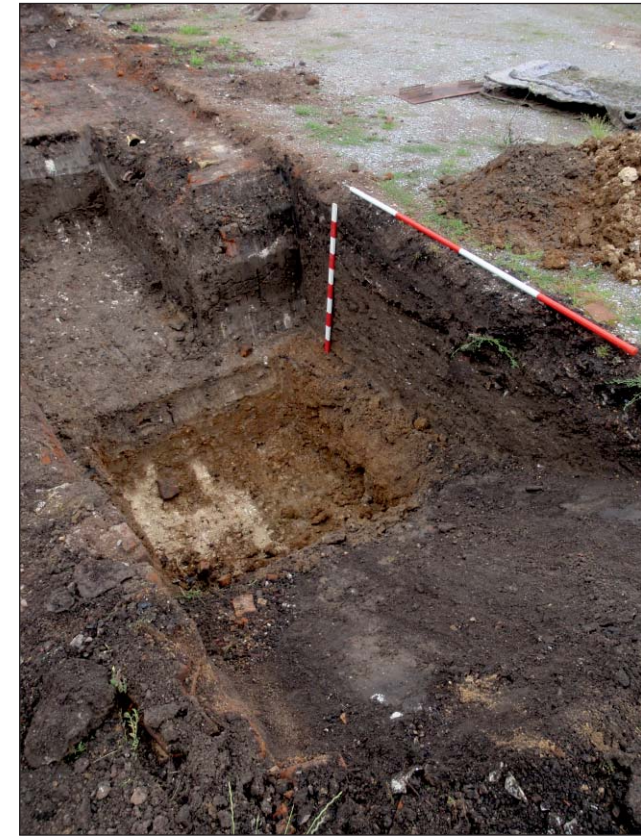
Plate 2: East facing section of sondage at northern end of Trench 1 showing overburden and natural geology, view from north-east

4.2.2 Due to the depth of the overlying archaeological deposits, it was not possible to expose natural geology across the base of the trench. A machine excavated test pit investigating the natural geology was dug at the northern end of the trench to a maximum depth of 1.5m BGL (**Figure 3, Plate 2**). A small hand dug test pit, measuring 0.50m by 0.50m, was excavated at the southern end of the trench up to 1.80m BGL, but natural geology was not encountered in this sondage.

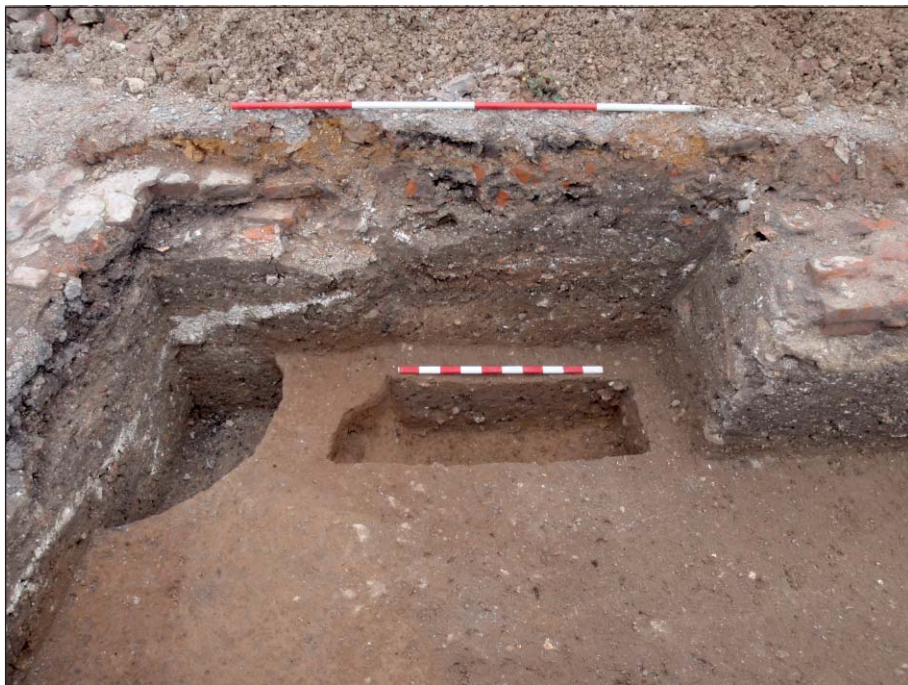
Plate 3: Pits 107 (left) and 136 (right) viewed from the west

- 4.2.6 Pit **136** was partially exposed in the central part of Trench 1 (**Figure 3, Plate 3**). The exposed dimensions of the pit measured 2.74m by 1.85m and the feature was up to 0.70m deep. Natural river terrace gravel was recorded in the base of the feature. The pit contained two deliberate backfills of domestic rubbish and animal bone, medieval tile fragments and a piece of slag were recovered from the upper fill **137**. Pit **136** is thought to have been sealed by soil horizon **109**.

- 4.2.7 Located immediately to the north of pit **136** was sub-circular pit **107**. Pit **107** (**Figure 3, Plate 3**) was partially exposed within the trench and was characterised by steep, slightly undercut sides. It measured 0.9m by 0.45m and was excavated to a depth of 0.6m. Due to health and safety concerns, it was not possible to fully excavate the feature, and although the section was stepped, the hand excavation ceased at 1.4m BGL. Pit **107** contained a single fill (**108**), a mixed mid grey-brown, gritty silty-clay, which contained tile, animal bone Laverstock-type coarseware pottery of the 13th or early 14th century and a perforated whetstone.

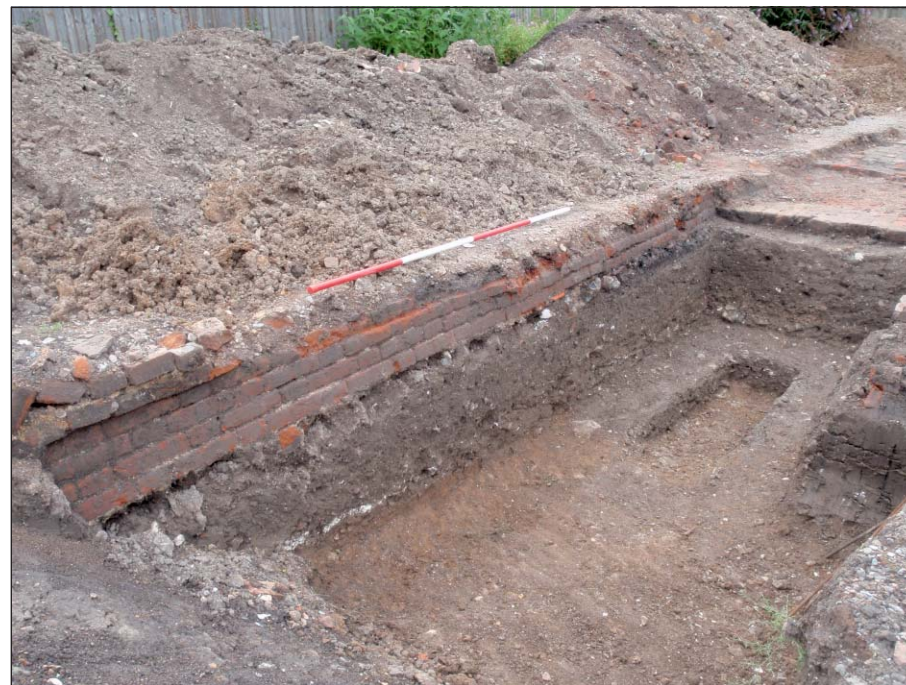
Plate 4: Wall 119, view from north-west

(5.1m by 0.36m and up to 0.42m in height, **Figure 2; Figure 3, Plate 4**). The wall was aligned north-northwest to south-southeast and was constructed from unfrogged red brick laid in Flemish bond, built on a mixed flint rubble and black coal and cinder footing. The wall probably represents a party wall or plot boundary and correlates well with Salt Lane property boundaries recorded on the 1881 1st edition Ordnance Survey map.

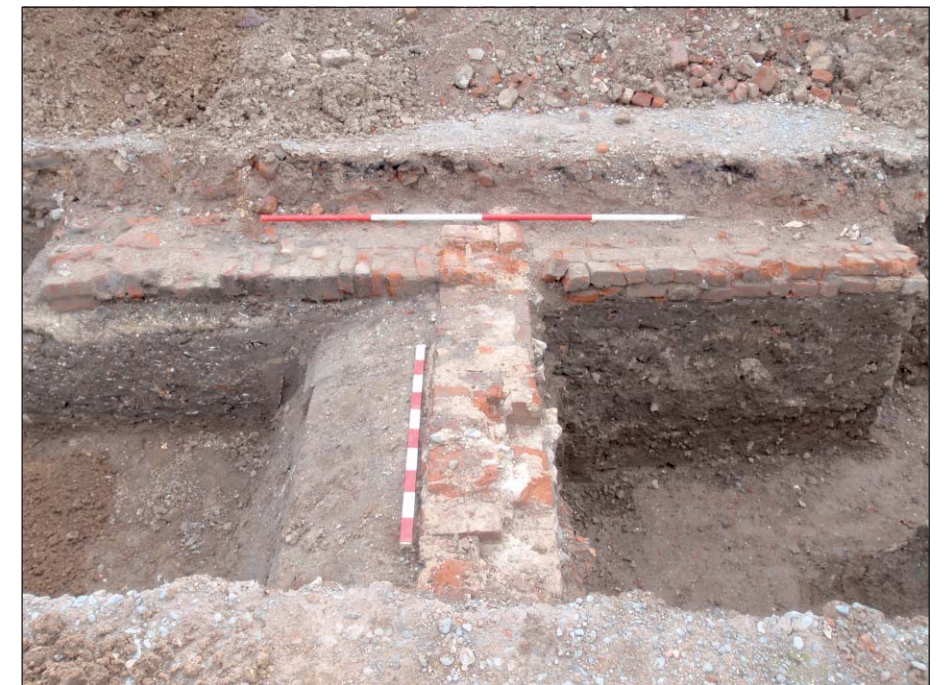
Plate 5: Walls 125, 126 and 127 of Building 1, view from west

- 4.2.11 At the southern end of the trench, a number of walls were recorded and probably formed part of a house/building that fronted onto Salt Lane (**Building 1, Figure 2 and Figure 3, Plates 1 and 5**). Buildings are recorded at this location on the 1611 John Speed's Map of the City of Salisbury; however it is more likely that Building 1 represents remains of structures illustrated on the 1881 First Edition Ordnance Survey map. Wall **126** survived to two courses of brick and was 2m long by 0.37m wide and up to 0.16m in height. It was constructed from unfrogged red brick and was built on a mortared flint cobble footing. The wall was aligned approximately east to west and was visible across the base of the trench. Walls **125** and **127** recorded on roughly north-south alignment at the eastern edge of Trench 1, butted wall **126**. Wall **125**, which extended 1.7m to the north, comprised a single course of unfrogged red brick and was 0.33m wide and was up to 0.21m in height. Wall **127**, which extended to the south for 1.76m, was 0.23m wide and up to 0.14m in height and comprised two irregular courses of unfrogged red brick.

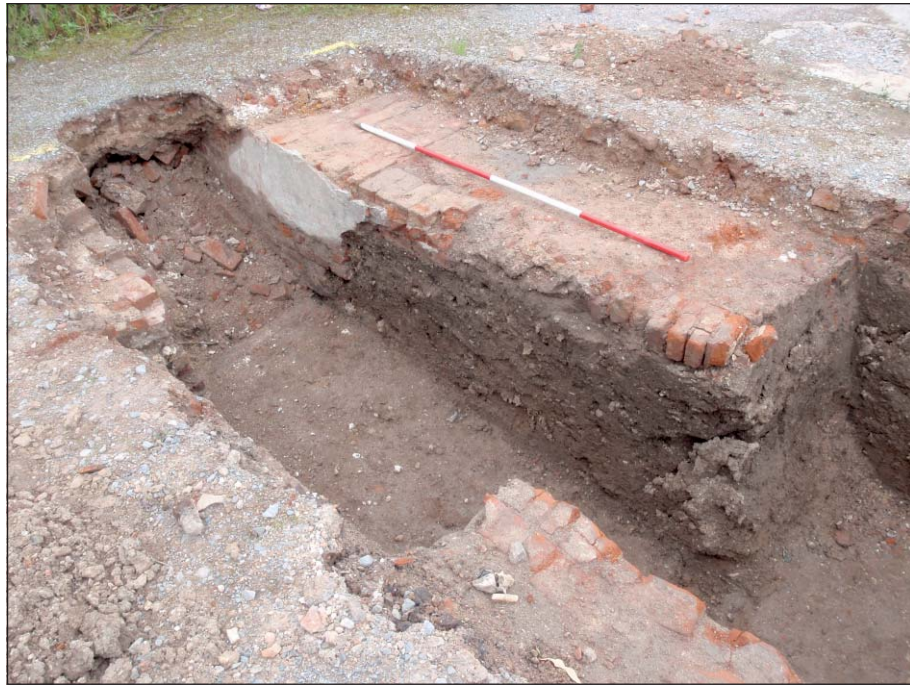
Plate 6: Cellar of Building 1 comprising walls 129, 130 and 133, view from north-east

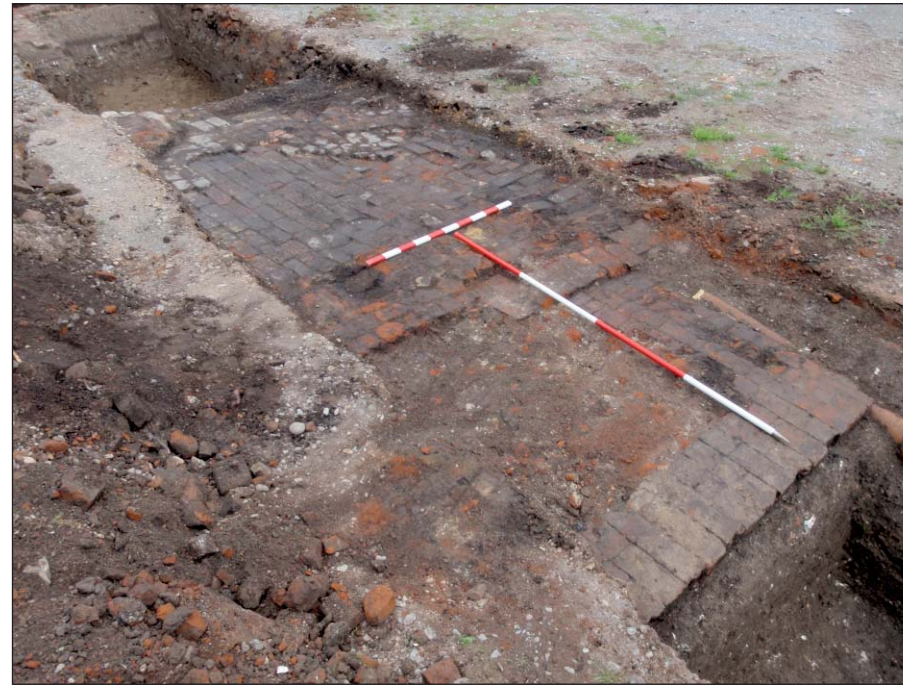
Plate 7: Yard surface 102, view from north-east

- 4.2.13 A brick yard surface (**102**) was recorded in the central area of Trench 1 (**Figure 2; Figure 4, Plate 7**). The exposed surface measured 4.55m by 2m and was constructed from a single layer of predominately machine made unfrogged red brick and. Similar surface **121**, fragmentarily preserved, was recorded to the north. Three brick built wall footings were recorded on the northern edge of yard surface **102** (walls **122, 123** and **124**) and may represent garden walls or outhouses associated with **Building 1** to the south. These structures may relate to structures recorded on the 1st edition Ordnance Survey map of 1881. Small sections of truncated post-medieval brick walls were also recorded in association with surface **121 (120** and **134)**.

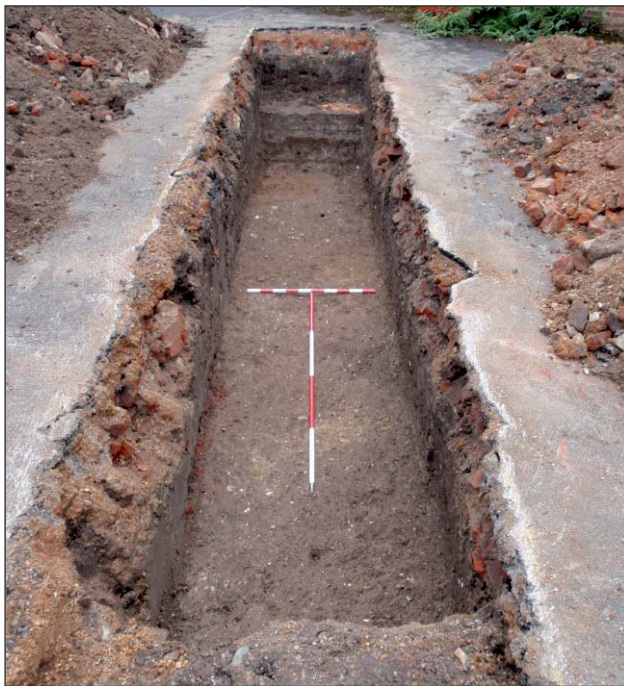
Plate 8: General view of Trench 2 from north-west

4.3.1 Trench 2 was located in the northern half of the Site in an area of tarmac car park (**Figure 2; Figure 4, Plate 8**). The trench measured approximately 10m by 1.50m and was excavated to a depth of 1.1m BGL (47.76m aOD). Tarmac and made ground were present above the medieval to post-medieval garden soils, a probable small medieval cess pit and an unexcavated feature were identified within the base of the trench.

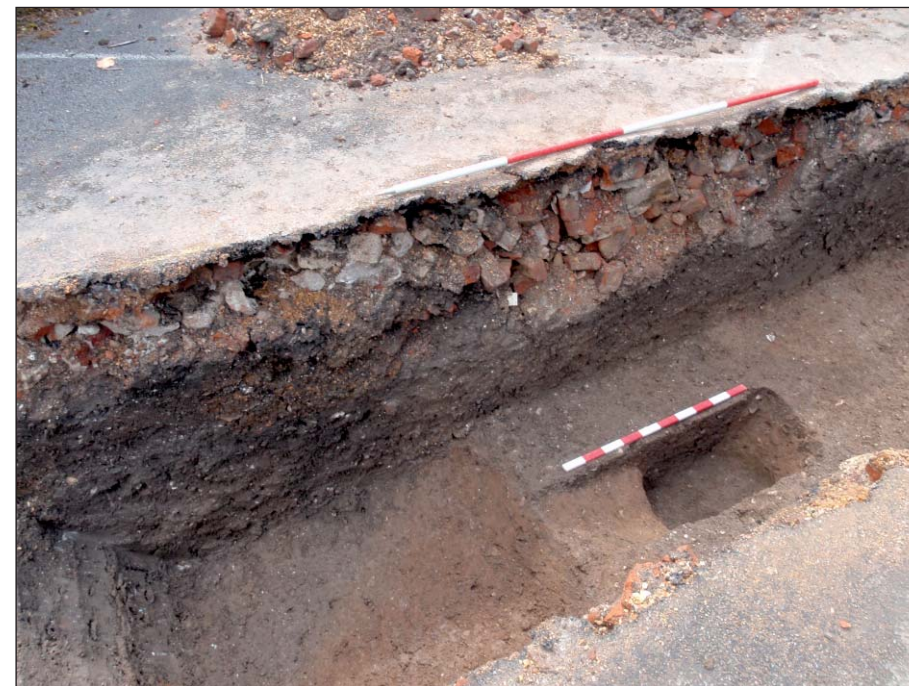
Plate 9: North-east facing section of pit 207

4.3.3 Medieval features were recorded within the base of the excavated trench at a depth of 1.1m BGL (47.7m aOD). Due to the depth of the overlying deposits and Health and Safety concerns, it was only possible to excavate one of the features safely. Pit **207 (Figure 4, Plate 9)** was oval in plan and was characterised by steep, straight to convex sides. It measured 1.38m by 1.1m and was excavated to a depth of 0.4m. The pit contained two deposits, the lower fill **209** comprised loose friable mid greenish-grey silty-loam that may represent a 'cess' type deposit. Finds of medieval pottery, tile, animal bone and oyster shell were recovered from the deposit.

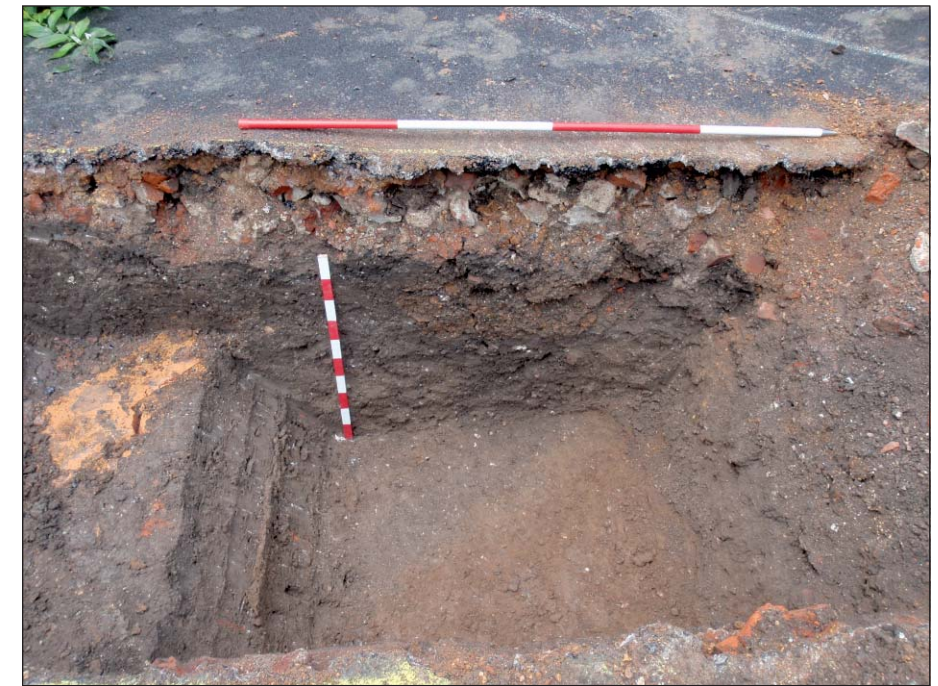
Plate 10: North-east facing section of maching-dug sondage in Trench 2 showing pit 213

4.3.4 Within the machine excavated test pit, at the south-eastern end of the trench, a possible pit (**213**) was recorded (**Figure 1; Figure 4, Plate 10**). The pit was only partially exposed within the trench and measured 1.05m by 0.83m. The excavation of the feature was not possible, on Health and Safety grounds, as the pit was situated at 1.47m BGL (47.54m aOD).
