World War II Air Raid Shelter,  
Cheriton Sports Ground,  
Cheriton Road,  
Folkstone, Kent

Historic Building Recording

Report reference: 77310.02

**June 2011**

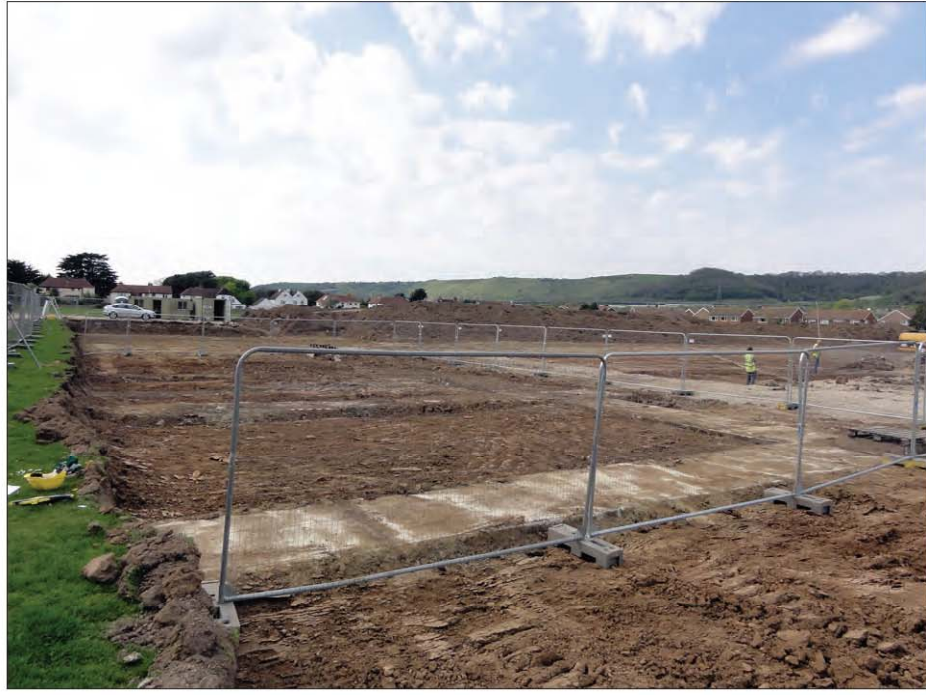
Plate 1: View across the exposed roof of the air raid shelter following top soil stripping. Looking West.

- 4.2.1 The structure covers a rectangular area, which measures approximately 19m north-south and 28m east-west (**Figure 3, Plates 1 and 2**). The layout of the structure is symmetrical and comprises four north to south orientated trenches or galleries (**Tr 1c, 1d, 2b and 2c**), measuring approximately 18.8m by 1.4m. These trenches are linked by an east-west aligned trench (**Tr 1b and 2a**), measuring 28m by 1.5m, which forms the northern extent of the shelter. The two western trenches (**Tr 1d and 1c**) are linked at the southern extent by **Tr 1e**; the eastern trenches mirror this formation and are connected to the south by **Tr 2d**. At the centre of **Trench 1b/2a**, an additional trench runs southwards (**Tr 1a**). This trench formerly led to the main entrance and has been bricked up (**Plate 5**). Recesses are located at the northern extent of **Trenches 1d, 1c, 2b and 2c** and at the southern extent of **Trenches 1d and 2c**.

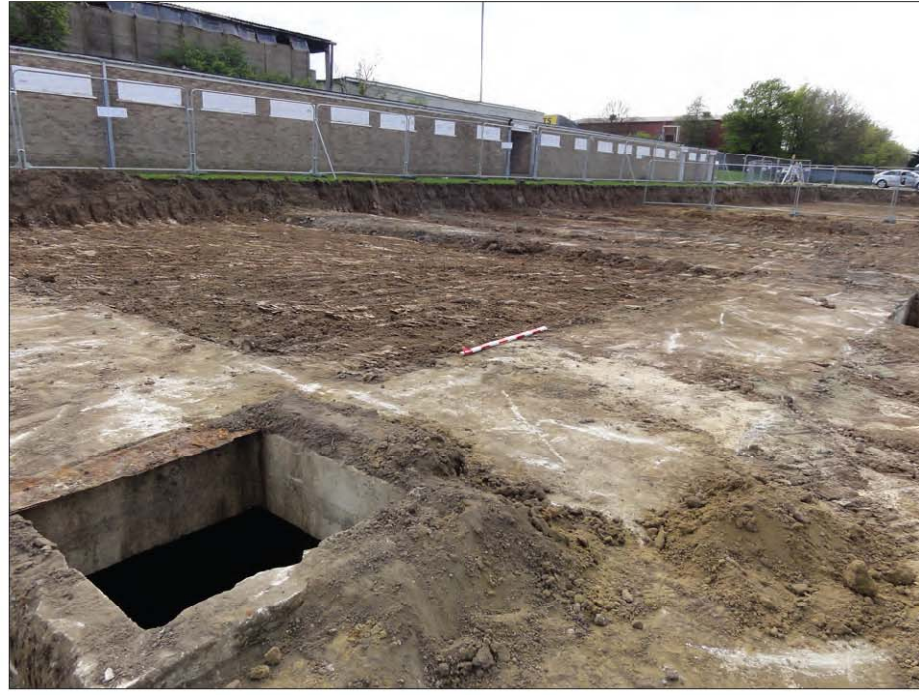
Plate 2: View across exposed roof of air raid shelter. Looking south-west.

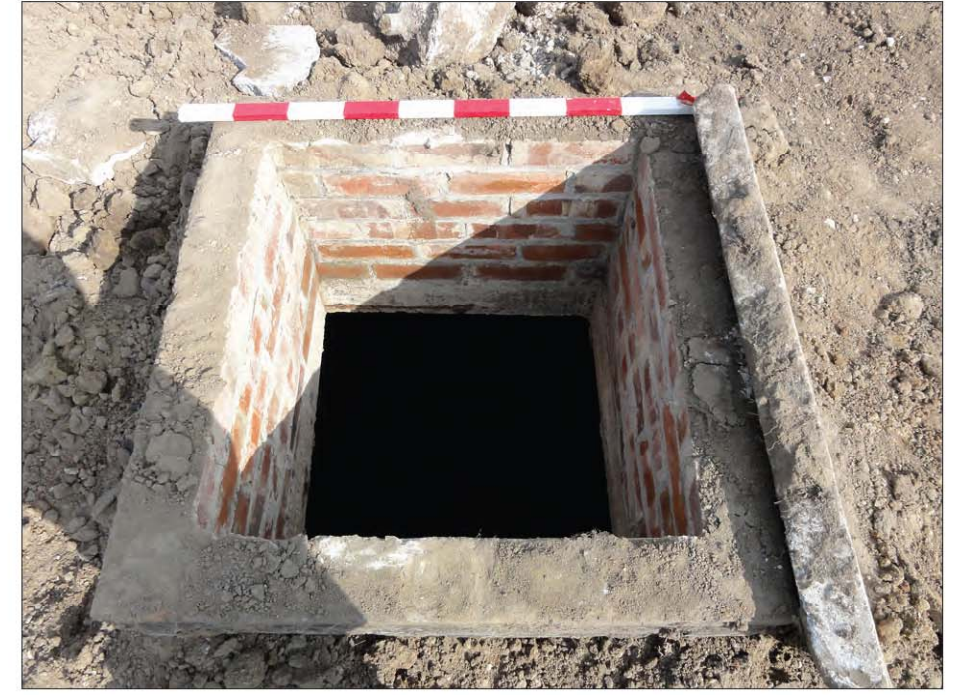
Plate 3: Surface view of manhole at north-west corner of shelter (Phase 1).

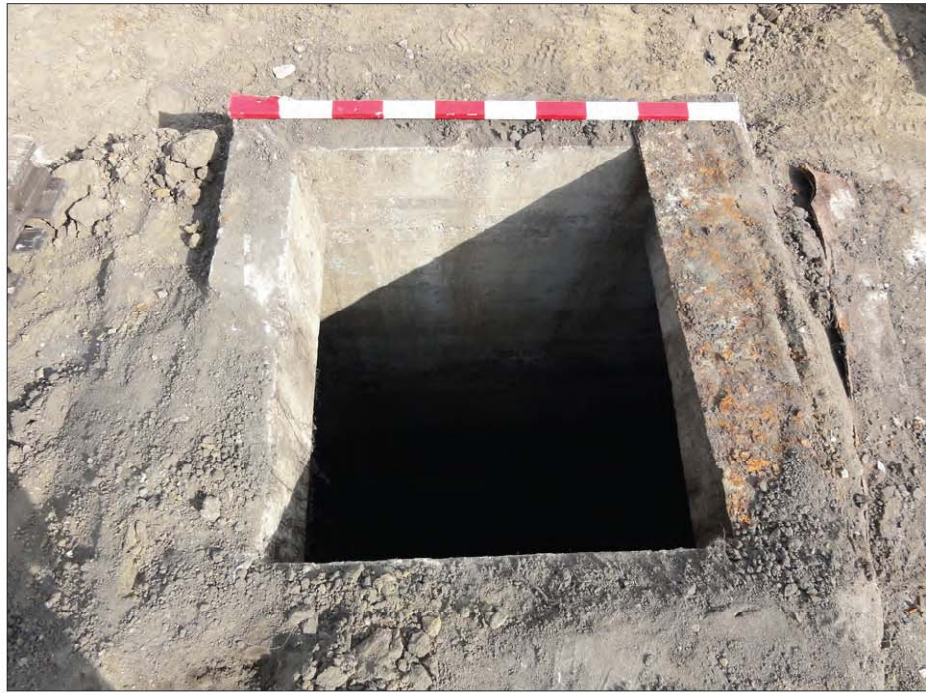
Plate 4: Surface view of manhole at north-east corner of shelter (Phase 2).

constructed wholly of concrete and measured 1.1m by 1.3m (**Plate 4**). At the time of the Site inspection, both exposed shafts had been covered for safety. No remnants of the original coverings were noted during the building recording.

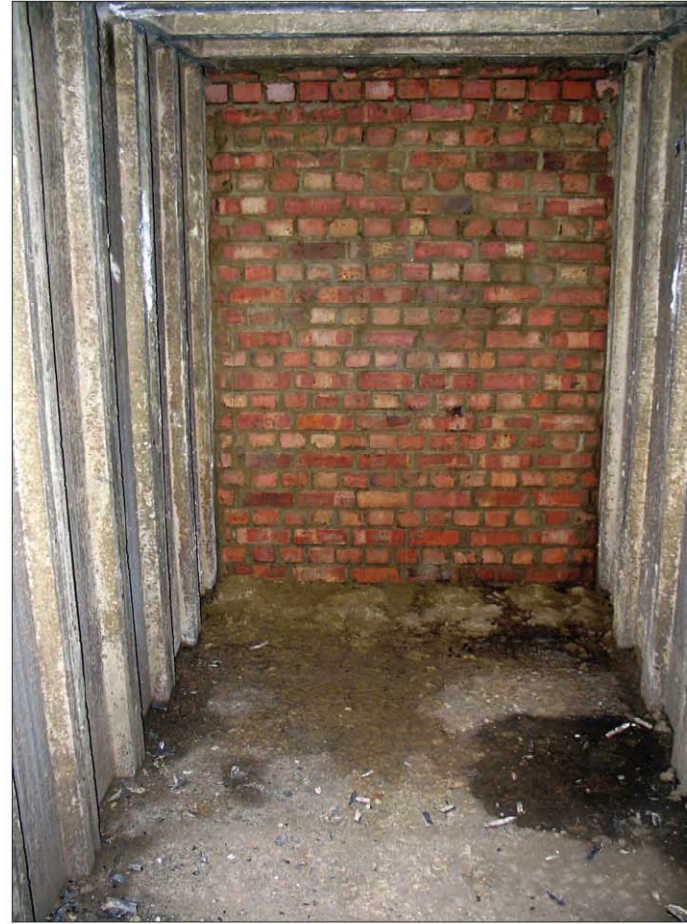
4.3.9 The southern extension of **Trench 1a** has been blocked by a fletton brick wall (**Plate 5**). This insertion is likely to have taken place following decommission of the shelter and infilling of the entrance. At surface level, the poured concrete walls of the entrance ramp are partially visible.

Plate 5: Bricked up former entrance, Tr 1a. Looking south.

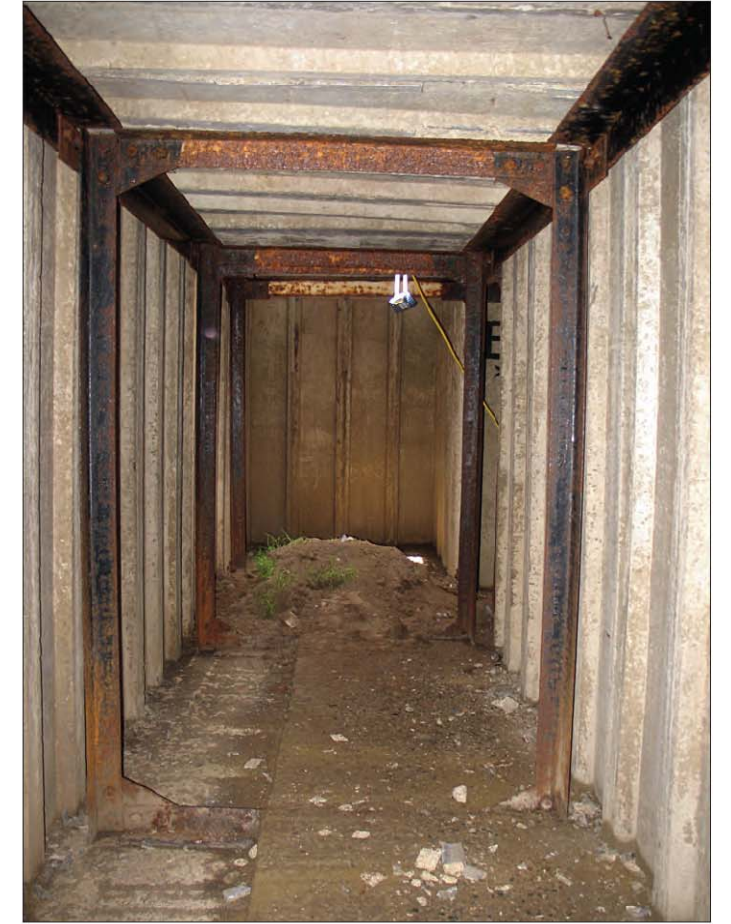
- 4.5.3 There was limited evidence for drainage within the structure. However, a lowered concrete floor within **Tr 1c** was identified beneath the former bench seat (**Plate 6**). It is possible that this gully may have served as a gutter.

Plate 6: Phase 1 shelter, Tr 1d. Looking south.

- 4.2.2 The trenches are of 'square-type' construction, referring to the shape of the trench cross-section (**Figure 4: Phase 1, Plate 6 and Phase 2, Plate 7**). The height of the corridors ranges from 2.0m from the floor slab in the western trenches (**Tr 1a-e**) to 2.20m in the eastern trenches (**Tr 2a-d**). Manholes, likely to mark the location of ventilation shafts, which could have been used as emergency exits, were noted at the NE, NW, SE and NW corners of the shelter above the junctions of adjoining trenches (**Plates 2-4**).

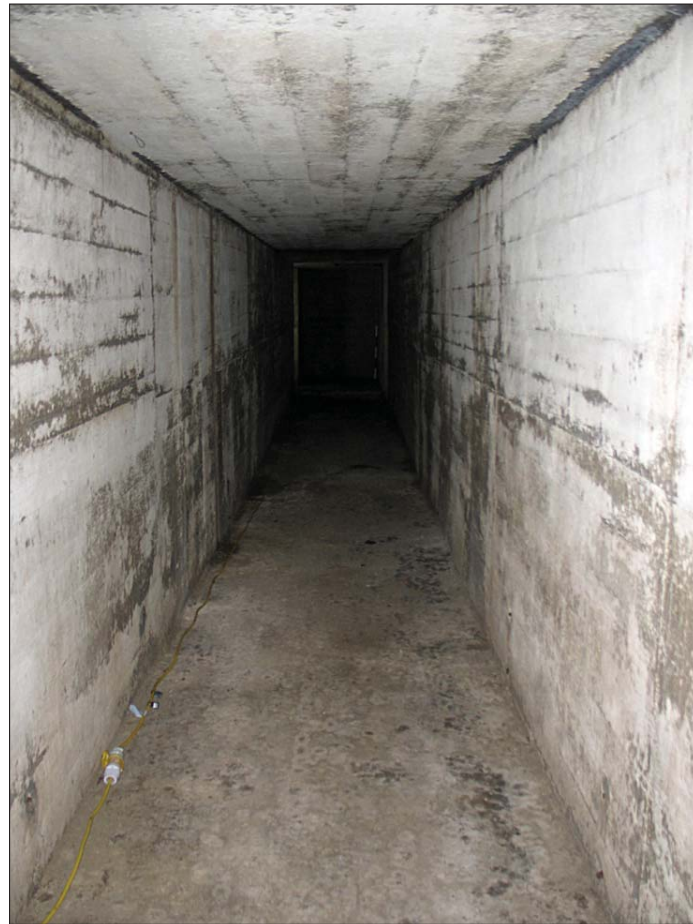
Plate 7: Phase 2 shelter, Tr 2b. Looking south.

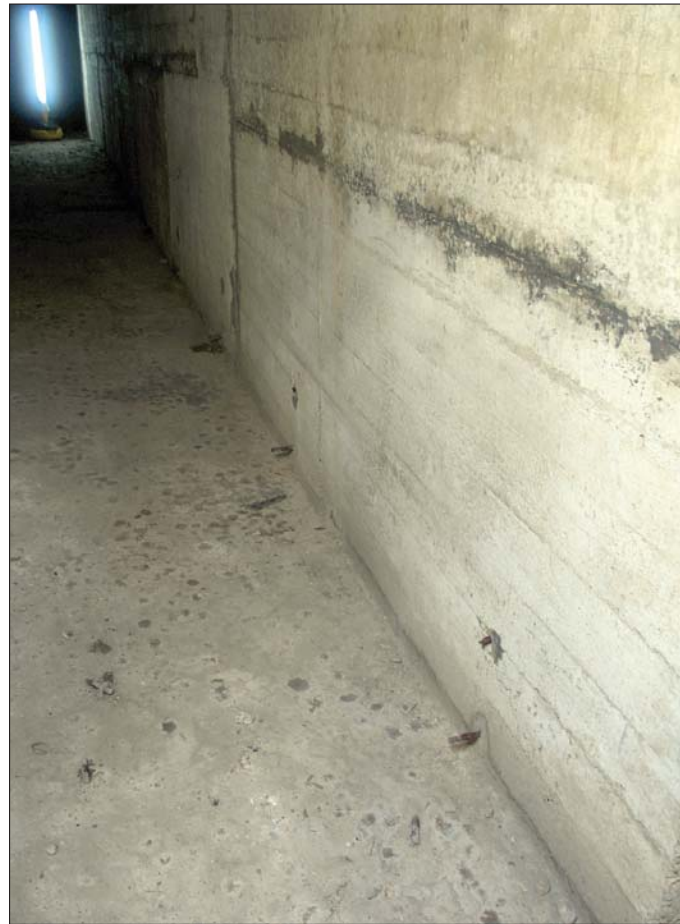
- 4.5.2 Evidence for bench seats and/or bunks along the internal walls has been noted in the form of projecting studs along the west facing wall of **Tr 2c**, the north facing wall of **Tr 2a**, the west wall of **Tr 1d** and the east wall of **Tr 1c** (**Plate 8**).

Plate 8: Studs along west wall of Tr 2b, former bench supports. Looking south-west.

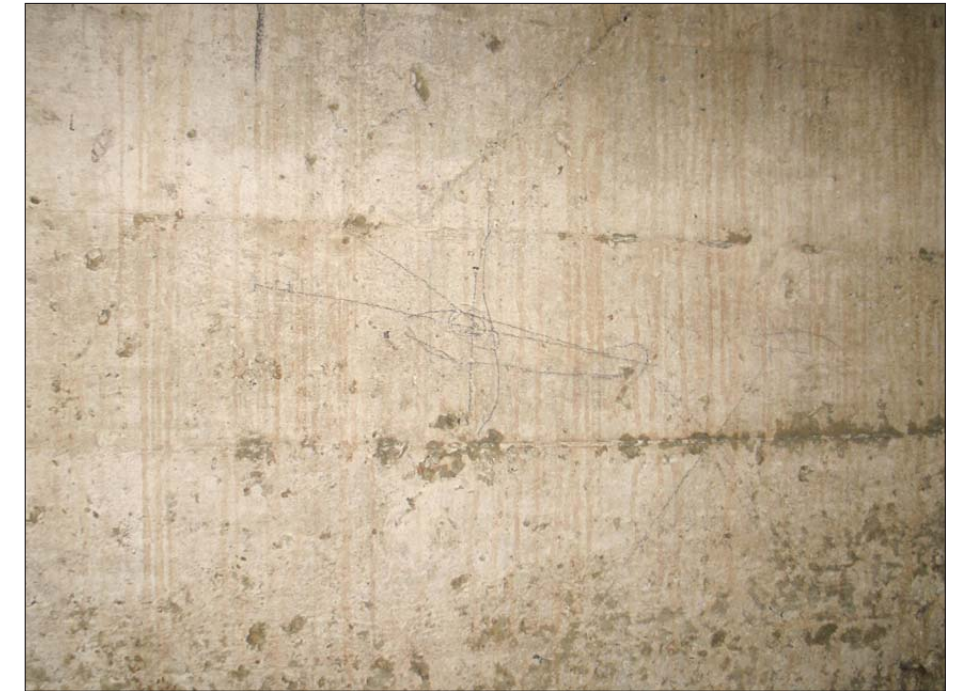
Plate 9: Graffiti fighter plane, Tr 2c. Looking west.

- 4.5.4 The most enlightening features within the shelter are the graffiti largely contemporary with its war time use. Graffiti includes references to the war including a fighter plane (**Plate 9**) and a possible bomb or zeppelin (**Plate 10**) on the east facing wall of **Tr 2c**. Slightly more abstract are the depiction of a pipe in the style of Magritte, the quotation “should a painter tell” on the north wall of **Tr1b**, ‘O’s and X’s’ (**Plate 11**) and a U-shaped design set with in a square on the south wall of **Tr 2d**.

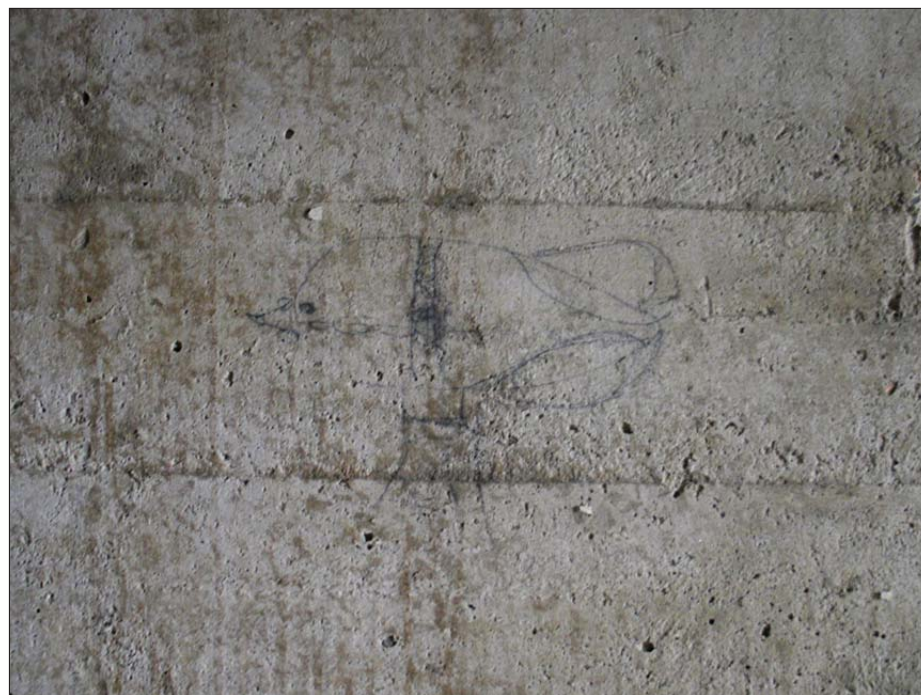
Plate 10: Graffiti Zeppelin, Tr 2c. Direction unknown.

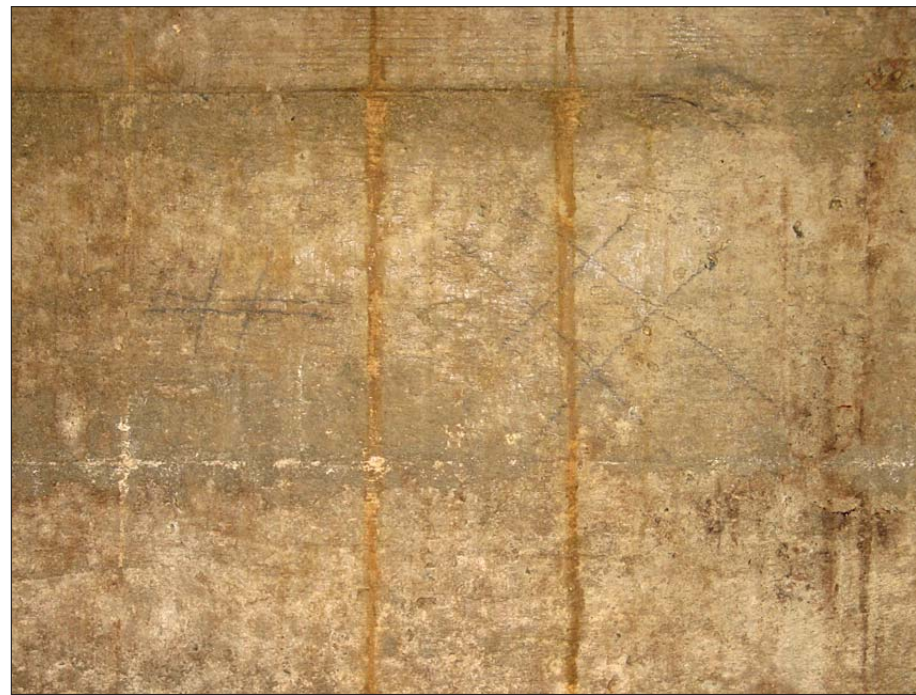
Plate 11: Graffiti, O's and X's, Tr 1b. Looking south.

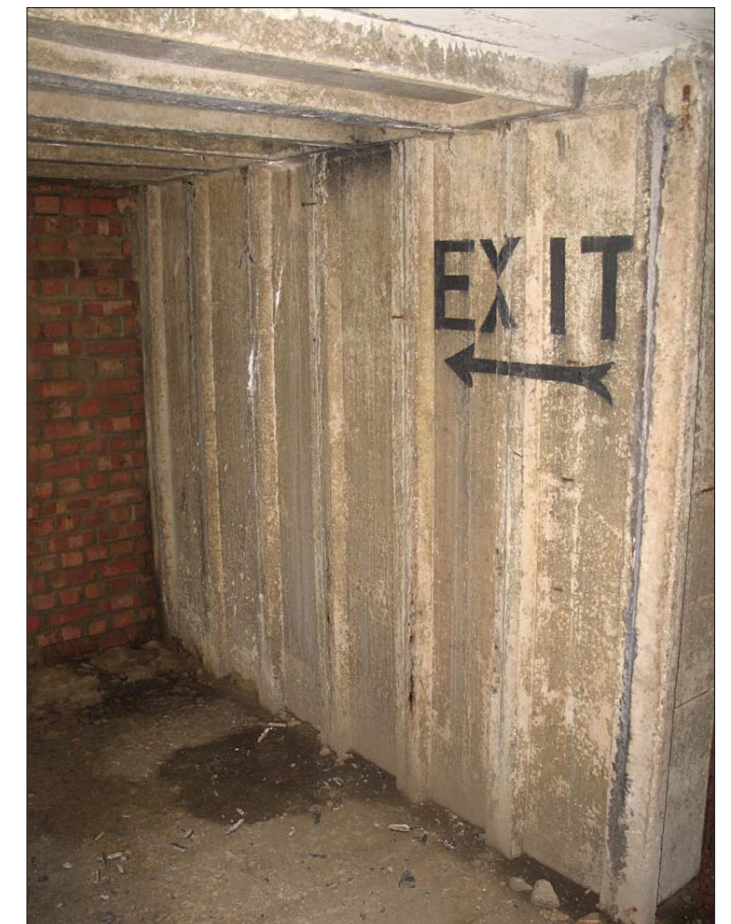
- 4.5.6 A number of EXIT signs (**Plate 12**) are painted on the walls pointing towards the central exit at the end of **Tr 1a** (now blocked up), the location of these signs are annotated on **Figure 3**.

Plate 12: Exit sign close to entrance, Tr 1a. Looking south-west.

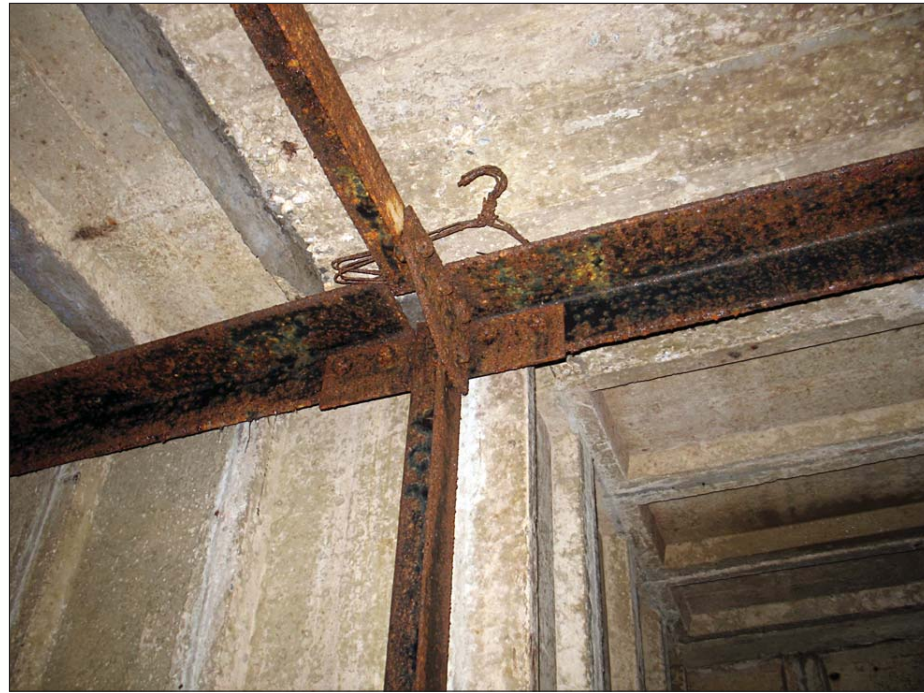
- 4.5.7 The only surviving artefact reflecting occupation of the shelter is the insertion of two rusted coat hangers behind the overhead steel frame in **Tr 1b**, **Plate 13**).

Plate 13: Coat hangers behind girder. Tr 1b. Looking north-east.

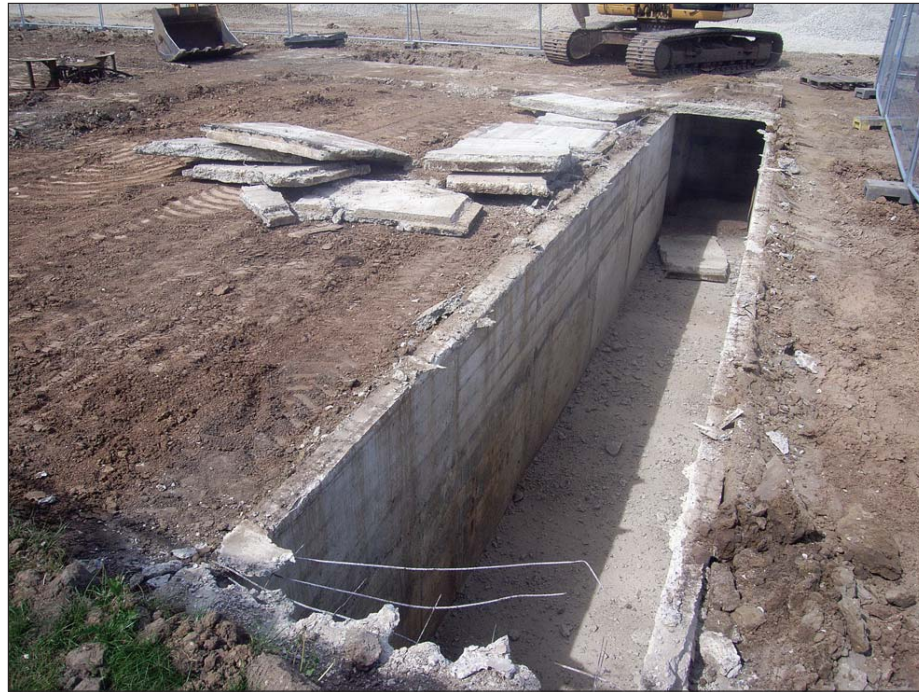
4.3.8 In addition to the walls, the floor and roof comprise shuttered poured concrete reinforced with quarter inch twisted steel bars (**Plate 14**). The average shuttering length across the build is 2137mm. Several square sockets in floor slab mark the location of shuttering posts. The floor slab within the Phase 2 measures approximately 152 mm in depth.

Plate 14: View along Tr2c showing exposed concrete and wire frame during demolition. Looking north.

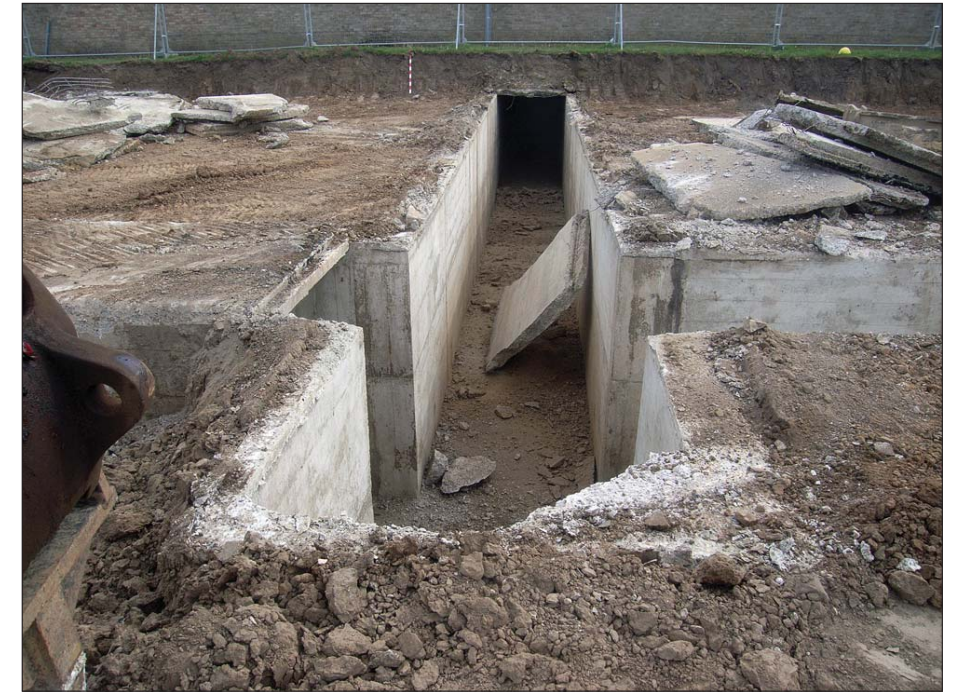
Plate 15: Tr 2b during demolition. Looking south.

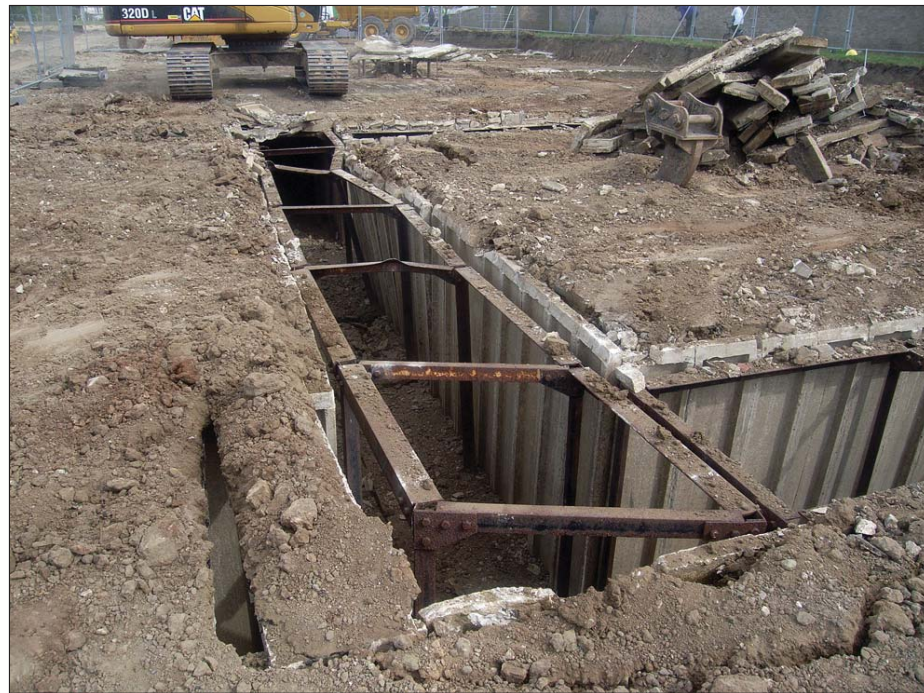
Plate 16: Junction of Tr 1b and Tr 1d during demolition. Looking south-east.

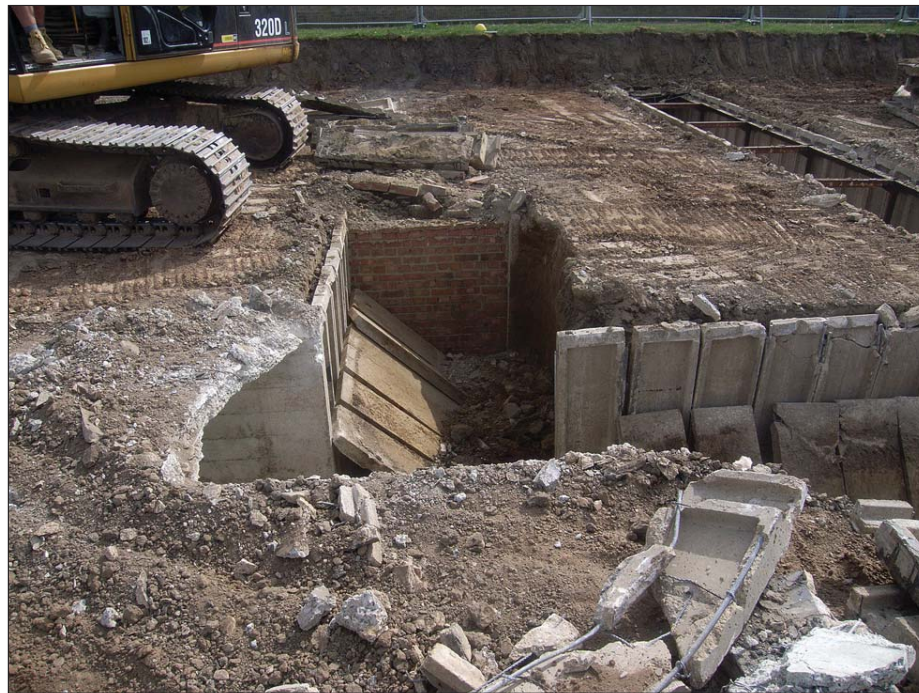
Plate 17: Bricked up entrance exposed during demolition works. Looking south
