Land at St. Breaca Close, Breage, Cornwall

Archaeological Evaluation Report

Report reference: 87270.03
Royal Cornwall Museum Accession Number: TRURI:2012.28

October 2012

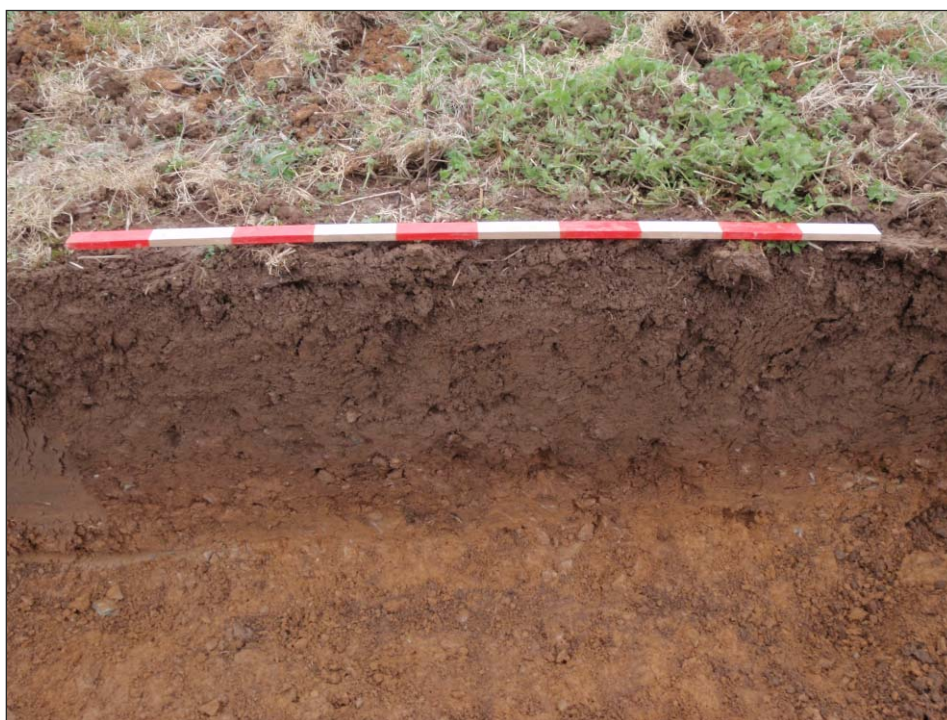
Plate 1: Northeast facing representative section of Trench 1

- 5.2.1 The natural soil sequence observed across the Site was consistent throughout (**Plate 1**). The topsoil was a 0.35m deep mid-dark brown silt clay loam predominantly covered with rough vegetation. At the southern extent of the proposed development area, Trenches 4 and 7 extended into a ploughed arable field. Traces of the incorporation of topsoil and subsoil, likely derived from the area of the recent housing development immediately to the north of the Site, were evident in Trenches 1, 2 and 3. Below the topsoil was a mid grey brown silty clay subsoil varying from 0.15m to 0.40m deep, which exhibited a very diffuse interface with the underlying natural geology. The underlying geology comprised a light yellow brown sandy silty clay with common poorly sorted sub-angular stone, often occurring in distinct outcrops. The natural geology appeared to be comprised of the weathered upper surface of underlying bedrock.

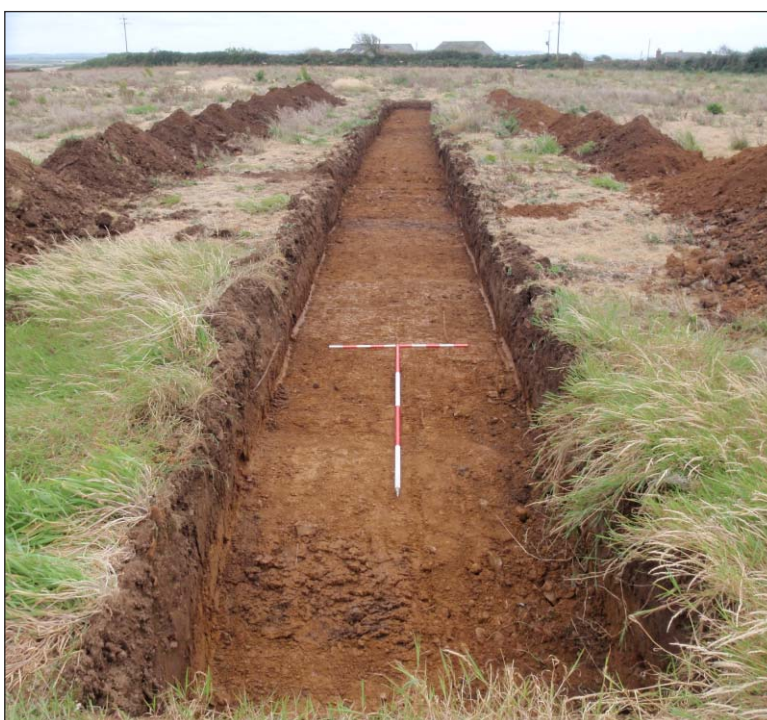
Plate 2: View of Trench 1 from the west showing hedgerow 104 and modern disturbance

- 5.3.1 Within Trench 1 (**Plate 2**) a linear feature was identified. On excavation the feature proved to be the remnant of a former hedgerow. The feature was orientated north east – south west, measured 1.2m wide by 0.03m deep and was observed to extend beyond the bounds of the trench area. The feature had irregular sides and an irregular base, suggestive of root activity, and contained a single fill of mid grey-brown silty clay. This feature was located between two closely spaced, parallel, linear geophysical anomalies and is likely to correspond with them.

- 5.4.1 Areas of modern disturbance were evident within the northern ends of Trenches 1, 2 and 3. This consisted of two parallel linear features clearly originating from wheel rutting in Trenches 1 and 2 (plates 2 and 4), in association with some mixing of the topsoil and subsoil observed during machining. Occasional fragments of modern pottery and ceramic building material were also noted in these locations. This disturbance is believed to have derived from incorporation of reworked topsoil and subsoil in conjunction with plant movement during ground works associated with the recent housing development immediately to the north of the Site.

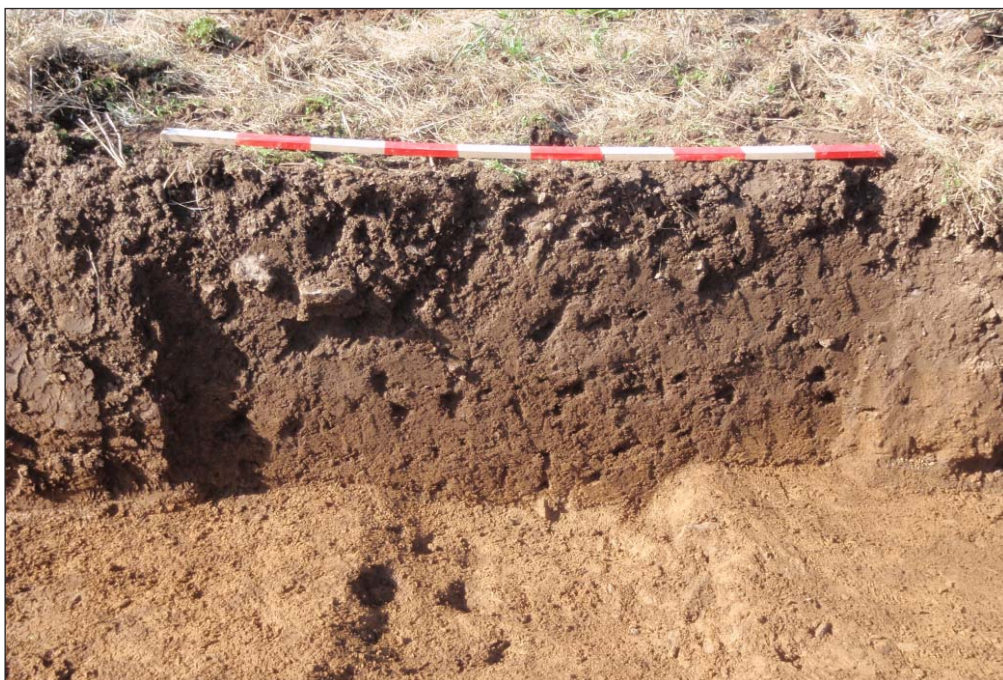
Plate 3: Representative section of Trench 4 showing hedgerow 404

- 5.3.2 Within Trench 4 (**Plate 3**) a shallow linear feature orientated west north west – east south east was excavated and recorded. On excavation the feature was interpreted as the remnant of a former hedgerow ditch. The feature had an irregular profile suggestive of root activity. It measured 0.42m wide by 0.12m deep and extended beyond the bounds of the trench area. The feature contained a single fill of mid grey brown silty clay.

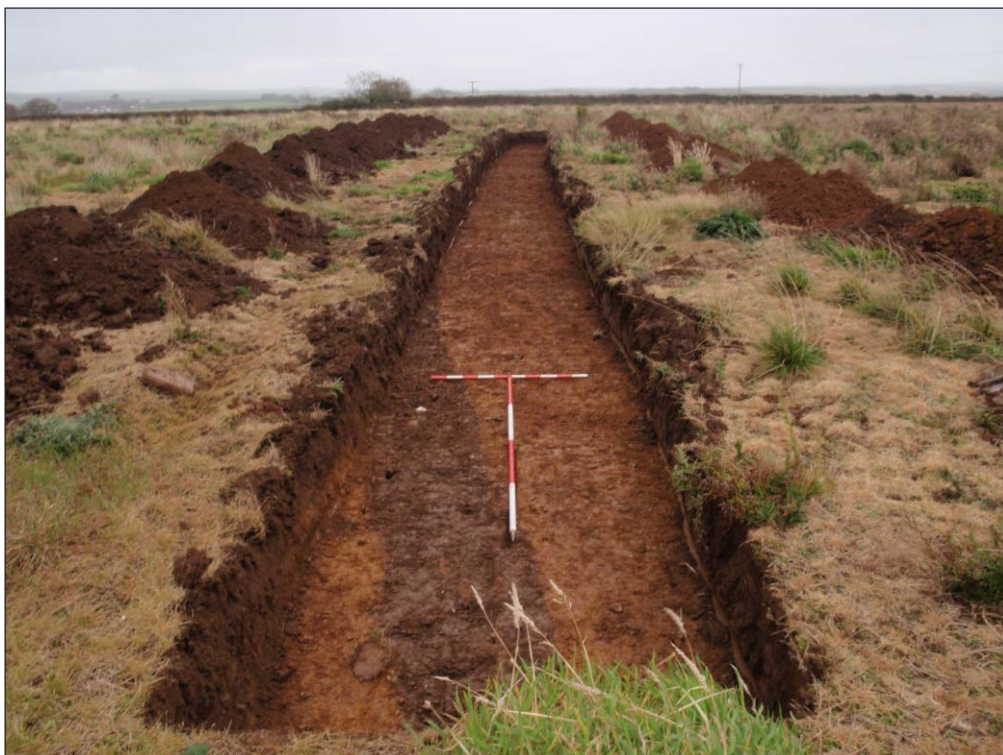
Plate 4: View of Trench 2 from west-northwest showing wheel rutting
