**55 CHANTRY STREET, ANDOVER,  
HAMPSHIRE**

**Archaeological Evaluation Report**

**November 2012**

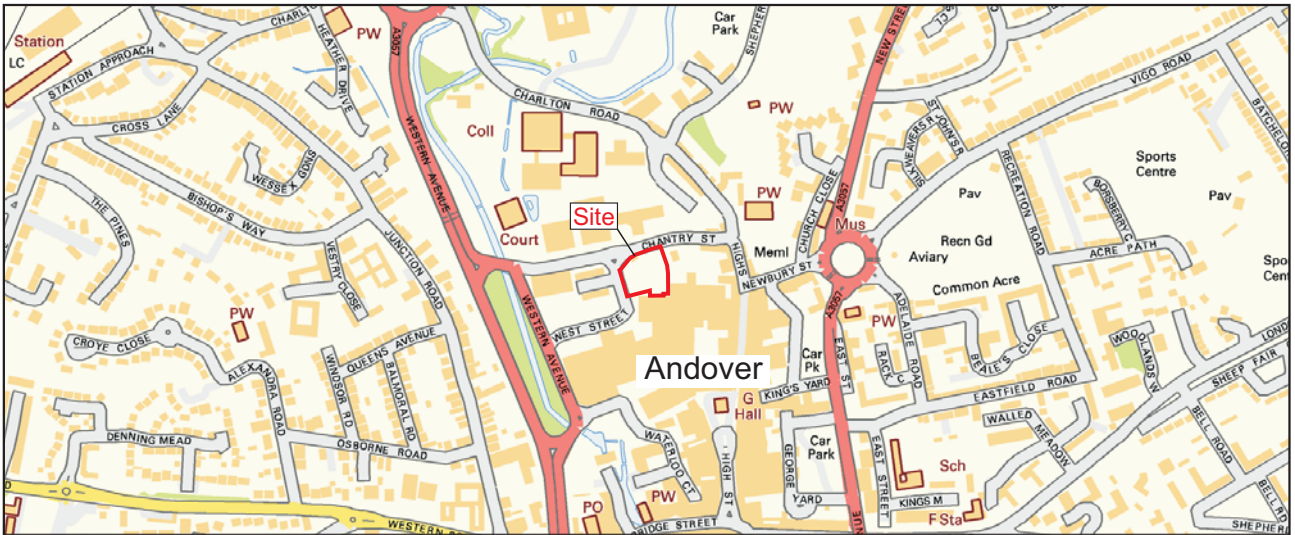
Figure 1

Site location plan

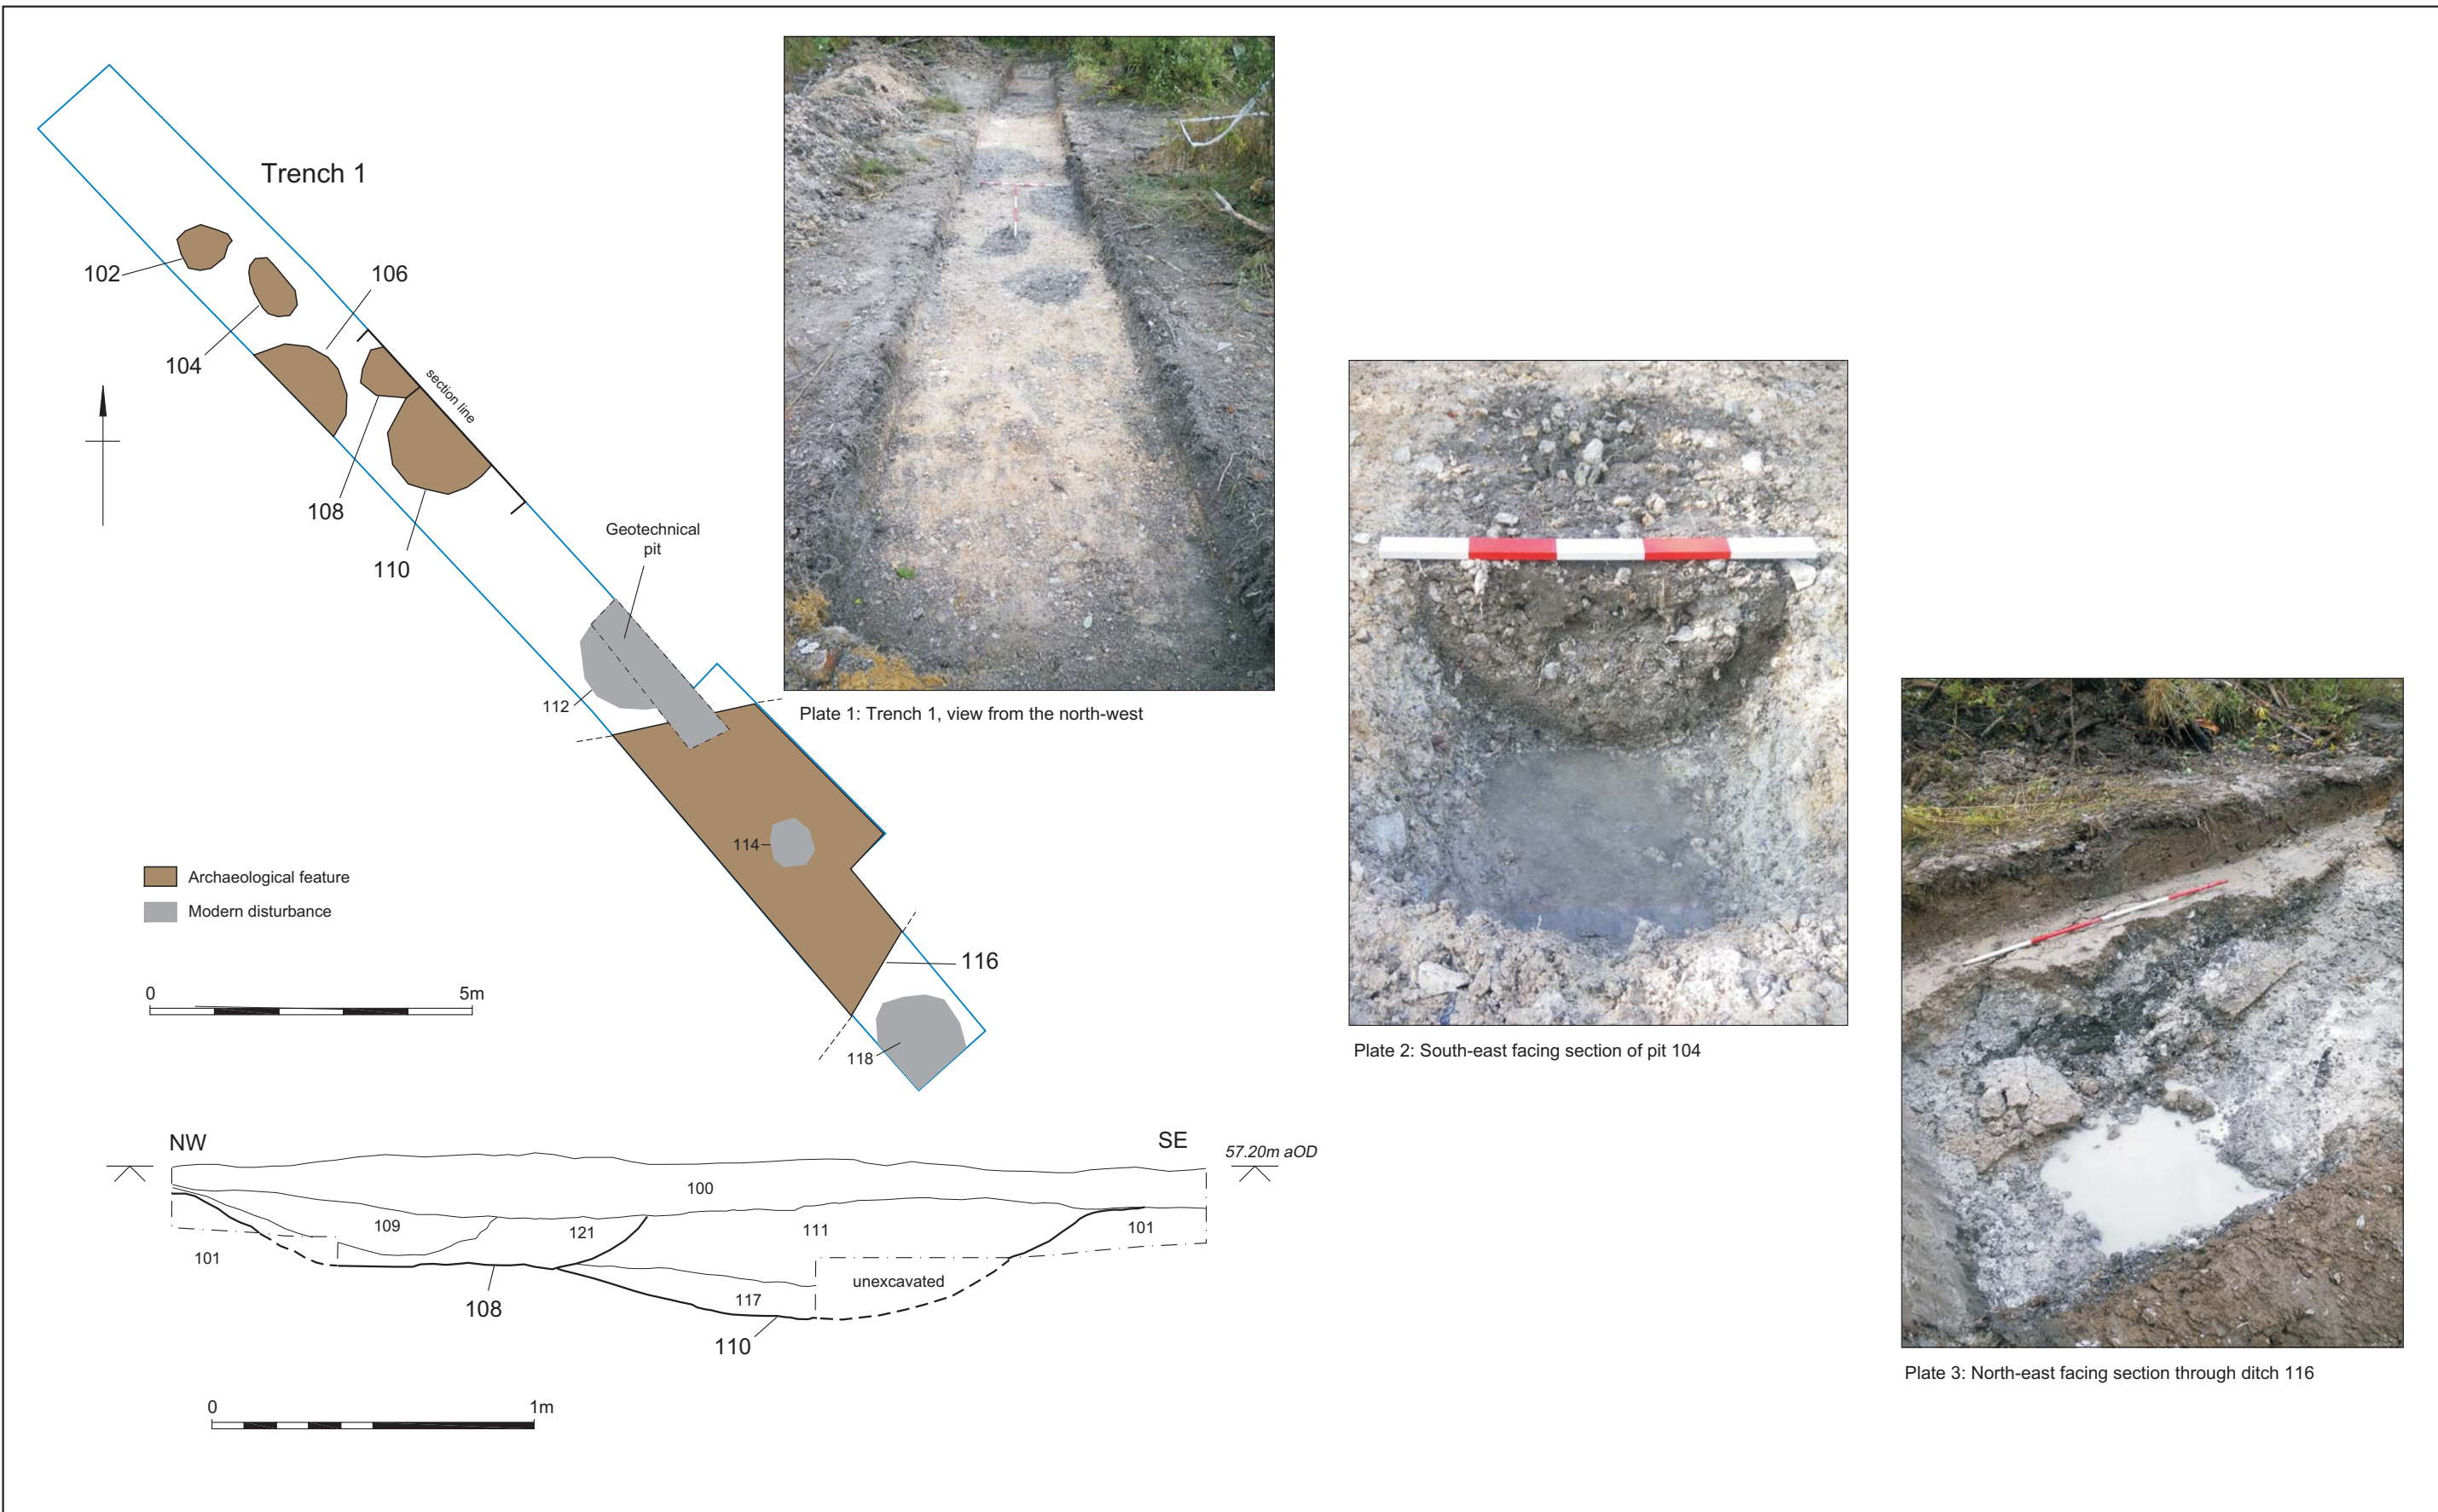
Figure 2

- 3.2.2 Between 0.08-0.19m of disturbed topsoil **100** was found to overlie the natural chalk **101**. Eight pits (**Figure 2, Plate 1**) were recorded within the trench, three of which, located within the south-eastern part of the trench (**112, 114** and **118**) were modern. Ditch **116** was also recorded in the south-east of the trench.

- 3.2.7 Cutting pit **110** on the north-western edge was pit **108** (**Figure 2, section**). No dating evidence was recovered from its lower slightly cussy fill **121** but a

- 3.2.8 Within the south-eastern part of Trench 1 and cut by pit **114** was a large east – west aligned ditch **116** (**Figure 2, Plate 3**). Following agreement with the County Archaeologist, a slot was dug across the feature by machine, but the ground conditions proved too unstable for detailed recording. A sequence of deposits was identified (**122, 123, 124, 125** and **126**), the primarily fill of which, **122**, suggested wet and waterlogged conditions. Above **122** was a substantial deposit of fine re-deposited chalk **123** indicative of deliberate backfilling, possibly to infill the ditch. The three secondary deposits above this (**124, 125** and **126**) are likely to reflect gradual infilling with changes in characteristics reflecting different activities and conditions on Site. This feature is likely to be a continuation of a ditch found in the previous investigation area on the western edge of Site where it was seen to curve round to the south-west.

Trench 1: survey, section and plates

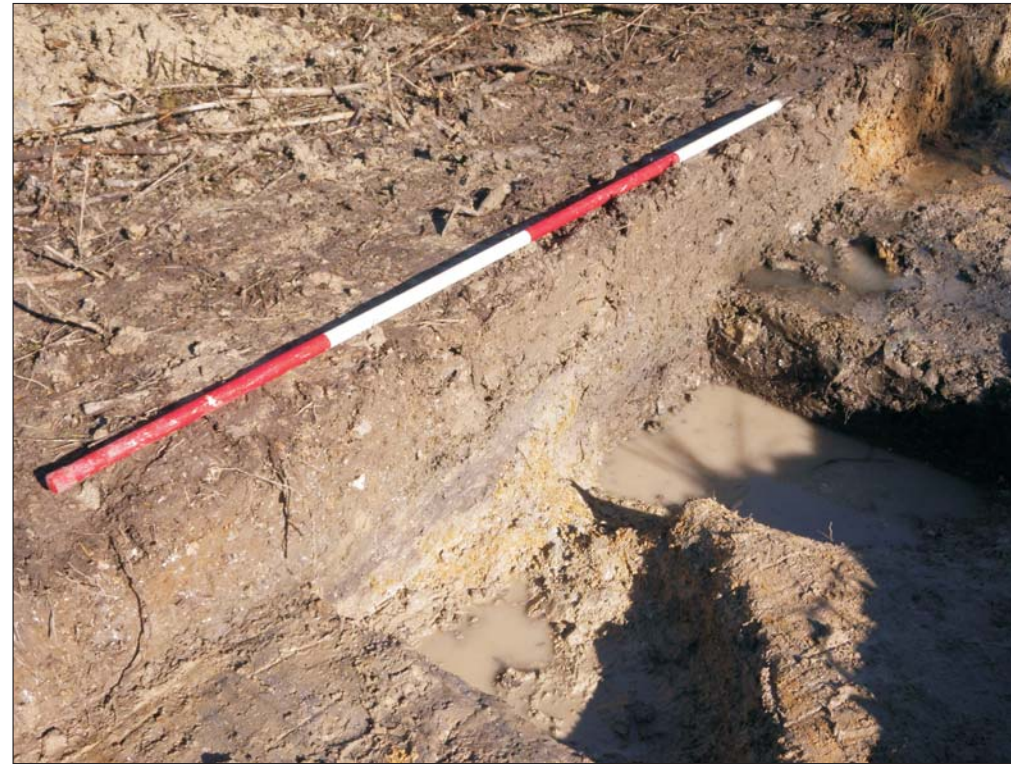
- 3.2.12 Intercutting pits **203** and **206** were not fully seen in plan as they extended beyond the north-western edge of the trench (**Figure 3, Plate 5** and **section**). Pit **203**, the earliest feature contained a lower humic deposit **205** overlain by a blue clay deposit **204** and a final mottled silty clay fill **210**. The blue colour of the clay within **204** is indicative of oxygen-poor, anaerobic conditions. With the exception of a single sherd of early medieval pottery, no other dating evidence was recovered from this deposit. The later pit **206** was situated on the southern edge of pit **203** and also contained three deposits (**207, 208** and **209**) which were slightly siltier than those in the adjacent pit. This feature was undated.

Plate 5: Pits 203 and 206, oblique view from the north-east

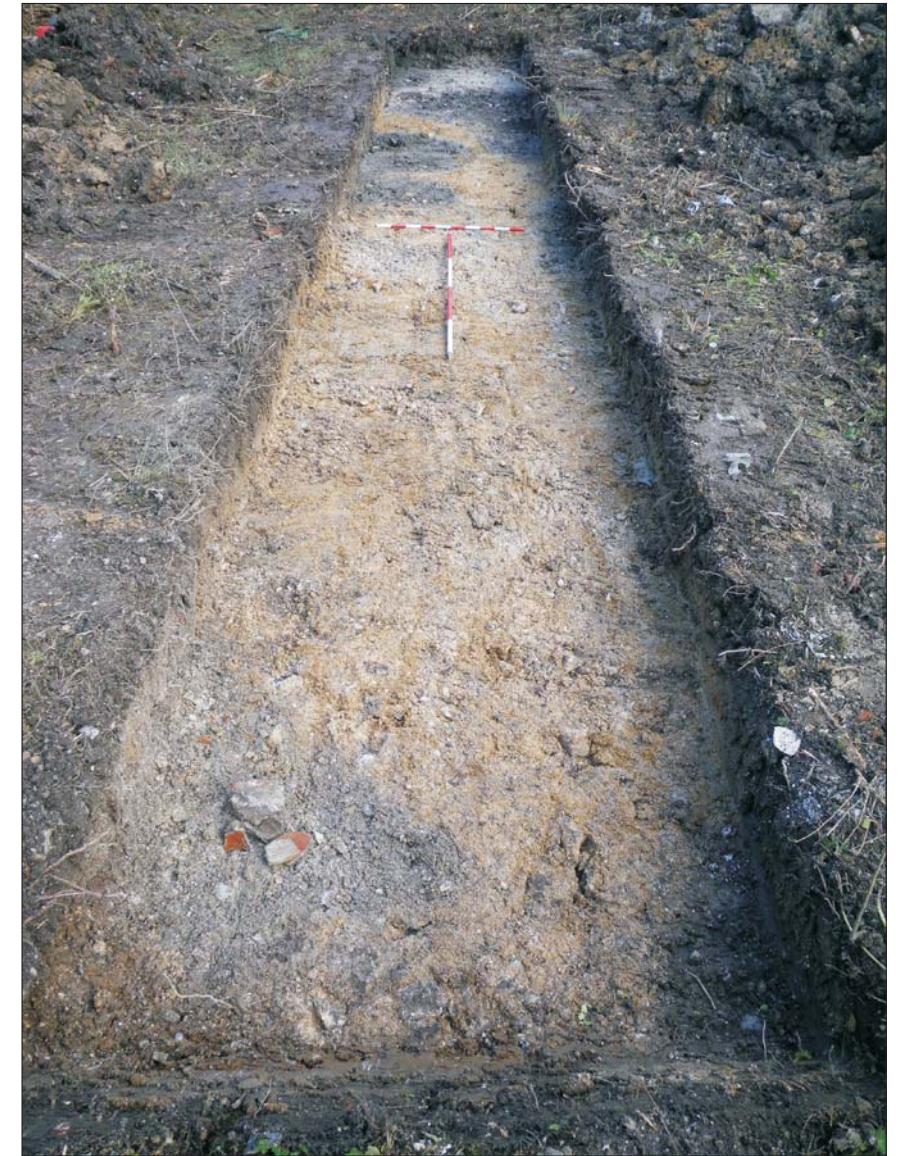
- 3.2.11 Three pits were located in Trench 2 (**203, 206** and **212**) (**Figure 3, Plate 4**), and are likely a continuation of the activity seen in Trench 1 and the previous excavation areas. A modern feature was just visible on the south-eastern edge of the trench but remained unexcavated.

Plate 4: Trench 2, view from the south-west

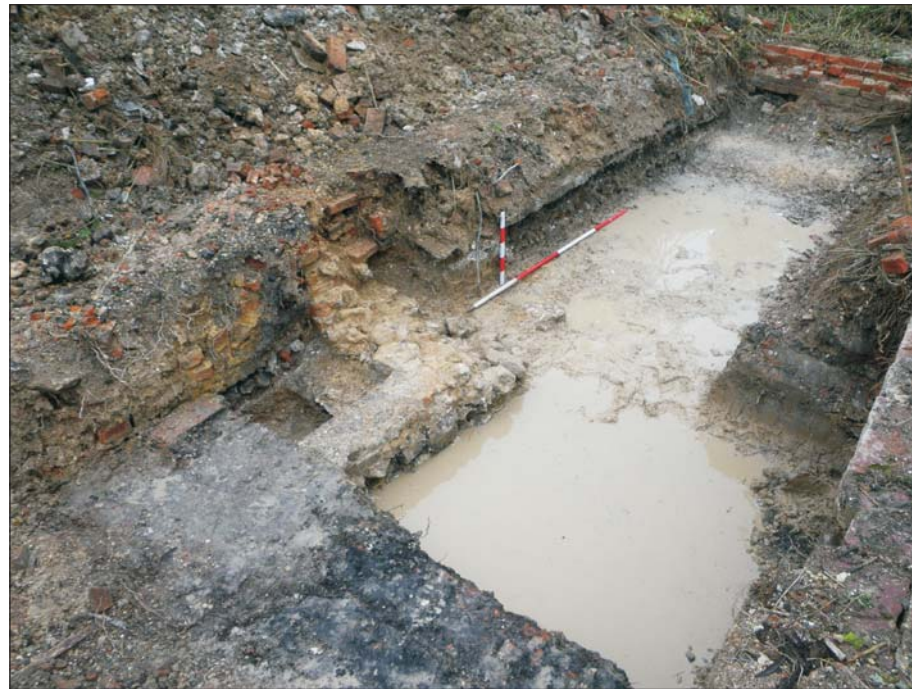
- 3.2.16 Visible in the north-western edge of the trench was brick-built wall **306** (**Figure 4, Plates 6, 7 and section**). The shape and characteristics of these bricks and the coarse lime mortar suggests strongly that they are related to the 16<sup>th</sup> century phase of Ford Cottage and formed part of the brick plinth supporting the timber frame. This wall itself was constructed on **305**, a stone wall constructed from large flint nodules, north-west to south-east aligned with a south-west return. It is not possible to determine whether this is a foundation for **306** or an earlier wall, however, the mortar characteristics were slightly different implying that it may be an earlier phase. Against the south-western face of wall **305** was an area of flint nodules **312**, which may be a part of a foundation for **305**. There was no visible construction cut for either wall.

Plate 6: Trench 3, view from the north-east

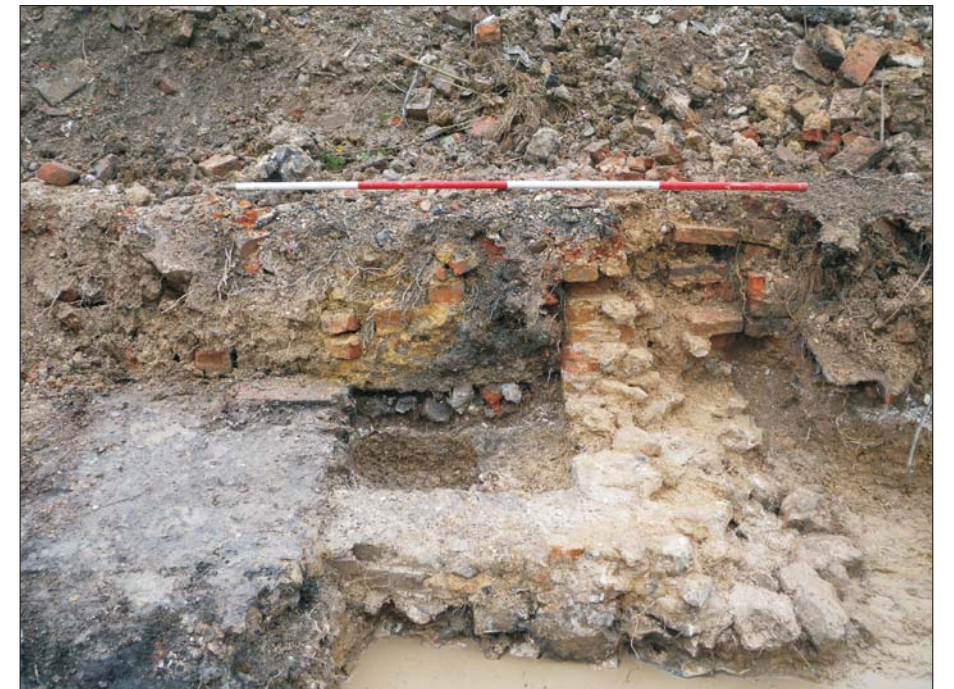
- 3.2.17 Banked up against **305** and **312**, was **307** a fairly homogeneous clay rich deposit containing little chalk (**Figure 4, Plate 7 and section**). It seems most probable that this is a deliberate levelling or bedding layer. To the north-east of wall **305** and overlying deposit **307** was a linear depression filled with flint, **303**. Given the waterlogged nature of the Site and the relatively soft geology this may well be a foundation, potentially for a pathway or general consolidation of an area prone to flooding. This feature cut the natural chalk geology (**308**).

- 3.2.18 Overlying **303** and **307** on the north-eastern side of wall **305** was a thin but defined layer of chalk **304** (**Figure 4, Plate 7 and section**). Again it seems likely that this is a deliberate bedding deposit which has slumped slightly into the top of **303**. On the north-eastern end of the trench, deposit **304** lay directly beneath the hardcore **302**.

Plate 7: south-east facing section of structures in Trench 3
