Chatsworth District Heating Scheme, Chatsworth House, Bakewell, Derbyshire

Archaeological Watching Brief

Ref: 84410.03
February 2013

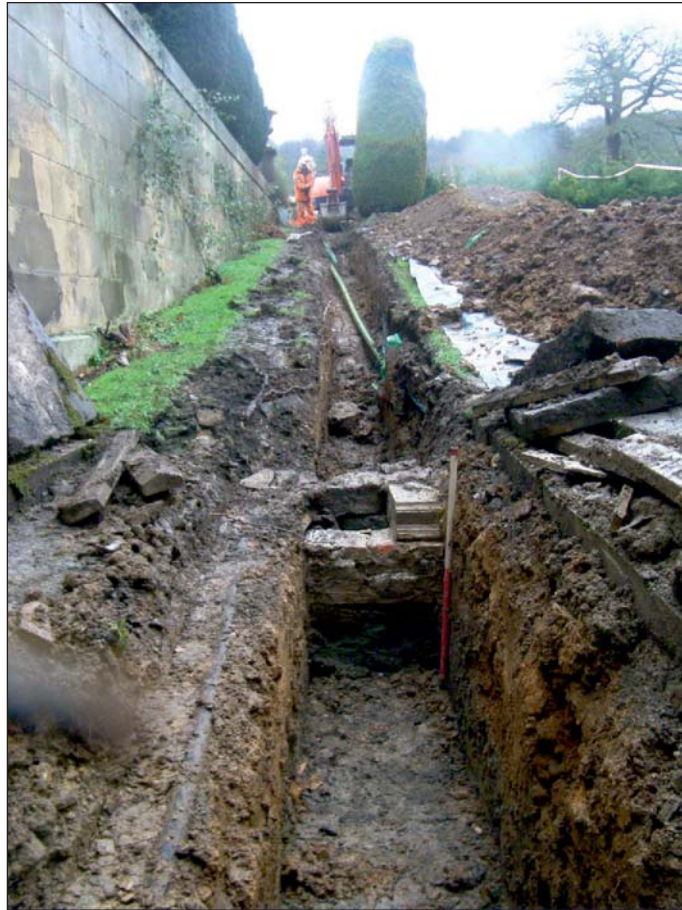
- 4.4.2 Possibly contemporary with the North Range was **1009**, a north-south aligned brick lined culvert at the base of the bank. A reused piece of moulded masonry was incorporated within the cap of this structure (**Plate 1**).

Plate 1: View of southern end of Trench, looking east from the North Range, noting culvert **1009** with reused stone

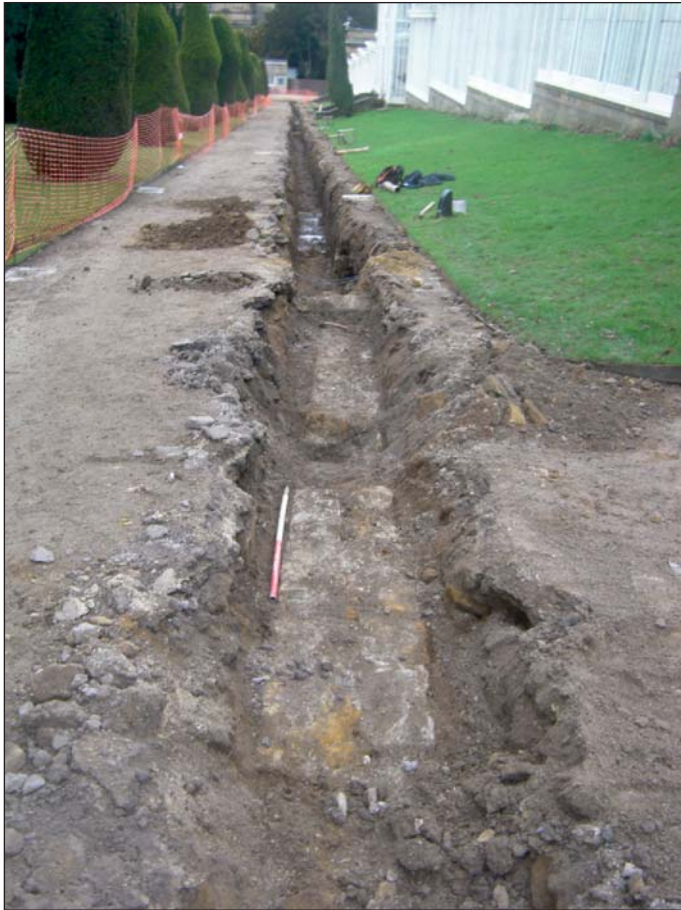
Plate 3: View of Trench, looking west along path beside the Conservative Wall greenhouse, noting wall **1042**

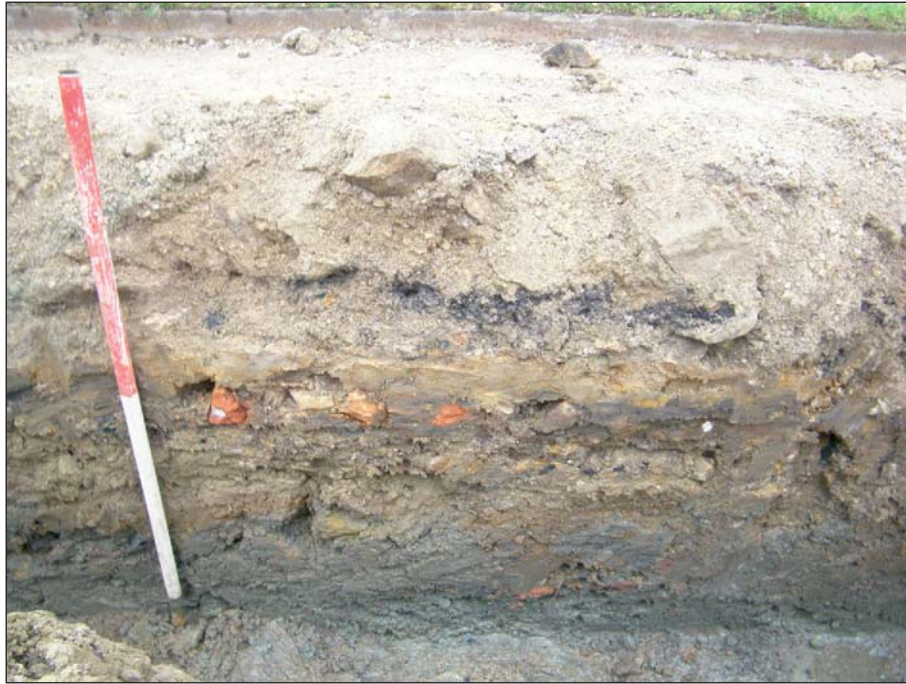
4.2.1 The earliest phase was represented by clay deposit **1005** encountered at a depth of 0.9m within the drive parallel to the east of the house and within the western half of the path to the south of the Conservative Wall glasshouse (**Plate 9**). Based on inclusions of organics and infrequent rubble fragments, the clay was evidently disturbed and may well represent the base of a large pond that was formed in this part of the gardens in the mid to late 17th century.

Plate 9: Representative south facing section within Trench to the southwest of the Conservative Wall glasshouse; noting clay deposit **1005** at base

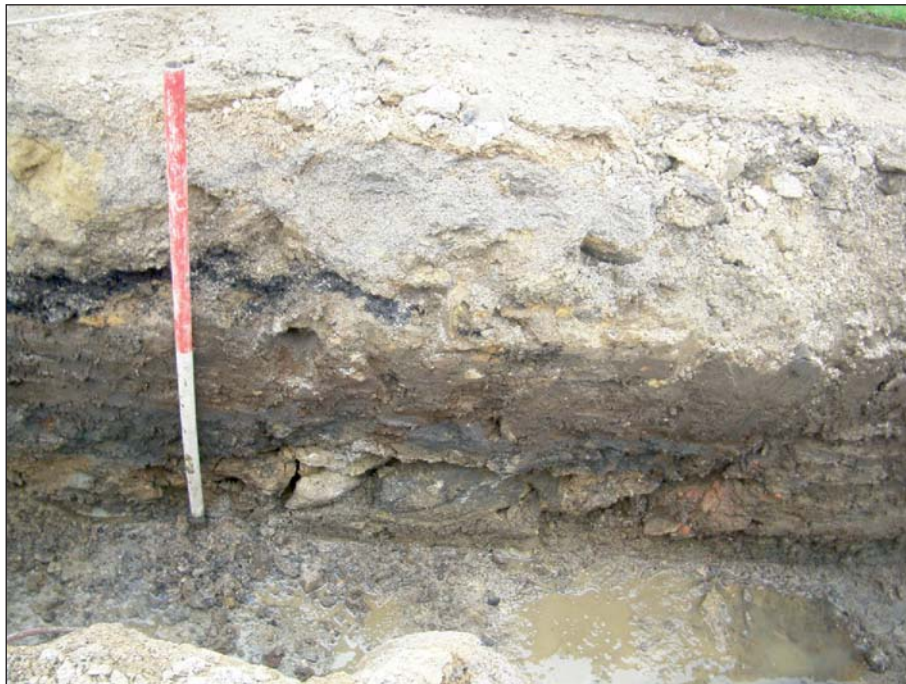
4.2.2 The clay deposit was bounded to the east by narrow loosely structured stone deposit **1025** that could represent the remains of a robbed out wall (**Plate 10**). Beyond **1025** the base deposit in the trench comprised orange brown sandy clay **1026**.

Plate 10: Detail of possible structure **1025**

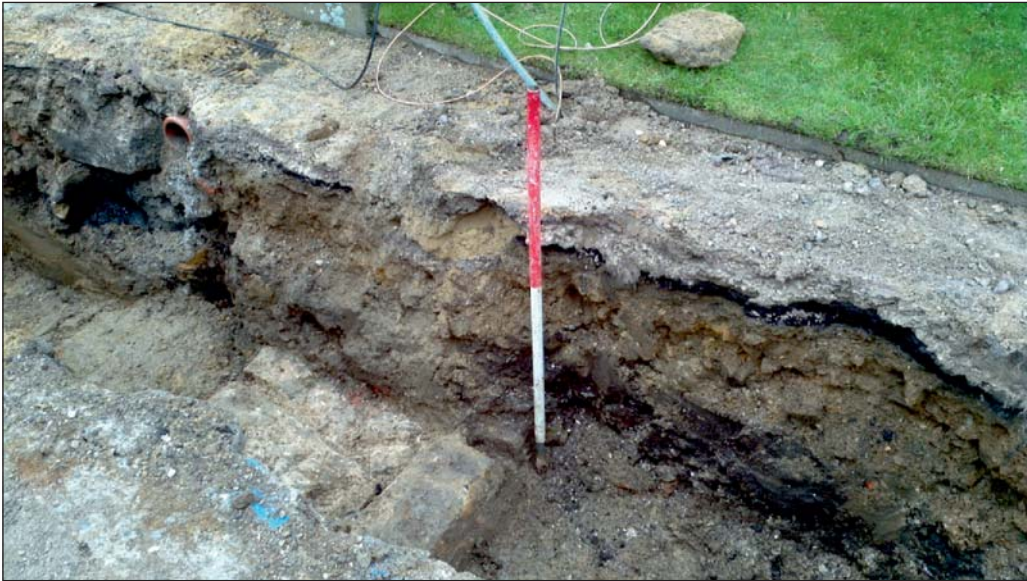
4.2.3 Approximately 30m east of **1025**, to the eastern side of the central staircase of the Conservative Wall glasshouse, was the base course of wall **1018** running north-south at a depth of 0.9m (**Plate 11**). Abutting this structure to the east was buried topsoil **1034** within which fragments of 19th century flower pot and window glass were recovered. The buried topsoil was approximately 10m wide, and bounded to the east by a possible sandstone structure, possibly a parallel structure to **1018**, that had been disturbed by the insertion of a modern drain (**1033**; **Plate 12**). The survival of vertical cut **1045** bounding the edge of the buried soil in line with the eastern edge of structure **1018** suggests it had been robbed out after the formation of the soil. Structure **1018** lies on the approximate line of the historic boundary between the pond and the orchard observed on the 1617 plan (**Figure 3**).

Plate 11: Detail of structure **1018**, noting vertical cut **1045** bounding dark buried soil deposit **1034**

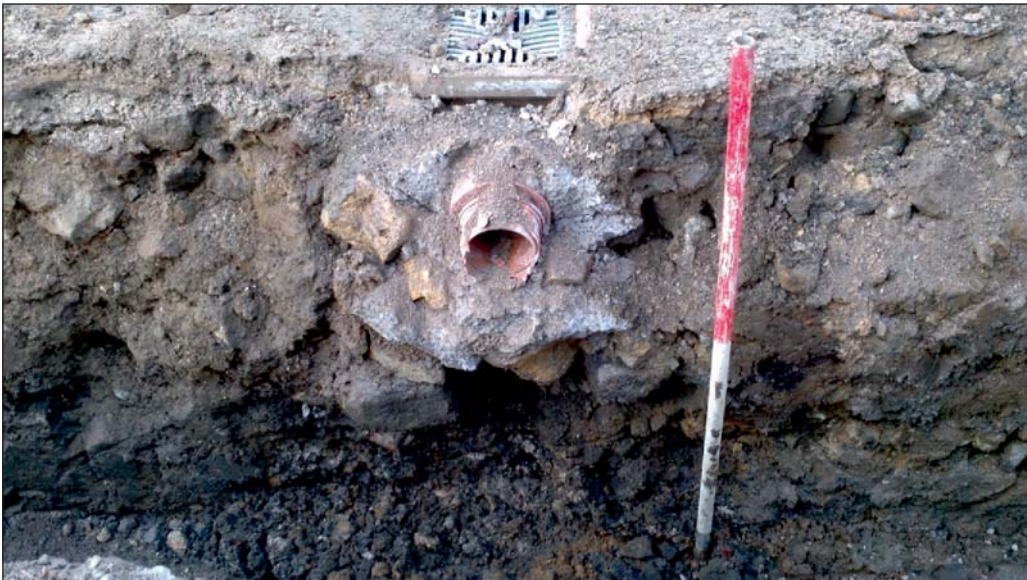
Plate 12: Detail of possible disturbed structure **1033**, bounding eastern extent of **1034**

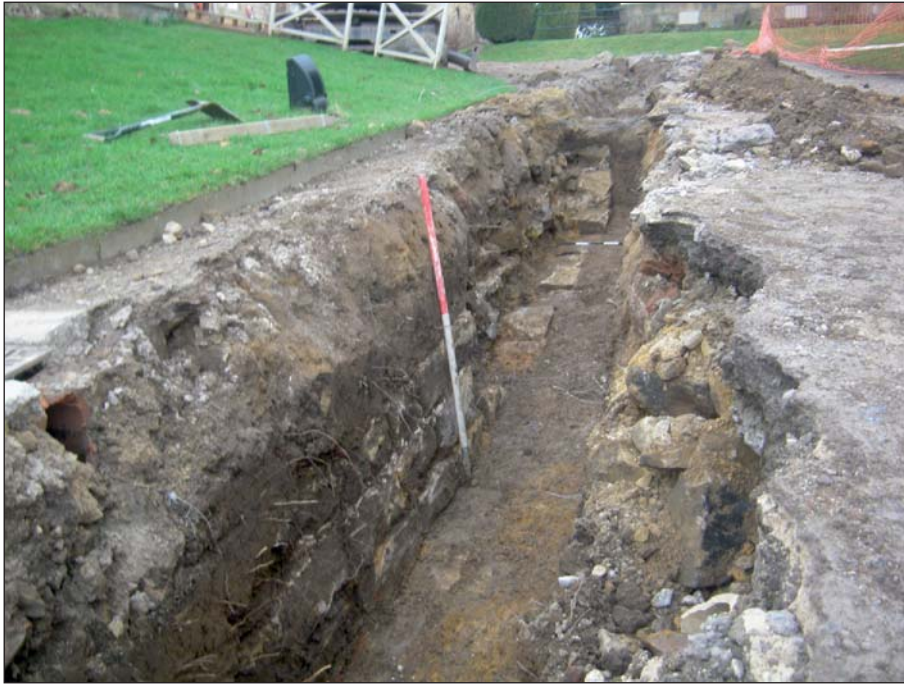
4.2.4 Also contemporary was structure **1042**: a 20m section of wall encountered at the eastern end of the path south of the Conservative Wall glasshouse (**Figure 8**; **Plate 13**). The wall, which ran at a slight angle to the surrounding structures, was of slightly rounded sandstone blocks bonded with a lime mortar. Three courses of stonework were exposed within the trench, with an additional projecting foundation course observed at the base of the excavation, possibly indicating that the ground surface at the time of construction was approximately 1m below the present. The alignment of the wall suggested it continued beneath the Conservative Wall glasshouse to the west, whilst at its eastern end the wall appeared to have been truncated by culvert **1014**. The wall either terminated west of the

main glasshouse or turned south to run parallel to it, however, interpretation was hampered by several modern intrusions relating to utility trenches for a gutter, data cable duct and water pipe. This wall is tentatively dated to the 17th century based on comparison to similarly constructed walls within the grounds, and may well represent the northern wall of the 'ould orchard' of William Senior's 1617 map of Chatsworth manor.

Plate 13: View of wall **1042**, looking northeast

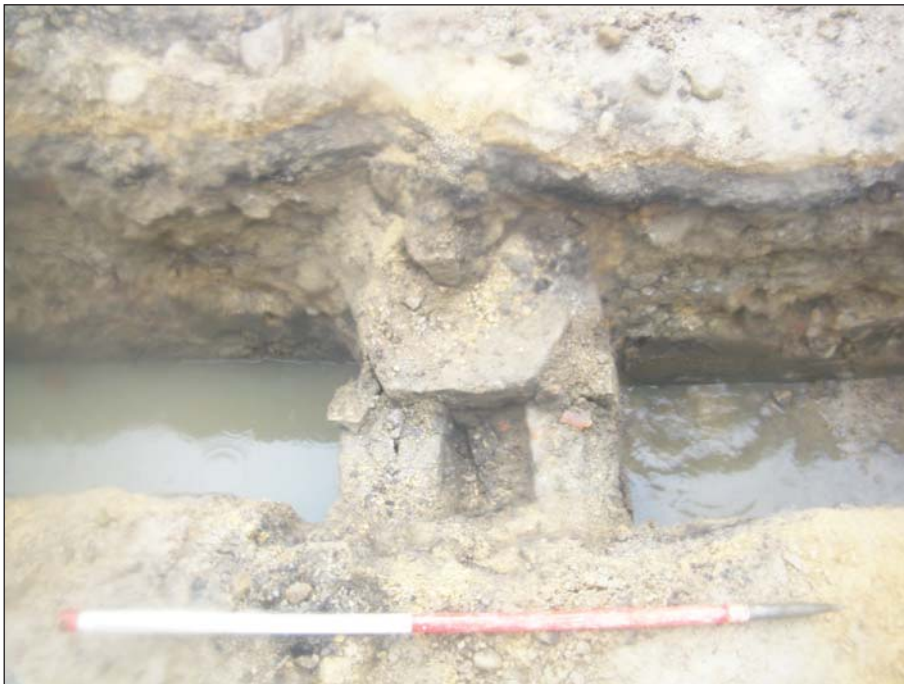
- 4.3.2 A thick overlying deposit of made ground (deposits **1002**, **1020**, **1032** and **1035**), likely reflecting the final level of the grounds in the 18th century, contained a network of culverts (locally known as soughs). No construction cuts were observed for these culverts, suggesting they were laid contemporaneously with the made ground. The earliest examples of these comprised stone built structures **1013**, **1014**, **1015**, **1017** (structure **1041** was possibly a continuation of this), **2013**, and **2014** which all comprised stone rubble built sides with large capstones (**Plates 14-17**).

Plate 14: Detail of east-west aligned stone culvert **1013** in path south from Flora's Temple

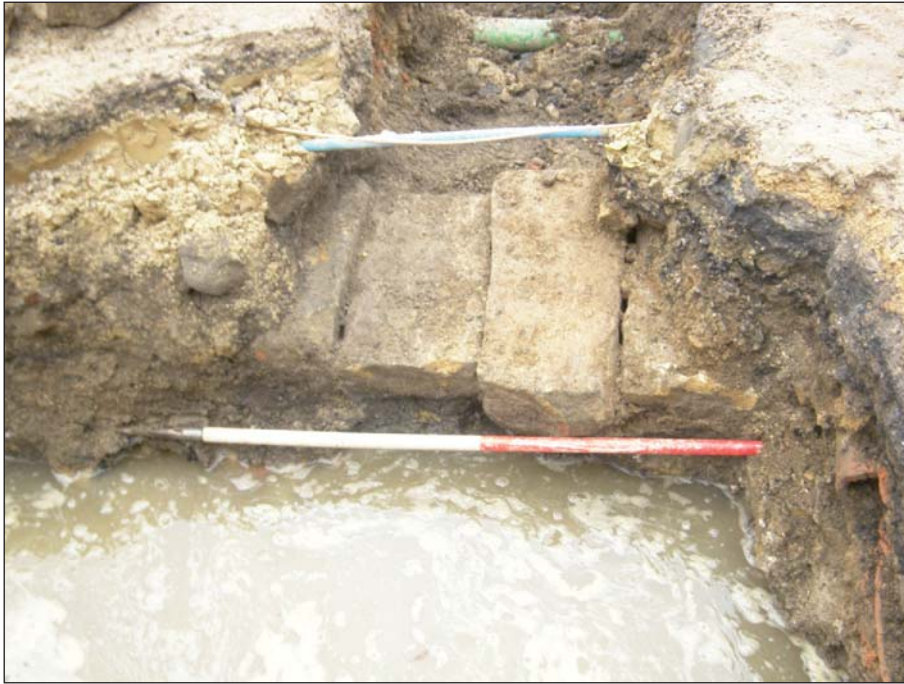
Plate 15: Detail of east-west aligned stone culvert **1014** at corner of Trench as it turns to run parallel with the Conservative Wall glasshouse

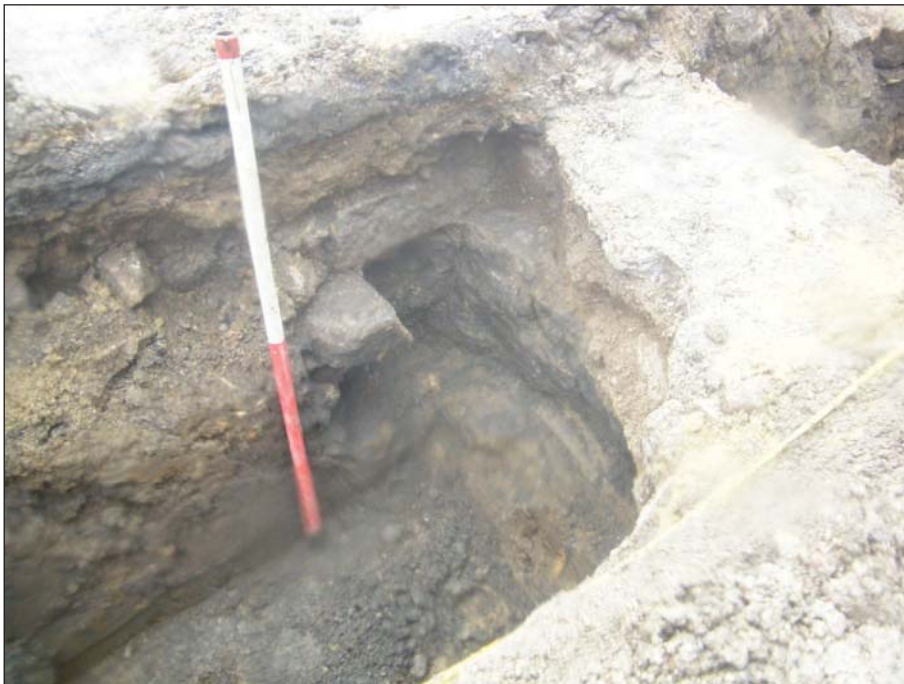
Plate 16: Detail of north-south aligned stone culvert **1015**, at western end of Trench parallel with the Conservative Wall glasshouse

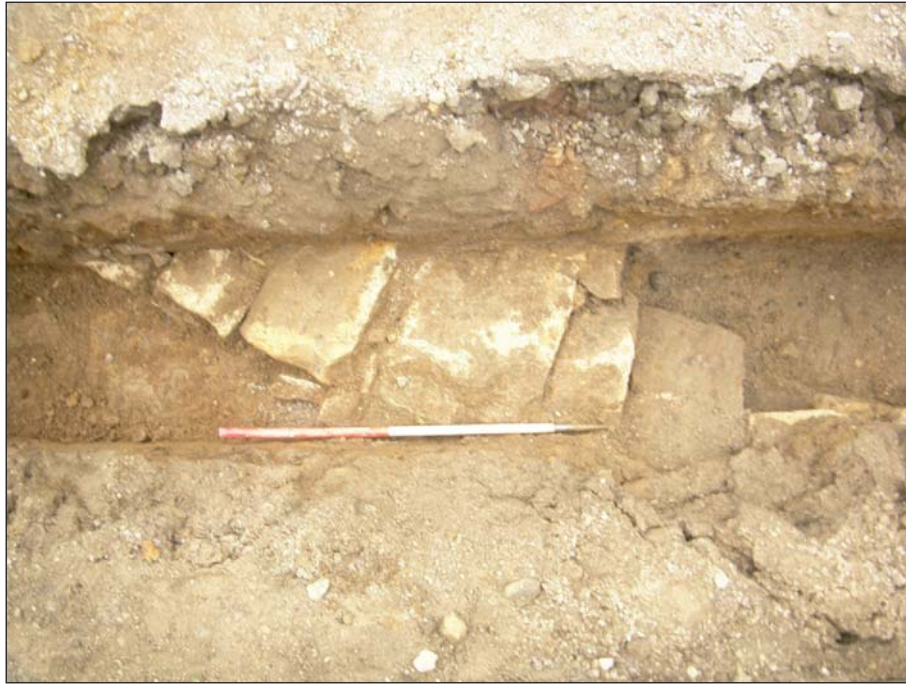
Plate 17: Detail of northwest-southeast aligned culvert **1017** towards centre of Trench, parallel with the Conservative Wall glasshouse

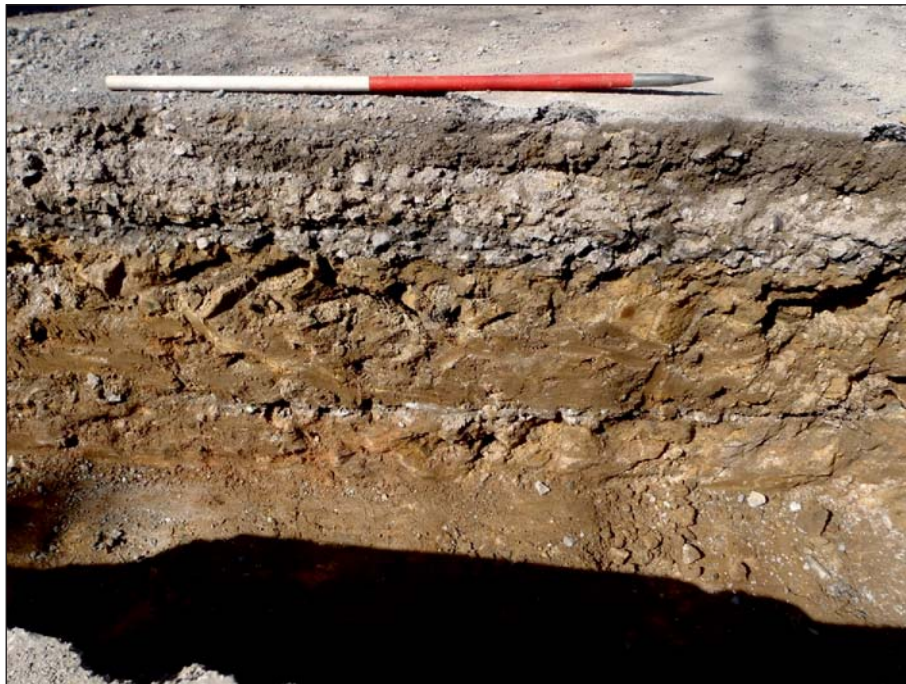
- 4.3.3 Towards its eastern end, the Scheme rises up the hillside and passes the stables constructed 1750-60 for the 4th Duke of Devonshire by the architect James Paine. The deposits encountered in this area comprised rough large stone deposits **2007**, **2010**, **2011** and **2012** likely formed during the construction of the stables (**Plate 18**).

Plate 18: Representative section of Trench east of Stables (contexts **2008-2012 & 2015**)

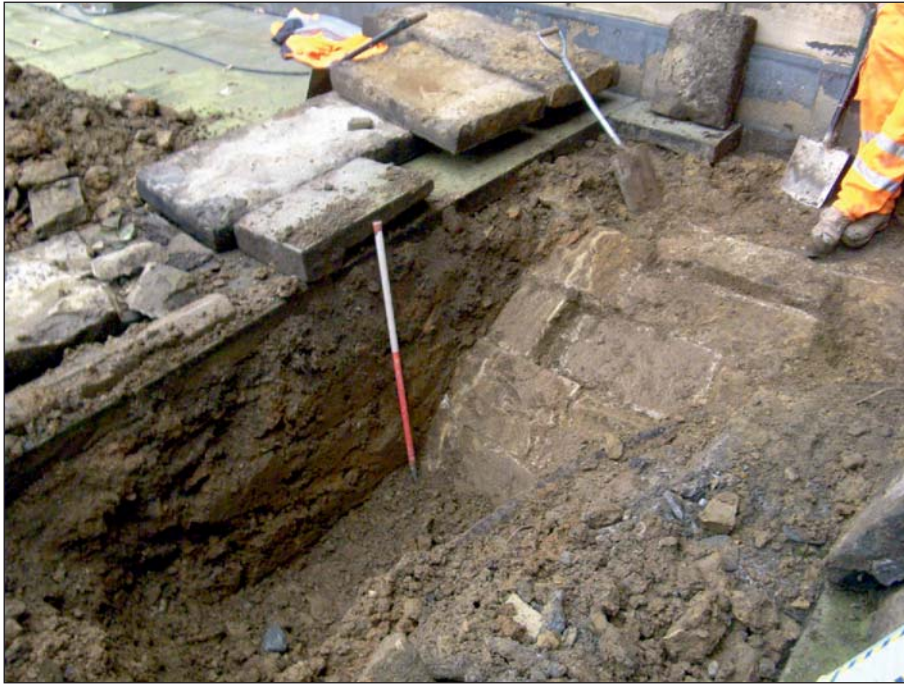
- 4.4.1 At its western end the Scheme exposed the curved profile of lime mortared sandstone block footings **1007** corresponding to a sub-ground level alcove within the North Range (**Plate 19**). The footings were abutted by mid-grey clay **1010**. It was not possible to determine whether there was a cut for the foundations due to extent of disturbance created in the vicinity from an existing plastic water main. The North Range was constructed 1820-1845.

Plate 19: Detail of exposed curving foundations **1007** to North Range

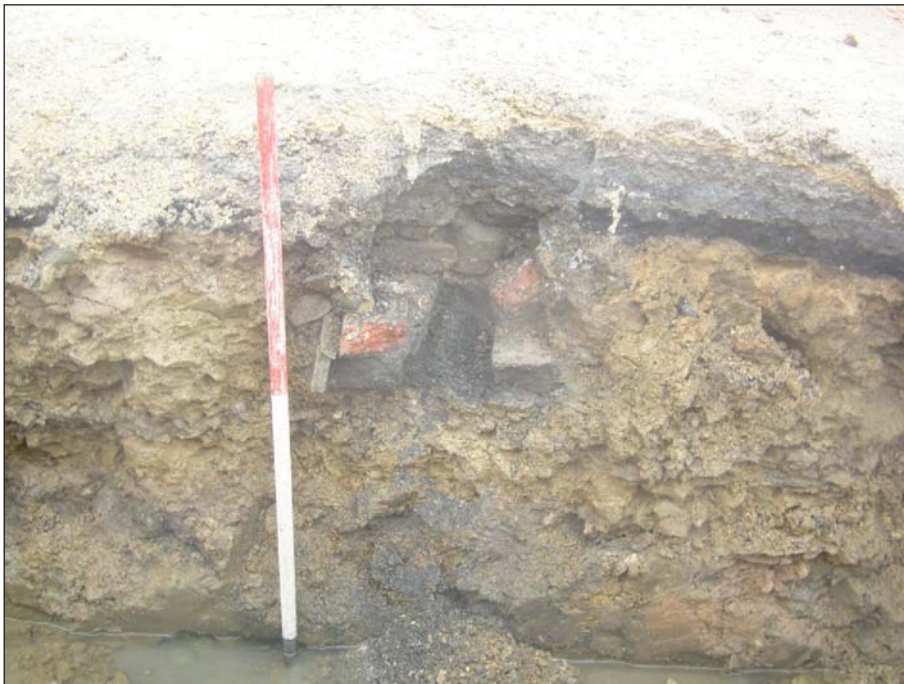
Plate 20: Example of brick lined culvert **1012** in path south from Flora's Temple
