Canadian Estate, Bulford, Wiltshire

Archaeological Evaluation Report

Ref: 76850.04
February 2013

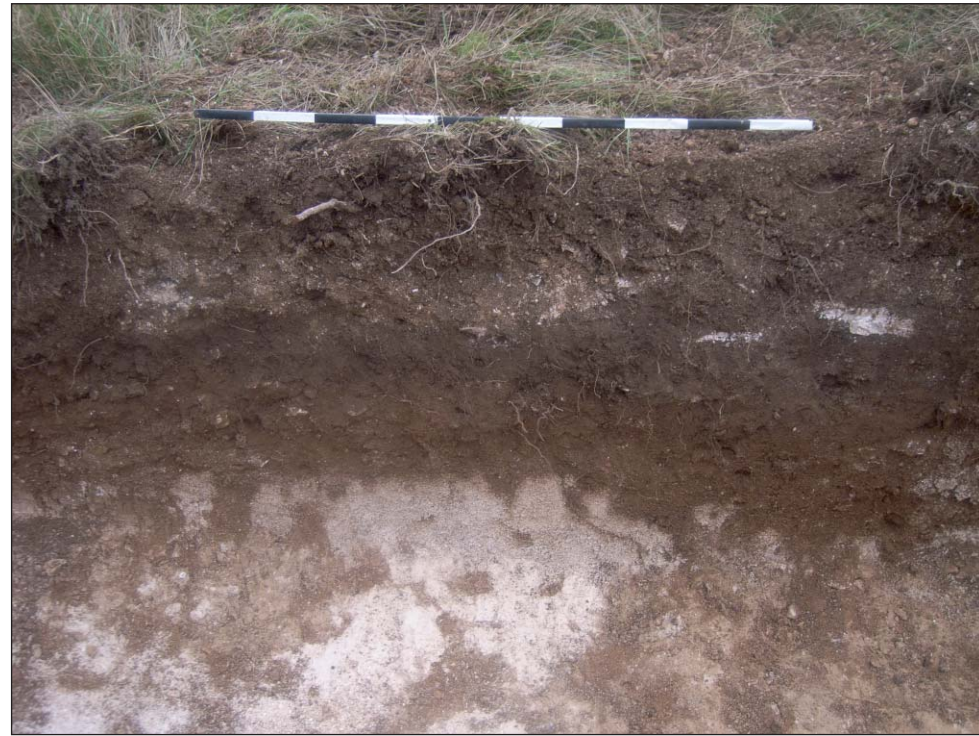
- 4.1.4 **Trenches 2, 3 and 4** lay to the south-west of the development area. Here modern levelling layers (**202, 203, 302 and 402**) were recorded above the natural colluvium. No archaeological features were encountered though modern utility trenches were observed in **Trenches 3 and 4**.

Plate 1: North-east facing section of Trench 3

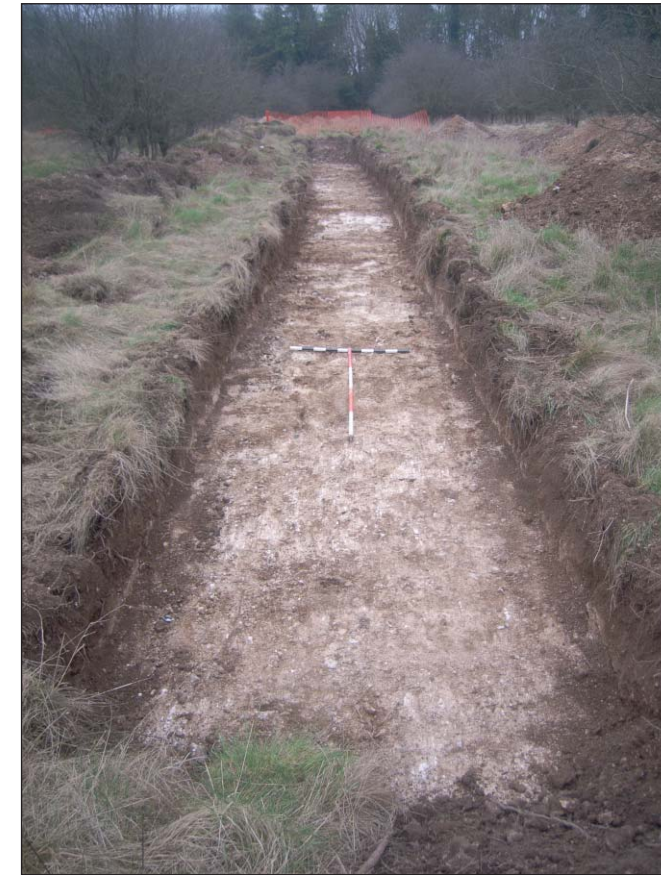
Plate 2: Trench 3, view from north-west

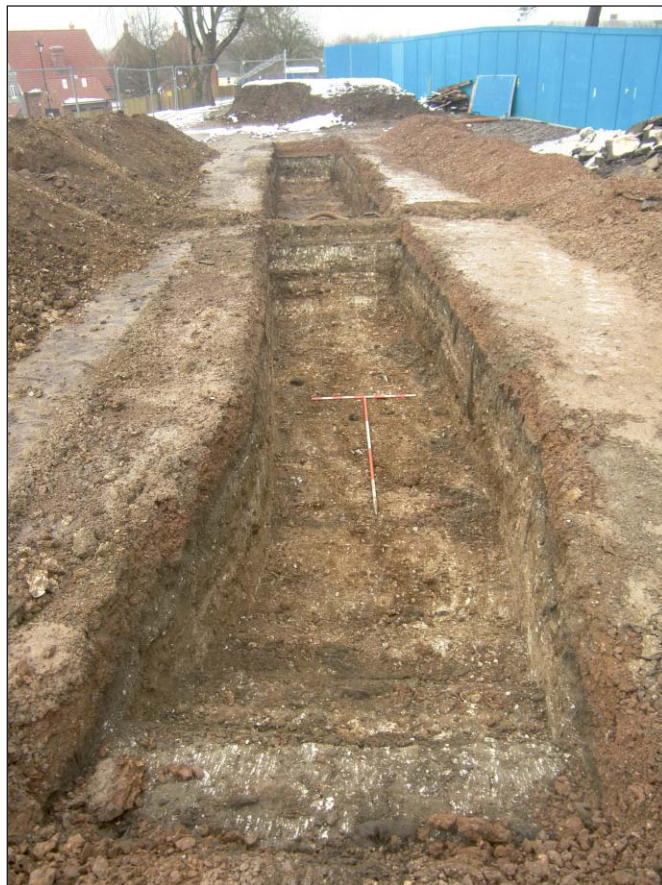
- 4.1.5 The second and final phase of trenches consisted of the mechanical excavation of two trenches to the north-east of the main development site (**Trenches 5 and 6**), within the current Site compound. Here a substantial depth of made ground deposits were encountered in each trench; excavation continued to 1.2m without encountering the natural geology.

- 4.1.8 A modern utility was also encountered in **Trench 5**.

Plate 3: Trench 5 view from south-east

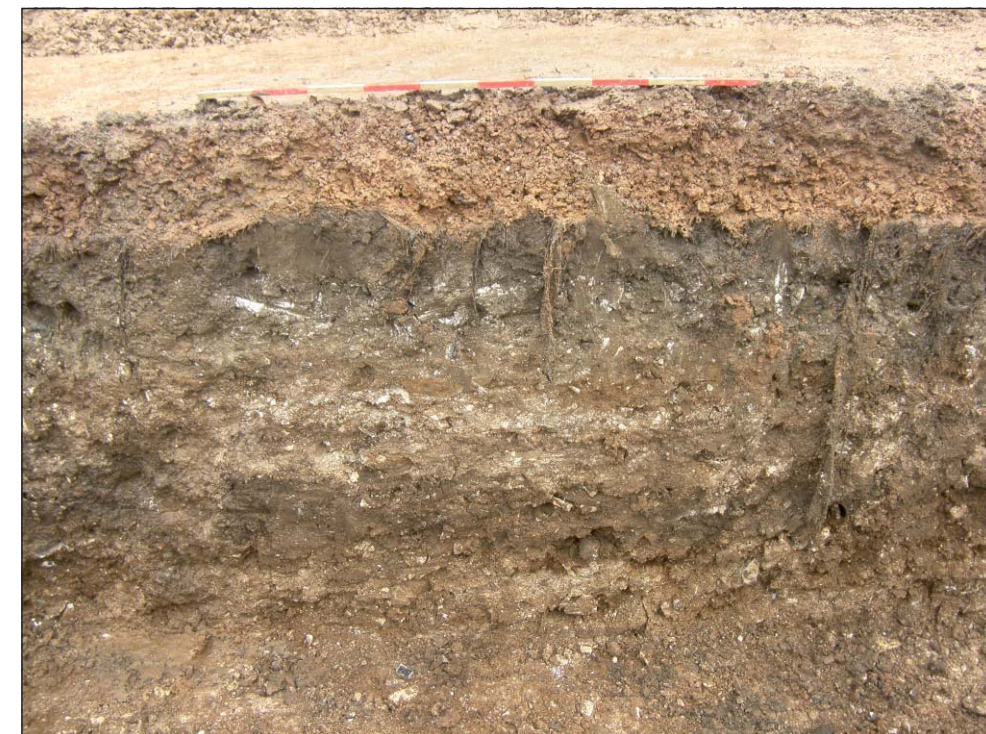
Plate 4: South-west facing section of Trench 5
