WORTLEY TIN MILL, WORTLEY,
BARNESLEY,
SOUTH YORKSHIRE

Archaeological Desk-based Assessment and Survey

Prepared for:
Hunshelf Parish Council

Project No: 87410.01

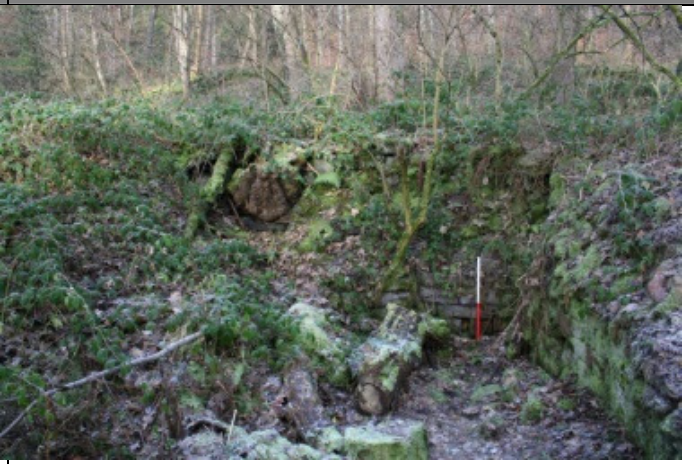
Feature No	Description	Group	Photo
101	Retaining walls between the Tail race and wheel 3 to the west of the Site. Same as 102 and forms a right angle which is abutted by 103 but possible tied into 104. The wall is constructed from rough cut sandstone and not bonded. The function of this wall is unclear.

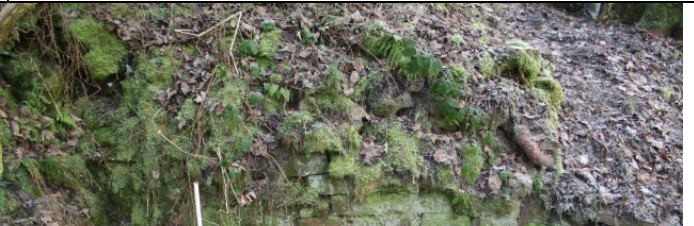
102	Part of retaining wall with 101. Tied into 101 and same build.

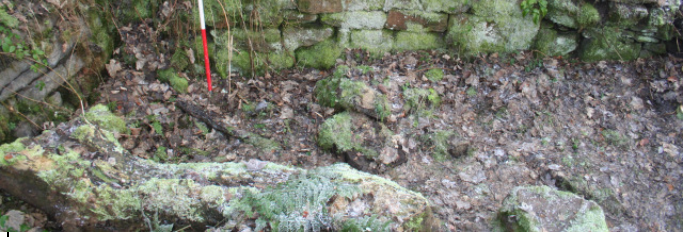
103	North south short rubble wall constructed from random stone. 103 abuts the south end of 102.

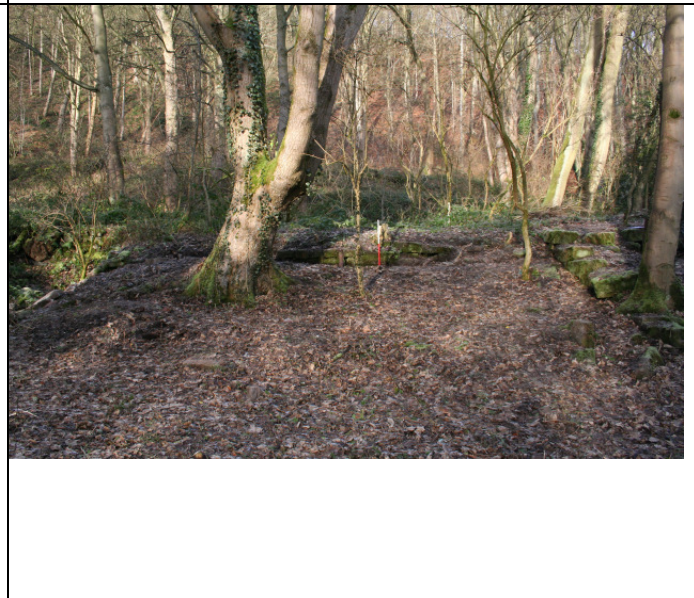
104	East west retaining wall, similar construction to 101, built between 102 and 105 of wheel 3. The wall separates two working zones, to the north and south.

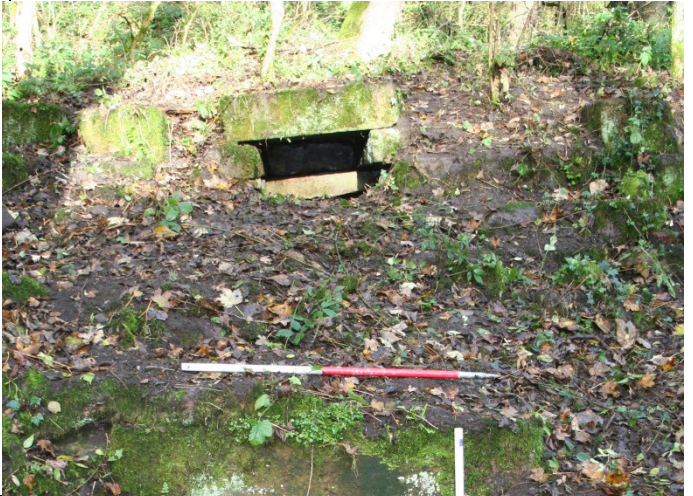
Feature No	Description	Group	Photo
105	Western wall of a former wheel pit 3, possibly later than wheel pit 2. Constructed from large ashlar blocks, possibly due to mechanical movement.	Wheel 3

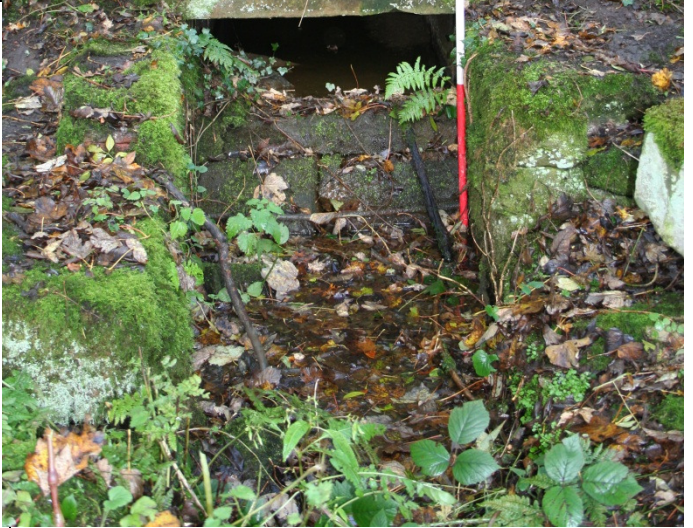
106	East wall of wheel pit 3 same build as 105. Creates a narrow channel with 105. 105 and 106 have an Fe bolt at their southern ends which are fixed in with concrete. The entrance into the channel between 106 and 105 at the north rises the water channel turns into it, suggesting it may have once housed a wheel. The pit has flagstones placed over suggesting it was decommissioned	Wheel 3

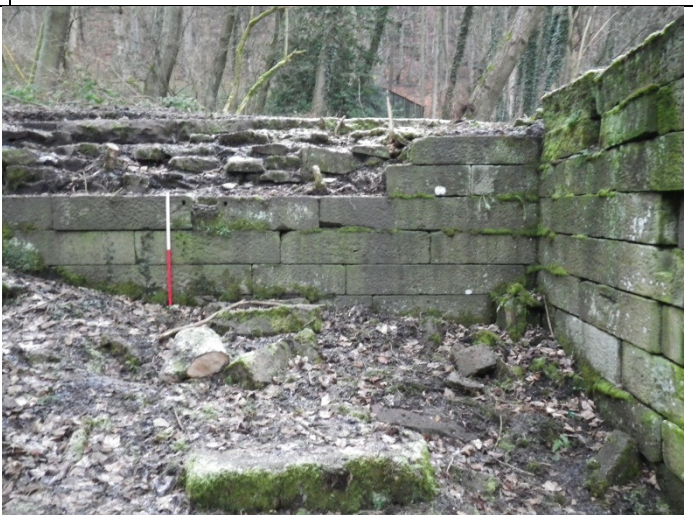
107	Large Ashlar wall running east west with a central hole possibly for supporting an axle. Part of wheel pit 2 and could be the larger wheel. Wheel 3 crosses the tale race from the wheel at a right angle, suggesting it is earlier than wheel 3.	Wheel 2

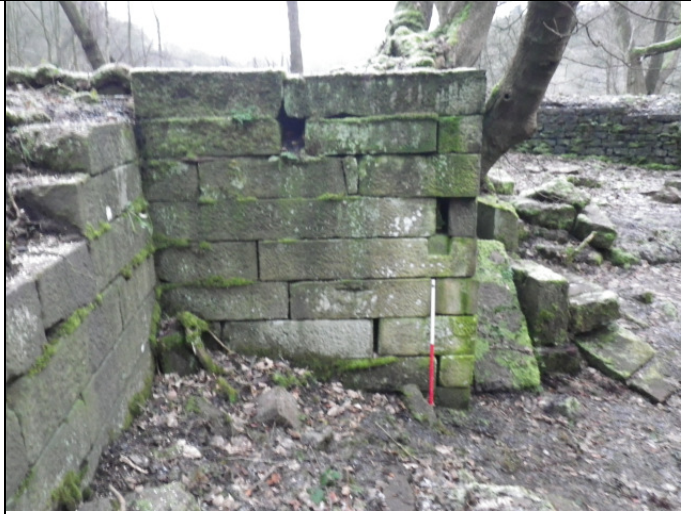
Feature No	Description	Group	Photo
108	Same as 107, but forms a dogleg that abuts 110. The west facing element has a joist hole, possibly for an ancillary structure associated with the wheel to the south of 107.	Wheel 2

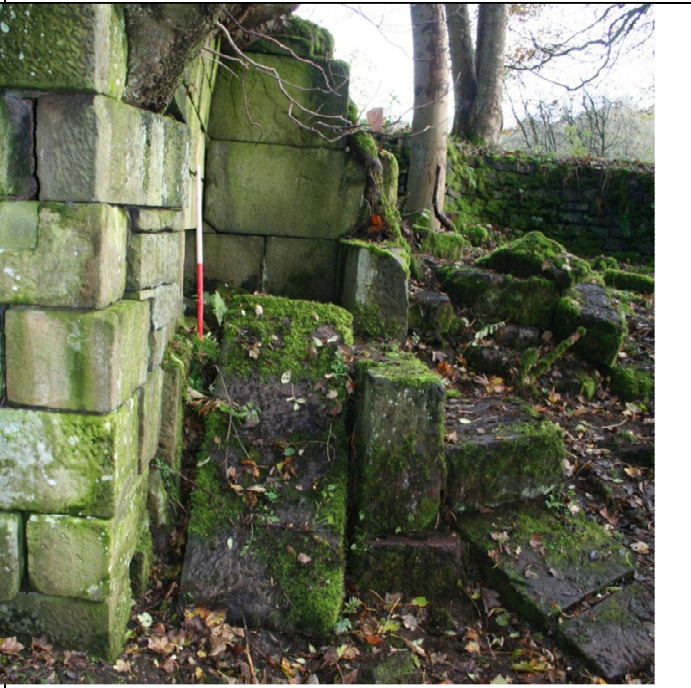
109	Sluice gate and shuttle for wheel pit 2. Has parts of the Fe gate remaining, and masons marks on the shuttle walling. Constructed from thin large Ashlar blocks	Wheel 2

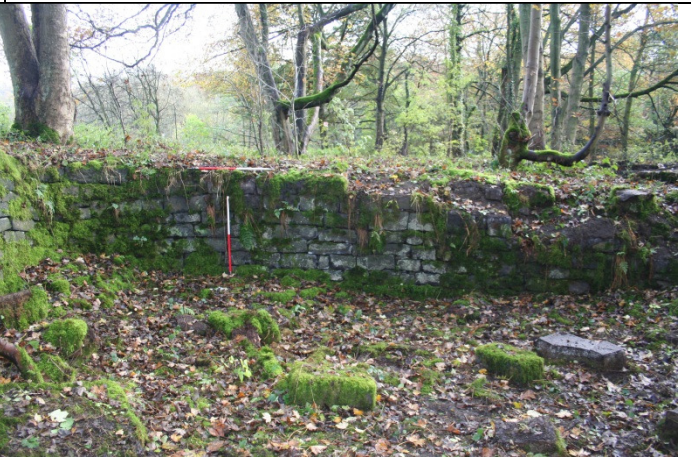
110	Semi circular roughly built wall which possibly acts as a split for goits. The wall sits the east of the main complex of structures. The area does not appear to be roofed on the OS maps.

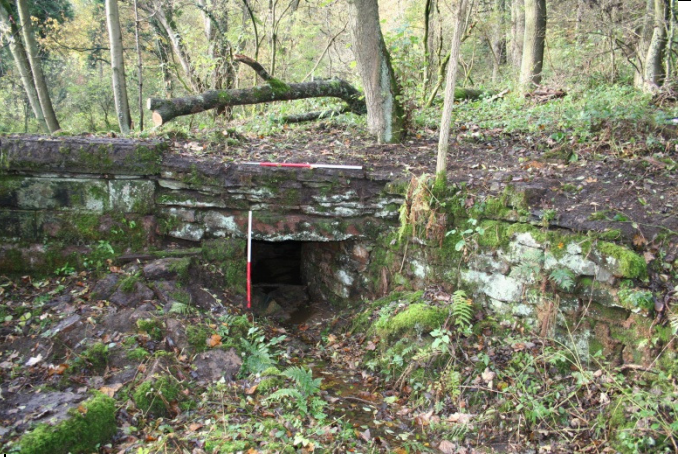
Feature No	Description	Group	Photo
111	Roughly built sandstone grot running east west to the north of wheel pit 2 and into wheel pit 3. Possibly diverted by 108. North walling

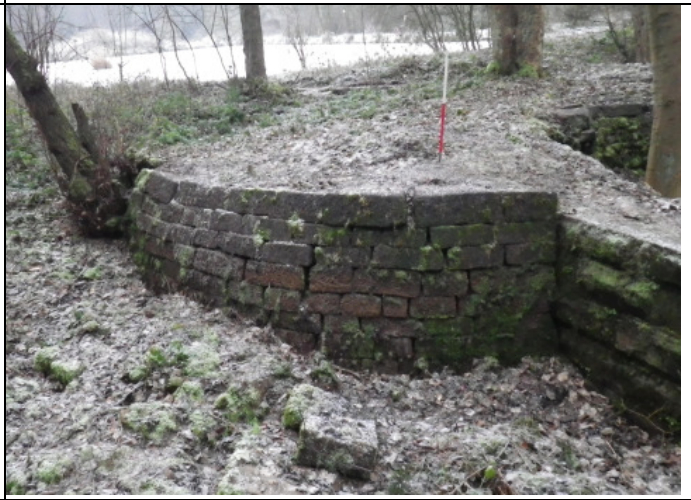
112	Well hewn semi-circular wall abutting 108. Directs the flow of water into Wheel 2. The wall abuts 110 suggesting it is a later build or more likely a rebuild.

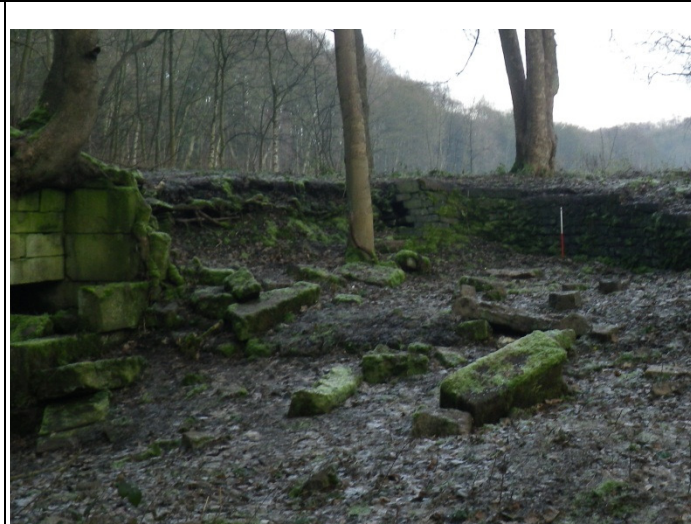
113	Linear bank of stones possibly representing a former wall running north south from 109.

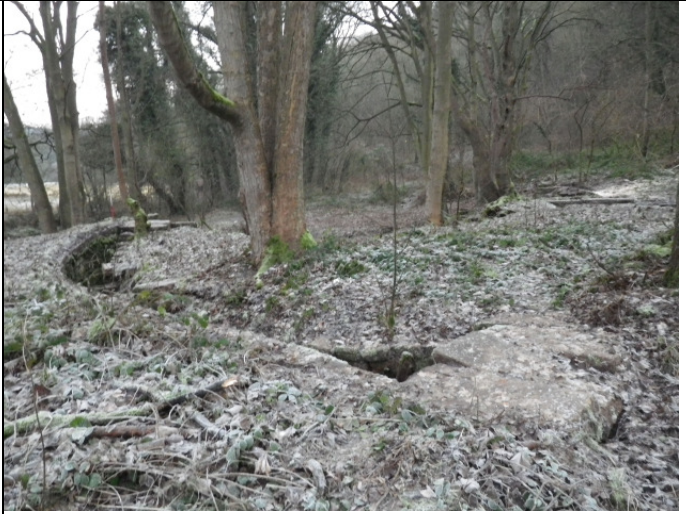
- 6.2.10 Two large stones span the width of the goit at its dam end and wheel end (**114**). Elsewhere on Site, similar stones have been observed to be associated with sluice gates, and it is likely that these may have been used to access a sluice that would have controlled the water supply to Wheel 1. South of the centre of the goit was a stone spanning its width and keyed into either wall. It was situated approximately 1.2m below the top of the wall and of unknown purpose.

Feature No	Description	Group	Photo
114	Roughly built curvi-linear tail race. Head race and wheel pit. Two separate foot bridges have been built at either end by spanning the channel with large flat stones. These may be platforms which were placed to operate a sluice.	Wheel 1

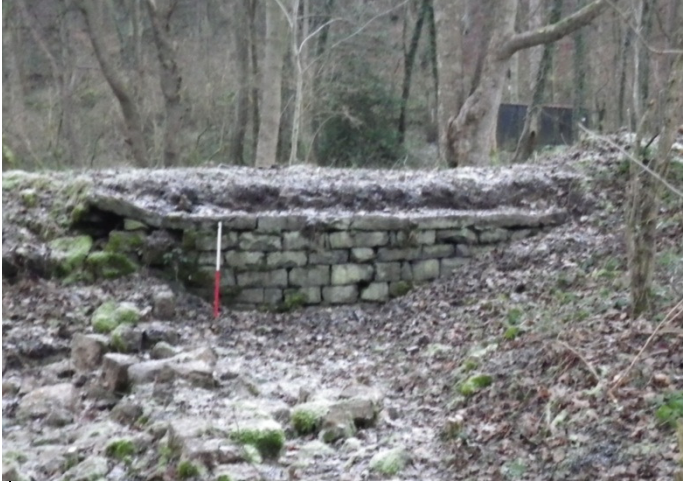
115	Retaining wall for 114 separating it from 116. Roughly lain sandstone

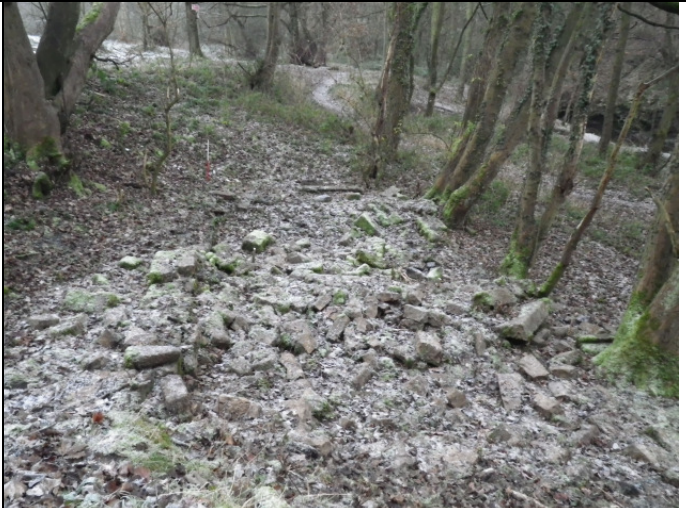
- 6.2.14 Structure **116** formed a rectangular building separated into two cells by an internal division. The structure is covered in rubble and demolition material. The survey revealed the possible location of two doorways in the north and south walls of the western cell, although this may be a result of differential decay of the walls. The walls are built from dressed, sandstone blocks measuring 0.4 x 0.2 x 0.2m, hewn to a greater standard than the nearby mill race **114**. Some of the rubble suggests that the structure would have had large pieces of masonry within its walling, suggesting an industrial rather than domestic origin, although these may be intrusions from Wheel 1. The building appears on the 1801 plan (**Figure 5**).

116	Rectangular structure with two cells and possible doorways to the north west, south and an internal door way to the north of the dividing wall. Rubble suggests possible industrial use due to large load bearing stones.

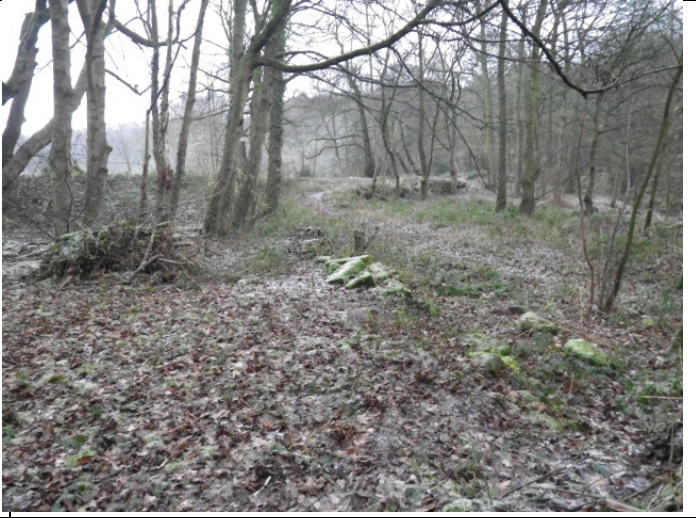
Feature No	Description	Group	Photo
117	Boundary wall exiting as an east west linear bank.

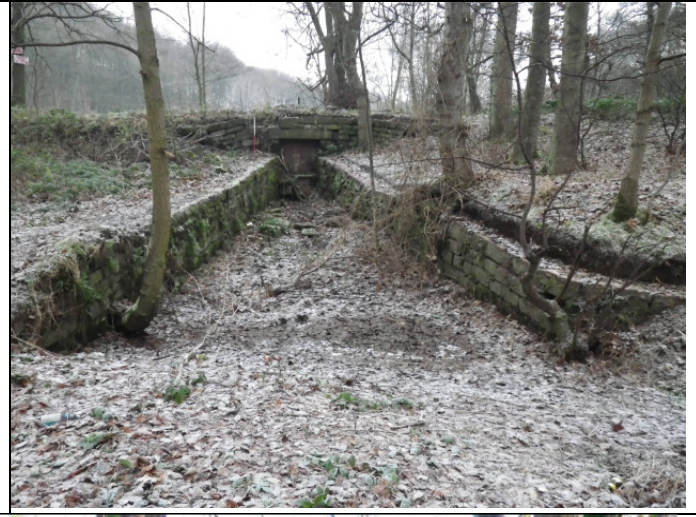
- 6.2.36 An overflow from the dam (feature **118**) is situated to the south east of the mill complex. The observed structure is built from sandstone blocks. The original sluice has been replaced by red brick blocking and an Fe valve.

118	Outflow/bypass at south west of dam. Built from Sandstone blocks. Original sluice has been replaced by red brick blocking and an Fe valve.

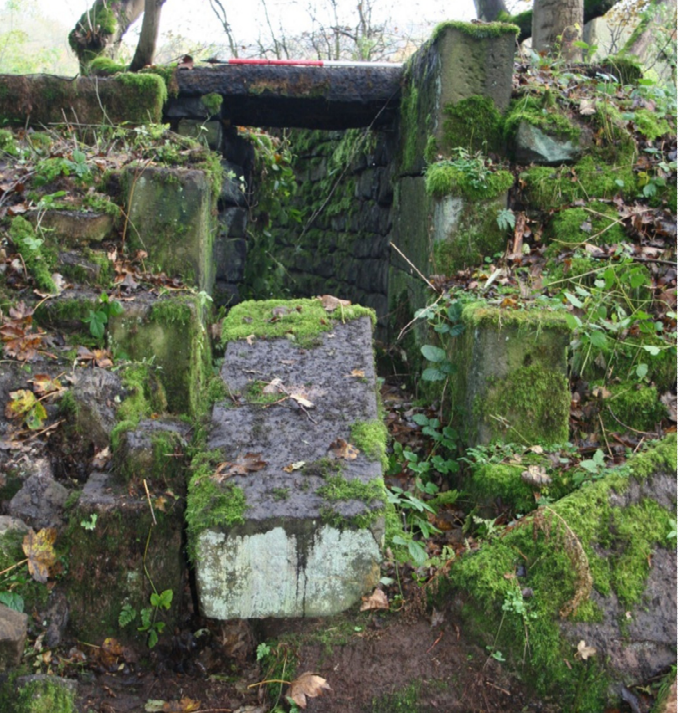
119	Remnant of substantial ashlar structure indicating location of the wheel house structure for Wheel 1. Clearance around the structure revealed a continuation of the parallel walls of the wheel pit structure extending to the west.	Wheel 1

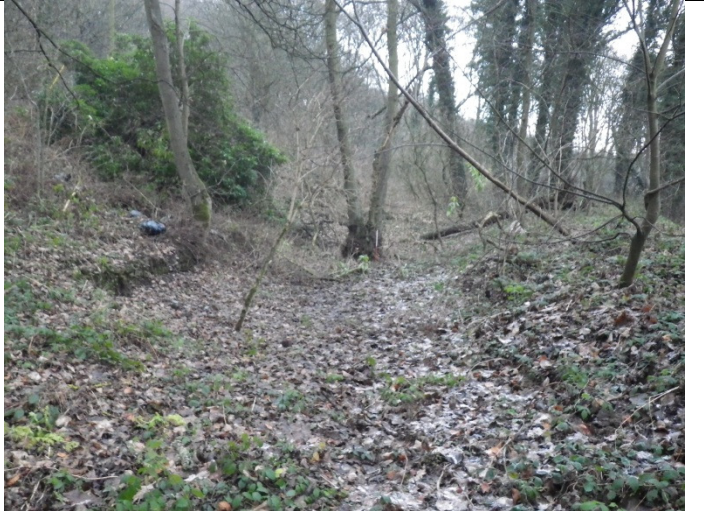
Feature No	Description	Group	Photo
120	<p>Linear shallow ditch forming the remnant of the tail goit from the mill towards the Don. Now dry and presumably silted up. One section of masonry wall was observed on the northern bank of the goit.</p>

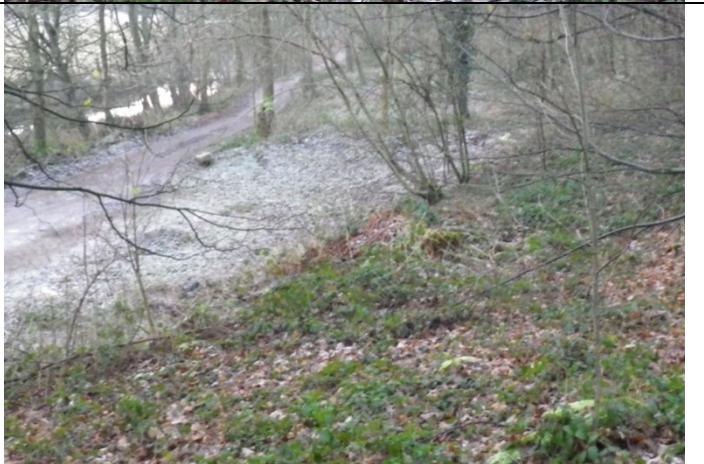
121	<p>The site of the lower terrace of cottages is evidenced by a large level building platform. No structural remains were visible above ground.</p>

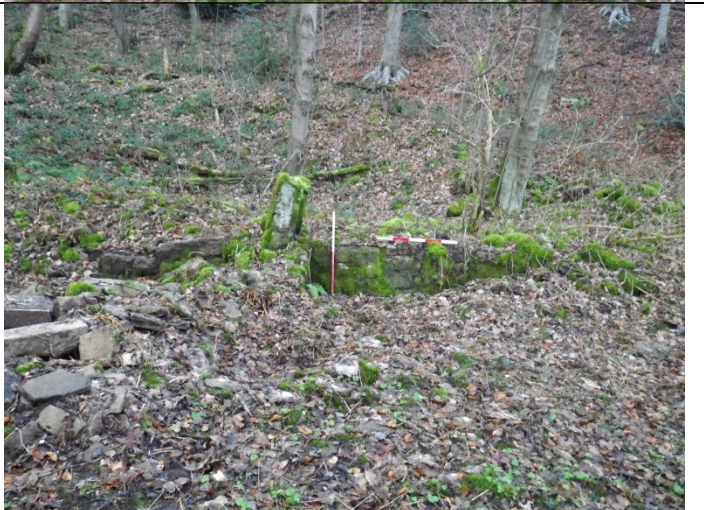
122	<p>Collapsed stone structure forming a 'T' shape in plan. This building is situated in the location of the northern cottages but correlates with a smaller structure built following the demolition of the cottage between 1936 and 1955. The new structure is reputed to have been used as a pig sty.</p>

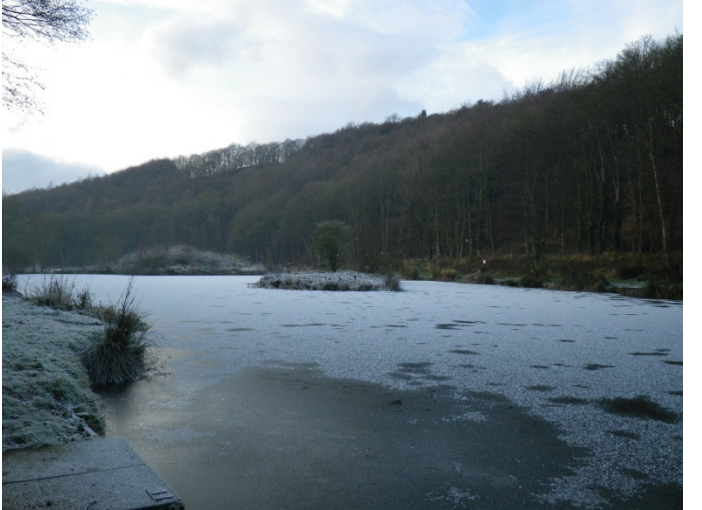
Feature No	Description	Group	Photo
123	<p>Mill pond, now fishing reservoir, situated to the east of the mill complex. Altered in the late 20th century but largely respects the northern boundary of the original mill pond. In conversion to fishing the pond was divided by a land bridge, with a second detached island situated towards the centre of the eastern half of the pond.</p> <p>[The image for this asset is taken from the eastern end of the pond – looking west].</p>

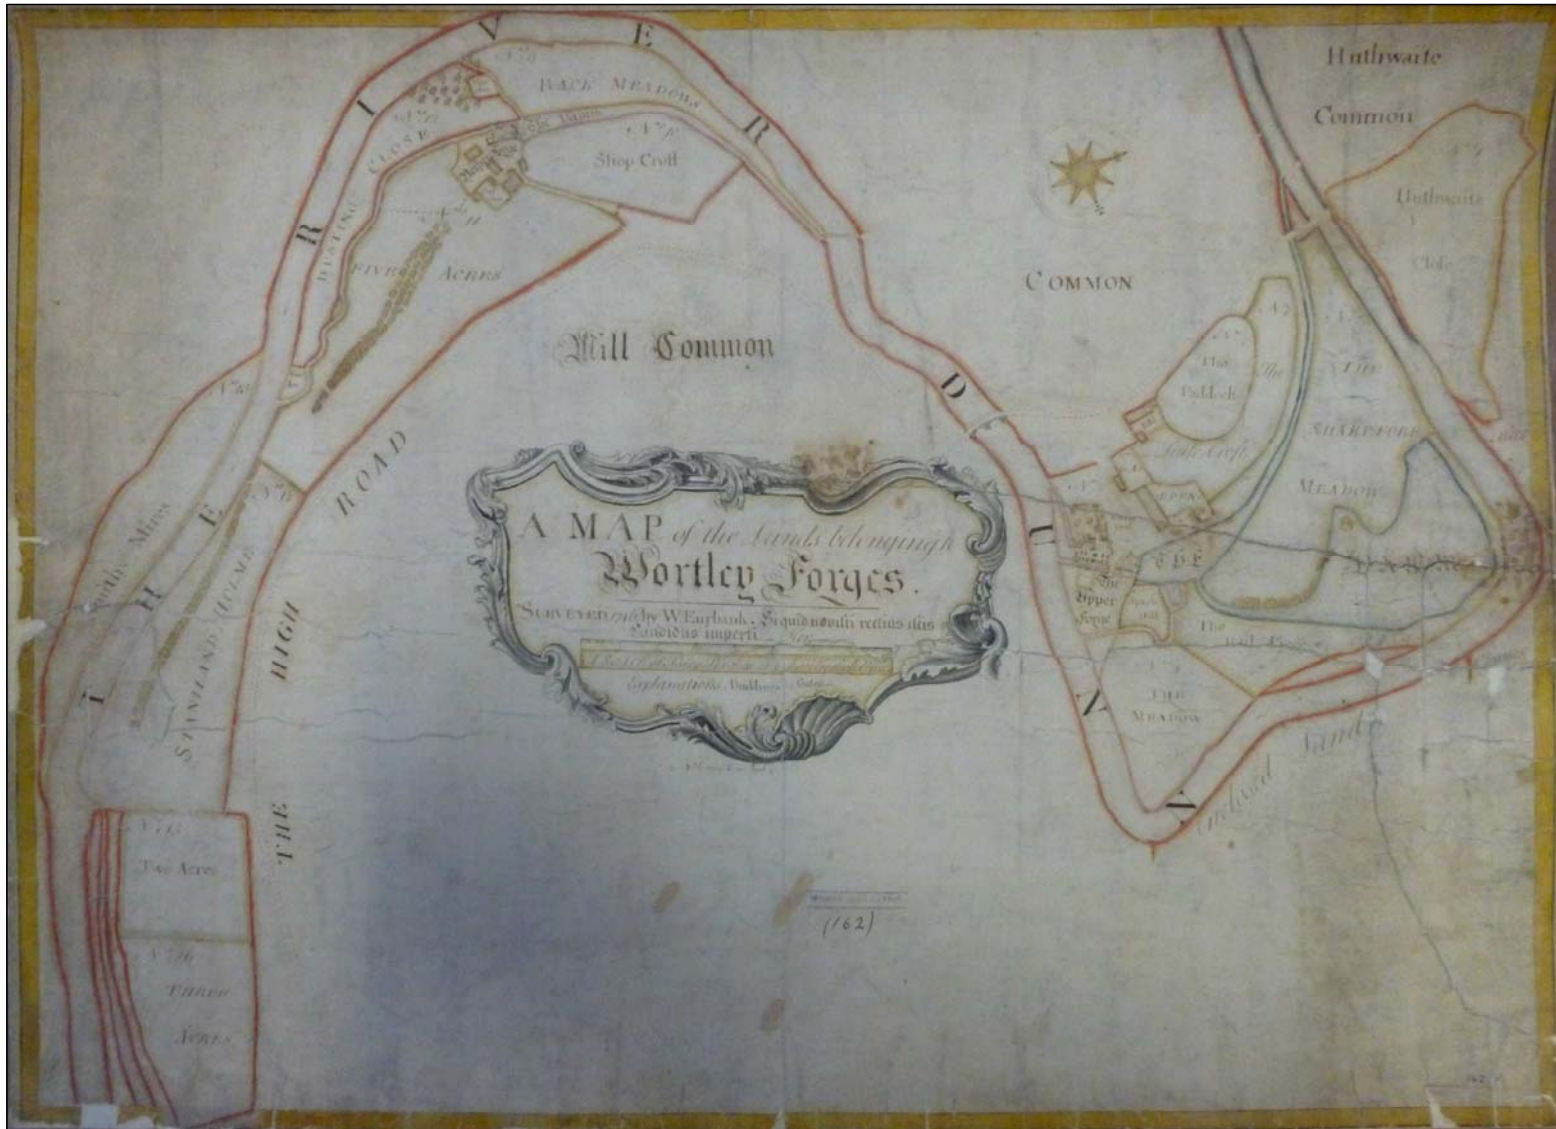
Figure 3

Reproduced with permission of Sheffield Archives
Sheffield Archives ref. WC/162

- 3.4.12 In parallel with this growth a group of interconnected industrial sites developed during the post-medieval period along a 4 km stretch of the River Don stretching north from the Site within the rural landscape of Penistone, Tankersley and Silkstone parishes. The area was favourable for industrial enterprise as the raw resources for iron working were abundant in the area with the Don possessing the raw power to drive the processes. The works developed in a spread out chain along the river in order for each to pull the maximum possible energy from the 3-4m fall of the river between each site (SYTHT 2009, 5). A map from 1746 depicted the lands held with the Wortley Forges (**Figure 3**), but no similarly early plan was found for the Site.

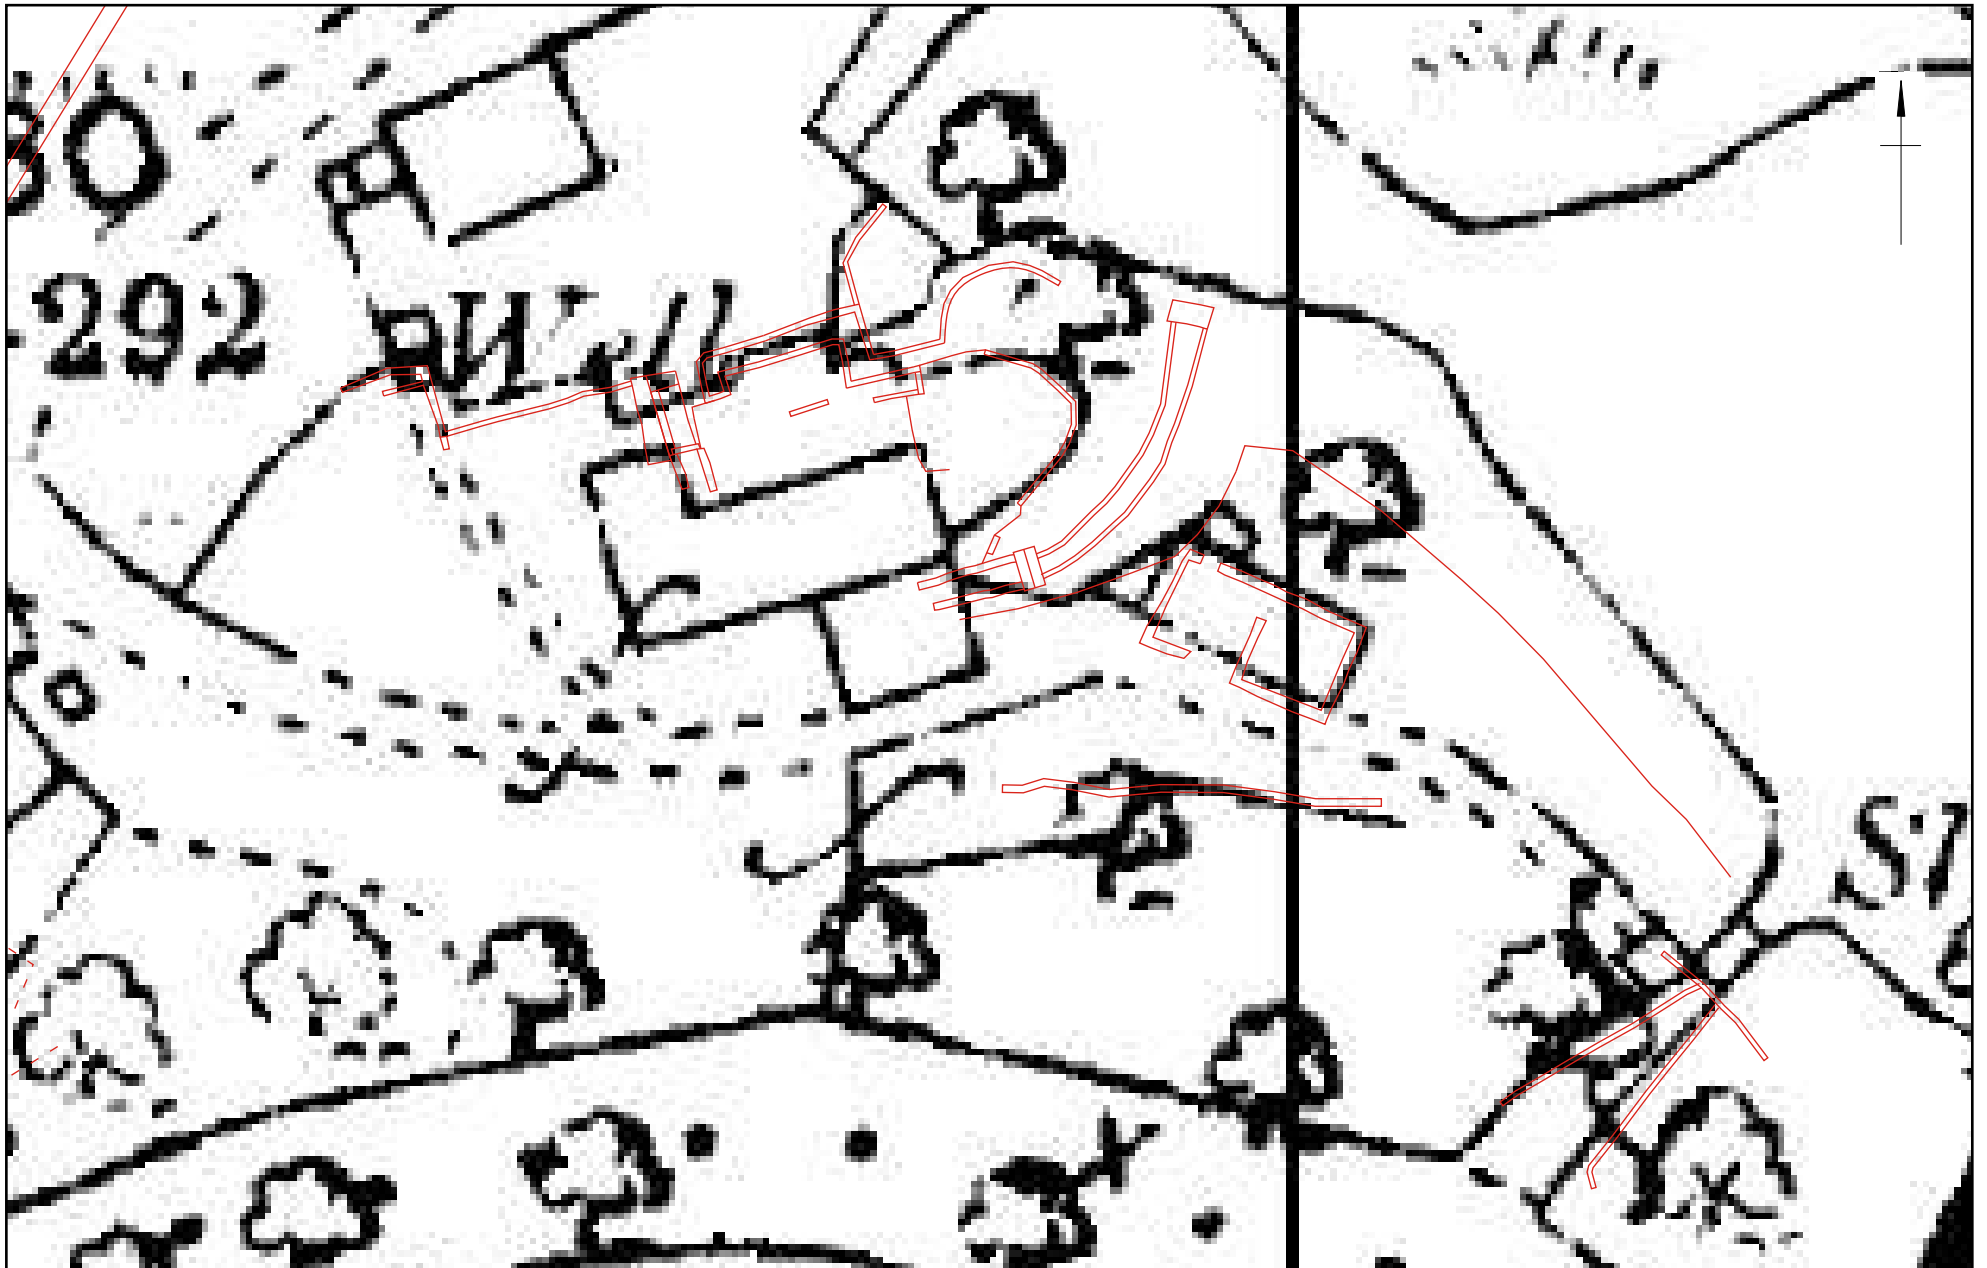
Figure 10

Detail of Tin Mill survey overlain onto 1893 OS map

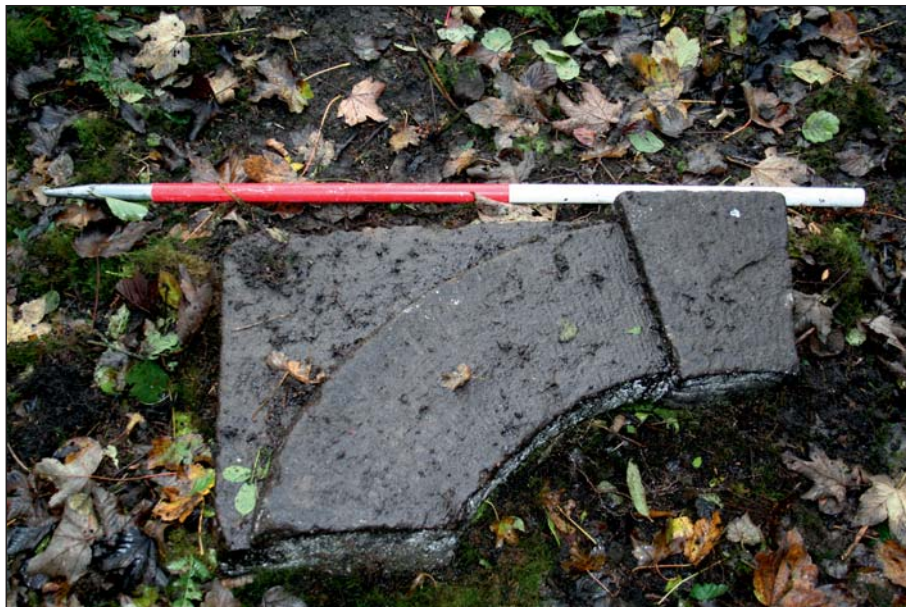
Plate 2: Main working area: arched door lintel, with false 'keystone'

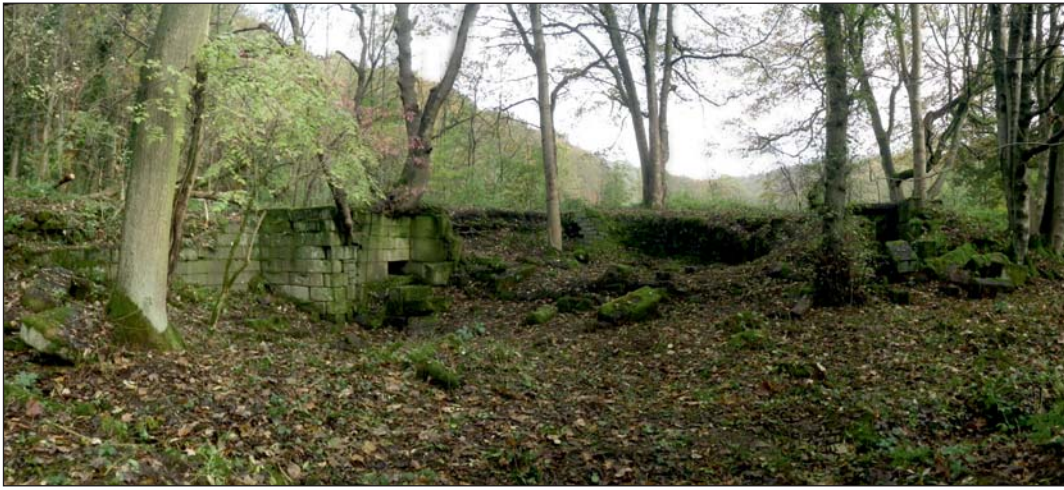
Plate 3: Main working area between Wheels 1 and 2

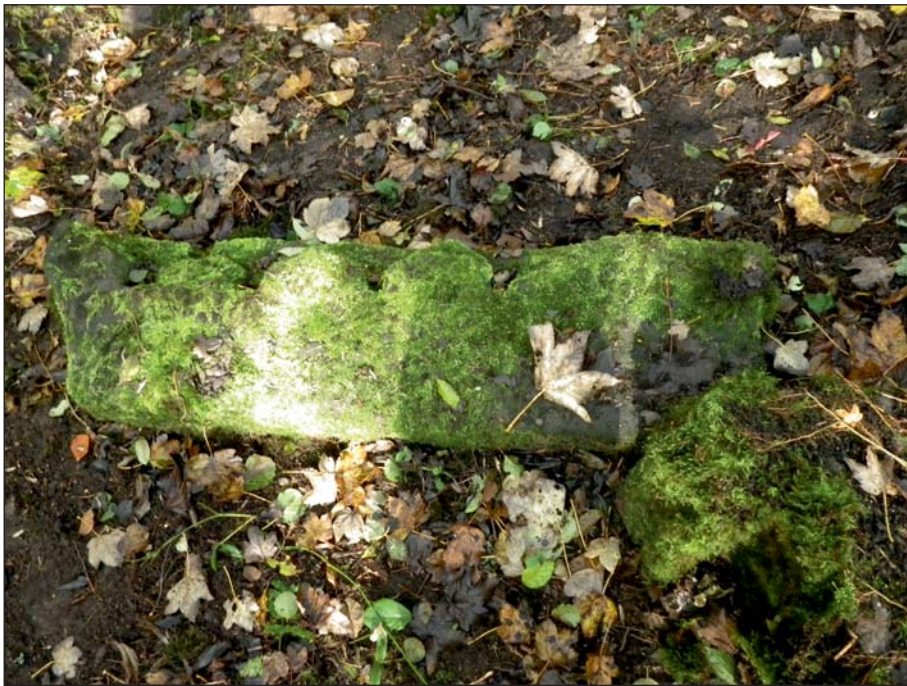
Plate 4: Main working area: 'cogged' stone

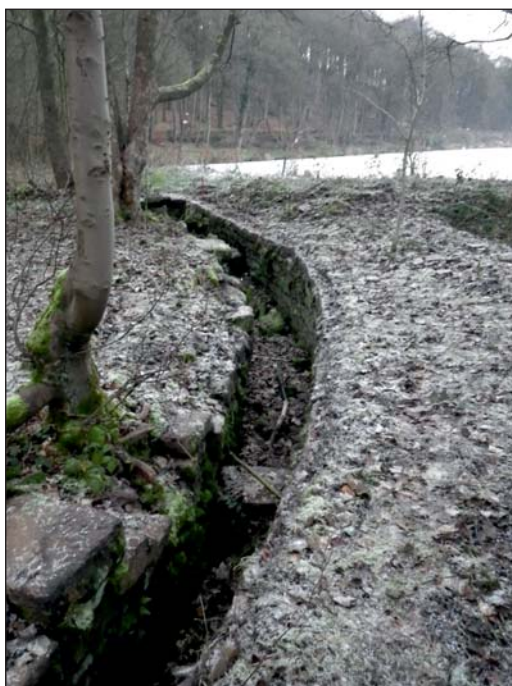
Plate 5: Curved head goit for Wheel 1 (114)

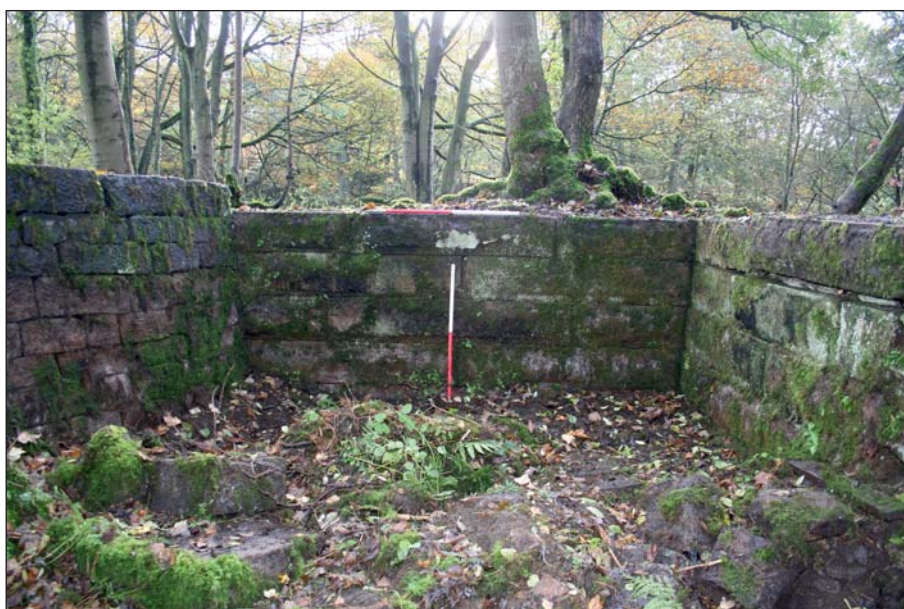
Plate 6: North elevation of **108** within forebay

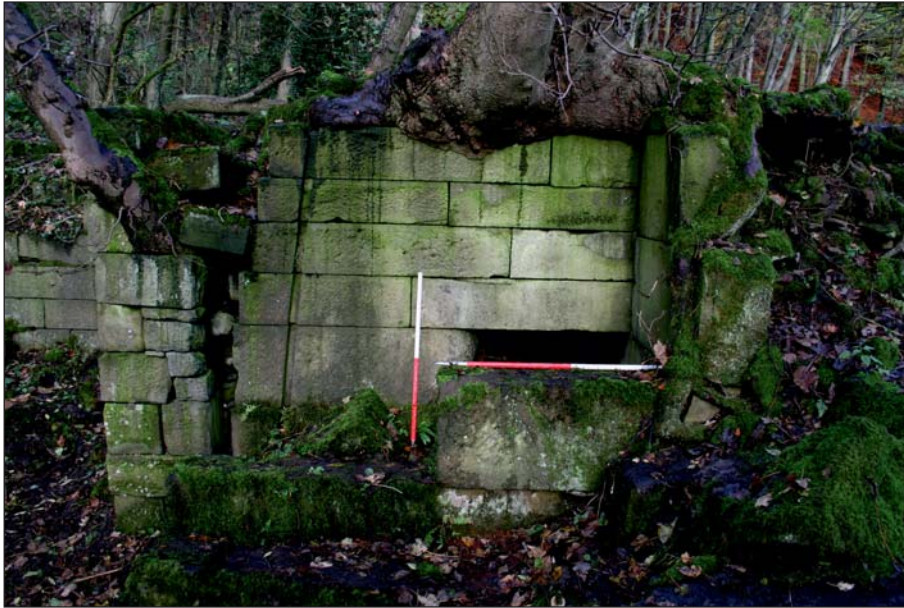
- 6.2.19 Chamber **109** (**Plate 7**) has two shaped stone slopes to direct the water: the first through a large low square opening in the north wall of the chamber allowing water from the dam to access the chamber (now silted up on the north side); with the second directing the water from the first slope westwards towards the shuttle and evidently there to Wheel 2. This dog-leg has resulted in wear on the southern wall of the chamber. Interestingly the arrangement of the inlets indicates that the head of water was already close to present ground level when it reached the wheel, suggesting a large part of the wheel house structure could remain below ground level.

- 6.2.23 The 1985 survey (**Appendix 2**) records the same features, although makes no reference of the extensive root damage now forcing apart structures **107** and **108** (**Plate 7**).

Plate 7: South elevation of **108**, showing inlet, channel for shuttle and damage caused by vegetation

- 7.2.1 The Site is covered in mature trees, some of which are growing out from the structures themselves. The result is that the growth has prised open parts of the surviving structure causing decay and erosion. Features deemed to be specifically at risk of this comprise **117** and **118 (Plate 7)**. It is considered that a strategy of selective tree removal could prevent further deterioration, although repairs may be necessary to the structure itself to prevent collapse.

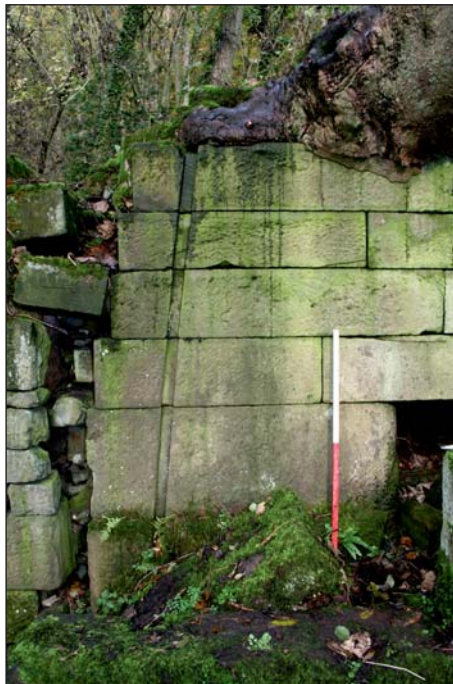
stones with the channel were pre-cut prior to being erected. Blocks displaying similar numbers were evident in the rubble where the southern wall of the structure had fallen away suggesting it had been built in a similar fashion. The channel had likely held a shuttle for moderating water flow, and broken iron plates filling the base of the channel were observed in a gap between a fallen stone.

Plate 8: Detail of channel and numbered stones in **108**

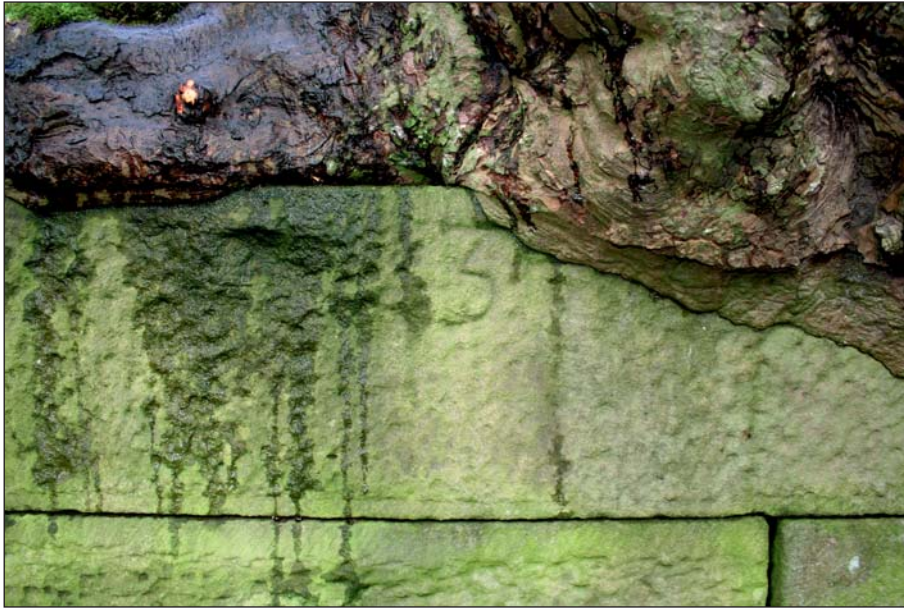
Plate 9: Masonry marks, a '3'

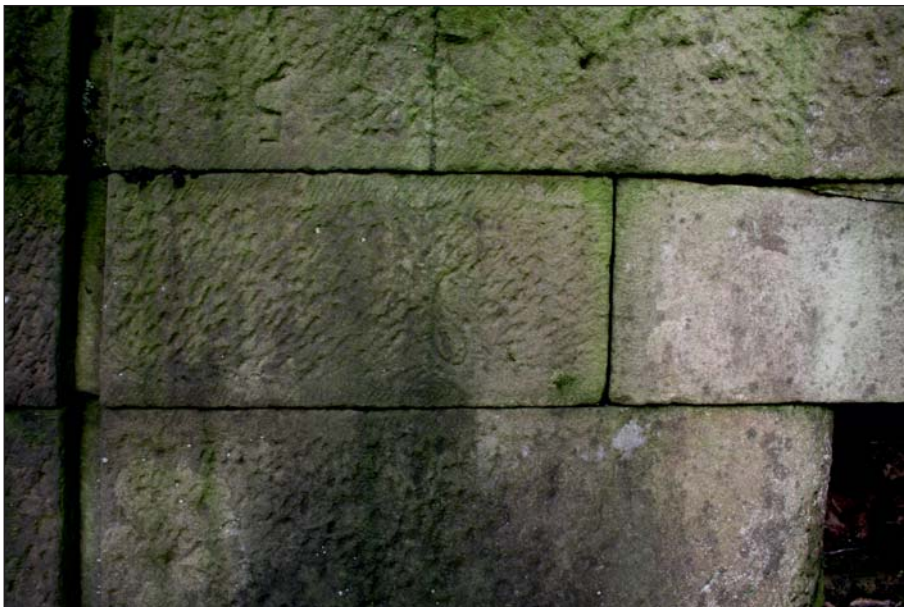
Plate 10: Masonry marks, a '5' (inverted) and '6'

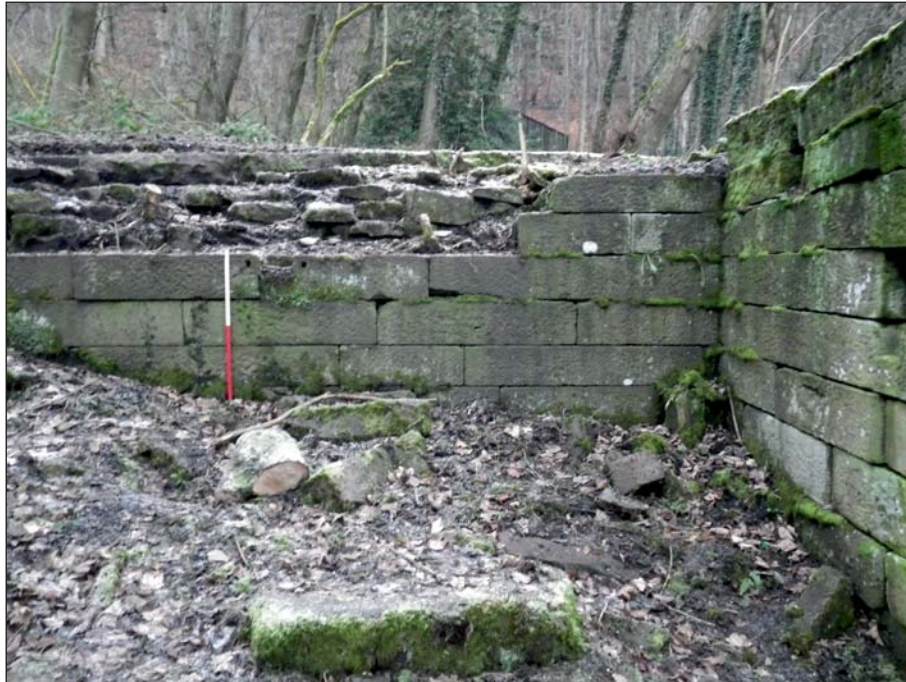
Plate 11: South facing elevation of **107**, defining the presumed location of Wheel 2

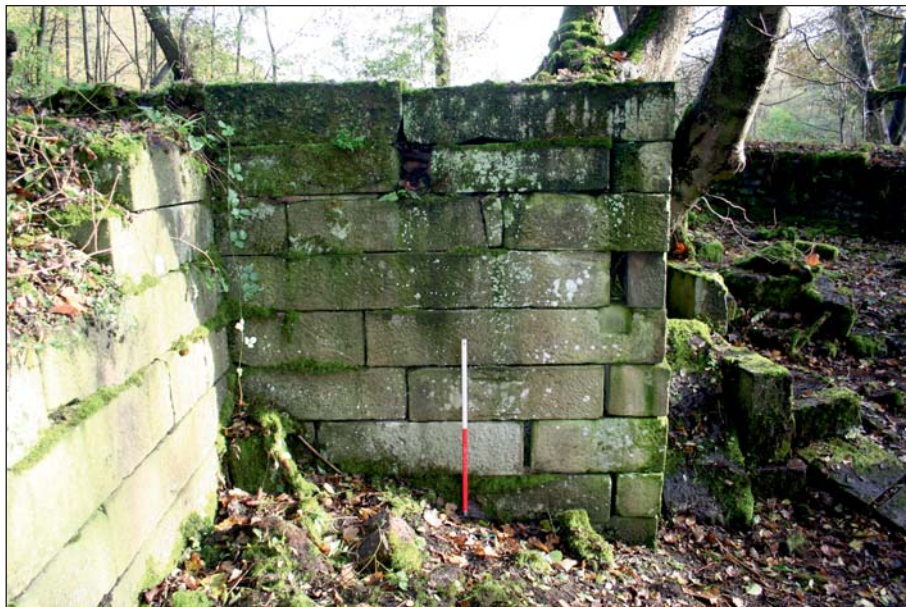
Plate 12: Possible beam slot in west facing elevation of **107**

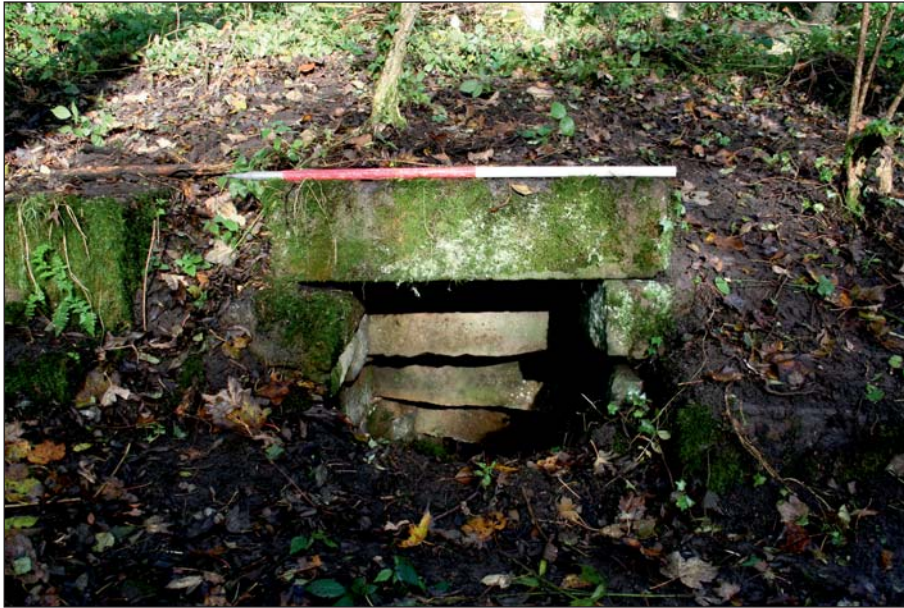
Plate 13: Detail of void between **105** and **106**, showing stepped roof of goit between the dam and Wheel 3

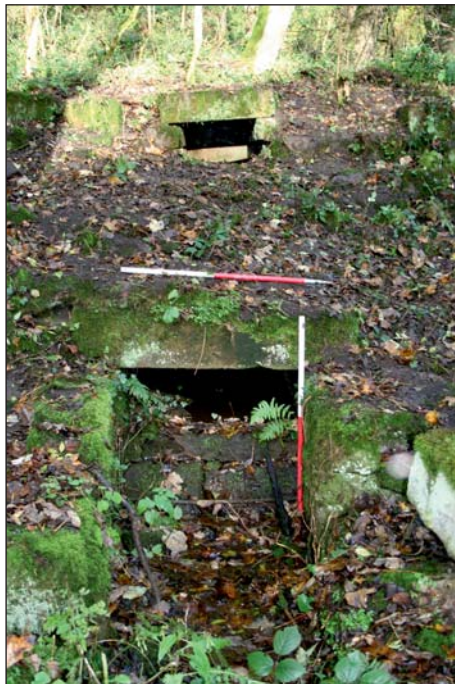
Plate 14: Detail of **105** and **106** delineating presumed location of Wheel 3

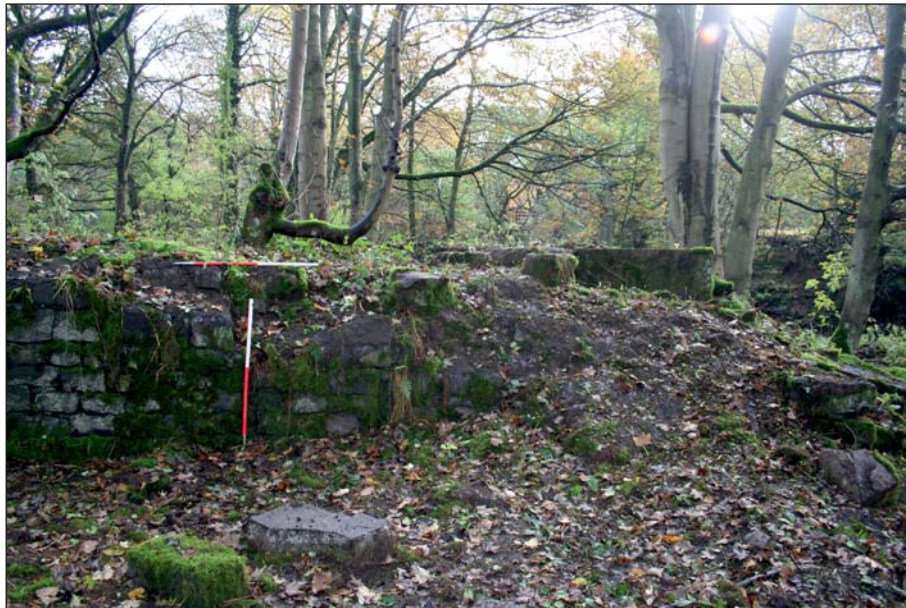
Plate 15: Example of collapse of retaining wall 110

- 7.2.2 It is considered that all of the remaining above ground elements of the buildings are at risk of further decay from frost and rain penetrating the structure where the core fabric is exposed and where mortar has eroded. A considered strategy of conservation work repointing the structure and capping exposed cores would reduce the risk of further decay from this threat. In the case of the retaining wall structure **110**, existing areas of collapse (**Plate 15**) may need to be repaired or reinforced to prevent damage to the remaining structure.

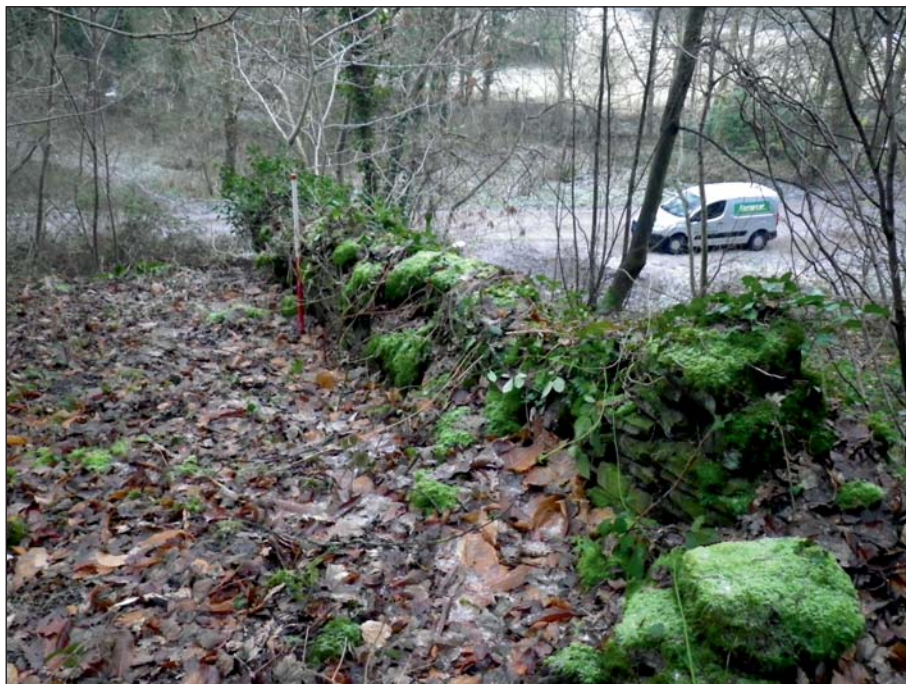
- 7.2.3 The survey also identified a number of dry-stone revetment walls within the hillside above the former cottages (**Plate 16**). The condition of these structures is considered to be at risk from gradual decay.

Plate 16: Example of revetment walls on hillside above the mill
