The Well House, Rectory Road, Church Oakley, Hampshire

Historic Building Assessment Report

Report reference: 76460.01

January 2011

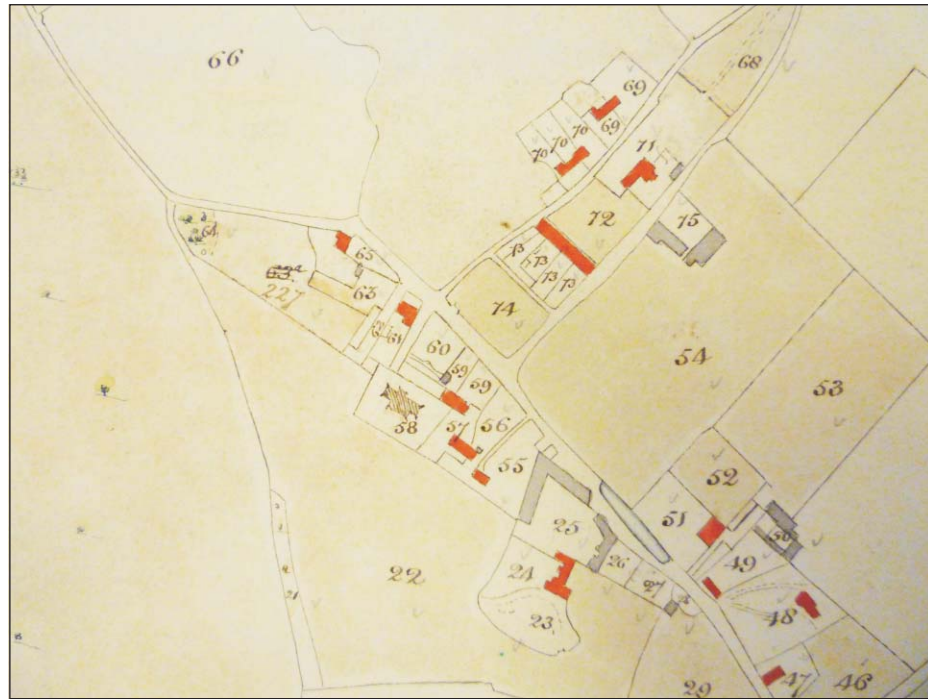
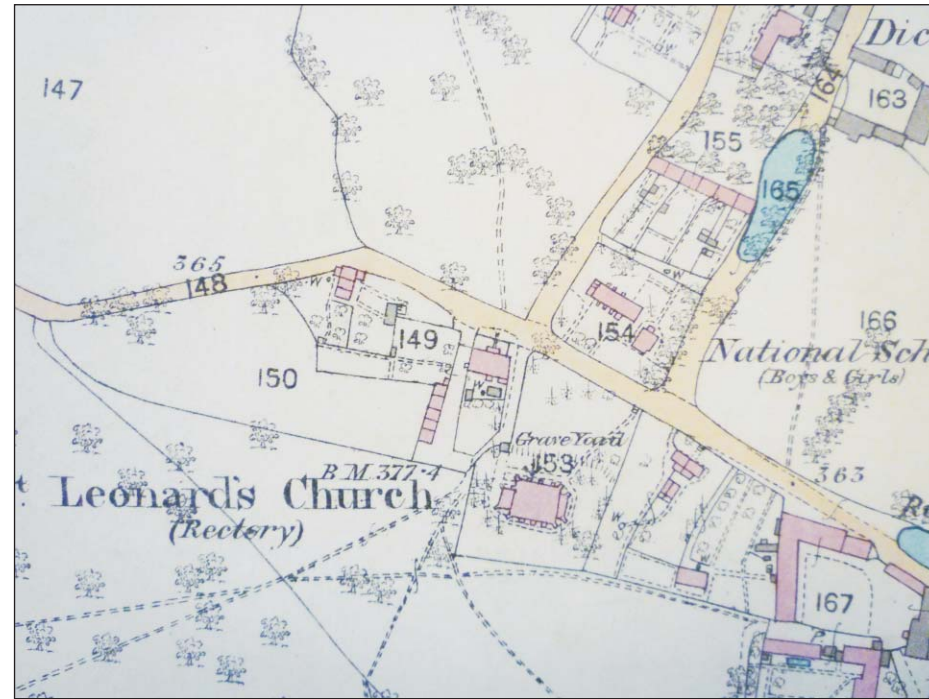
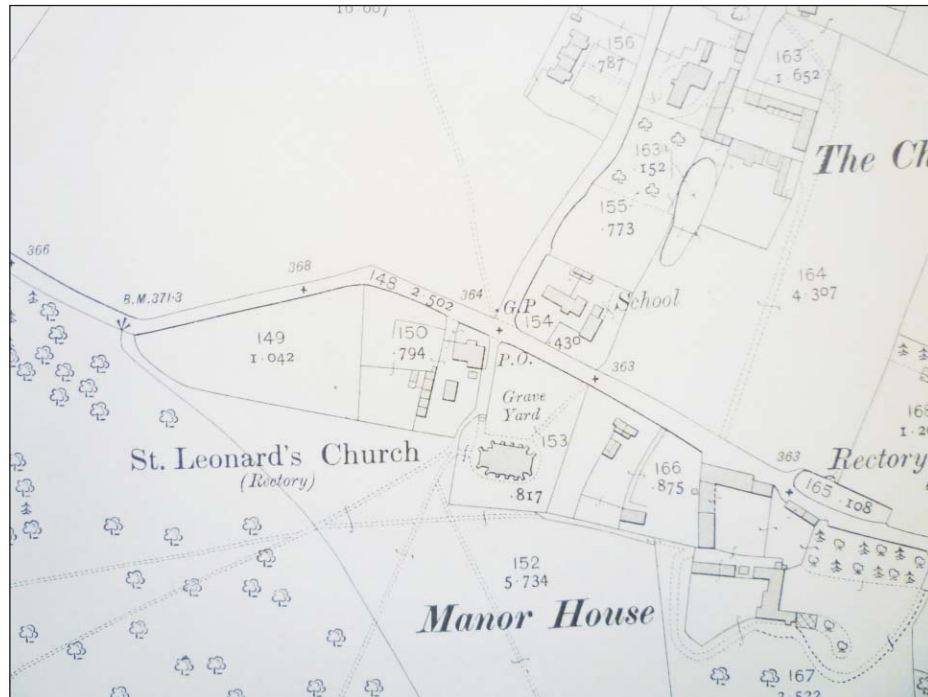
1841 Church Oakley Tithe map

1872 Ordnance Survey 25":1mile map

1896 Ordnance Survey 25":1mile map

1910 Ordnance Survey 25":1mile map

1932 Ordnance Survey 25":1mile map

1937 Ordnance Survey 25":1mile map

3.2.1 The first detailed evidence of the property comes from the 1841 Church Oakley Tithe map (HRO Ref: 21M65/F7/51/2) (**Figure 2**) and associated apportionment (**Appendix 1**), which describes the building as a 'House and Yard' owned by the lord of the manor, William Beach and occupied by Robert Barrett. The property depicted on the Tithe map appears as an L-shaped structure situated on the south side of Main Street (the former name of Rectory Road) between two short lanes leading to the rear of the property. The eastern lane is still in existence leading to St Leonard's Church whereas the western lane (denoted as *Drove yard*) led to a rear yard and row of outbuildings located to the south-west of the house (**Figure 2**).

3.2.3 The property is shown in greater detail in the 1st edition Ordnance Survey map of 1872 (**Figure 2**) differing markedly from the L-shaped arrangement depicted on the 1841 Tithe map. The building appears as a roughly rectangular structure with front porch and two small extensions on the east side of the rear (south) elevation, which would appear to be the rear stair turret and south end of the present Kitchen. To the immediate south of the property two small outbuildings and a well are also depicted. The row of outbuildings to the south-west of the house, shown on the earlier Tithe map, is divided into five units possibly representing stables or storage sheds.

3.2.4 The 1896 Ordnance Survey map (**Figure 2**) shows a similar scene to that depicted in 1872, although one of the two outbuildings to the rear of the house had been removed to be replaced by a larger rectangular outbuilding, possibly representing a purpose-built bakehouse. The map also reveals that the building was functioning as the post office by this time having taken over this responsibility sometime between 1891-1895 from a property situated further to the east of Church Oakley on Rectory Road.

3.3.2 The 1910 Ordnance Survey map reveals that the building had been extended to the south with the present rear extension wings in place by this time. It is likely that the gap between the two wings to the immediate south of the rear stair turret was infilled with a small porch sheltering the rear entrance into the building (**Figure 2**).

3.3.5 The 1932 Ordnance Survey map (**Figure 2**) suggests that the footprint of the house remained unchanged, although under new management the number of outbuildings to the rear and south-west of the property had expanded suggesting a much enlarged business. Cooper & Field's business appears to have remained that of bakery, grocers and post office, although the store did extend into hardware and haberdashery (*ibid* 51).

- 3.3.8 The 1937 Ordnance Survey map (**Figure 2**) shows a slight difference in the footprint of the building with a small open area shown between the two principle rear wings. It is assumed that a porch in this position which originally sheltered the rear entrance was removed sometime between 1932 and 1937. This was later infilled with the present flat roofed two-storey toilet block by the time of the 1961 Ordnance Survey map (not reproduced). The 1937 map also reveals that the porch on the front of the property had been removed by this date.

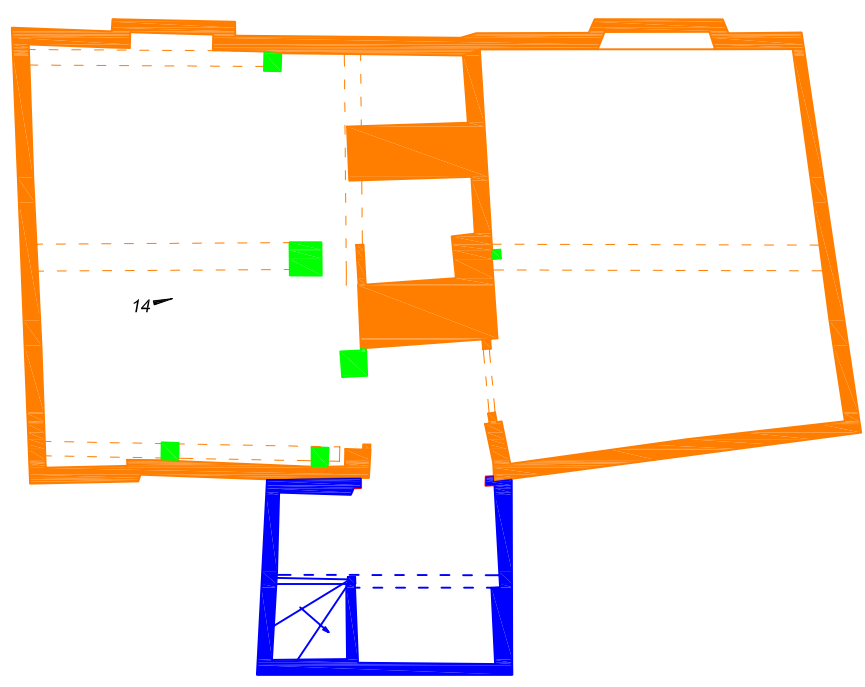
Figure 3

The Well House: phased cellar plan

- 4.2.13 Within the western chamber a large hardwood bridging beam supports the floor above, with irregular common joists visible below replacement timber floorboards. Within the eastern chamber the floor timbers above are obscured beneath a later suspended ceiling. The western chamber shows signs of some repair and modification has taken place during the 20th century with strengthening work in the form of brick pillars and buttresses providing extra support for the floor above (**Plate 14, Figure 3**).

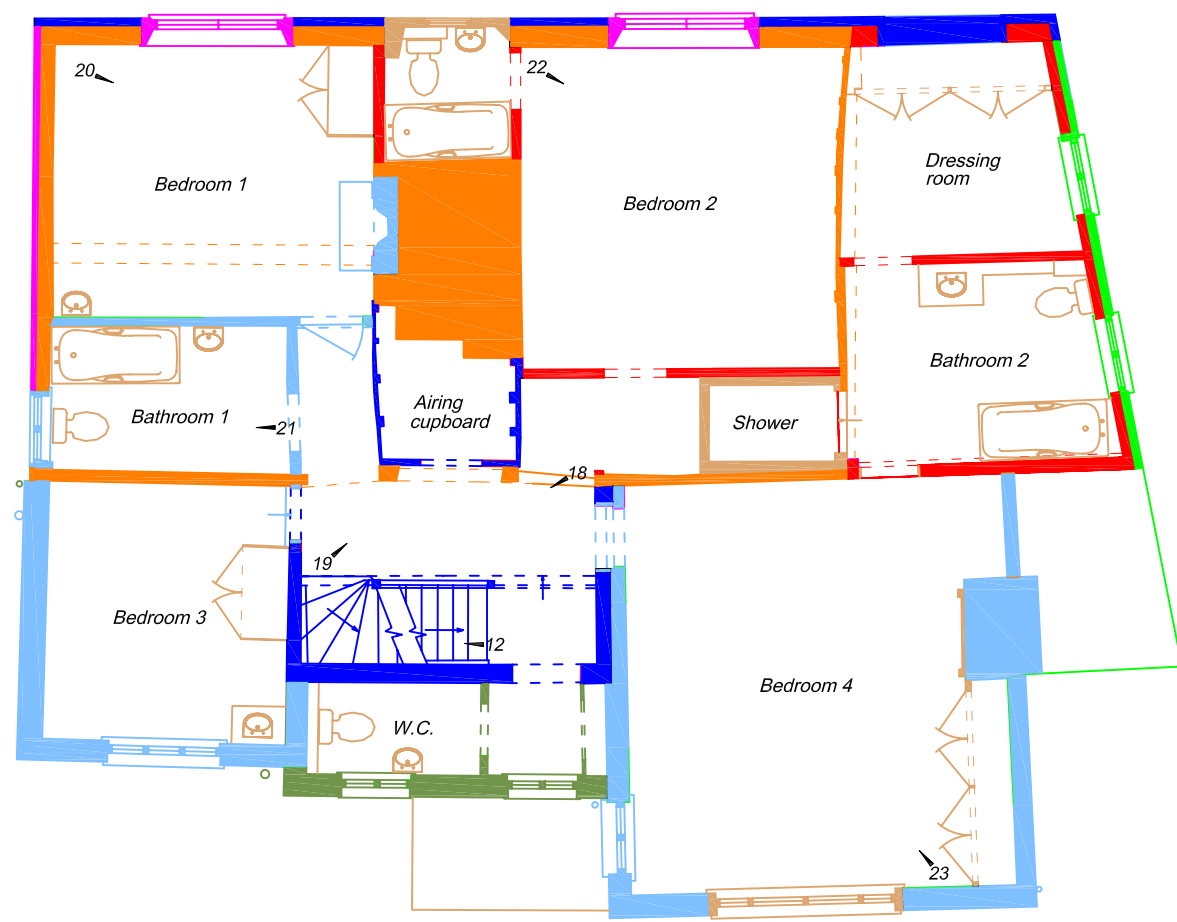
Figure 5

The Well House: phased first floor plan

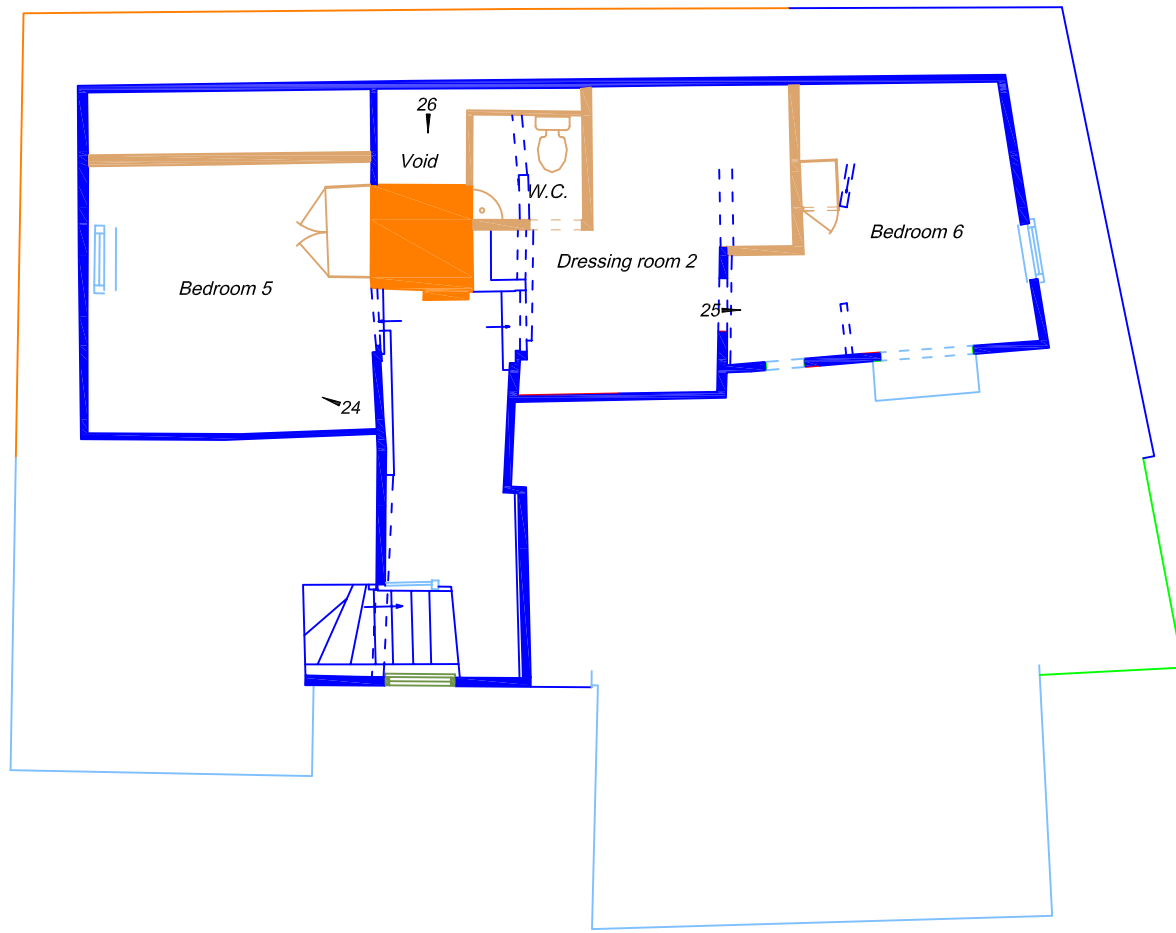
Figure 6

The Well House: phased attic floor plan

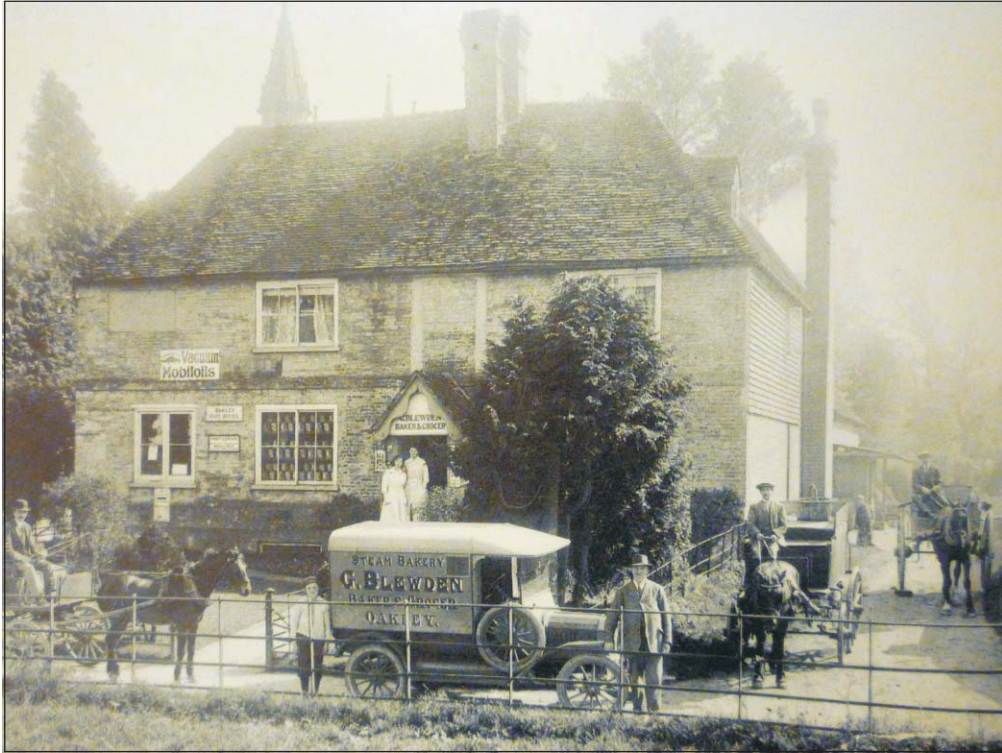
Plate 1: Early 20th century photograph of the building occupied by Giles Blewden and his family

- 4.1.4 Original decorative features are limited to a central plat band at first floor height and a high brick plinth. The original windows have been largely replaced by later inserted early–mid 19th century eight-light horizontal sliding sash windows and a single late 19th century - early 20th century casement on the ground floor. These later windows have replaced original smaller casement windows the dimensions of which can be seen at the eastern end of the elevation at first floor height where a shallower window opening survives, although this has been later infilled. A bulls-eye window above the doorway is likely to date from the mid-late 20th century replacing a blank panel shown in an early 20th century photograph (**Plate 1**).

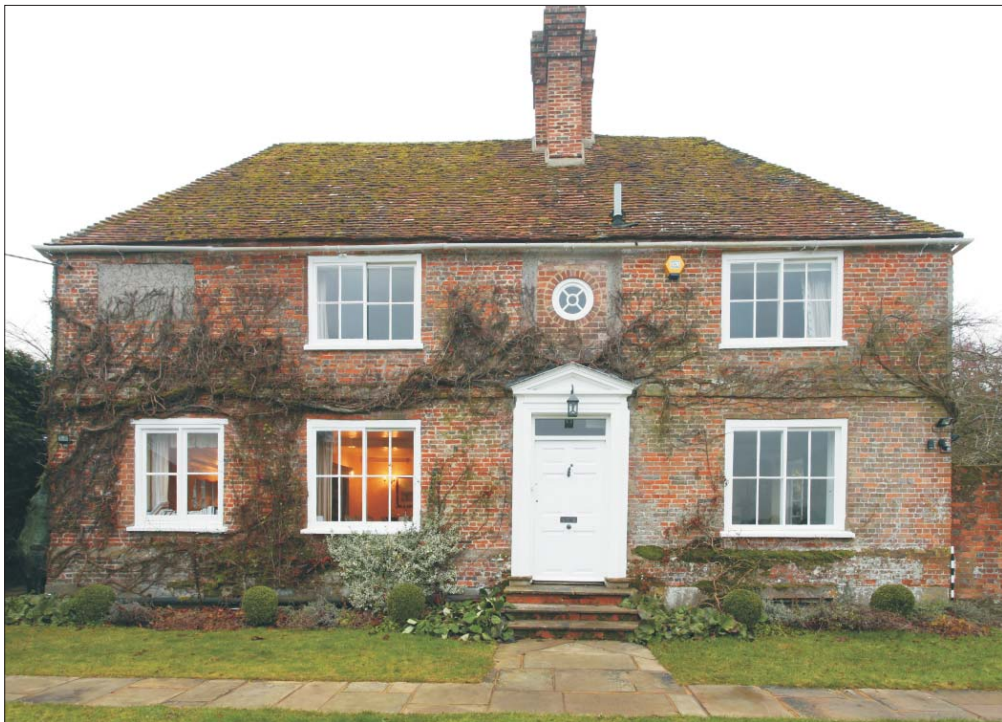
Plate 2: North elevation

- 4.1.3 The front range comprises a two-storey building of four-bays orientated east-west along its long axis (**Plate 2**). The structure contains the earliest part of the property which comprises a simple two-and-a-half bay, timber-framed cottage likely constructed during the late 16th – 17th century, which was later extended to the east by one bay. The front of the property is asymmetrical constructed of red brick in no particular bond and pale lime mortar with later repointing in Portland cement. The small size of the bricks and lack of recognisable bond suggests a 17th - early 18th century date for the brickwork which represents a re-fronting of the earlier timber frame following its extension to the east.

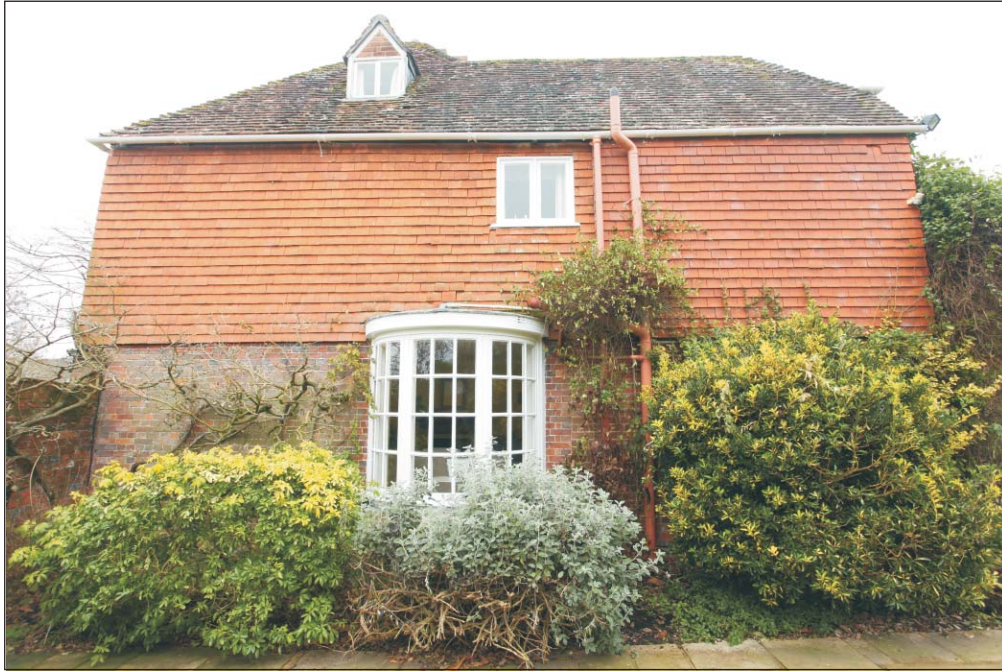
Plate 3 : West elevation

- 4.1.6 The West elevation of the property was developed in two phases with the northern part formed from the re-fronting of the west wall of the front range during the early - mid 19th century and the southern part comprising a late 19th - early 20th century extension (**Plate 3**). The ground floor of the west elevation of the front range (including the corner and westernmost part of the front elevation) comprises red brick in English bond with pale lime mortar representing a later cladding/strengthening episode which obscures/replaces the original timber frame exterior. A straight joint in the brickwork to the south of the present late 20th century bay window marks the line between the front range and the late 19th - early 20th century extension (**Plate 4**).

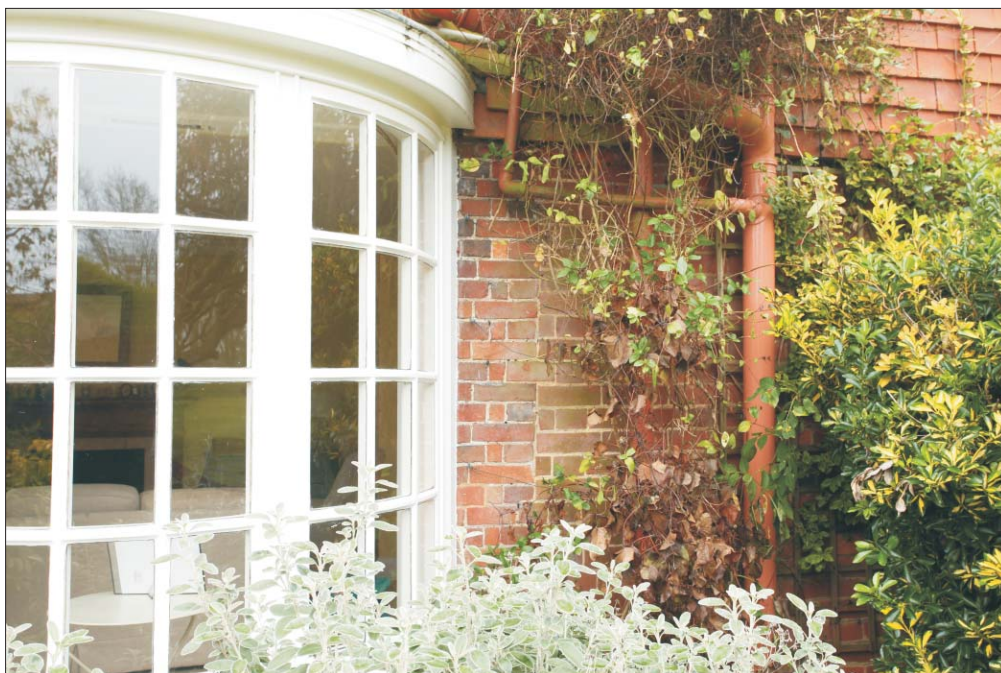
Plate 4 : West elevation - straight joint visible in the brickwork

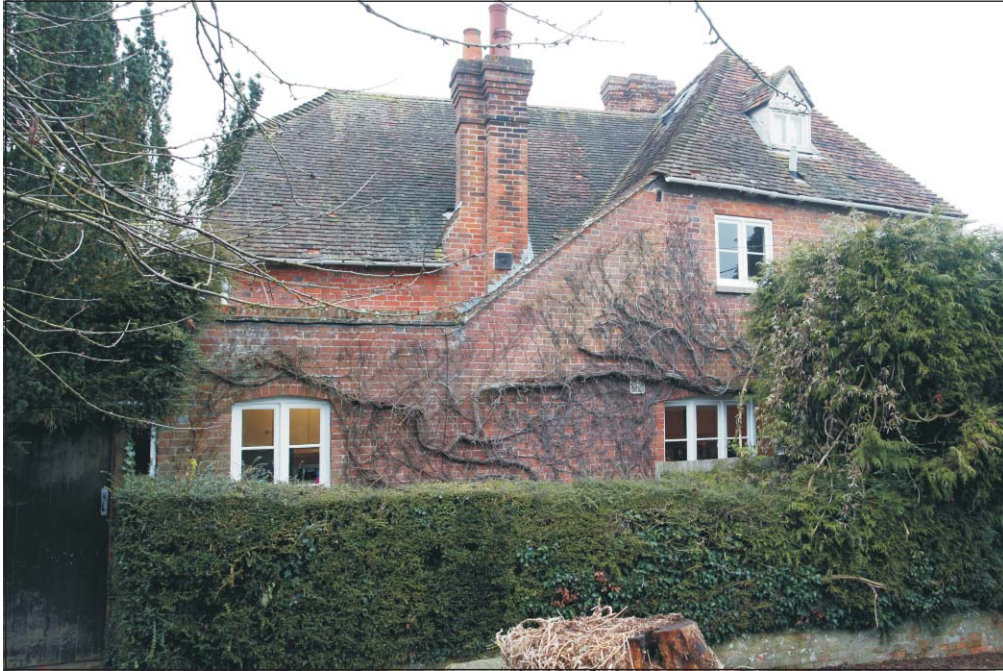
Plate 5 : East elevation

- 4.1.8 The east elevation comprises red brick in Flemish bond and is divided in two representing a late 19th – early 20th century re-cladding/strengthening over the original timber frame and extension to the south during the late 20th century. The exposed tie beam of the frame is visible under the eaves and above the protruding wall plate (**Plate 5**).
- 4.1.9 The east elevation is pierced by a number of casement windows with moulded stone sills and cambered brick arches at ground floor level. A flat-roofed extension adjoining the south-eastern corner of the property dates from 1968-72 constructed in similar style.

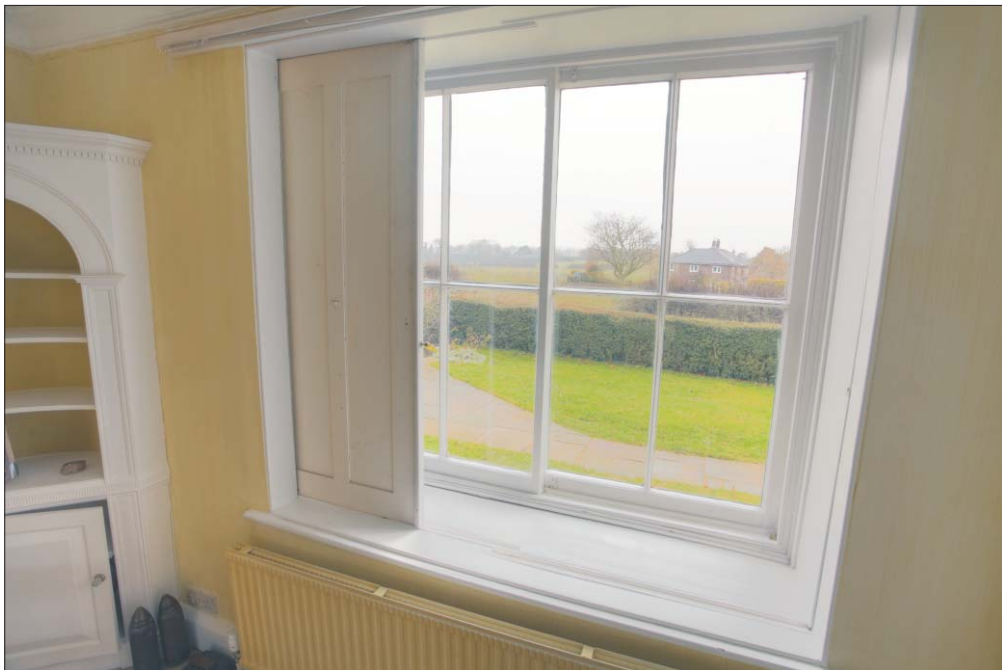
Plate 10 : Sliding shutter within horizontal sliding sash window

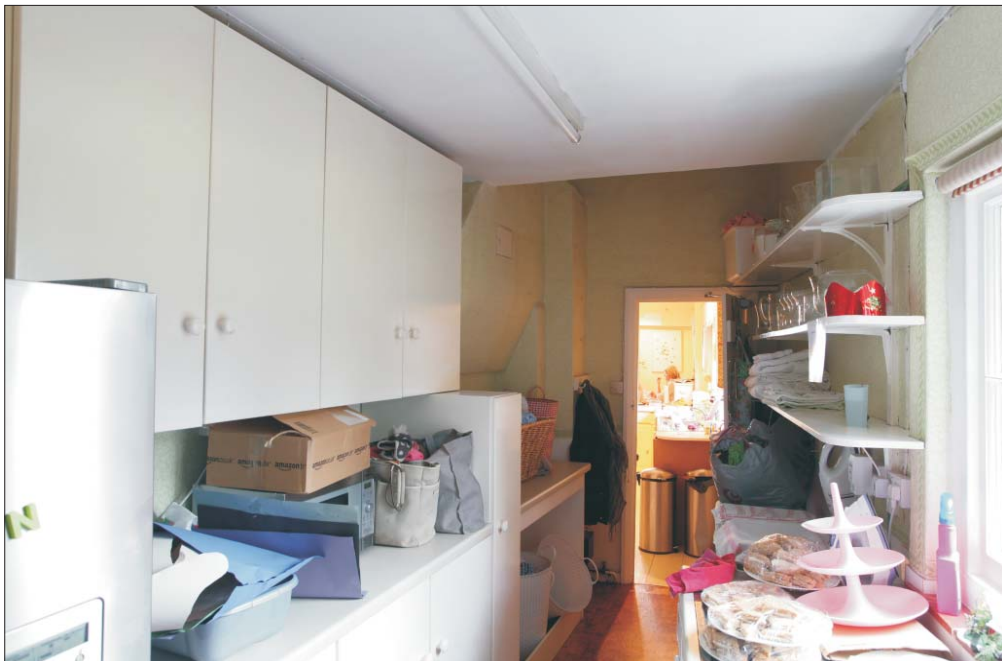
Plate 16 : Ground floor - Scullery

- 4.2.17 To the south of the Kitchen is the Scullery which also comprises an irregular shaped room which is broader at the southern end and narrows to the north (**Plate 16, Figure 4**). The narrowness of the room is accentuated by the modern fitted units on the east and west walls creating a central passageway that leads from Kitchen to the Nursery. At the southern end of the room are a single toilet cubicle and cupboards adjacent to an entrance doorway on the east wall. The Scullery is a later extension of the building with the earlier external stacks of the Kitchen and Family Room visible at the northern end of the Scullery on the west wall.

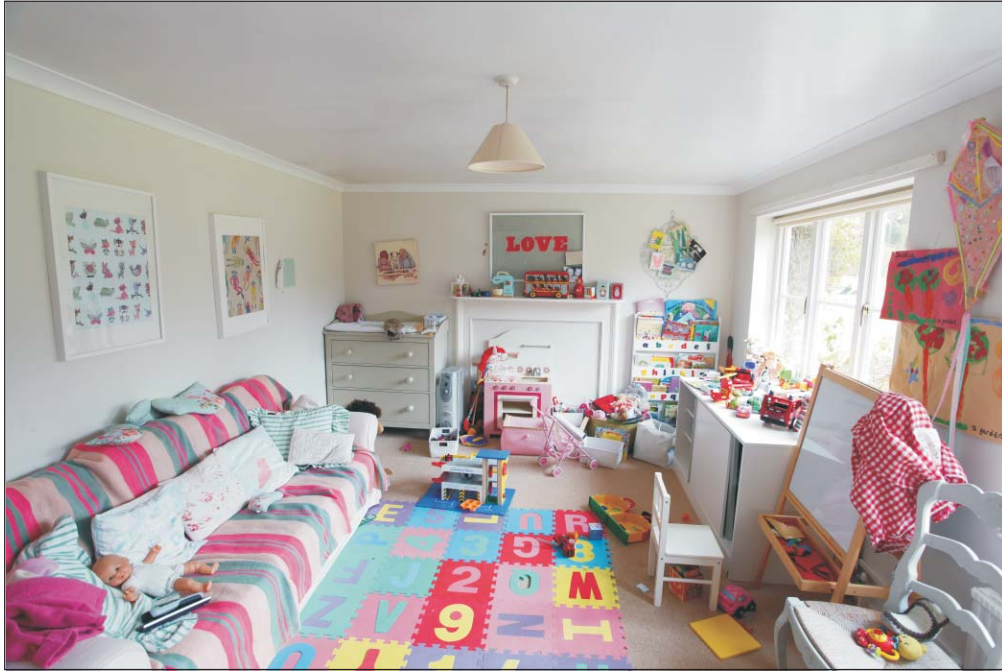
Plate 17 : Ground floor - Nursery

- 4.2.18 To the south of the Scullery is the Nursery adjacent to a doorway in the west wall leading into the rear garden. The Nursery is a late 20th century extension comprising a roughly rectangular room which is illuminated by two large six-light windows on the west wall (**Plate 17, Figure 4**). The room is plain with modern finishes including a plain cornice. A blocked fireplace is situated on the south wall.

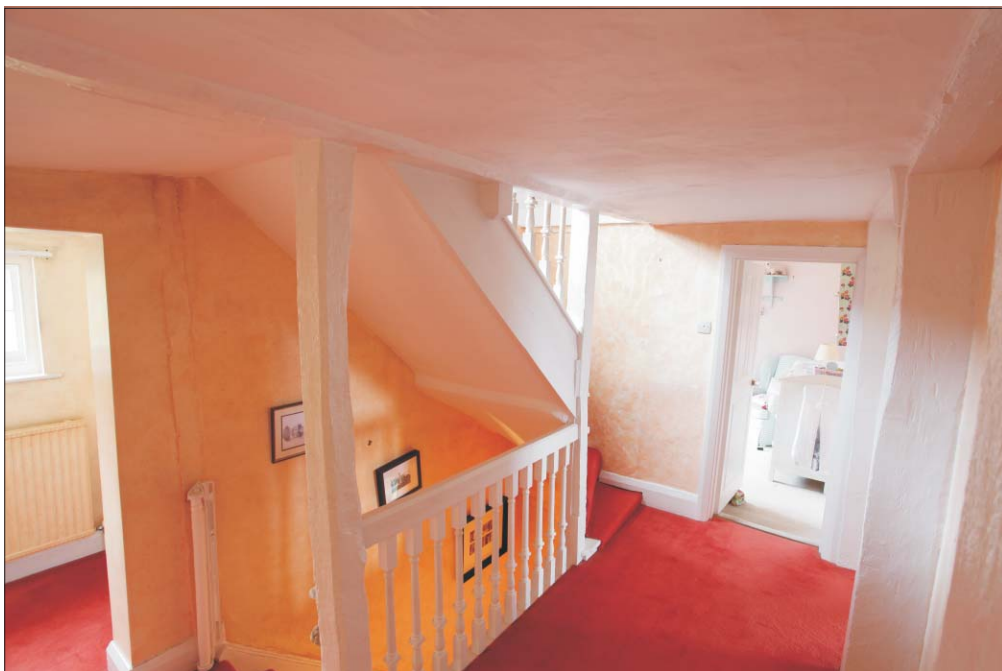
Plate 18 : First floor - Landing

- 4.3.1 Within the stair turret on the first floor the Landing comprises an east - west orientated passageway providing access into most of the principal rooms on the first floor (**Plate 18, Figure 5**). The large timbers which originally made up the former rear wall of the three-bay cottage are exposed on the northern wall of the Landing. To the south of the stair turret a short passageway leads to a small toilet cubicle accessed via a four panel door. The cubicle is similar to the ground floor arrangement with mid 20th century casement window on the south wall.
- 4.3.2 A large airing cupboard situated centrally within the north wall of the Landing is of lightweight timber framed construction, the timbers visible within the

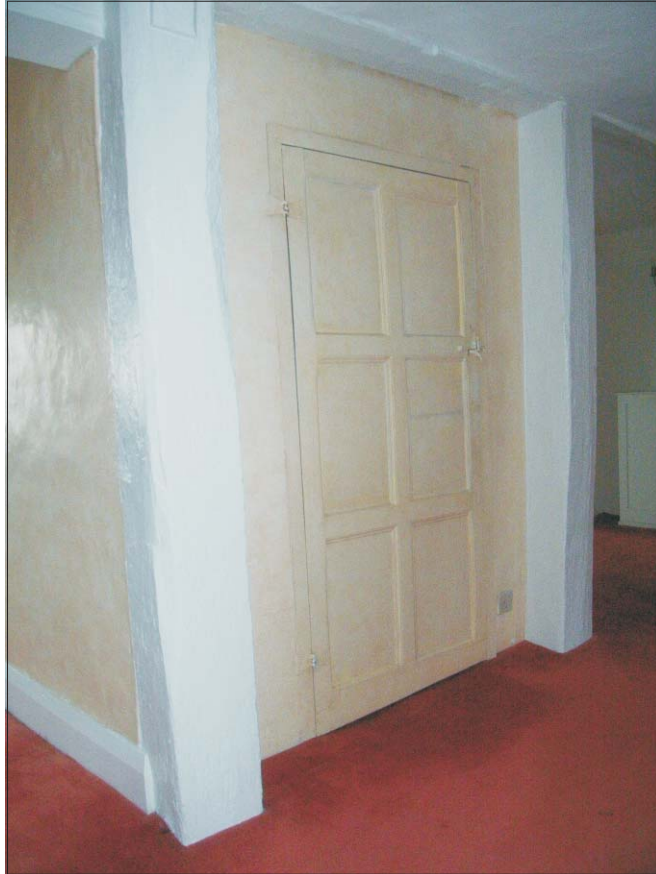
Plate 19 : First floor - Entrance to airing cupboard

interior (**Plate 19**). The cupboard is accessed via a 17th - early 18th century six panel door featuring butterfly hinges, although a rectangular scar on the inside indicates that it formerly possessed a lock case. The door currently features a 19th century latch. Unfortunately the modern screws within the hinges suggest that the door may not be in its original position. Either side of the airing cupboard two doorways originally led into the west and east first floor chambers following the construction of the rear stair turret. Later infilled mortice sockets visible within these door jambs indicate the doorways are later insertions which were cut through the frame removing the braces which originally occupied this position.

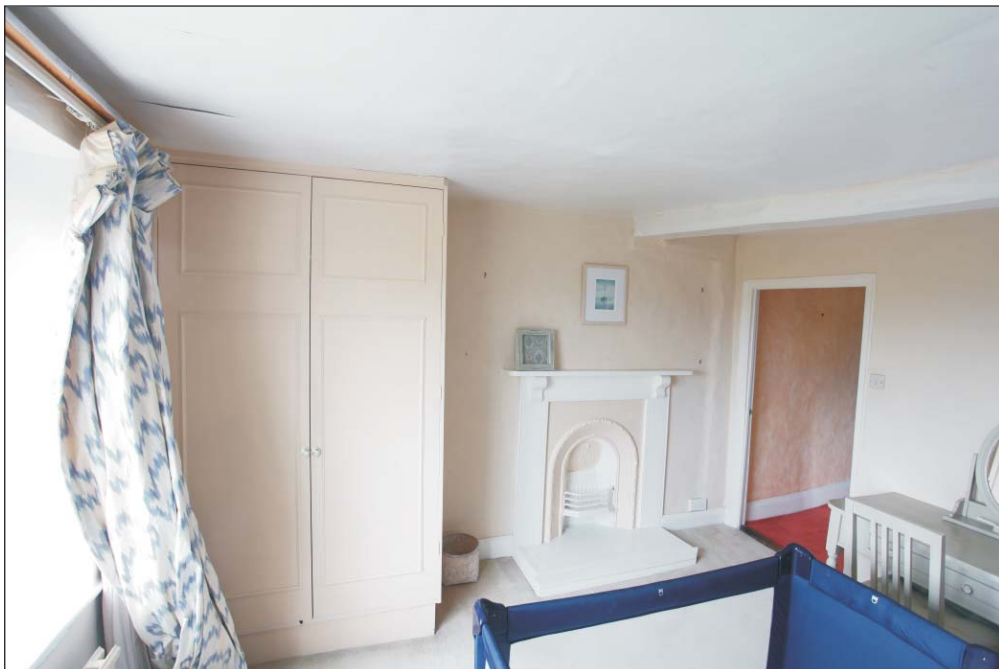
Plate 20 : First floor - Bedroom 1

- 4.3.3 Within the front range the original first floor chamber to the west of the chimneystack has been subdivided probably during the late 19th - early 20th century to form Bedroom 1, Bathroom 1 and a short connecting passageway leading from the Landing.
- 4.3.4 Bedroom 1 comprises a plain rectangular room decorated with modern finishes and plain chamfered skirting seen elsewhere throughout the house (**Plate 20, Figure 5**). Historic features include a large chamfered and plain stopped bridging beam present within the ceiling. The original fireplace has been later infilled with a more modest mid-late 19th century cast iron hearth set below a plain bracketed mantelshelf. A modern fitted wardrobe occupies the north-eastern corner of the room.

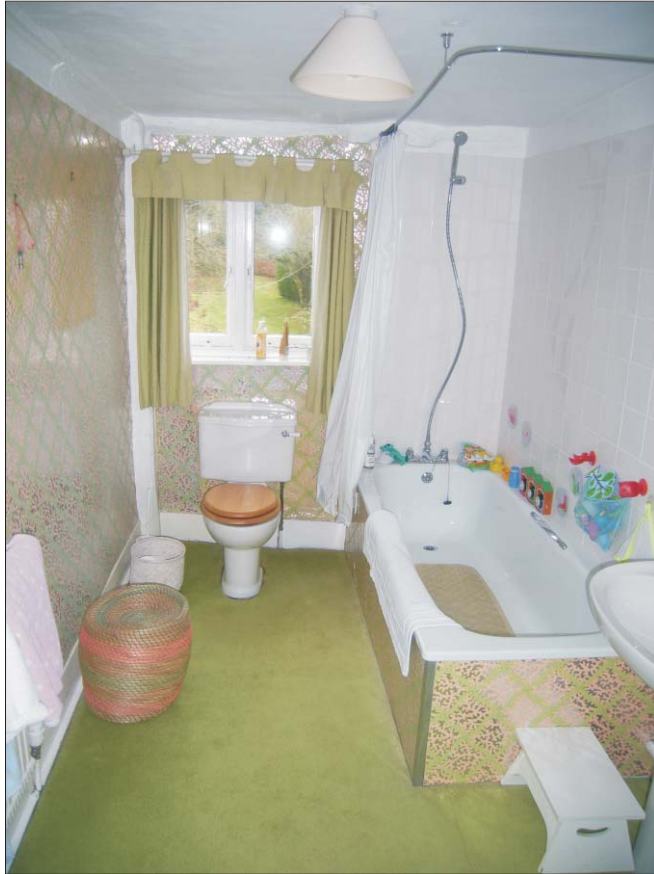
Plate 21 : First floor - Bathroom 1

- 4.3.5 To the south of Bedroom 1, Bathroom 1 is modest sized bathroom shared by Bedroom 1 and Bedroom 3. As mentioned, the room comprises a 19th - early 20th subdivision of a larger chamber with the present arrangement containing modern finishes throughout (**Plate 21, Figure 5**). Following the creation of this new room a casement window dating to the late 19th - early 20th century was likely inserted in the west wall.

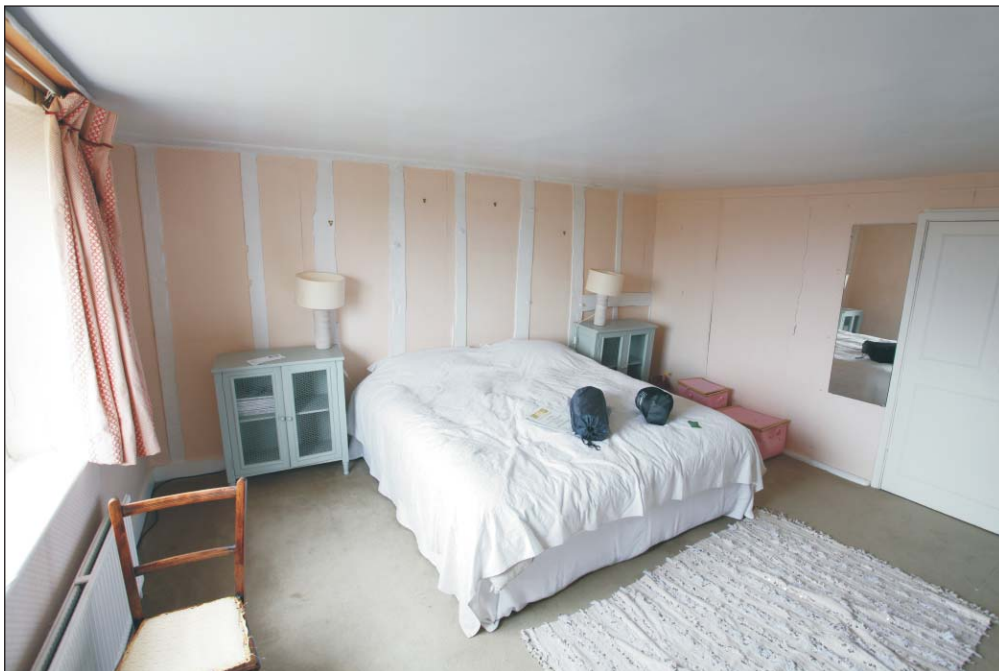
Plate 22 : First floor - Bedroom 2

- 4.3.7 Bedroom 2 is similar to Bedroom 1 comprising a square plan room decorated with modern finishes (**Plate 22, Figure 5**). A suspended ceiling has hidden the presence of a bridging beam however, exposed timber studwork is visible on the east wall comprising a mixture of new and reused timbers. A plank and batten door with 18th century strap hinges is situated at the northern end of the west wall leading into a small ensuite bathroom situated to the north of the chimneystack with mid-late 20th century bathroom

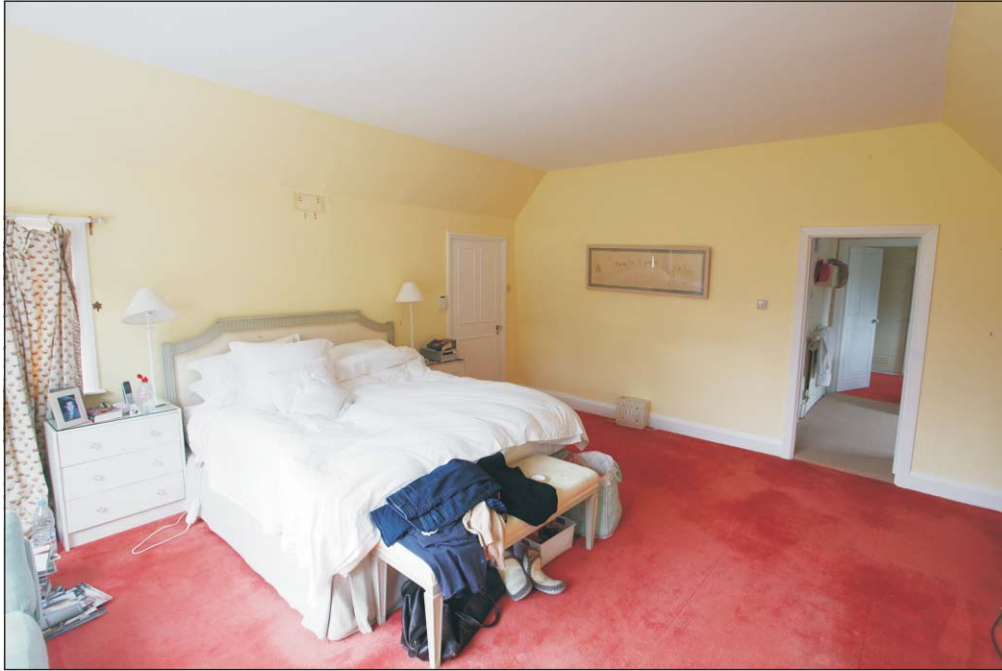
Plate 23 : First floor - Bedroom 4

- 4.3.9 Similarly to Bedroom 3, Bedroom 4 was created during the late 19th - early 20th century expansion phase when the house was extended to the south. This large square-plan room comprises the principal bedroom within the property with ensuite Bathroom 2 and Dressing room 1 to the north (**Plate 23, Figure 5**). The room is decorated with modern finishes throughout with fitted wardrobes situated along the southern half of the east wall adjacent to a blocked classical style fireplace.

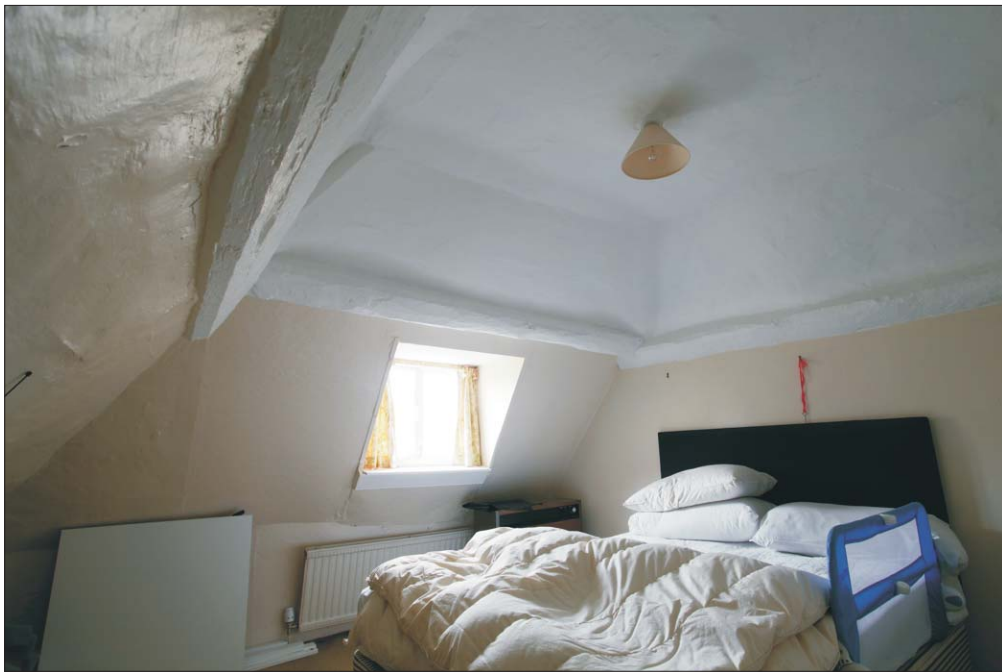
Plate 24 : Attic floor - Bedroom 5

- 4.4.3 Bedroom 5 comprises a small square room with steeply sloping walls extending to the floor on the west and south sides (**Plate 24**). The room is

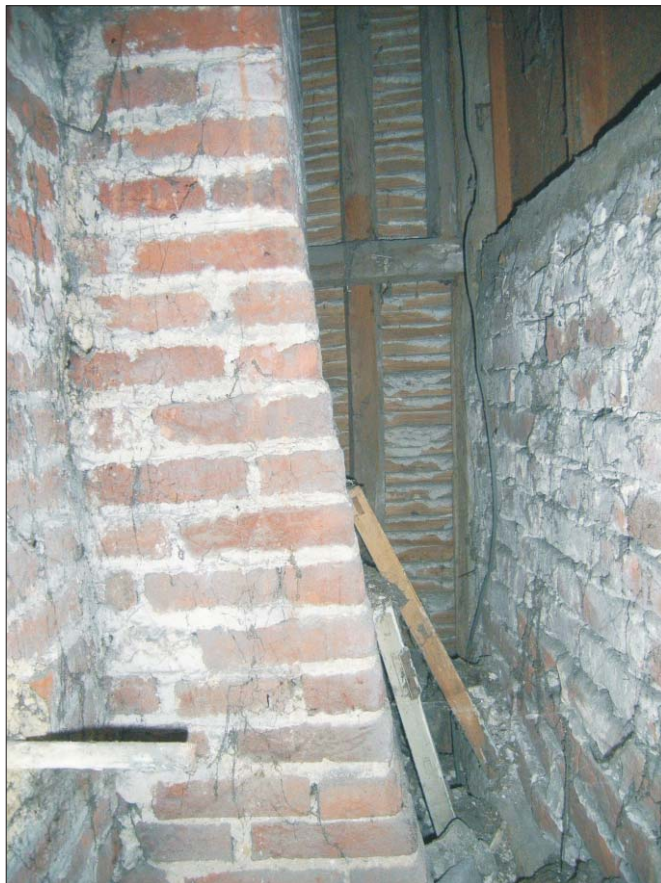
Plate 26 : Attic floor - Exposed stack and framing detail within roof-space above front range

- 4.4.5 A modern toilet cubicle has been created within the north-west corner of Dressing room 2 within which an access hatch allows access into a void to the north of the chimneystack. A limited view of the roof structure revealed a queen-post truss arrangement of large hardwood timbers with principal rafters running up to a ridge piece. The one truss observed was partially infilled with rubble brick nogging at a later date although the main walls of the garret are constructed from lath and plaster. The chimneystack is constructed from small sized red bricks with pale lime mortar (**Plate 26**).
