Den Brook  
North Tawton, Devon

Archaeological Evaluation and Mitigation Report

This report presents the results of an archaeological trial trench evaluation undertaken by Wessex Archaeology in November and December 2012 on land to the south-east of North Tawton, Devon (NGR 268700 100250) prior to the construction of a wind farm.

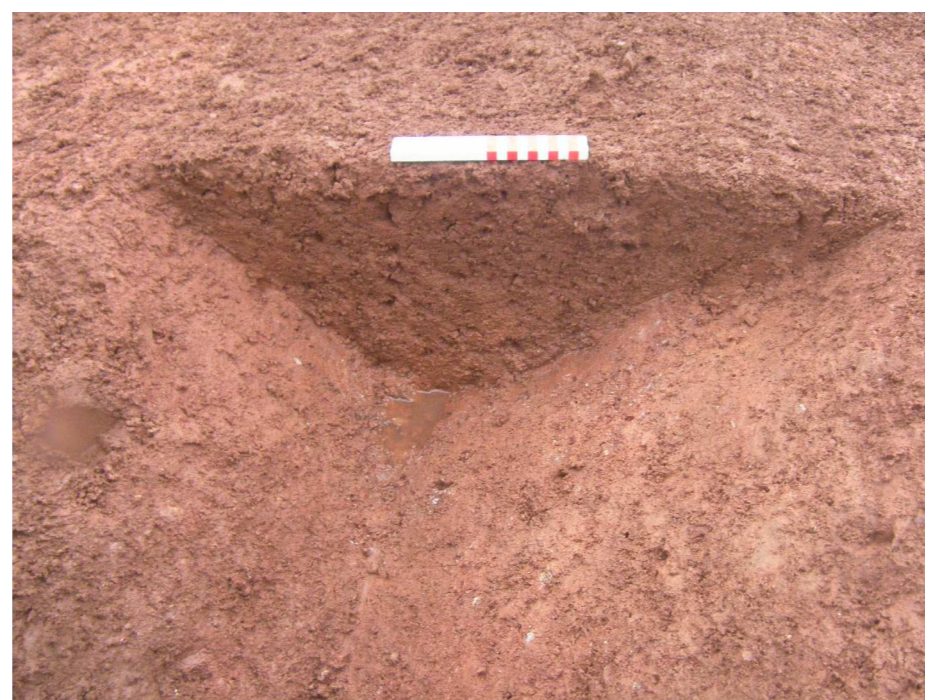
Plate 1: North-east facing section of ditch 104

- 3.2.8 **Trenches 1 and 3** both contained 'V-shaped' south-west – north-east aligned ditches (**104 and 303**), roughly parallel to the road (**Figure 2, Plates 1 and 2**). Projecting the alignment of these features suggests that they are either closely parallel or part of the same feature; the profile and deposit characteristics are very similar. **Ditch 303** cut deposit **306** a colluvial deposit within possible plough headland **305** (**Figure 2, Plate 2**).

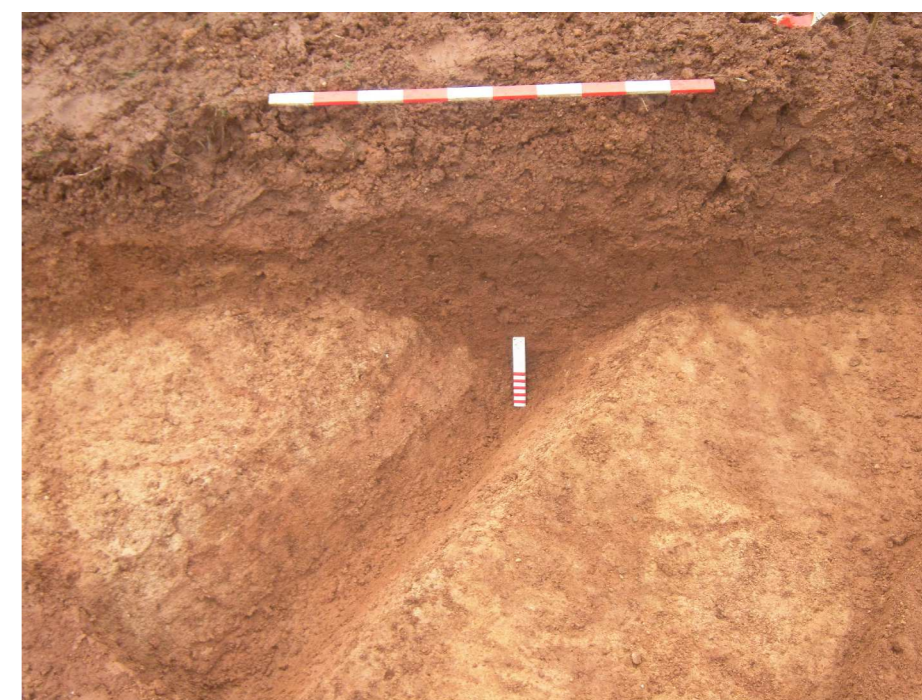
Plate 2: North-east facing section of ditch 303 and possible plough headland 305

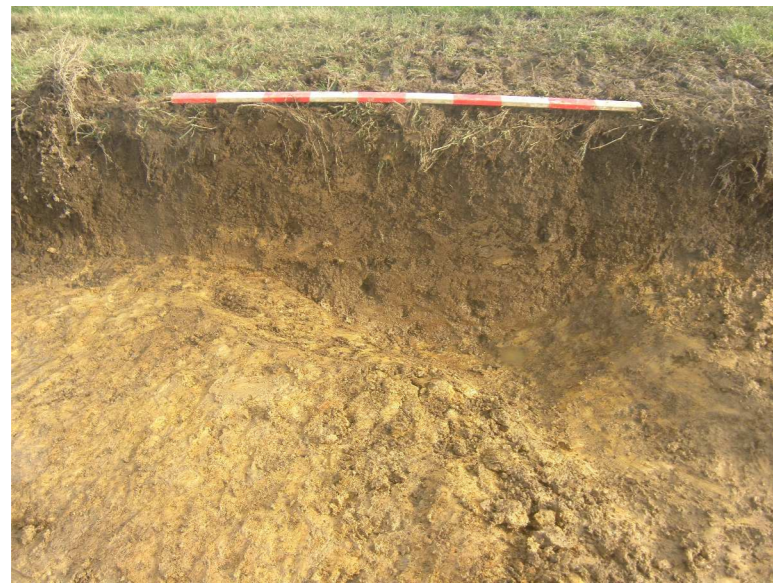
Plate 3: South-west facing section of ditch **1305**

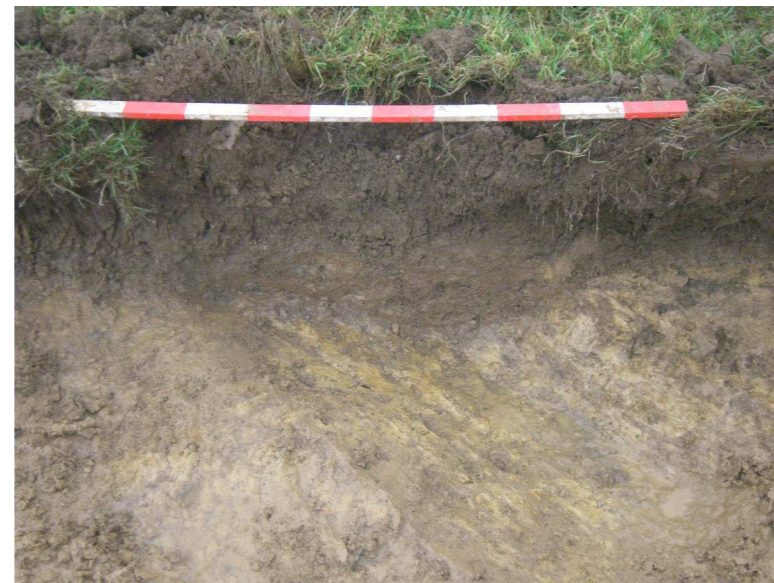
Plate 4: South-west facing section of ditch **1405**

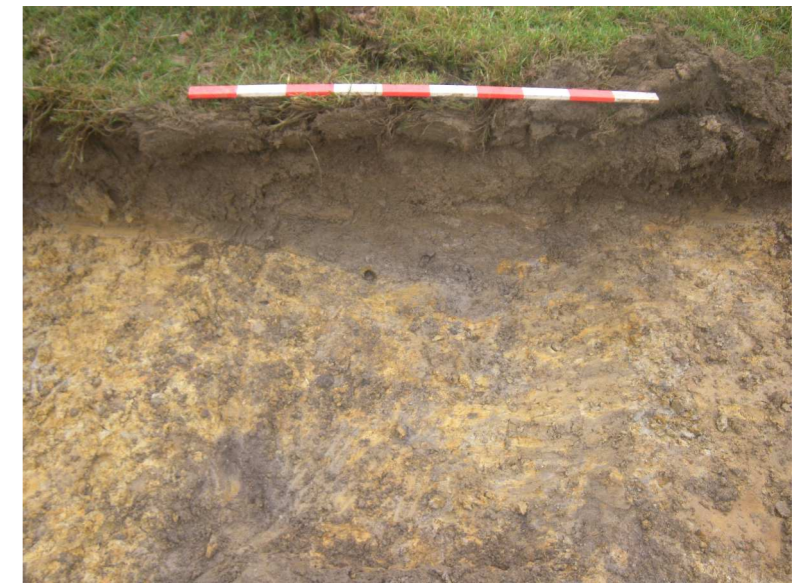
Plate 5: West facing section of ditch **1403**

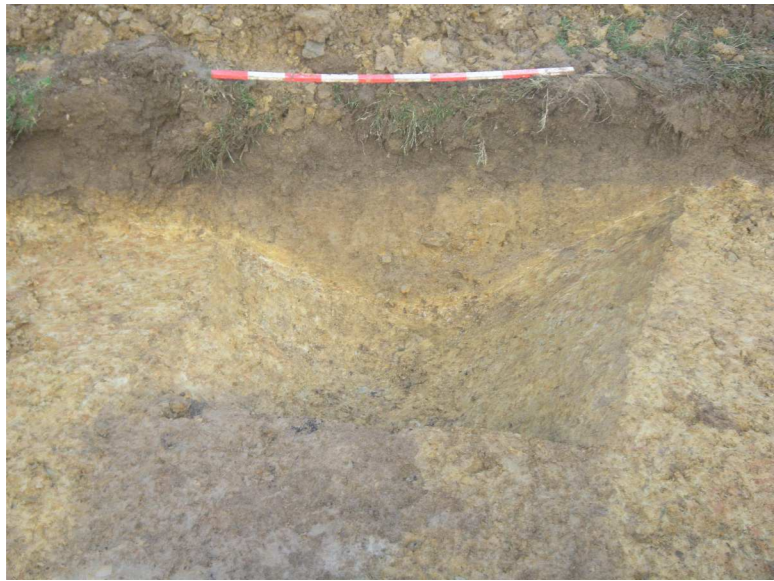
Plate 6: South-east facing section of ditch 1103

- 3.2.10 **Trench 11** included the possible ring ditch feature identified by the geophysical survey (**Figure 4**). Although a corresponding ditch **1103** was found at the southern end of the trench (**Figure 4, Plate 6**) nothing was located to correspond to the northern part of the arc. Ditch **1103** which contained a primary fill (**1105**) and two secondary fills (**1104, 1118**) appeared to have been heavily truncated. To the north of this was a series of postholes (**1106, 1108, 1112, 1114 and 1116**) and a small pit **1110**. Four of these postholes (**1106, 1112, 1114 and 1116**) were very similar, containing a slightly mixed fill with remnants of the stone post-packing. In contrast **1108** had a much darker fill with fragments of charcoal (**Figure 4, Plate 7**). An environmental sample taken from this feature did not identify any other charred remains within the feature. Within the narrow confines of the trench it was difficult to establish the arrangement of the postholes but based on the current configuration **1106, 1112, 1114 and 1116** seem to form two parallel lines. At the request of the County Archaeologist an additional trench (**Trench 26**) was opened at the northern end of **Trench 11** parallel to the fenceline, however, no further postholes were present. Pit **1110** contained three fills (**1111, 1119, 1120**) which were very red in colour (**Figure 4, Plate 8**), this colour may be partly due to heating but may also be natural colouring from the source material. Red coloured natural geology is not found in this area but does underlie the fields further to the north.

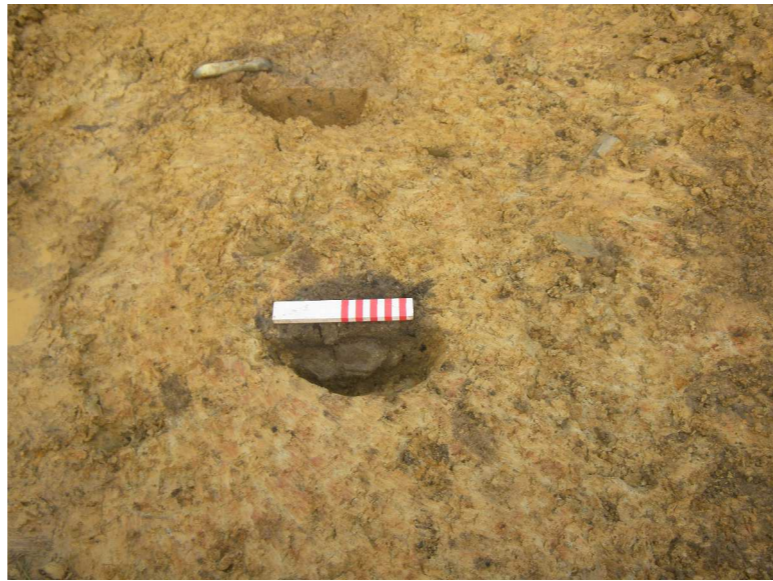
Plate 7: Postholes 1106 and 1108, view from south-east

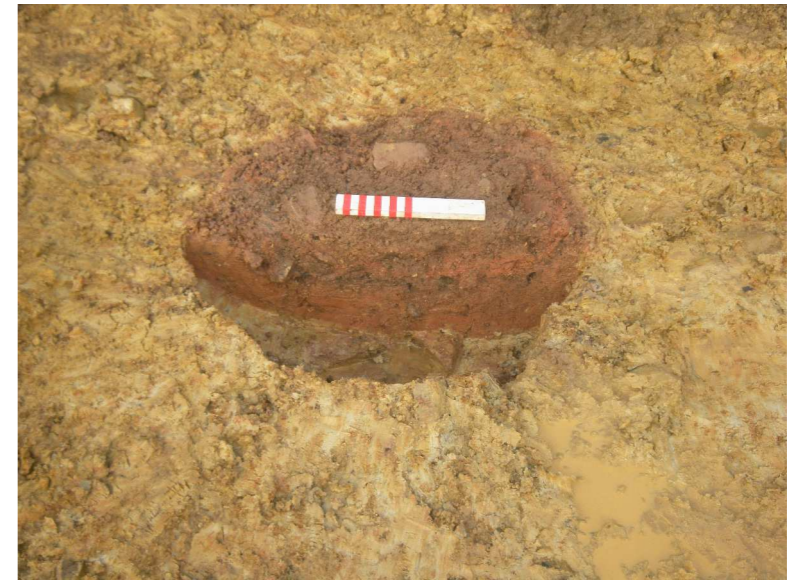
Plate 8: South-east facing section through pit 1110

Fragments of charcoal were apparent within the upper and lower fills (**1111** and **1119** respectively). Deposit **1111** was sampled and found to contain a small amount of charred grain in addition to the charcoal; this may suggest settlement activity in the vicinity. All three fills as interpreted as deliberate backfills of material, potentially derived from a nearby domestic hearth.

5.3.1 Wood charcoal was noted from the flots of the bulk samples and is recorded in **Table 2**. A large quantity of wood charcoal fragments greater than 4 mm, including both round wood and mature wood pieces, was retrieved from pit **1110**.

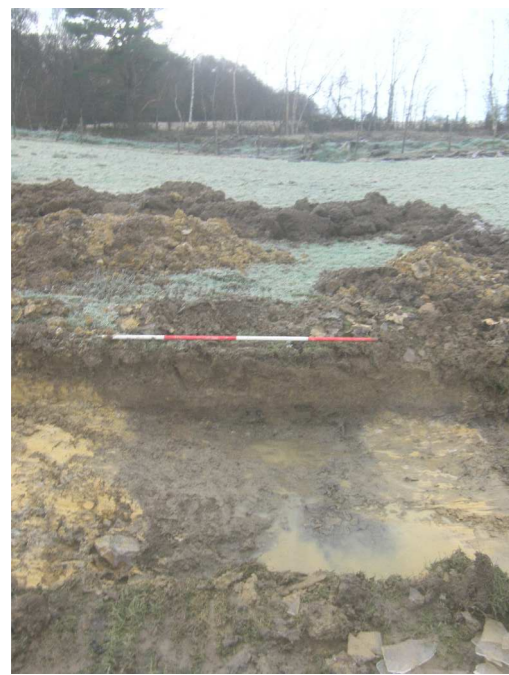
Plate 9: North-facing section of ditch 1903

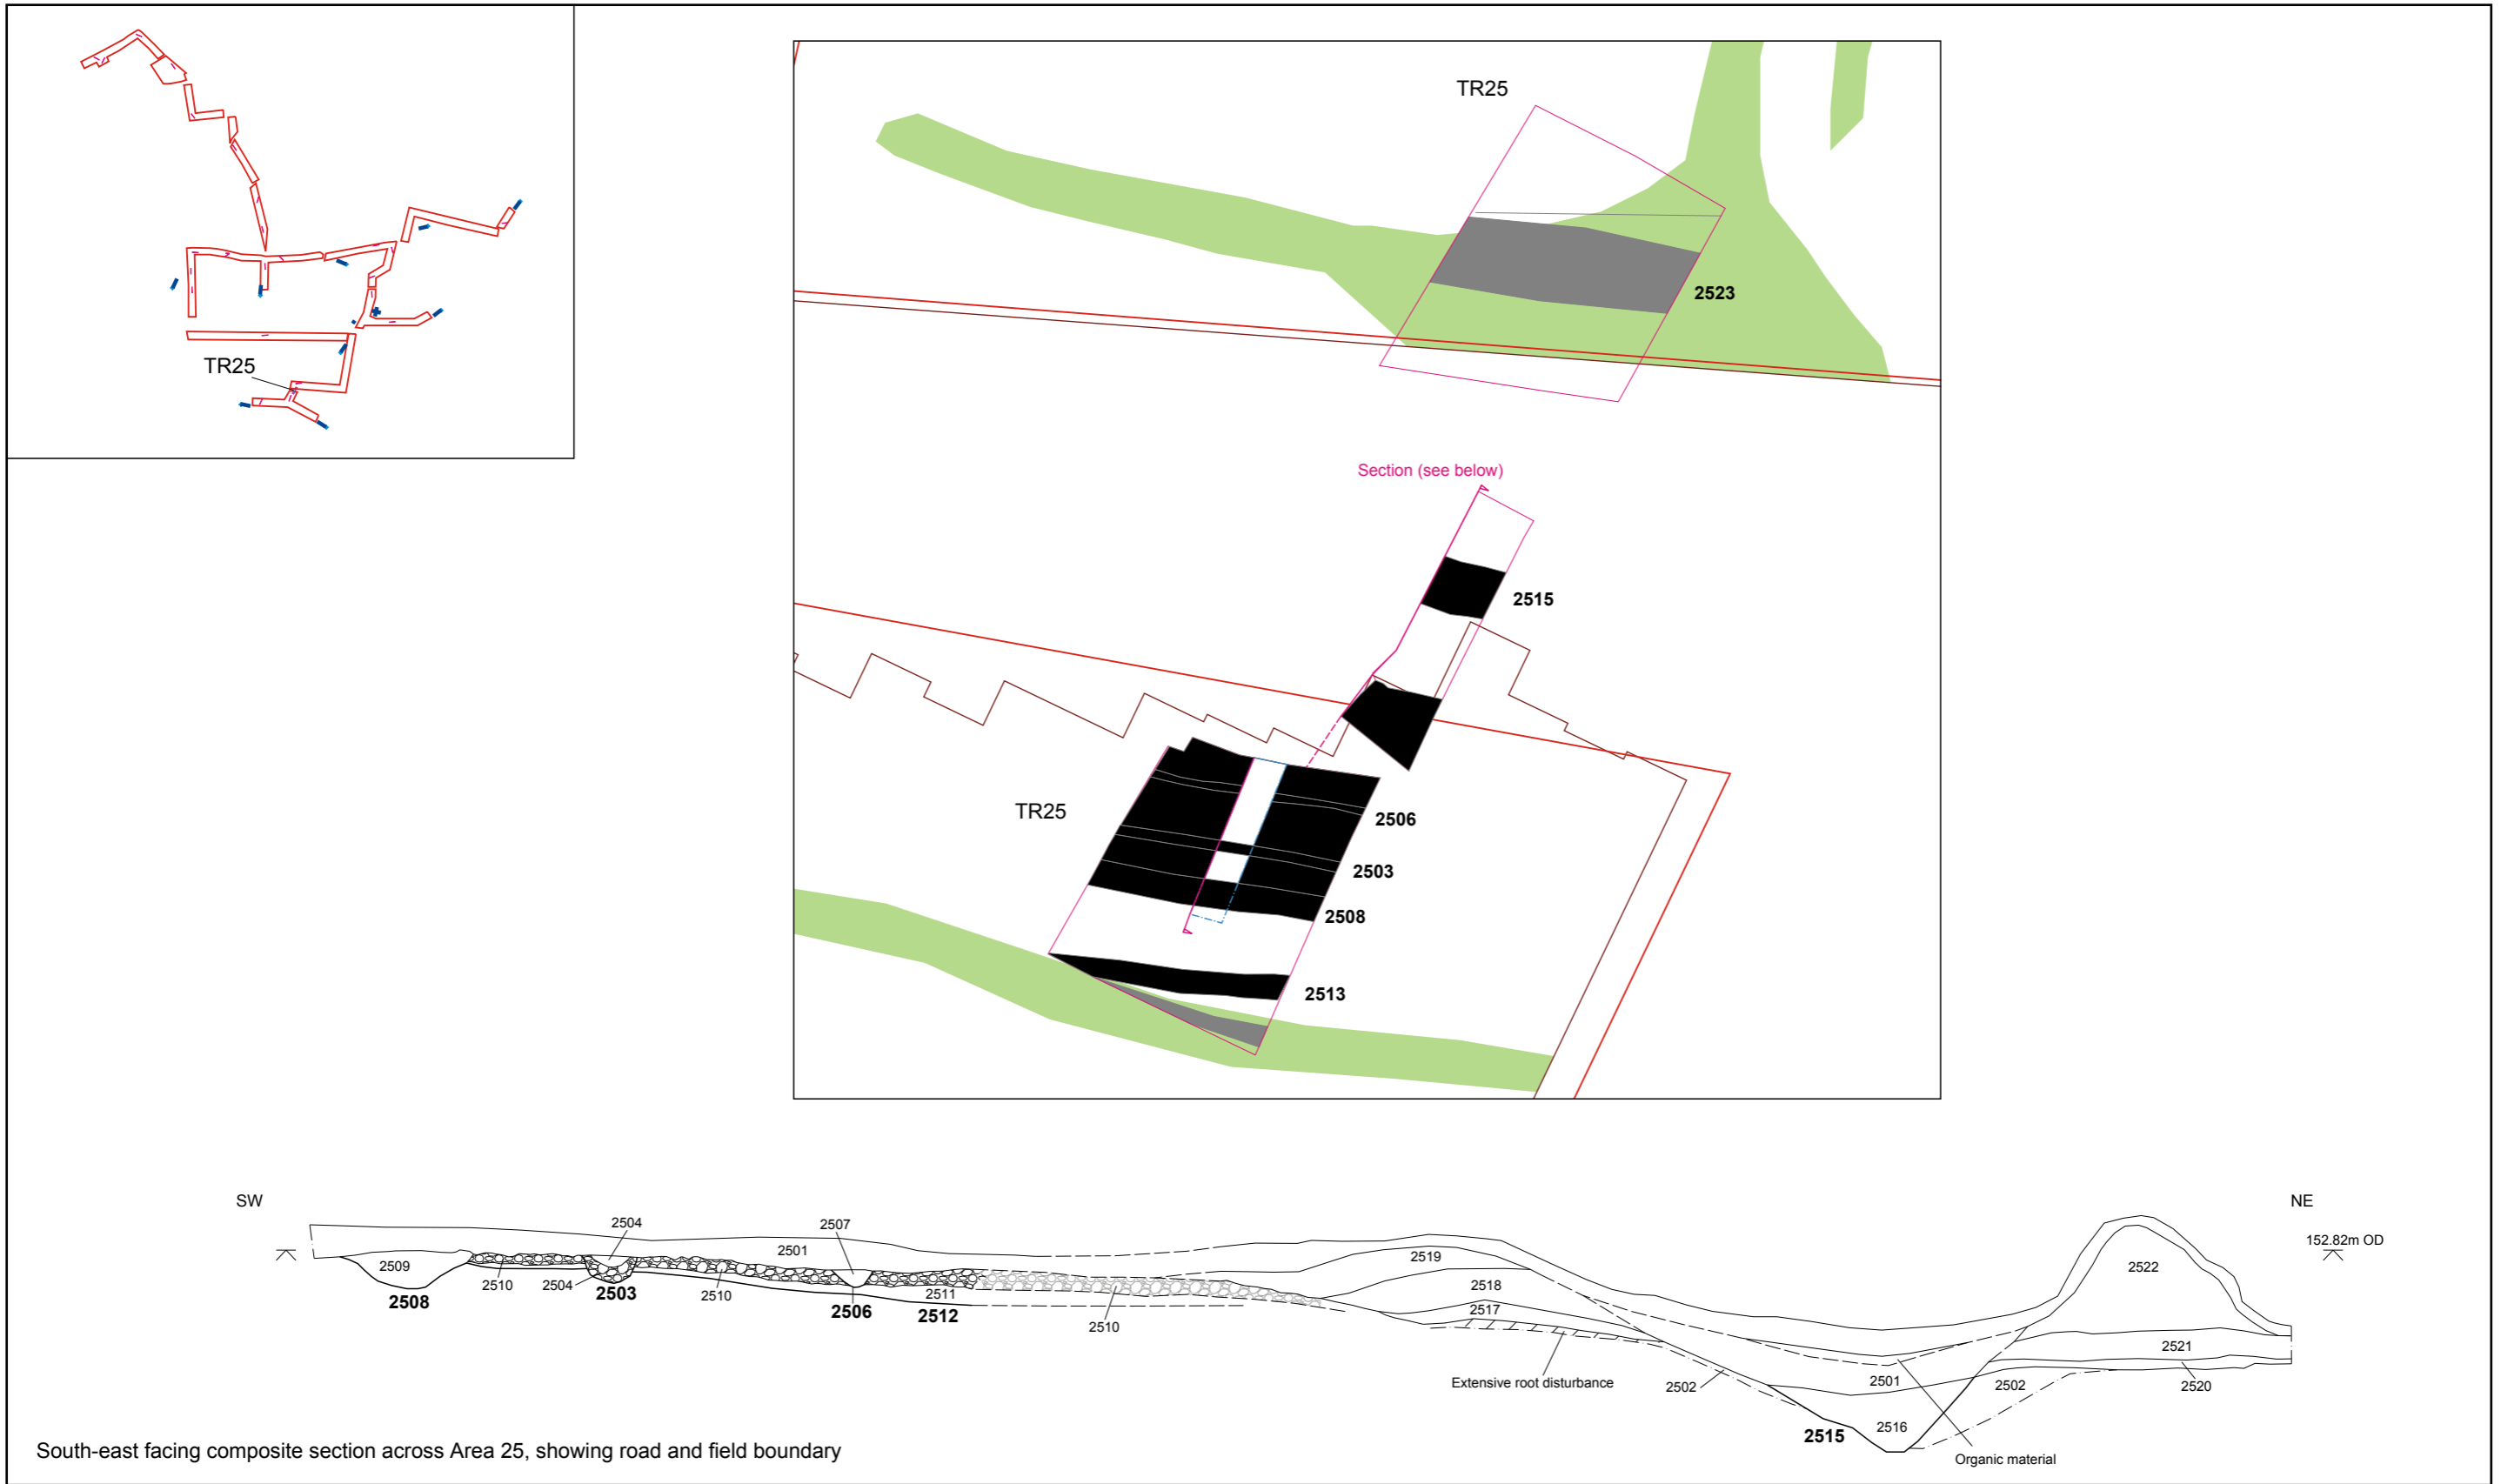
South-east facing composite section across Area 25, showing road and field boundary

- 6.1.1 This investigation successfully located the remains of the known Roman road which was found to survive in relatively good condition with much of the stone metalling still *in situ*. Two wheel ruts were apparent within its surface and a ditch was located on the southern edge. The wheel ruts are contemporary with the use of the road though this usage may extend beyond the Romano-British period. The full width of the road was not seen, as the northern edge was truncated and disturbed by the double hedgerow and ditch of the present parish boundary, but was recorded as over 7m wide. Another ditch lay just to the south of the road on the same alignment.

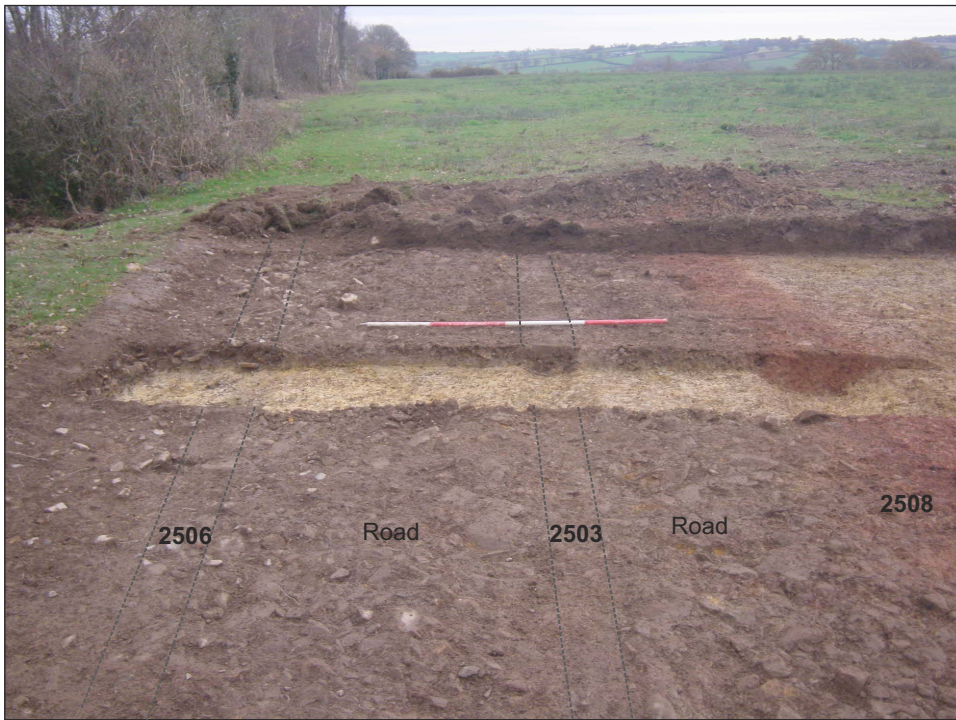
Plate 11: North-west facing section of wheel ruts **2503** and **2506**, road **2512** and ditch **2508**

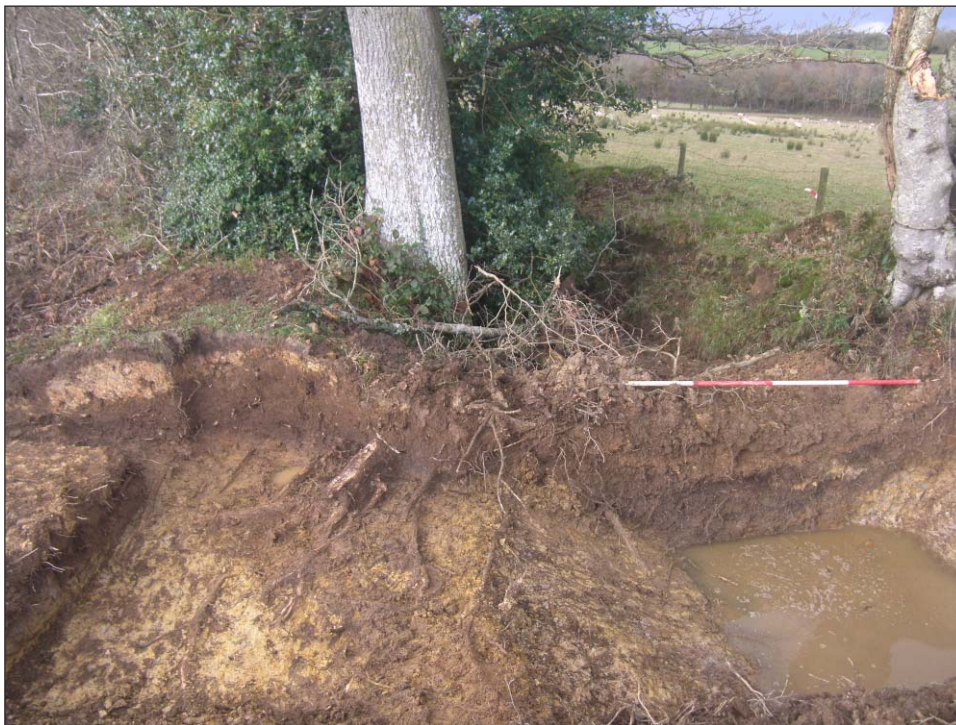
Plate 12: South-east facing section through field boundary
