Gregory's Bank Industrial Estate Gregory's Bank, Worcester

Archaeological Watching Brief

Ref: 88601.01
July 2013

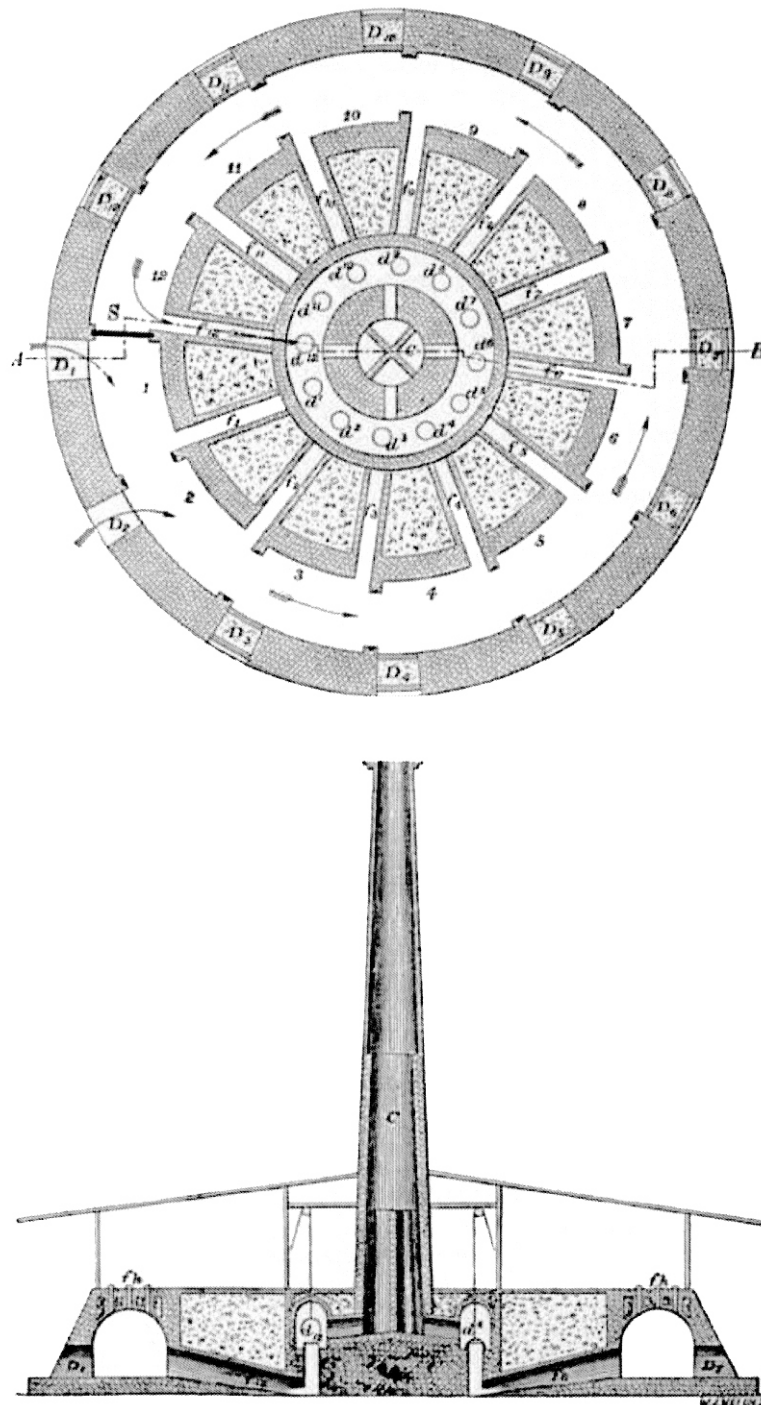
Figure 2

- 2.2.4 The process and production of bricks in a Hoffman Kiln is a circular or annular flow (www.chestofbooks.com) (See **Figure 2**). The 'flow' of production is as follows: Chamber 1 is being filled with raw or green bricks, Chamber 2 is being emptied of cold fired bricks, Chambers 3,4,5,6 contain bricks which have been fired and are cooling. Chambers 7 and 8 contain bricks which are in the process of being fired. The fuel for this purpose is supplied through the fire-holes along the top of the chambers. The fuel (probably coal)

Historic plan and cross section of typical Hoffman Kiln showing process flow

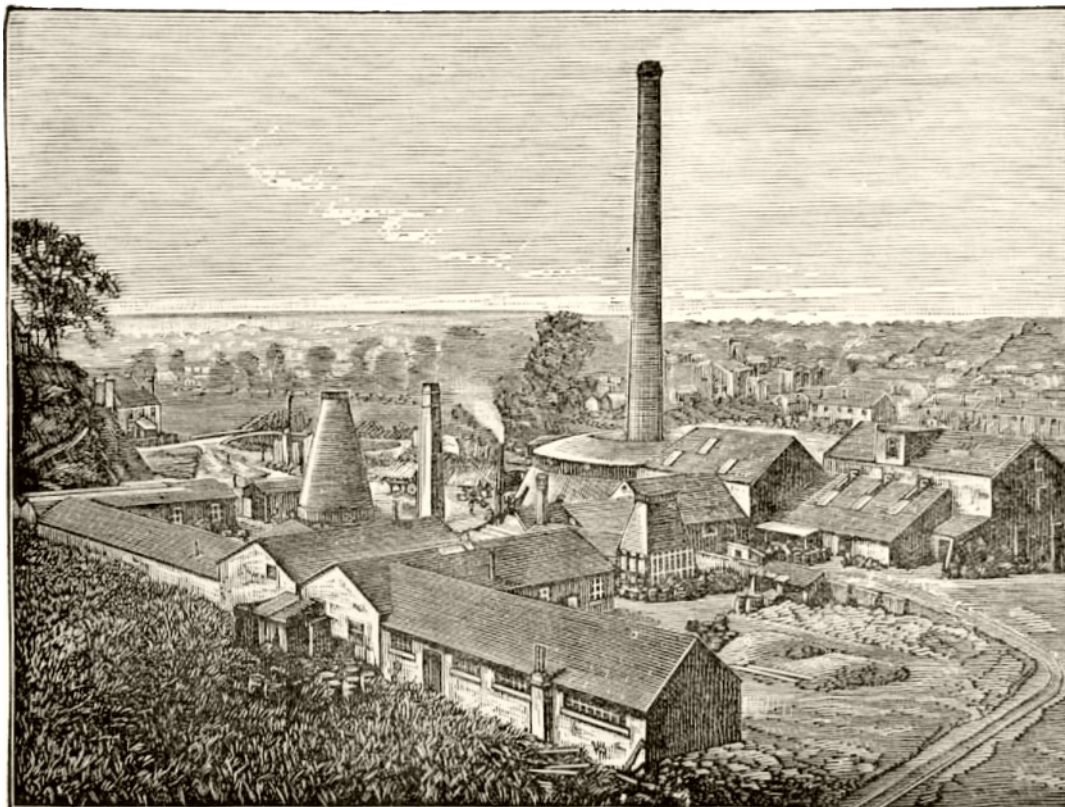
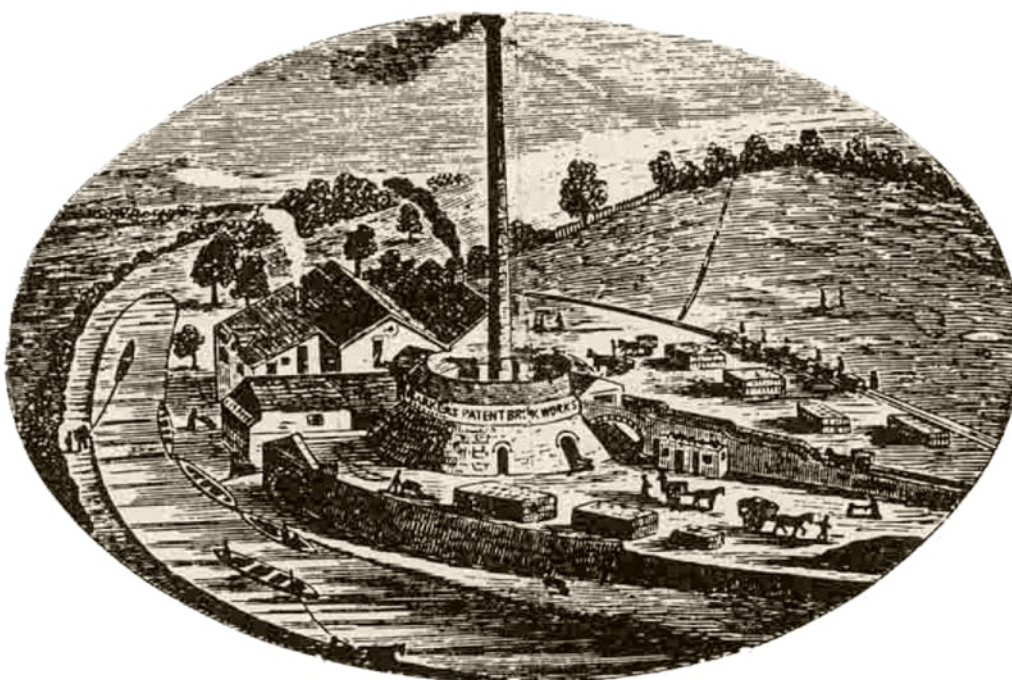
Figure 4

was transported by horse and cart up to the level of the fire-holes via an inclined ramp, this feature can be seen on the 1886 Ordnance Survey plan together with the 1880's sketch of the works and the 1920 engraving (**Figures 3-4**). Chambers 9,10,11 and 12 are drying and becoming very hot from the heat created from chambers 7 and 8. The cold air is fed through the open doors of chambers 1 and 2 and proceeds in the direction shown on the figure by the arrows. The air becomes partly heated by passing over the cooling bricks 3,4,5 and 6, it then enters chambers 7 and 8 where it gets super heated and then passes into chambers 9,10,11 and 12 to dry and heat the green bricks. It then meets the blocking screen between chambers 12 and 1, travels down the sloping flue of Chamber 12 and is allowed to pass into the base of the main chimney by a raised damper.

1880's sketch and 1920 engraving showing brick works with Hoffman Kiln and inclined ramp for fuel

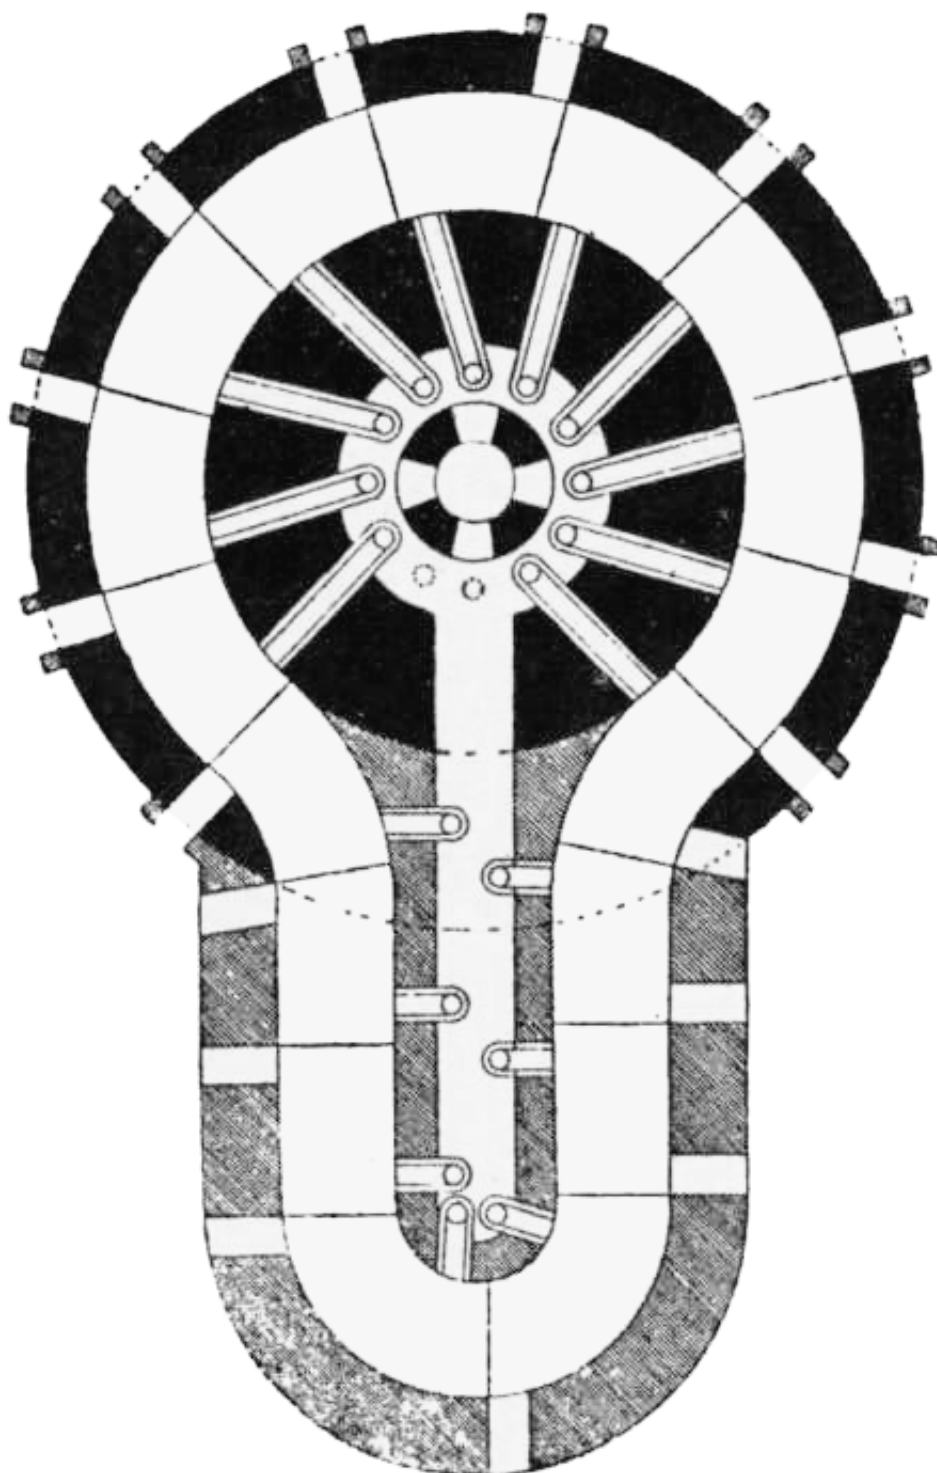
Figure 5

- 4.4.2 Curiously, the plan alignment of the flue was at angle to the projected centre of the kiln and not aligned radially (**Figure 1**). It is known from documentary evidence (www.lowtechmagazine.com), that there were some variations to the basic plan form of the radial flues in a Hoffman Kiln. **Figure 5** shows an adapted annular Hoffman kiln into a 'shank' kiln. What is interesting, is, that the plan shows the original annular kiln with angled flues and not radial. The angled plan alignment of the flue recorded at Gregory's Bank would fit this plan but, sadly, no other flues survived so; a comparison could not be made with any of the other flues on-site which would have confirmed this.

Plan of Hoffman Kiln adapted into a 'shank' kiln

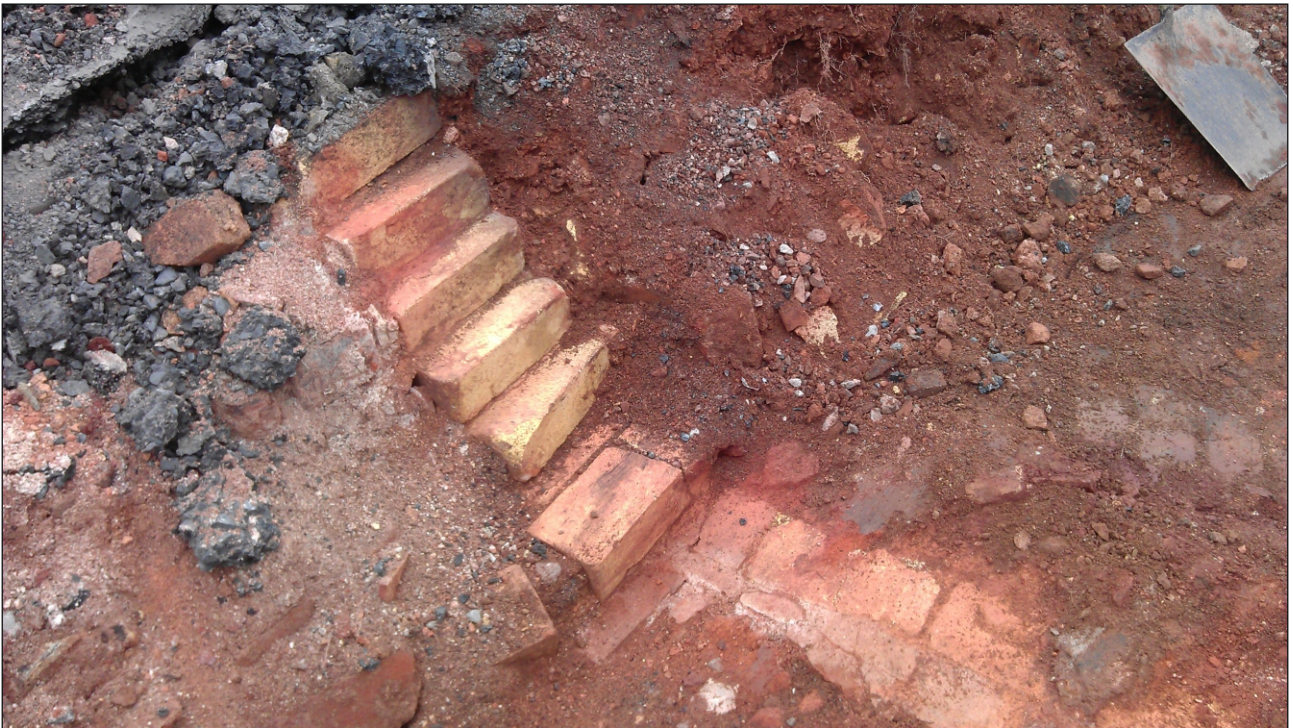
- 4.2.1 A small segment of outer kiln wall was identified (**context 1004, Figure 1**) It was constructed from a mixture of yellow and red bricks. Although badly damaged, and only an internal 'skin' of bricks survived, it could be seen that the bricks were laid in header bond (**Plate 1**) to provide strength. The full thickness of wall was not determined due to the outer layer of bricks being removed.

Plate 1: Surviving section of outer wall of kiln

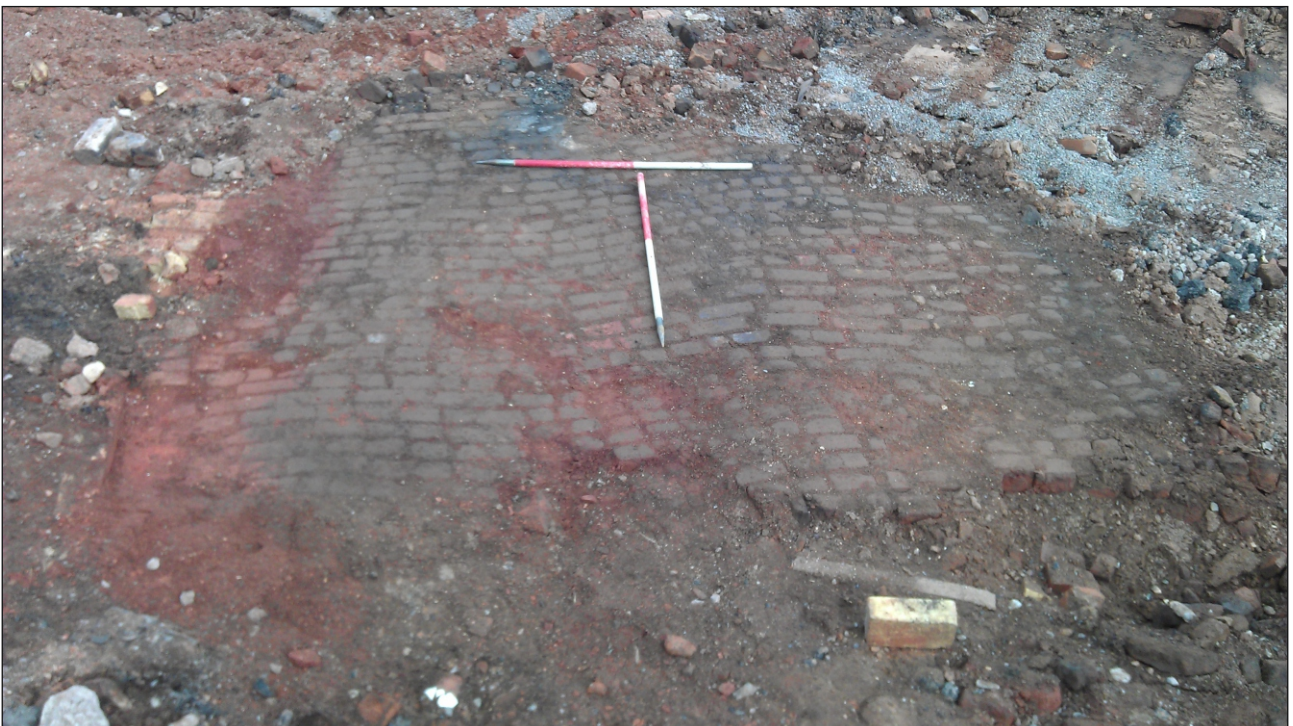
- 4.3.1 An area consistent with a chamber floor was exposed (**context 1003, Plate 2**). Measuring approximately 2m square it consisted of a gently undulating surface of brick sets or pavers. These were laid in a hap-hazard manner with no identifiable pattern. What was apparent, from the exposed upper surface, was the amount of scorching consistent with the area being a firing chamber floor.

Plate 2: Exposed area of firing chamber brick flooring

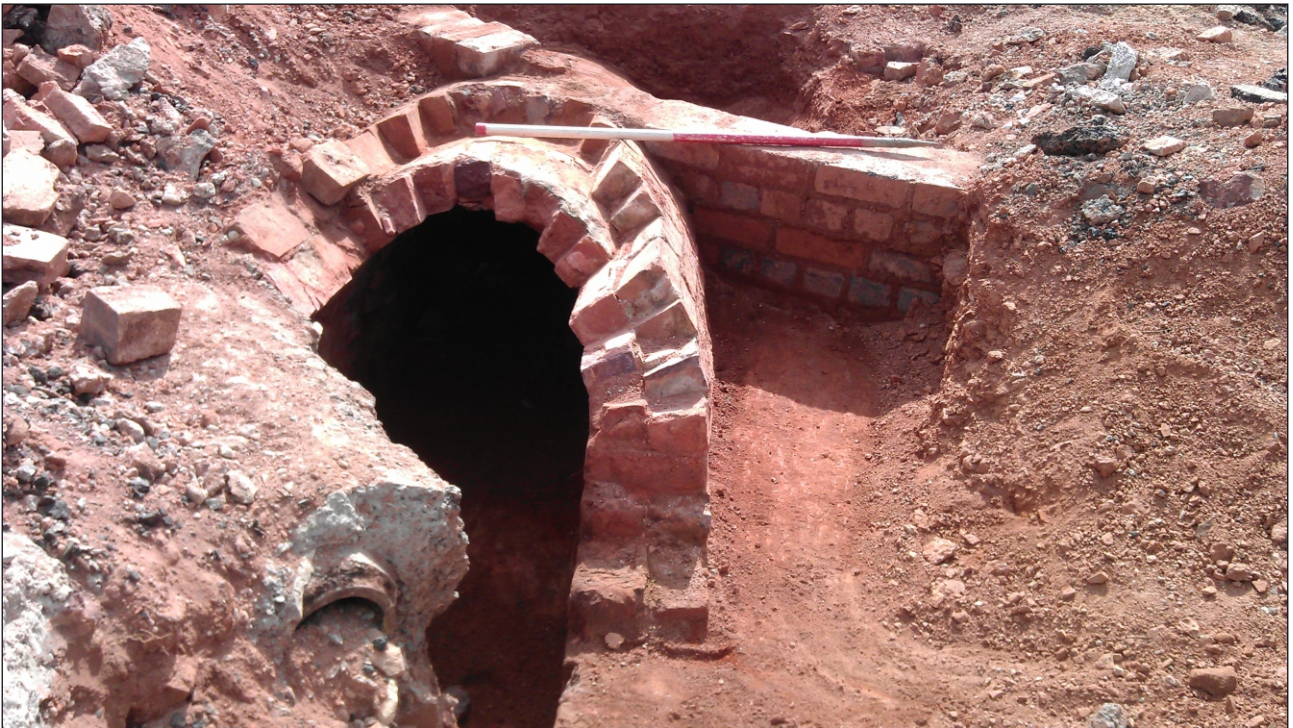
- 4.4.1 Arguably, the most readily identifiable feature recorded on-site was the remains of a smoke flue (**context 1006, Plate 3**). This feature once formed part of a series of flues radiating from the centre of the kiln and provided an exhaust flue to the smoke generated by the firing process. The flue had an arched profile measuring 1.07m wide and 0.87m high (**Plate 4**). The total length recorded was 2.73m. The arch was constructed from a double layer of 'compass' bricks founded on parallel walls also constructed in brick and laid in English Bond. All of the bricks are recorded as being bonded by cementitious mortar. The flue was constructed at an angle pointing down toward the centre chimney area at an approximate slope of 10%. It was recorded passing through a narrow brick wall (**context 1007, Plate 5**). This narrow wall was a single brick wide (9") laid in English Bond for additional strength. This narrow wall was thought to be the outer wall of the damper area. No evidence was found of a damper opening in the top of the flue.

Plate 3: Smoke flue showing arched brick profile

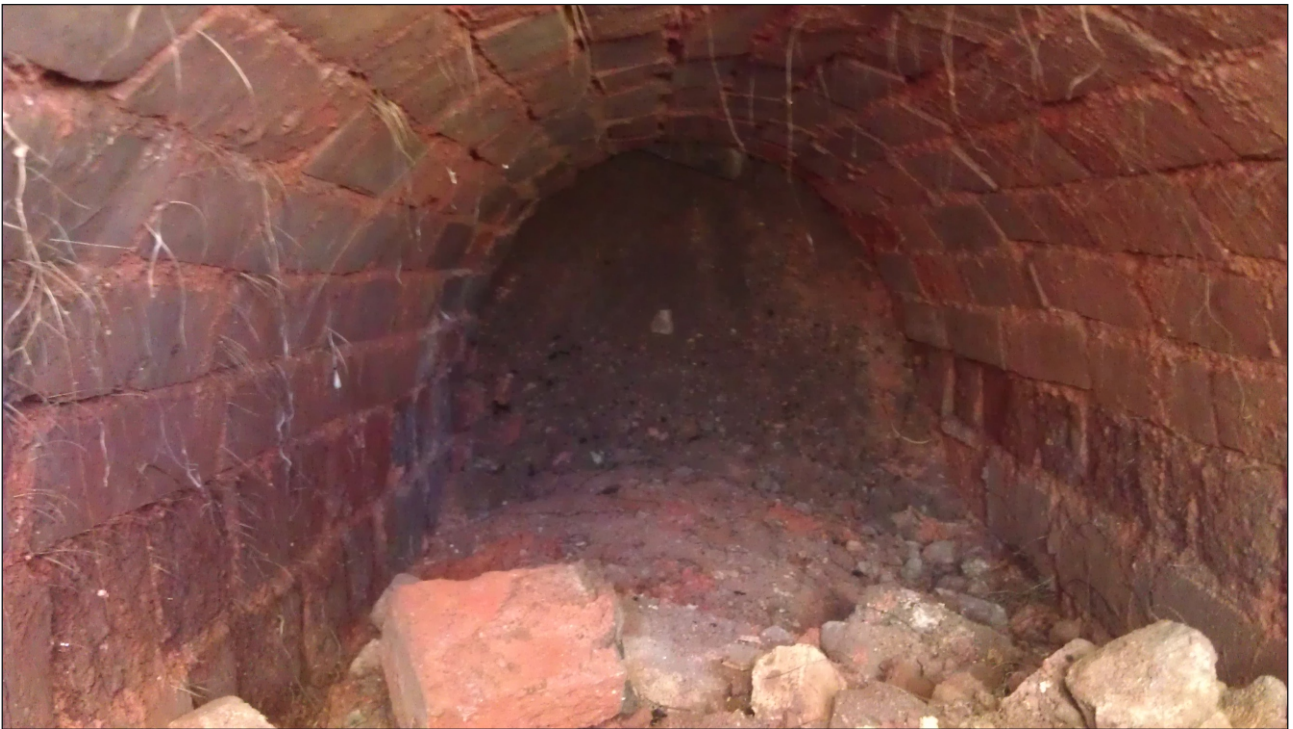
Plate 4: Interior view of flue showing profile

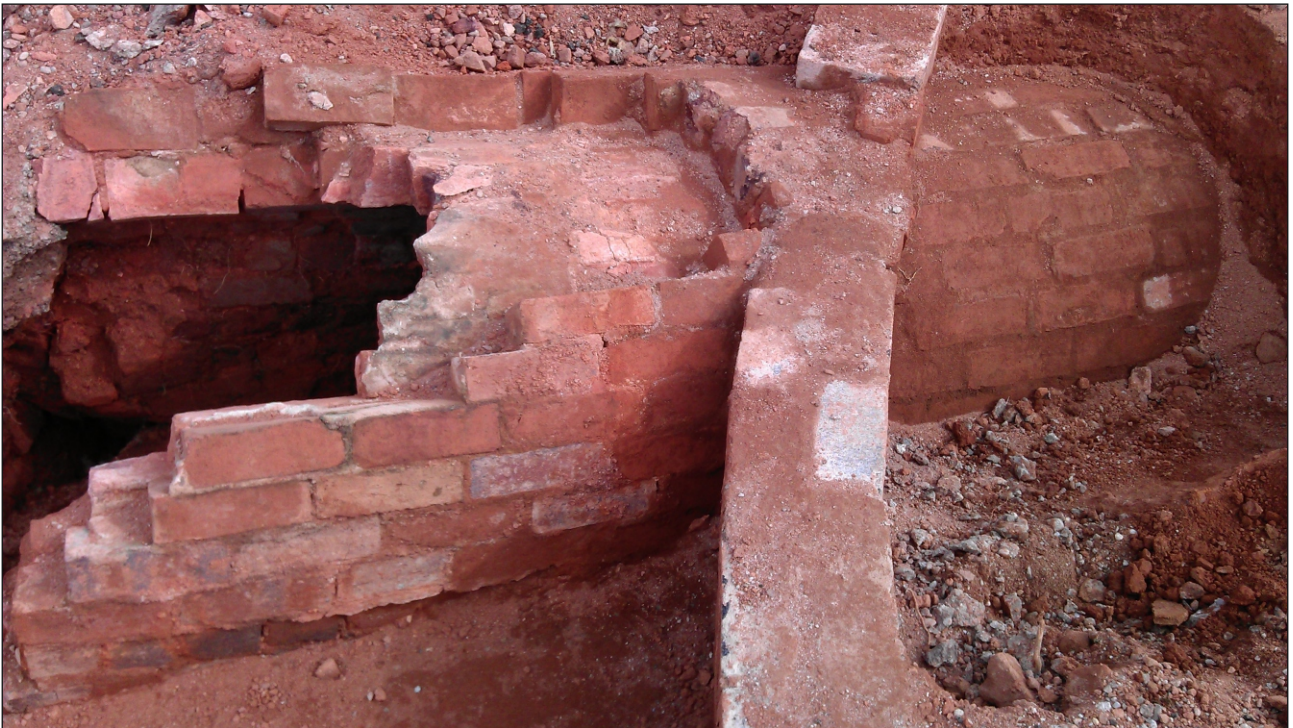
Plate 5: Angled smoke flue passing through outer wall of damper area

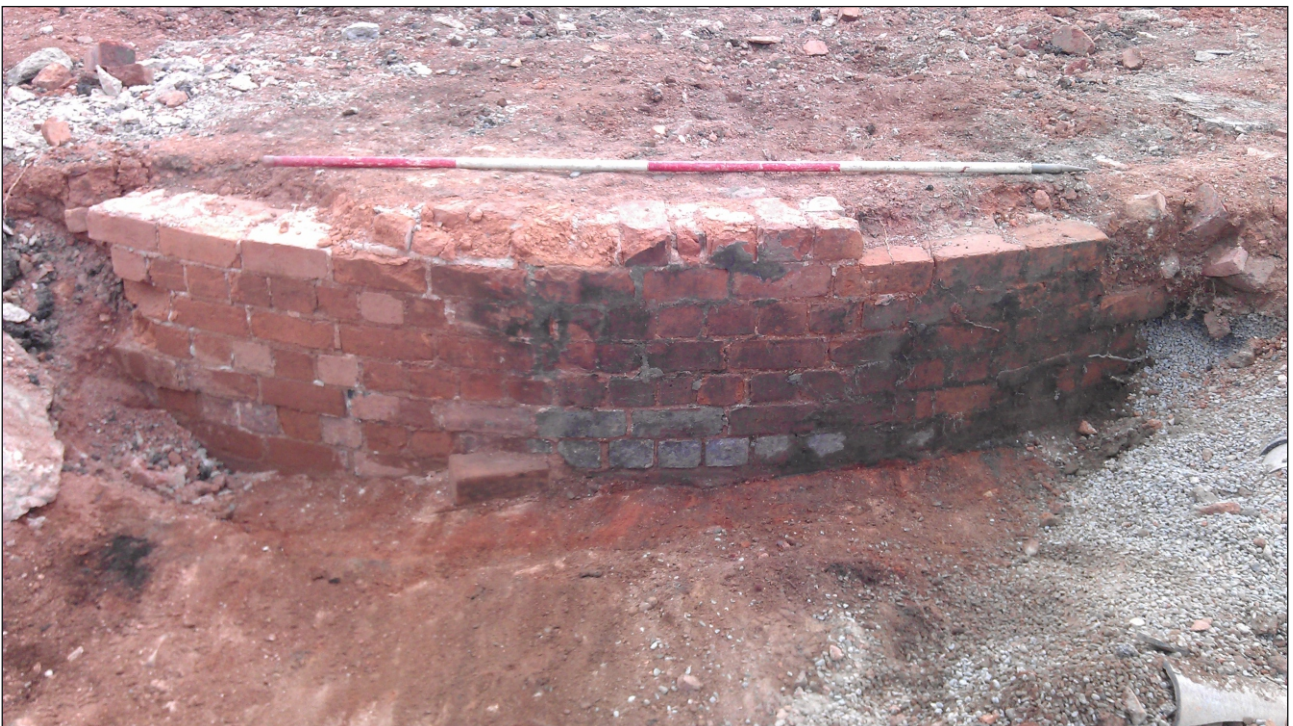
- 4.5.1 A section of curving inner walling, probably relating to the central chimney foundation, was also recorded (**context 1005, Figure 1**). This section of walling measured approximately 2m long and was constructed from the same bricks as the other recorded features on-Site. (**Plate 6**). Laid in a typical English Bond, the extrapolated diameter of 7.31m would be consistent with the measurements provided by Robert. M and Francis in their published article on the chimney dimensions. What was not seen was the interior core of the chimney base or foundation it had apparently been destroyed by later groundwork.
- 4.5.2 There were no signs of the 'second kiln and chimney' noted on the earlier image and these are thought to have been destroyed by the construction of buildings in the 1950s associated with the industrial estate.

Plate 6: Section of central chimney foundation
