**STABILISATION OF EMBANKMENTS & TUNNEL,
HMP THE VERNE,
PORTLAND, DORSET**

Heritage Statement

Report reference: 86630.01

August 2012

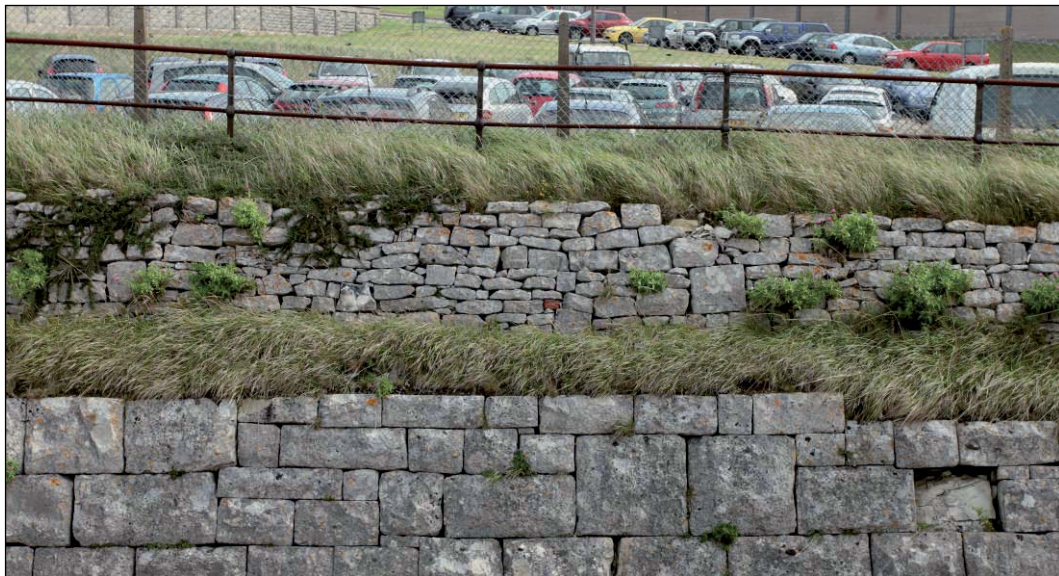
Plate 14: Detail of 'dry-stone' wall construction material and style viewed from west

5.2.4 The wall itself is effectively of dry stone construction with no visible bonding mortar. It has been built of predominantly random coursed rubble limestone blocks of varying sizes. Some of the blocks are squared or rectangular but many are small, broken, un-worked fragments (**Plate 14**). Occasional flint nodules and bricks have also been used in its construction but these are very rare.

5.2.5 Since its construction in the period between 1909 and 1945, there is no record of any alteration and repair to this structure.

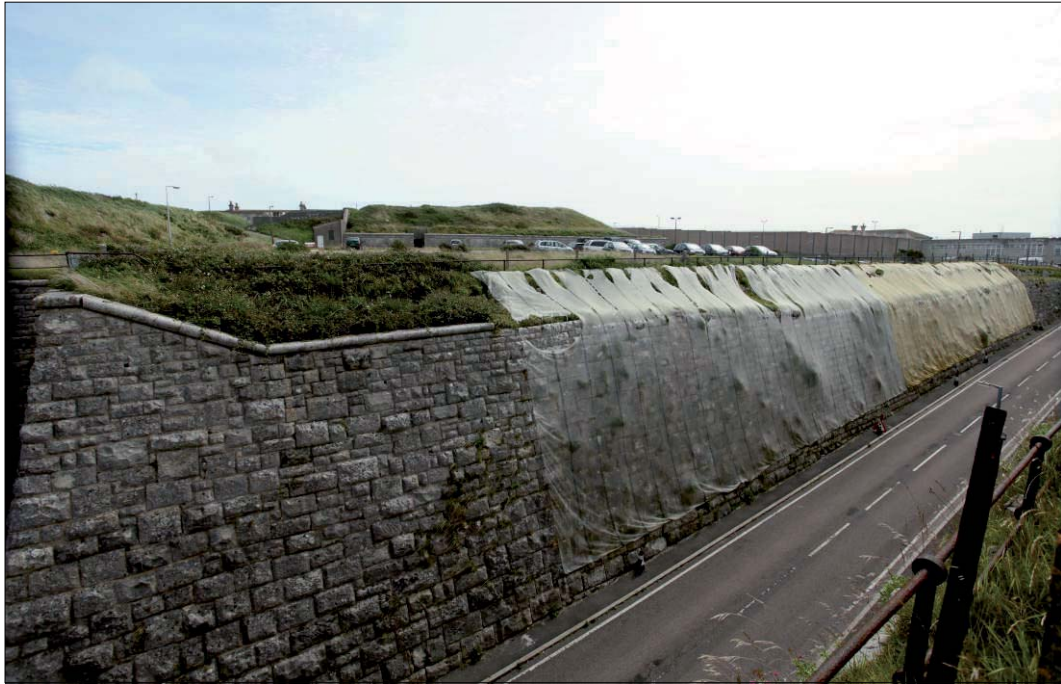
Plate 15: East revetting wall viewed from north-west showing surviving bull-nosed coping stones to main wall

5.2.6 The east revetment wall (**2**) consists of large limestone blocks laid in broken courses. Along the north end of the top of this wall are limestone bull-nosed copings (**Plate 15**). These features appear to have once extended along the length of the wall but have now mostly been removed along its length. This has left the top of the east revetment wall slightly stepped and the top edge with a degraded appearance.

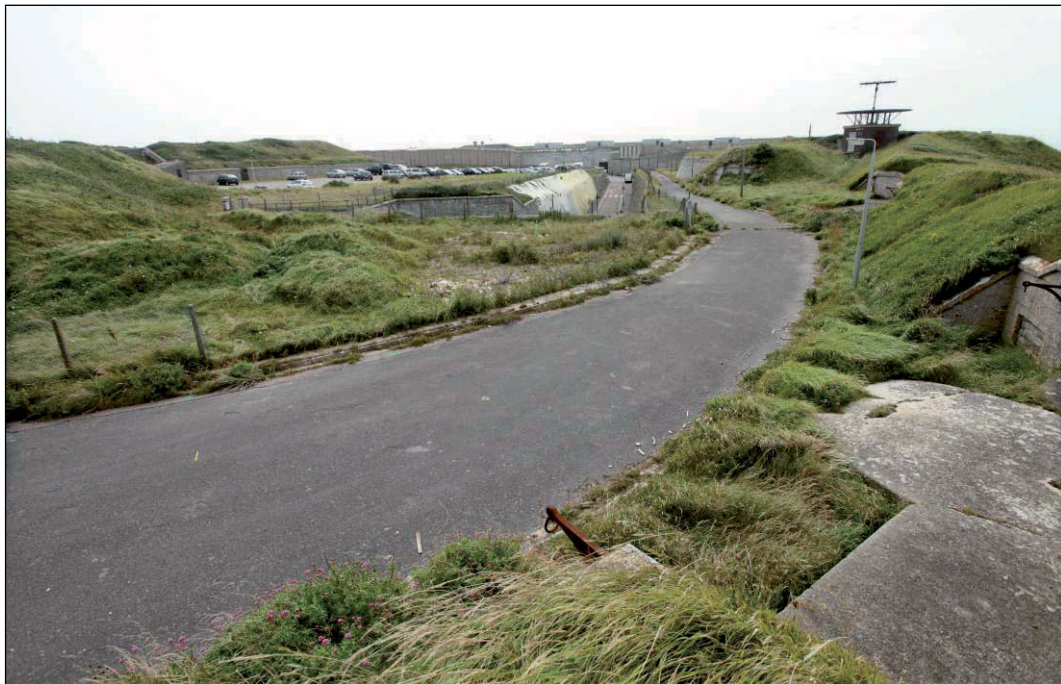
Plate 16: General area directly over main tunnel entrance viewed from north-east

- Area of land above tunnel**
- 5.2.9 This area, located directly above the tunnel entrance into The Verne comprises gun emplacements (5 and 6), a tarmac access road (8), earthen embankments related to defensive earthworks along the north side of the Citadel (7; **Plate 16**), and an area of waste ground immediately above the tunnel.

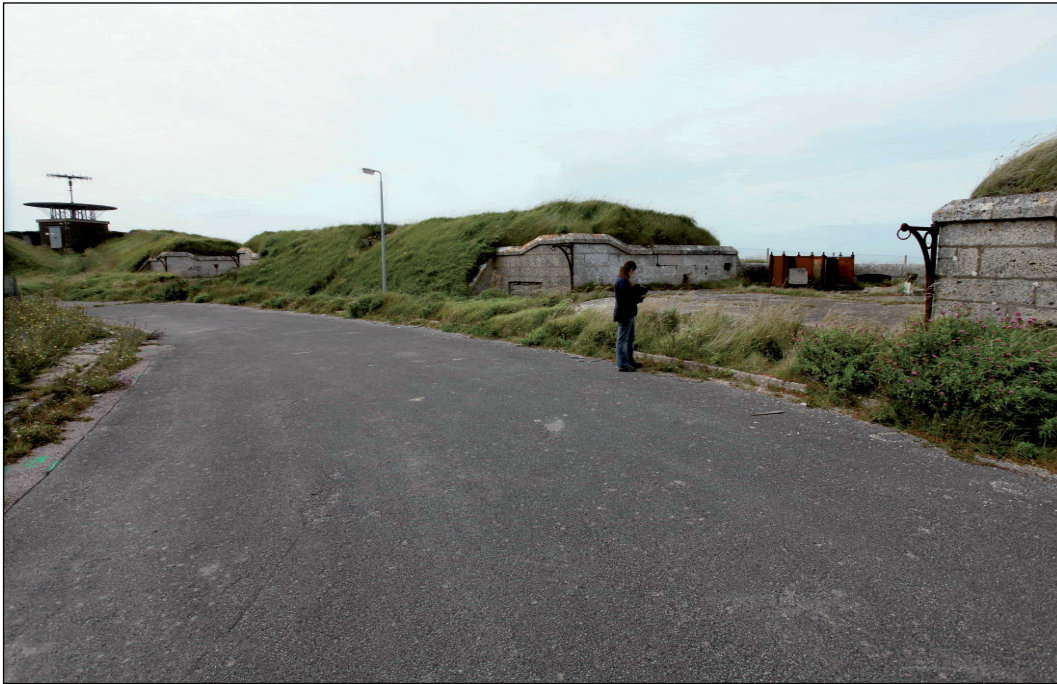
Plate 17: Ground level aspect of 12.5 inch gun emplacement and service road viewed from north-east

- 5.2.10 To the north-west of the tunnel is a 19th century gun emplacement (5), part of a series of batteries along the west side of the Citadel (**Plate 17**) which housed 12.5 inch R.M.L guns. Along the north edge of the area is a raised embankment (7), part of the earthen defence system.

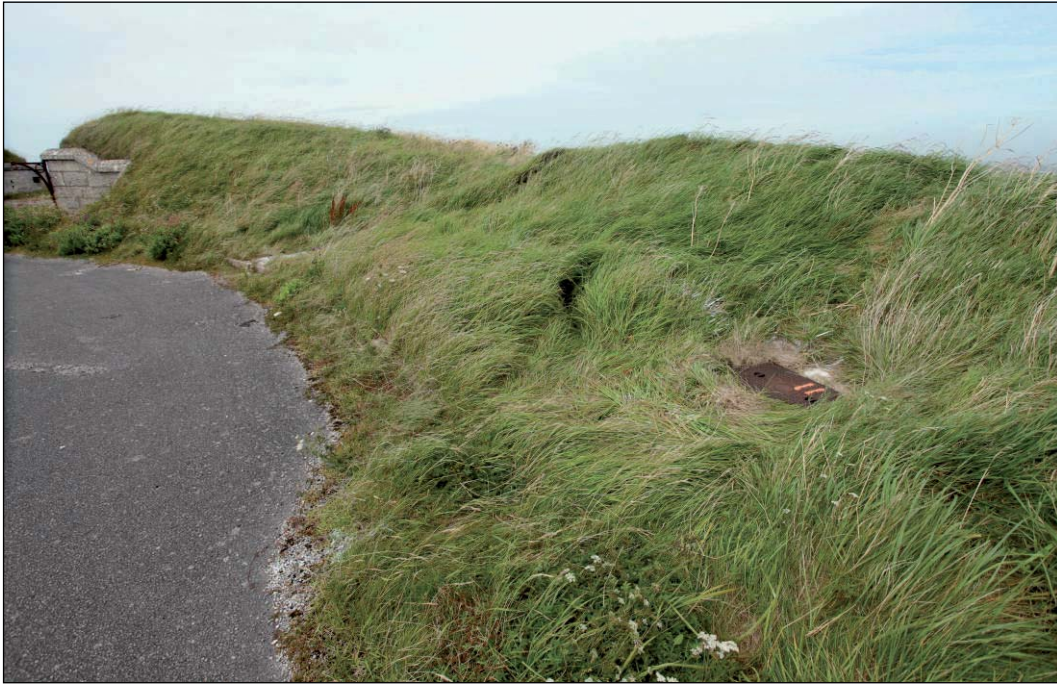
Plate 19: North embankment above main entrance viewed from east

- 5.2.12 Along the northern edge of the road are a series of street lamps, but these lie outside the area of the development proposals, although their cables may lie below ground surface and cross the impact area. The defensive embankment (7) along the north edge of the area stands to a height of approximately 1-1.5m (**Plate 19**) and is presently covered in long grass. The presence of man-hole covers along the south side base of the embankment suggests that there are services (as yet unknown purpose) running along this part of the Site.

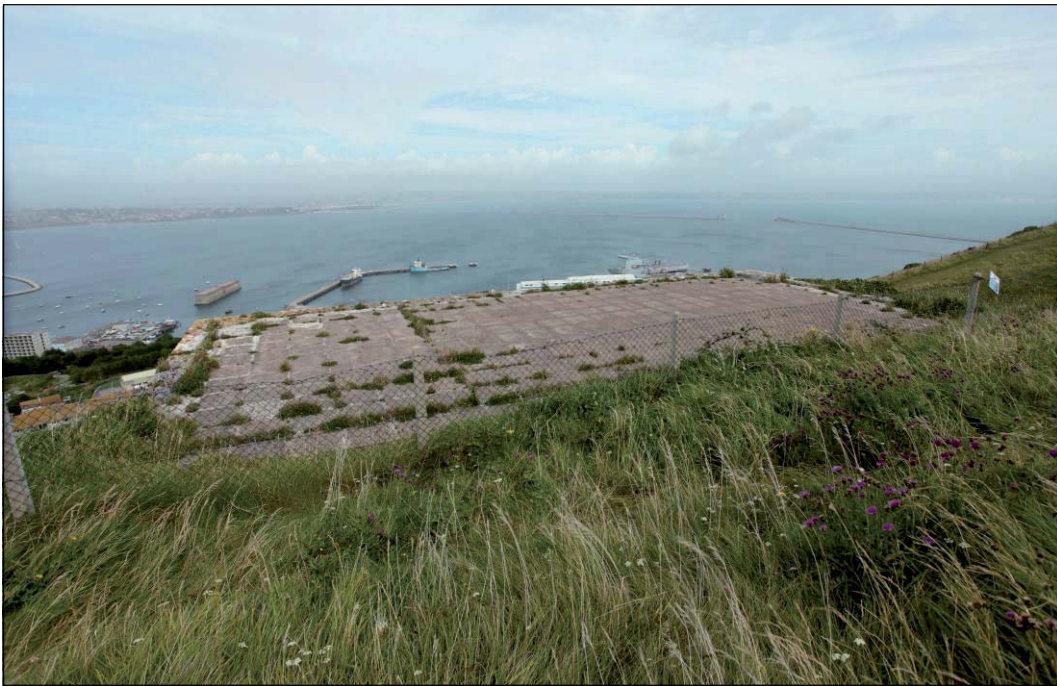
Plate 20: Top of main entrance 'terrace' viewed from south

- 5.2.13 Beyond the defensive embankment to the north the ground slopes down to a concrete post and chain link fence and, beyond, to the exposed top of the main gate. This is characterised by a flat rectangular area which is presently covered in pale red patio slabs (**Plate 20**). The Estates Manger has indicated that these were installed in c.1975 (Clive Otton, *pers. comm.*)

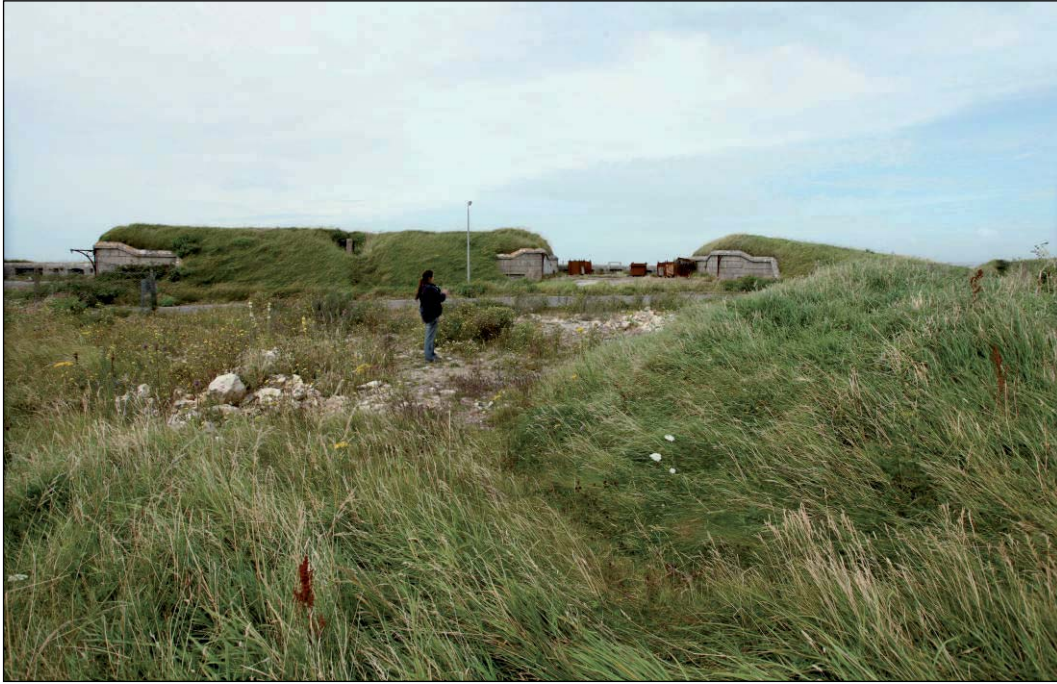
Plate 21: Area directly above south tunnel entrance viewed from east

- 5.2.14 There is anecdotal evidence that over the years, the area above the tunnel on the south side of the tarmac road was used to dump masonry waste and rubble (HMP The Verne Estates Manager Clive Otton, *pers. comm.*). Several lorry loads of this debris were removed in recent years (*ibid.*) but there is still some waste material littering the ground surface, partially overgrown in places (**Plate 21**).

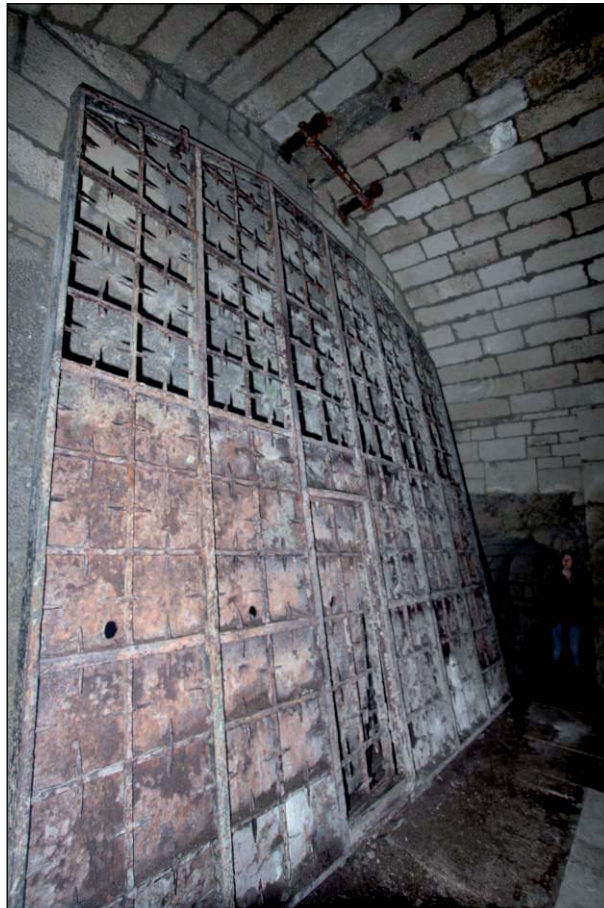
Plate 22: Detail of portcullis

- 5.2.23 The portcullis is constructed from wrought iron 'I' section framing held together by rivets and, in places, iron bolts. The whole structure is suffering from rust caused by salt spray over many years. The rear or south side, originally the interior side of the portcullis when it was *in situ*, is covered in iron plating to approximately half its height. Within this plating are a series of circular rifle loop holes. In the centre is a single door opening with three iron draw bolts.

- **North entrance:** Restore stone crest above entrance; investigate and repair masonry cracking.
- **Portcullis:** Secure portcullis to wall of chamber at a secure angle; remove counterweight;

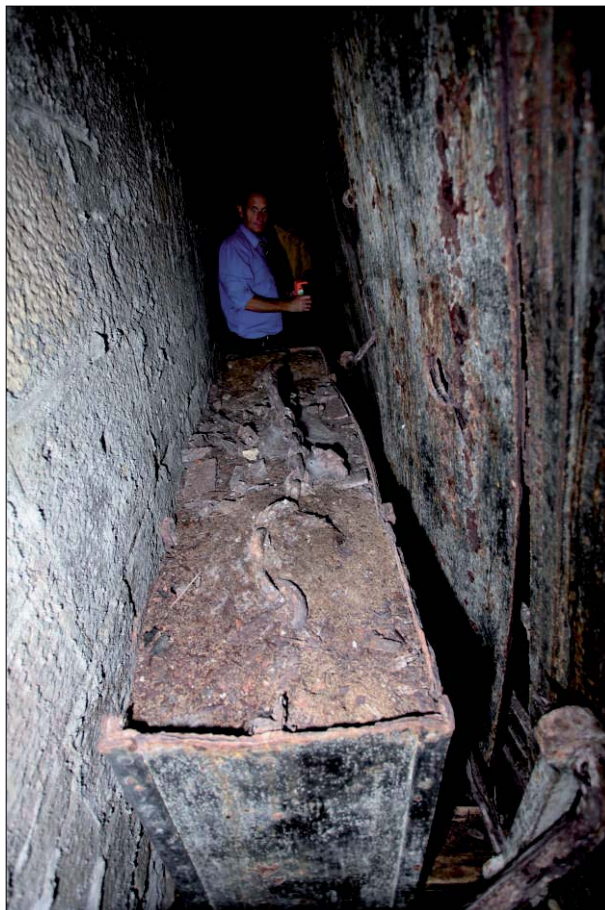
Plate 23: Detail of counter balance weight

- 5.2.24 The counter balance weight is contained within a rectangular metal box consisting of iron plates held in place at each corner by lengths of bolted angle iron (**Plate 23**). On the outside of the box and fixed into the floor surface are vertical iron railing supports. These are thought to be positioned to prevent anyone standing directly under the counter balance weight when it was in the raised position. The horizontal rails are now missing.

- 5.2.25 Along the sides of the box are opposing pairs of flat iron plates. Each pair is probably fixed together through the width of the box for added support. The top of the counter balance weight also appears to be an iron plate with two lengths of large chain passing through the upper iron plate and fixed into the body of the weight box. It is not known, at this stage, what the interior of the weight box contains, but it may be concrete. The two lengths of chain are fixed to a central iron ring which would have originally been fixed to a single length of vertical chain (now missing). This vertical chain would have passed up-and-over a pulley high up on the south wall of the chamber and then over the vaulted ceiling to the north. The pulley is no longer present but the frame survives (**Plate 24**). It then divided into two and passed over two pulleys fixed directly over the portcullis. The secondary pulleys or fixing frame are no longer present only the remains of the fixings for the frame can be seen within the masonry fabric. There is evidence of other fixings which relate to the raising of the portcullis in the vaulted ceiling but none remain in-situ.

scope of replacement, where possible. It is recommended that following removal of the sheet steel lining to the tunnel, the tunnel lining should be subject to recording, prior to the removal of any historic fabric. It is recommended that further recording work, possibly comprising a full digital photographic survey, be undertaken in relation to the masonry wall prior to its removal. It is considered that the portcullis could benefit from conservation *in situ*, and it is strongly recommended that an alternative be sought to the proposed removal and demolition of the counterweight.

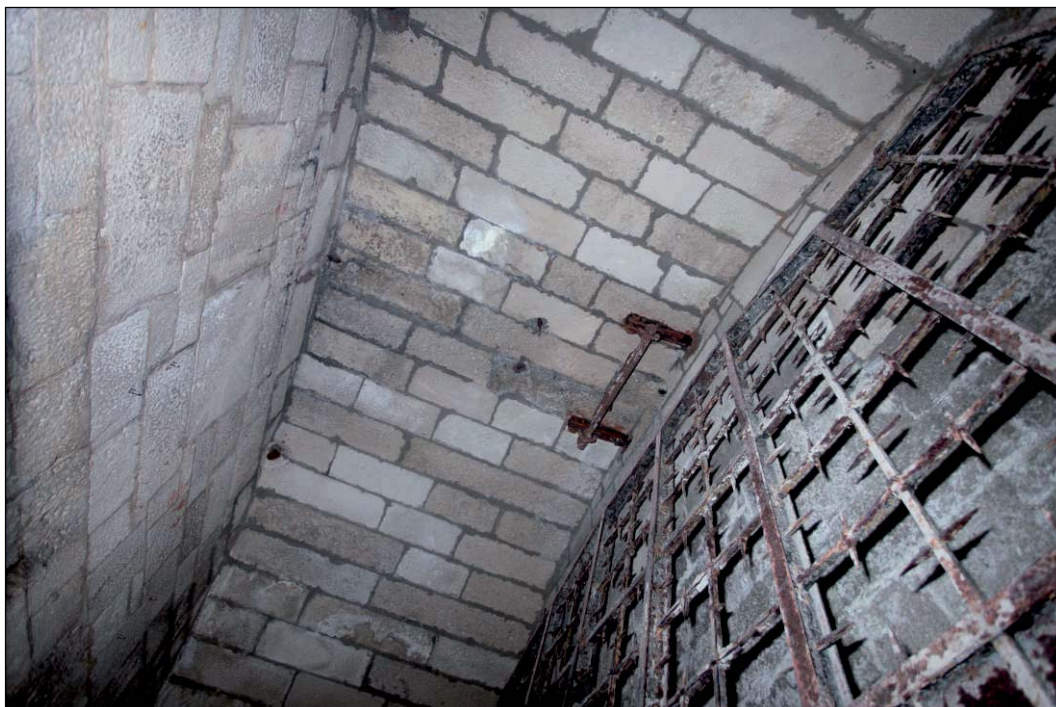
Plate 24: Vaulted ceiling of portcullis chamber showing remains of iron fixings for raising the portcullis

- 5.2.26 The chamber floor and wall fabric have been the subject of both repair and re-pointing. The stone floor slabs around the portcullis slot have been either re-laid or replaced. Some of the slabs have been machine cut to maintain the portcullis slot (**Plate 25**). This suggests that some replacement of floor slabs has taken place. The jointing of the vaulted ceiling appears to have been re-pointed using cement based mortar (**Plate 24**).

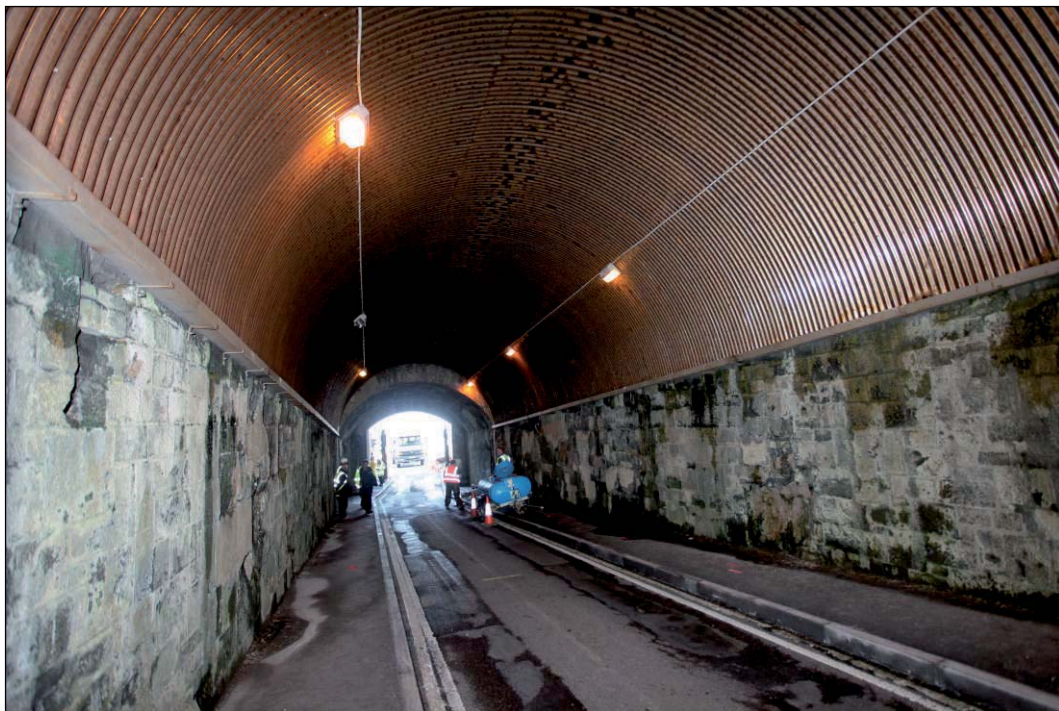
Plate 26: Main tunnel entrance roof lining viewed from south

- 5.2.18 At the time of the site visit the tunnel roof lining was *in situ* (**9**). It consisted of pre-fabricated corrugated interlocking sheeting (**Plate 26**). This sheeting only covers the intrados of the tunnel and at the base of both sides of the sheeting is a gutter to catch water. The gutter is supported on metal brackets which have been fixed directly into the wall fabric. The tunnel walls are exposed and it is clear that water ingress is having a detrimental effect on the stone walls. The walls are constructed from squared limestone blocks of varying sizes and laid in broken courses. Many areas of stone walling have spalled away and patching repairs have been undertaken in a variety of materials and styles (**Plate 27**). This includes both lime and cement mortar resulting in a poor finish quality. The opposing accesses to the

preferable. In addition, design methodologies should emphasise the careful and skilled removal of modern features such as the existing steel tunnel lining and cementitious mortar, in order to avoid damage to surrounding historic fabric.

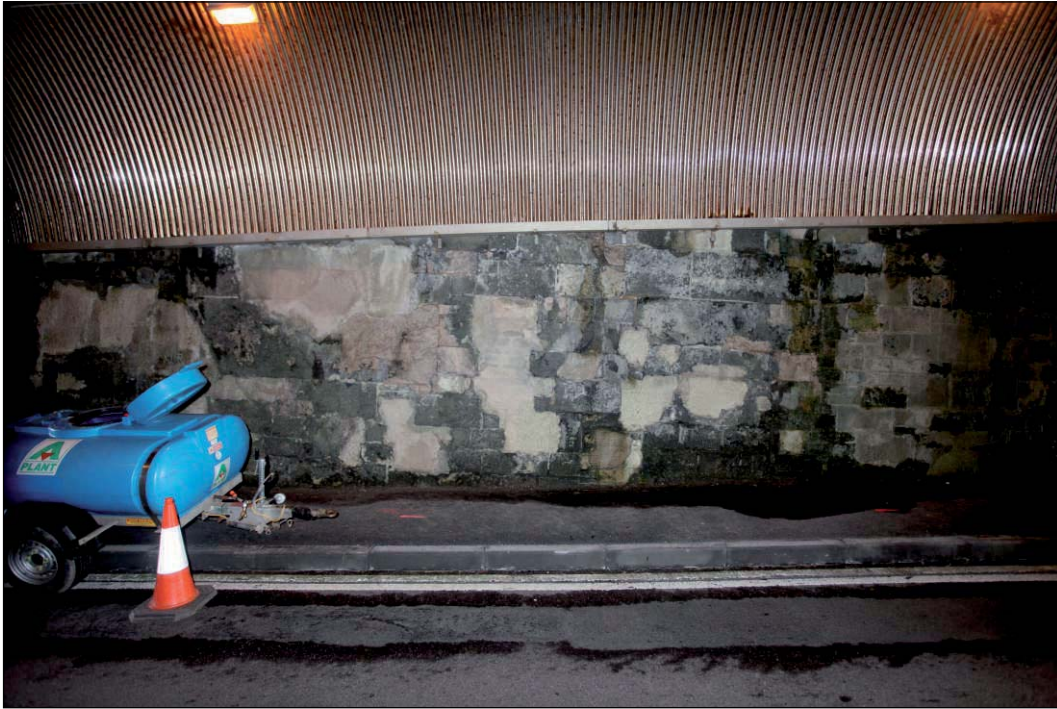
Plate 27: Example of deteriorating tunnel wall fabric showing many repairs viewed from west

- 6.1.7 The present tunnel stone facing is in a poor condition. It has been subject to patchwork and piecemeal repairs over many years but still remains a significant feature of the Citadel. Its present appearance is poor and one of gradual erosion due to the water ingress. If this is arrested soon much can be saved and restored. Although the intrados of the tunnel could not be seen it is assumed that it is in a similar condition to the walls of the tunnel. Due to its importance as part of the main entrance into the 19th century Citadel, it retains a high level of significance.

- 8.2.1 On the basis of the above findings, it is suggested that further work may be required by English Heritage and/or the Planning Officer for Dorset County Council in advance of and during the proposed works.
- 8.2.2 A key recommendation is that the proposed repair works to masonry, in particular within the tunnel and north entrance, and to the revetment walls, be designed in consultation with a suitably qualified and experienced conservation architect and/or conservation engineer. Many of the proposed repairs seem to entail potential removal of historic fabric, and it is recommended that design solutions be sought which could avoid or minimise the scope of replacement, where possible. Alternative solutions to the removal of cracked and damaged facings and blocks would be greatly

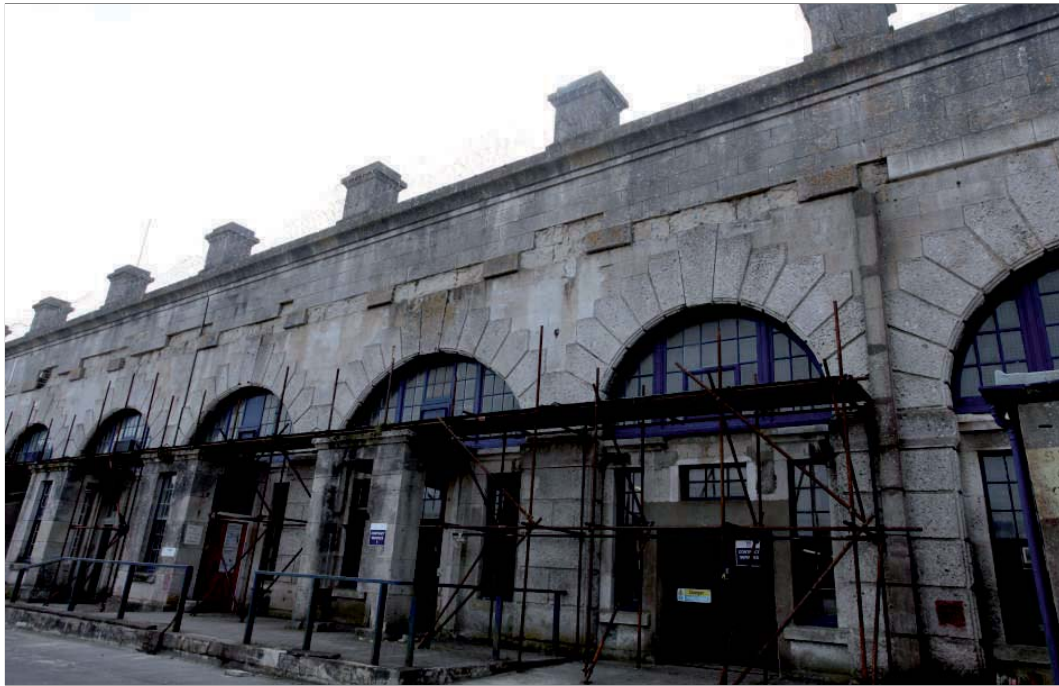
Plate 31: South casemates string course showing earlier concrete repair to top right of image

- 5.2.28 The string course along this section of the casemates has been the subject of repair in the past. The Estate Manager (Clive Otton) has informed us that recently much of the repair work, particularly at the west end, was undertaken using reinforced concrete (**Plate 31**). Metal reinforcing bars can be seen extending from the east end of the previously 'repaired' section. Some of the original dressed stones that form the string course have already been cut-back in preparation for new, better matched, stones to be inserted. It is understood that the selection of a suitable replacement stone is underway before any further works are carried out. It is not known if the intention is to replace the entire section of reinforced concrete string. An attempt to 'distress' or alter the appearance of the concrete string has been made by the mason responsible by adding aggregate to the mix. From a distance, this effect appears good, but, concrete will age differently to the

original limestone and may prove damaging in the long term as the reinforcing bars corrode and spall the surface finish.

- **Casemates:** Repair string course, repoint and reface where necessary.
- **Boreholes and geotechnical investigations:** To be carried out in various locations including above the tunnel, and in the staff car park.
