**STABILISATION OF EMBANKMENTS & TUNNEL,
HMP THE VERNE,
PORTLAND, DORSET**

Heritage Statement

Report reference: 86630.01

August 2012

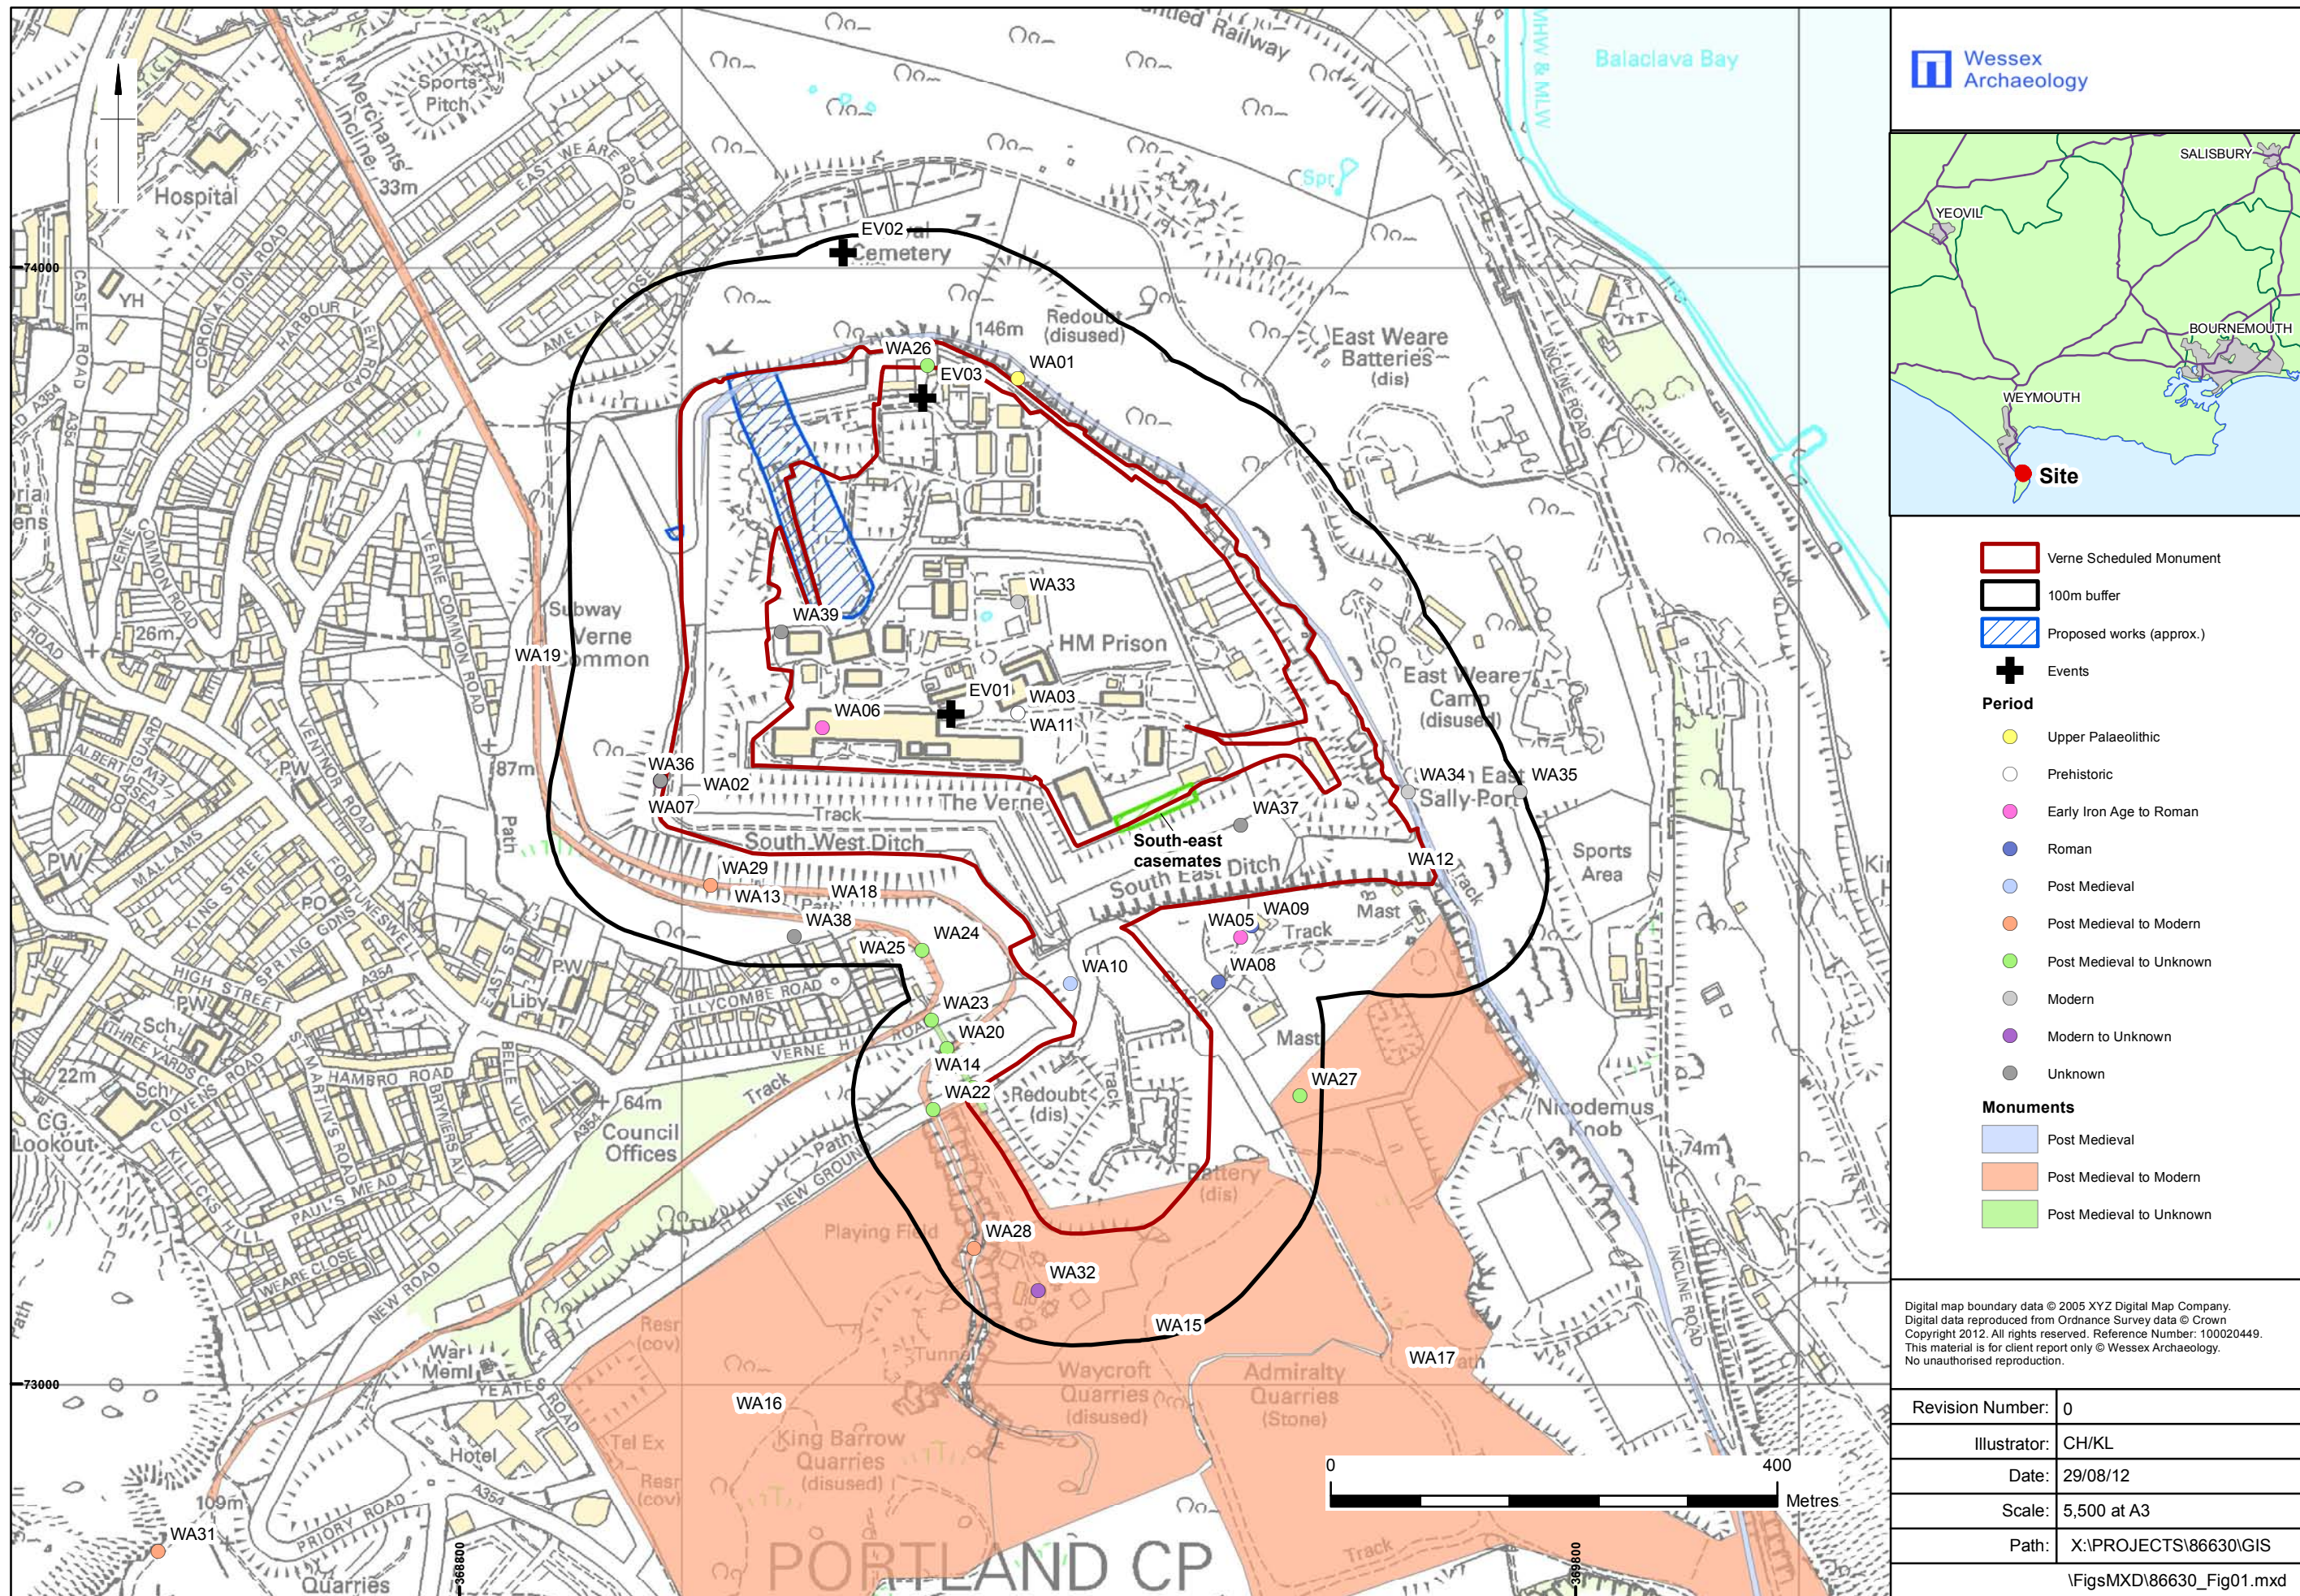
Figure 1

Site location plan showing Statutory Designations and Dorset HER Data

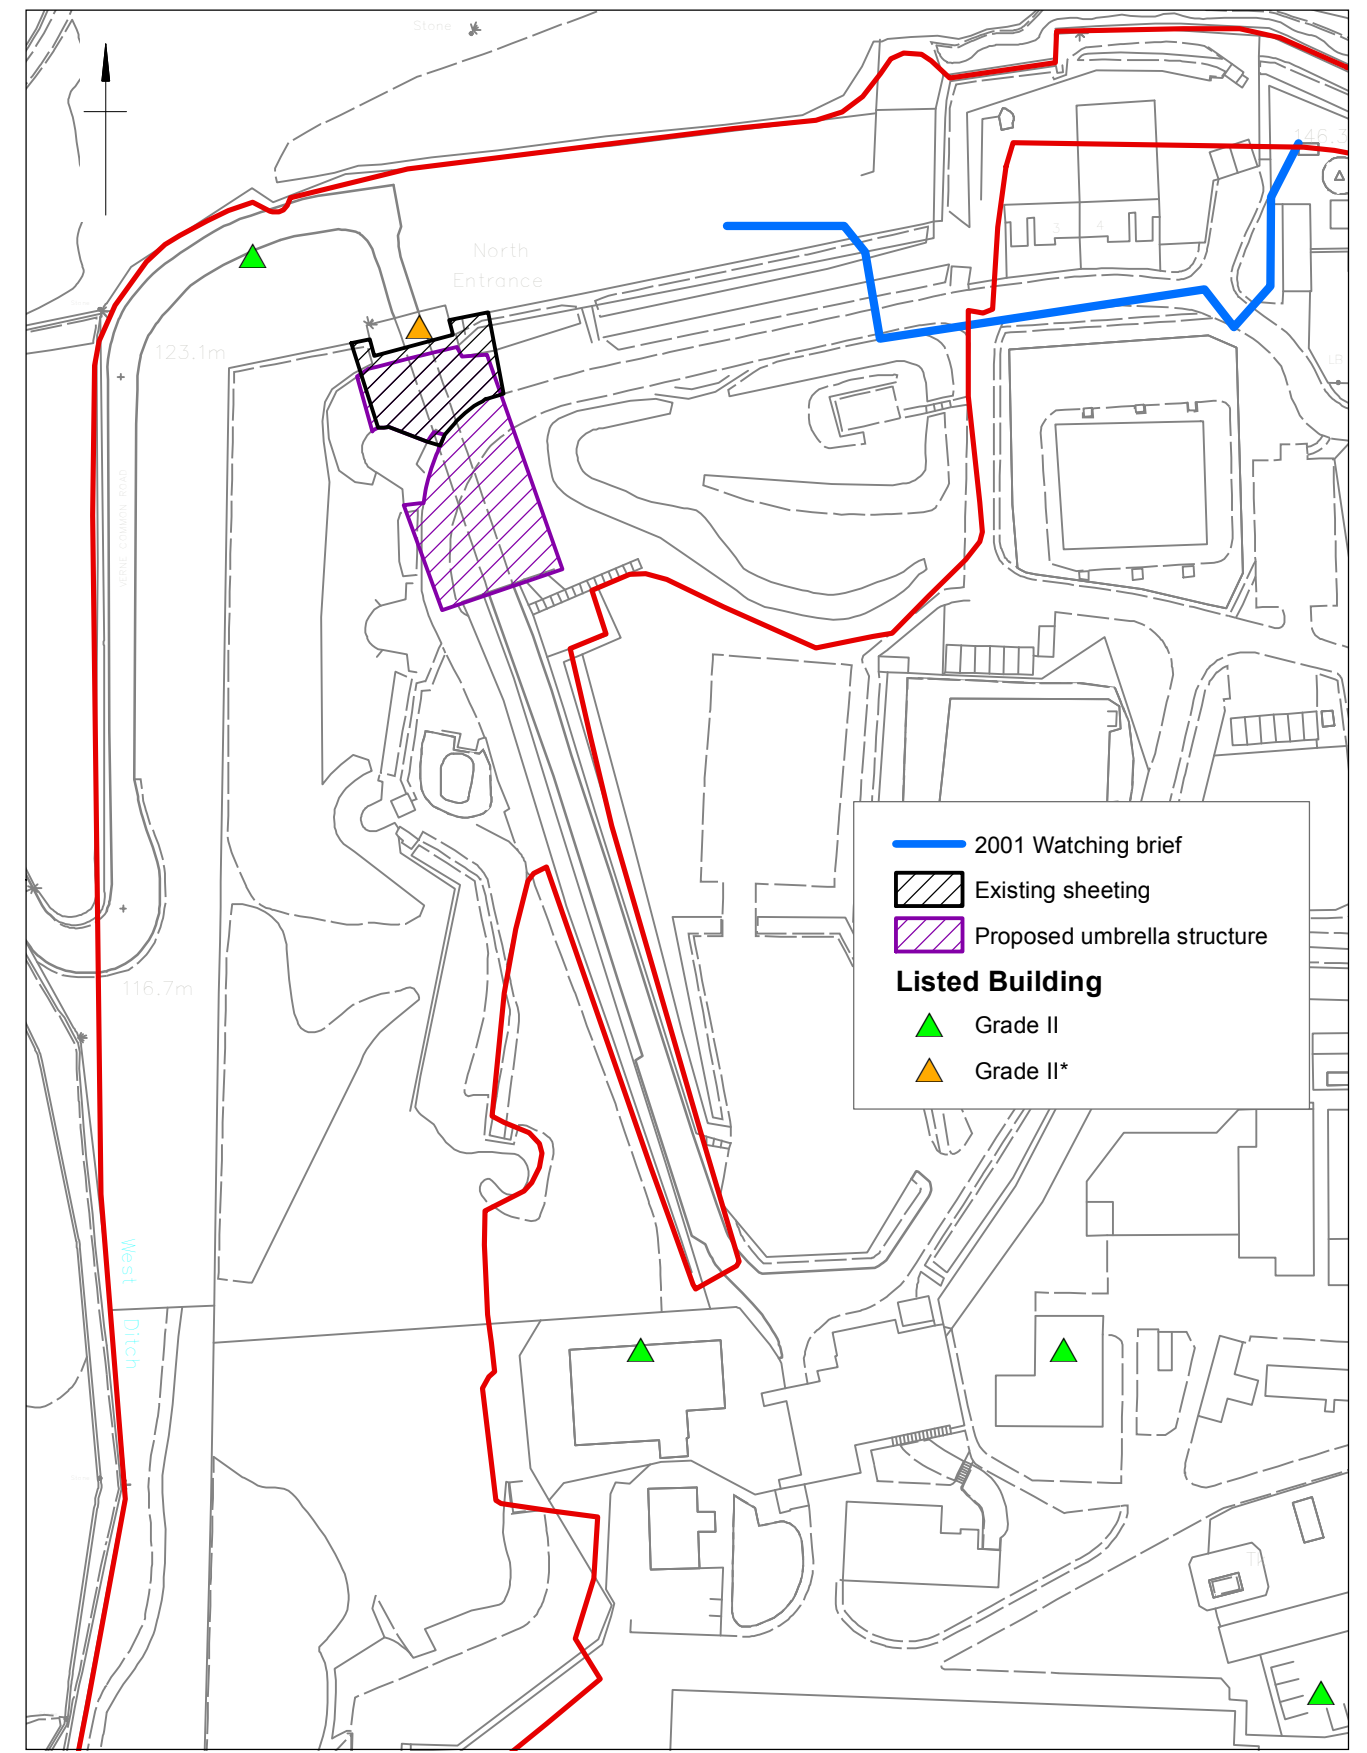
Figure 2

Site plan showing key elements of the Verne Citadel and areas of proposed works

- 5.2.17 It is therefore possible that an area of the embankments immediately above the tunnel (**Figure 2b**) is no longer entirely *in situ*, having likely been partially removed and reinstated. A watching brief undertaken in 2001 observed the excavation of cable trenches through an area of the northern embankments to the east of the main entrance (**Figure 2b**). The watching brief recorded a 1.8m deep section through this area of the rampart. Below topsoil, the rampart was observed to comprise of loosely packed Portland stone (Wessex Archaeology 2001). It is assumed that the embankment immediately above the north entrance would have been of similar construction prior to any drainage and repair works.

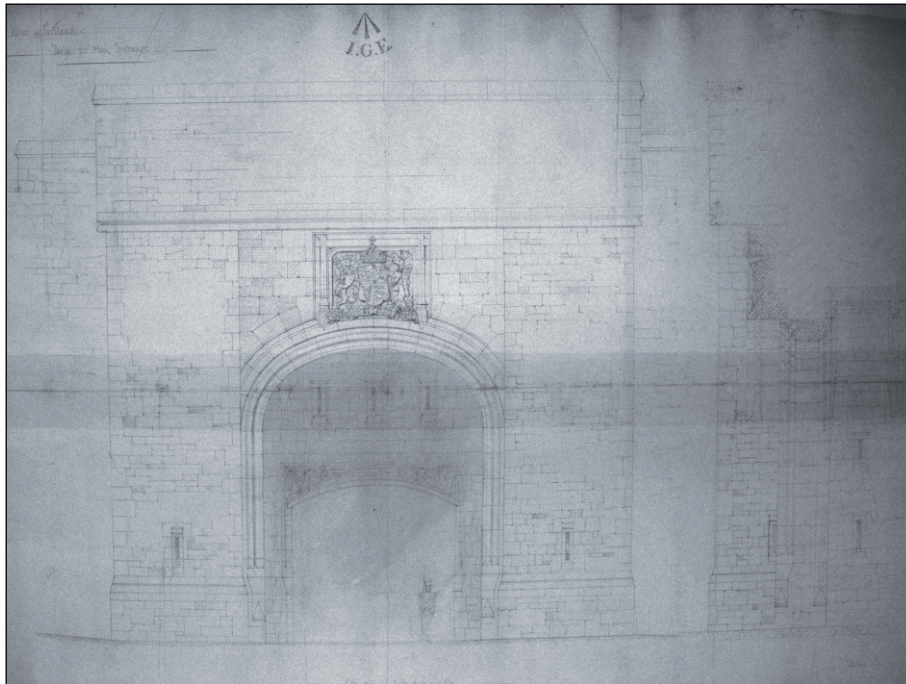
Plate 2: Pencil design of main north gate entrance dated 1868

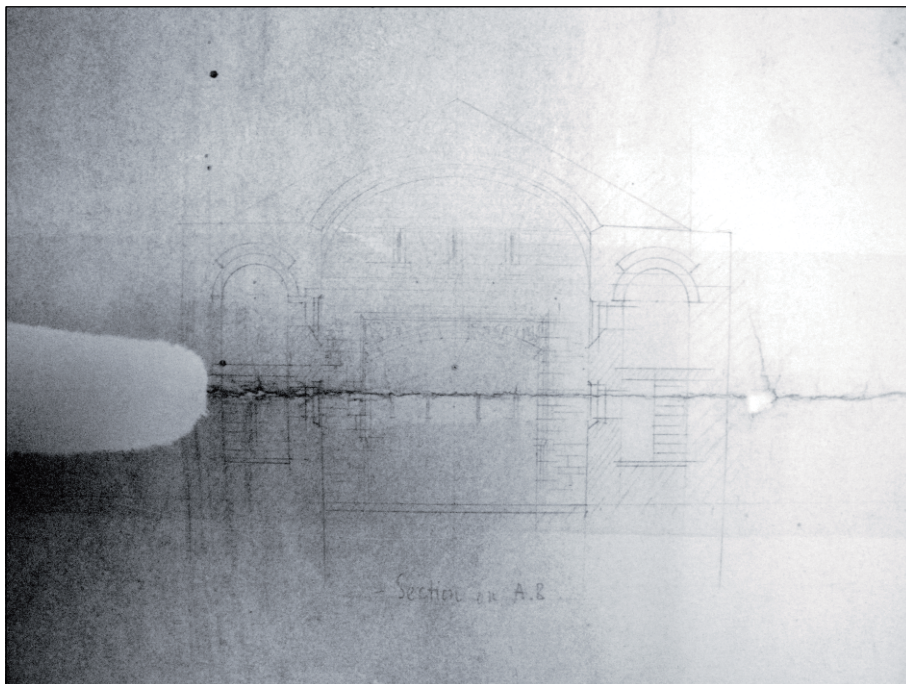
Plate 3: Pencil design cross section through arch dated 1868

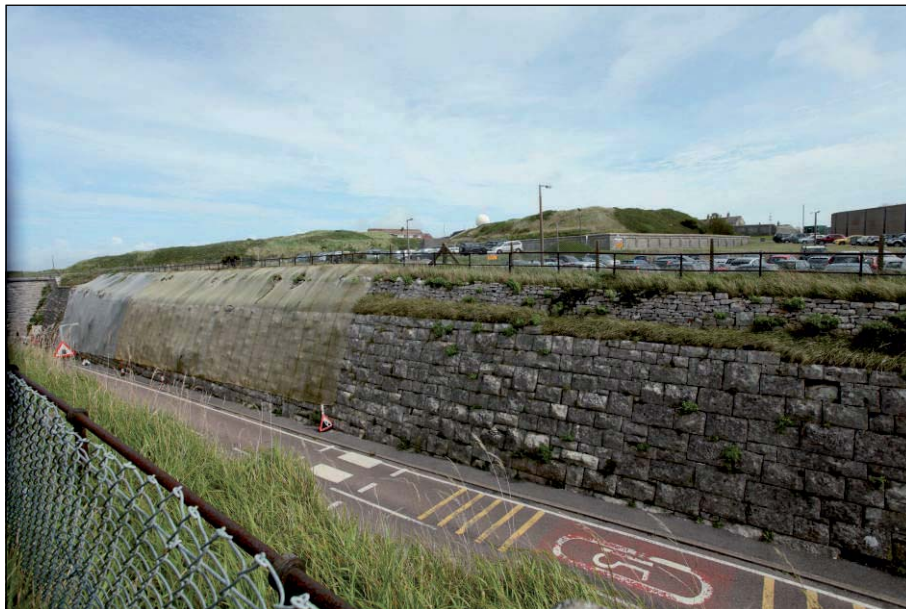
Plate 12: View along east revetting wall of access road showing 'dry-stone' wall above main wall viewed from south-west

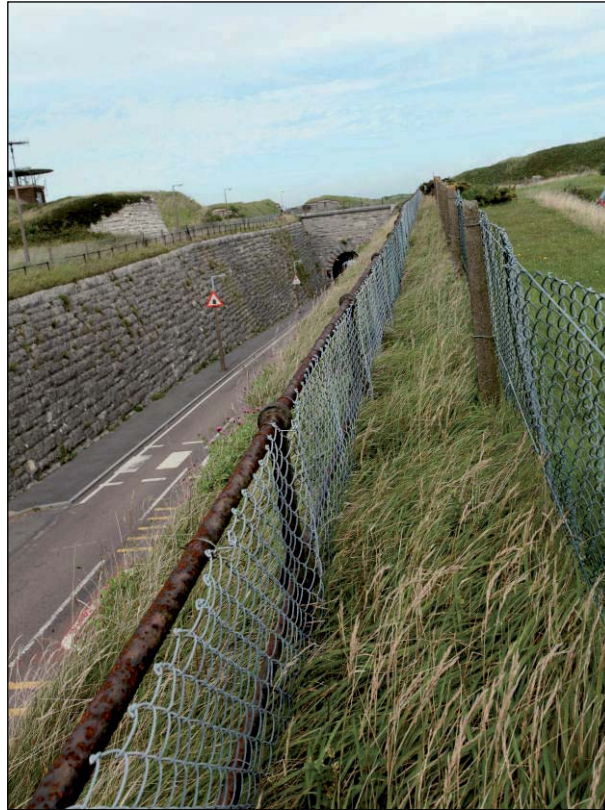
Plate 13: View looking north along top of 'dry-stone' wall showing iron railings and chain link fence viewed from south

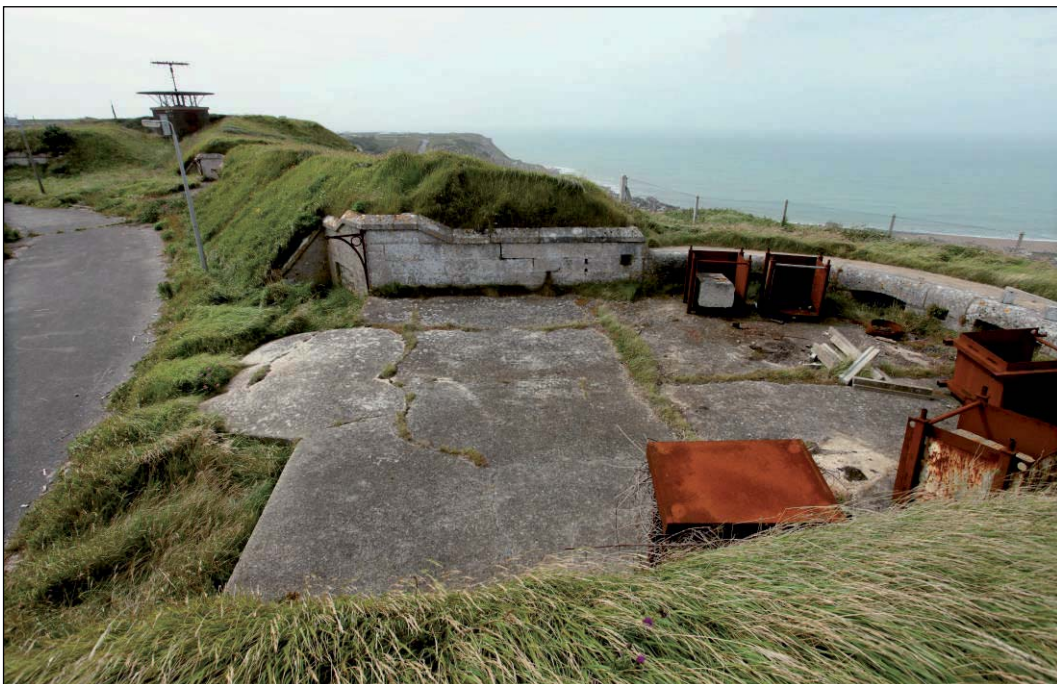
Plate 18: Overlooking 12.5 inch gun emplacement showing concrete apron and present condition viewed from north

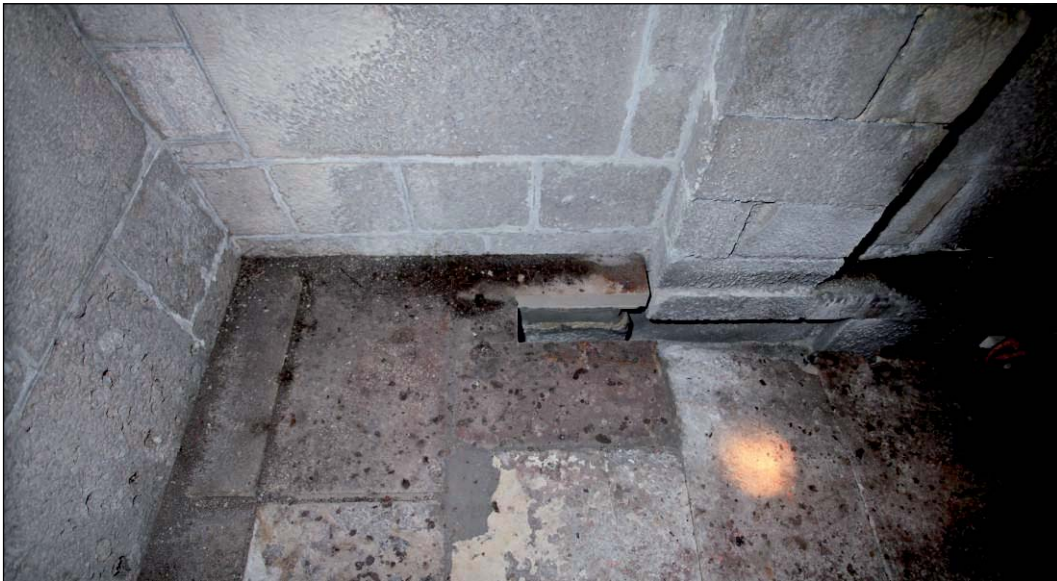
- 5.2.26 The chamber floor and wall fabric have been the subject of both repair and re-pointing. The stone floor slabs around the portcullis slot have been either re-laid or replaced. Some of the slabs have been machine cut to maintain the portcullis slot (**Plate 25**). This suggests that some replacement of floor slabs has taken place. The jointing of the vaulted ceiling appears to have been re-pointed using cement based mortar (**Plate 24**).

Plate 25: Evidence of re-flooring within portcullis chamber

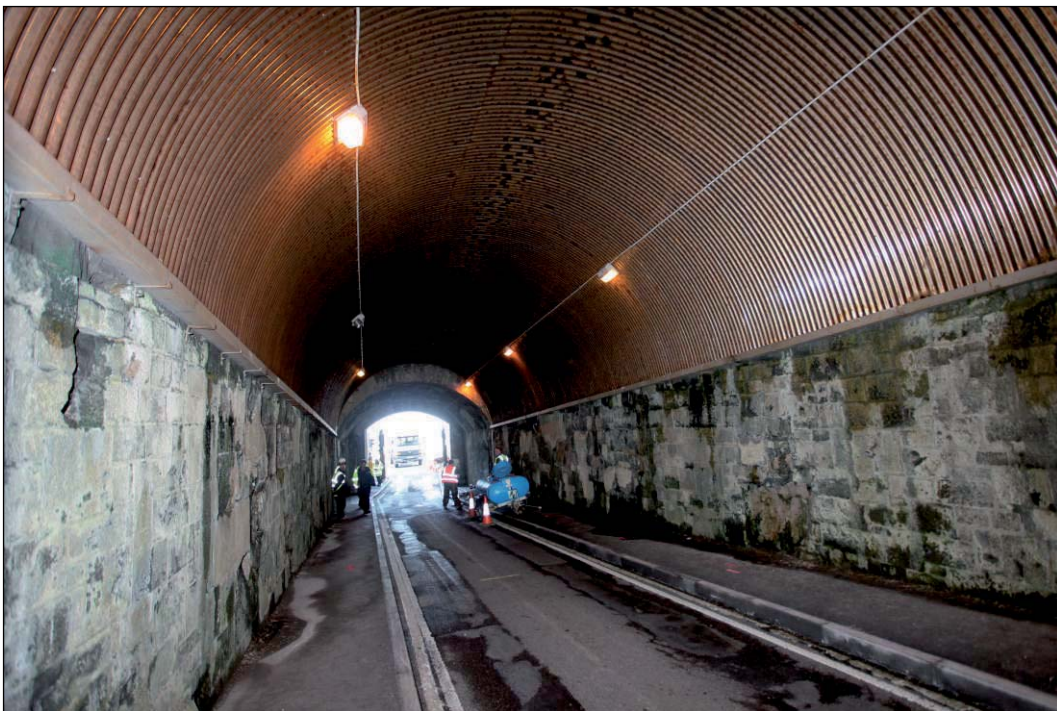
- 5.2.18 At the time of the site visit the tunnel roof lining was *in situ* (**9**). It consisted of pre-fabricated corrugated interlocking sheeting (**Plate 26**). This sheeting only covers the intrados of the tunnel and at the base of both sides of the sheeting is a gutter to catch water. The gutter is supported on metal brackets which have been fixed directly into the wall fabric. The tunnel walls are exposed and it is clear that water ingress is having a detrimental effect on the stone walls. The walls are constructed from squared limestone blocks of varying sizes and laid in broken courses. Many areas of stone walling have spalled away and patching repairs have been undertaken in a variety of materials and styles (**Plate 27**). This includes both lime and cement mortar resulting in a poor finish quality. The opposing accesses to the

Plate 26: Main tunnel entrance roof lining viewed from south

- 8.2.3 It is recommended that following removal of the sheet steel lining to the tunnel, the tunnel lining should be subject to recording, prior to the removal of any damaged stones or historic fabric.

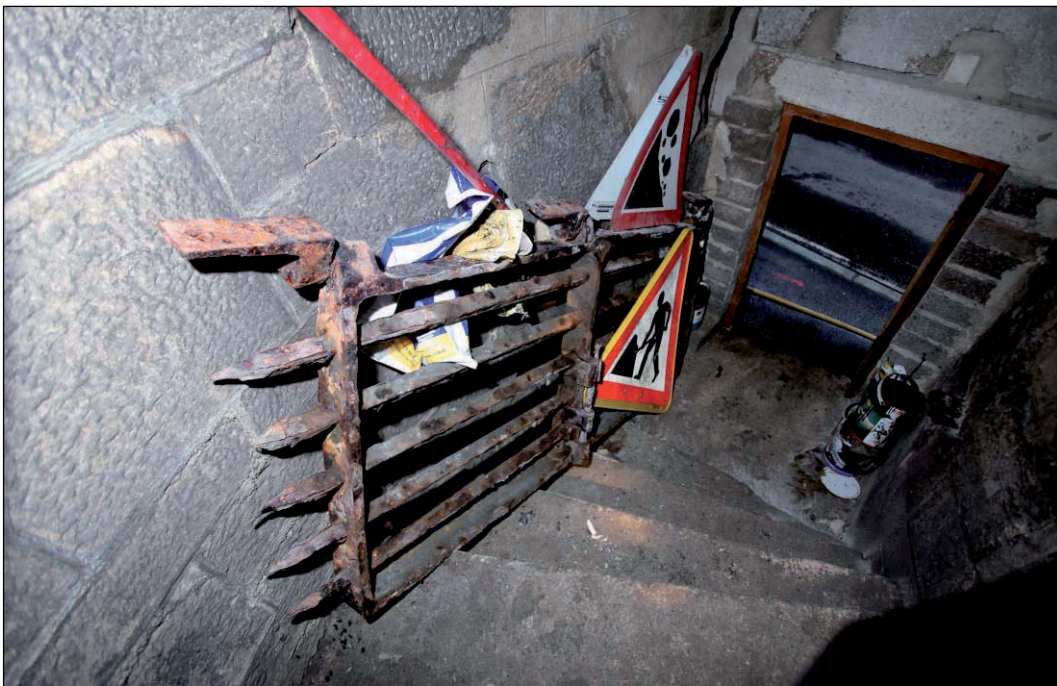
Plate 28: East portcullis chamber access gate removed and placed against internal wall

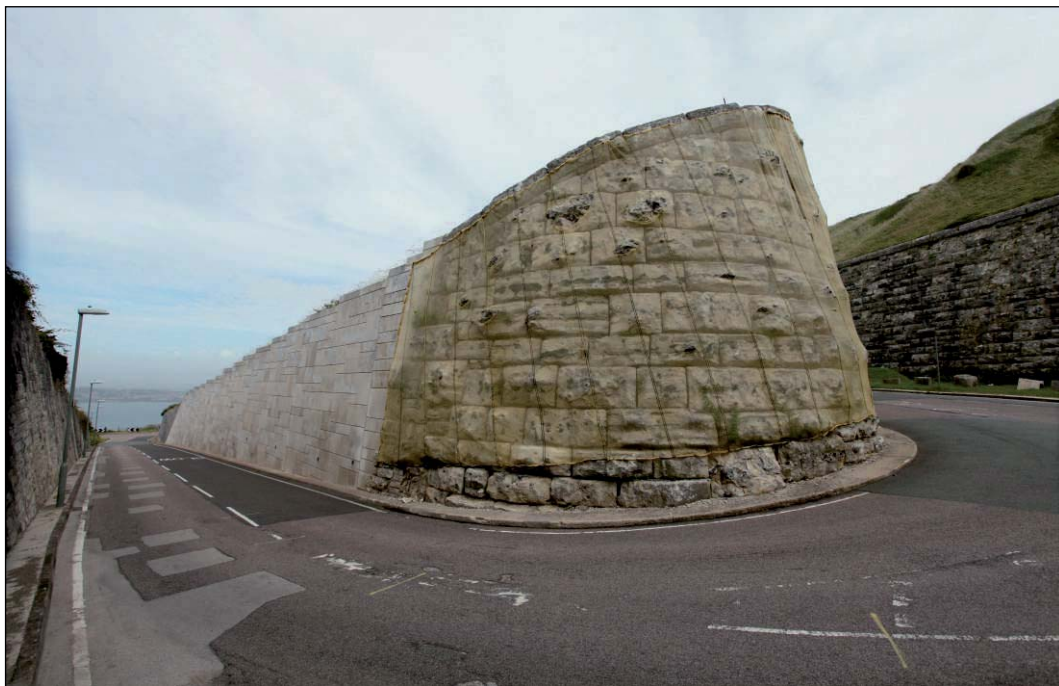
Plate 32: Roadside walling stone-faced and covered with protective netting
