Hollow Panson Farm, Torridge, Devon

Archaeological Evaluation Report

Ref: 100220.03
August 2013

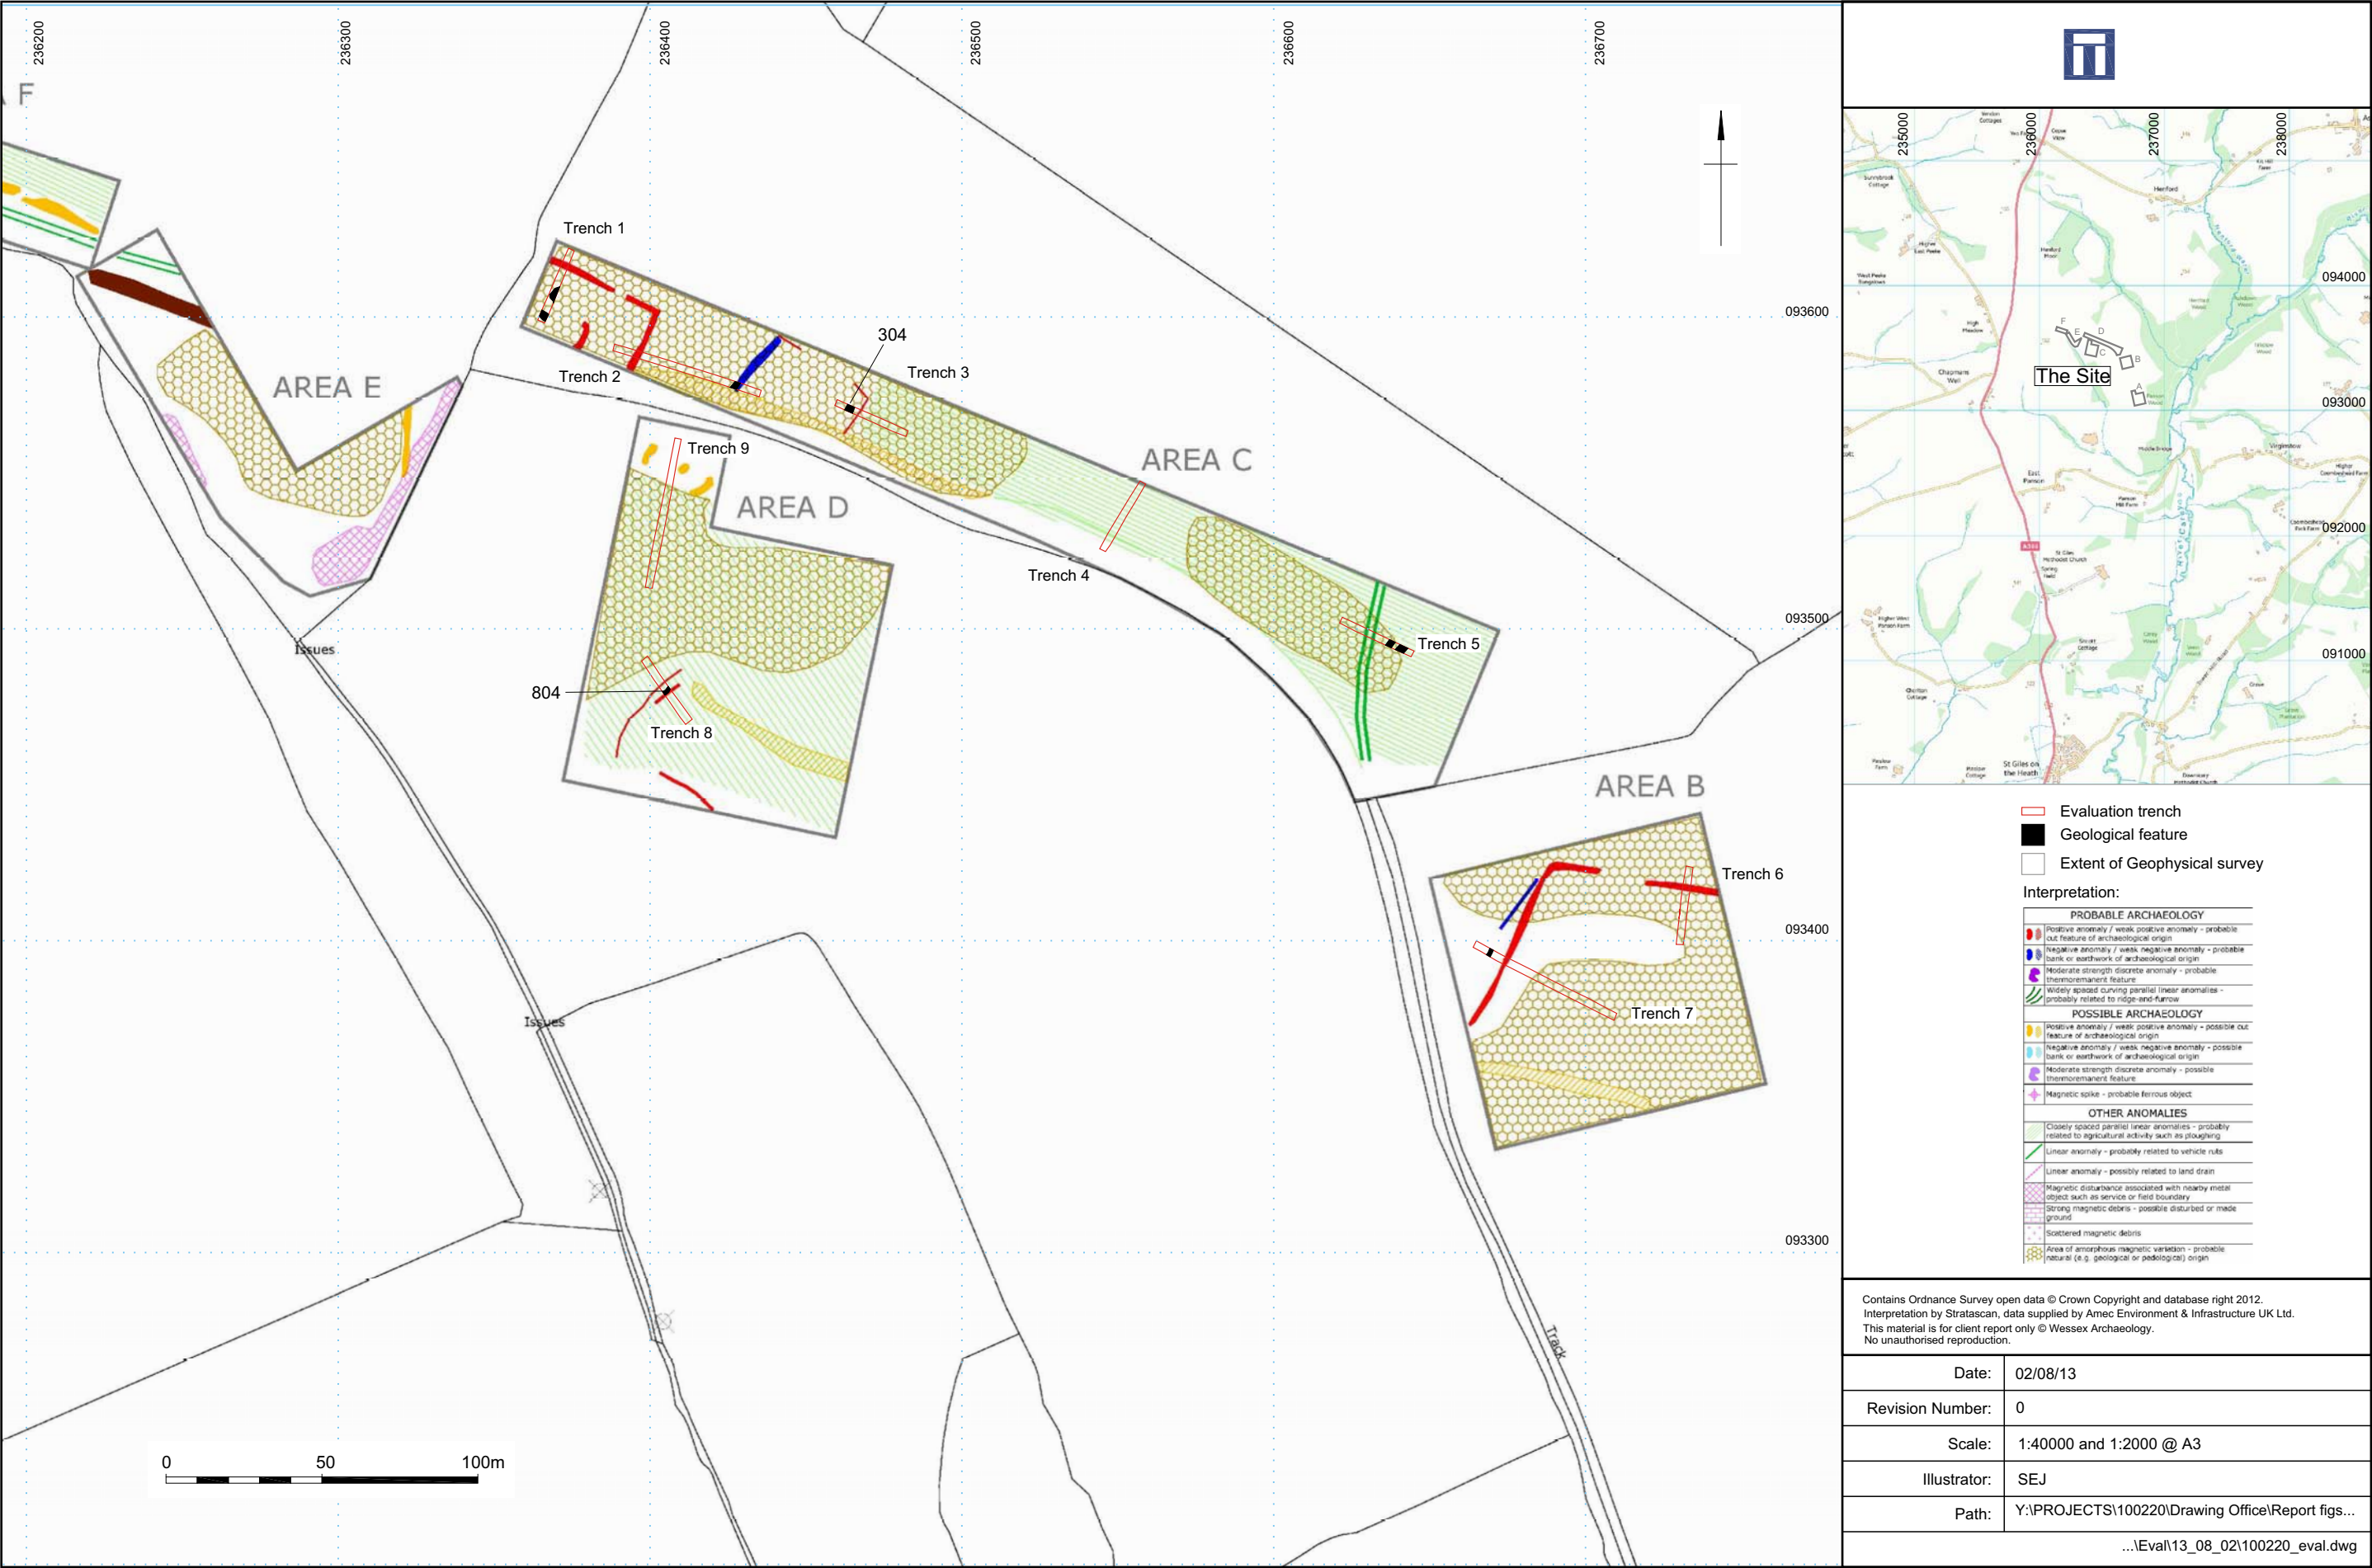
Figure 1

- 4.1.2 No archaeological features or deposits were found in any of the trenches, however geological variation and features were shown to account for the majority of the geophysical anomalies (**Figure 1, Plates 1 and 2**).

- 4.1.3 The geophysical anomaly located at the northern end of Trench 9 in Area D was the result of ground compaction caused by the turning of agricultural vehicles. Similarly the parallel responses in Trench 5 in Area C were the continuation of a modern trackway.

- 4.1.4 No features could be seen to account for the geophysical response at the north end of Trench 1 or within Trench 6, but these may reflect geological variation below the depth of excavation.

Location of Site, evaluation trenches and results of geophysical survey

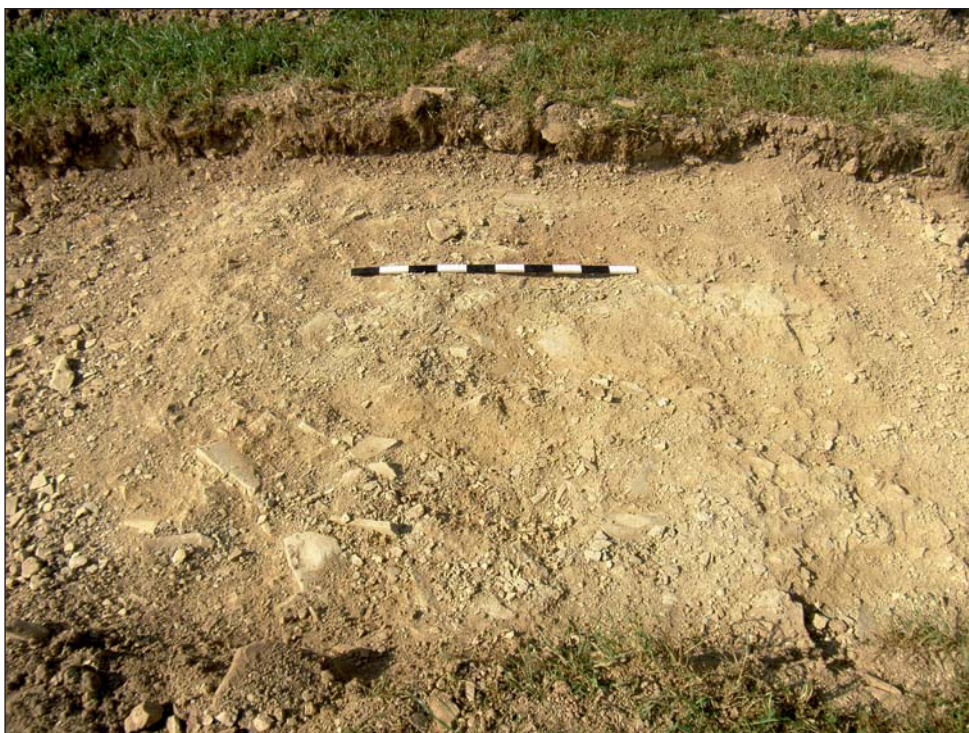
TRENCH 3			
Dimensions: 25.00x2.40m		Max. depth: 0.40m	Ground level: 145.75-150.00m aOD
Easting: 236471		Northing: 093568	
Context	Description		Depth (m)
301	Topsoil	Modern topsoil. Pale brown sandy clay loam. 2% stone, sub-angular, <1-3cm. Fairly loose and friable. Homogeneous. Bioturbated. Under grass. Slightly diffuse interface with 302. Overlies 302.	0.00-0.18 bgl
302	Subsoil	Modern subsoil. Pale brown clay loam. 15% stone, sub-angular, <1-5cm. Moderately compact. Fairly homogeneous. Fairly clear interface with 303. Overlies 303.	0.15-0.40 bgl
303	Natural	Natural geology. Weathered mudstone within pale yellow-brown clay and occasional pale orange sandy loam. Compact.	0.37+ bgl
304	Geological feature	Band of fragmented mudstone. Natural geological feature. Unexcavated.	-

Plate 1: Geological feature 304, viewed from the north-east

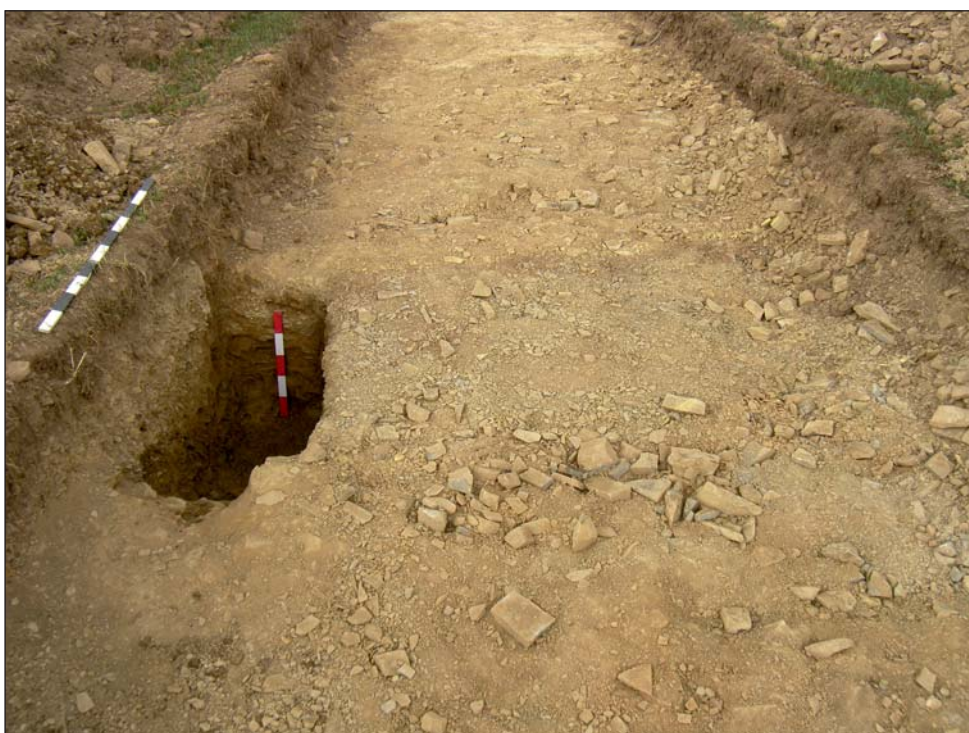
interface with 803. Overlies 803.	
803	<i>Natural</i>	Natural geology. Weathered mudstone within pale yellow-brown clay and occasional pale orange sandy loam. Compact.	0.30+ bgl
804	<i>Geological feature</i>	Band of fragmented mudstone. Natural geological feature.	0.10-1.04 bgl

Plate 2: Geological feature 804, viewed from the south-east
