Castleford Bus Station, Castleford, West Yorkshire

Archaeological Evaluation

**Archaeological Evaluation
Detailed Interim Report**

Report Ref: WA88920.02

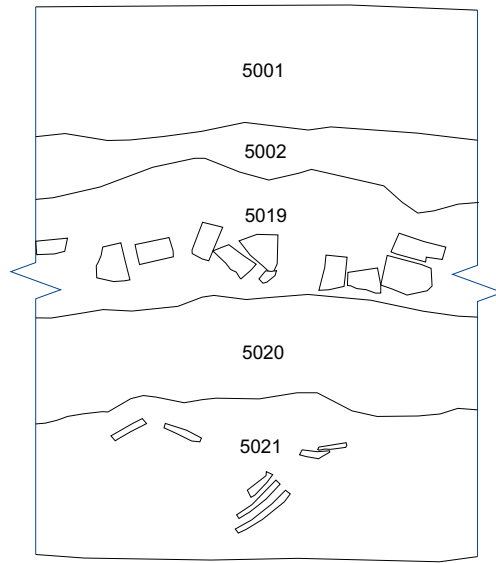
Trench 5, section 8, south-east facing 1:20

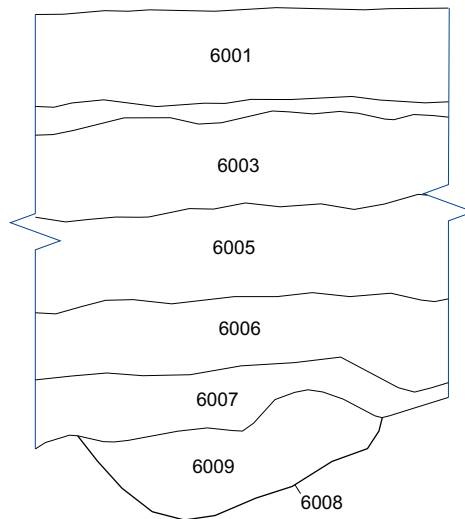
Trench 6, section 9, south-east facing 1:20

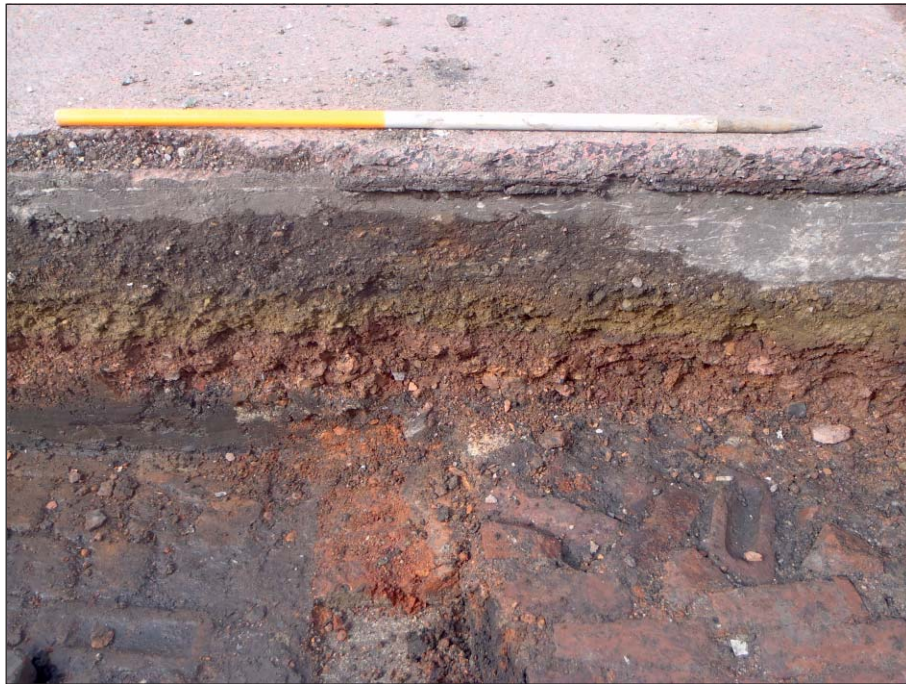
Plate 1: **Trench 1**, demolition layer 1003 truncated by floor **1022**, from southeast

- 4.2.2 The structures associated with the glassworks were all located in the southwestern half of the trench, with the modern features to the northeast. A layer of industrial waste and demolition rubble, **1003**, lay over all the structures in the southwestern area and was typically 0.4m thick. **1003** was most likely associated with the final demolition and levelling of the glassworks. This layer, present over the whole southwestern half of **Trench 1**, ended abruptly at floor **1022** and appeared to be cut by it (**Plate 1, Figure 5**). The floor and the structures to the northeast of it were constructed of modern frogged bricks and were overlain by a layer of red crush, **1002**, which also lay over the demolition layer **1003**, and extended the full length of **Trench 1**. The existing bus station surface was built on top of this crush layer.

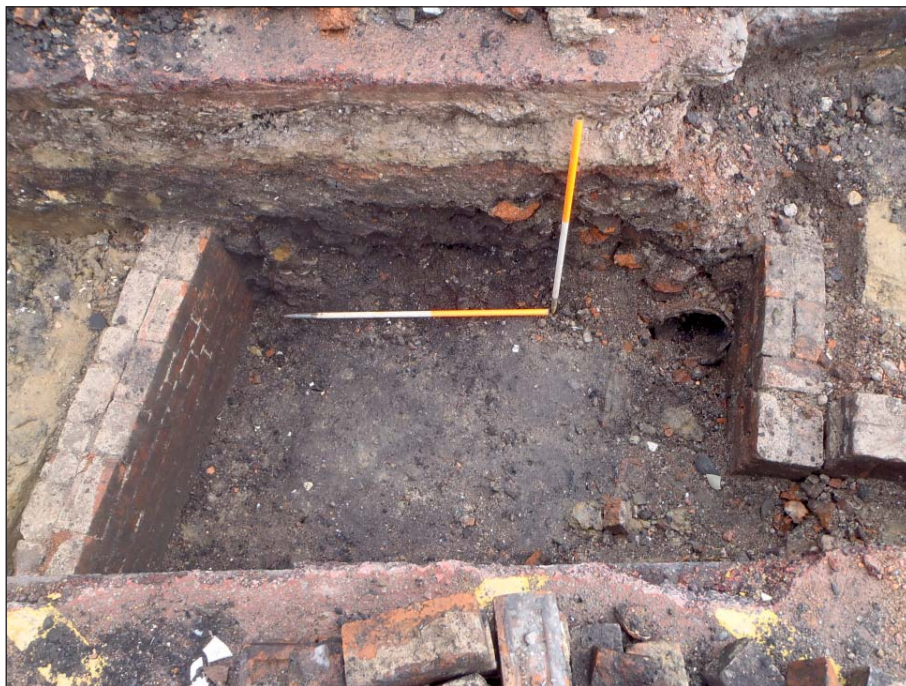
Plate 2: **Trench 1**, walls **1014** and **1015** and possible cellar, from northwest.

- 4.2.4 Between walls **1014** and **1015** the demolition layer, **1003**, was much deeper than elsewhere in **Trench 1**, filling a possible cellar (**Plate 2, Figure 5**) and including a large quantity of glassworking waste, kiln spacers, pottery, brick fragments and one complete Codd bottle.

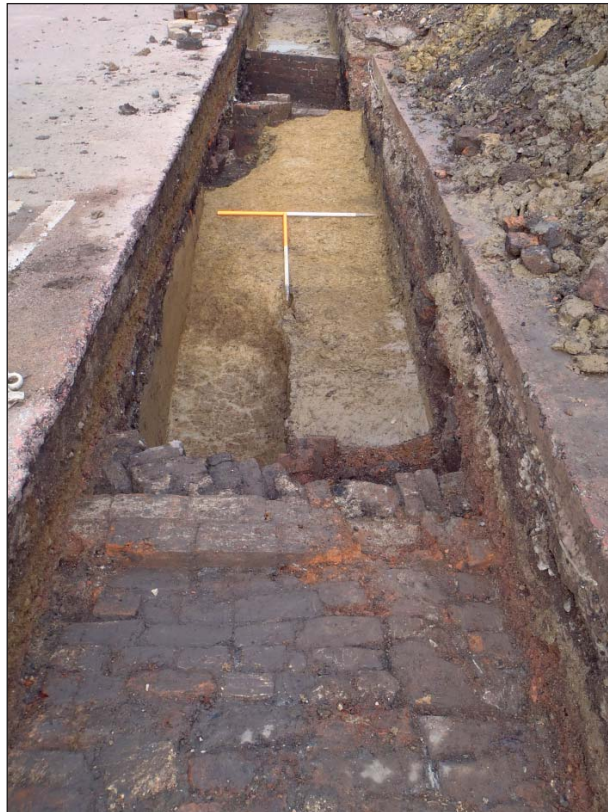
Plate 3: **Trench 1**, structures **1010** and **1011** plus field boundary **1028**, from southwest

4.2.5 The only feature in **Trench 1** that may have pre-dated the glassworks was a ditch (**1028**), at 15.80mOD, cut into the natural clay **1004** (**Plate 3, Figure 6**). No finds were recovered from the fill, though the ditch appears to match up with a field boundary visible on the 1852 maps.

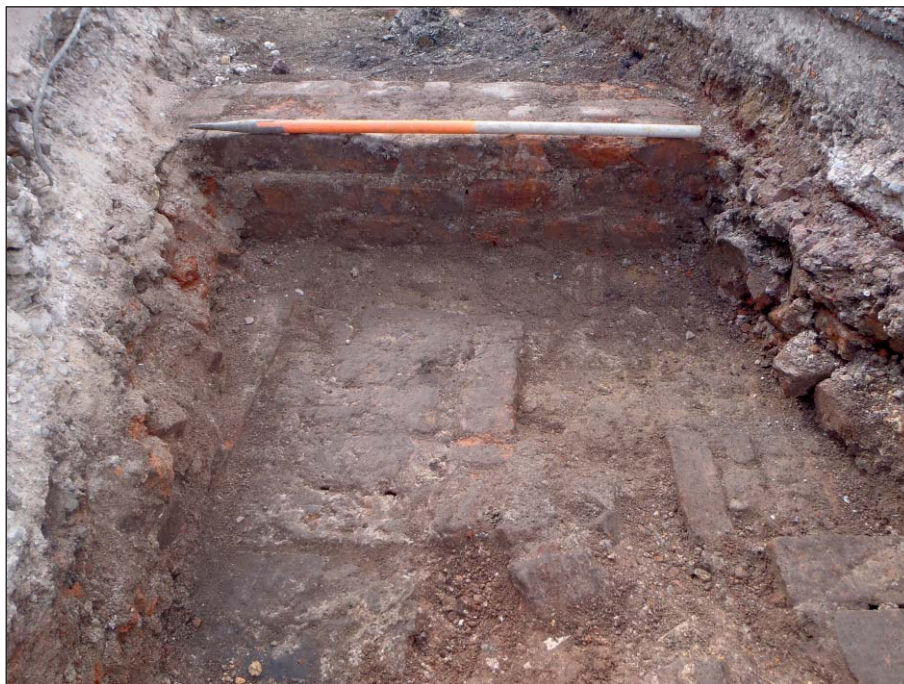
Plate 4: **Trench 2**, wall **2011** from east.

4.2.8 A north-south oriented wall, **2011** (**Plate 4**) was constructed of three skins of red brick, thicker than other walls observed in the trench. The structures to the east of **2011** (**2005-2010**) formed a series of floors and possible bases (**Plate 5**) with what appear to be dividing walls (**2006** and possibly **2008**, though this may be a step).

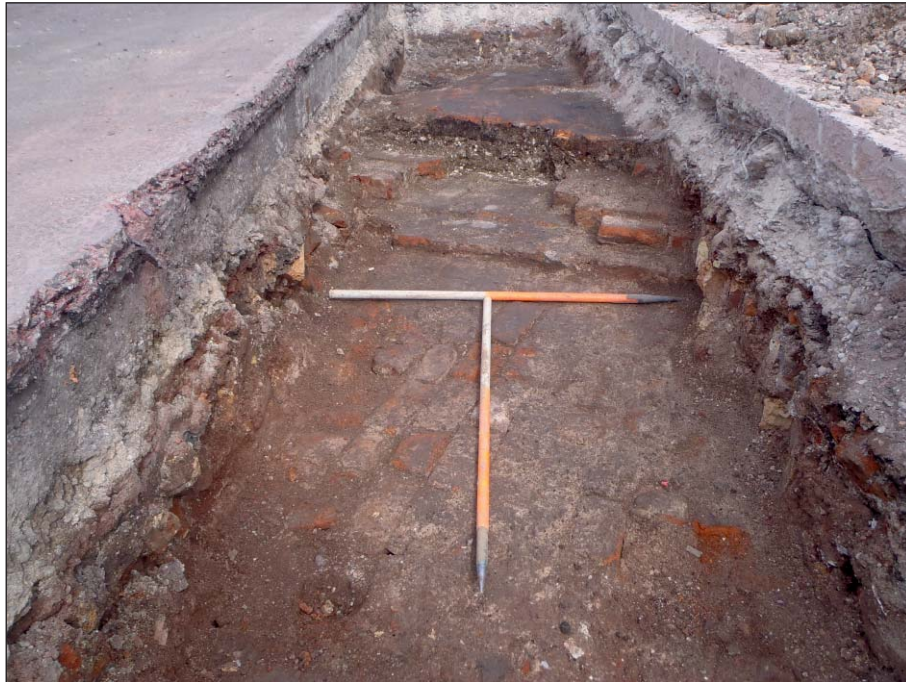
Plate 5: **Trench 2**, Structures **2005-2010** forming floor and possible base, from southwest

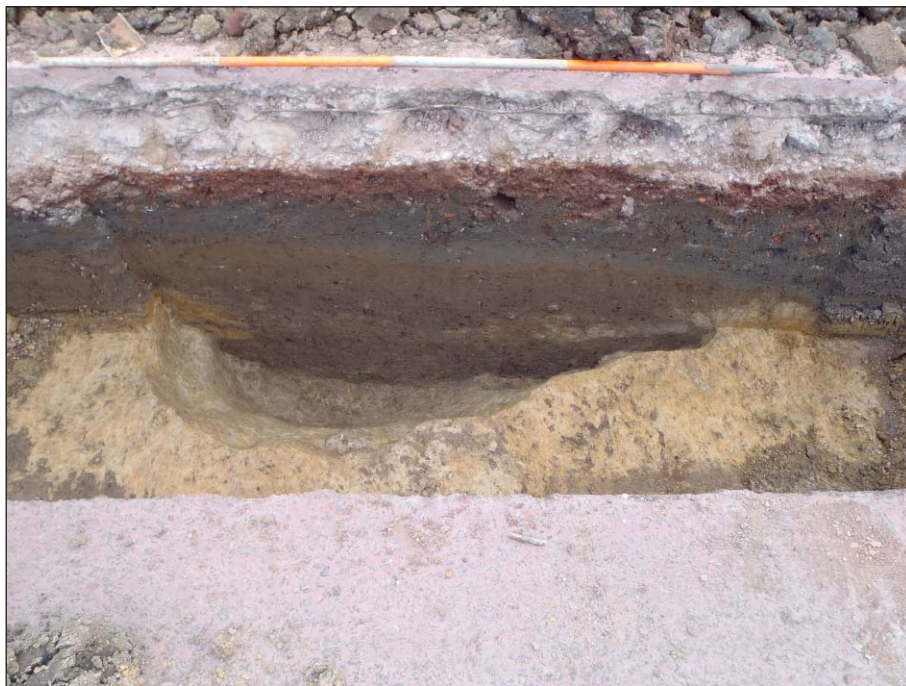
Plate 6: **Trench 3**, pit **3006** from northwest.

4.2.13 A large pit **3006** was revealed towards the eastern end of the trench, protruding from the southern section (**Plate 6**). The feature was 2.2m across and 0.5m deep and filled by deposits **3007** and **3018**, the lower fill of which (**3007**) contained several sherds of Romano-British pottery.

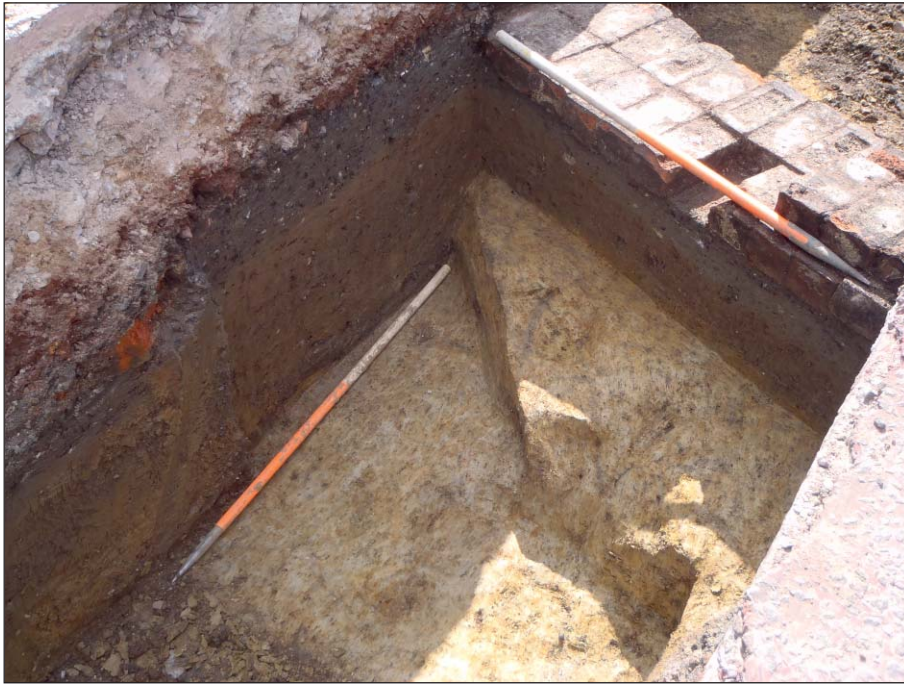
Plate 7: **Trench 3**, ditch and beamslot **3008** and wall **3010**, from north.

4.2.14 A possible beamslot or ditch **3008** was identified approximately 5m to the southwest of the pit, running north to south across the trench (**Plate 7**). The feature was 0.92m in width and 0.23m deep with sharp sloping sides. The secondary fill contained Romano-British ceramic (**3009**).

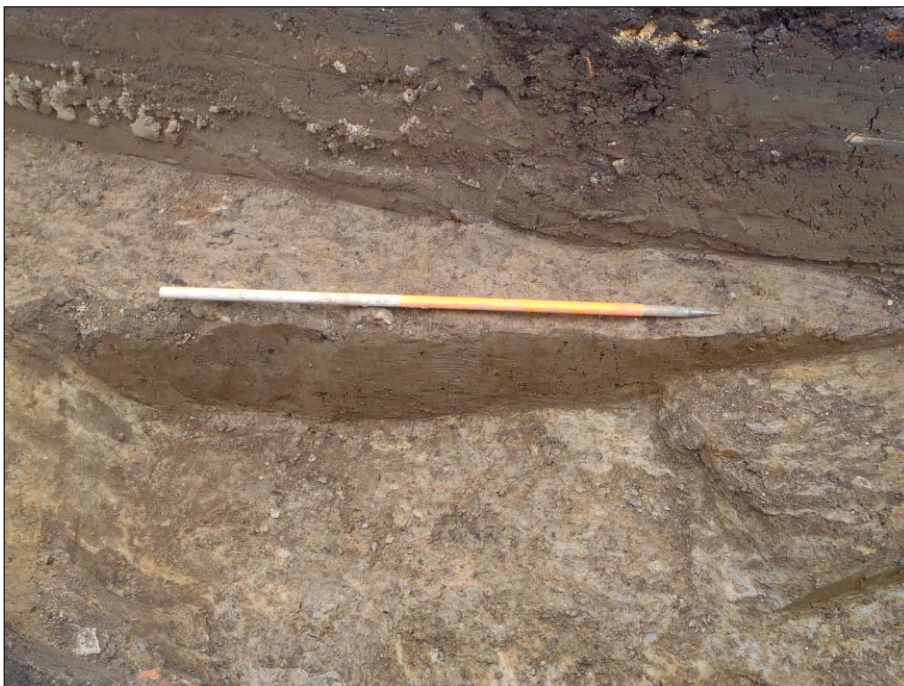
Plate 8: **Trench 3**, ditch **3004** from northwest.

4.2.15 A further feature was a ditch (**3004**) at the southwestern end of the trench, running northwest to southeast (**Plate 8**). The ditch was 1.92m in width and 0.38m in depth and contained Romano-British pottery and a fragment of Romano-British CBM.

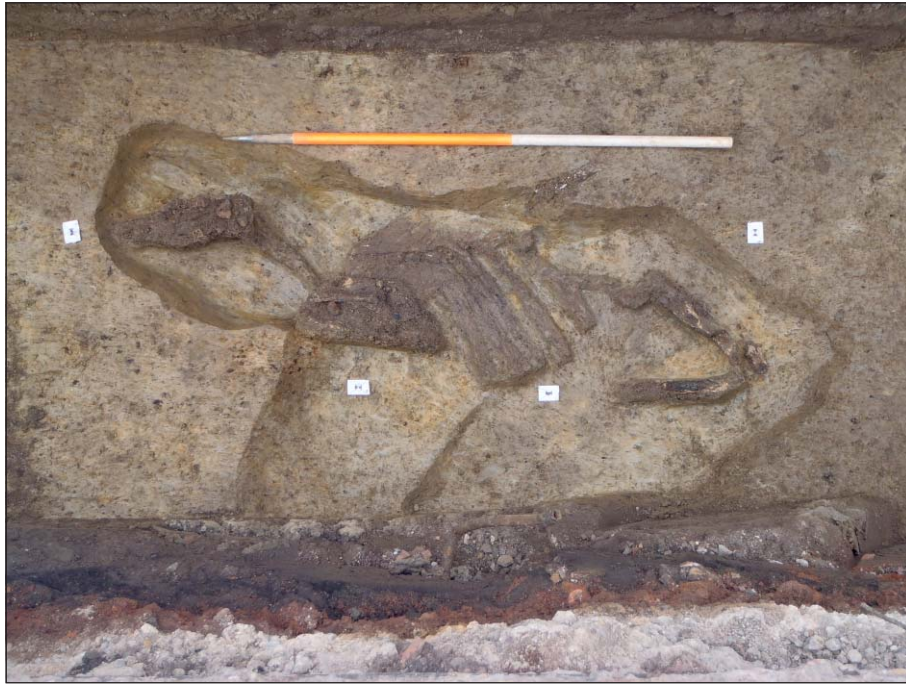
Plate 9: **Trench 3**, Cow inhumation **4032** (ABG1).

5.7.1 Other finds comprise a small quantity of animal bone; a few fragments of clay tobacco pipe (plain stems and part of a 19th century bowl); and one oyster shell. Animal bone included a cow burial from **Trench 4**, ABG 1, which appears to be that of a fairly young animal. The bone was in very poor condition.

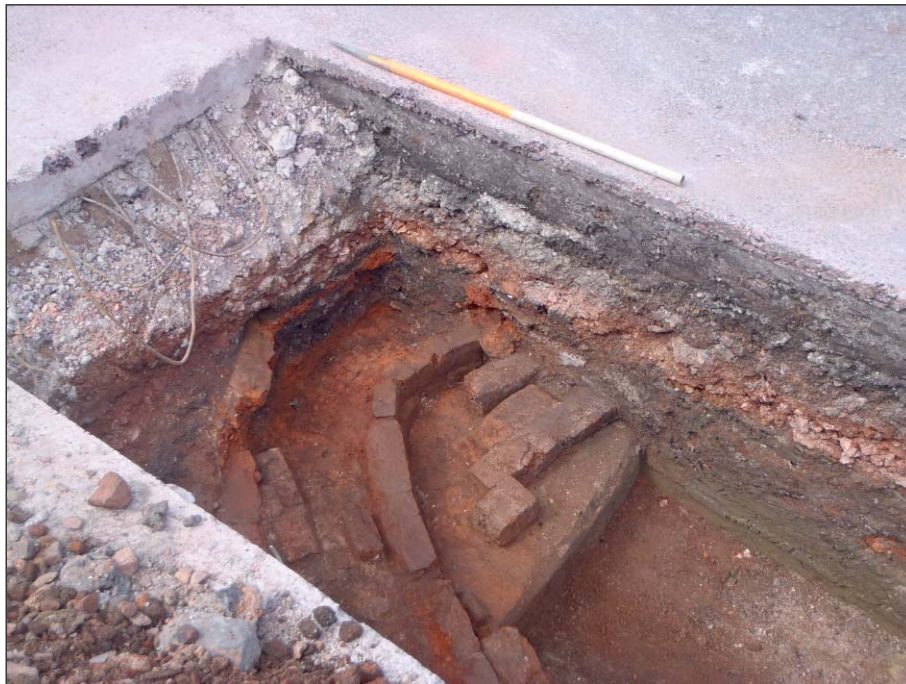
Plate 10: **Trench 4**, possible flue **4004**, from east.

- 4.2.21 At the southwestern extreme of the trench was a curvilinear structure, **4004**, made up of two parallel rows of red brick bedded on a clay layer **4034**, the latter an apparent levelling deposit visible across much of the Site and overlying the natural clay. The bricks and surrounding clay were heavily heat affected suggesting **4004** may be the remains of a flue (**Plate 10**). A similar but much more heavily damaged structure (**4005**) was identified approximately 2m to the northeast.

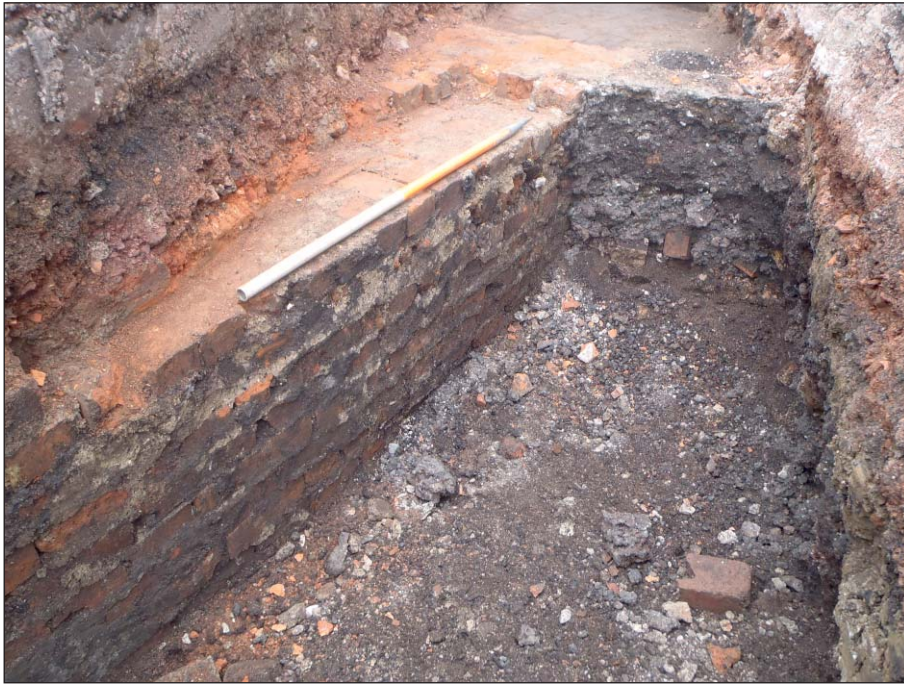
Plate 11: **Trench 4**, wall **4011** and possible cellar, from southwest.

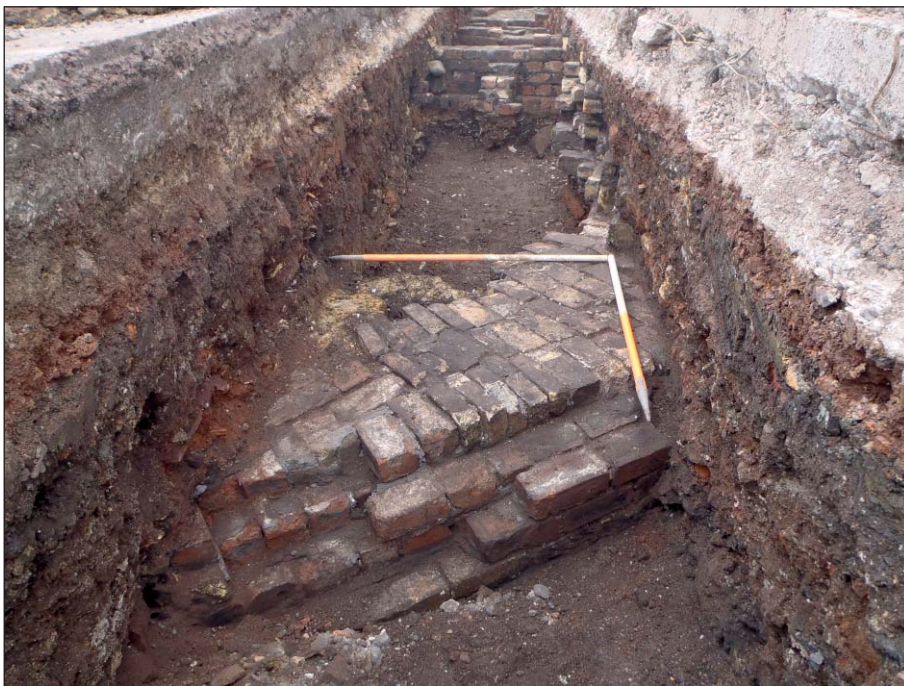
Plate 12: **Trench 4**, Firebrick structure **4015**, from southwest.

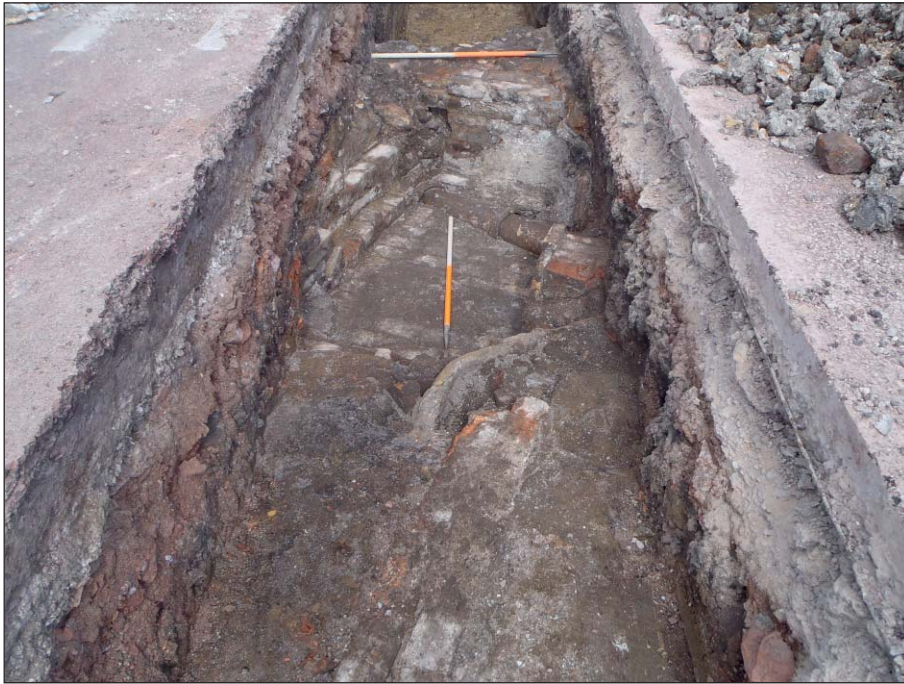
Plate 13: **Trench 5**, possible water tank **5005**, from southwest.

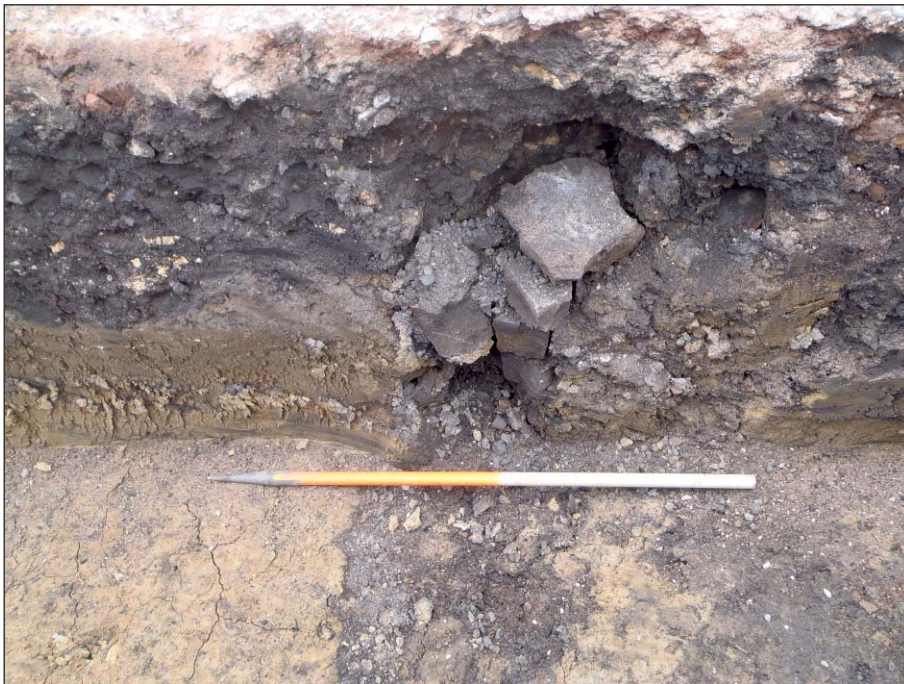
Plate 14: **Trench 5**, wall **5008**, from northwest.

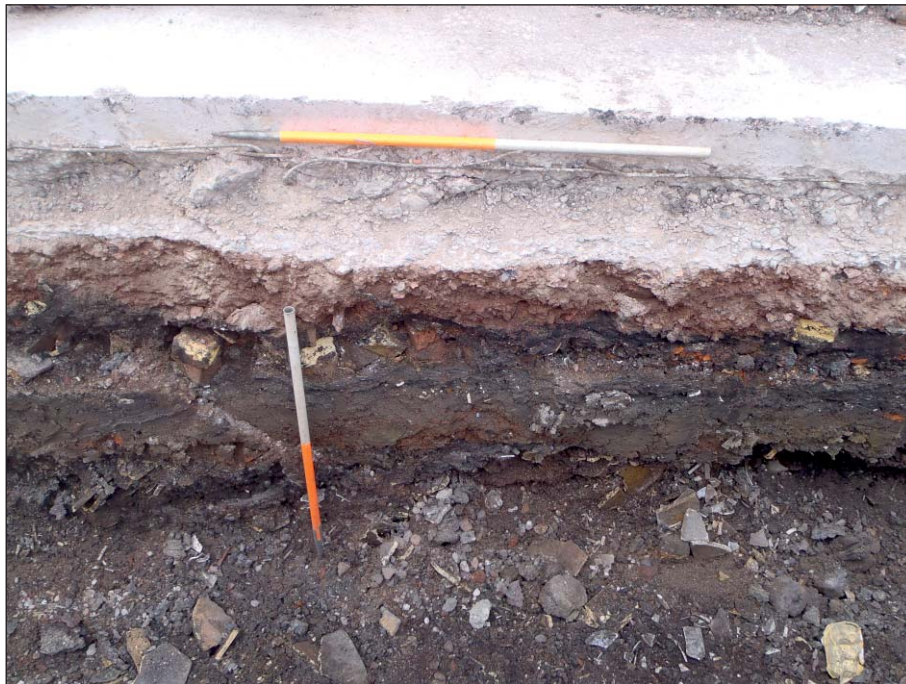
Plate 15: **Trench 5**, northwest facing section of Trench 5 showing rubbish deposit **5021**.
