Langley Park House Buckinghamshire

Archaeological Watching Brief Report on a Geotechnical Test Pit

Ref:55180.02

January 2004

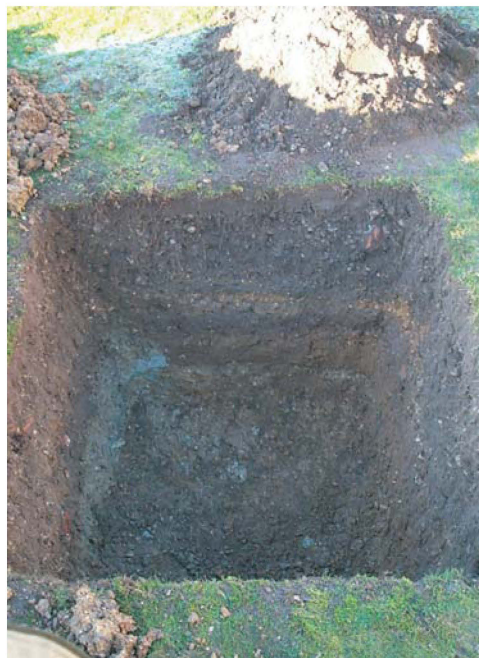
Figure 2

Diagrammatic section drawing and photograph of geotechnical test pit

- 7.1.1 In accordance with the approved Specification, the geotechnical test pit was excavated by hand under constant archaeological supervision. The test pit measured approximately 1m square, and was excavated to a depth of 1m (**Figure 2**).

- 7.1.3 Upon completion of the excavation, the test pit was recorded using Wessex Archaeology's *pro forma* recording sheets. A drawn record was produced which included a 1:10 scale drawing of one section and a location plan, relating the position of the test pit to Langley Park House itself.

- 8.1.2 A total of six archaeological layers were recorded, including the topsoil/turf layer. Natural strata was not reached.
- 8.1.3 Without exception, the layers appeared to represent imported material, almost certainly associated with the construction of the apparently artificial mound upon which the main house is constructed. Finds recovered from these deposits suggest a Post-medieval date for the deposits, although closer dating proved impossible due to the nature of the material recovered.
- 8.1.4 Full descriptions of the recorded archaeological layers are available in tabulated form as **Appendix 1**.
