LONGNOR SEWAGE TREATMENT WORKS, STAFFORDSHIRE

Archaeological Evaluation

July 2012

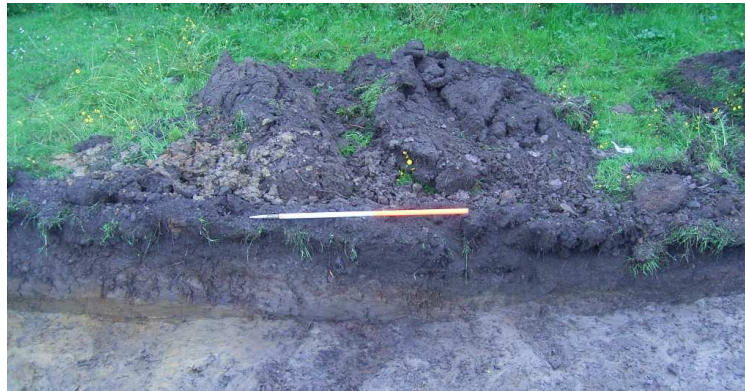
Plate 1: Trench 4, representative section, from the north.

5.6.2 No archaeological features or deposits were observed, only a sequence of sterile, possibly re-deposited, natural layers **402 - 404** (**Figure 2; Plate 1**). The possible platform and adjacent earthwork are probably the result of the re-deposition of sterile natural deposits during the canalisation of the River Manifold immediately to the south.

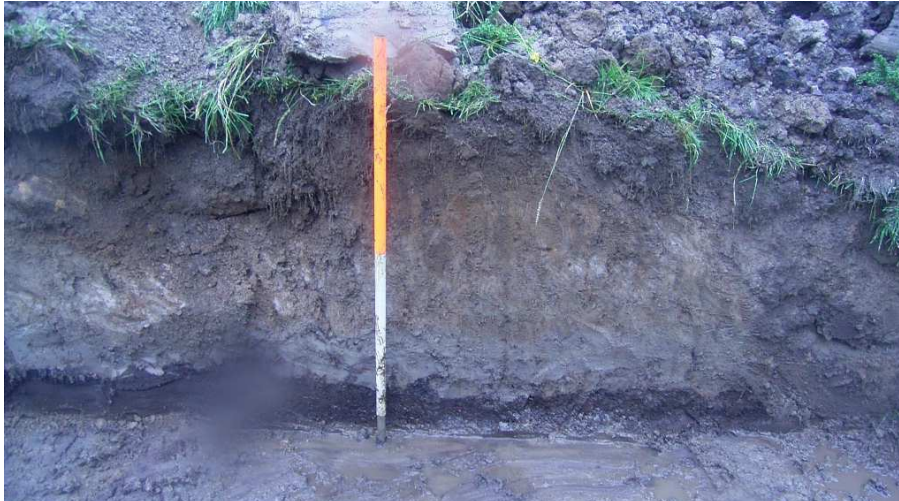
Plate 2: Trench 5, representative section, from the south.

5.7.1 Trenches 5 and 6 were located across an earthwork ridge running north-south through the eastern side of the Site (**Figure 3**). The trenches both measured 10m by 2m.

5.7.2 Below the subsoil was sterile, possibly re-deposited, clay **502/ 602** extending to a maximum depth of 0.9m bgl (slightly higher in Trench 6), where a thin layer of peat or peat-like material **503/ 603** was encountered (**Figure 3; Plate 2**). The peat **503/ 603** in turn overlay a further deposit of sterile clay **504/ 604**, possibly natural in origin. No artefactual evidence was recovered from the peaty material and an environmental sample was taken from the deposit for further assessment (see Section 7 below).

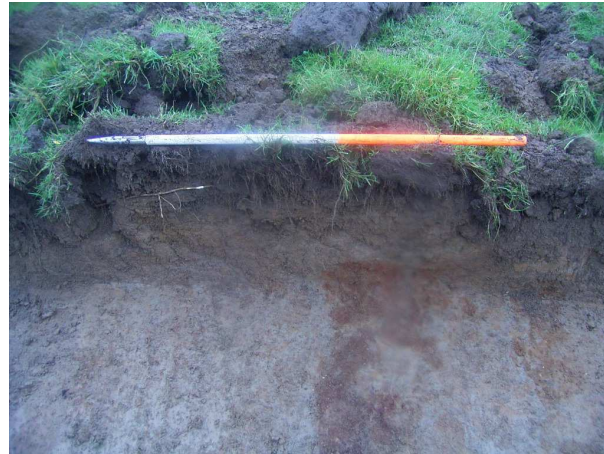
Plate 3: Trench 7, representative section, from the south.

5.8.2 The earthwork comprised silty clay forming a bank **702** approximately 2.5m wide and 0.33m high (**Figure 4; Plate 3**). The bank is the continuation of a field boundary extant to the north of the trench.
