## A6020 MAINS RENEWAL, HASSOP, DERBYSHIRE

Archaeological Watching Brief

Report reference: 77031.03

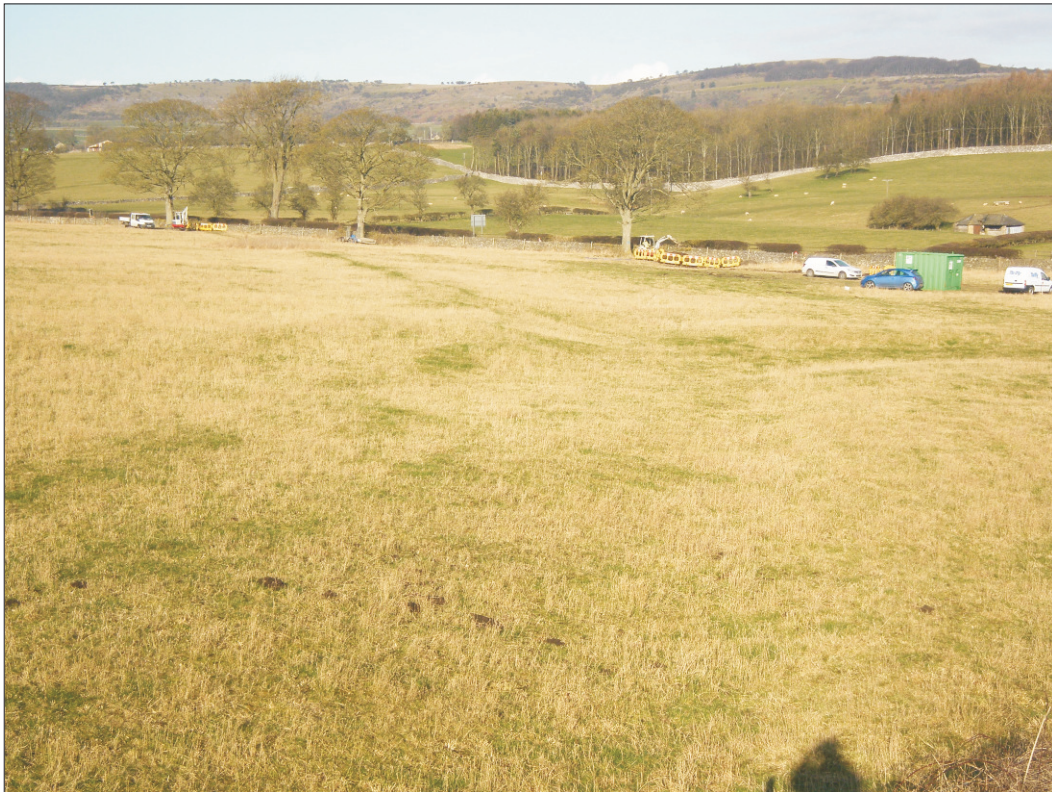
**Front Cover:** The Scheme, view from southeast

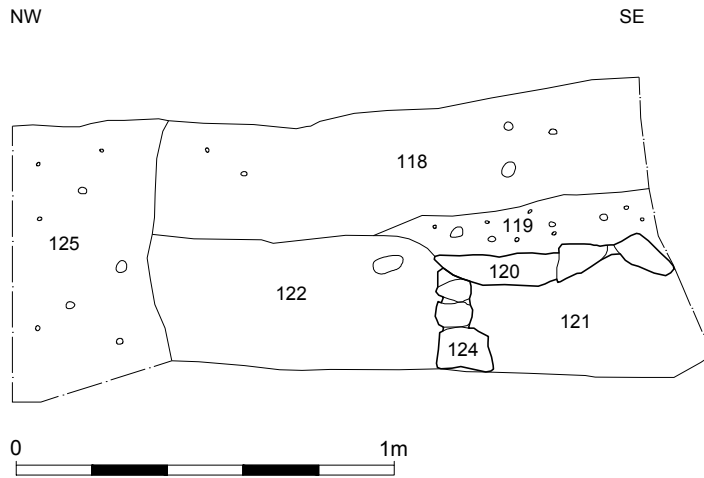
Partial section through Grindleford to Newhaven Turnpike Road, contexts 120, 121 & 124

4.2.5 In the northern section of the trench a 0.8m long partial section of the Grindleford to Newhaven Turnpike Road was observed (**Figure 2**). The insertion of the original water pipe cut through the turnpike road, therefore no new disturbance was caused by the current works. The turnpike (**120**) appears to cut into the subsoil (**122**) and the partial section observed consisted of three limestone blocks, roughly dressed with a flat face uppermost, all of varying sizes, laid edge to edge above a silty clay bedding deposit (**121**). At the western edge of **121** were three edging stones (**124**), the top two limestone, the bottom one Derbyshire Black Chert.

119	Disturbed ground – Dark grey brown friable silty clay. Frequent sub-angular limestone 0.01 – 0.05m. Located just above S[120]	0.3 – 0.45m
120	Structure – 1759 Turnpike. Three large limestone pieces, the western-most 0.4m long by 0.14m thick, the other two 0.2m length by 0.15m thick (widths unknown as turnpike was only seen in section), all roughly shaped but with a flat top edge. The eastern-most stone may have been disturbed by the former water main cut as it was observed at an angle to the others. At the very west end of the three stones three more stones were observed. They were placed one on top of the other, the top two being limestone, roughly squared to 0.1m diameter, the bottom one 0.15m, roughly squared Derbyshire Black Chert. These three upright stones may be an edging layer to hold the foundation layer (121).	0.45 – 0.75m
121	Turnpike Foundation – Mid greyish yellow brown silty clay. Found inside the area contained by S[120]. A thin lense of pale yellow sandy clay was found near the bottom of this layer.	0.0.5 – 0.8m

122	Subsoil – Dark yellow grey silty clay. The turnpike appears to cut through this deposit	0.3 – 0.7m
123	Degraded mudstone, probably an outcrop of bedrock.	0.7m +
124	Edging stones of Turnpike road	0.3m – 0.8m
125	Former Pipe Trench Backfill – Dark grey brown loose silty clay. Frequent sub-rounded and sub-angular limestone 0.01 – 0.1m diameter; frequent black shale-like material 0.05 – 0.1m

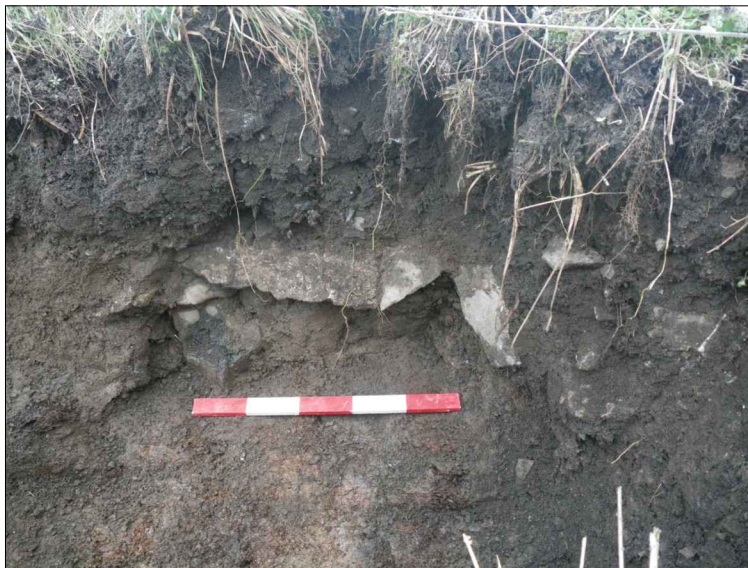
Section through Grindleford to Newhaven Turnpike Road, contexts 120, 121 & 124

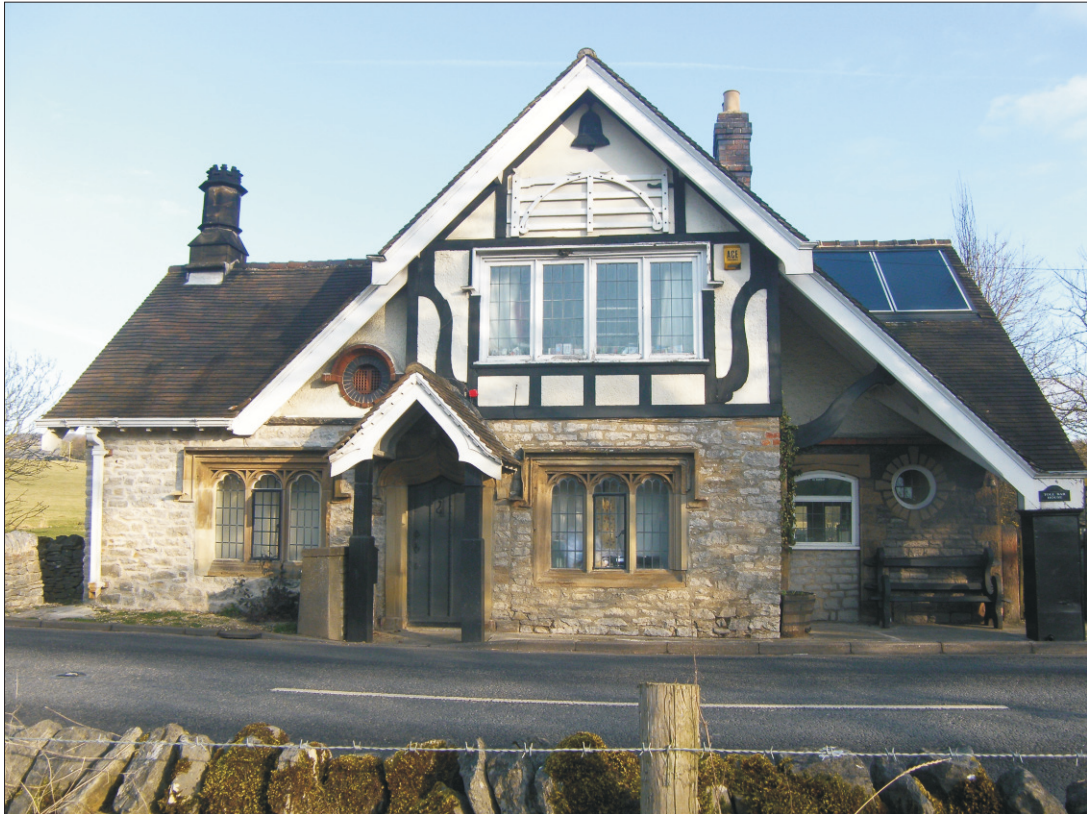
**Back Cover:** Toll Bar House

2.2.2 At the western extent of the Scheme is Toll Bar House (**Back Cover**), or Rowdale Toll House, situated on the Edensor Ashford Turnpike of 1812-1875. The House was built at least by 1812 and may have been built over an earlier cottage. The position of the gate is shown on the 1879 1:2500 Ordnance Survey map.
