GM Waste - Exide Battery Works, Over Hulton, Greater Manchester

Archaeological Evaluation Report

Report reference: 76750.02

April 2011

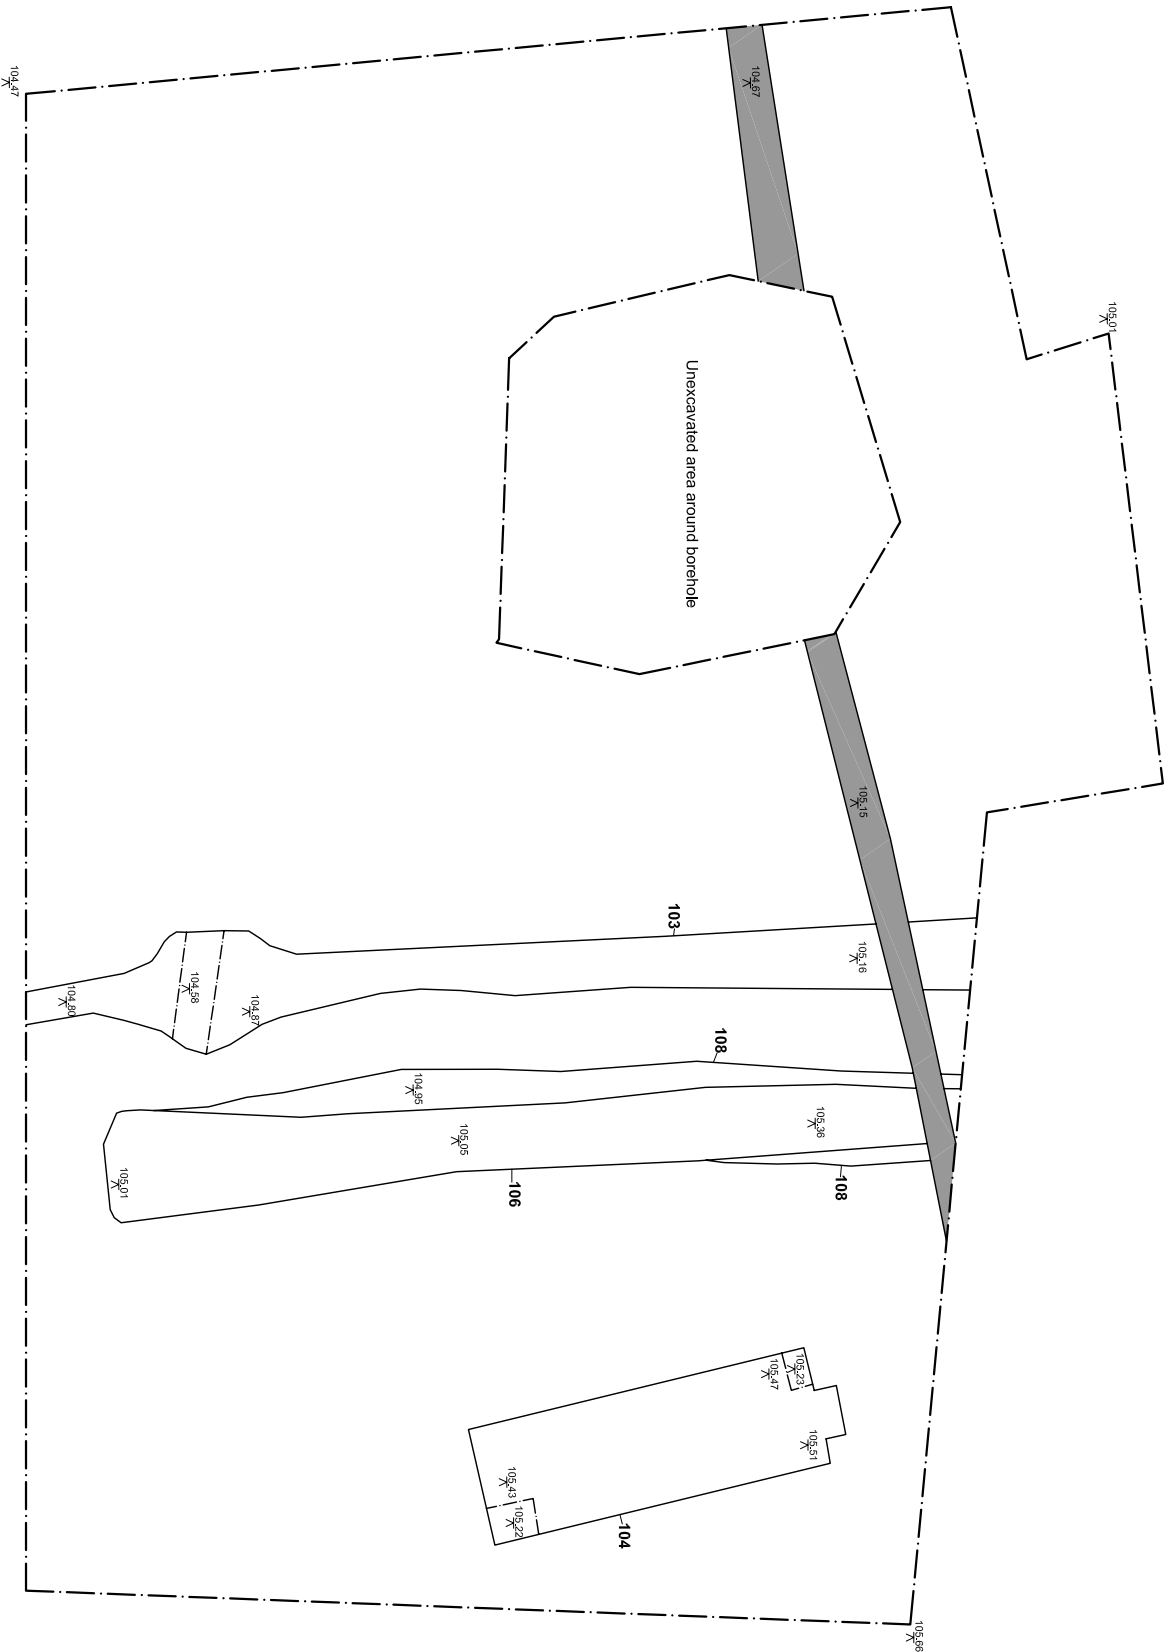
Figure 2

Trench 1: Plan

- 4.3.1 The largest area, Trench 1 (**Figure 2, Plate 1**), was located to evaluate the level of survival of the 18th-century Bank House and its subsequent development. Excavation indicated that the house was substantially demolished and that the area was heavily remediated prior to its use as hard standing for a compound, probably associated with the construction of the current Exide Battery Works complex in the 1970s.
- 4.3.2 Four cut features were uncovered in the base of the trench (**Figure 2**). To the north eastern edge of the trench was a 5m x 1.9m x 0.18m deep feature **104**, rectangular in shape. The feature was filled by light grey sandy clay **105**. The fill contained recognisably 19th-/ 20th-century pottery (**Appendix 3**), suggesting some contemporaneity with the later developments of Bank House.

4.3.3 Two parallel linear features in the centre of the trench (**Figure 2**) extended from the north western limit of excavation to, or near to, the south eastern limit of excavation. One of the features **103** was excavated to a depth of 0.4m and was filled by material that was indistinguishable from the made ground (see below). The linear **108** to the immediate north east was later truncated by an apparent machine trench **106** which was filled by a mixture of silty sand, timber and thick oil. Both features were later truncated by a modern land drain (**Figure 2**) which was filled by gravel hardcore. The features did not align with any of the structures associated with Bank House on the historic mapping and were interpreted as drainage trenches, possibly associated with later development at Bank House.

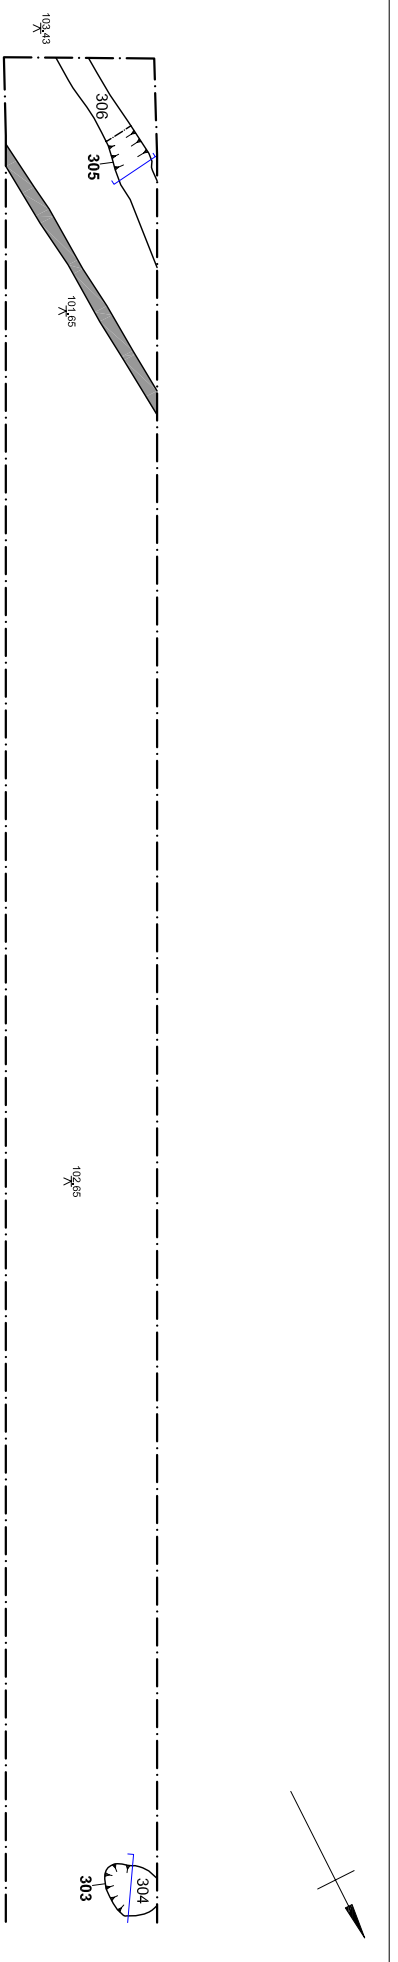
Figure 4

Trench 3: Plan

4.4.2 Potential archaeological features were recorded in Trenches 3 and 5. Trench 3 contained a heavily truncated north to south aligned ditch **305** at the southern end of Trench 3 (**Plate 3**) and a truncated pit **303** central to Trench 3 (**Figure 4**). The ditch **305** does not correlate with any of the known features on the historic mapping. No artefacts were recovered from these features.

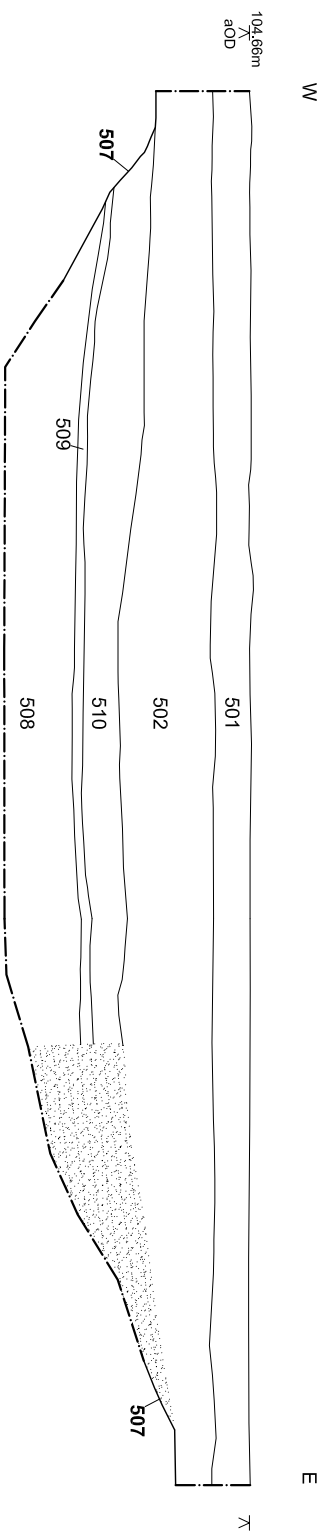
Figure 7a

4.4.3 Trench 5, in its western side, contained two substantial parallel linear ditches, (**Figure 6, Plate 5**), separated by a narrow and shallow gully. All of the features were aligned in a north to south direction. The earliest of the ditches **507** measured 6.85m wide by at least 0.8m deep. A layer of peat **509** had built up over the lower silty fill **508**, suggesting organic build up in waterlogged conditions (**Figure 7a**). The resultant hollow was in-filled by a 0.2m thick deposit **510** of waste, including late 19th-century to early 20th-century pottery and glass (**Appendix 3**). The ditch appears to correlate with the location of a field boundary shown on historic maps of the area (1893-1970) suggesting that this division was formed by a wide drainage ditch.

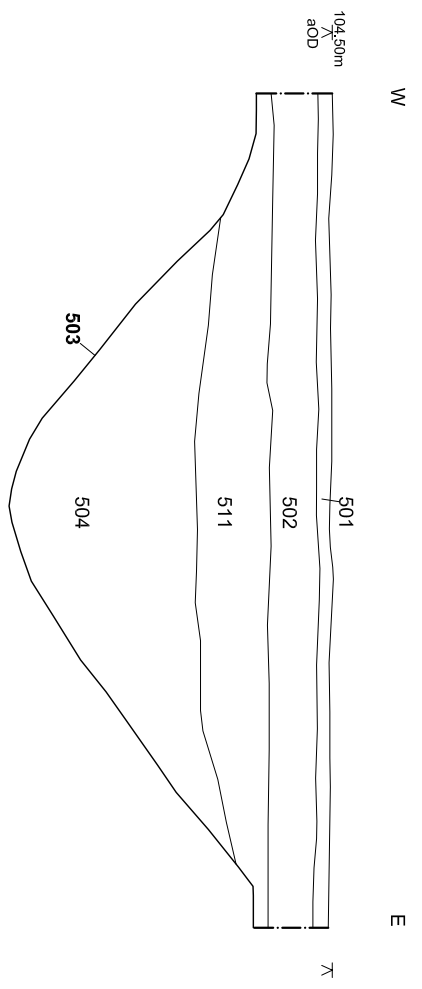
Figure 7b

4.4.4 To the west of ditch **507** was a 4.35m wide, 45° straight sided, 2m deep ditch **503** (**Figure 6**). The ditch had silted **504** up to a level of 1m and was sealed (**Figure 7b**) by material **511** similar to made ground deposits in the other trenches. The ditch does not correspond with any boundaries shown on any historic mapping for the Site and the only artefacts recovered from the feature were handmade bricks of uncertain date in the upper filling **511** (**Appendix 3**). However, the excavator's opinion is that **503** was a later replacement of **507**, as immediately prior to the modern landscaping, this ditch must have existed as a hollow earthwork in the land surface.

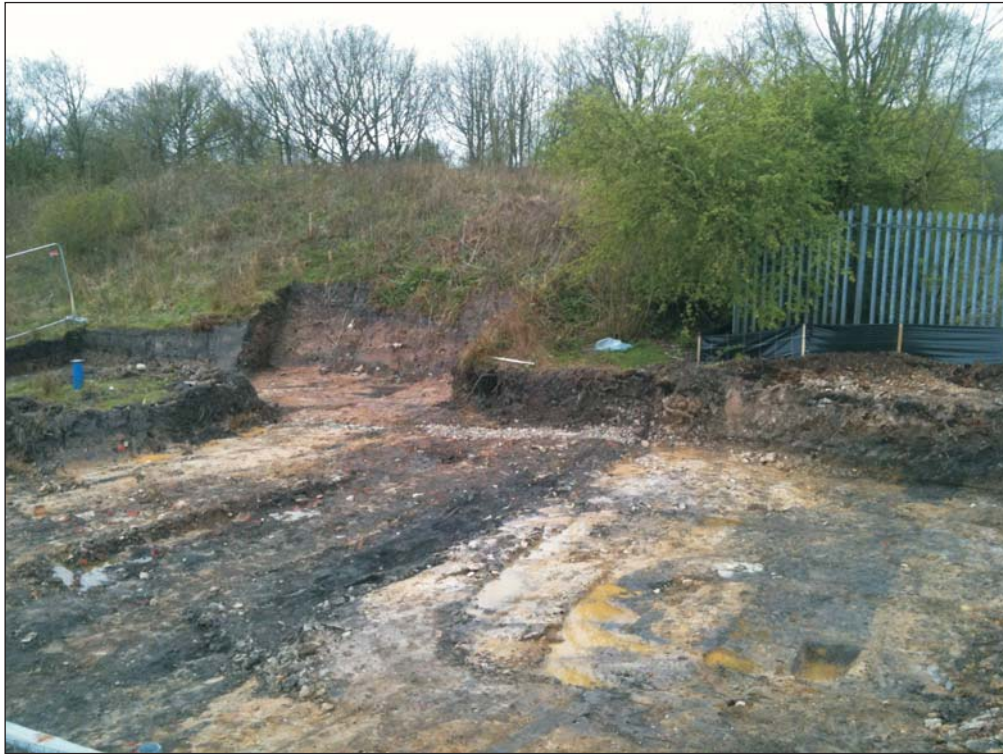
Plate 1: Trench 1, general shot following excavation, looking south west.

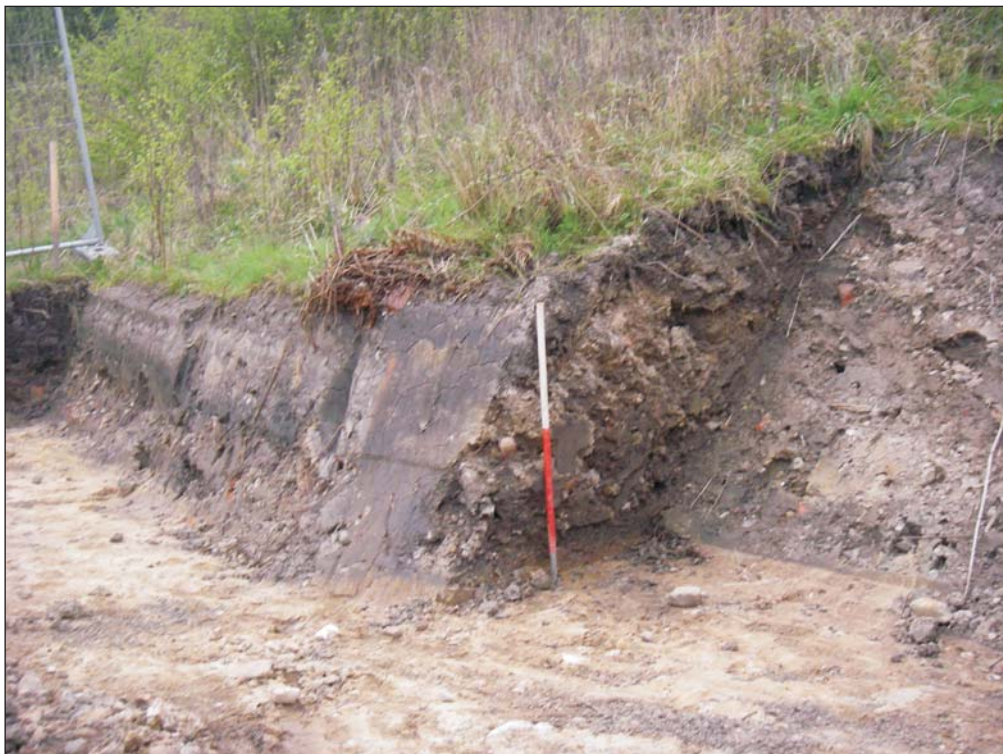
Plate 2: Trench 1, showing made ground forming part of the mound, looking south west.

4.3.4 Overlying these features was a highly compacted layer of made ground, which consisted of a mixture of brick rubble, sandstone blocks, plastics, rubber and a washing machine in a matrix of brown silty sand. The deposit covered the entire trench to a depth of 0.3 – 0.4m and also formed the majority of the existing mound (**Plate 2**) at the south western end of the trench, where it rose to a recorded 1.3m depth. This material was similar in appearance to material uncovered in Trenches 2 – 5 and was overlain by peaty topsoil.

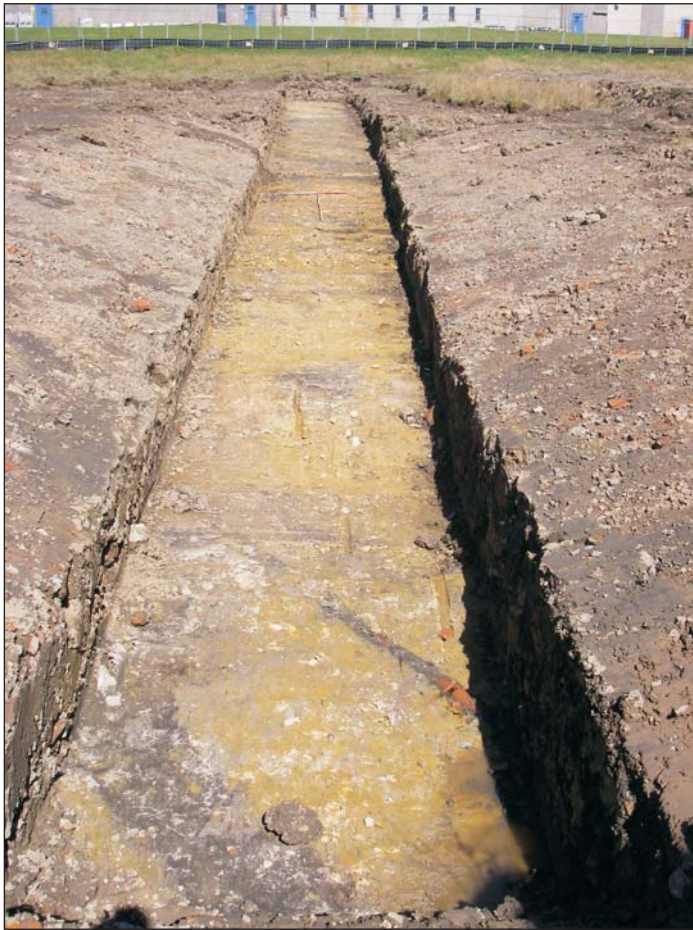
Plate 3: Trench 3, ditch **305** (foreground) and modern made ground. Looking northeast.

4.5.2 A similar sequence of deposition was noted above the level of natural geology in all of the trenches, albeit to varying depths. The initial deposition was a heavily compacted layer of very dark grey silty clay which contained brick rubble, sandstone blocks, variously sized stones, plastic, rubber, wood, glass and slate. This deposit was around 0.4m thick at the north of the Site within Trench 5, where it was used to infill the hollow left within one of the former ditches **503**, and 0.9m thick at the south of the Site within Trench 3 (**Plate 3**).

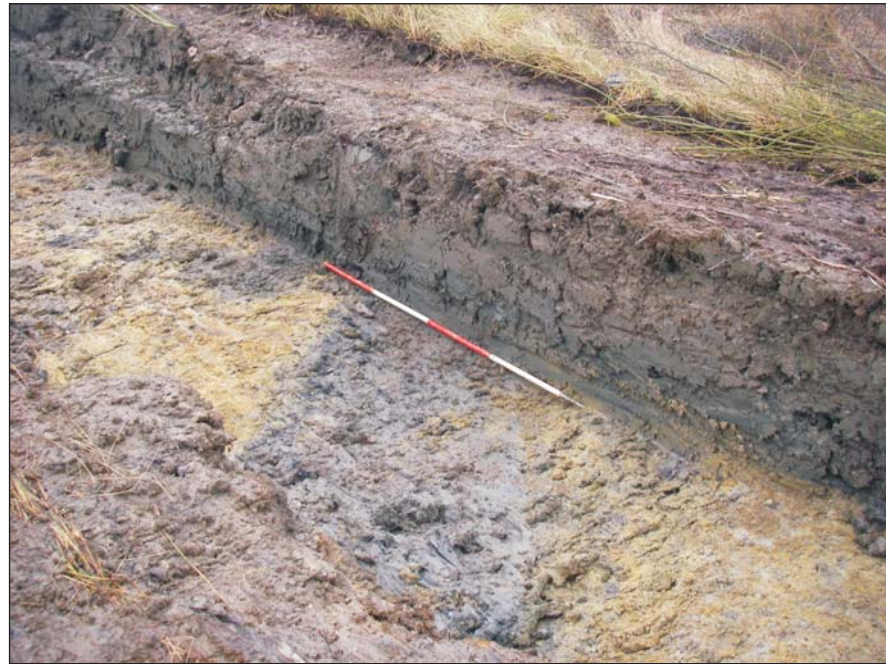
Plate 4: Trench 4, linear feature **403**, looking east.

4.5.4 The landscaped natural ground surface sloped heavily down from the north to south with a sculptured raised bank evident along the southern edge of the Site, adjacent to the former open cast mine. A shallow ditch **404**, with a fill containing modern black bin liners was uncovered at the south west end of **Trench 4** (**Figure 5, Plate 4**). This ditch probably formed the base of the earthwork.

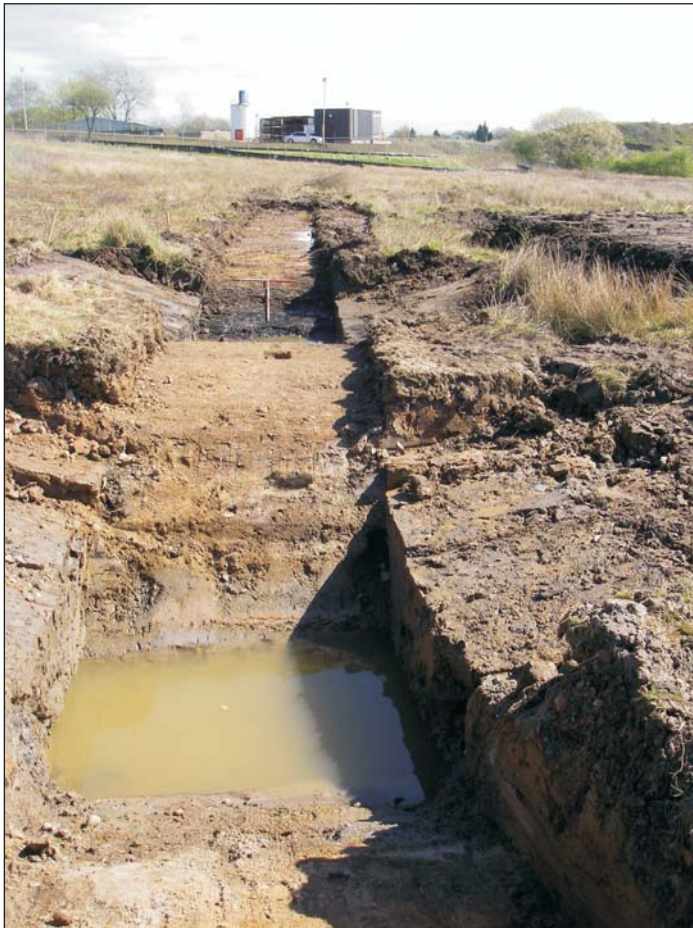
Plate 5: Trench 5, parallel ditches **503** (foreground), **507** and gully **505** (centre). Looking east.

4.4.5 Between the two large ditches was a 0.35m wide fairly straight sided gully with a flat base **505**, measuring 0.15m deep (**Figure 6**). The gully was filled by a grey sandy clay fill **506** which contained no artefactual material.

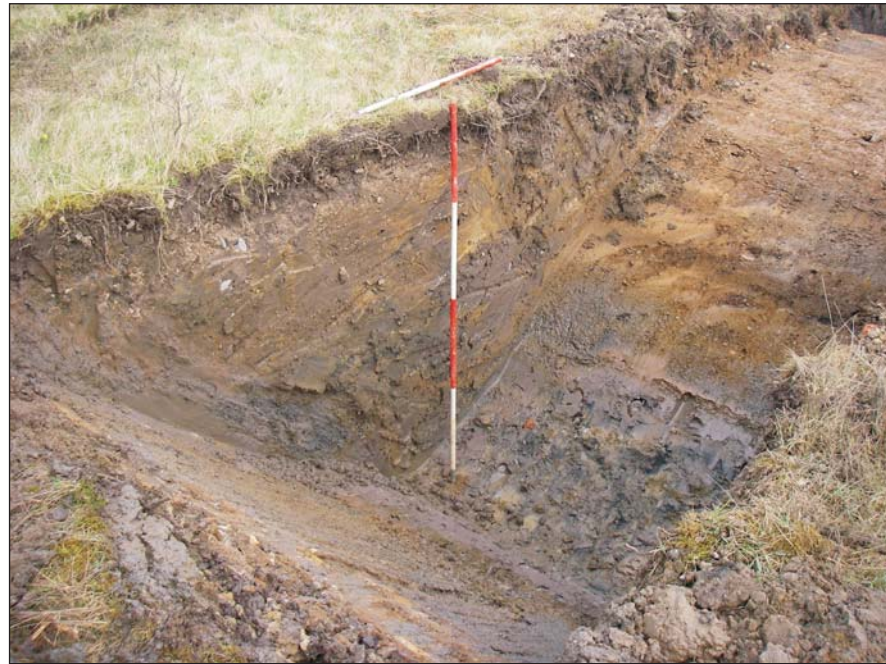
Plate 6: Trench 5, ditch **503**, looking northeast.
