**THE MANOR HOUSE
STOKE POGES, BUCKINGHAMSHIRE**

Archaeological Evaluation Report

Report 69151.03

May 2008

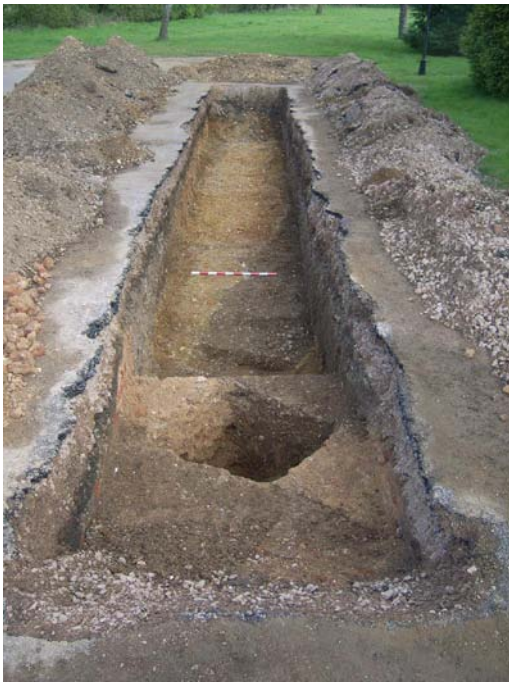
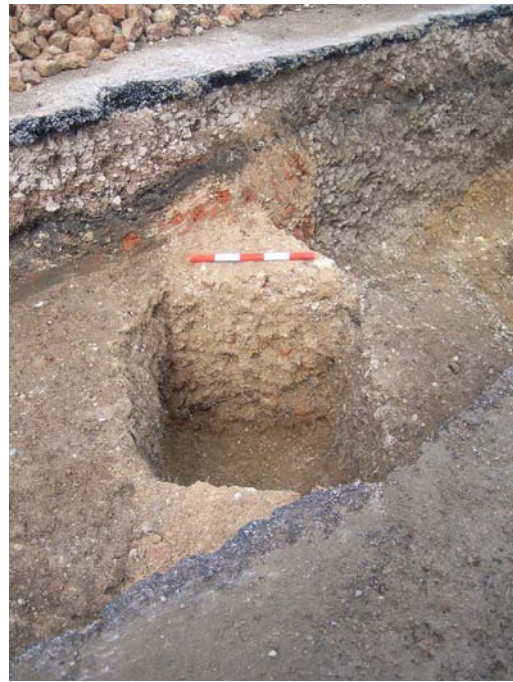
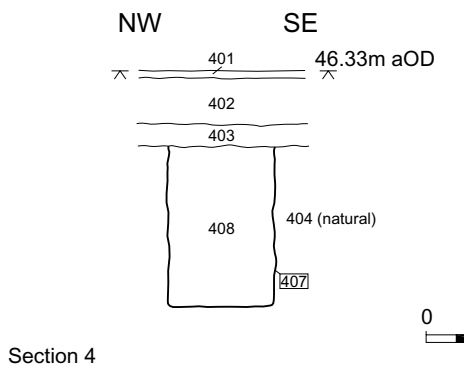
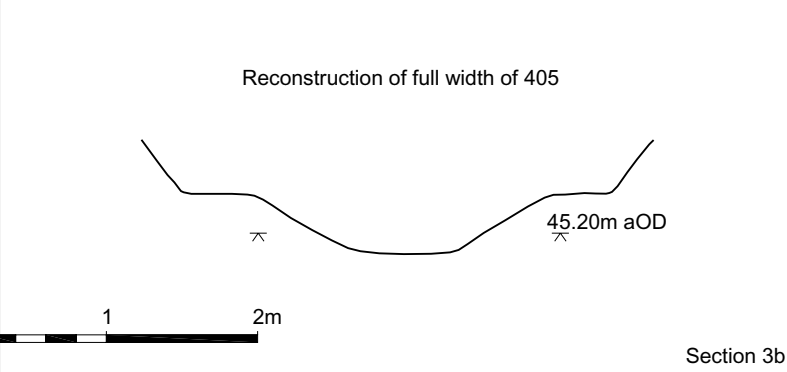
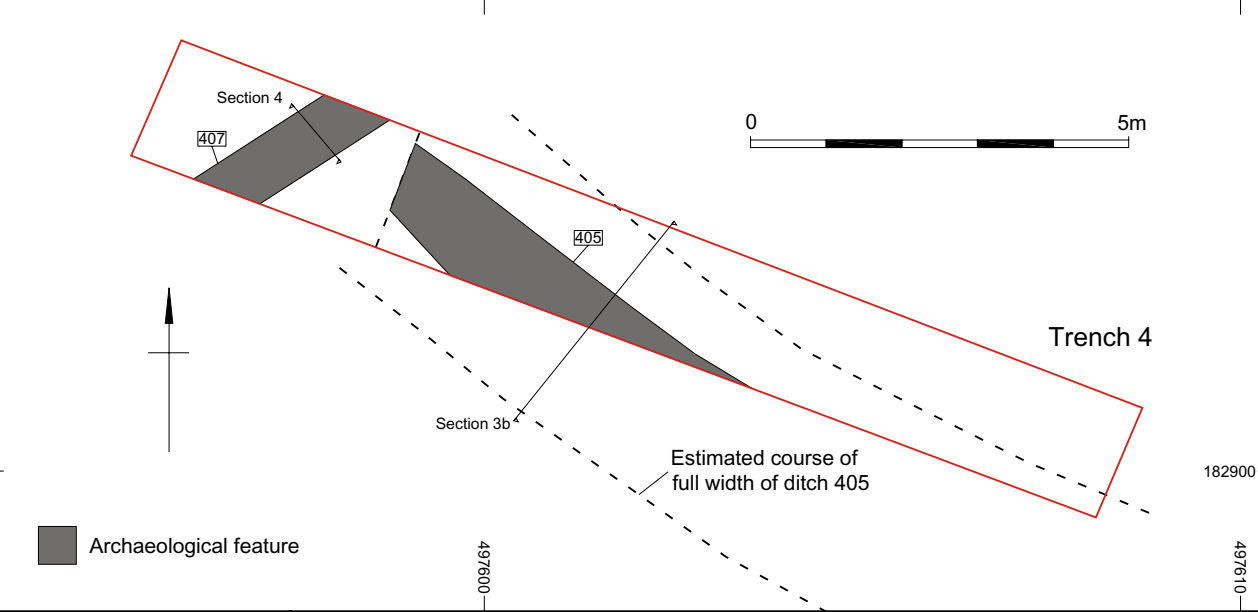
Figure 2

- 4.2.1 A large north-west to south-east aligned, slightly curving ditch **405** was identified in Trench 4 (**Figure 2**). The gravelly fill **406** contained little datable material; only a few small fragments of brick and a handmade iron nail were recovered. The ditch is likely to have been more than 3.50m wide, and at least 1.00m deep with a complex stepped profile and may have formed a boundary in the medieval deer park or perhaps the later landscape, although this is not evidenced in early cartography.

- 4.2.2 Ditch **405** was cut by a robbed out brick wall, **407**, at the west end of Trench 4. This substantial robber trench was aligned south-west to north-east, and was 0.70m wide and 0.50m deep. The wall had been constructed of frogless bricks and lime mortar. No complete example of the brick was recovered and no brick fragments were retained. One fragment of post-medieval glazed pottery was recovered from the crushed lime mortar and brick fill **408**, although this is more likely to date to the episode of demolition/robbing, rather than the construction of the wall itself. No evidence of an associated building was noted, which may indicate the feature relates to a walled garden or boundary.

View looking east

Section through 407 looking north-east

Features in Trench 4

- 3.2.3 All trenches were opened by a JCB excavator fitted with a toothless grading bucket.
- 3.2.4 Trench 4 was extended 3m as part of an agreed contingency towards the west to reveal the full section of robbed out wall **407**.

5.7.1 Fragments of brick were recovered from **408**, the fill of robbed-out wall **407**. They were unfrogged in form, although none were complete enough to be positively dated. The use of unfrogged bricks continued into the 18th century, although locally made examples are recorded up to a century later. As no complete examples were recovered the brick fragments were not retained.

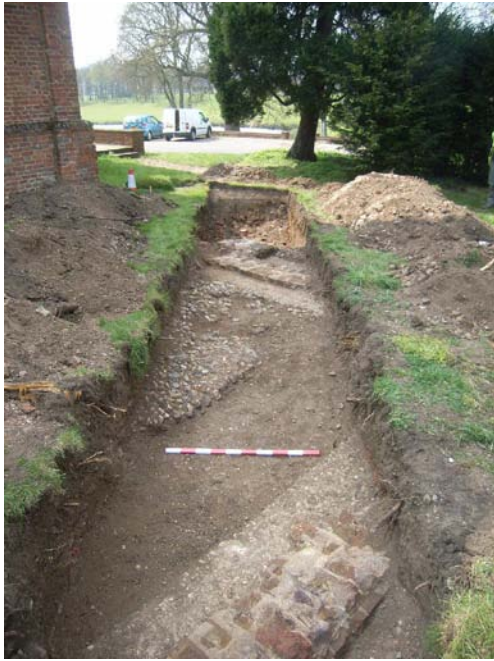
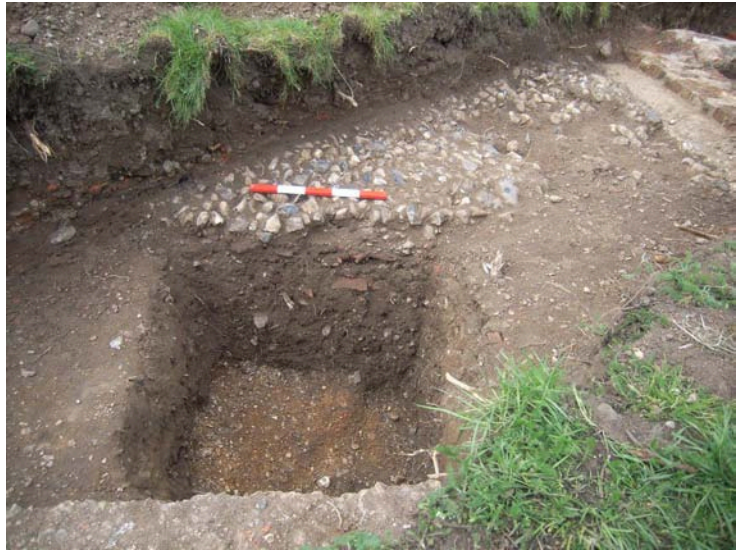
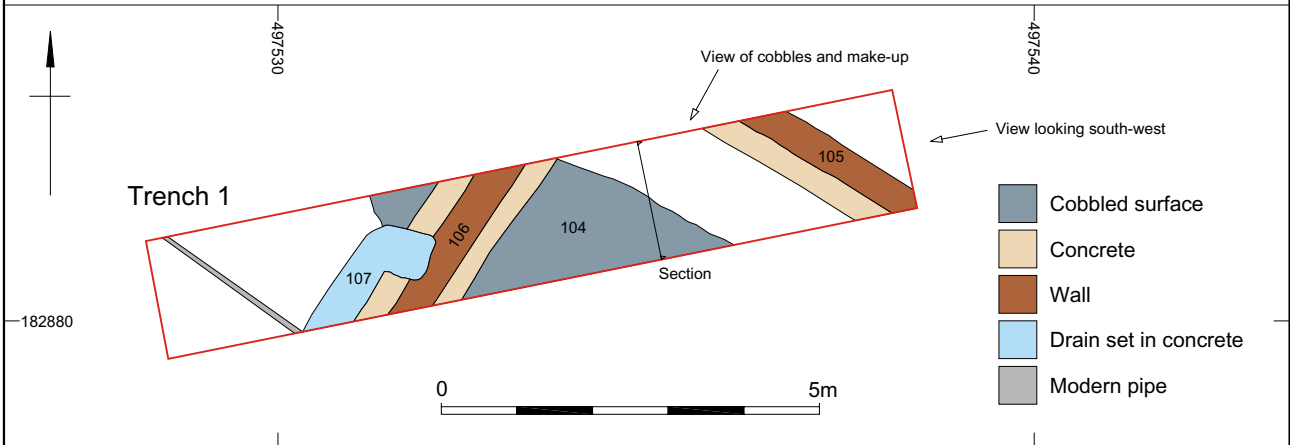
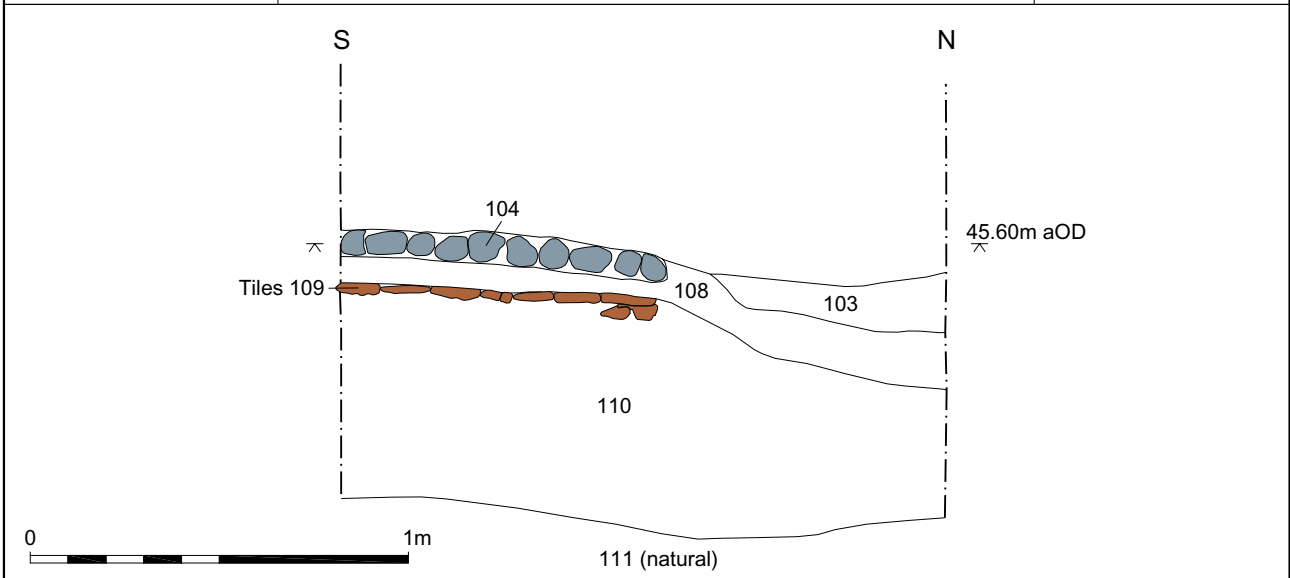
Figure 3

- 4.2.3 The cobbled surface **104**, positioned immediately to the north of the Manor House, was sitting on, and bedded into, a shallow deposit **108** (**Figure 3**). This had been laid on a thin deposit of used and broken peg tiles **109** which may have been utilised as a rough surface or simply built up during building works at the Manor House. Under the peg tile layer was a 0.6m thick make-up or dump layer **110**, which lay over the natural geology. This dump layer **110**, like the bedding layer **108** above, contained frequent fragments of pottery, clay pipe, early onion-shaped glass bottles and peg tile dating to the later 17th century. The cobbled surface **104** had a north-eastern edge 6.30m to the north-east of the Manor House wall and parallel with it. The cobbled surface was covered by sandy silt layer **103** that contained modern material.

- 4.2.4 Brick wall bases **105** and **106** were laid on 1.20m wide concrete footings (**Figure 3**). Both wall bases and the modern gully with drainpipe **107**, belonged to the small north wing that was built onto the house in the 20th century and demolished in 1983.
- 4.2.5 A larger cut **210** was noted in the southern edge of Trench 2. It was cut from just under the turf and was probably a planting pit in the garden.

View looking south-west

View of cobbles and make-up

Features in Trench 1

- 3.2.5 A sondage was hand dug adjacent to cobbled surface **104** in Trench 1. This was later extended so that the majority of **104**, along with make-up layer **110**, was removed and the natural gravel beneath was exposed. The excavated spoil was inspected for finds.

- 7.1.2 There is evidence of rebuilding work having taken place in the late 17th century when layer **110** was deposited just to the north of the house. A layer of used and broken peg tiles lay on top and this was used as a temporary surface until bedding layer **108** and cobbled surface **104** were laid down shortly afterwards. The cobbled surface may have originally extended from the wall of the house out to the north-east and supports the hypothesis in the Desk-based Assessment (WAH, 2008) that the extant building would have formed part of the original service wing of the house.

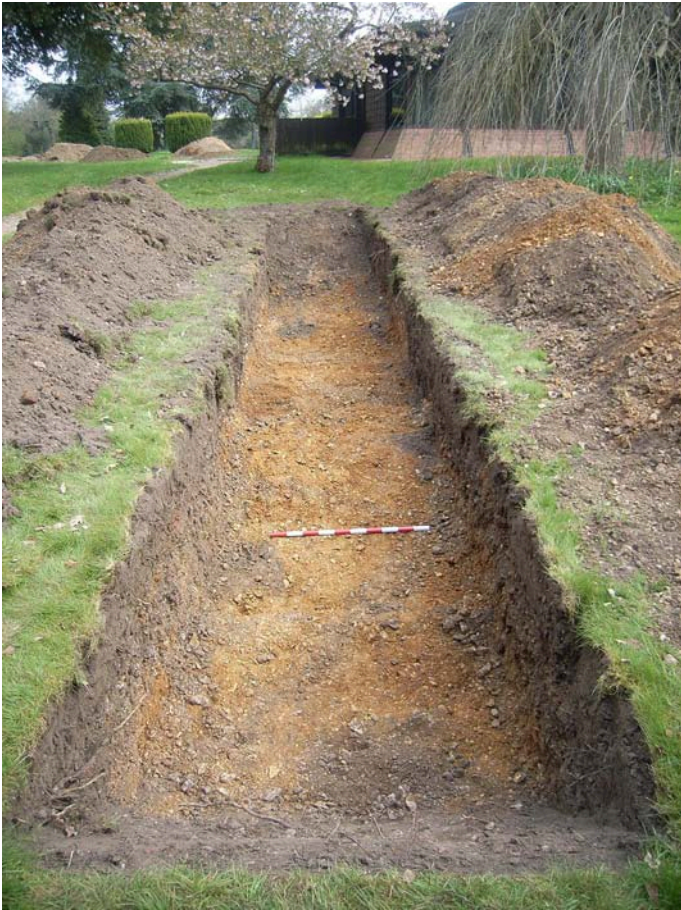
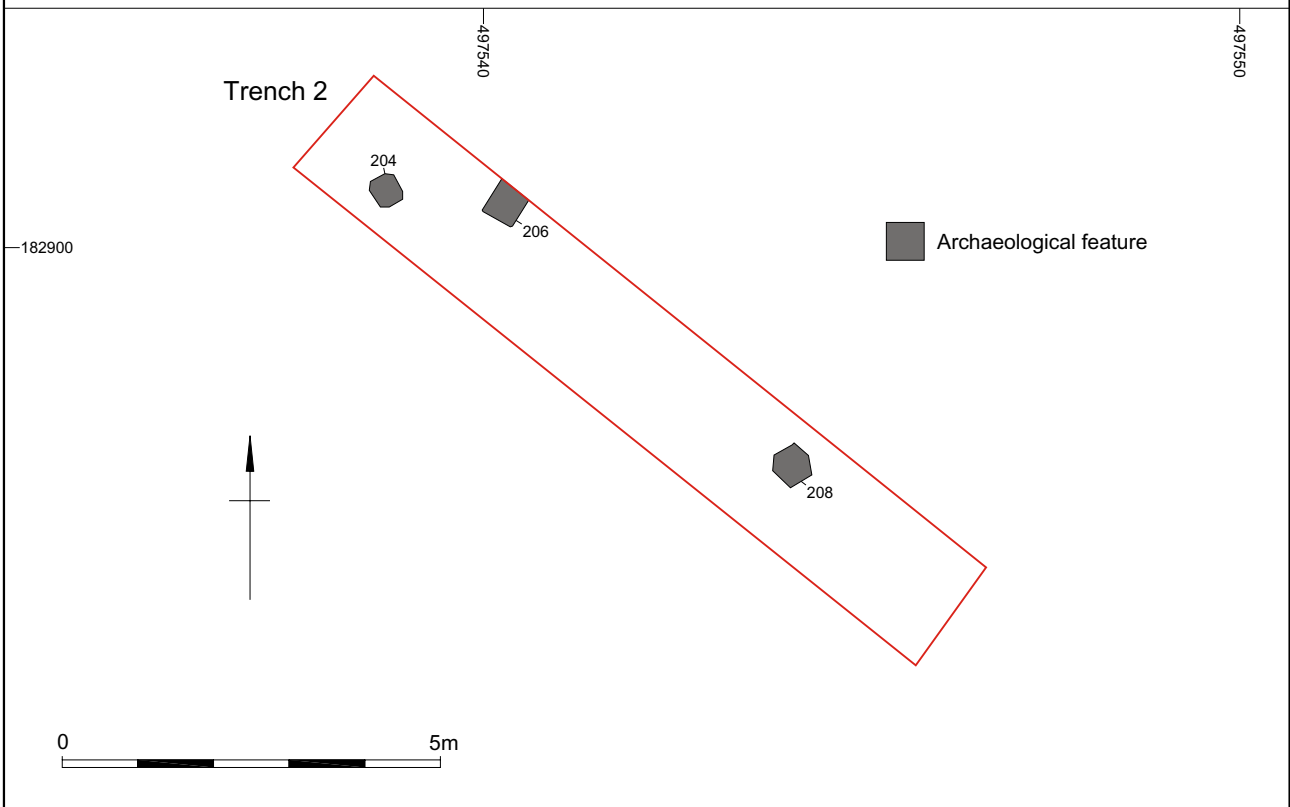
Figure 4

- 4.2.7 Postholes **204**, **206** and **208** in Trench 2 contained little dating evidence (**Figure 4**), although **204** contained occasional brick fragments and **206** contained occasional brick fragments and a fragment of limestone, possibly from a floor. This showed the postholes to post date an episode of nearby building. If it is assumed that this was the original 1555 Manor House, or rebuilding work associated with it, then the postholes must be post-medieval or later in date.

View looking south-east

Features in Trench 2

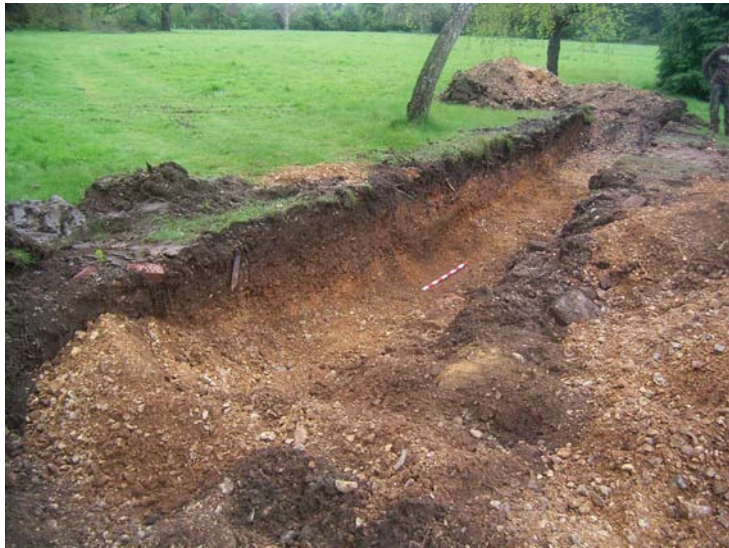
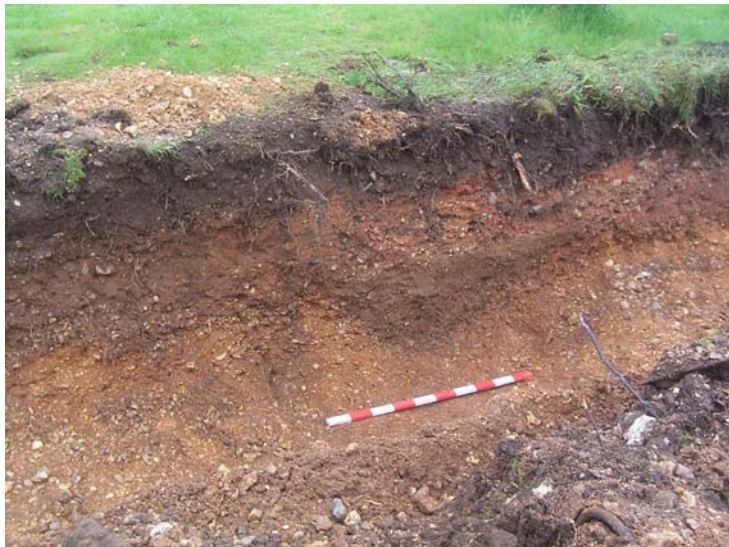
- 4.2.8 No dateable material was recovered from ditch **704** or the similarly aligned dump layer **702** in Trench 7, within the eastern part of the Site (**Figure 5**). Both features were aligned north to south. The dump layer **702**, which contained a proportion of crushed brick, lay directly beneath the turf and topsoil and it is likely to be of post-medieval or modern origin.

View looking south

Section through 704 looking south-east

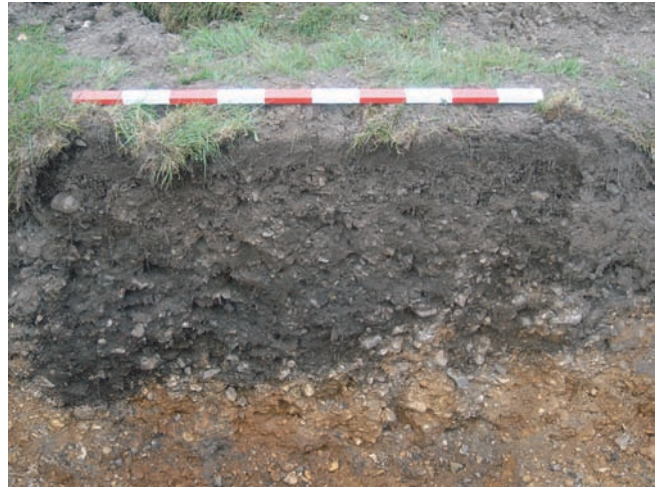
- 4.2.6 The make-up or dump layers seen in Trenches 2 and 6 (**Figure 6**) are both of probable modern date; although dateable material was only recovered from layer **603** in Trench 6, the nature of both deposits was similar and likely to represent a single episode.

North facing representative section of Trench 2

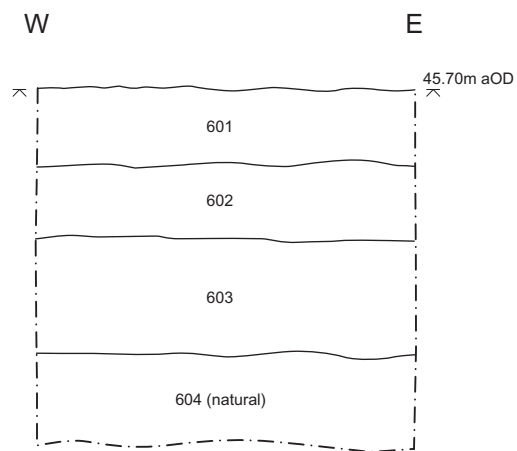
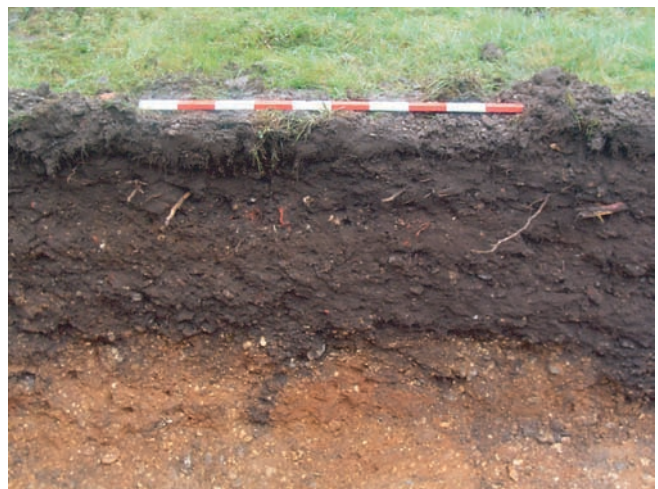
North facing representative section of Trench 6

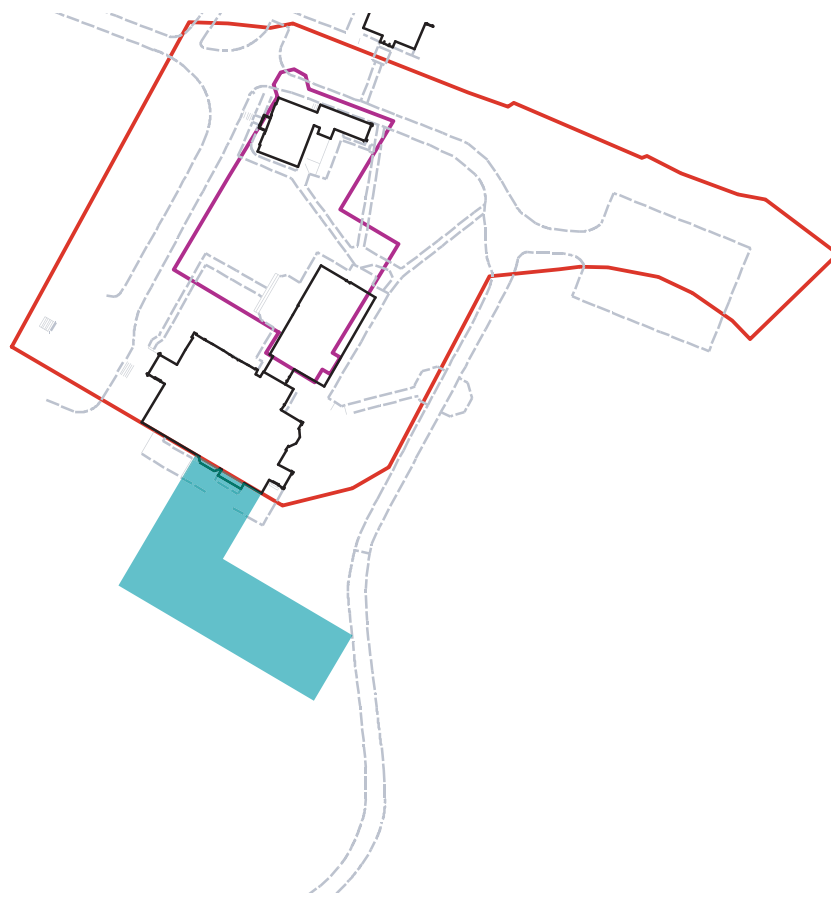
Figure 7

- The Site
- Proposed Basement
- Suggested extent of 1555 Manor House

Suggested original plan of 1555 Manor House

No evidence of any northern extension to the 16th century Manor House was found within the evaluation trenches. A raised platform, noted on the south-western side of the existing building, suggests the original ground plan may have extended towards the south-west of the present building. A further return to the south-east would have given it an approximate Z-shaped outline.

- 7.1.4 No evidence of a northern extension to the 1555 Manor House was found within the evaluation trenches. There was however, a straight-sided raised area that extended towards the south-west at right-angles from halfway along the south-western side of the existing building (**Plate 1**). This was 34m long before returning towards the south-east. The south-eastern corner of the existing building also showed several features indicative of internal walling. It would seem that the original ground plan of the 1555 Manor House may have extended towards the south-west before returning towards the south-east, suggesting an approximately Z-shaped plan (**Figure 6**).

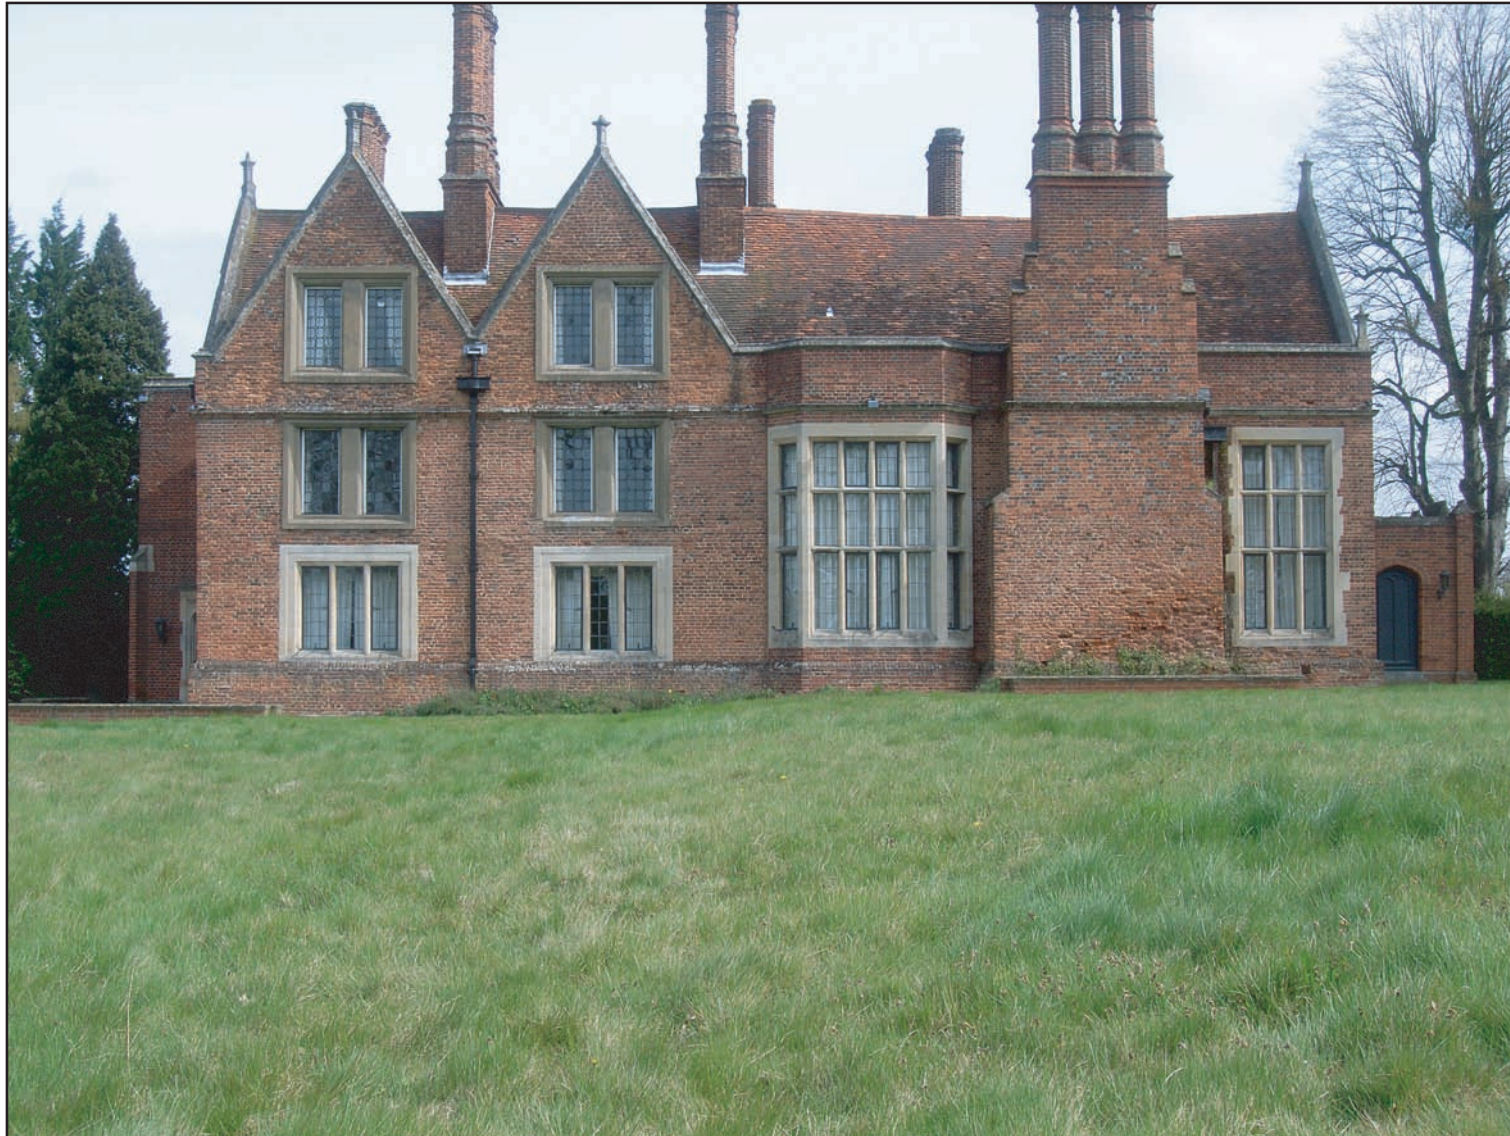
Plate 1: Manor House looking north-east. Note step in landscape
