## Burford Priory Burford, Oxfordshire

Archaeological Evaluation and Assessment of Results

Ref: 71501  
March 2010

**Archaeological Evaluation**

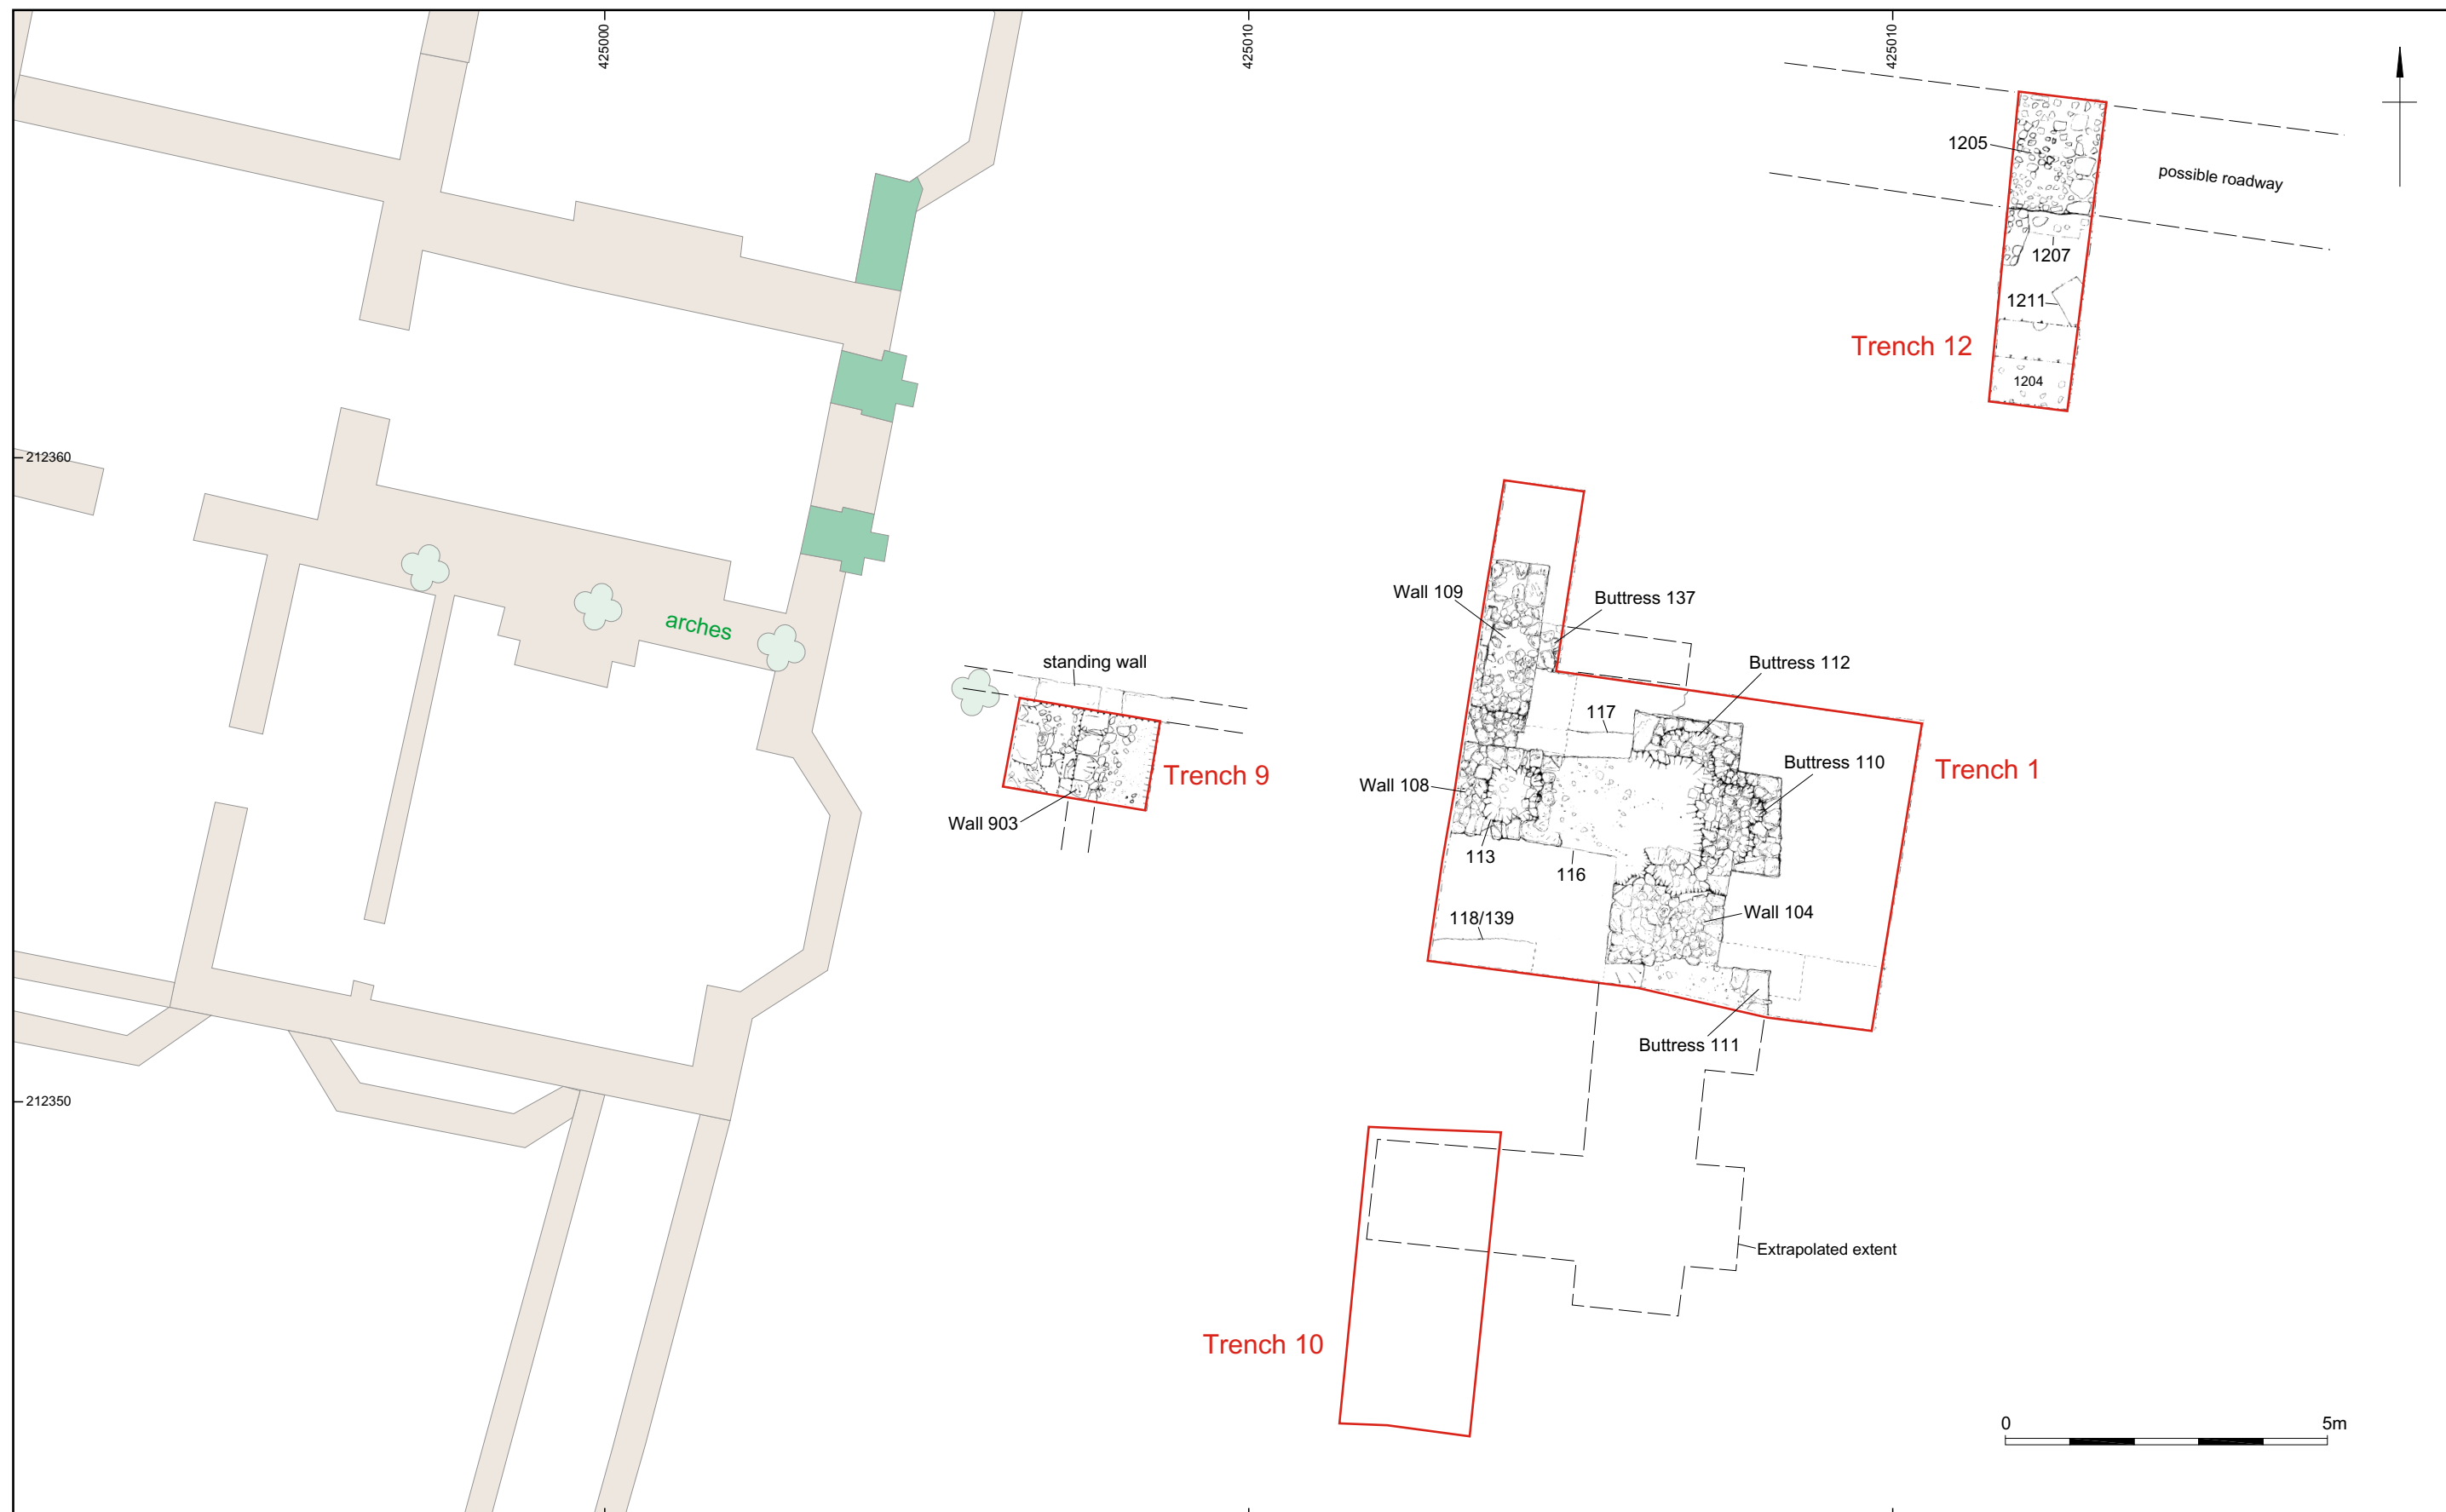
Figure 4

Area 1: trench plans

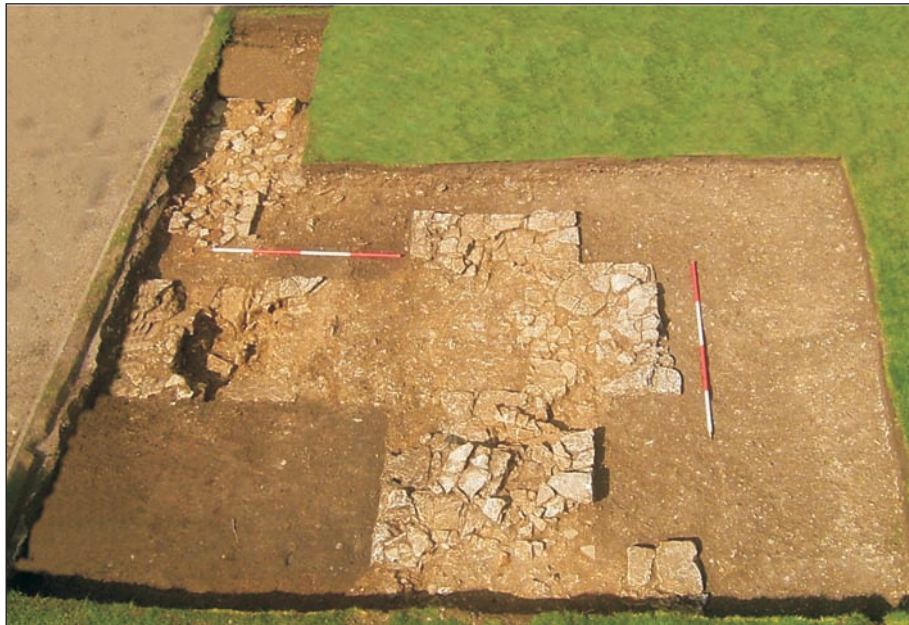
Plate 1: Trench 1, view from the south

- 4.4.5 Trench 1 was positioned to investigate GPR anomaly (A) (Resistance anomaly 1) and to investigate a possible continuation of the row of 13th century arches observed in 1908 and subsequently moved. It was thought that this arcade was part of a building which could be interpreted as either the infirmary hall or its associated chapel.

- 4.4.7 The buried ground surface/occupation layer pre-dated the construction of the building - it had been cut through by foundation trench (116), but would have remained the surface associated with the building in its lifetime. The foundation trench (116) contained the walls of the north-east corner, (104) and (108), with supporting buttresses (110), (111) and (112). Only the foundations of these structures remained, all evidence of upstanding walls having been robbed. Wall (108) comprised the northern wall, which would have been aligned with the medieval arcade identified in 1908.

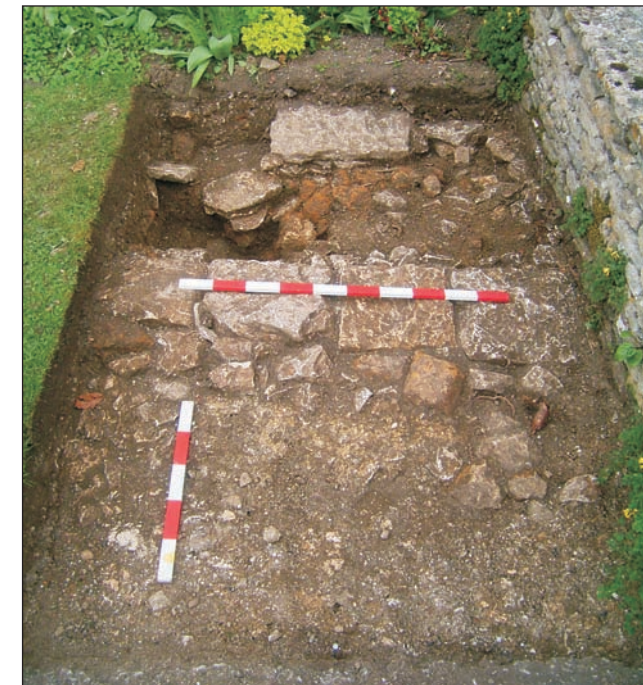
Plate 3: Trench 9, view from east

- 4.4.12 Trench 9 was positioned west of Trench 1, to the south of the front door of the Priory, to investigate the site of a postulated pier base, a continuation of the medieval arcade observed in 1908. The trench was adjacent to a modern garden wall leading from the front door.
- 4.4.13 A single wall (903) ran parallel to the existing house frontage (**Figure 4, Plate 3**), but its nature was not fully ascertained as it was butted on either side by compact rubble layers (906) and (907), and appeared to have been truncated by a robber trench (904). A single sherd of 12th/13th century pottery was recovered from the fill of the robber trench. No evidence of the pier base was observed. The archaeology was sealed by a levelling layer (902) containing both medieval and post-medieval pottery.

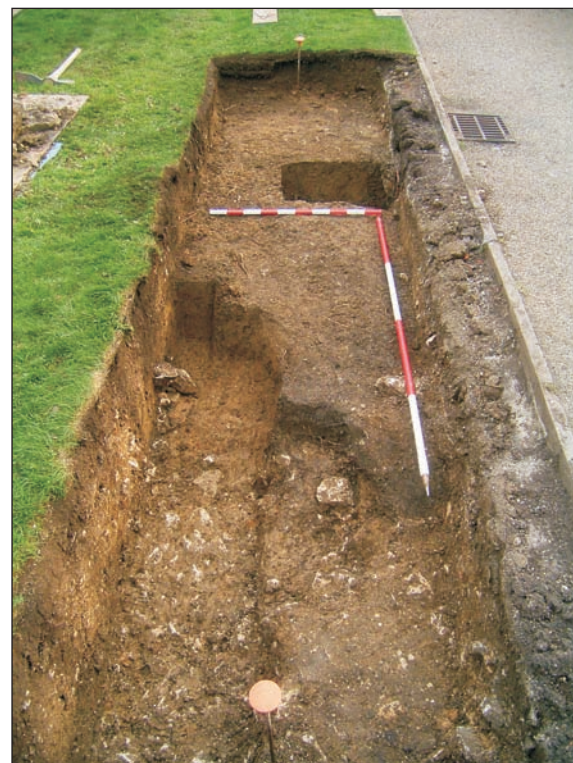
Plate 4: Trench 10, view from north

- 4.4.14 Trench 10 lay to the south of Trench 1, over GPR anomaly (A) (Resistance anomaly 1); it marked the site of the postulated southern wall of the building uncovered in Trench 1, i.e. parallel to wall (108).
- 4.4.15 The natural geology was sealed by reworked natural. This was cut by ditch (1004); the function and date of this feature are unclear, but it was cut by a later robber trench (1006) for the removal of the wall. These features were observed only in section (**Figure 5, Plate 5**). No evidence was found for a corresponding southern aisle.

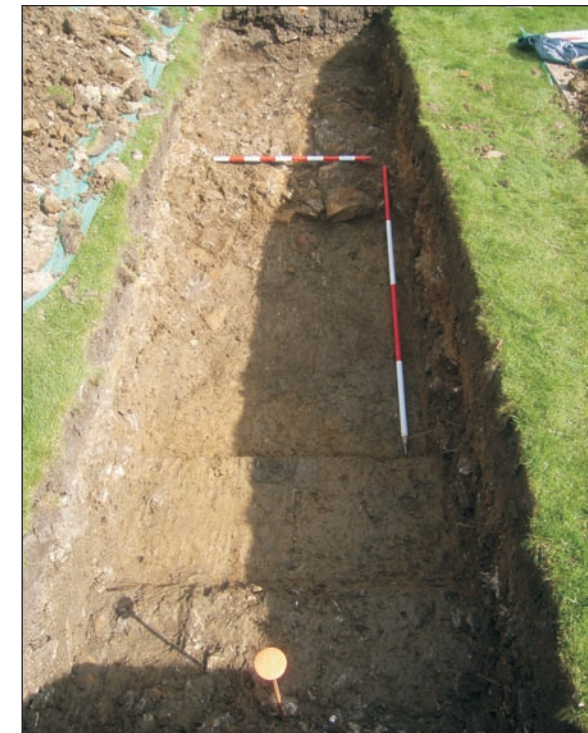
Plate 6: Trench 12, view from south

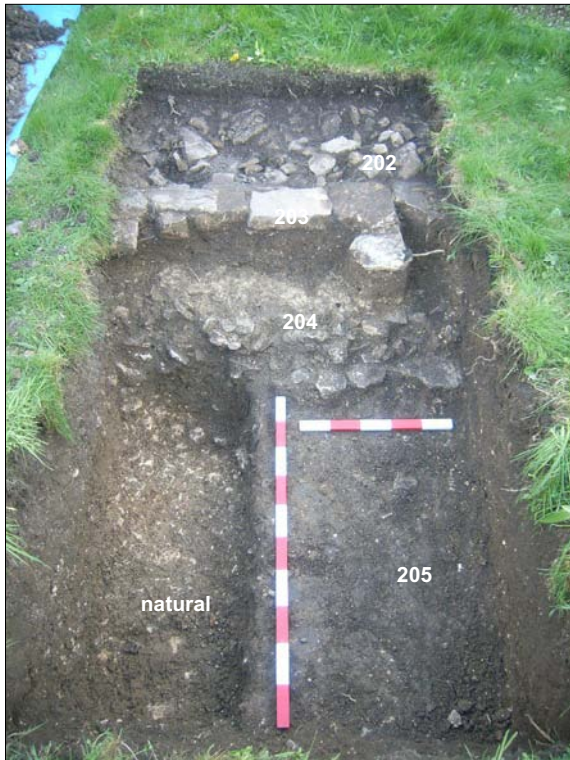
Plate 7: Trench 2, view from north

- 4.4.21 Trench 2 was positioned adjacent to an area which produced sherds of medieval pottery in the shovel test pits. Two structures were revealed within the trench which related to the area's use as a kitchen garden. Drain (202) ran across the southern end of the trench, and contained medieval, post-medieval and modern pottery. Towards the northern end of the trench was an insubstantial wall foundation (204), interpreted as a garden feature. This lay beneath layer (205), which contained medieval and post-medieval pottery.

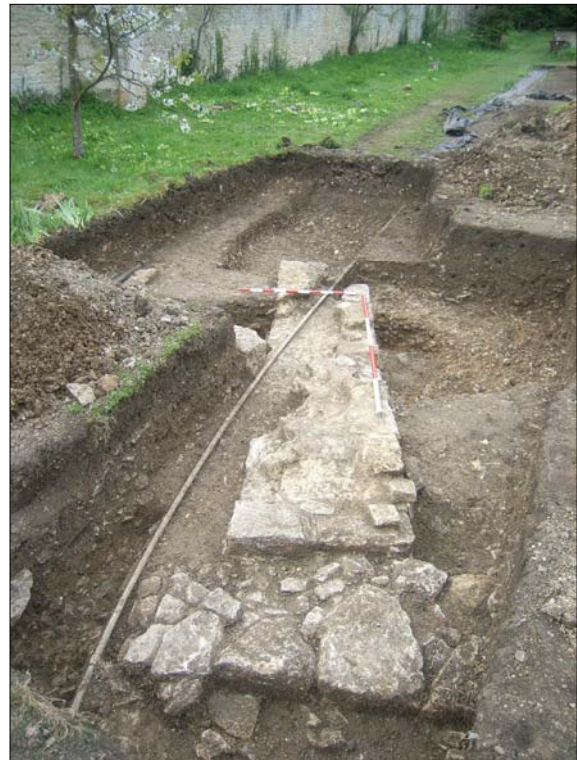
Plate 8: Trench 3, view from north-west

- 4.4.23 The natural geology (324) was cut by the earliest identified archaeology, pit (305), which contained early medieval pottery (**Figure 6, Plate 9**). The overlying layer (303/320) contained post-medieval pottery. This layer was cut by the foundation trench (311) for wall (306), and also by foundation trench (318) for wall (309). Wall (313) may have been contemporaneous; it butted wall (306) (**Figure 6, Plate 8**). These walls were interpreted as being the foundations for a possible post-medieval belvedere, a viewing platform over the vista to the north. Infilling the gap between walls (306) and (309) was (310), a deliberately dumped deposit containing pottery ranging in date from Romano-British to modern. The three walls (306), (309) and (313) were removed by robber trench (314).

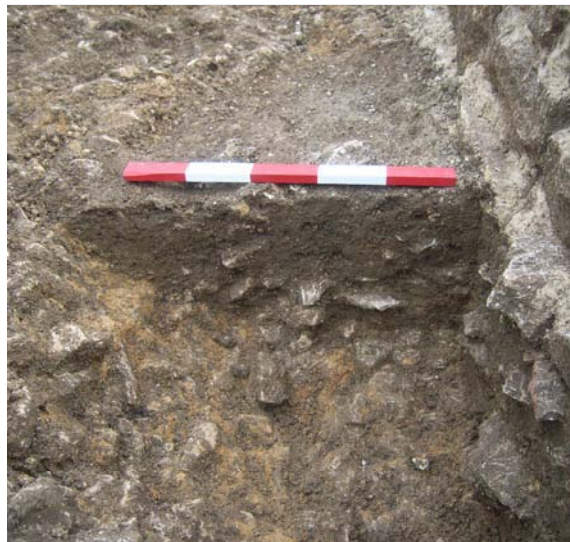
Plate 9: Trench 3, south-east facing section of pit 305

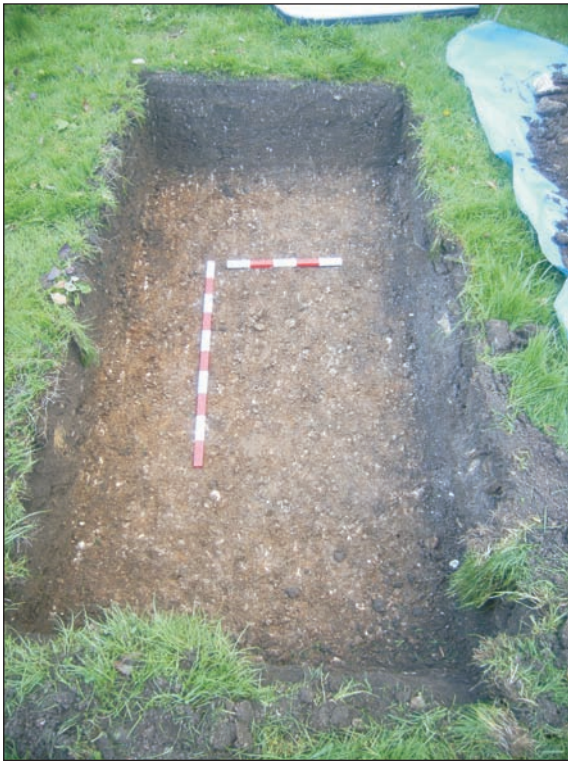
Plate 11: Trench 5, view from east

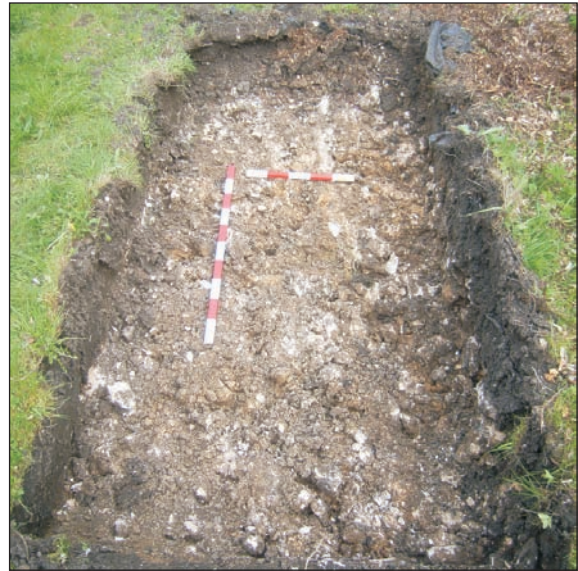
Plate 12: Trench 7, view from north-west

- 4.4.29 Trench 7 revealed truncated and disturbed natural (702) below topsoil (701). No archaeological features or deposits were observed.

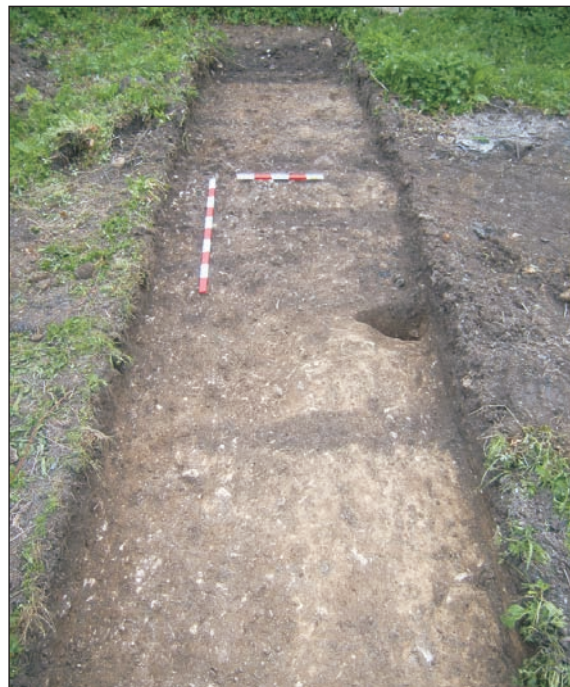
Plate 13: Trench 8, view from north-east

- 4.4.30 In Trench 8 the disturbed natural (803) was cut through by a number of modern garden features (not recorded). No archaeological features or deposits were observed.

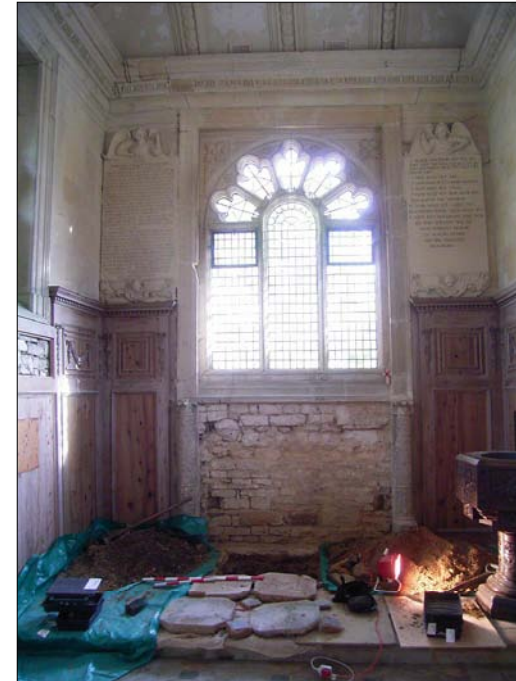
Plate 14: Trench 11 location within the Lenthall Chapel

- 4.4.19 Trench 11 was excavated within the late 17th century Lenthall Chapel to investigate an earlier stone structure partly overlain by the chapel and visible outside the building beneath the southern wall.
- 4.4.20 No structures were observed within Trench 11, and the earliest recorded deposit was (1107) a possible ground surface, which contained a single sherd of 12th/13th century pottery. This deposit was possibly equivalent to layers (107/115/128) in Trench 1. Layer (1107) was overlain by a series of deposits associated with the building of the Lenthall Chapel, (1106), (1105) and (1104). Layer (1104) was cut by a modern service trench (1103) and sealed beneath the current ceramic tiled and stone flagged floor (1101) of the chapel (**Figure 9, Plate 15**).
