Groby Old Hall Groby, Leicestershire

Archaeological Evaluation and Assessment of Results

SCHEDULED ANCIENT MONUMENT 17066

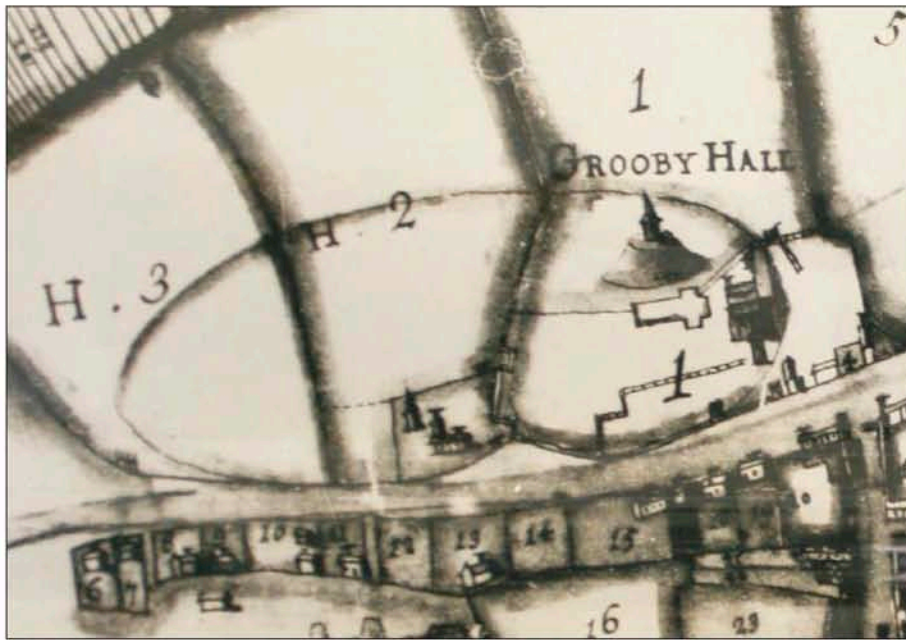
Plate 1: Detail of 1757 map by John Doharty (ROLLR PP443)

- 7.7.1 Despite the Leland reference (Smith 1907, 17) to the demolition of the keep, a tall building with a pitched roof is clearly shown on the 1757 map on the summit of the motte (**Figure 2, Plate 1**). An engraving in Nichols (1811, 634) dated to 1790 shows a squat and substantial structure on top of the motte, although in contrast to the map no pitched roof is visible (**Figure 2, Plate 2**). Neither Trenches 1 and 4, nor the earlier excavation, found any evidence of a later structure, although Davison in the 1960s did suggest that the apparently flat and level top to the inner wall could provide a base for a timber superstructure. The 1790 engraving also shows the ruined chapel with the south-west corner largely surviving. Apart from the known upstanding remains, no other structures are visible, although the mid-ground shows a number of suggestive lumps in the field. At the far right of the picture is the boundary wall shown on the 1757 map, confirming that the south-eastern extent of this was a low wall. The upstanding part today is likely to be the portion visible just beyond the gate. It is not clear whether the south-eastern part of the wall was ever more than a boundary feature. However, the incorporation of sandstone quoins into the brick tower to the south-east implies that this feature pre-dates the late 15th century building phase (ULAS 2009b, 7).

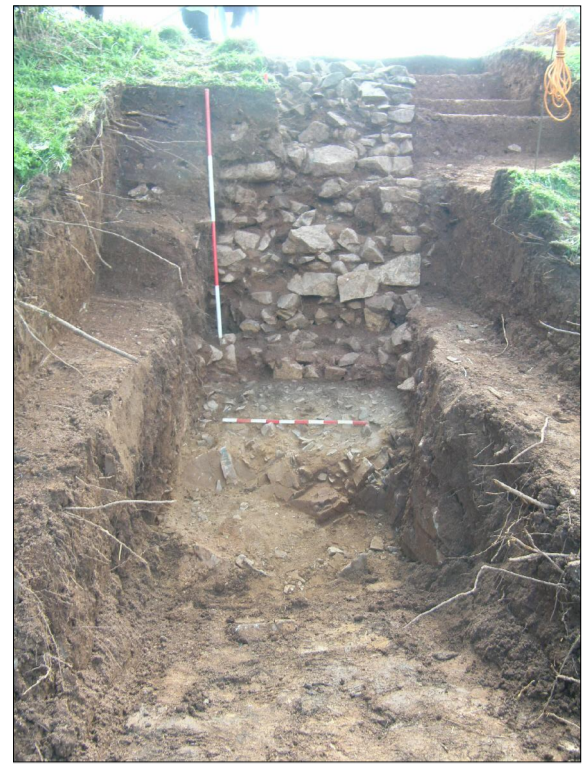
Plate 4: Wall 105, disturbed by quarry cut 110, from the north-east

- 4.3.6 A large, stone-built, north-east – south-west aligned wall (105) was located, 2.6m high and built upon a rubble foundation (109) which directly overlay the natural regolith (108), or weathered bedrock (**Figure 4, Plate 4**). Built up against this was the material for the motte, (103) a mid red clay. Excavation in Trench 2 showed this to be re-deposited natural boulder clay which overlay the bedrock.

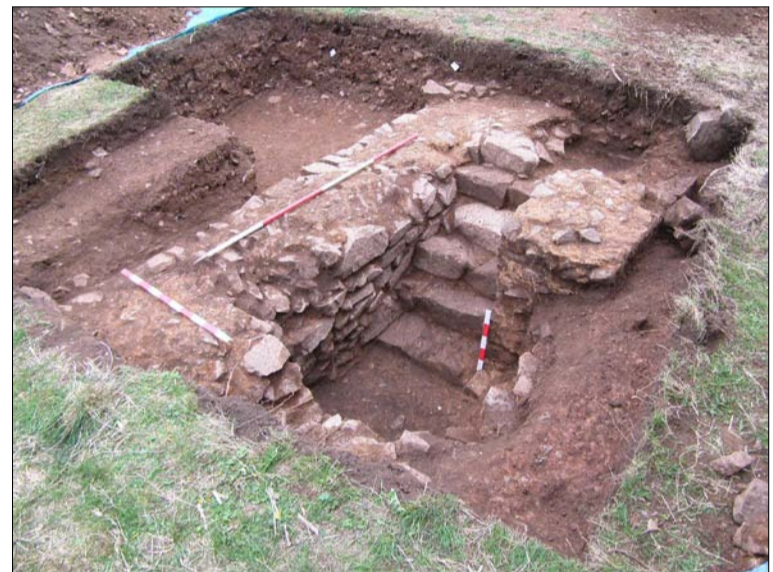
Plate 5: Stairs 412, outer wall 410 and inner wall 409, from the east

- 4.3.8 Trench 4 was positioned to re-locate the stairway found in the 1960s excavation and to extend and confirm the 1960s findings.
- 4.3.9 The original 1960s excavation trench was situated on the eastern part of the summit of the motte (see **Figure 1**). This was located and numbered as (403), and modern material was obtained from its backfill (404).

- 4.3.10 In addition to the wall and staircase identified in the 1960s, what was originally believed to be rubble composing part of the motte makeup was found to compose a larger outer wall (410), the southern return of that identified in Trench 1 as (105). The staircase (412) was built into the fabric of this outer wall, but only abutting the inner wall (409) (**Figure 4, Plate 5**). There were some differences between the two walls, the blocks used in (409) being generally smaller, the overall width much less and the mortar more flush with the stonework. No stratigraphic relationship between the two walls could be established, they abutted each other at the south-eastern end of the trench.

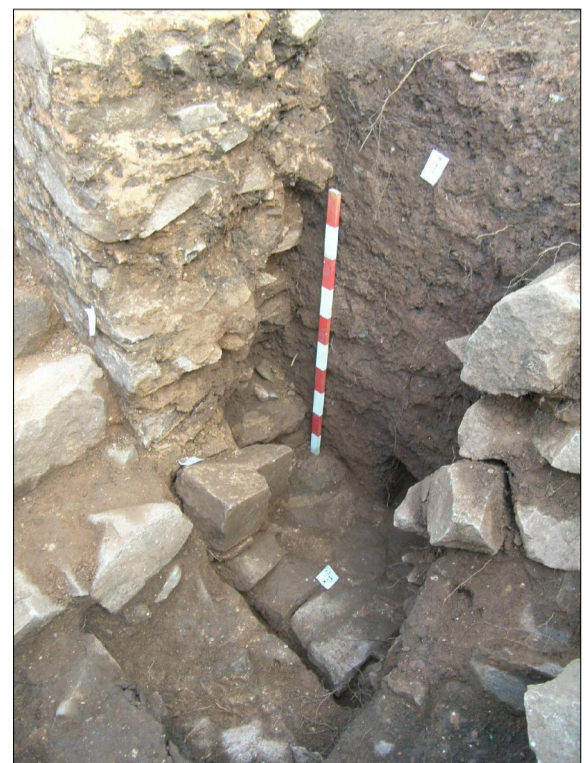
Plate 6: Doorway within 409 after removal of 406

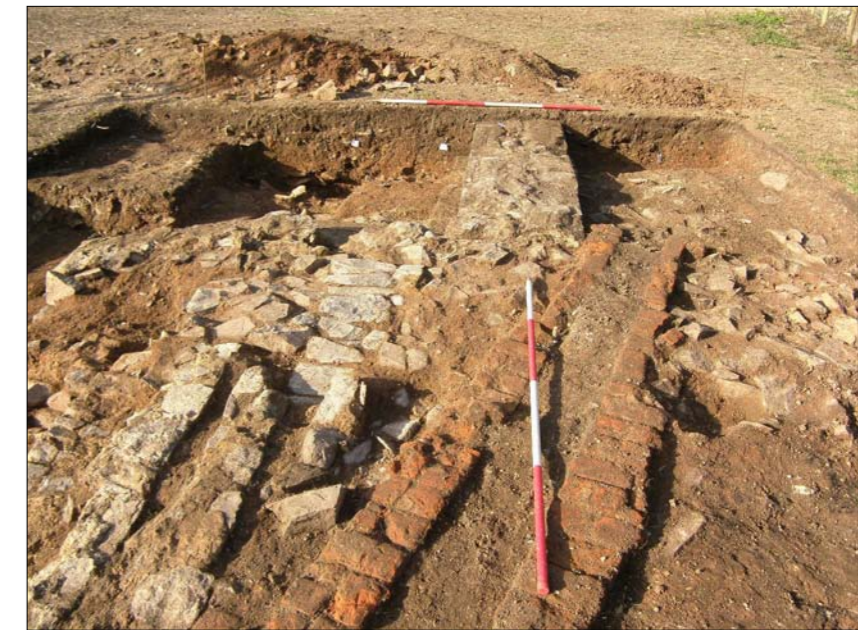
Plate 11: North-east facing section Trench 5

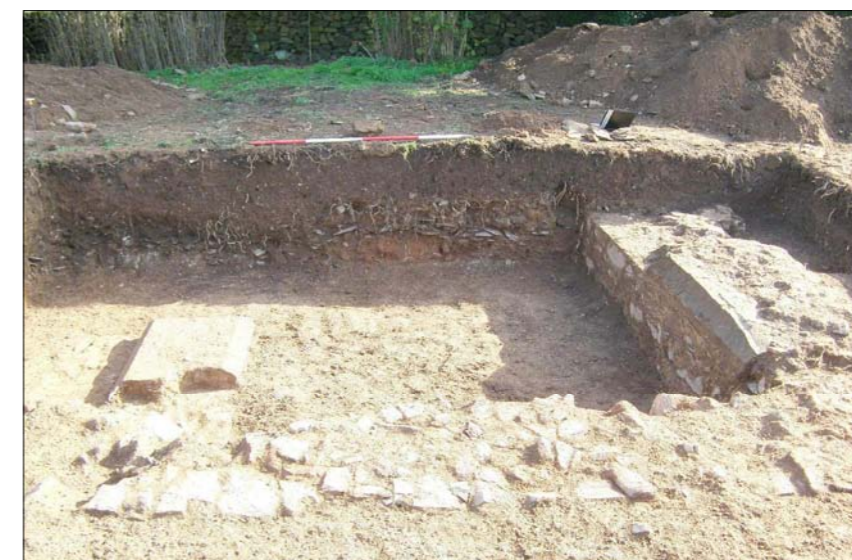
Plate 13: South-west facing section Trench 6

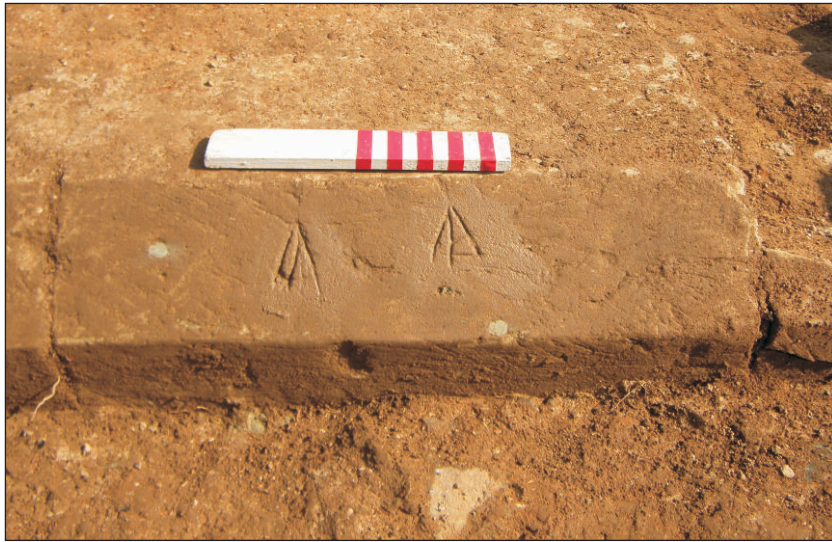
Plate 15: Two of the masonry marks on plinth 605

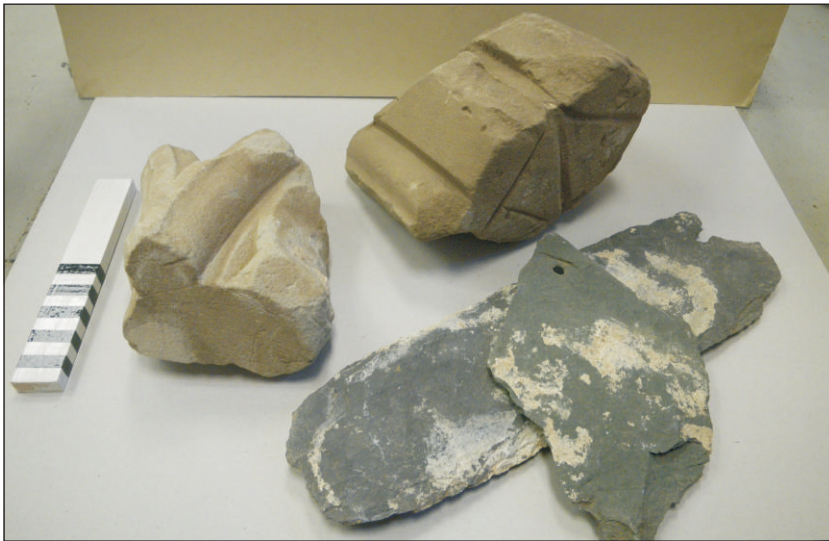
Plate 16: Fragments of architectural mouldings from 620, roof slates from 604

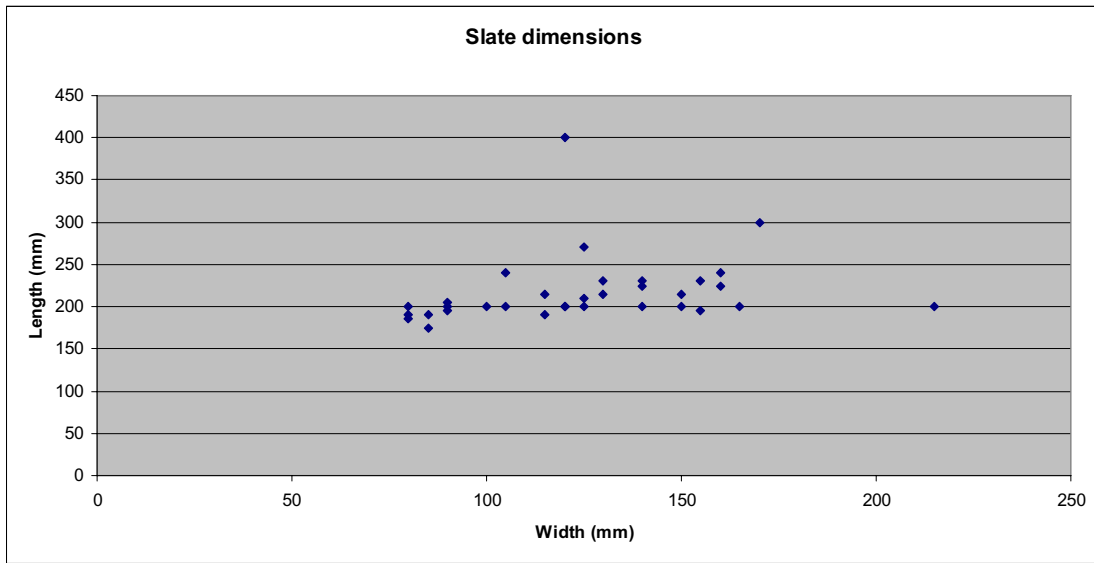
Figure 11: Chart showing stone roofing slate dimensions

- 5.4.4 Of the 112 slates collected, 75 had at least one complete original dimension (usually width). All appear to have been top-hung slates, and many had broken across the peg hole at the top. There is a substantial variation in slate size – widths range from 80mm to 215mm, and lengths from 185mm to 400mm. Within this range, and for those slates that have both surviving dimensions, there do appear to be certain discrete sizes, for example a small, narrow slate (width 80-105mm; length 185-200mm), and a long, narrow slate (one example, 120mm x 400mm), but between these extremes lies a continuum (see **Figure 11**), with lengths concentrated between
