National Horse Racing Museum  
Newmarket, Suffolk

Archaeological Evaluation and Assessment of Results

**Ref: 77506**  
**April 2013**

# KING CHARLES II ROYAL PALACE AND STABLES, NEWMARKET, SUFFOLK

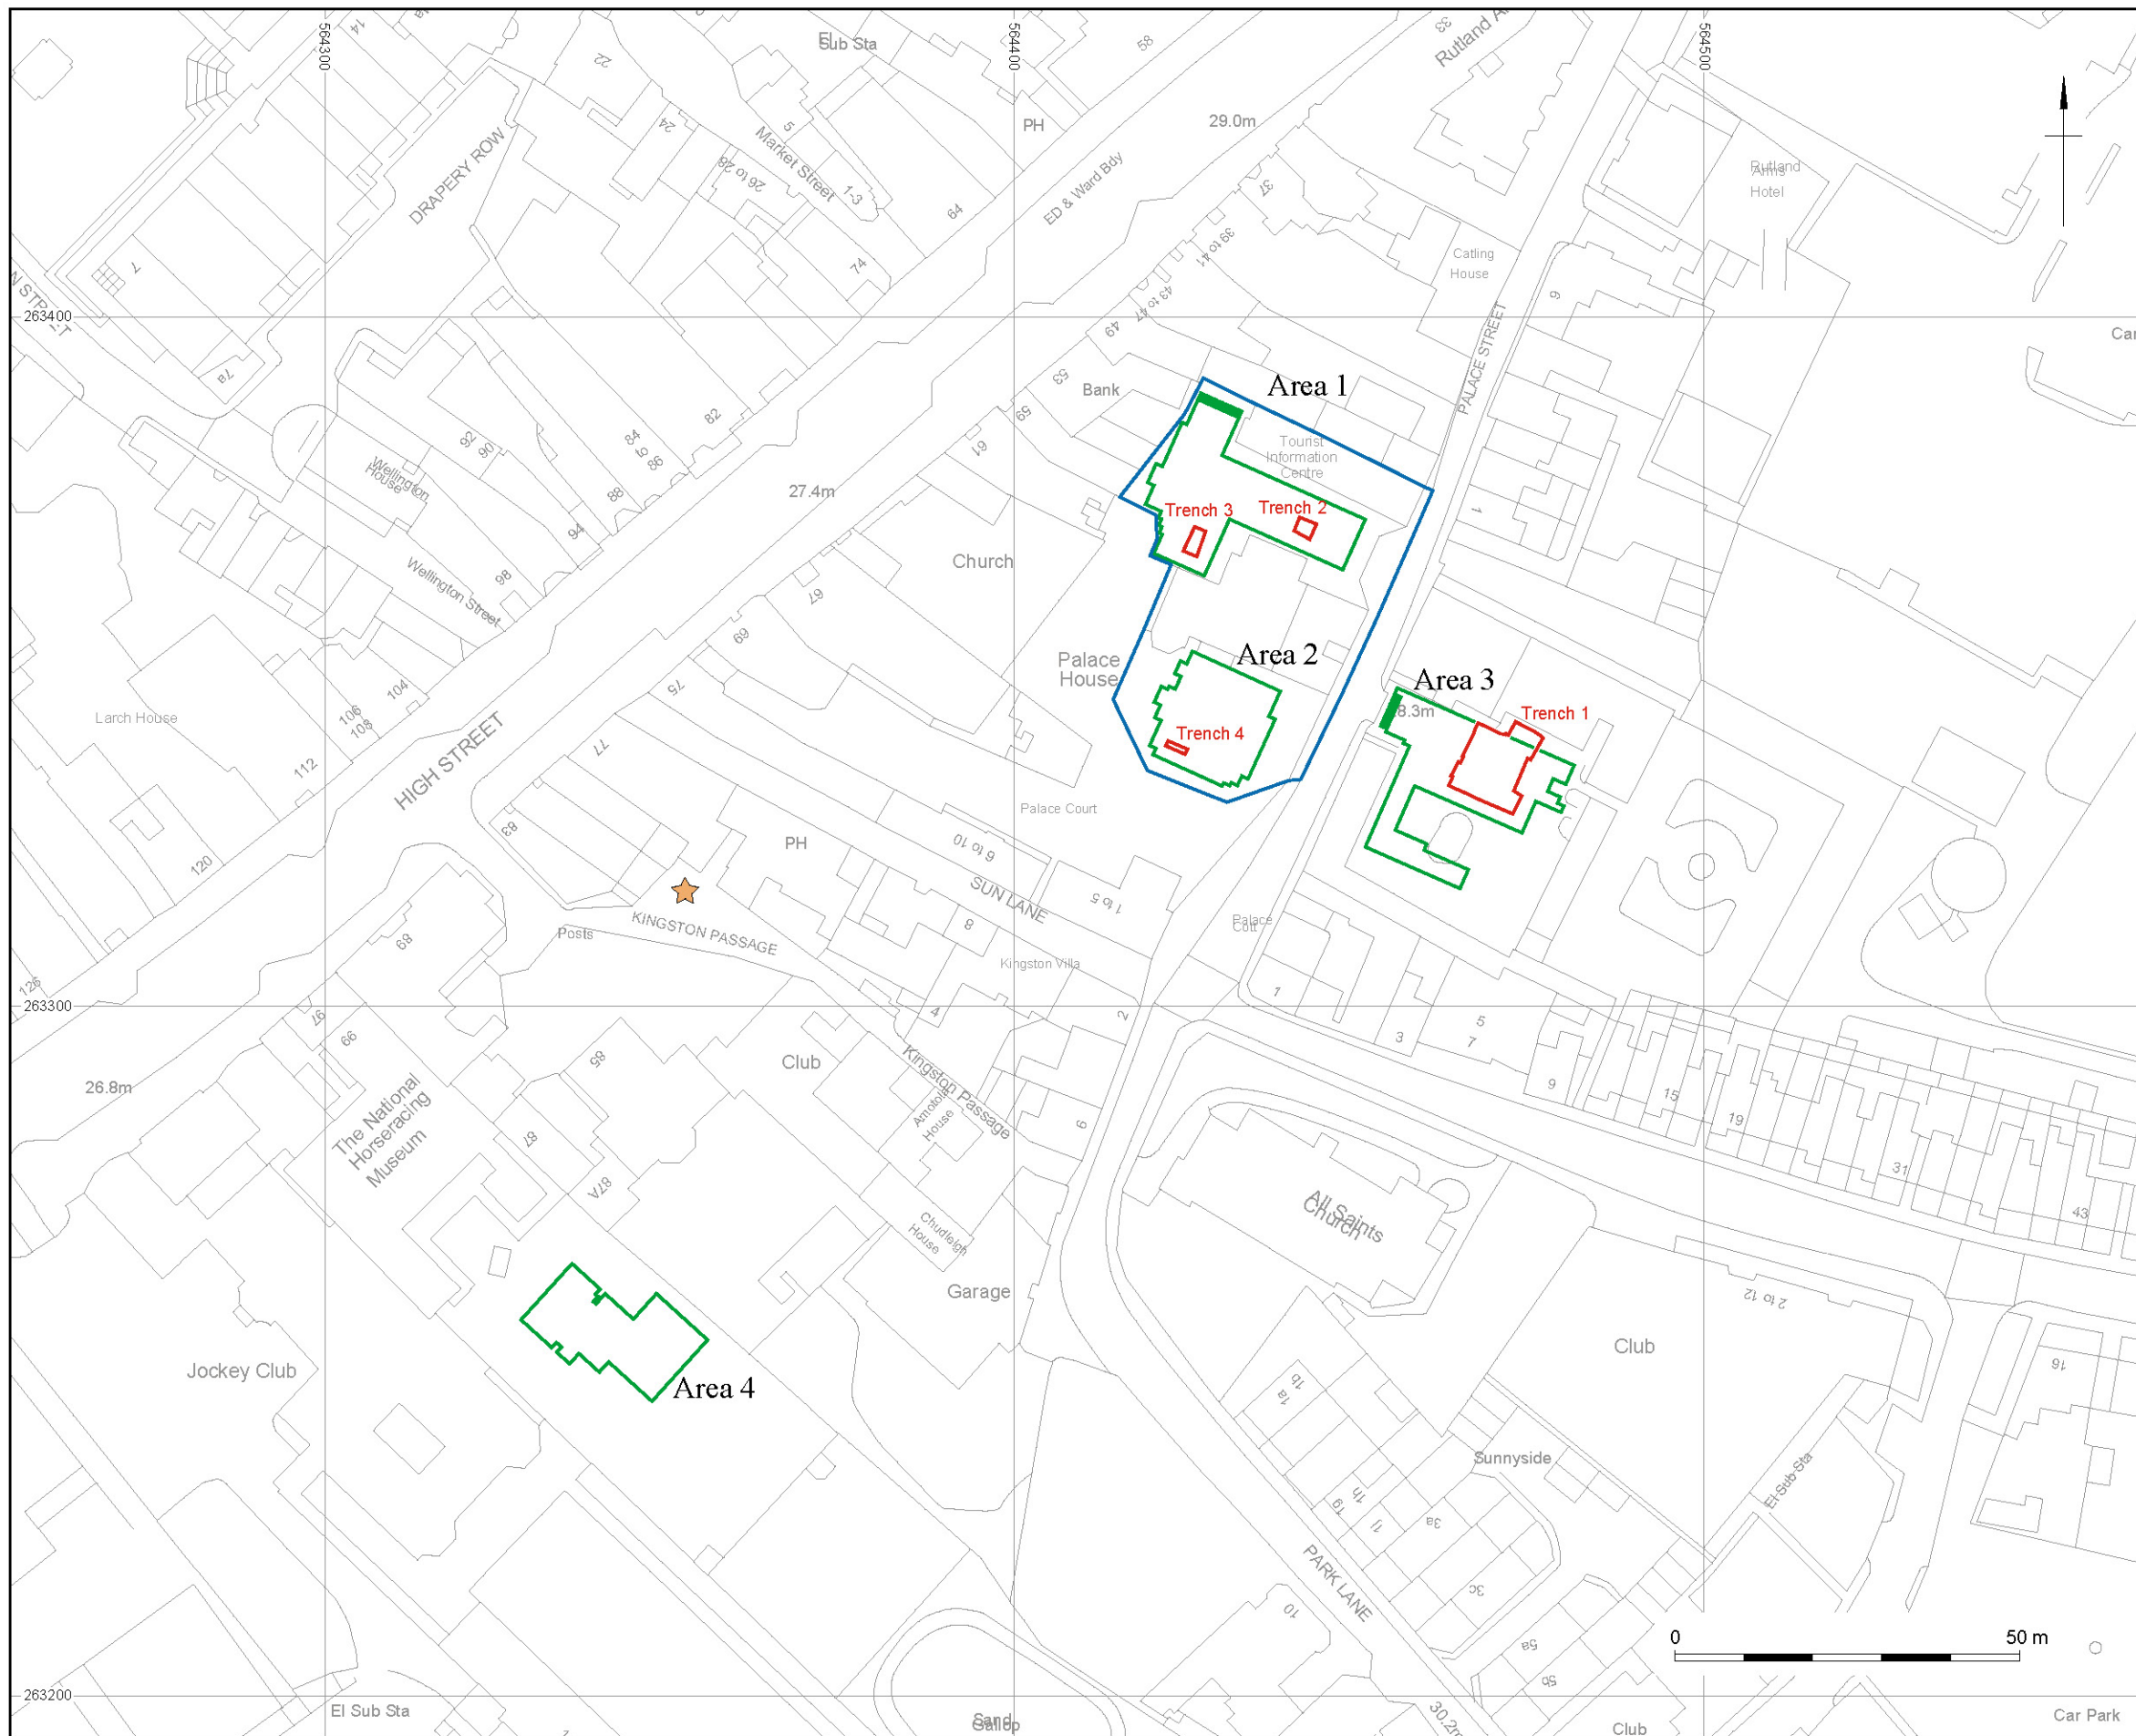
Figure 1

- ▬ Evaluation trench
- ▬ GPR survey area
- ▬ 1996-1997 excavation area
- ★ 'Old Kings Yard' on Chapman's map (1787)

Site location plan

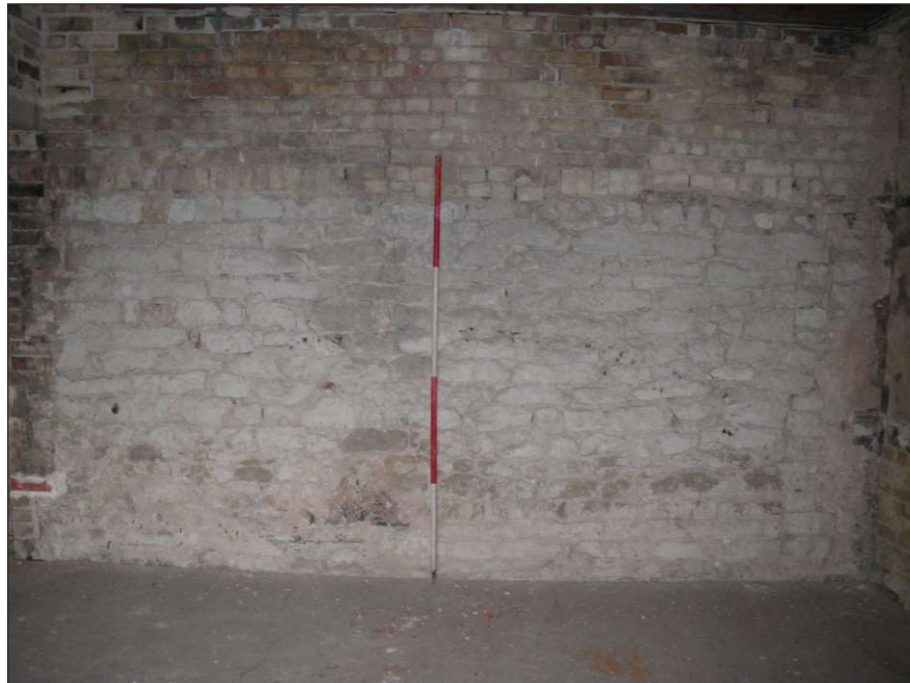
Plate 1: Reuse of northern stable wall within later trainer's house

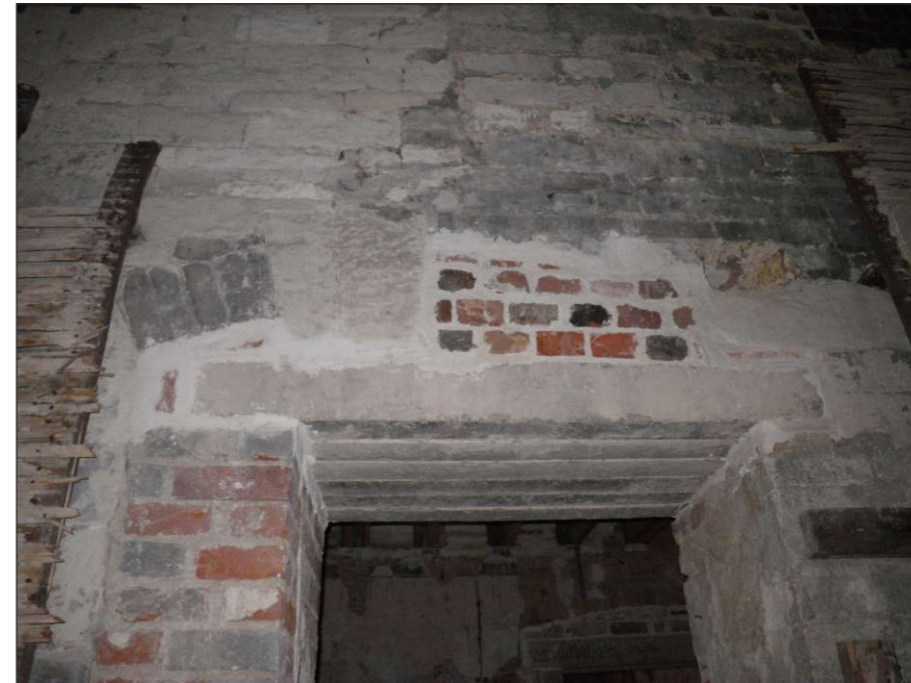
Plate 2: Reuse of remnants of voussoir windows from original stables

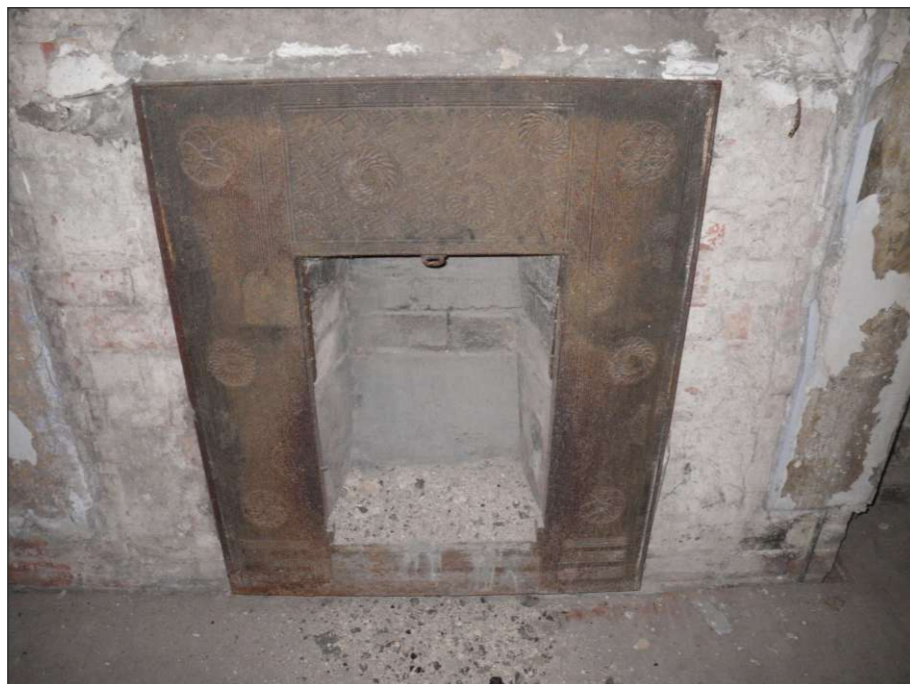
Plate 3: Thomas Jekyll design fireplace c. 1870, in Trainer's House

- 5.3.3 The Public Health Map of 1850 confirms the presence of the stable blocks. However, by the time of the 1886 Ordnance Survey map the stable block had been replaced by a house (the Trainer's House). These dates are confirmed by the presence of a fireplace within the eastern first floor of the building which is a Thomas Jekyll design produced by Barnard, Bishop and Barnard of Norwich c.1870, and which appears to have been part of the original build of the Trainer's House (**Figure 4: Plate 3**).

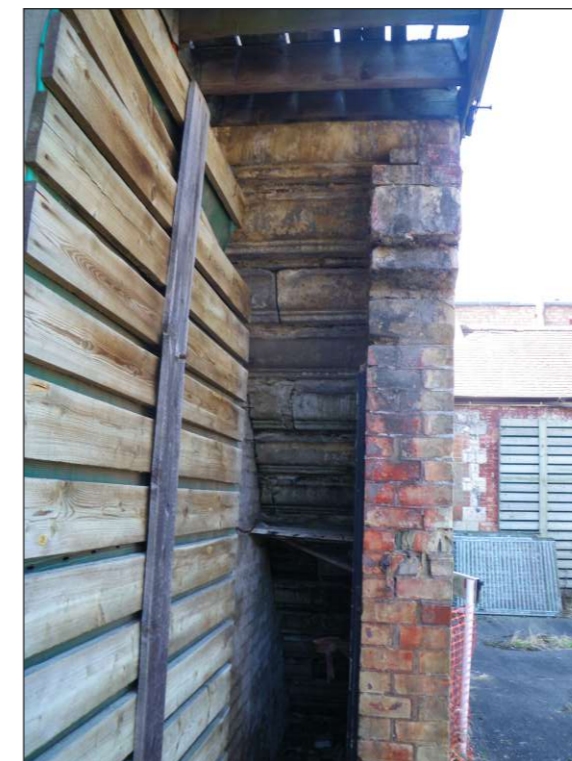
Plate 4: Moulded stone pieces reused within staircase on outside of later stable block

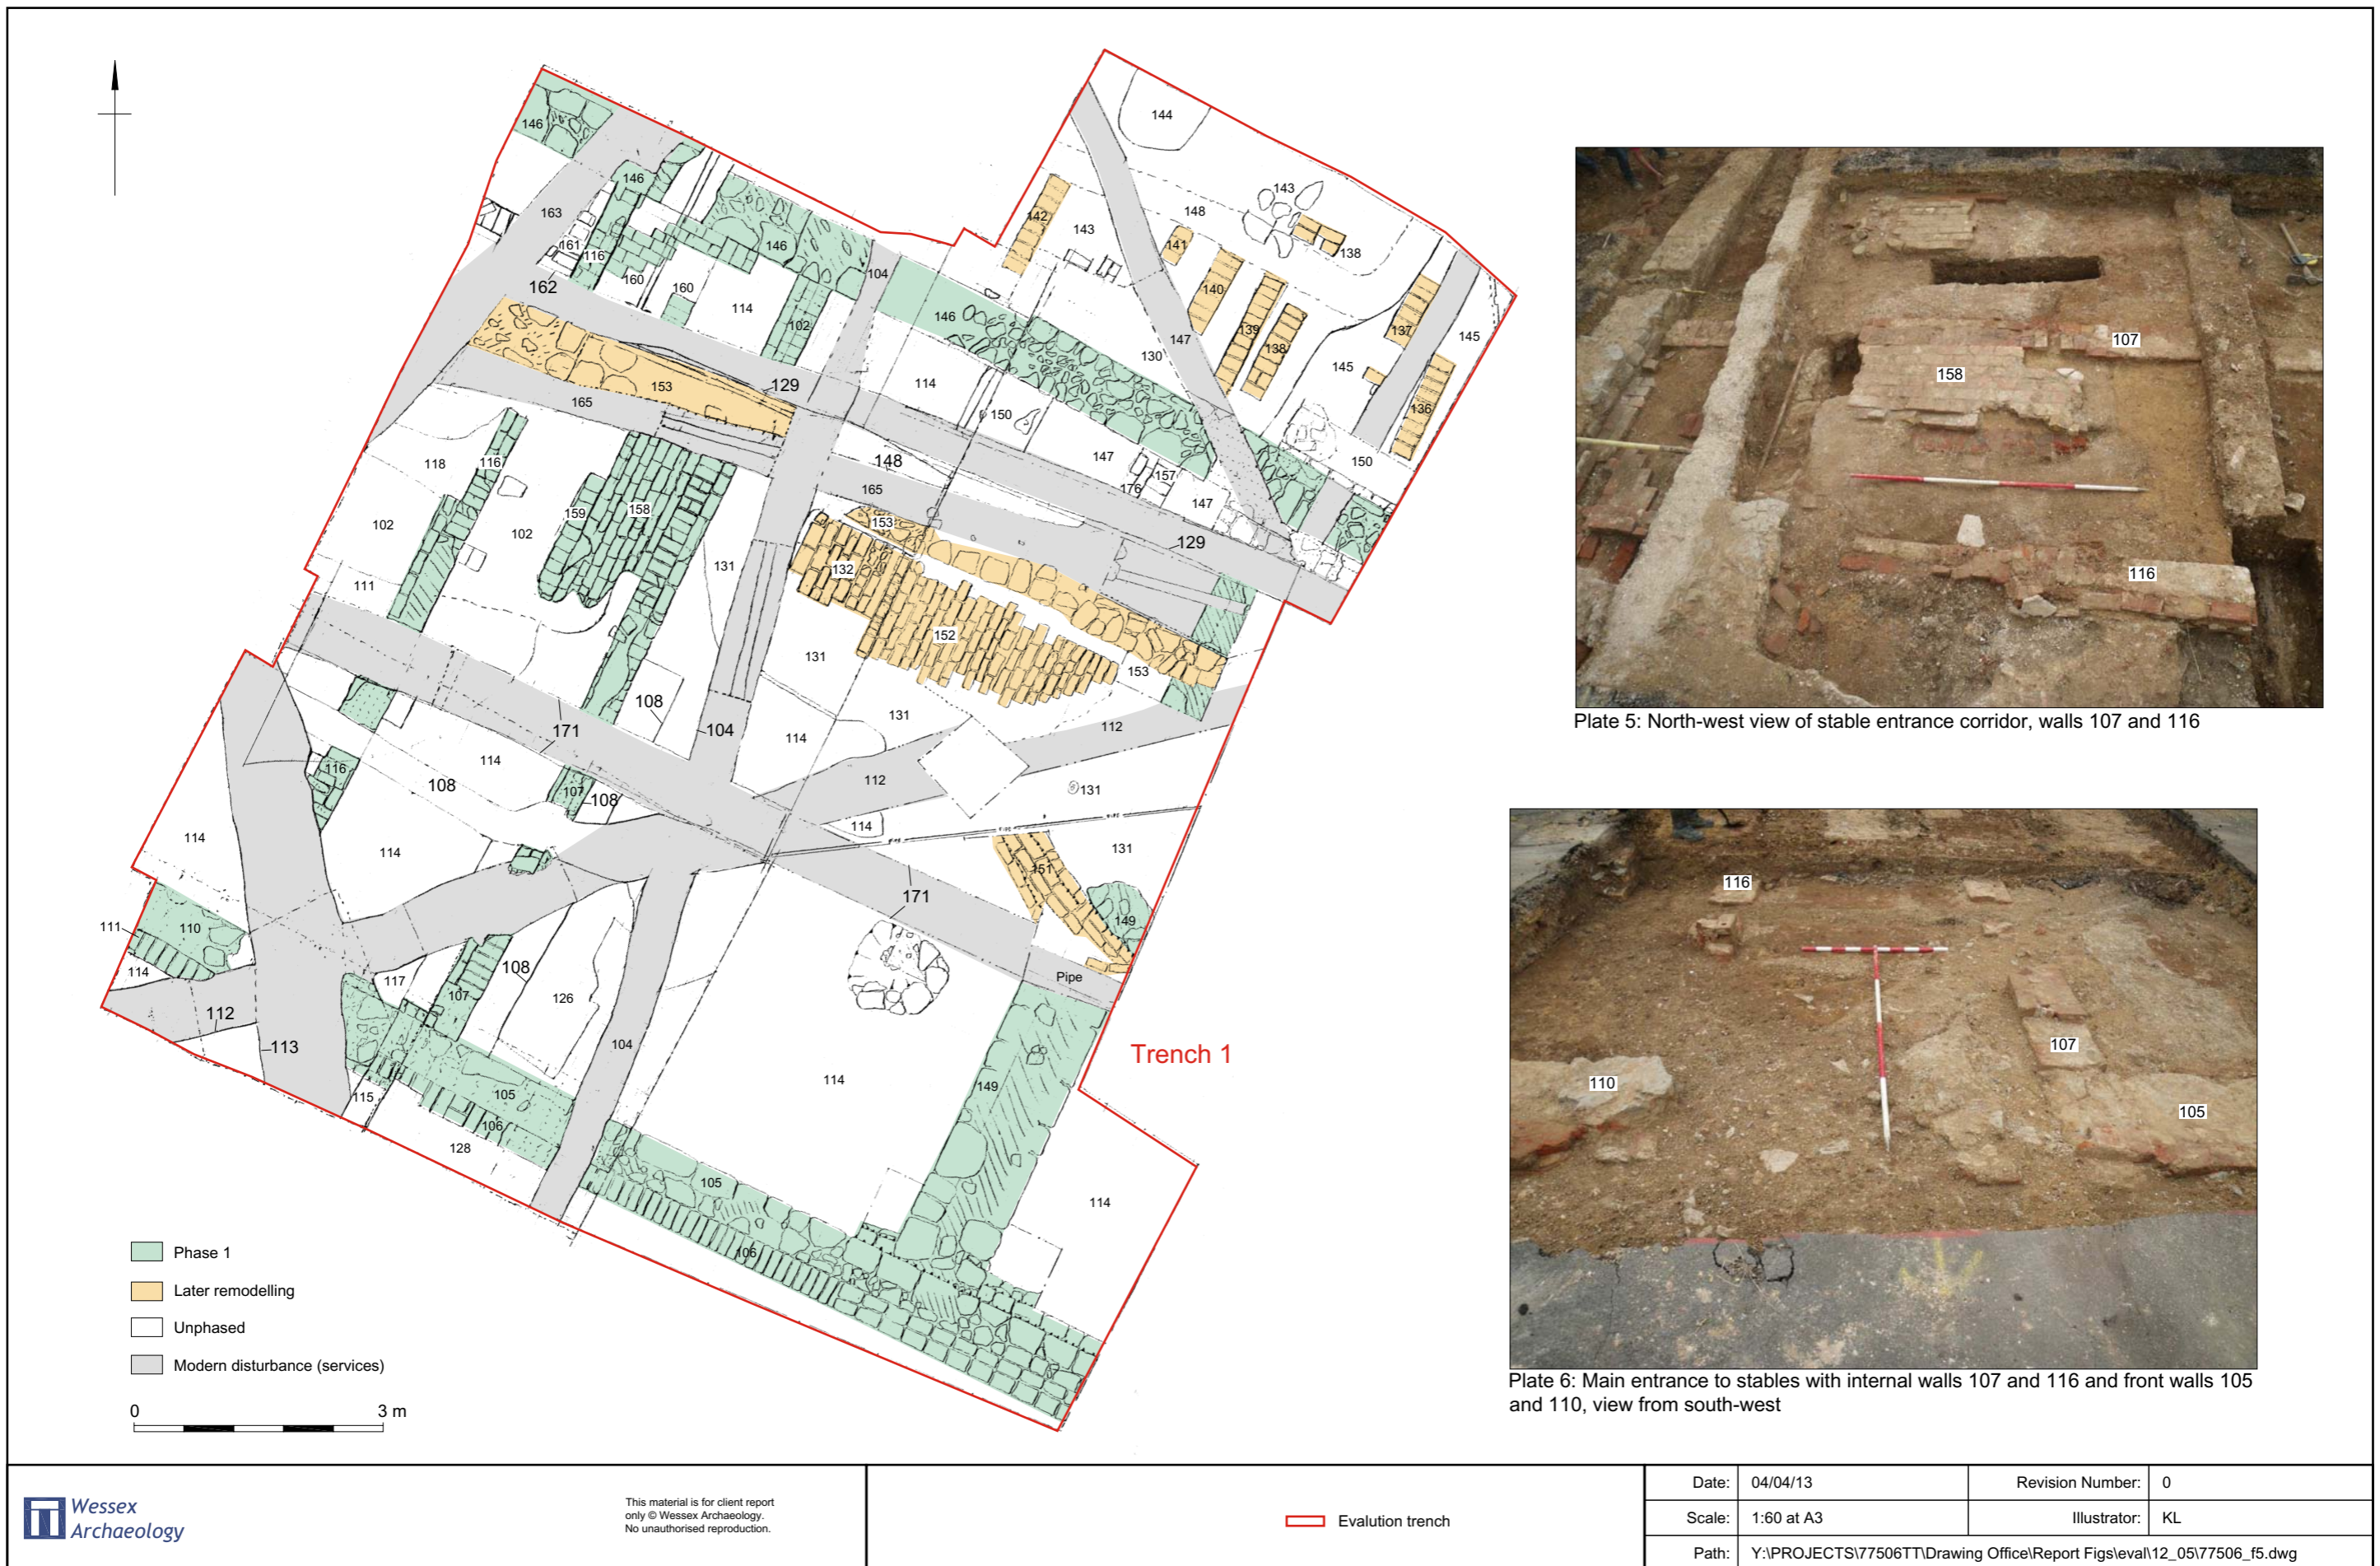
Figure 5

Trench 1: plan and photographs

- 5.4.3 The outside wall of the stables, facing the stable-yard, had a foundation comprising roughly square-cut clunch blocks with no bonding (**105/110**), but its importance as the front wall and location of the main entrance was shown by its brick facing (**106/111**). This would have been an imposing two-storey frontage.

- 5.4.4 The central wall (**146**) of the stables was exposed along the northern edge of Trench 1, oriented north-west to south-east. This wall was also clunch-built, and formed the 'spine' on to which the two rows of individual stalls would have backed, although no traces of the individual stalls themselves were observed.

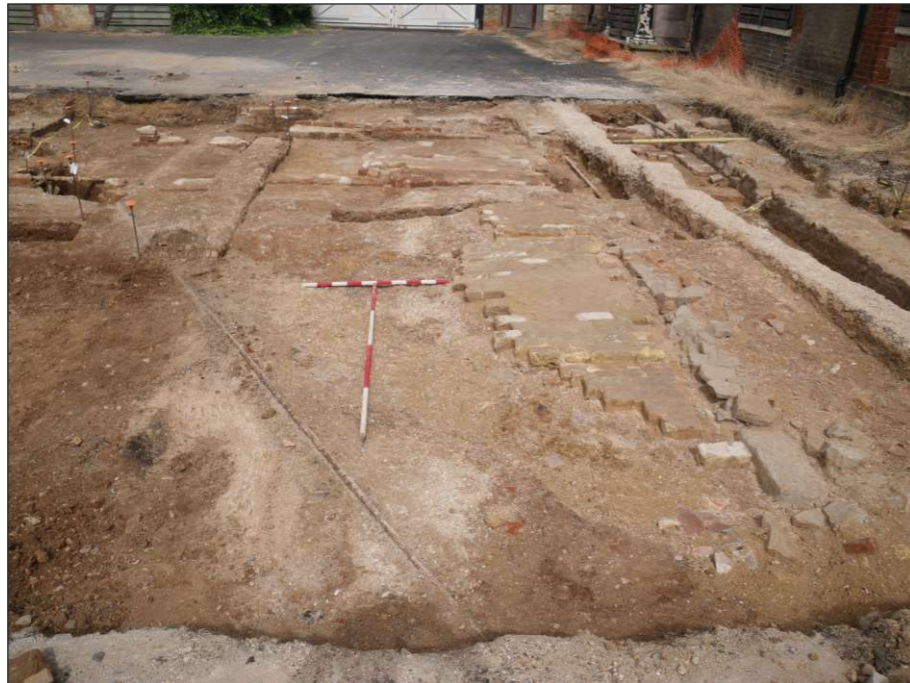
Plate 7: Trench 1, second phase stable renovation, internal floor 152 and clunch wall 153, view from south-east

- 5.4.10 A subsequent phase of renovation work took place within the stables. A yellow brick floor (**152**) was laid, consisting of a single layer of bricks. Within the floor area, individual stalls were denoted by lines of red bricks, indicating that each stall was c. 1.7m wide. This appears a little narrower than the stalls marked on the 1740s plan, which seem to be closer to 2m wide (see **Figure 2**). The floor was laid on top of an area that had been robbed out and backfilled with demolition rubble (layer **131**). A single piece of pottery was found within the demolition layer which dated the layer no earlier than the 19th century. The dating is confirmed by the bricks used for the flooring, which were possibly London Stock.

152	Floor	Yellow brick floor; part of 19th century stable remodelling. Red bricks denote stall edges. Single brick thick; lime mortared. Stalls 1.7m wide. Flooring survived for length of 3.30m by up to 1.0m wide. Lay on top of bedding layer 166 and beneath that levelling layer 131.	0.10m high
153	Wall	Clunch wall, E-W aligned. Occasional brick inclusions. Poorly made, degraded mortar mixed with rubble debris with lots of voids; reused material. Belongs to 19th century remodelling phase. Respected alignment of floor 152; recorded length 8.00m; approx. 0.5m wide.	0.55m high
155	Fill	Light yellow-brown silty sand; fill of unexcavated feature 156.	-
<b>156</b>	<b>Cut</b>	<b>Unexcavated subrectangular feature, truncated to south by service trench 162. Relationship to central wall 146 unclear; could be robbed-out wall that abutted it or possibly truncated by the wall. Measured 0.63m by 0.61m.</b>	-

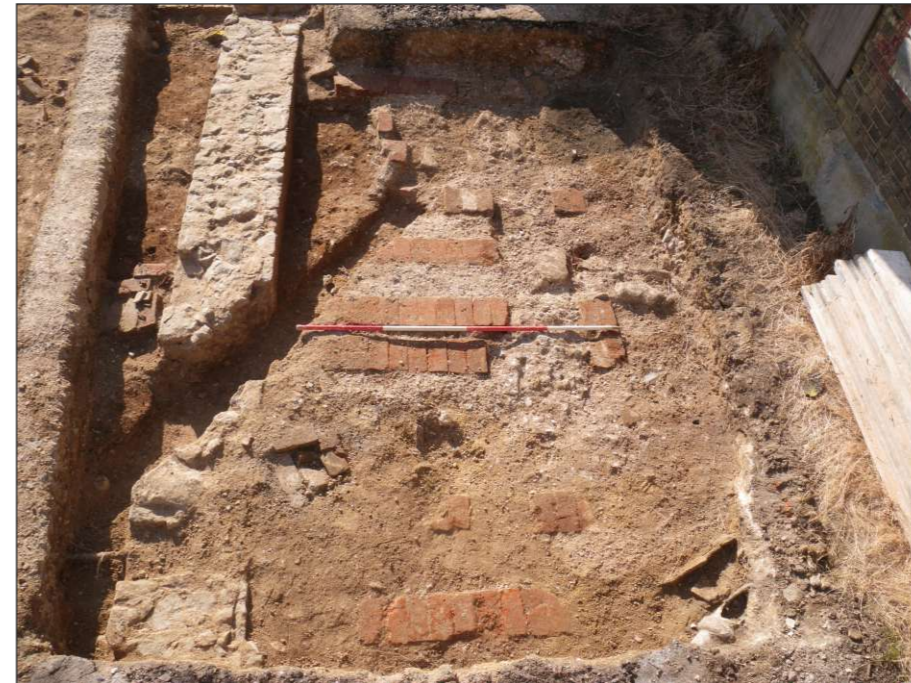
Plate 8: Brick pads 136–142 at north-east end of trench 1, view from south-east

- 5.4.15 Finally, a number of brick pads (**142, 141, 140, 139, 138, 137** and **136**) were recorded within the north-eastern corner of the trench (**Figure 6: Plate 8**). They appeared to have been laid in an area that had been excavated and then levelled (**145, 143**) with small pieces of building material, suggesting that the pads were a later addition to the building. The pads varied in length, but only because of truncation by modern services. They were one brick wide, and no mortar was observed on the upper surfaces, suggesting that they were never built up any higher; their function remains unclear. They were stylistically similar to each other but were unequally spaced.

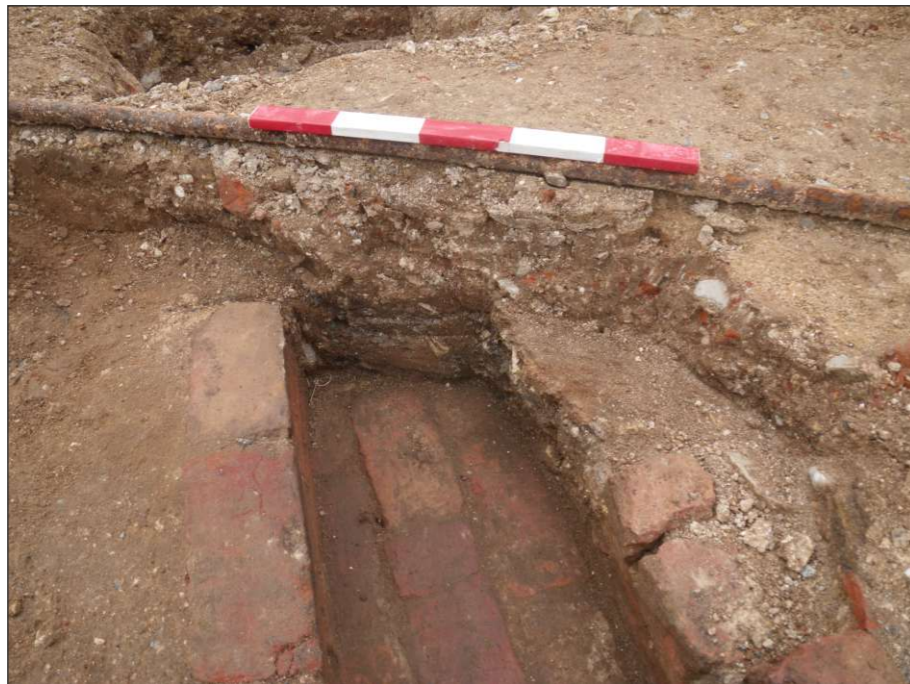
Plate 9: Trench 1, stable drain 151, view from south-east

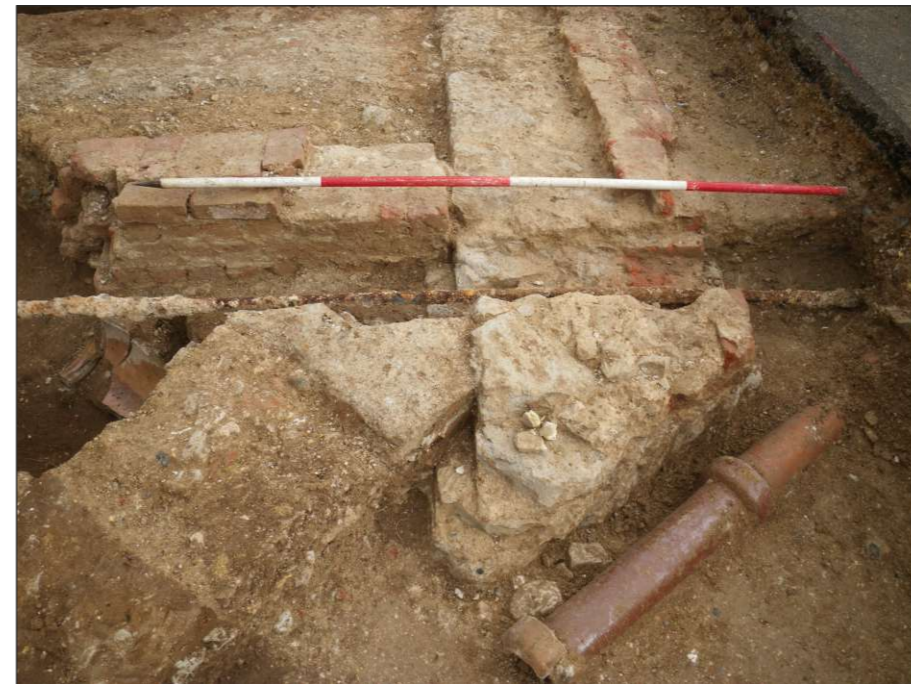
Plate 10: Trench 1, north-west view of walls 105–107

106	Wall	Red brick facing for wall foundation 105. Header coursing, although some bricks are aligned N-S and others have been split; two halves have been split and two halves mortared together in E-W alignment. Bricks 3 courses high.	0.20m high
107	Wall	Internal partition wall, red brick, heavily truncated by services. No clear bond changes, depending on the part of the wall. Lime mortar.	0.39m high
<b>108</b>	<b>Cut</b>	<b>Square foundation trench for wall 107. Extends 0.5m from the E edge of wall. Cut comes to abrupt end at NE end, half way down wall length. Cut not visible on western side of the wall, as truncated by service trench 115.</b>	<b>0.25m deep</b>
109	Fill	Deliberate backfill of foundation trench 108. Mid yellow-brown sandy silt. Inclusions: clunch, occasional, small and subrounded; brick, small, occasional; pebbles, small and angular.	0.25m thick
110	Wall	Clunch foundation wall; same as 105. Carved into roughly square bricks. Lime mortared. Unclear coursing. Faced with red brick 111.	0.50m high

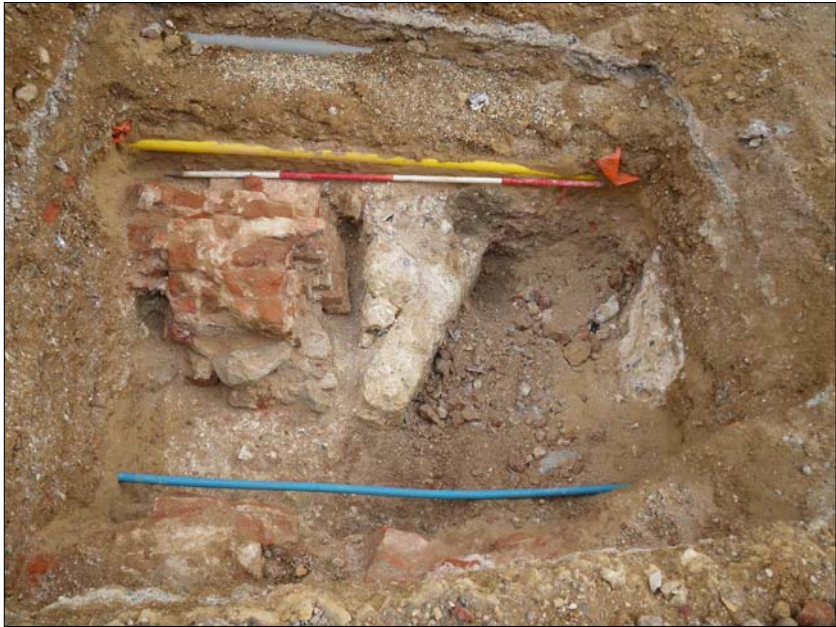
Plate 11: Walls 204, 205 and 206, view from north-east

- 5.4.17 The features within the trench had been severely truncated by later services (**212** and **208**) and a possible brick-topped culvert (**210**). Parts of three walls were recorded (**204, 205** and **206**; **Figure 6: Plate 7**). Red brick wall **204** was oriented north-east to south-west direction, and survived to a height of 0.5m; it sat on a footing constructed of clunch and broken bricks (**209**). The wall had been badly damaged by demolition and later service trenches.

206	Wall	Brick wall, aligned NE-SW, with brick footings; butted by wall 205 (possibly part of same wall as 205). Lime mortared; unfrogged bricks. Length 0.50m; width 0.70m; maximum height 0.50m.	0.50m high
207		VOID	
<b>208</b>	<b>Cut</b>	<b>Modern services, aligned east – west; length 2.47m within trench, and 0.4m wide.</b>	<b>Not fully excavated</b>
209	Structure	Footings for wall 204, consisting of clunch blocks and occasional broken brick fragments; lime mortared. 0.49m long and 0.92m within trench.	0.30m thick
<b>210</b>	<b>Cut</b>	<b>Cut of possible drain culvert, aligned NE-SW; not fully excavated. Undated.</b>	<b>1.02m deep</b>
211	Layer	Natural mid-white-grey chalk with flints. Flints <20mm, angular, poorly sorted.	1.02m thick
<b>212</b>	<b>Cut</b>	<b>Service trench, aligned east-west; length 2.24m by 0.56m wide.</b>	<b>1.40m deep</b>
213	Fill	Mid brown-white sand with flint inclusions, subrounded-sub angular, <100mm, poorly sorted, occasional. Contained demolition material, chalk, glass and roof tile,	Not excavated

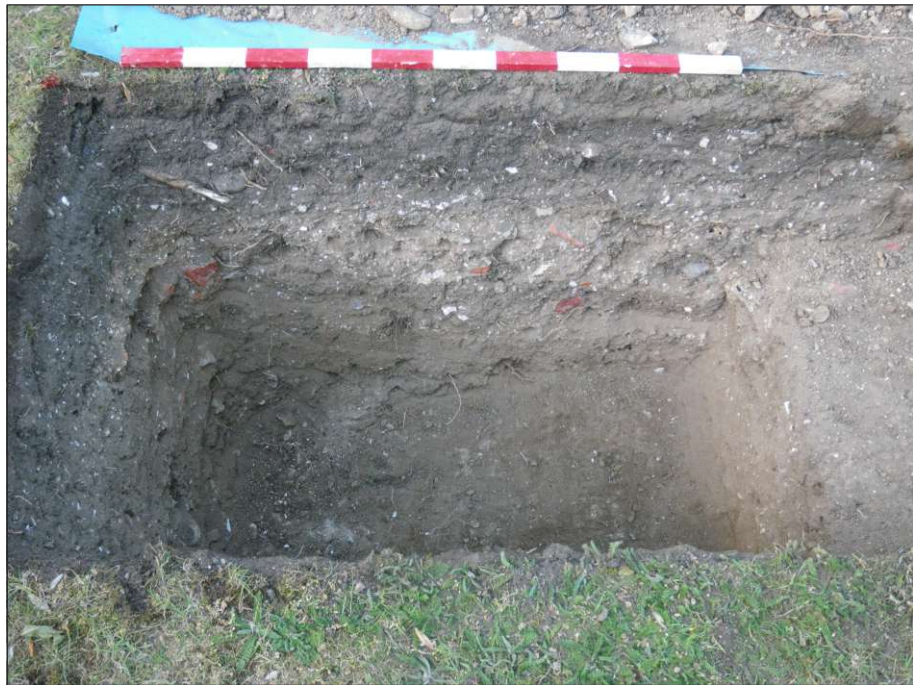
Plate 12: North-facing section of trench 4

406	Layer	Mixed deposit of mid-brown sandy silt and patches of light grey silty sand with occasional rounded flints, charcoal flecks and bone. Seemed to be deliberate backfill layer, but not excavated. Visible within sondage (0.9m) dug into trench.	0.78m+
407	Layer	Mid-brown, sandy silt layer with very occasional angular flint. Possibly the beginning of the backfill layer before reaching archaeological deposits.	0.6m-0.9m
