Plot 2 (Westover Group), Old Sarum Park, Old Sarum, Wiltshire

Archaeological Watching Brief Report

Wilts Council Planning Ref: S/2012/0423/FULL
Ref: 1009600.03
October 2013

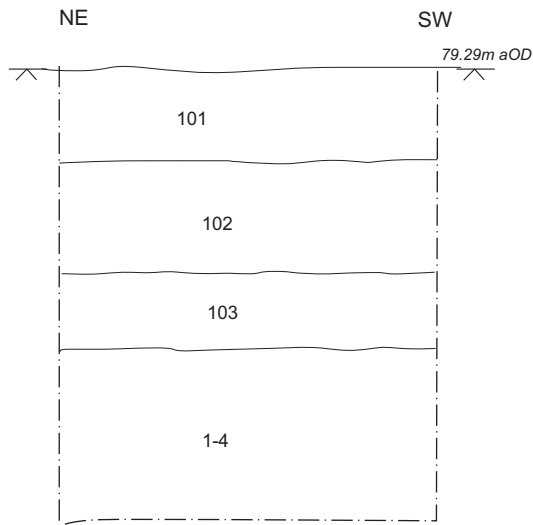
Section 1

North-west facing representative section of the northern half of the Site

- 4.2.2 The soil sequence of the Site can be divided into two distinct areas. Across the majority of the Site, excluding the south-eastern part of the foundation trench, there was a band of a pale brown silty clay containing common to abundant chalk inclusions, (layer **102**) (**Figure 2, Plate 1** and **Section 1**). This layer appears to be made-ground comprising of redeposited natural, used to build up and level the plot.

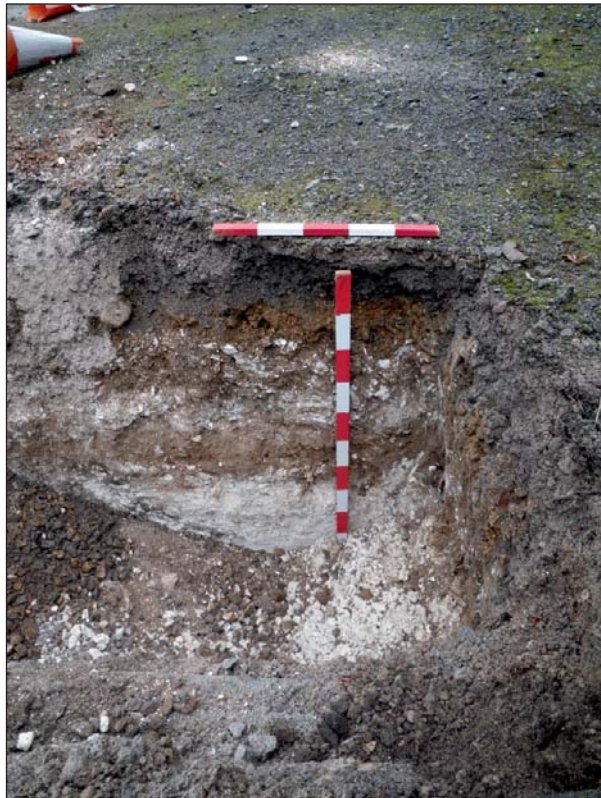
Plate 1: North-west facing section of the northern half of the foundation trench

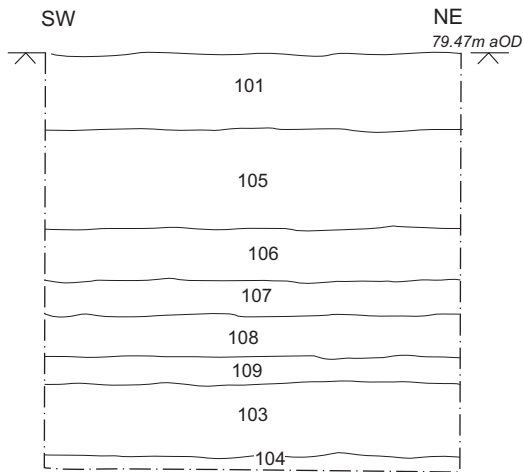
Section 2

South-east facing representative section of the southern half of the Site

- 4.2.3 The deposit sequence within the south-eastern part of the foundation trench (**Figure 2, Section 2**) was noticeably different to the rest of the site, as directly underneath the modern ground surface, demolition rubble (layer **105**) was encountered, which ranged in thickness from 0.20m to 0.50m. This demolition deposit originates from the final demolition of the RAF building which occurred in the 1970s or 1980s rather than construction, since layer **105** runs up and against the surviving sections of wall. Underlying this demolition rubble, a number of thin bands of modern deposits were encountered and which comprised of a band of 0.14m thick tarmac overlying a 0.09m thick band of hardcore material, possibly indicating a car park relating to the RAF building (**Figure 2, Plate 2**).

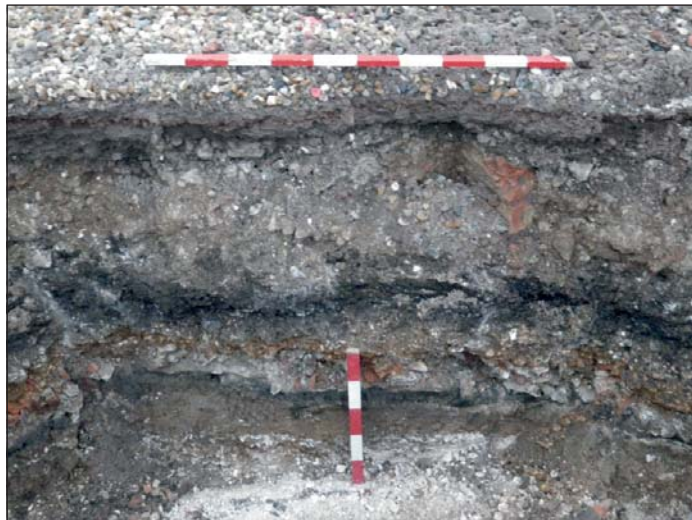
Plate 2: South-east facing section of the southern half of the foundation trench

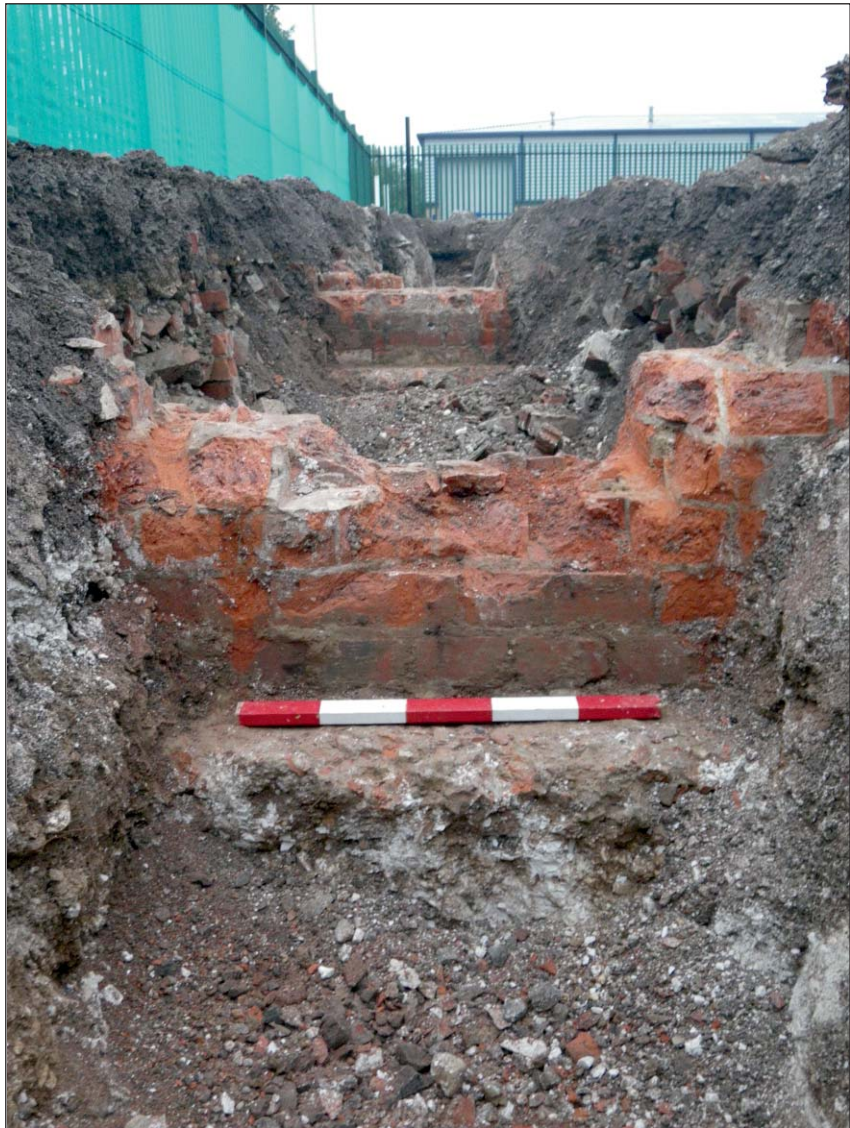
112	Structure	Wall – North-east to south-west orientated wall measuring 1.50m in length by 0.51m in width. Made up of a depth of 0.24m of concrete foundation with 6 courses of red brick (unfrogged but with holes through them) surviving in a regular coursing pattern and two courses of brick wide.
113	Structure	Wall – North-east to south-west orientated wall measuring 1.50m in length by 0.94m in width. Made up of a depth of 0.38m (0.91m wide) of concrete foundation with 4 courses of red brick (unfrogged but with holes through them) surviving in a regular coursing pattern and four courses of brick wide. Possible exterior wall.

Plate 3: Wall 112 viewed from the north-west

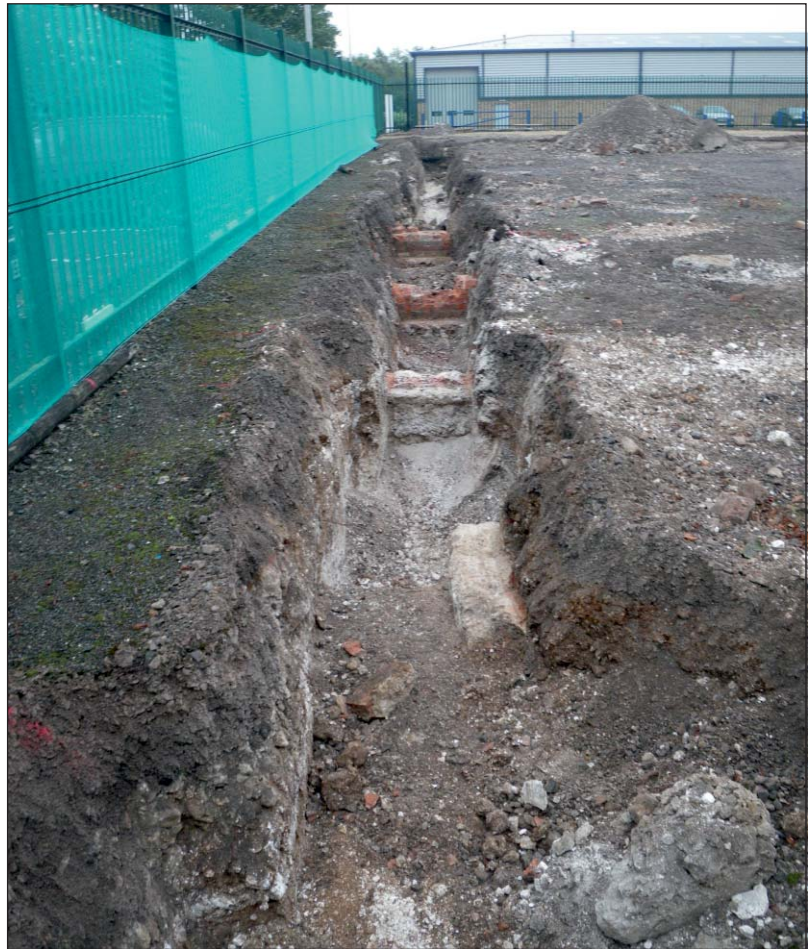
Plate 4: View of walls in the north-eastern foundation trench from the north-west

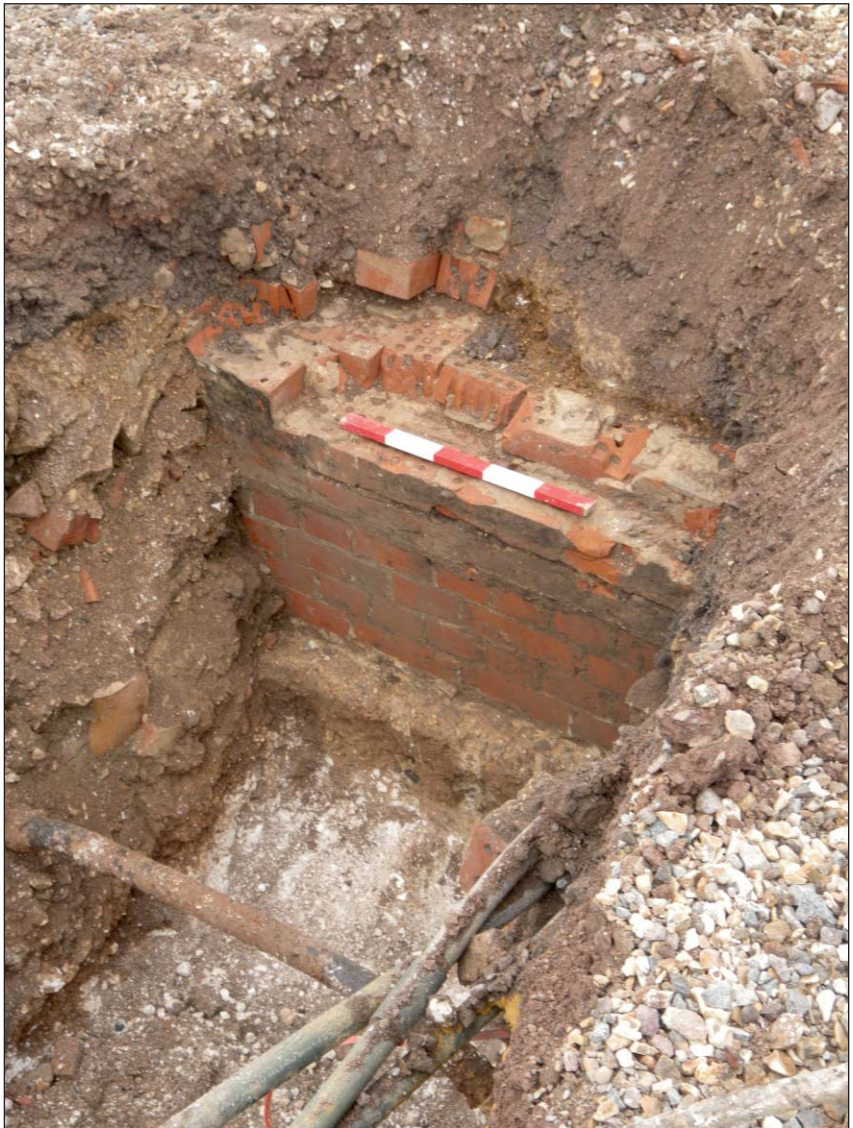
- 4.3.4 Walls **121** and **127** are the best indication of exterior walls and there location is approximately were one of the wings of the RAF building joins to the main building. While **127** only had four courses surviving and **121** had eight courses surviving, both are two courses wide and are constructed in the English coursing pattern. The reasoning behind these being exterior walls is that in addition to their thickness both have buttresses incorporated into them (**Plate 5**), suggesting that these walls would have been particularly substantial.

Plate 5: Oblique view of wall 121 from the east

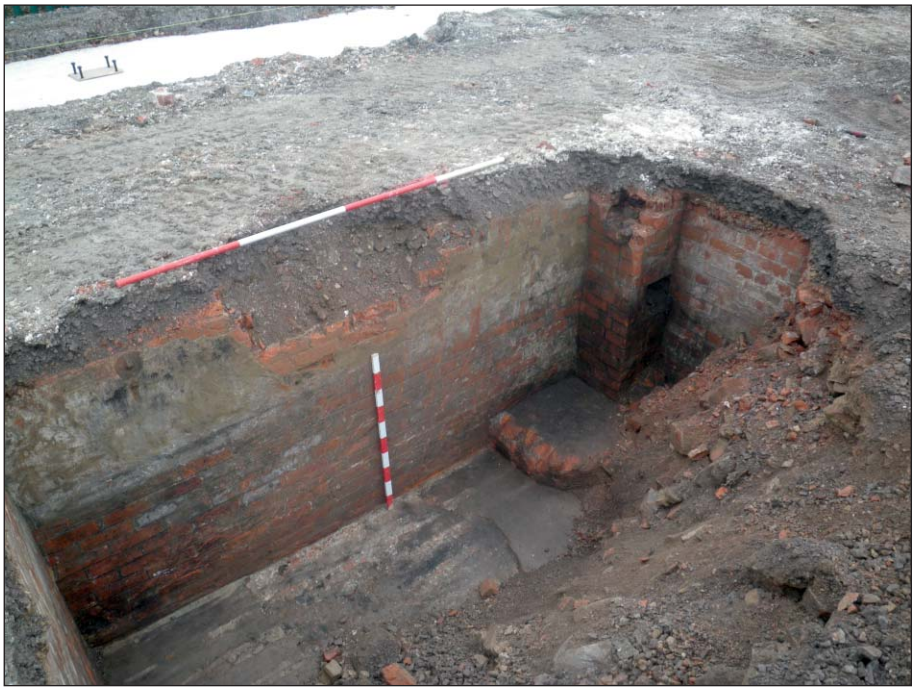
- 4.3.6 The basement room **160** was identified during the excavation of one of the interior construction pads. Measuring 3.35m by 2.45m (8.21 square meters) and in its present condition 1.43m deep it seems that the ceiling was removed during the demolition of the building and was then backfilled with demolition rubble (**Plate 6**).

- 4.3.7 After the footprint for the room had been dug out, a rough concrete foundation, **153**, was put down prior to the construction of the walls (**147, 148, 149, and 150**). These walls, surviving up to between 18 to 19 courses high, seem to be constructed in two different styles with **147** and **149** being of regular pattern and **148** and **150** being of English pattern. On wall **147**, there is evidence that the walls had a thin cement facing put onto part of the walls. This, in addition to evidence of fittings on wall **147** and **148**, suggest this was more likely to be a work room rather than associated with accommodation. In the eastern corner of **160**, a small square feature was identified, **151**. Bonded to walls **147** and **150**, this structure could represent a possible flue or chimney, with a metal lined square opening on the south-west facing wall of **151**, which was filled with soot.

- 4.3.8 One structure seems to have been added to **160** after the construction of the walls and possible flue. Made out of bricks, pad **155** is butted up against wall **147** and flue **151** and measured 0.65m by 0.65m and is 0.20m thick. This pad installation may have been associated with some heavy or bulky equipment. After the installation of pad **155**, a smooth concrete floor was put down within the room.

Plate 6: Room 160 viewed from the west
