Dynamic Bus Facility Chatham, Medway, Kent

Updated Archaeological Watching Brief Report:
Monitoring of the Services Diversion Trench Footprint,
Underpinning of the White House Foundations
and General Ground Reduction Below 1m

Report reference: 71184.03 and 71185.03

June 2011

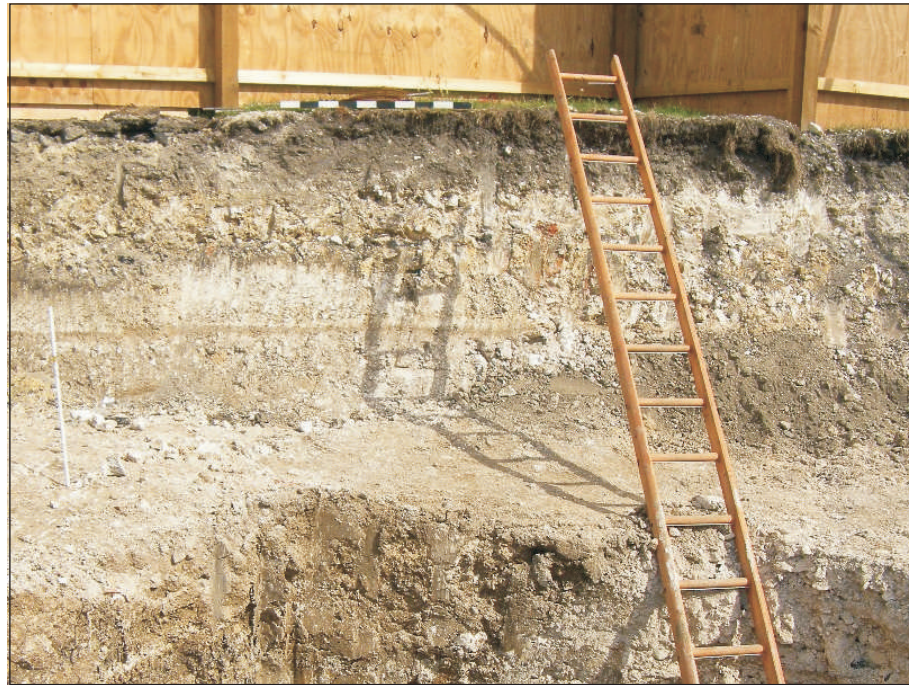
5.2.1 Topsoil, tarmac or paving slabs overlay the made ground deposits across the monitored area (**Figure 3, Plate 1**). The topsoil **101**, situated within the south-west and extreme north of the observed service trench excavations, comprised dark brown silt/clay/loam with sparse sub-rounded pebbles.

Plate 1: Stratigraphic sequence showing topsoil and made ground deposits

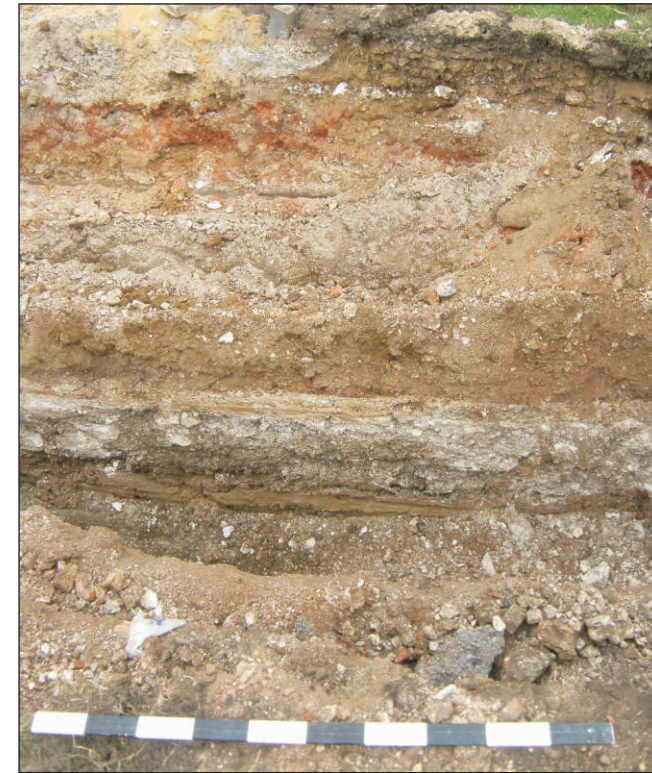
Plate 2: South-east facing section of trench showing made ground layers

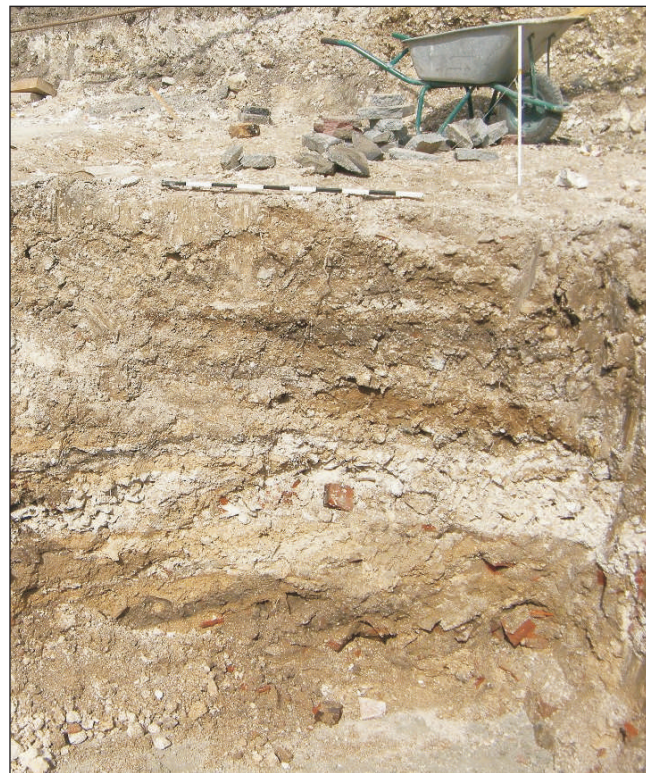
Plate 3: North-east facing section of value chamber excavation

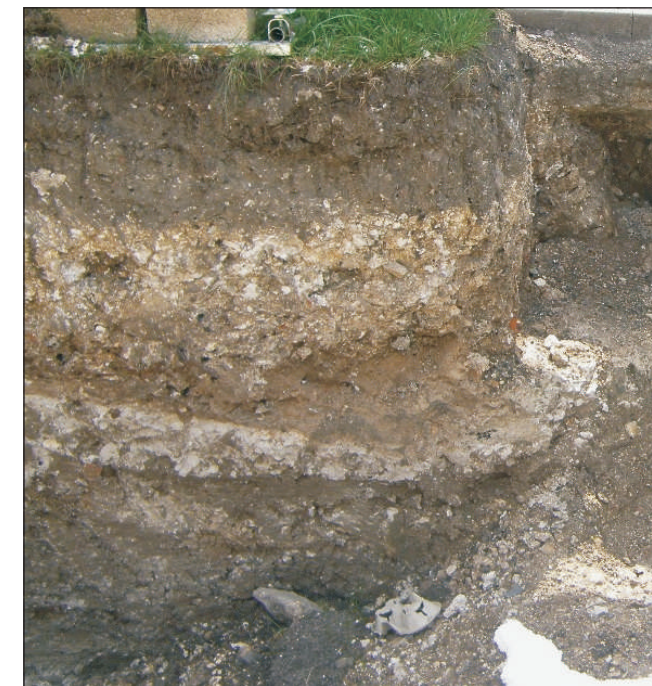
House foundations (layer **1002**, **Figure 5**, **Plate 9**). To the south of the pumping station, a layer of possible buried topsoil **134** was recorded (**Figure 3**, **Plate 4**). These layers are thought to be associated with the 19th century land reclamation and subsequent levelling. A similar made ground deposit (**1001**) was recorded inside the White House, beneath the floor level and is thought to have been formed during the construction of the building (**Figure 5**, **Plate 10**).

Plate 4: West facing section showing possible buried topsoil

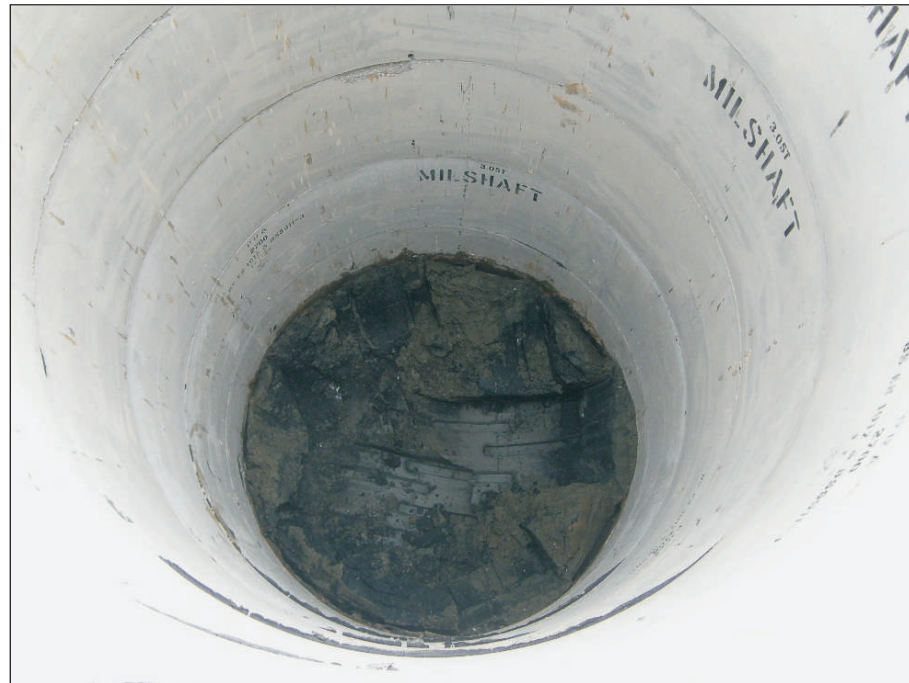
- 5.2.3 Finds observed within the deposits comprised brick and tile fragments, which were dated to the 19th and 20th centuries.
- 5.2.4 During the excavations for the installation of the pumping station, two layers of alluvium were observed to underlie made ground deposit **126**.
- 5.2.5 An orange brown sand/gravel deposit **127** was observed at a depth of 4.5m – 5.25m below ground level. It overlay a smooth black organic silt/clay alluvium **128** (**Figure 4**, **Plate 5**), recorded to the depth of 6m, at which the excavation ceased.

Plate 5: View of alluvium 128 in pumping station shaft

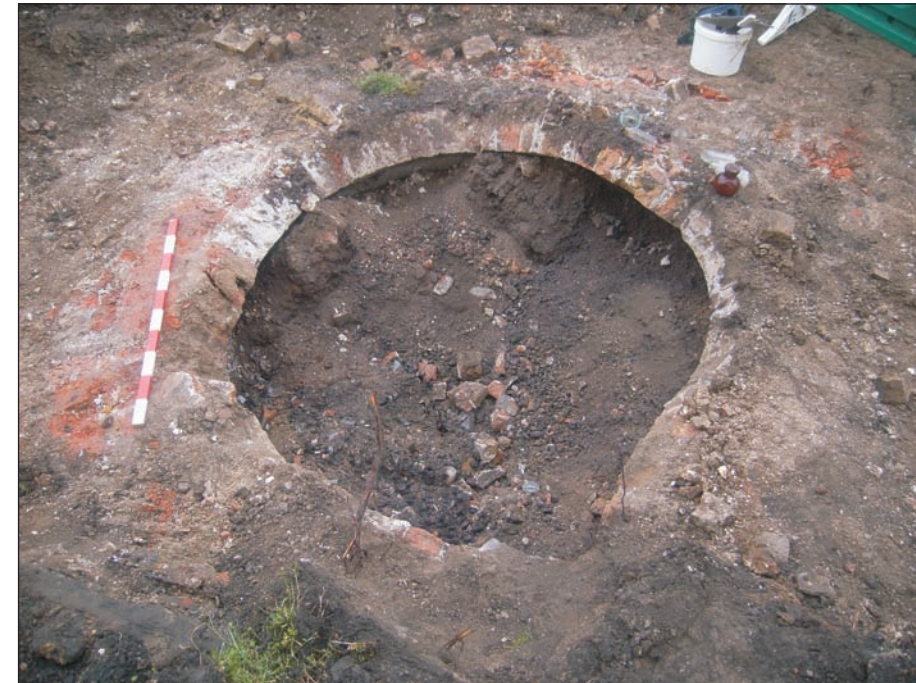
Plate 6: Water tank 103, view from east

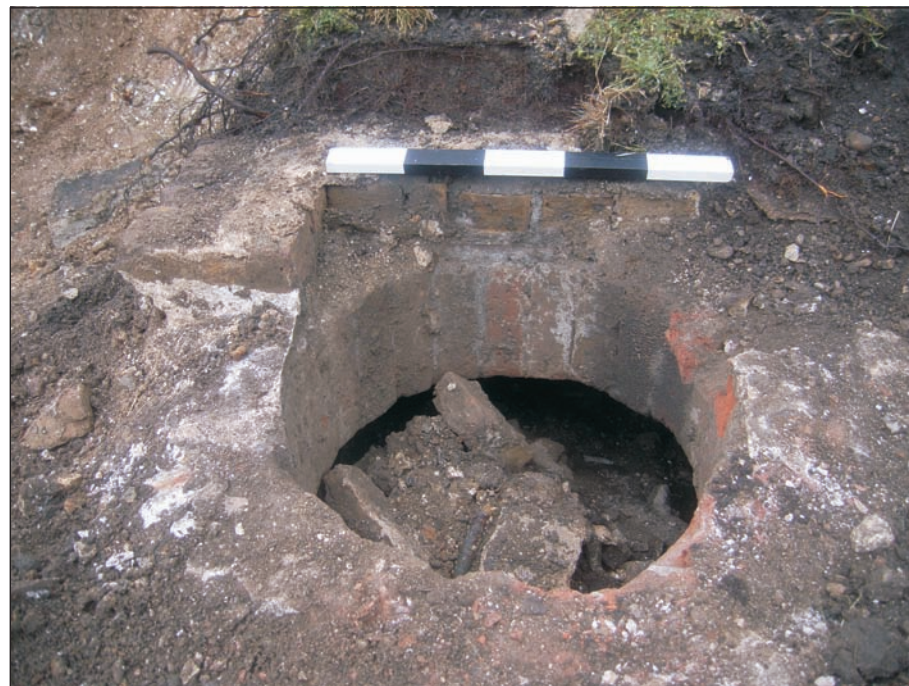
- 5.3.3 A circular access shaft in the centre of tank **108** (**Figure 4**, **Plate 7**) had a diameter of c. 0.48m and the observed external surface diameter of the structure was c. 0.8m. A square stone wall was constructed around the access shaft likely to hold a manhole or other covering.

Plate 7: Water tank 108, view from east

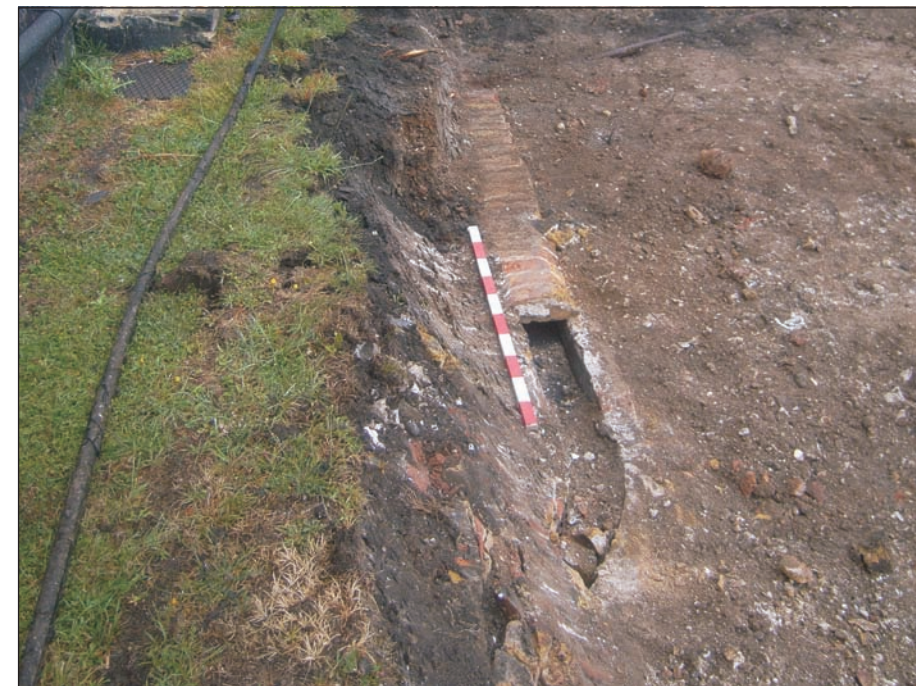
- 5.3.5 Brick culvert **106** (**Figure 4**, **Plate 8**) was observed to run between the White House and the water tank **103**, at approximately southwest-northeast alignment. The culvert contained a lead pipe and was c. 0.23m wide. Another section of the pipe was observed outside the south-eastern wall of the White House (**Figure 5**, **Plate 11**).

Plate 8: Brick culvert 106, view from south-east

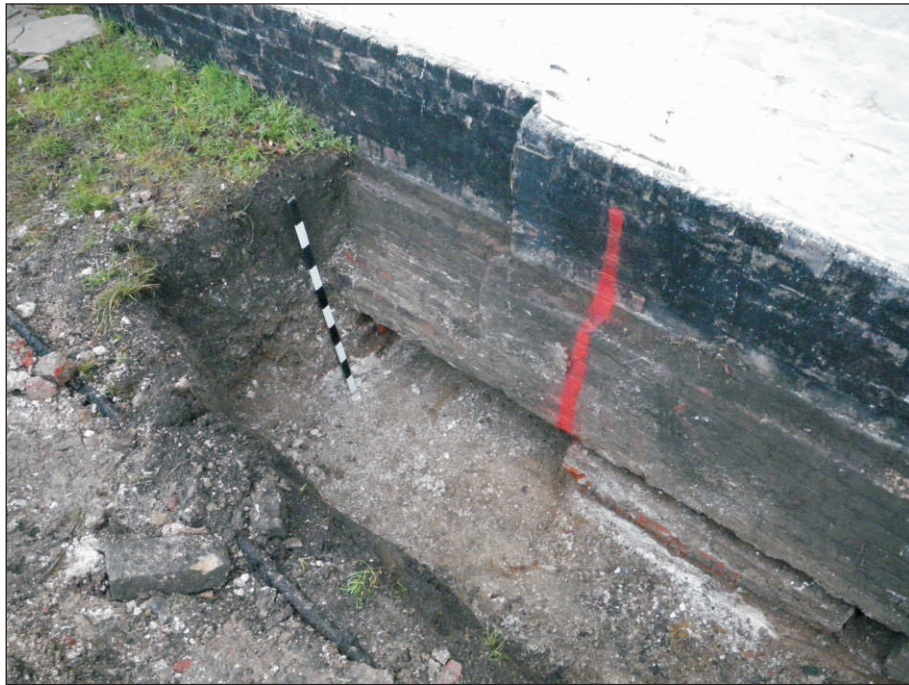
5.2.2 A sequence of made ground layers was recorded across the Site (**109 – 128, 131 - 133, 135 and 136**). The made ground deposits, which comprised multiple layers of redeposited soil with building debris, redeposited chalk and building rubble with crushed red brick, were observed to the south of the White House (**Figure 3, Plate 2**) and during excavation of the pumping station chamber (**Figure 3, Plate 3**). The same layer is thought to have been present in the external trenches excavated for underpinning of the White

Plate 9: The White House foundations, showing made ground layer 1002, view from east

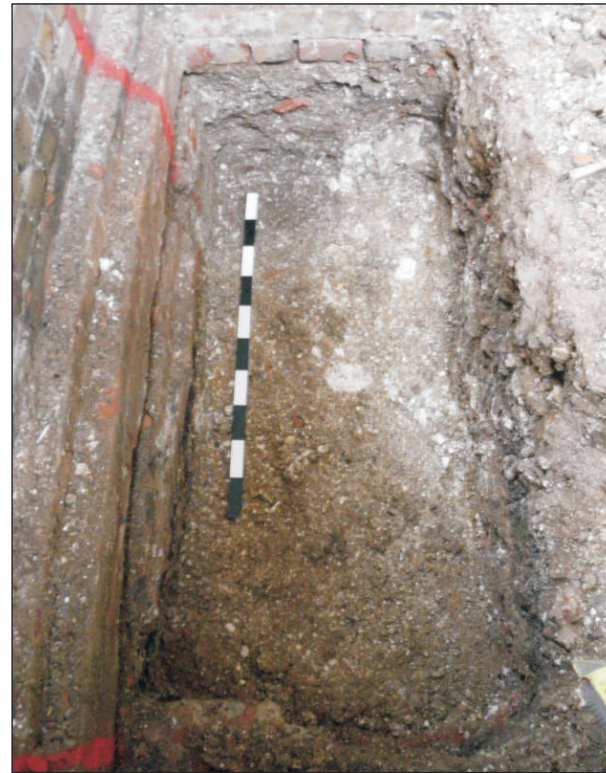
Plate 10: South internal corner of White House, showing made ground layer 1001, view from north-east

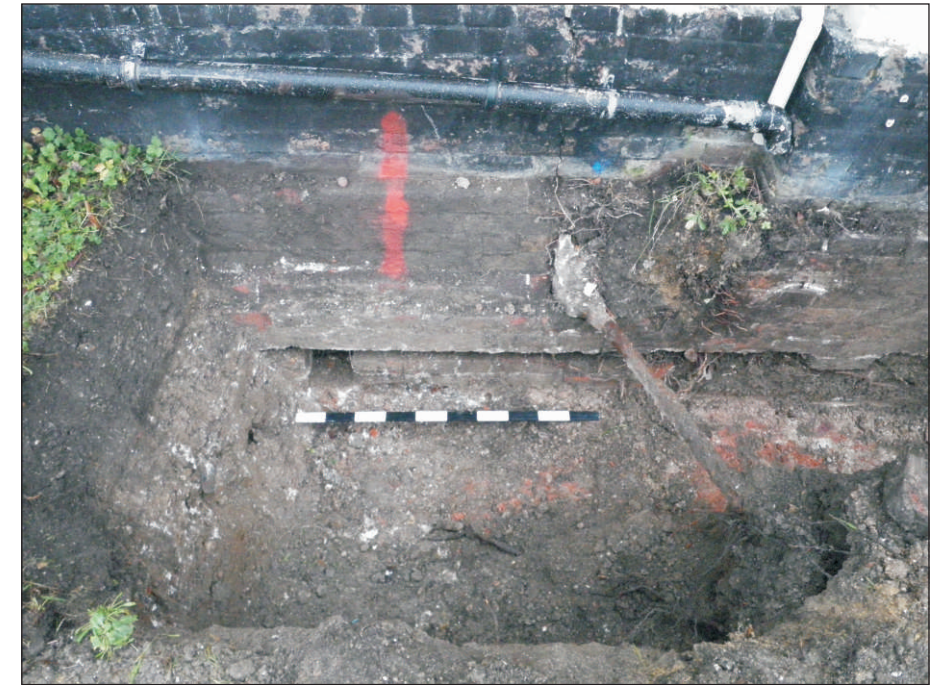
Plate 11: Metal pipe, which corresponds with culvert 106, view from south-east

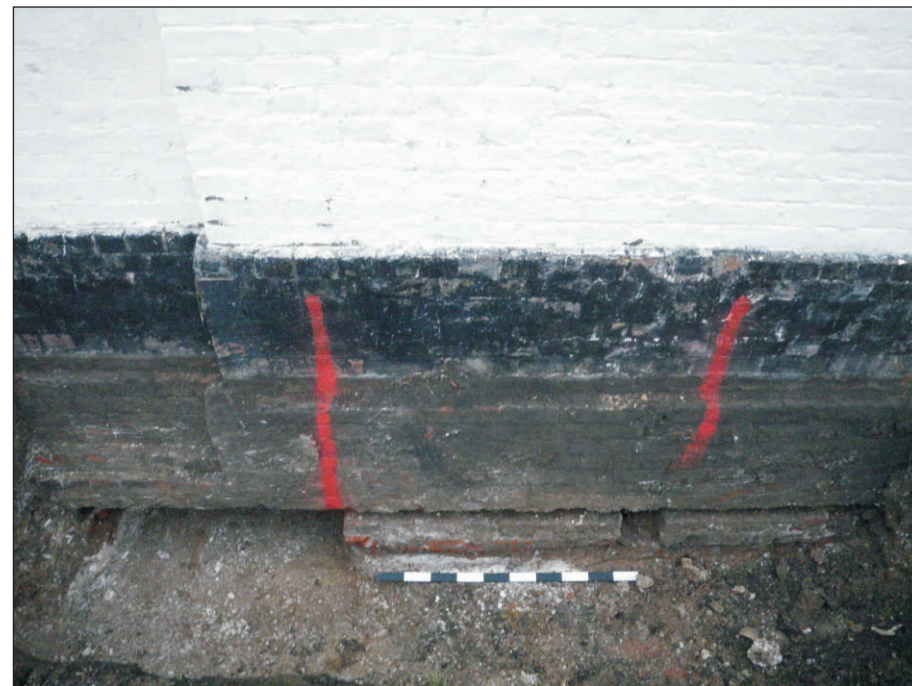
- 5.3.7 The White House was built in an area of reclaimed land and subsequent landscaping and no features or deposits predating the construction of the building were recorded. The foundations of the White House were made of red bricks in alternating header and stretcher courses (English bond), differing from the Flemish bond used for the walls. Towards the base of the

Plate 12: The White House foundations – external face, view from south-east

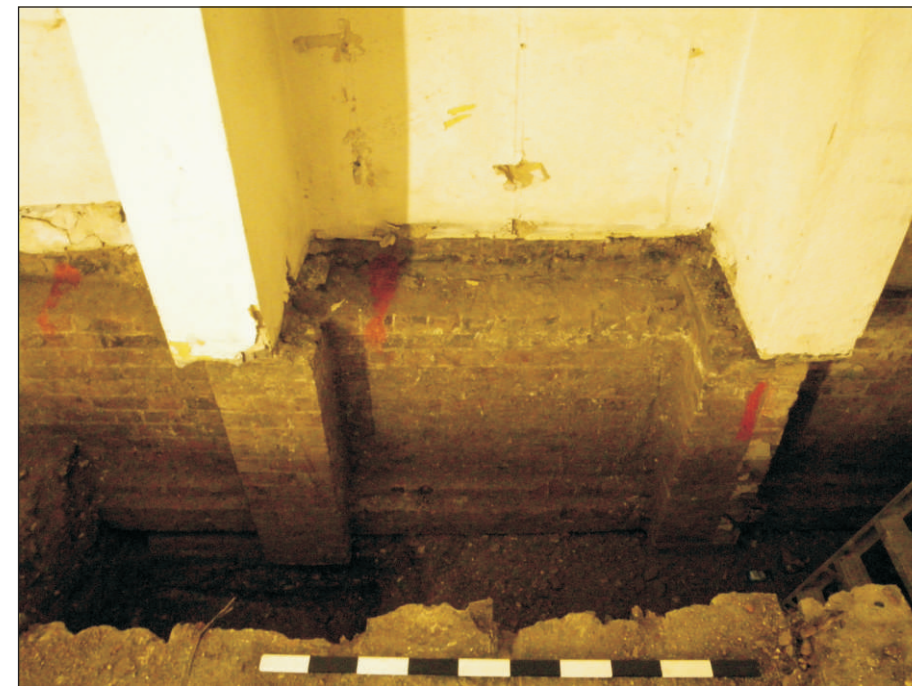
foundations, a void the size of a single brick course surrounded narrow brick wall. The void is thought to have been left by a wooden beam, which had rotted away. The wooden beam and the narrow foundation wall overlay two further courses of brick (**Figure 5, Plate 12**). The base of the foundations extends beyond the face of the wall by 0.25m externally and 0.10m internally (**Figure 5, Plate 13**).

Plate 13: The White House foundations – internal face, view from north-west
