Vere Road Car Park, Vere Road Broadstairs, Thanet, Kent

Archaeological Evaluation Report

Report reference: **76970.01**

March 2011

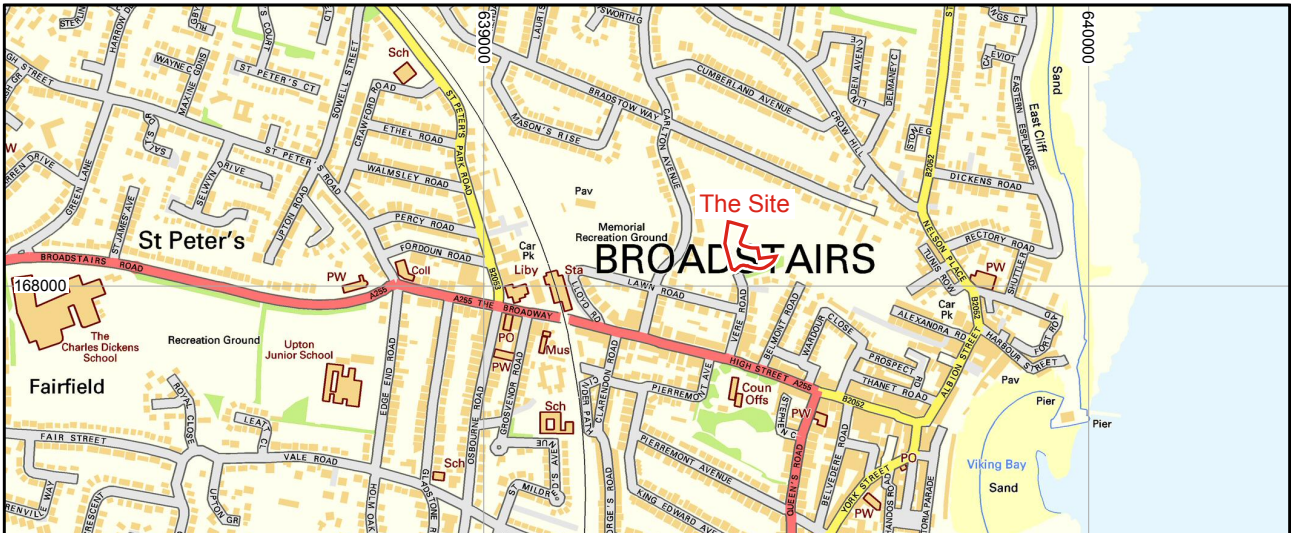
Figure 1

- 5.1.1 Six trial trenches were excavated positioned across the Site as illustrated in **Figure 1**. **Trench 1** was located to the north of the Site and revealed the tarmac car park surface (**101**) and underlying make up material (**102**) overlying subsoil/ hillwash (**103**) above natural (**104**) as summarised in Appendix 1.

Site location and trench location plan

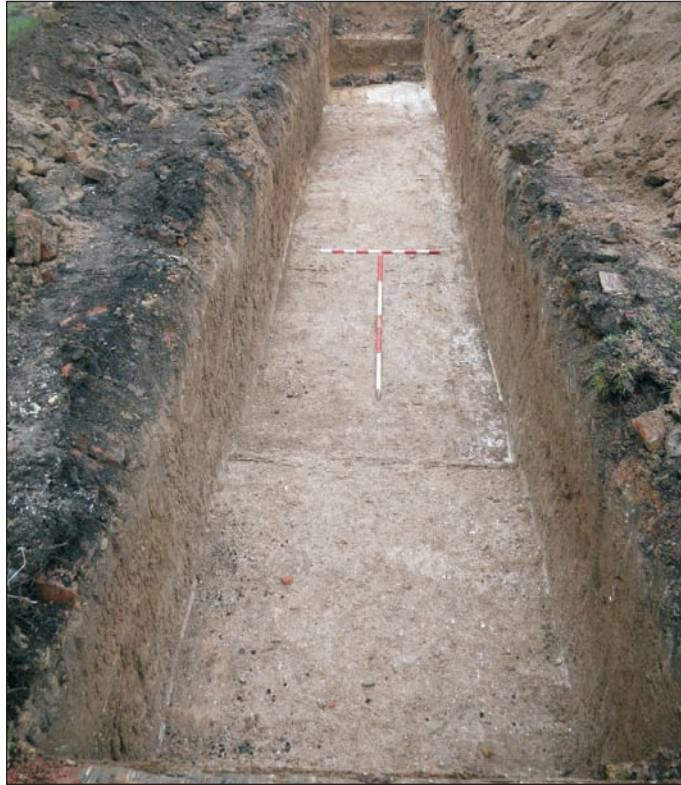
- 5.1.2 **Trench 2** was position to the north of the Site and revealed the tarmac car park surface (**201**) and underlying make up material (**202**) overlying made ground (**203**) with two underlying layers of colluvium/ hillwash (**204**) and (**205**) above natural (**206**) as detailed in Appendix 1.

- 5.2.4 **Trench 2** revealed a similar soil sequence to **Trench 3** however an additional layer of made ground (**203**) was recorded underlying the made ground/hardcore (**202**) overlying two layers of colluvium/hillwash (**204**) and (**205**) above natural (**206**) as summarised in Appendix 1.

Plate 1: Trench 2 plan

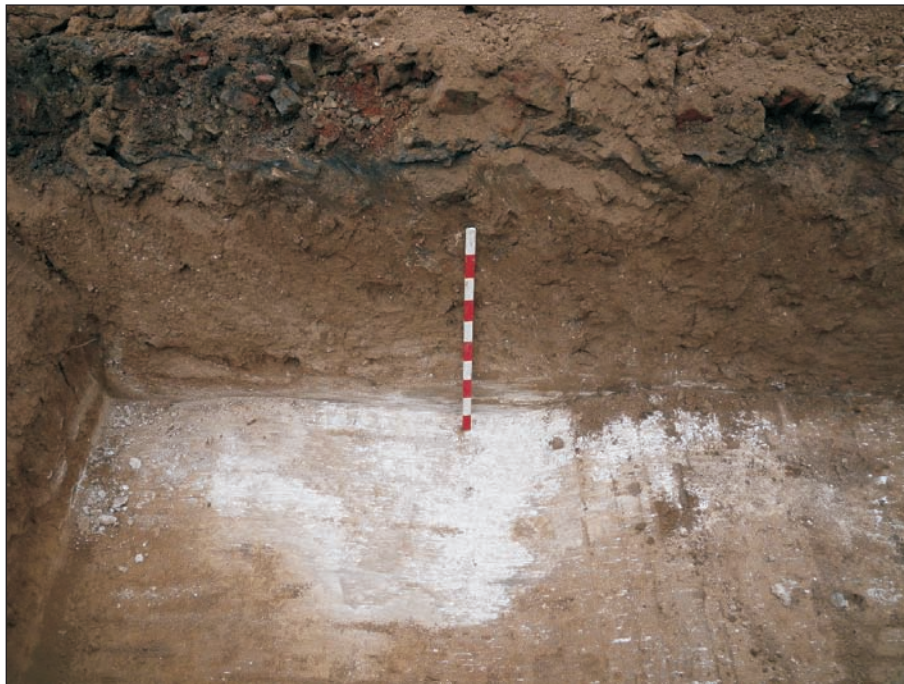
Trench 2	Dimensions :	13.90m x 1.80m x 1.55m	
	Land use:	Car and coach park	
	Coordinates:	639412.959, 168081.716	23.631m AOD
Context	Category	Description	Depth
201	Tarmac Surface	Tarmac car park surface, overgrown with soil and grass at the north-eastern end of the trench	0-0.08m
202	Layer- Made Ground	Hardcore, yellowish green sand with frequent bricks	0.08m-0.25m
203	Layer- Made Ground	Dark brownish grey silty clay with frequent charcoal and chalk flecks and flint piece	0.25m-0.32m
204	Colluvium/ Hillwash	Mid yellowish brown silty clay with flecks of chalk	0.32m-0.86m
205	Colluvium/ Hillwash	Light grey brown silty clay with flecks of chalk and flint	0.85m-+
206	Natural	White chalk	1.40m+

Plate 2: Trench 2 southeast facing section
