## The Manor of the More Northwood, Hertfordshire

Archaeological Evaluation and Assessment of Results

Ref: 85202  
July 2013

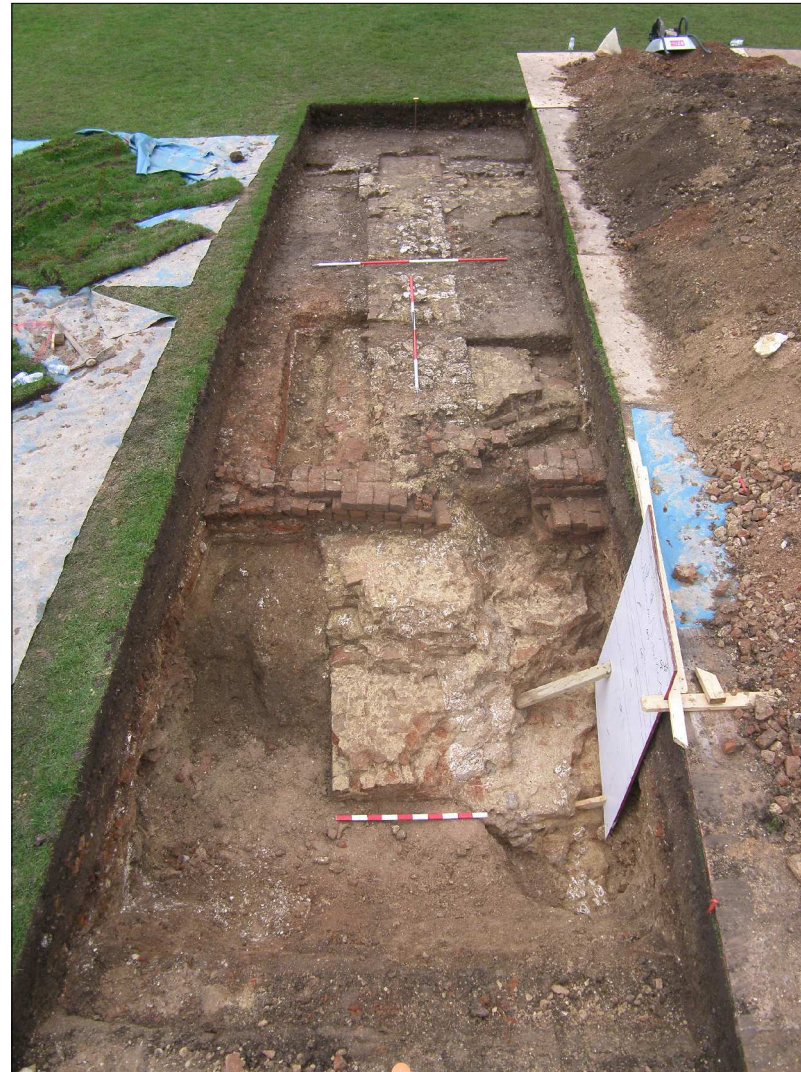
Plate 1: Trench 1, view from south (scale 2x2m)

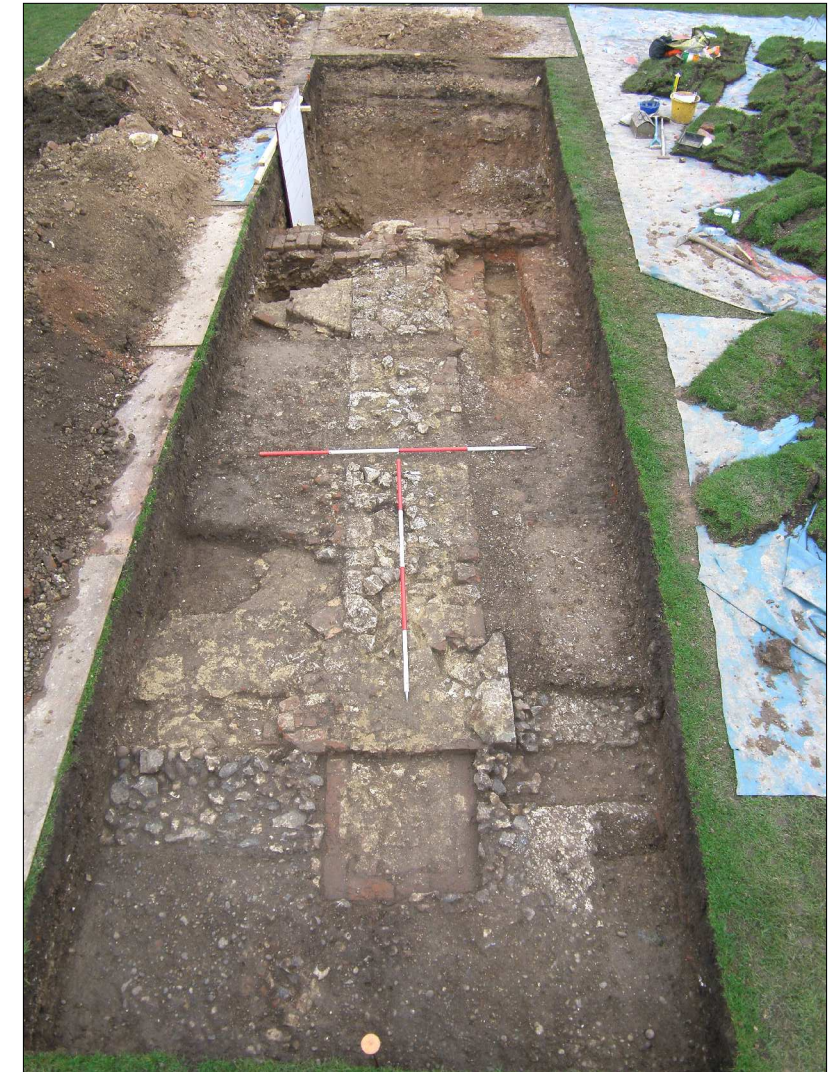
Plate 2: Trench 1, view from north (scale 2x2m)

4.3.6 Also cutting deposit **118** was **143**, the foundation trench for the eastern wall of the entrance of the gatehouse (**105**), constructed on a stepped footing (**135**) (**Figure 5, Plate 2**). A chalk rubble, load-bearing structure (**137**) was located at the southern end of wall **105**, partially projecting out into the moat. This possibly supported the northern end of the bridge crossing the moat. Structure **137** was subsequently enhanced and reinforced by the addition of brick and chalk rubble structure **136/139** for a larger and perhaps more elaborate entrance-way. Structure **136/139** formed the foundation for the eastern of the two gatehouse towers or turrets which had been previously interpreted as semi-octagonal

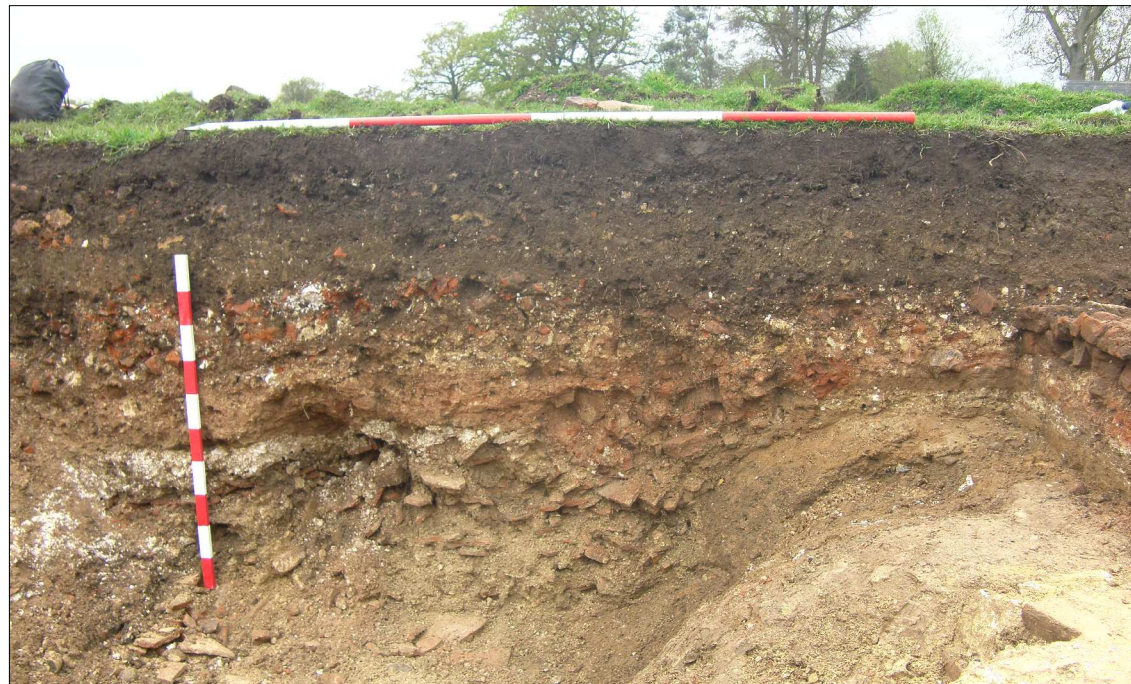
Plate 3: East facing section of in-filled moat 125 (scales 2m and 1m)

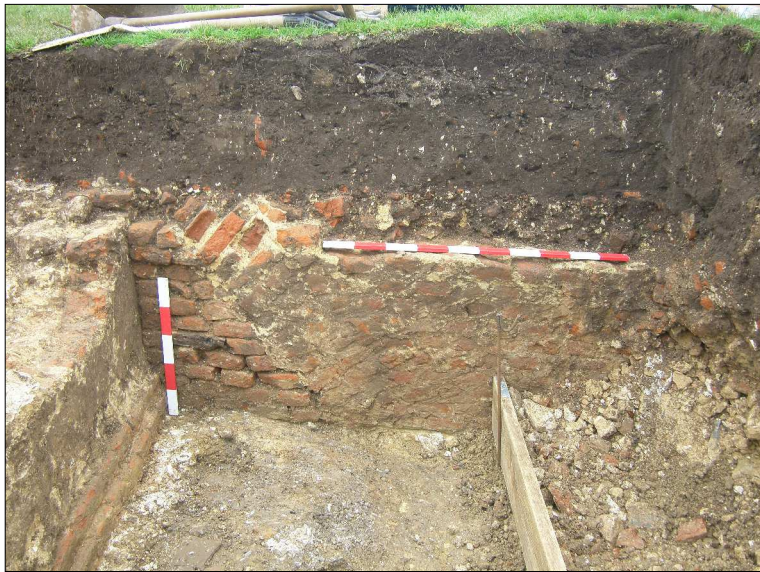
Plate 5: East facing elevation showing retaining arch 224, and blocking 209 within the cellar of the Great Hall (scales 1m and 0.5m)

- 4.3.18 Following the blocking of the doorway, wall **210** was butted on its northern side by a retaining arch constructed inside the cellar. The arch (**224**) was constructed upon a chalk footing (**245**); it was not fully exposed, but it was clear that it been added in an attempt to correct some failing in the structure. The void between **210** and **224** was subsequently filled by blocking wall **209** (**Figure 7, Plate 5**). This remedial work possibly took place during Cardinal Wolsey's occupation in the years after 1521 (Period VI), although a later date associated with Henry VIII's occupation from c. 1531 (Period VII) is also a possibility.

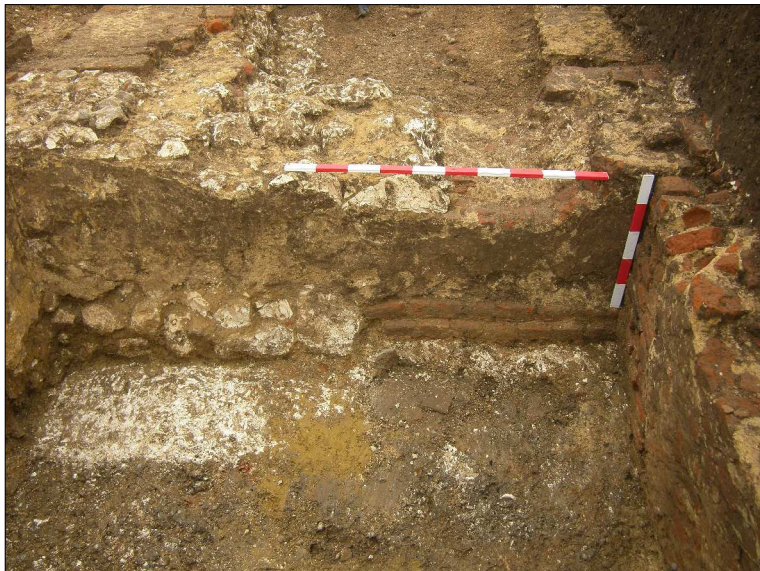
Plate 6: North facing elevation showing blocking wall 210 within the archway in wall 208 of cellar of Great Hall (scales 1m and 0.5m)

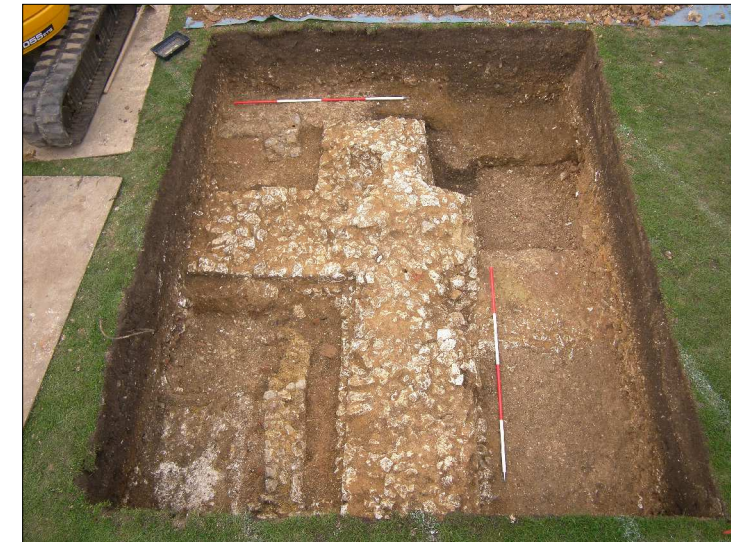
Plate 7: Trench 3, view from south (scales 2x2m)

- 4.3.25 Following the removal of the timber building, layer **319** and surface **323** were laid down to create working surfaces during the major works of the Period IV construction. A single large foundation trench (**327**) was cut through **319** (truncating walls **307** and **308**) for the construction of the north-east corner of the Great Hall, formed by walls **305**, **325** and buttress **326** (**Figure 8, Plate 7**). These walls were constructed in the same manner and

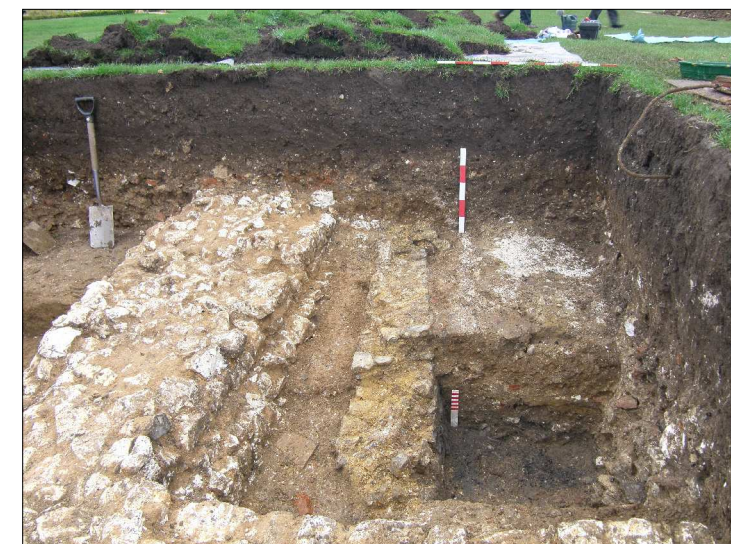
Plate 8: North facing section of Trench 3 (scales 1m, 0.5m and 0.2m)

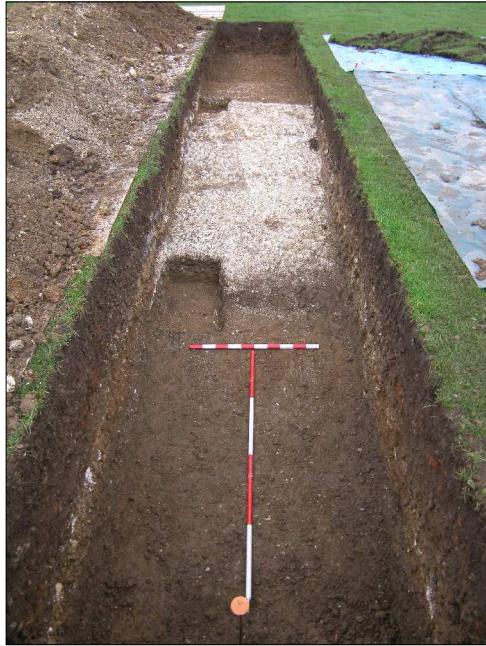
Plate 9: Trench 4, view from east

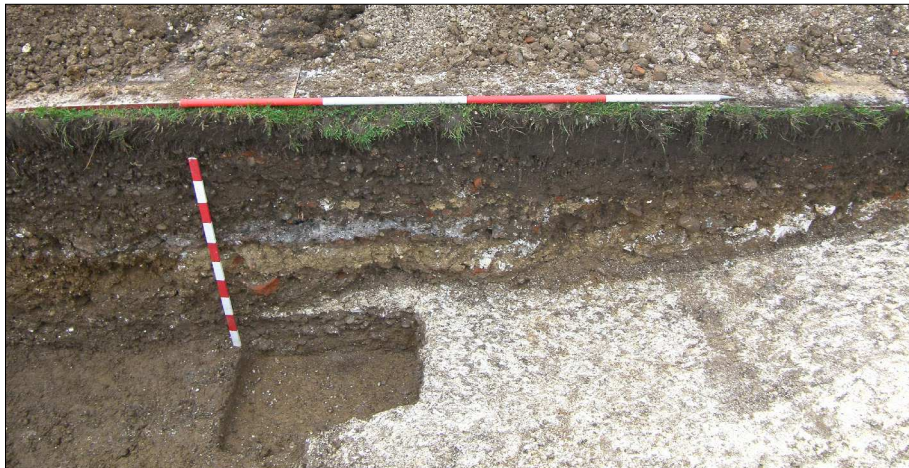
Plate 10: Trench 4, view from north

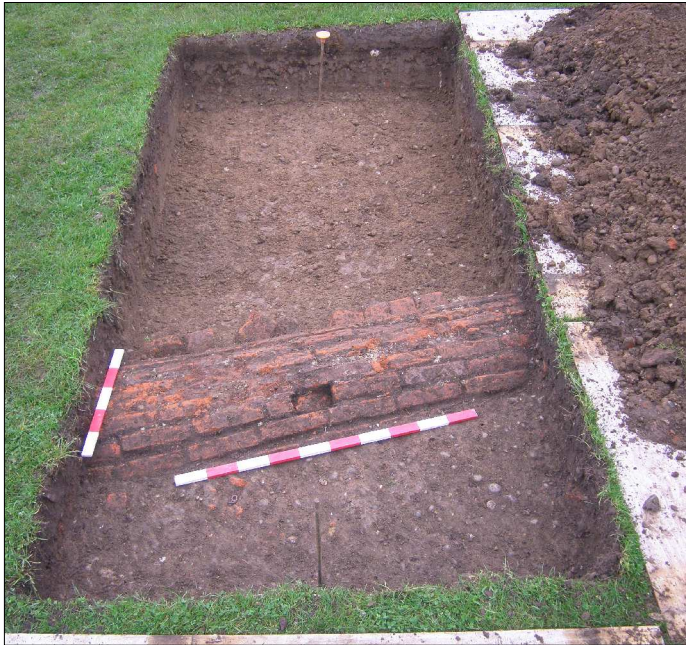
Plate 13: Trench 7, view from west (scales 1m and 0.5m)
