Islip, Oxfordshire

Archaeological Evaluation and Assessment of Results

Report reference: 59463.01

November 2005

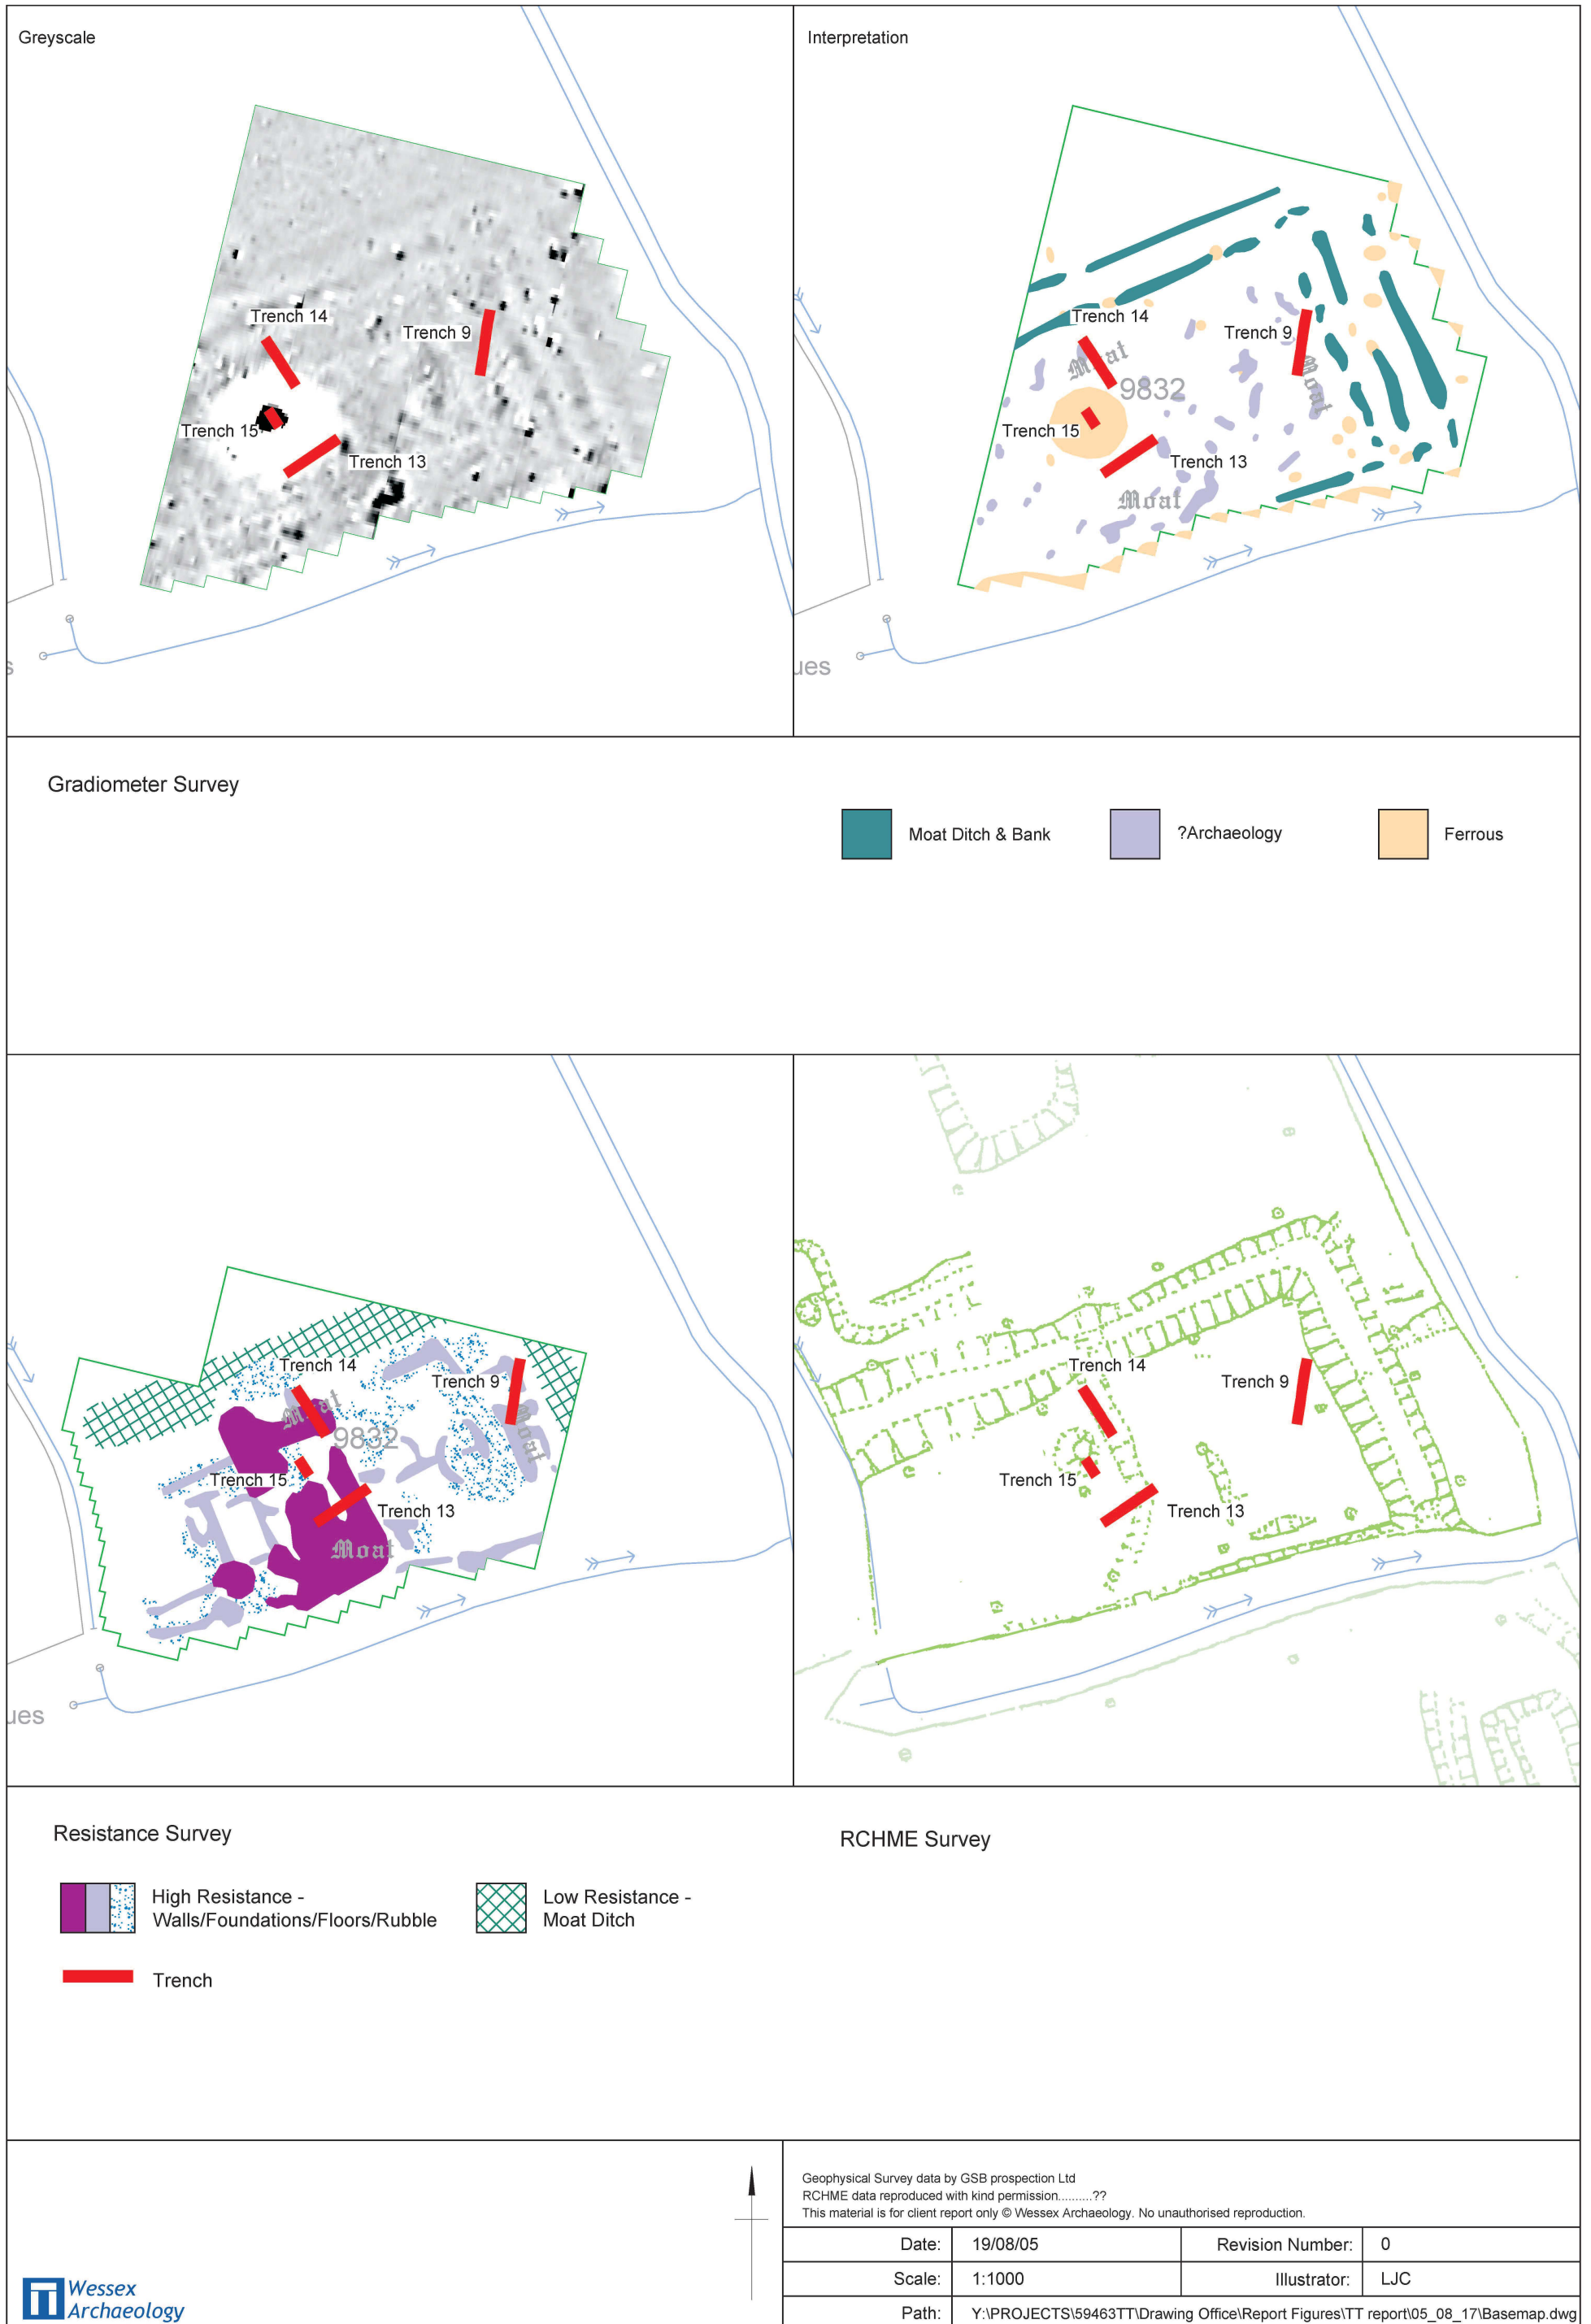
Figure 3

Geophysical and RCHME surveys of moated site

3.2.3 The survey of Area 8 was more successful, with the resistance survey providing a relatively clear plan of the building foundations associated with the medieval manor (**Fig. 3**). The survey revealed some easily discernible wall alignments, though parts of the moated area were less easily interpreted.

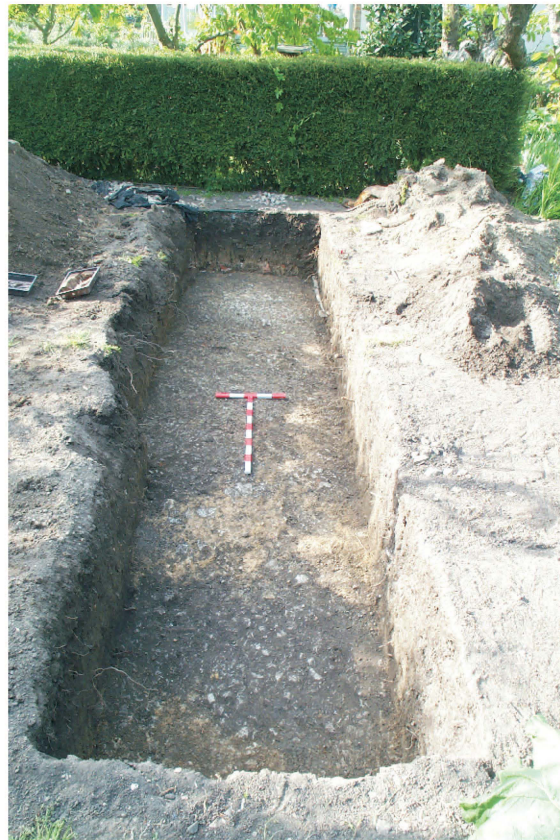
Trench 1 from the south

- 3.3.6 The most significant archaeological deposit identified in Trenches 1-3 was a very hard and compact metallised surface composed of light grey silt with almost 100 % limestone fragments (104/105, 207, 307). This deposit was initially believed to be natural geology, due to its compact nature, but was subsequently shown to be a band of natural limestone with areas of natural clay filled with redeposited natural limestone to create a hard-wearing yard

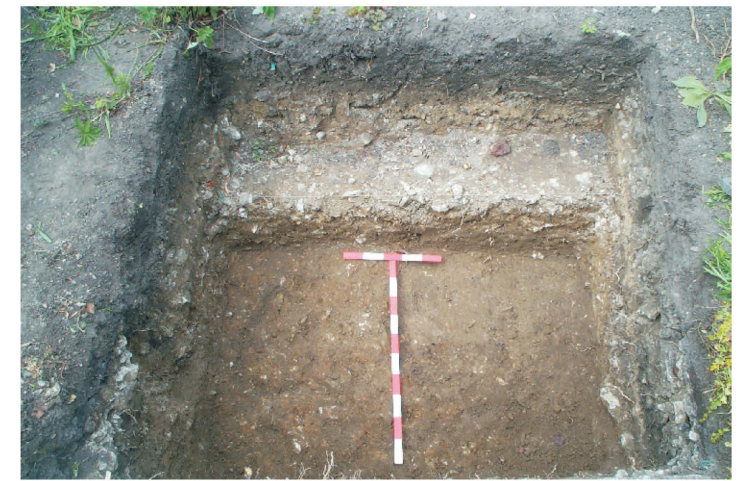
Trench 2, following partial removal of 207, from the east

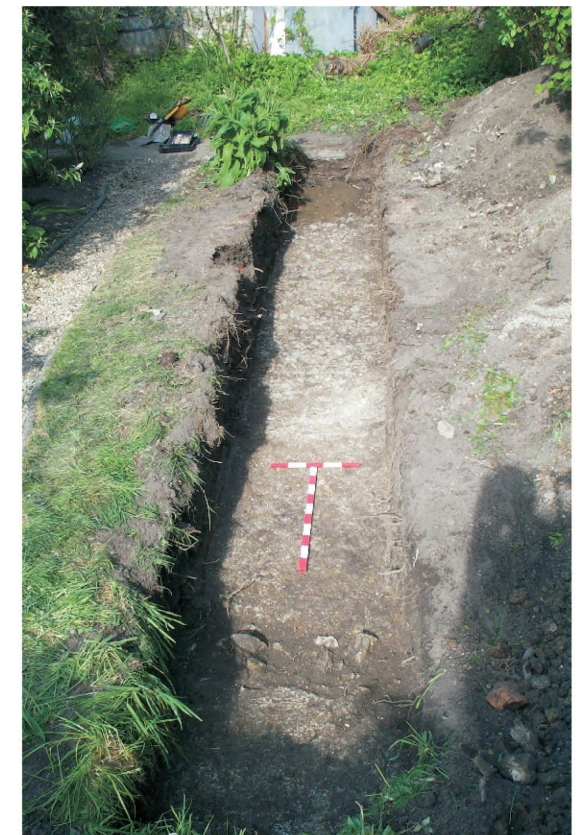
Trench 3 from the west

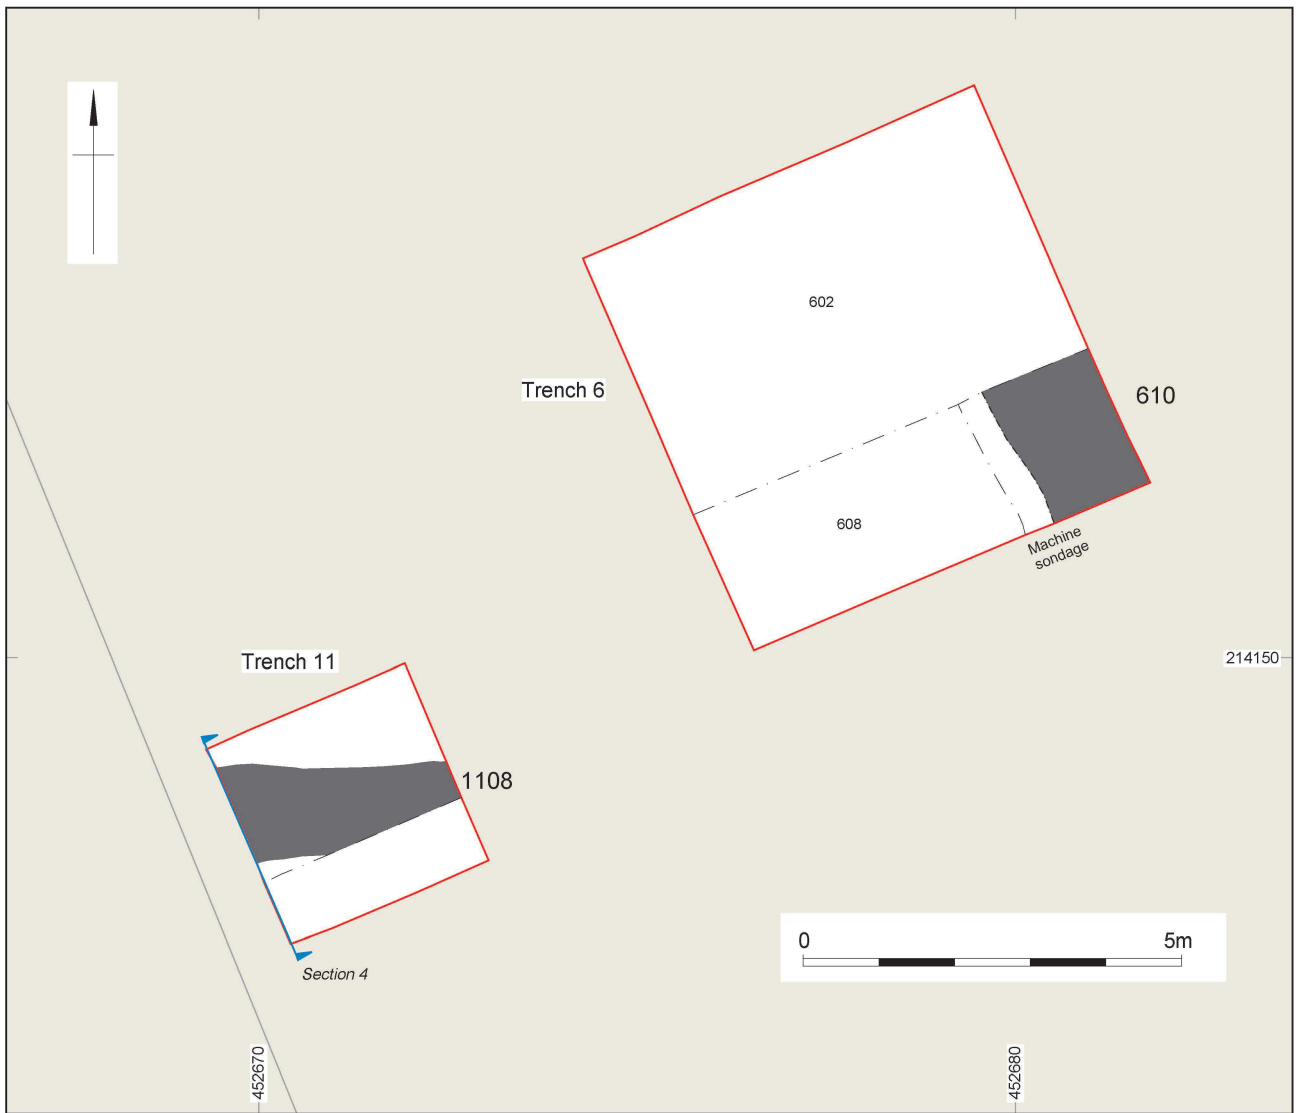
Figure 6

Trenches 6 and 11; plans and Trench 11; section

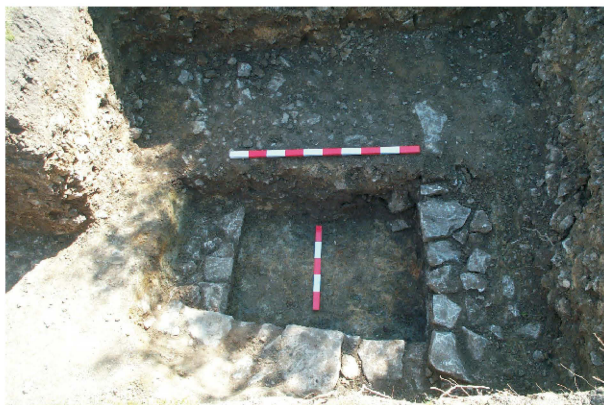
Trench 5, latrine pit 513 from the west

- 3.3.31 The latrine consisted of a roughly square pit (508) lined with dry stone walls consisting of roughly shaped limestone blocks with a number of re-used broken ceramic roof tiles. Lining walls (509), (510) and (511) were revealed following the removal of (506), a mid grey brown sandy silt deposit which sealed the walls. (506) contained fragments of limestone and may be evidence of the collapse of, or perhaps the demolition and robbing of the stone lining, which only survived to a maximum height of 0.28m. The ceramic roof tiles re-used in the latrine lining are broadly of post-medieval date, giving a construction date for the latrine some time after *c.* AD 1500.

- 3.3.32 It would also appear that a certain degree of emptying of the contents of the latrine may have occurred. Cess deposit (507) only survived to a thickness of 0.19m, and could be seen to overly urea-stained natural (512). The emptying of the latrine may have occurred just prior to the demolition/robbing of the lining, with the emptied cess material utilised as fertiliser. Finds recovered from sealing layer (506) included medieval and post-medieval ceramic building material and fragments of post-medieval pottery including 16th/17th century slipware and Border ware. No datable finds were recovered from (507). Mineralised plant remains contained in the cess deposit were probably a mixture of those that were growing in the vicinity, and those that entered the deposit with cess, and included dead-nettle, docks, henbane, mustard type, elder, bramble, and possible cherry/sloe, apple and fig.

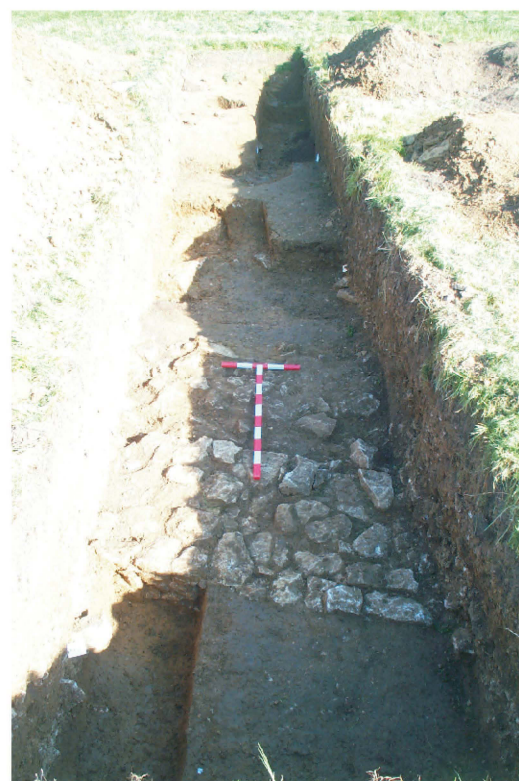
Trench 14, from the south

- 3.3.57 Trench 14 was positioned at right angles to the northern edge of the moat, again targeted upon high resistance geophysical anomalies. Following the machine excavation of the trench and subsequent hand cleaning, only a limited amount of excavation and investigation of deposits and features was possible due to time constraints; interpretation of the archaeology is therefore limited. The trench did, however, establish the date and condition of the surviving archaeology.

- 3.3.59 Cutting through (1406) was (1421), the construction cut for wall (1404). This was a roughly east-west aligned, unmortared wall, comprising roughly shaped limestone blocks bonded with mid yellow brown clay. It is unclear if the wall represents wall foundation below the ground surface or a positive structure above ground level. (1404) extended 1.60m in length, roughly 1m in width and survived to height of at least 0.30m (the sondage excavated alongside did not find the base of the wall).
