**COLLAFORD LANE,
DARTMOUTH, DEVON**

Archaeological Evaluation Report

WA Report reference: 83881.03

March 2012

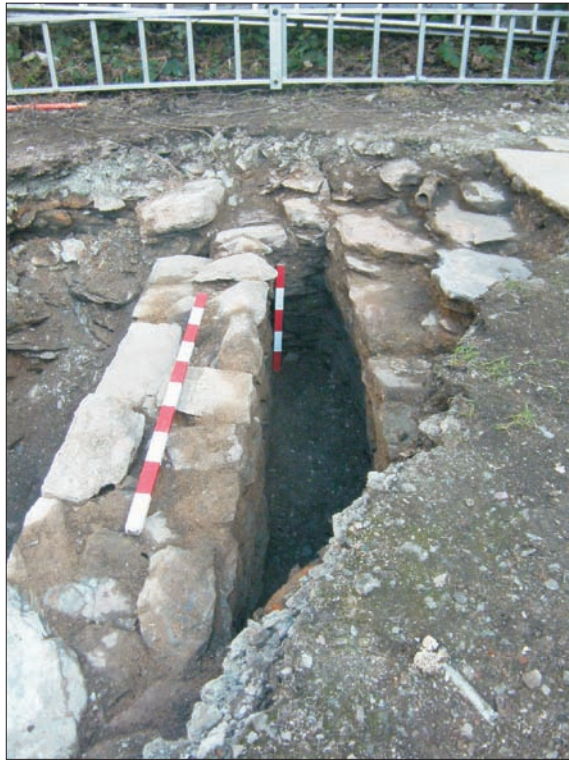
Plate 1: Walls 214, 215 and 216, view from west (1x1m, 1x0.5m)

- 4.2.1 The earliest structural remains on site are thought to be an east to west aligned stone wall **215** stone built wall (**Figure 2, Plates 1 and 2**). Only a small portion of the wall, which lay adjacent and parallel to later wall **214**, was accessible at the south-eastern end of **Trench 2**. An approximately

0.7m depth of wall **215** was exposed to reveal the northern wall face which comprised of randomly coursed stone slab facing bonded with pale yellow-white mortar. The exposed wall was poorly faced and slightly overhanging and from what was visible, did not appear to be bonded to north to south aligned wall **216** (**Figure 2 and Plate 1**).

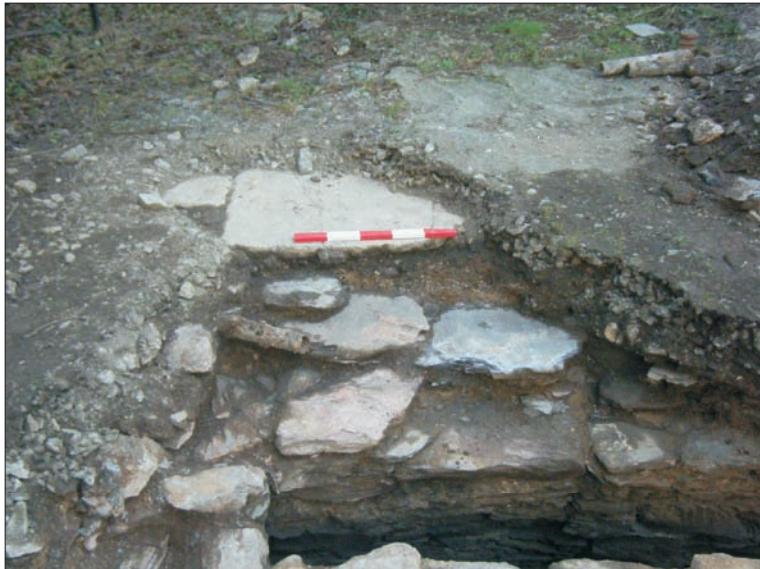
Plate 2: Surfaces 219, 222 and wall 215, view from north-west (1x0.5m)

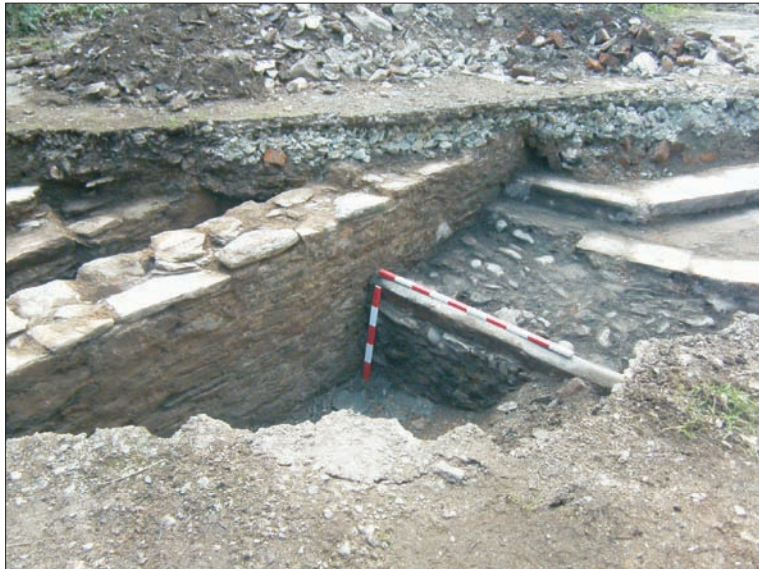
Plate 3: Wall 214, platform 208, surface 207 and coping 209, view from north-east (1x1m, 1x0.5m)

- 4.3.2 A retained platform, **208** (**Figure 2, Plate 3**) constructed of rounded cobbles, angular stone slabs and rare brick fragments bonded with a pale yellow-white cement mortar butted the northern face of wall **214** and was overlain by cobbled surface, **207**. The surface of **207** was darkly stained suggesting humic or charcoal rich occupational debris. Parallel to Collaford Lane and butting wall **214** a later single course of red brick had been mortared onto this western edge of the surface over which a curved cement coping had been lain which may have served to prevent run off into the sunken cellared area to the east. A later alteration to **207**, cut **210**, appears to have been a roughly rectangular cut to allow the insertion of a base of brick and stone fragments (**211**), possibly to support a pillar.

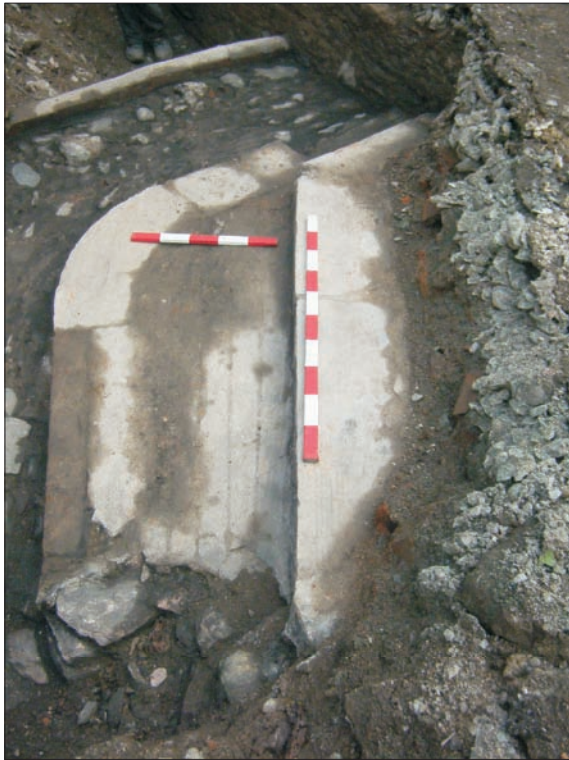
Plate 4: Steps 205 and 205, view north-west (1x1m, 1x0.5m)

- 4.3.3 Two stone built steps, **204** and **205** (**Figure 2, Plate 4**) led up from surface **207** to the south-west. The lower of the two, **205**, projected out by 0.7m and

comprised a curved line of edging stones bonded with a pale grey-white lime mortar and is likely to have contained a brick and stone rubble core, though this was obscured by an overlying mortar surface, **206** lain over the core of the step. Only 0.5m of the upper step **204** was visible but it could be seen to comprise of rectangular stone blocks bonded with a pale grey-white cement mortar. Pecked horizontal grooves were present on the upper and external step face, possibly as an anti-slip precaution. Remnants of mortar surface **206** were recorded on the external step face. This grey sandy cement mortar surface **206** was approximately 0.01m deep had scored grooves on the upper surface and was also found to overlying a portion of surface **207** (**Figure 2, Plate 5**).

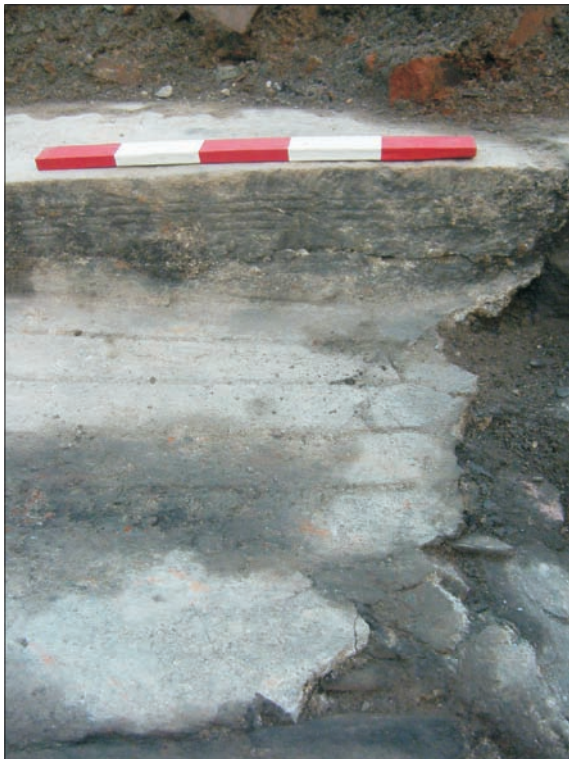
Plate 5: Detail of mortar 206, view from east (1x0.5m)

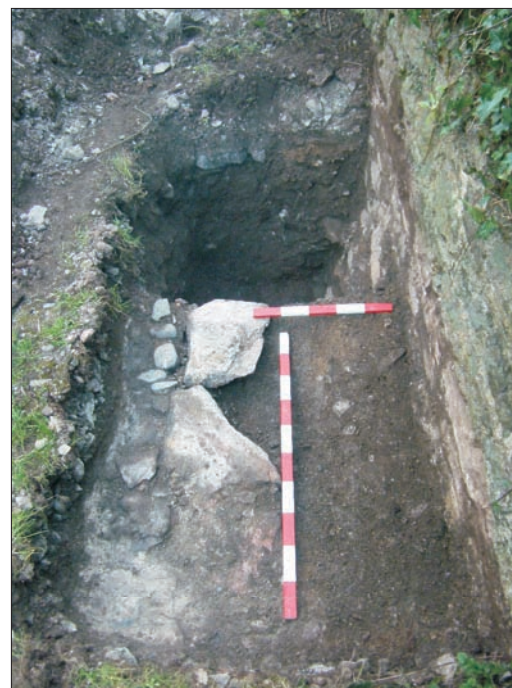
Plate 6: Test pit 3, view from west (1x1m, 1x0.5m)

- 4.3.6 A degree of landscaping appears to have been undertaken prior to and during the construction of St Saviour's Place. A landscaping or levelling deposit of re-worked natural clays (**309**) (within which fragments of slate and stone fragments were noted), was laid. The foundation trench, **306** for the front (northern) wall of St Saviour's Place cut through levelling layer **309**. The exposed elevation of the front (north) wall of the St Saviour's Place **308** (**Figure 3, Plate 7**) showed a single episode of construction. The basal foundation courses stepped out slightly from a formally laid string course overlain by randomly coursed and un-faced stone constructed to ground level, approximately 1m in height. The upper and visible part of the wall was formed of randomly coursed stone bonded with yellow white cement mortar. The construction cut was backfilled with a mixed and subsequently heavily bioturbated deposit of reworked topsoil and occupation debris (**307**). Deposit **305**, a levelled topsoil equivalent to layer **107** in Trench 1 (see 4.3.6 below), sealed the wall foundation. A bedding layer of yellow sand and degraded mortar (**304**) overlay deposit **305** and formed the foundation for a stone slab and cobbled yard surface, (**303**) which butted the above ground base of wall **308** (**Figure 3, Plate 6**).

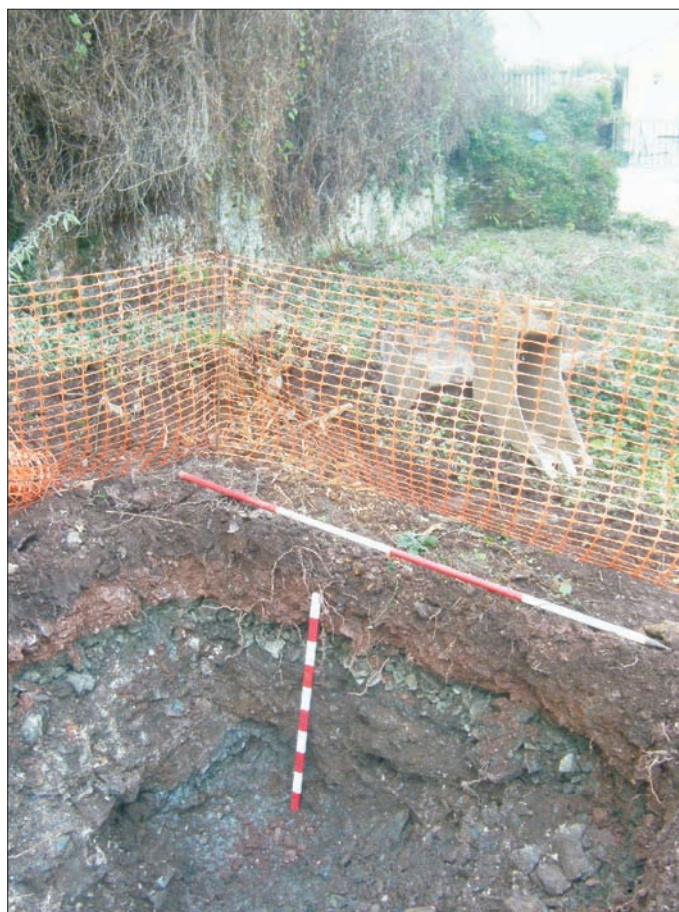
Plate 10: Test pit 4, from north-east (1x2m, 1x1m)

- 4.4.2 **Test pit 4**, which was situated within the footprint of the tenement block showed a succession of demolition deposits built up within this area (**404, 405, 406, 407 and 408**) relating to the demolition of the buildings after 1936 (**Figure 5, Plate 11**). The lowest of these (**408**), which was only seen at the limit of excavation, was a distinct layer of blue-grey slates likely to derive from the destruction of the roof of St Saviour's Place. This does suggest that further demolition deposits may lie beneath this. **Testpit 4** was excavated to a maximum safe depth of 1.2m nevertheless at just over 6m aOD this was around 1m above the base of the foundation of the front wall of St Saviour's Place, seen in **Testpit 3**.

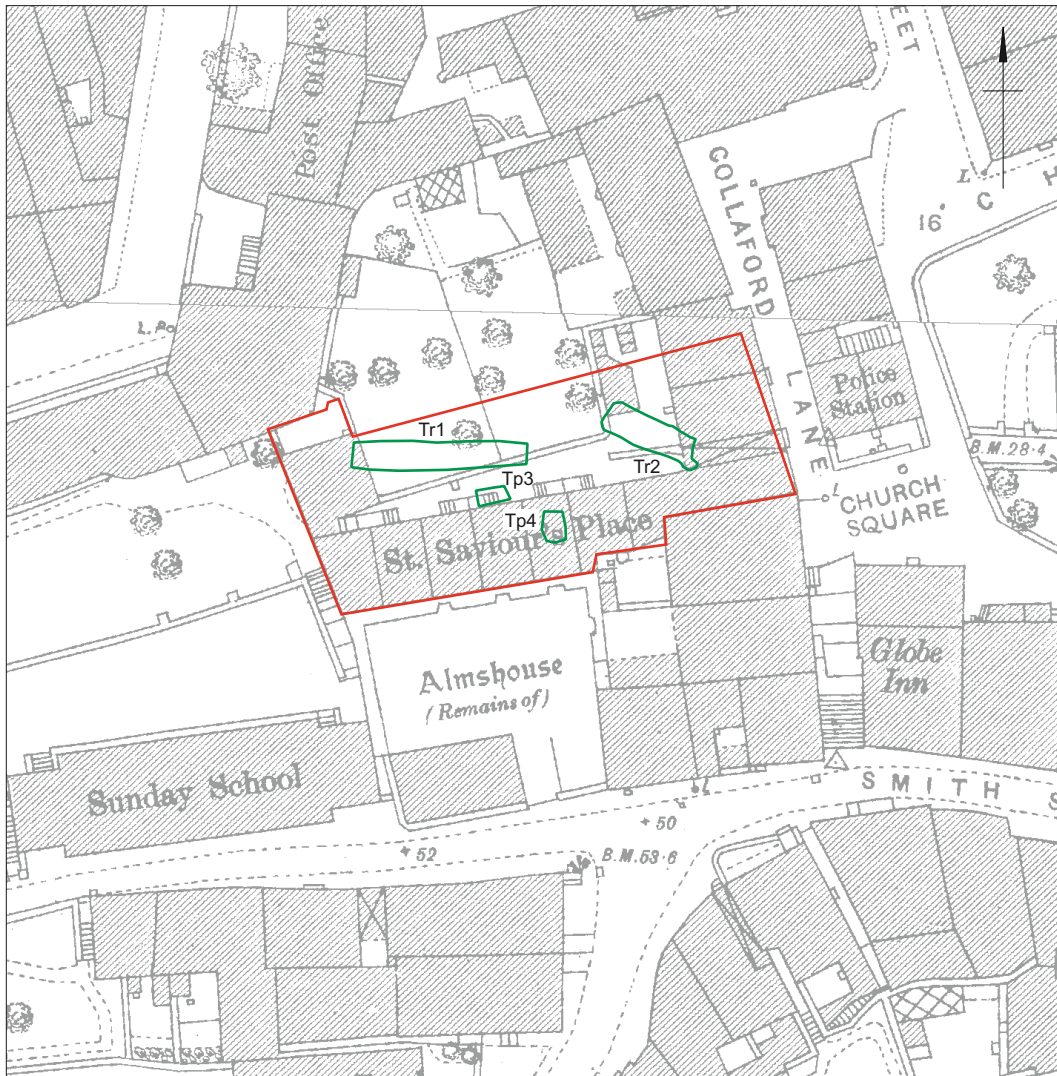
1888 Ordnance Survey Town Plan (Dartmouth 1:500)

- 6.1.1 Overall, the evaluation at Collaford Lane has largely succeeded in achieving its aims. The principal aim was to identify any surviving remains of the any structure or features which may be impacted by the proposed development. Archaeological remains recorded in during the investigation predominately conformed to the built environment reflected in the 1888-1936 OS maps (**Figure 6**).

- 6.1.8 A sequence of post-medieval/modern made ground deposits within a garden soil matrix correspond to the area of open ground depicted in the 1888 town plan (**Figure 6**). At this time this area of Site apparently lay within properties to the north but by the 1906 OS map the northern boundary of Site appears to have moved to its current position.

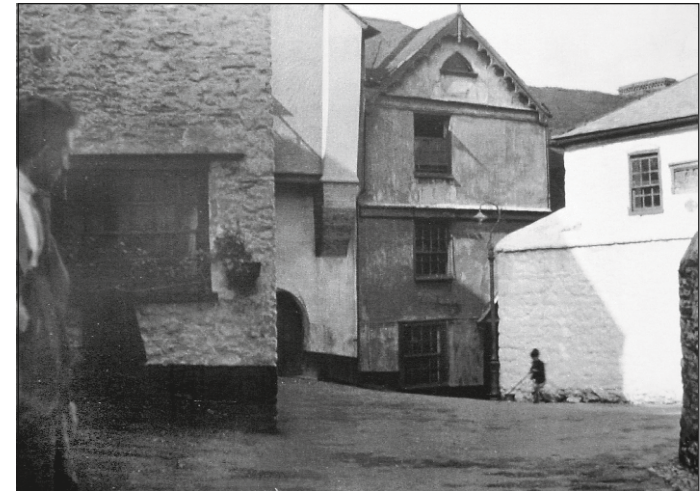
Plate 11: Collaford Lane/ eastern frontage of Site, view from west

- 6.1.2 The evaluation confirmed the below ground survival of the basement levels of properties which fronted the original Collaford Lane. However, as confirmed by an old photograph of the Site (**Figure 6, Plate 11**, Dartmouth Museum reference number B0304) the frontage of these buildings was in line with the frontage of Collaford House. Much of the footprint of these, therefore, would lie beyond the current eastern boundary wall. Hence the structures encountered in **Trench 1** are from the rear portion of these properties (**Figure 6, Plate 12**, Dartmouth Museum reference number B0310). The presence of fragments of brick within several of the structures in **Trench 2** would seem to suggest that the structures as they presently appear relate to the early modern usage of the Site. Nevertheless some traces in the photographs (**Figure 6, Plates 11 and 12**) of fancy bargeboards at the frontage and decorative detail around one of the dormer windows hint that these were once higher status buildings.

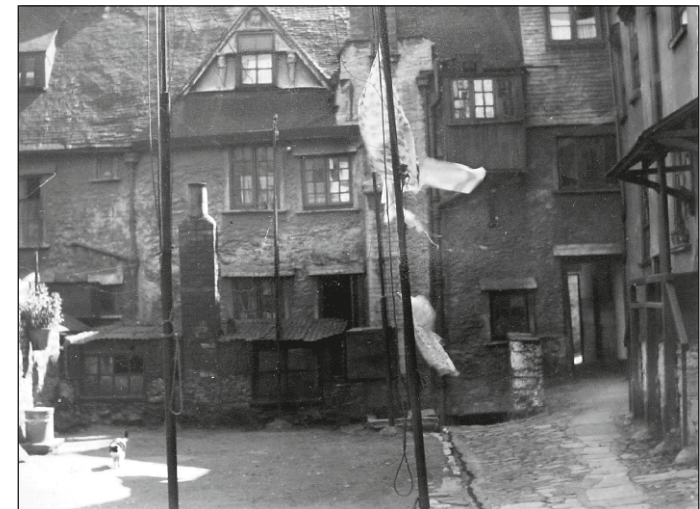
Plate 12: St Saviour's Place/ rear of Collaford Lane properties, view from west

- 6.1.3 A photograph showing the rear of the Collaford Lane properties (**Figure 6, Plate 12**) shows the access gunnel situated between the easternmost part

of the tenement block of St Saviour's Place with accommodation above. However, there are suggestions from the image that then north wall of this access once extended further (this could potentially be wall **215**). It may also be that the access originally ran to the north of this and that there were two detached properties on Site, later joined together and the access moved across, potentially to allow communal access to the basement levels. This idea is supported by an engraving in St Saviour's church (not illustrated) which appears to show two separate properties on the frontage and **Plate 11 (Figure 6)** which shows the southern part of the frontage projecting further out than the rest of the structure.

- 6.1.4 The chimney visible in **Plate 12 (Figure 6)**, possibly a boiler or wash house situated at basement level could well have been the source of some of the bricks within the demolition debris in **Trench 2 (202)**. The access to the basement levels, visible in the photograph is thought to correspond to steps **204** and **205** and wall **214**. Wall fragment **216** is likely related to the rear eastern wall of these properties.

- 6.1.7 A narrow area of flagstone paving came be seen in **Plate 12 (Figure 6)** bounded by cobbles this would correlate to the findings from **Test pit 3** where only a few slabs were located and none adjacent to the wall. This confirms **303** as the early modern yard surface. The 1888 mapping (**Figure 6**) would seem to suggest **Test pit 3** lay in the vicinity of one of the sets of steps leading to the tenement blocks and **Plate 12 (Figure 6)** confirms these made of to be stone. There were no traces of an adjacent structure visible on wall **308** indicating that the steps cannot have been keyed in to the main wall.
