**Mount Foundry,
Tavistock, Devon**

Archaeological Evaluation Report

Report reference: 63991.03

February 2007

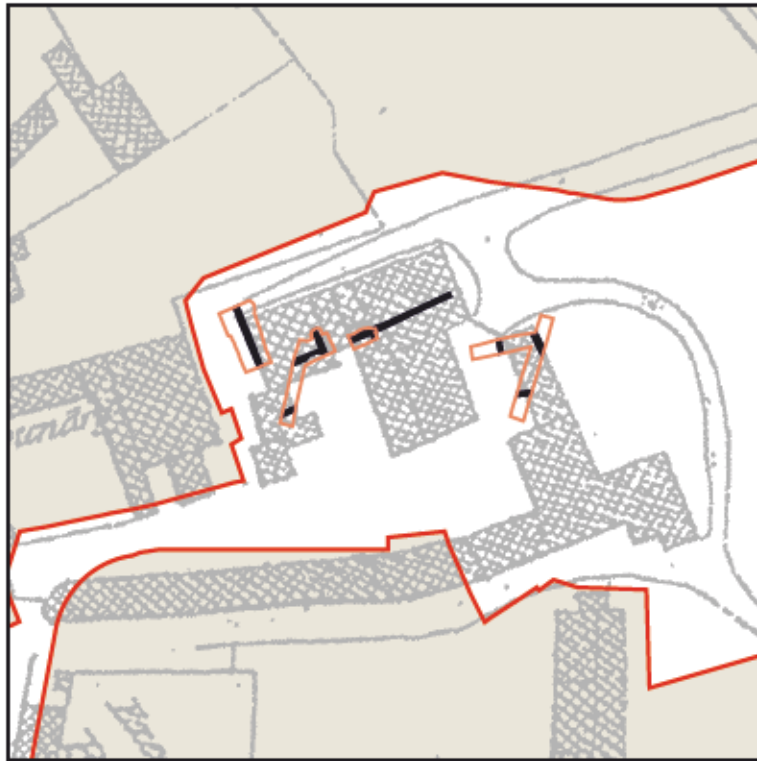
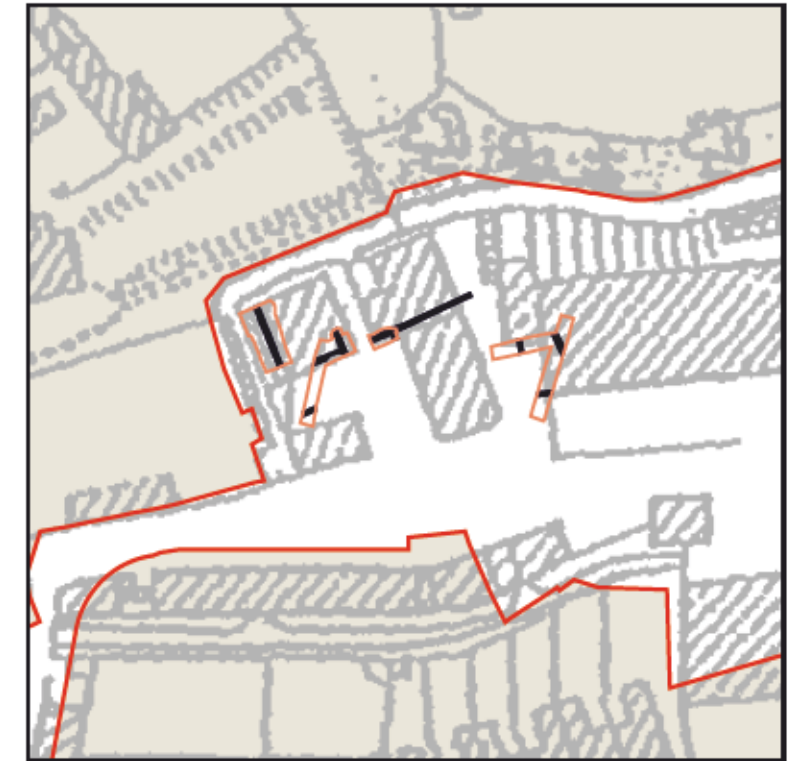
1842 map by John Wood

1885 Ordnance Survey map

1906 Ordnance Survey map

- 8.1.1 A good correlation of the excavated remains with historic mapping of the Site could be made and is shown in **Figures 3 a-c**.
- 8.1.2 **Buildings 1 and 2** are indicated on John Wood's map of 1842, although the presently recorded form of **Building 2** may represent a later remodelling (perhaps representing the layout mapped in 1885 and 1906). **Building 1** was clearly directly contemporary with construction of the leat revetting wall, as was channel **Structure 44**. Bonded joints were observed at its junction with **Walls 36 and 42**.

- 8.1.3 **Building 2** was probably constructed later (possibly replacing an original pre-1842 building?). Its bonding material was unlike the white lime mortar used in **Building 1** and there was no evidence that its walls were ever bonded into the leat revetting wall. The presence of an indistinct, narrow vertical zone of mortar patches on the revetting wall may confirm that **Building 2** was butted onto the pre-existing structure. **Wall 104 (Trench 4)** represents a tertiary construction phase of an uncertain date. The iron pipe north of **Wall 44** may be a modification associated with the installation of water-turbines.

- 8.1.4 Channel **Structure 44** appears on the 1885 mapping of the Site. It is not illustrated in 1842, but its existence at this time can be inferred from its clear structural unity with building remains and the upper leat revetting wall. The complex of buildings mapped to the south in 1842 (including **Building 3**) overlie the projected line of **Structure 44**, and may have been constructed above an artificially roofed (perhaps vaulted?) conduit.

- 8.1.5 Within **Area 2**, **Wall 11** is probably the eastern wall of a narrow building mapped in 1842. The absence of a corresponding western wall may be a consequence of later building work. **Walls 4 and 16** are on perpendicular alignments, and were constructed using similar grey cement-based mortar. They are probably directly contemporary with each other, and are most likely to be part of the east-west aligned range of structures built after 1885 and mapped in 1906 as part of the 'Worsted Factory'.

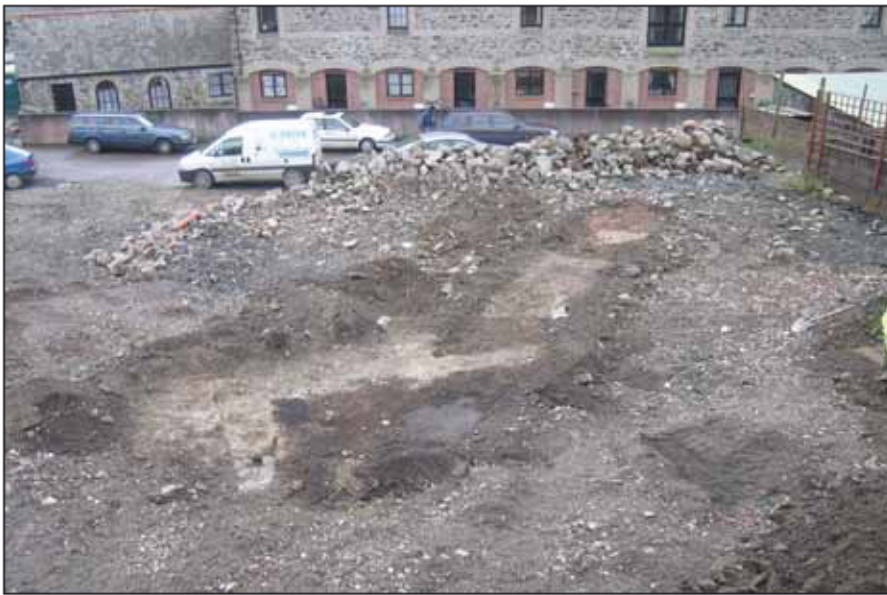
Plate 1: Trench 1 from the north west

- 5.2.2 At the northern end of **Trench 1**, the south-eastern corner of a building was exposed (**Building 1**), along with part of the narrow alleyway which separated it from a similar structure to the east (**Building 2**). The upper interface of these remains lay at the current ground-level, or immediately below a thin spread of redeposited rubble.

- 5.2.3 **Wall 36** was *c.*70m wide and built of white lime-mortar bonded slate, arranged so that the wall was roughly faced internally and externally. Partially overlying the truncated wall footing and occupying the area south of the **Building 1** was a demolition layer, **Context 33**, comprising up to 0.2m of mixed, redeposited mortar and slate fragments. On the eastern arm of **Wall 36**, a structural modification was evident: part of original wall had been removed and the resulting gap subsequently re-blocked with a narrower insert (**Context 37**), this time 0.5m wide and of slate and dark grey cement.

- 5.2.6 At the southern end of **Trench 1**, a single east-west aligned wall base (**Wall 30, Building 3**) was 0.5m wide, with slate facing stones on both edges and a rubble core. The whole wall was bonded with white lime mortar. Immediately south of **Wall 30**, a small (1m by 0.75m) patch of stone rubble in white crushed mortar (**Context 31**) may be demolition-related, or alternatively be a remnant of hardstanding/floor.

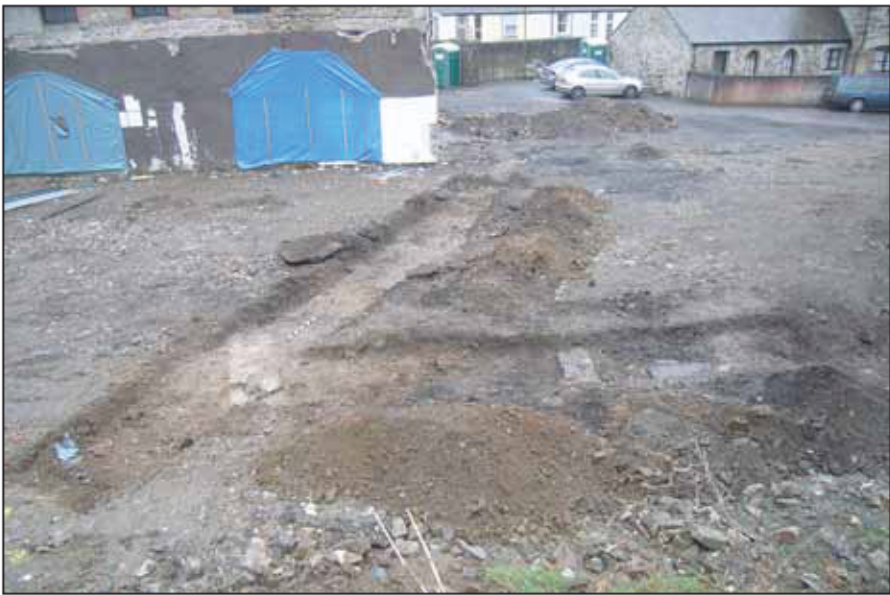
Plate 3: Trench 2 from the north west

- 5.3.2 At the northern end of **Trench 2** was a NNW-SSE aligned wall base (**Wall 11, Building 4**), 0.75m wide and consisting of undressed slate slabs and blocks, arranged to create rough facing to both sides. The wall core was of rubble, and the whole wall was bonded with white lime mortar

- 5.3.3 To the south, another wall base (**Wall 4, Building 5**) was aligned nearly east-west. This was 0.5m wide, and constructed of large slate and other stone pieces, along with brick and tile rubble, bonded with a coarse blueish-grey mortar. **Wall 4** was constructed within a 0.8m wide construction cut (**Context 3**), which had itself removed the southern half of partially-exposed sub-circular feature (**Context 23**), perhaps the remains of a small founding pit. The pit (**Context 23**) was not excavated, but two fills were evident: an upper disuse deposit (**Context 7**) comprising rubble material, and a lower fill (**Context 8**), a compact, black and 'oily' soil.

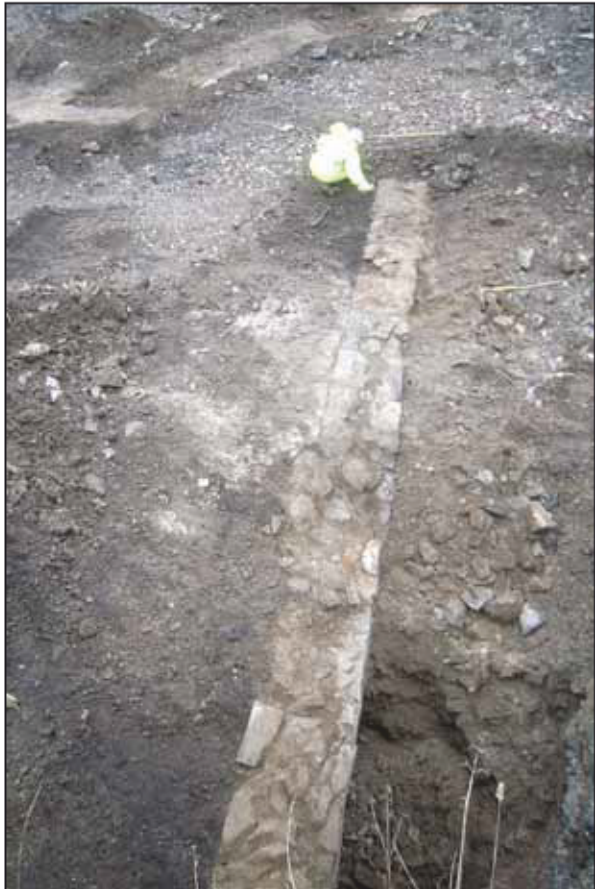
Plate 4: Walls 101 (foreground) and 100 (background), from the north west

- 5.2.14 **Wall 100 (Building 2)** was aligned NNE-SSW, of slate (and ?limestone) construction, roughly faced on its edges with a rubble core, and bonded with a soft mid-grey sandy mortar. Its construction appeared integral with the lower revetting **Wall 101** to the east, which had more recently been capped with modern cement. To the south, perpendicular **Wall 104** was 0.55m wide, and evidently of later construction: its northern end clearly butted against **100**.

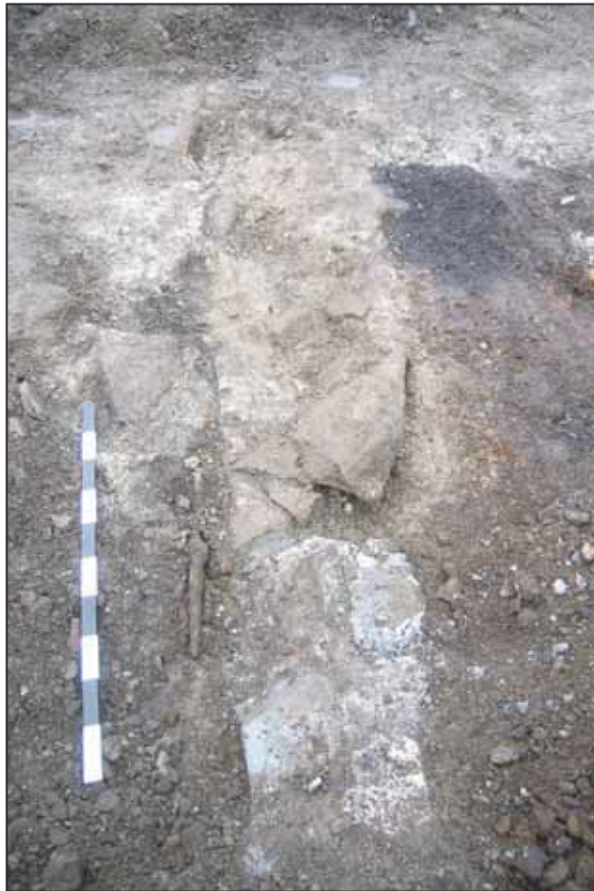
Plate 2: Trench 1, wall 38, from the north west

- 5.2.5 Immediately east of the building, a dumped deposit, **Context 38**, probably relates to demolition of **Buildings 1** and **2**. Partially exposed amongst this material was part of a rusted iron sheet, resting flush against the outer south east corner of the building.

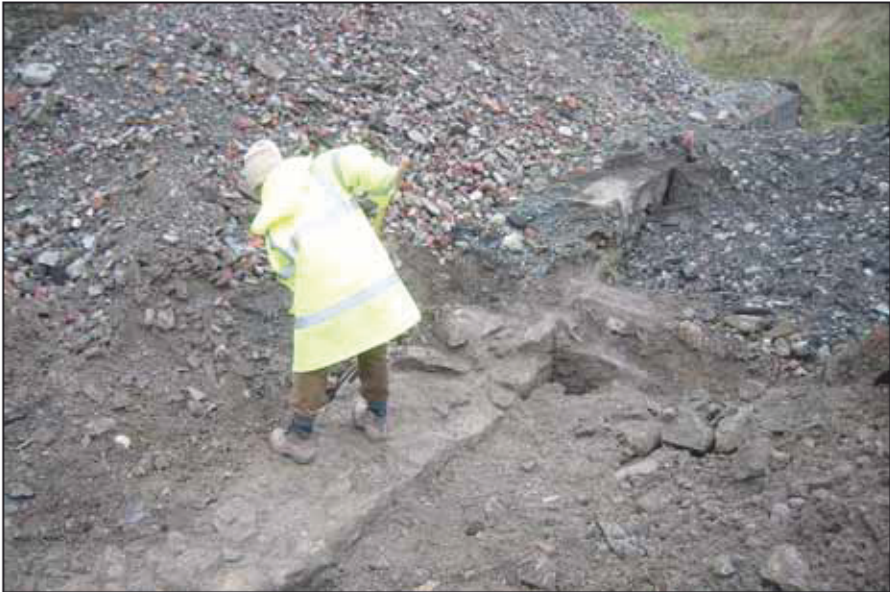
Plate 5: Wall 104 (to right) butting wall 100, from the south west
