# Castleward, Derby

Archaeological Excavation Report

Ref: 100160.02  
October 2013

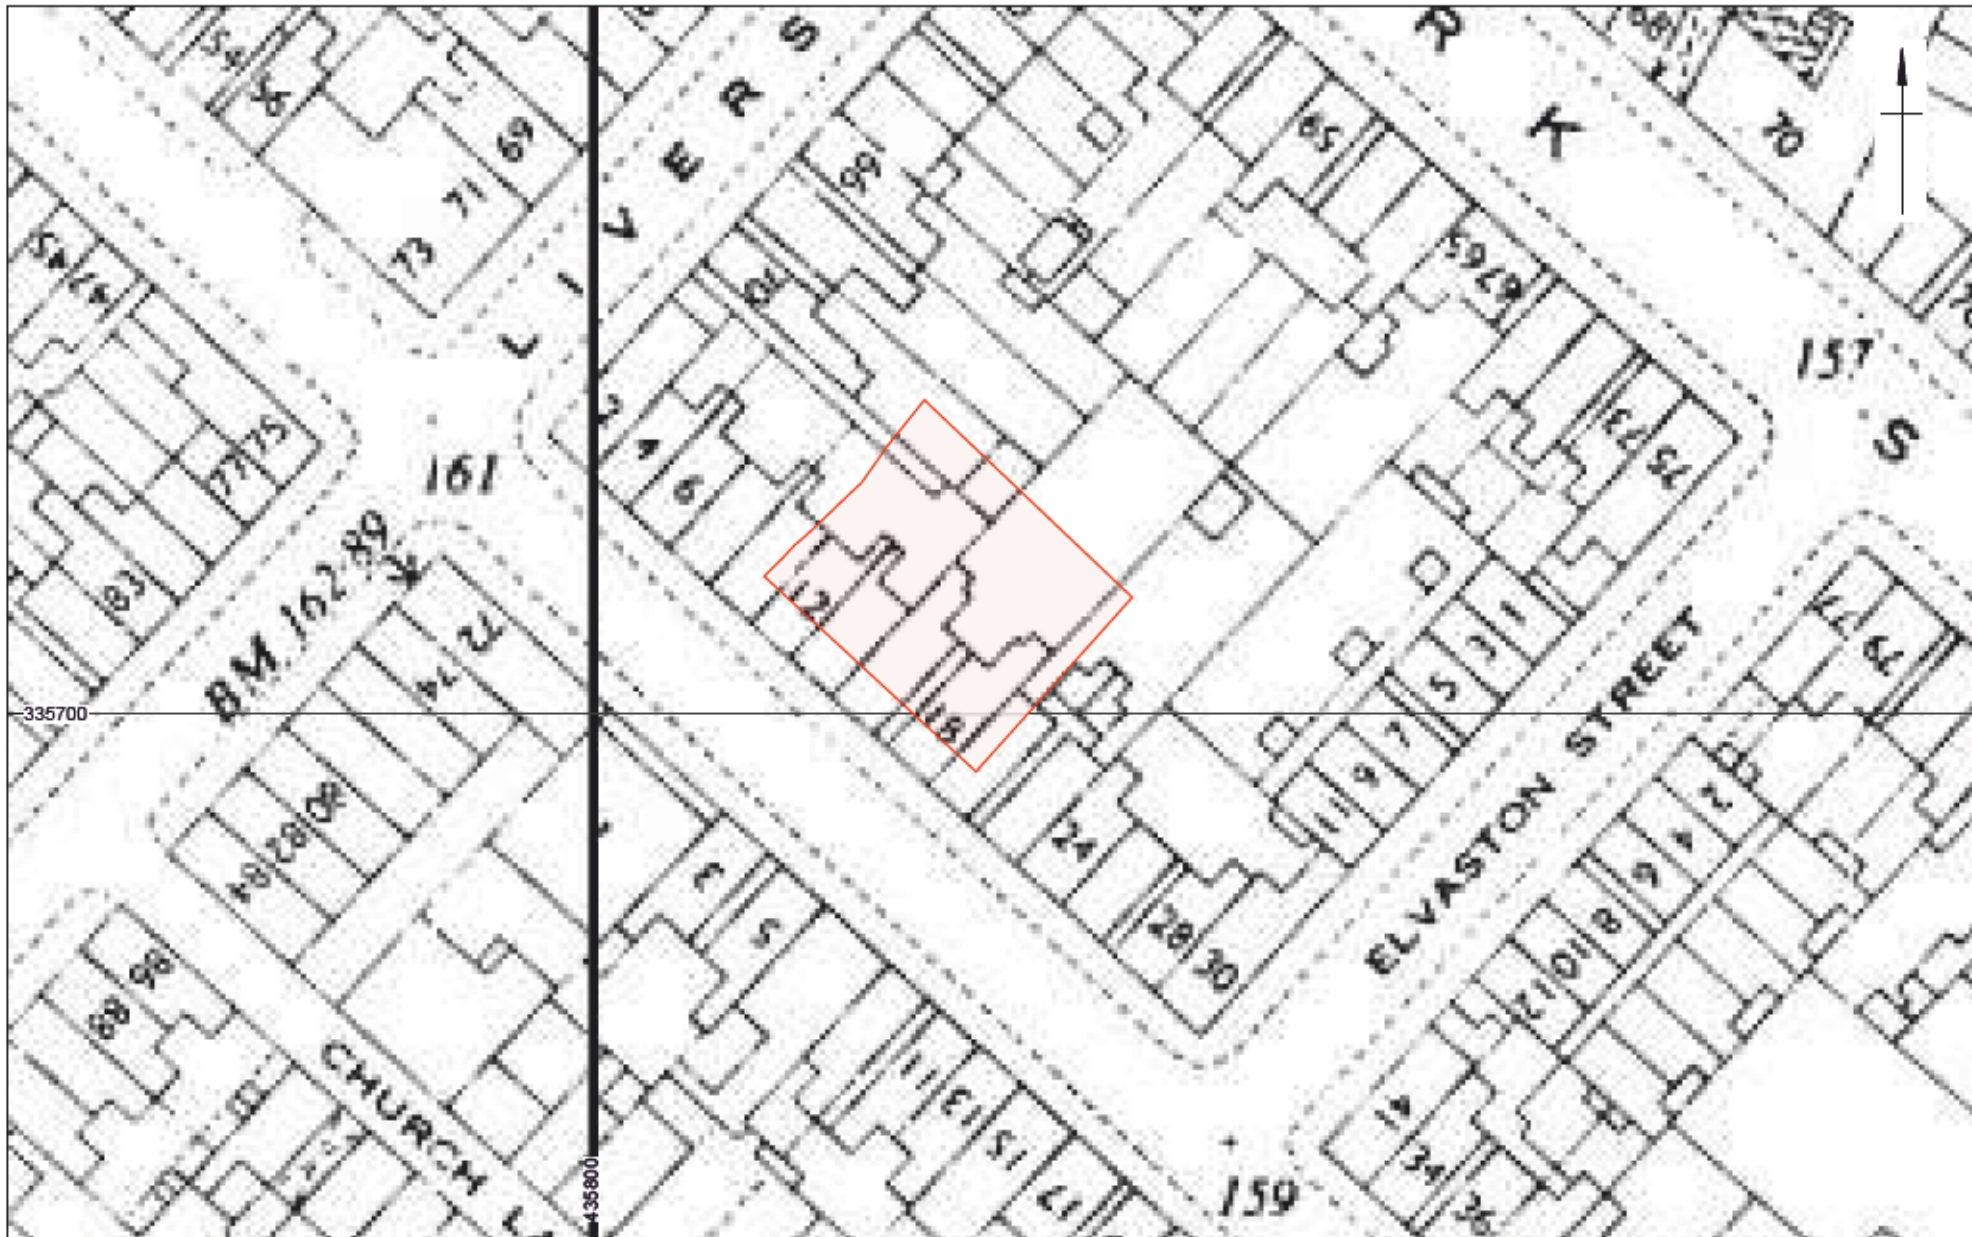
Figure 2

Site overlain on the 1852 Ordnance Survey map

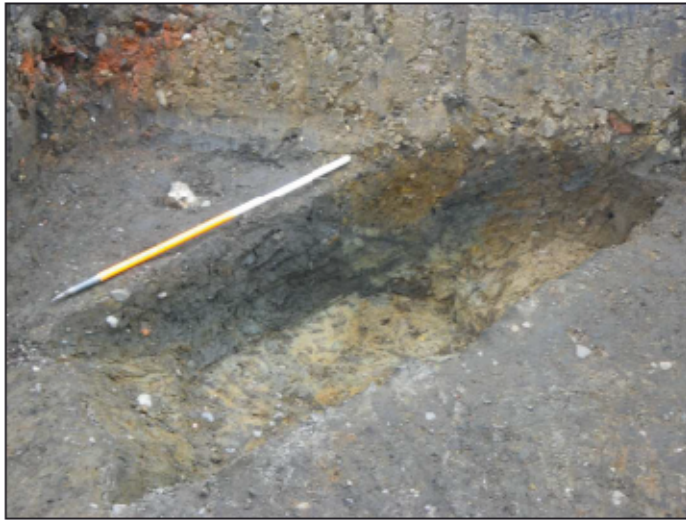
Section through features 1006 & 1112, looking east

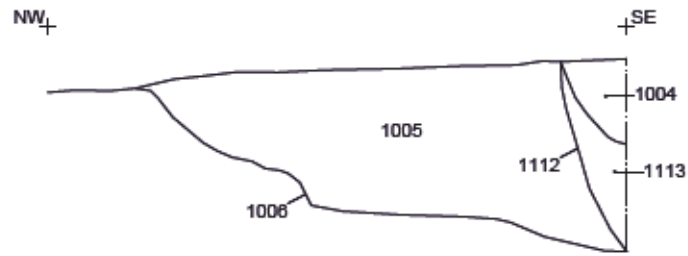
Section through features 1006 & 1112, 1:20

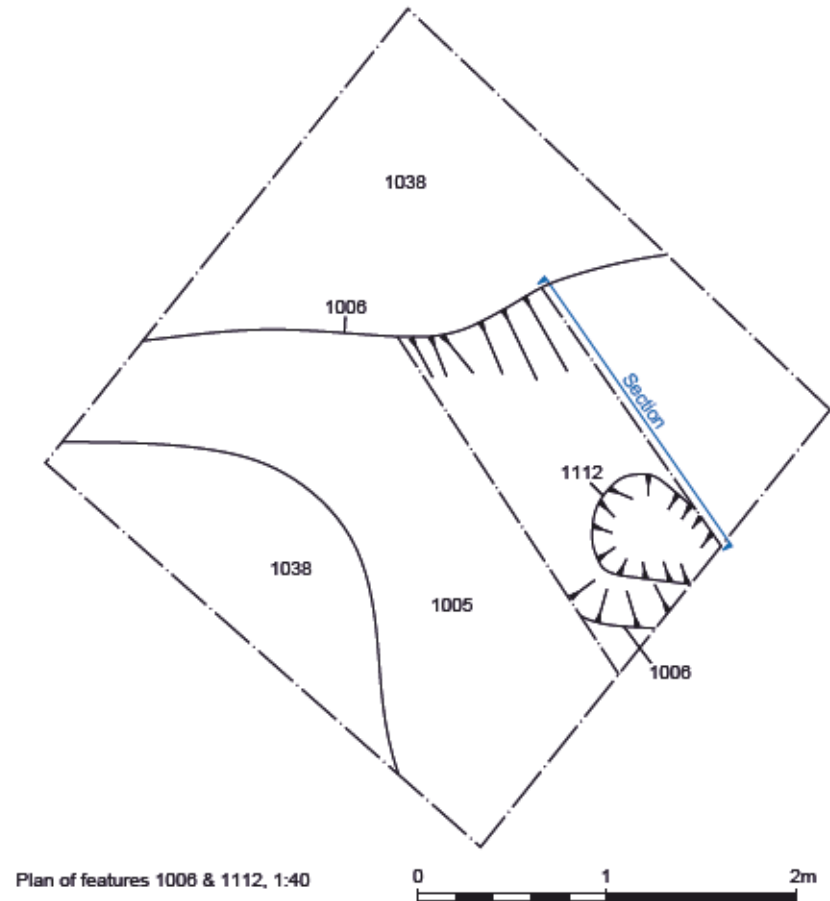
Plan of features 1006 & 1112, 1:40

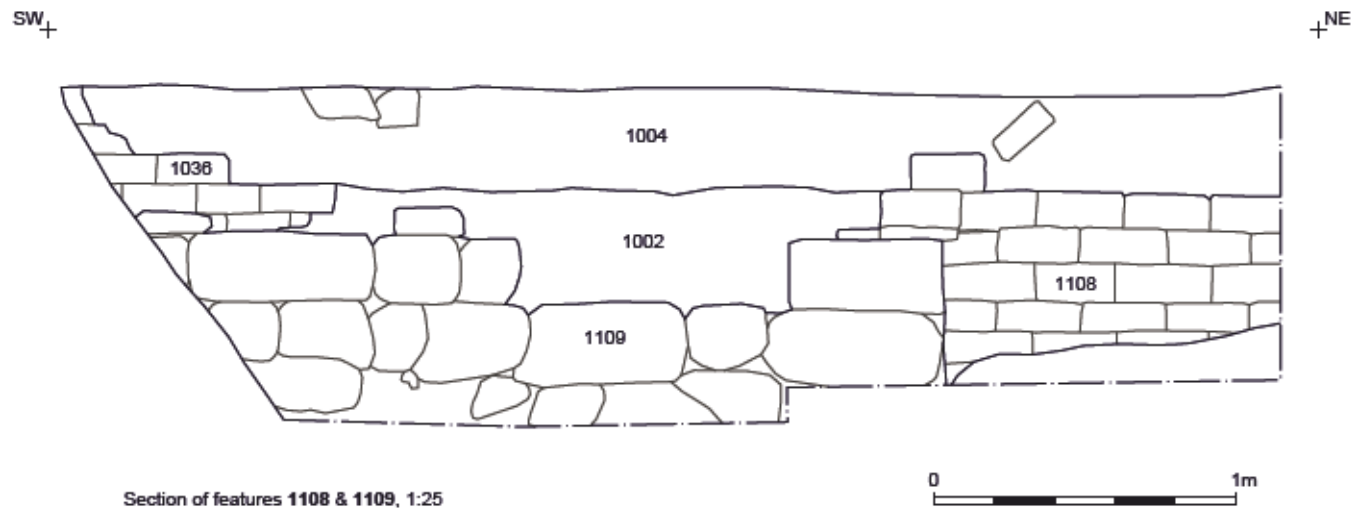
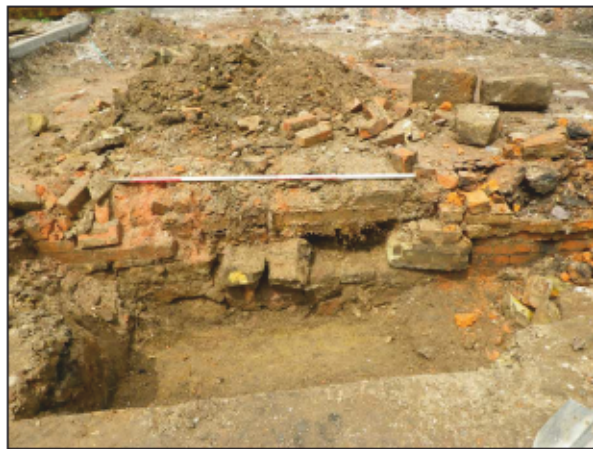
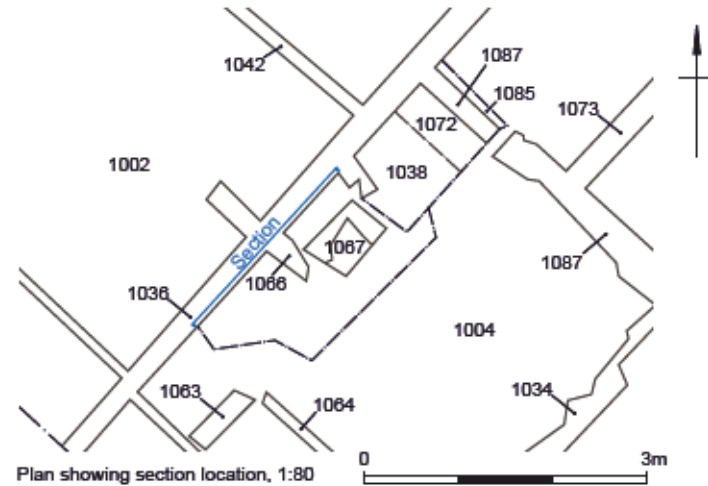
Section of features 1108 & 1109, looking north-west

- 4.4.3 Foundation **1109** was revealed only in section (**Figure 5**). It measured over 3m long by 0.4m wide by 0.65m high and comprised three regular courses of re-used sandstone blocks mortared together to form a relatively smooth-faced structure. Abutting this (and again only visible in section) was red-brick structure **1108** which measured over 1.1m long by 0.12m wide by 0.88m high and consisted of at least seven courses. The upper two courses of **1108** appeared to be integrated into the fabric of wall **1036**. Brick structure **1108** had also been laid directly onto Phase 1 deposit **1072**.

4.6.2 Wall **1042** at the rear of Houses 12 and 14 was built on sandstone foundation structure **1109** (where this butted against wall **1108**; **Figure 5**). The brick courses of wall **1042** had been identified in the evaluation trench as wall **245** on a sandstone foundation **246** (**Figure 3**). Houses 12 and 14 were separated by brick wall **1040/1044/1048** which was keyed into **1042**.

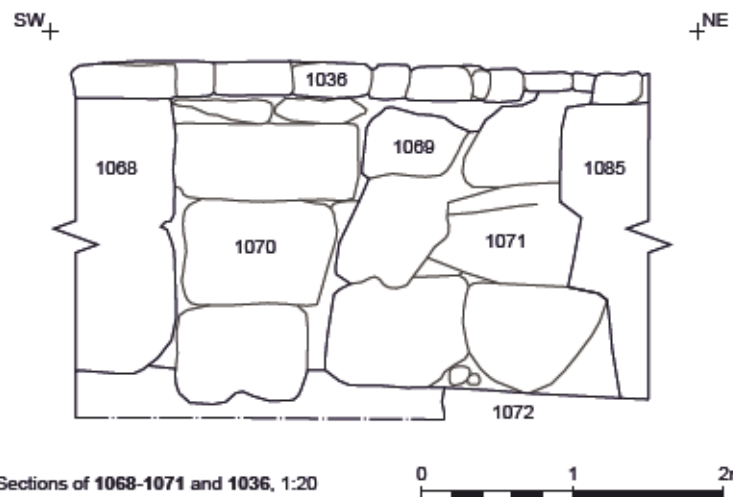
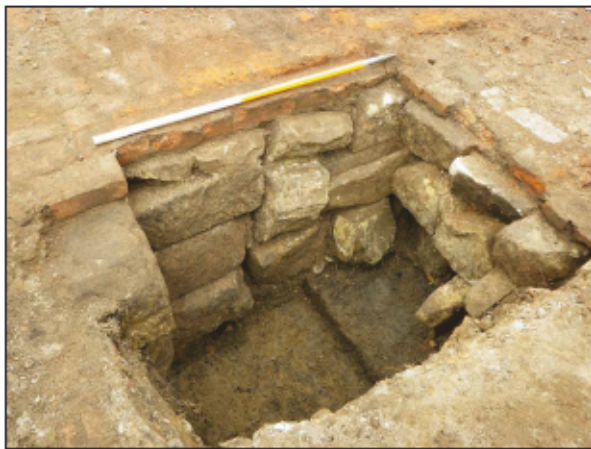
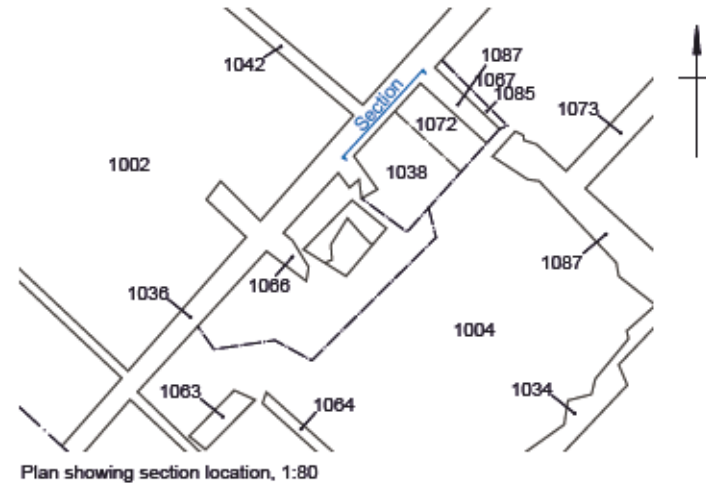
Features 1068-1071 and 1036, looking north

- 4.4.4 The southwest sides of foundations **1108** and **1109** were abutted by four rough sandstone foundation blocks (**1068-71**). Block **1071** was a re-used stone lintel or sill. The majority of mouldings and decorations had been removed from the stone but it had two dressed faces which had retained a chamfered edge and bowtell moulding. The broken masonry cannot be dated, but was clearly re-used from an earlier higher status building of unknown location. The sandstone these blocks were also overlain by wall **1036** (**Figure 6**).

- 4.4.5 Sandstone foundations also lay beneath the rear wall of House 16 (foundation **1085**, wall **1087**; **Figure 6**). Although only one brick course survived, it was clear that wall **1087** was keyed into brick wall **1036** at its northwest end.

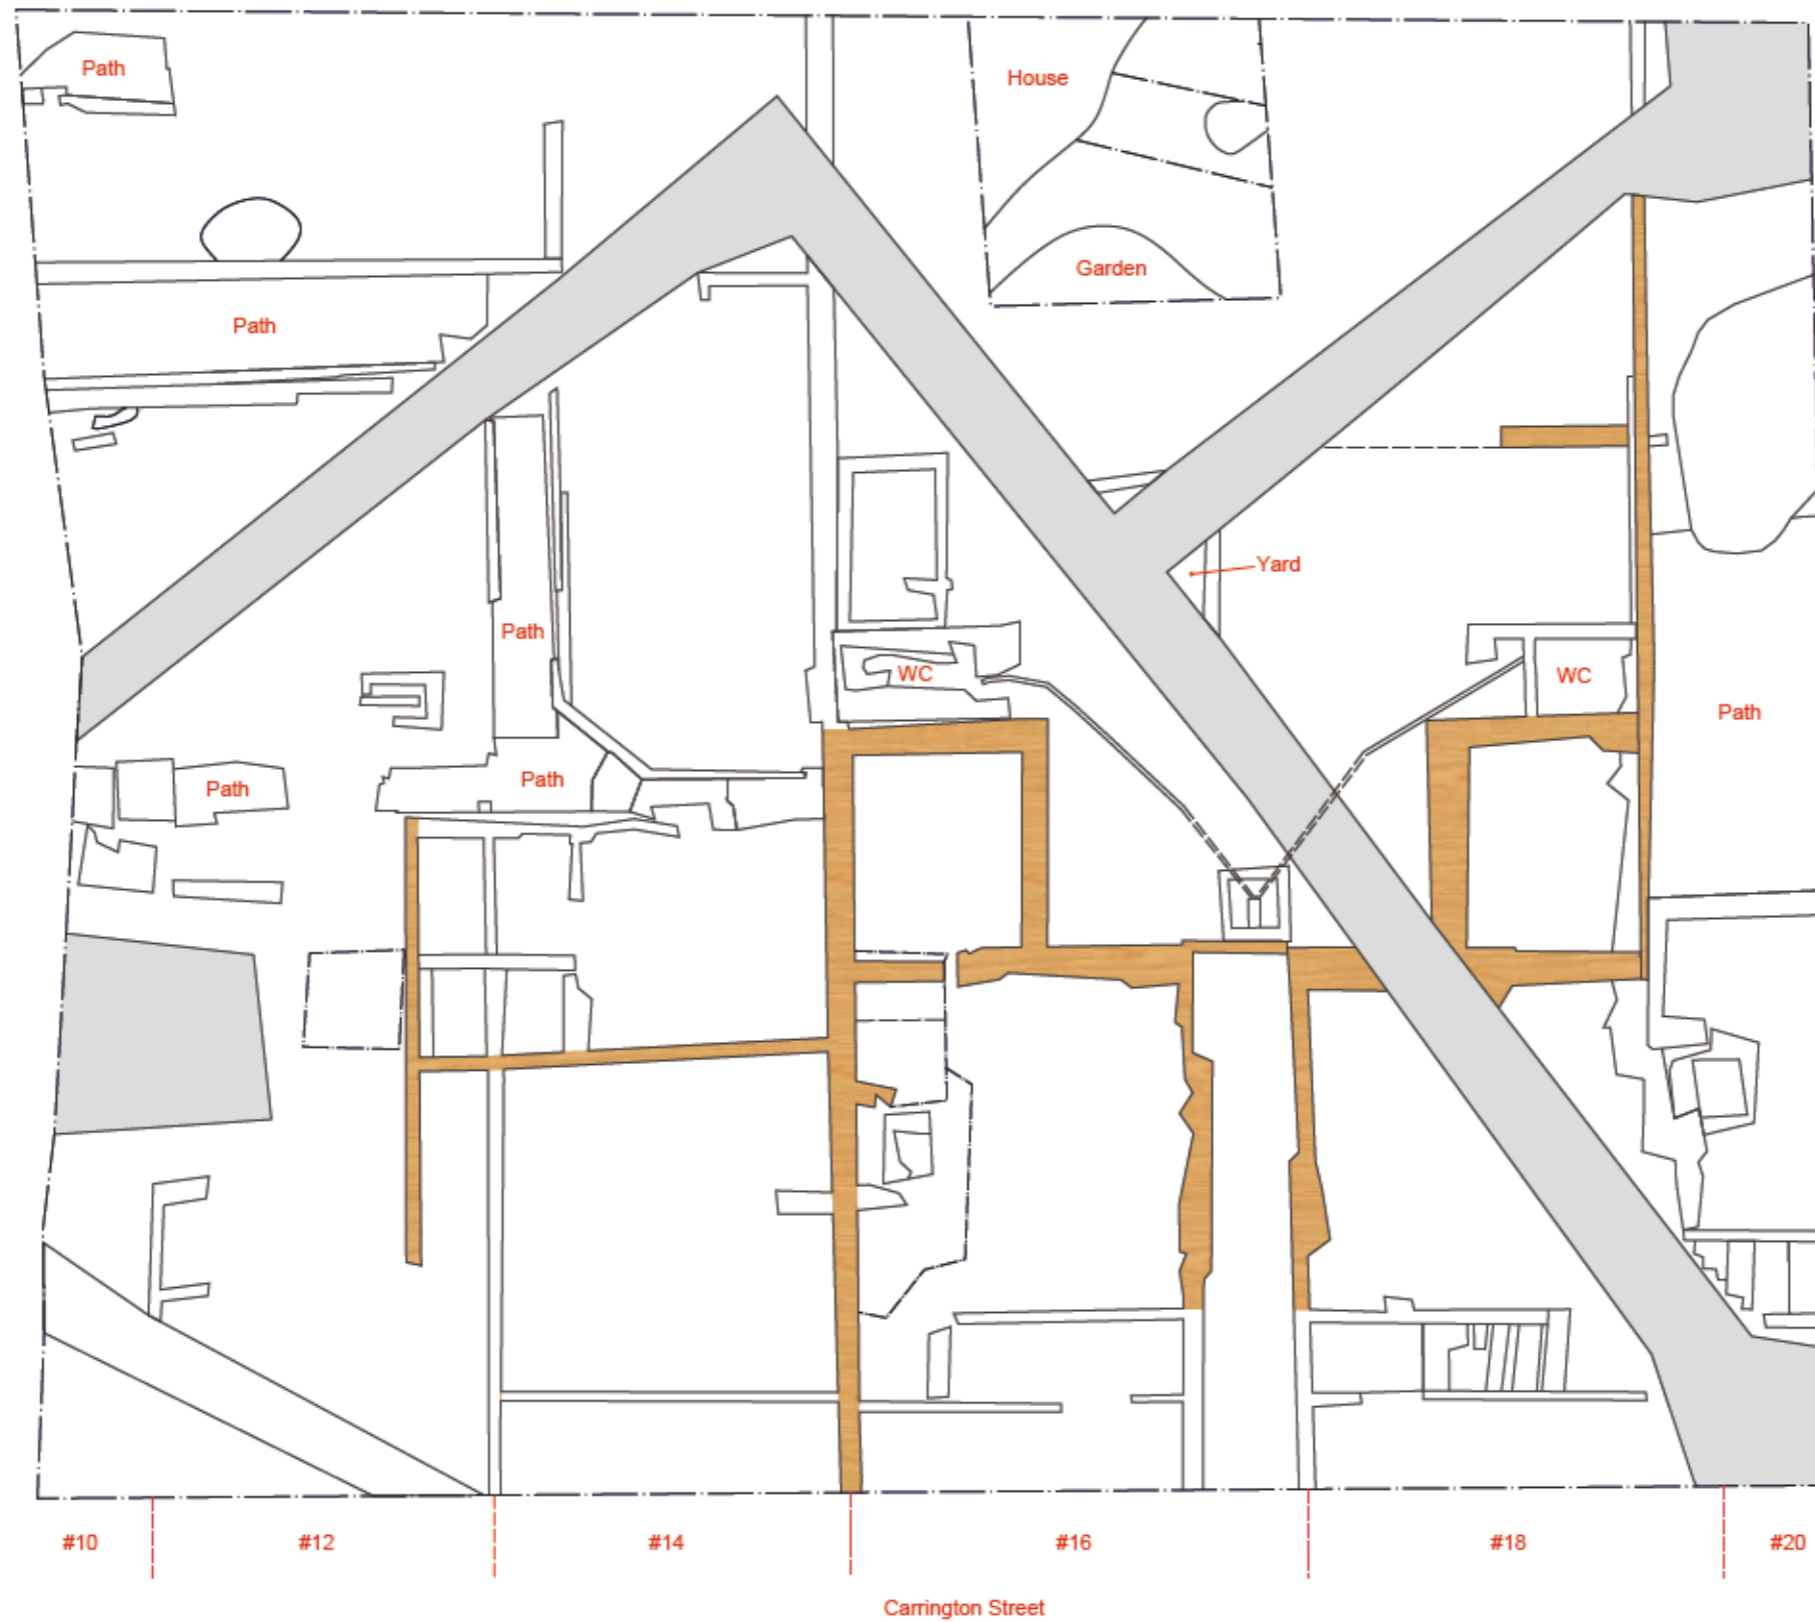
Figure 7

Plan of sandstone foundations

- 4.4.1 Excavation revealed that the properties had been partly constructed on sandstone foundations and partly on brick. Sandstone foundations appear to have only been used beneath the rear rooms and yard buildings of the properties (**Figure 7**). The front of the houses, where cellars were evident in Houses 18, 16 and 14, were supported on brick foundations (**Plate 1**).

brick-built cellars whilst the walls to the rear of the properties were founded on sandstone blocks. However the wall separating Houses 14 and 16 returned to brick foundations beyond the rear yards (**Figure 7**). Moulding and decoration on three of the sandstone blocks provided evidence that reclaimed masonry was being utilised for the foundations of Carrington Street. Although this stone appears to have been used previously in a higher-status building, the source property cannot be determined. Given the scale of development in the Castleward area in the mid-19th century, it is likely that there was great demand for building materials, and sources beyond the local area may well have been used.

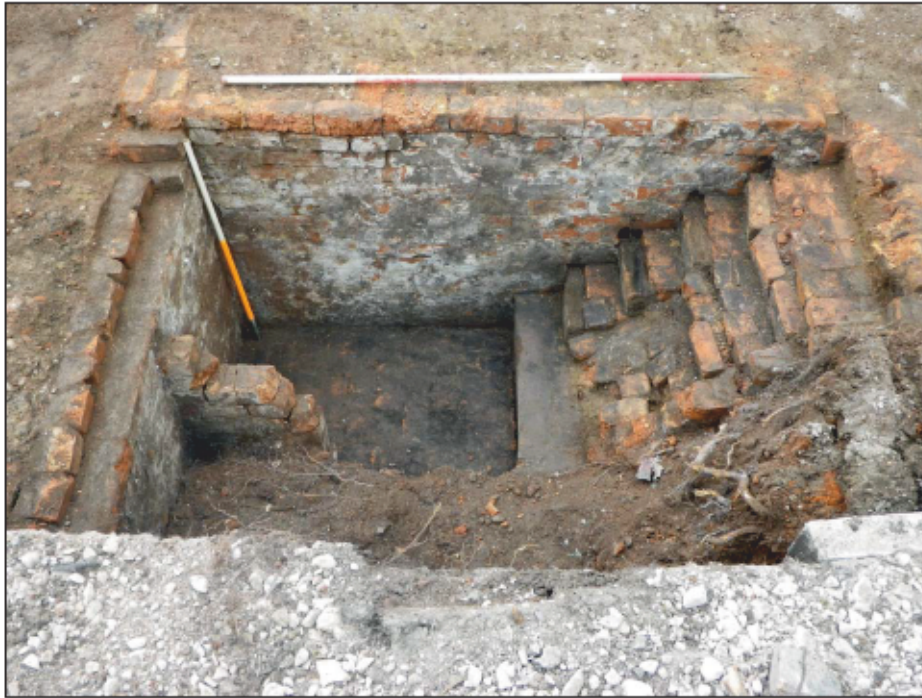
Plate 1: House 18 cellar, steps and walls

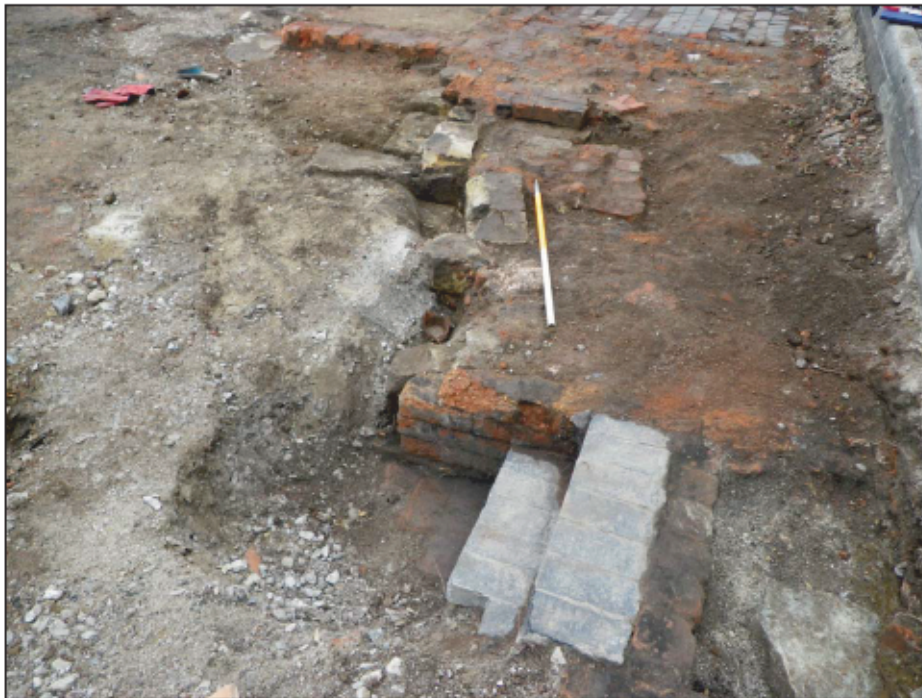
Plate 2: Wall 1008, steps 1007 and brick pad 1011

- 4.5.6 The rear room of House 18 measured 3.8m by 3.35m and was represented by walls **1027**, **1031** and **1020**, foundation **1008** and clay floor **1004** (**Figure 3**; **Plate 2**). Sandstone foundation **1008** appeared in plan to be angled away from the general room alignment but this may have been accentuated by later truncations (a modern drain and cut **1010**).

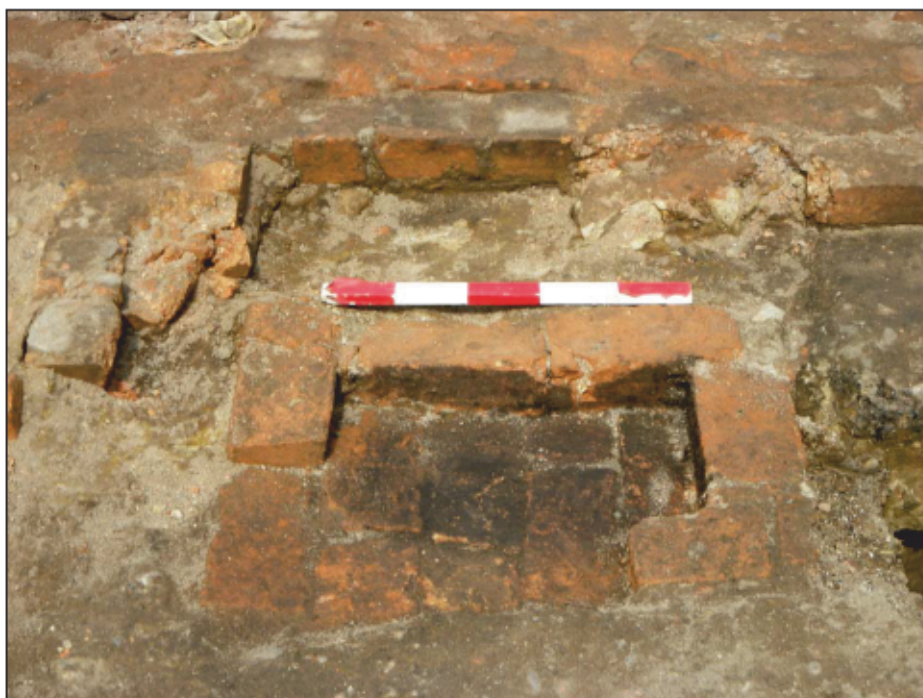
Plate 3: Hearth /Fireplace 1067

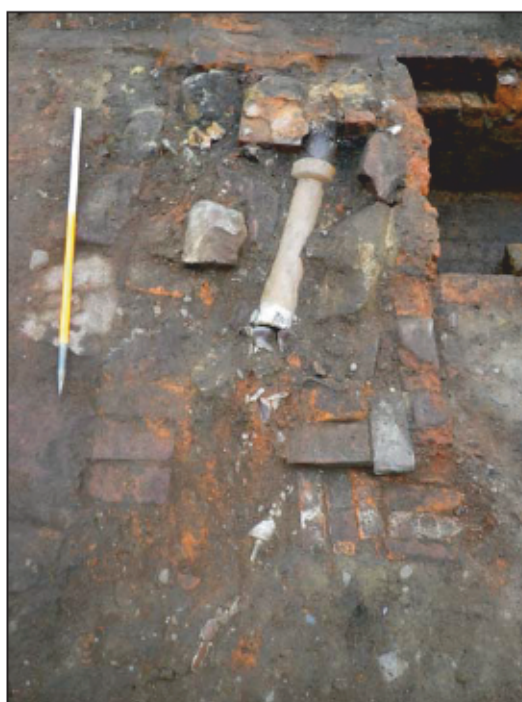
Plate 4: Privy 1075

- 6.1.5 The excavation of one of the outside privies and a manhole to the rear of Houses 16 and 18 revealed that the pipework associated with the toilet appeared to be located within shaped sandstone blocks laid within a highly confined space, above the clay layer which was found across the Site. The clay layer was part of the original build and provided yard surfaces and level floors within the rear rooms of the houses. Similarly, the brick manhole containing pipes from the outside privies was found to be abutted by the clay layer. No evidence of the re-building or demolition that would result from the later insertion of sewerage was identified and it is concluded that the drainage and sewerage was part of the original design and construction. This is significant because of the pre-1852 date of the construction of the houses.

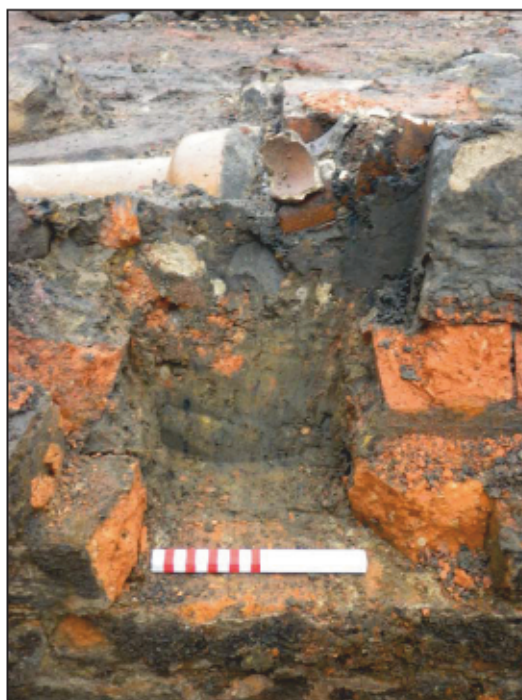
Plate 5: Clay 1004 below downpipe in Privy 1075

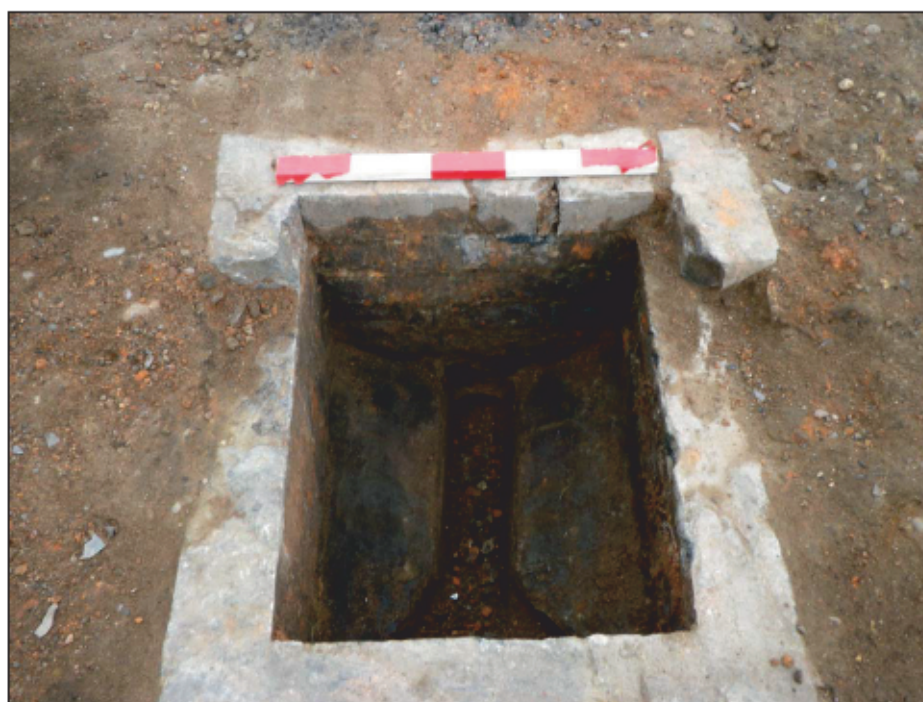
Plate 6: Drain manhole 1032

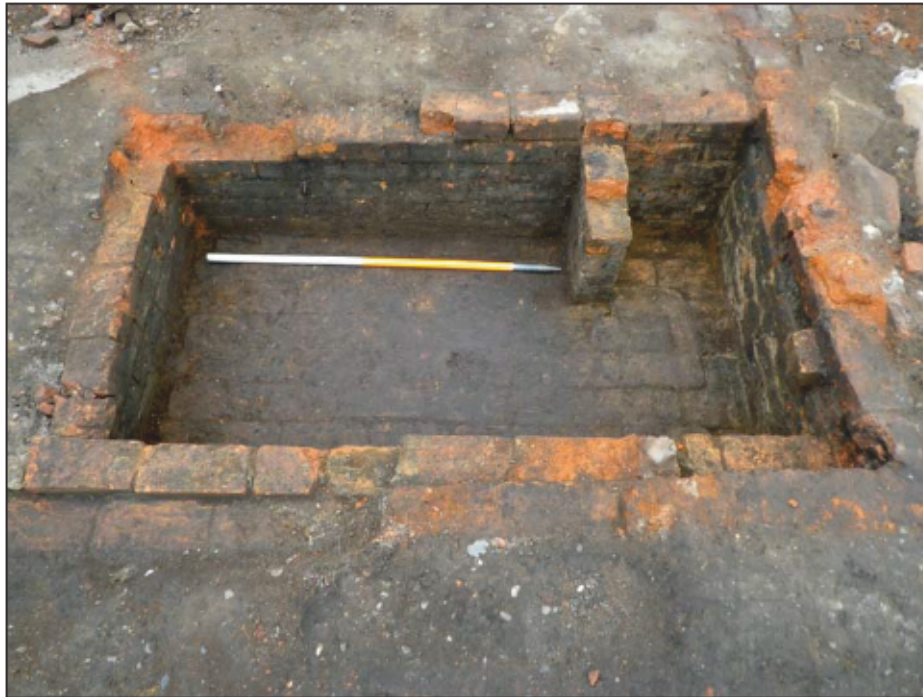
Plate 7: Structure 1008
