Newbury Racecourse Car Parking Area, Newbury, West Berkshire

Post-excavation Assessment Report

Report reference: 70092.03

November 2010

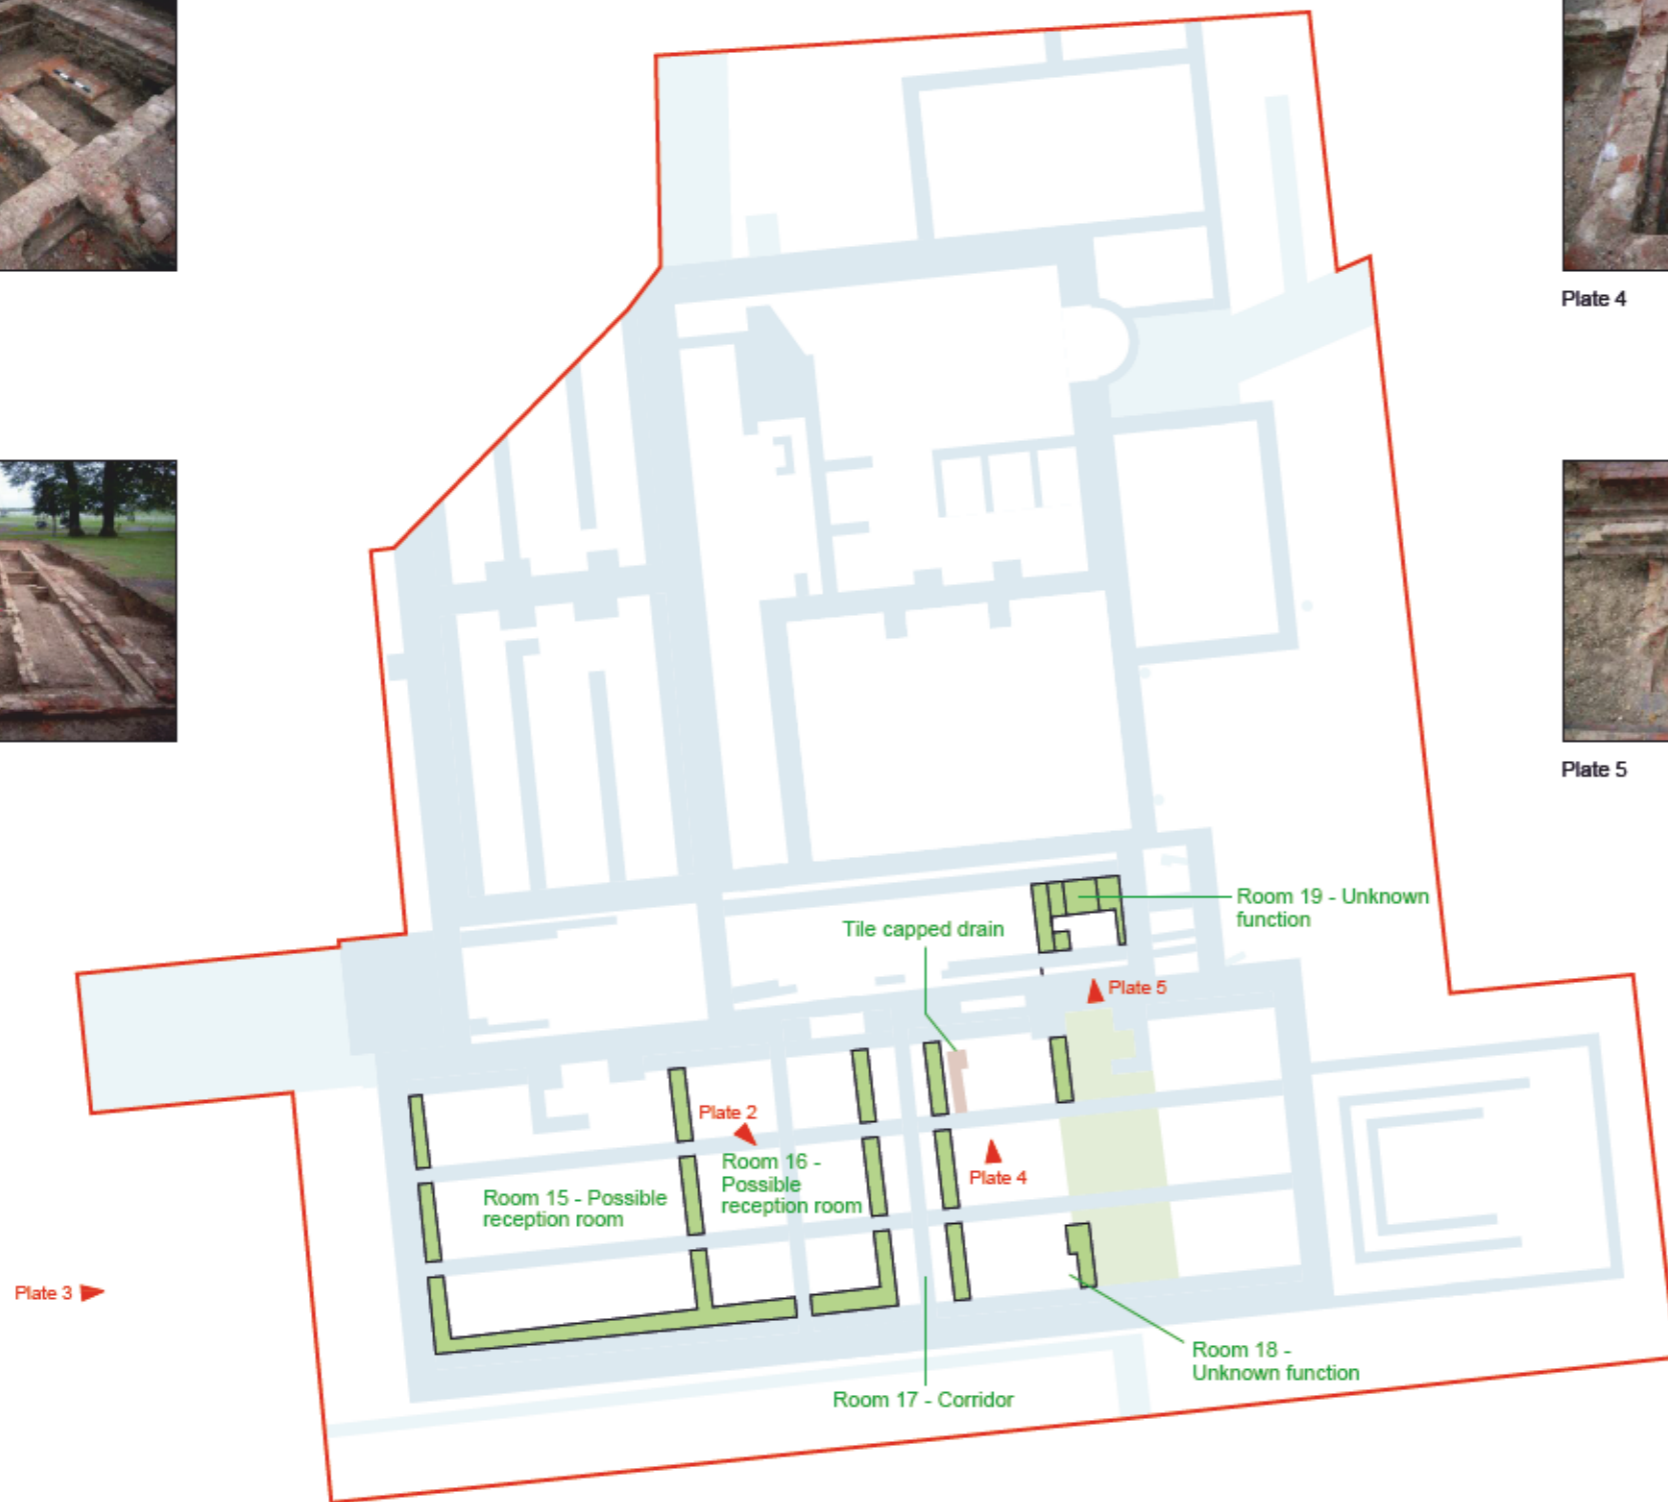
Figure 3

Floor plan of the Phase 1, Greenham Farm, structure and associated plate thumbnails

- 5.3.5 Elements of an earlier phase of building were identified beneath the southern range of the Round Oak floorplan. Sufficient wall lines of the rectangular structure, surviving as foundations and the lowest courses of the walls, survived to indicate that it was aligned north-south and that it stratigraphically predated Round Oak.

- 5.3.8 The external wall foundations, which were identified on the south and west of the Phase 1 building (**Figure 3** and **Plate 3**), were constructed of 13 inch English bond, with the two interior wall lines of 9 inch English bond.

- 5.3.10 The northern wall lines of the Phase 1 house were not exposed but may lie immediately beneath the north boundaries of Rooms 11, 12 and 13 of the later Round Oak building. A hand excavated test pit which was dug in the corridor (Room 9) of Round Oak, towards the centre of the original building, found no trace of the continuation of the earlier building with the exception of a possible external structure / boiler base (Room 19) to the northeast of the remains.

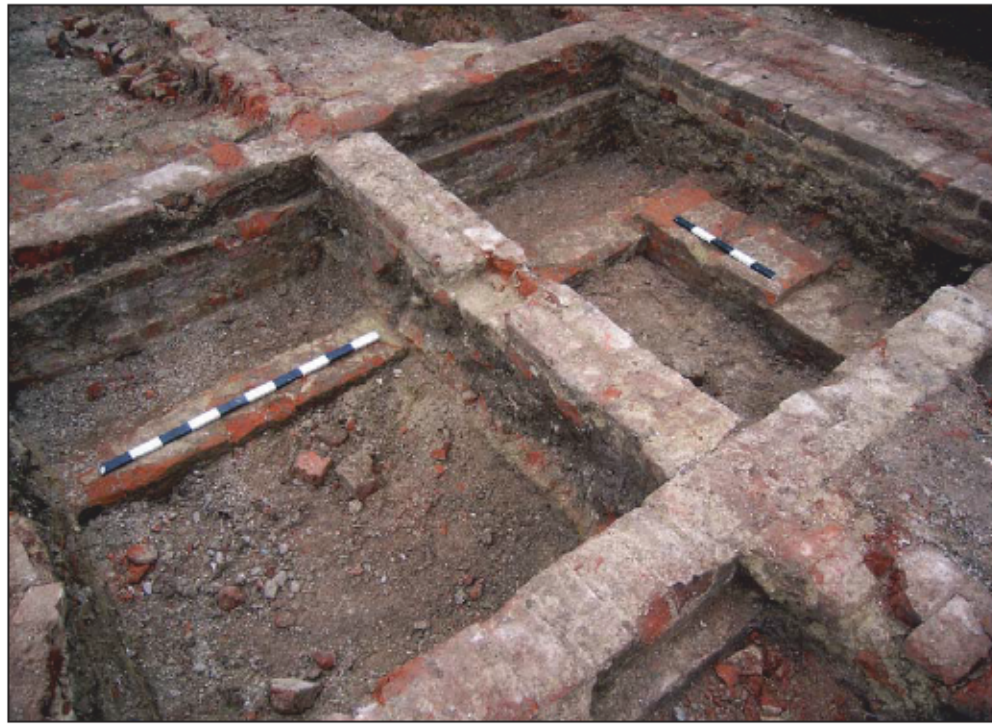
Plate 2: Corridor (Room 12) with the earlier wall lines of Room 16 below, viewed from the north-west

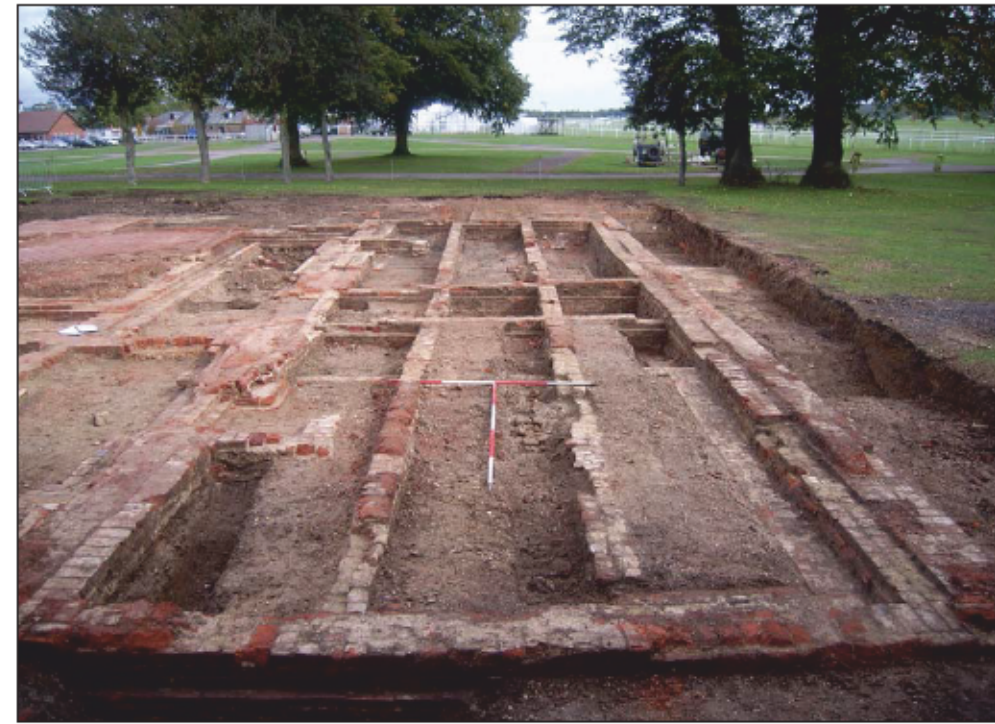
Plate 3: View of southern range, from the west, showing Phases 1 and 2 of the structure

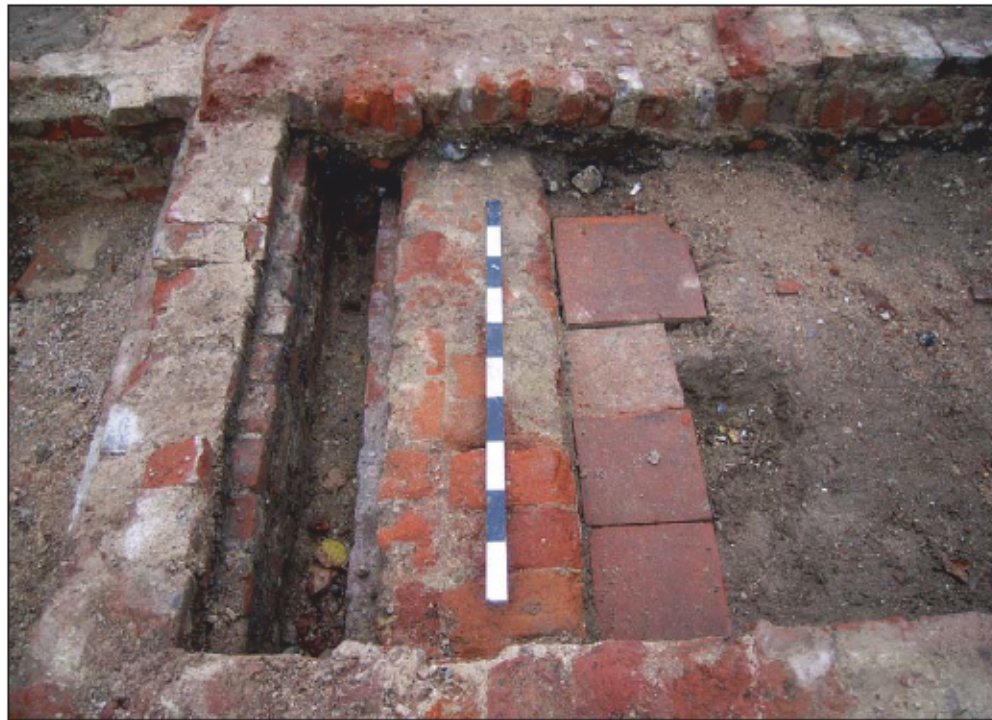
Plate 4: Detail of eastern side of Phase 1 corridor (Room 17), viewed from the south, showing the adjacent tile-capped drain

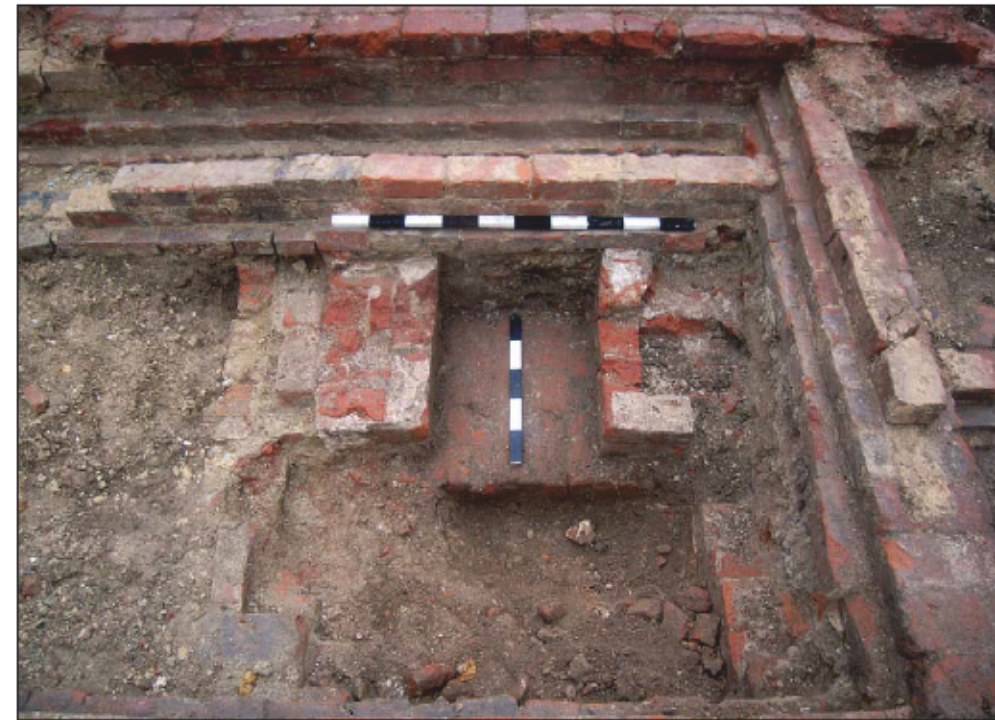
Plate 5: Brick construction of unknown use (Room 19) associated with the Phase 1 building, viewed from the south

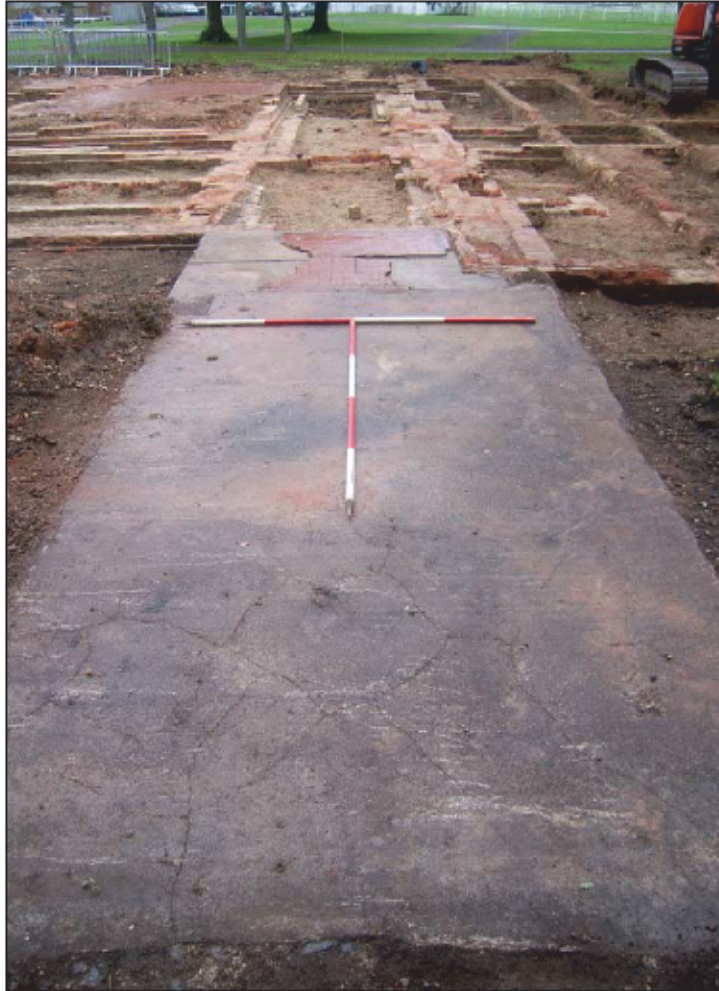
Plate 6: Main entrance leading into the central corridor (Room 9), viewed from the west

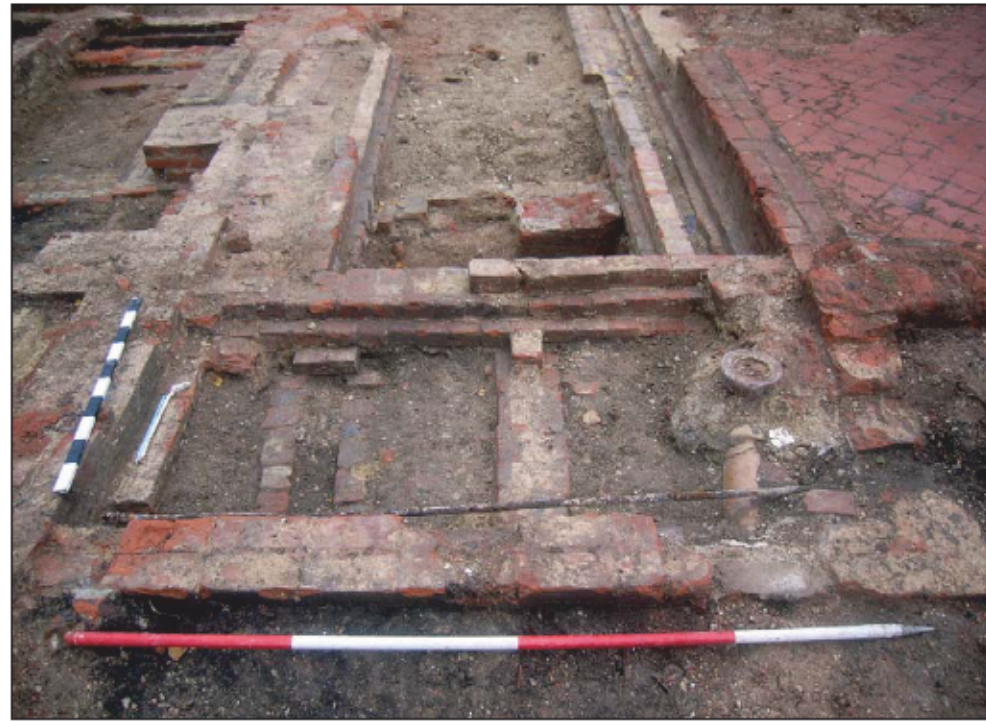
Plate 7: Toilet block (Room 8), viewed from the east

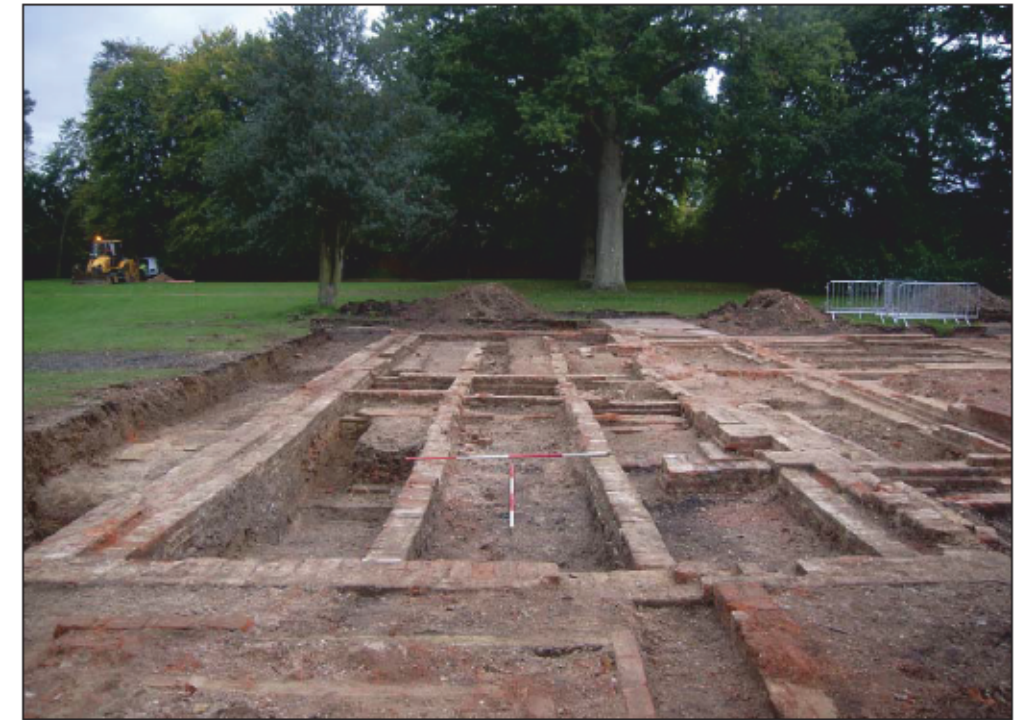
Plate 8: Reception rooms (Rooms 11 and 13) and central corridor (Room 12), viewed from the east

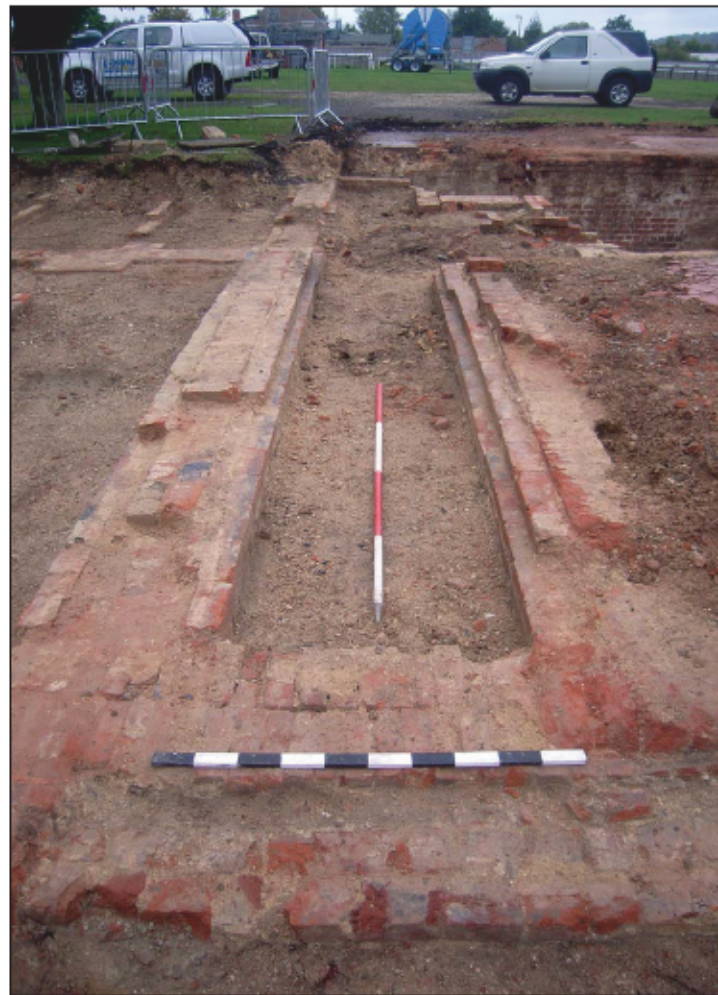
Plate 10: Corridor (Room 5) leading to the cellar (Room 1) and rear entrance, viewed from the south

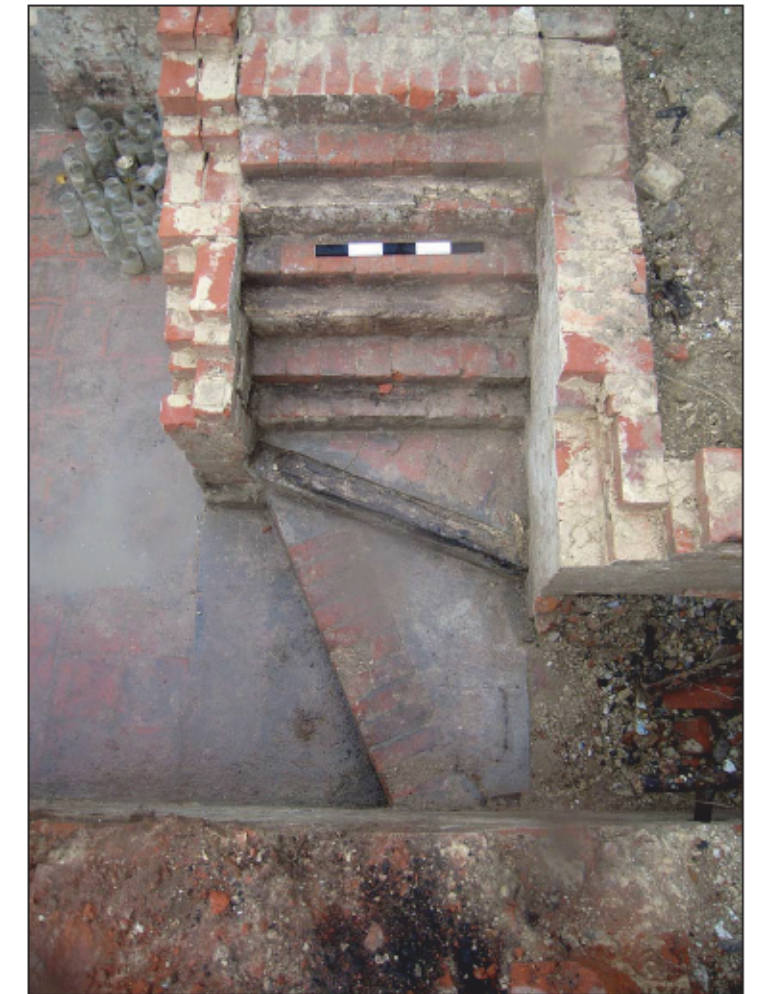
Plate 12: Stairs into the cellar (Room 1), viewed from the north

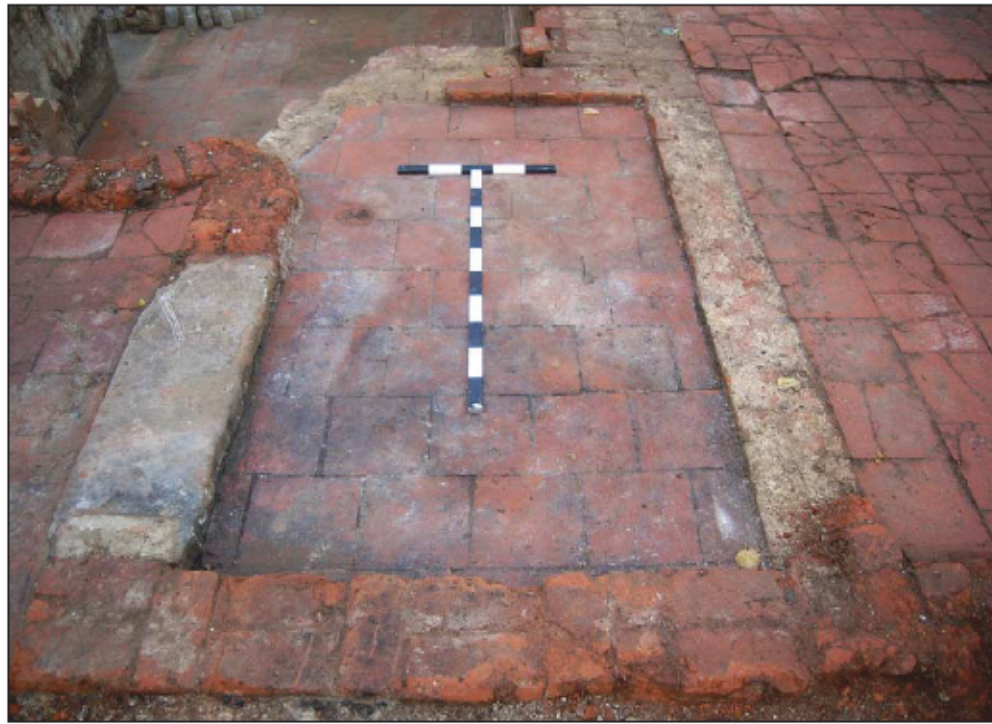
Plate 14: Outbuilding (Room 3), viewed from the east

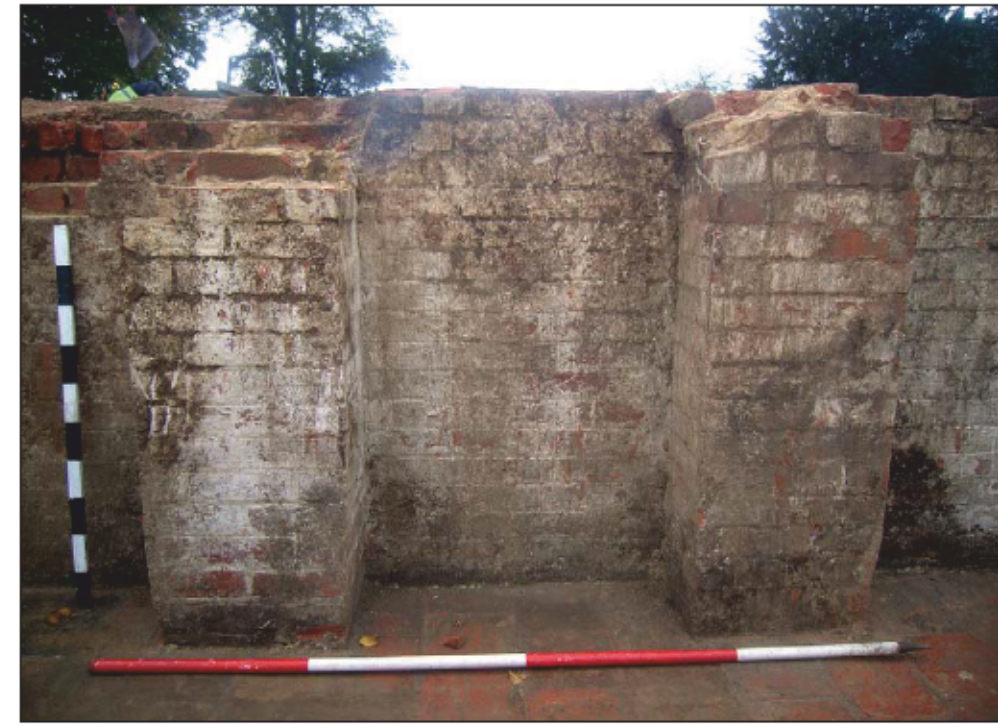
Plate 15: Chimney base in the cellar (Room 1) associated with the postulated kitchen above, viewed from the north

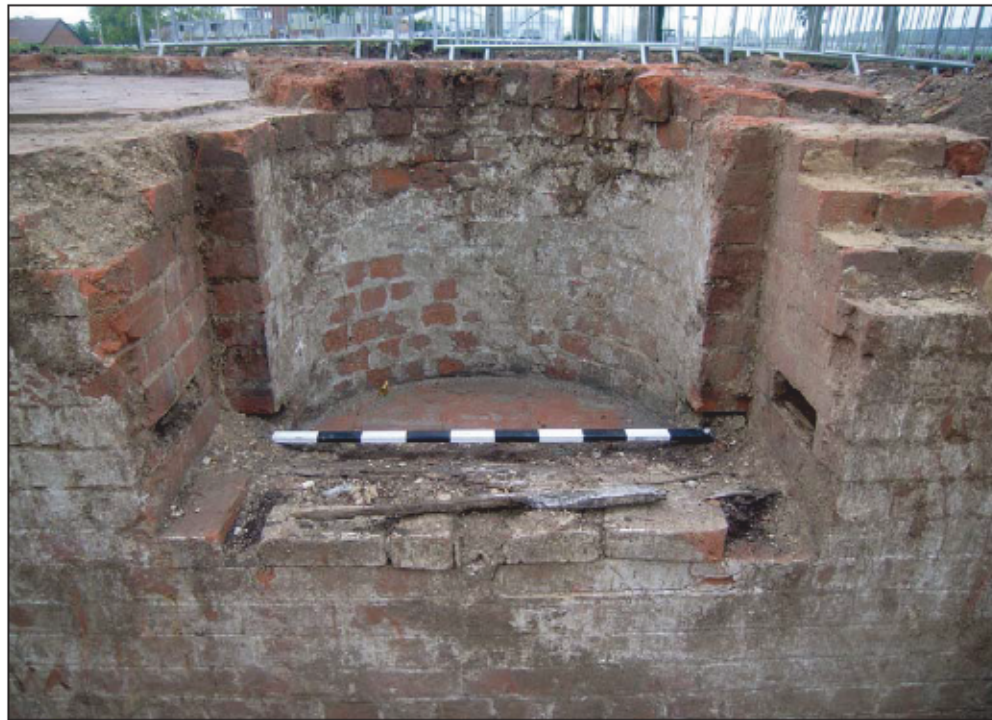
Plate 16: Cellar light in section, viewed from the west

- 5.3.26 The cellar (Room 1), which was divided into two areas by a central partition, would have been illuminated, in the northern area, by a semi-circular, glazed cellar-light in its northeast corner (**Plates 16 and 17**). The southern area of the cellar was internally partitioned and evidence for collapsed slate shelving, in conjunction with a large selection of preserving jars (see below), was observed during machine excavations (**Plate 18**).

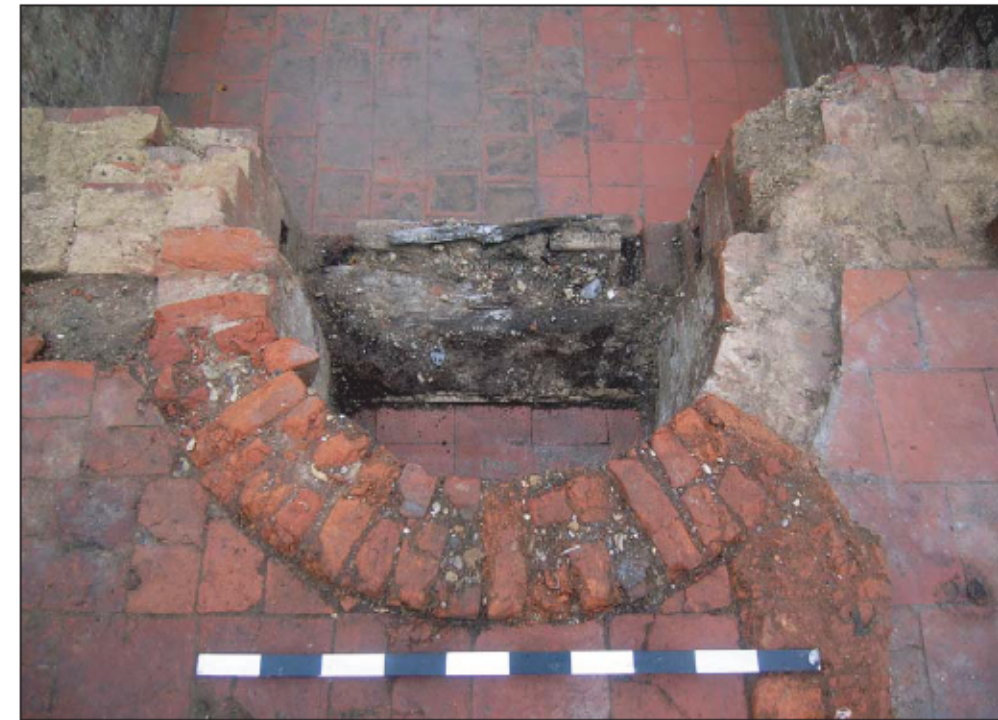
Plate 17: Cellar light in plan, viewed from above

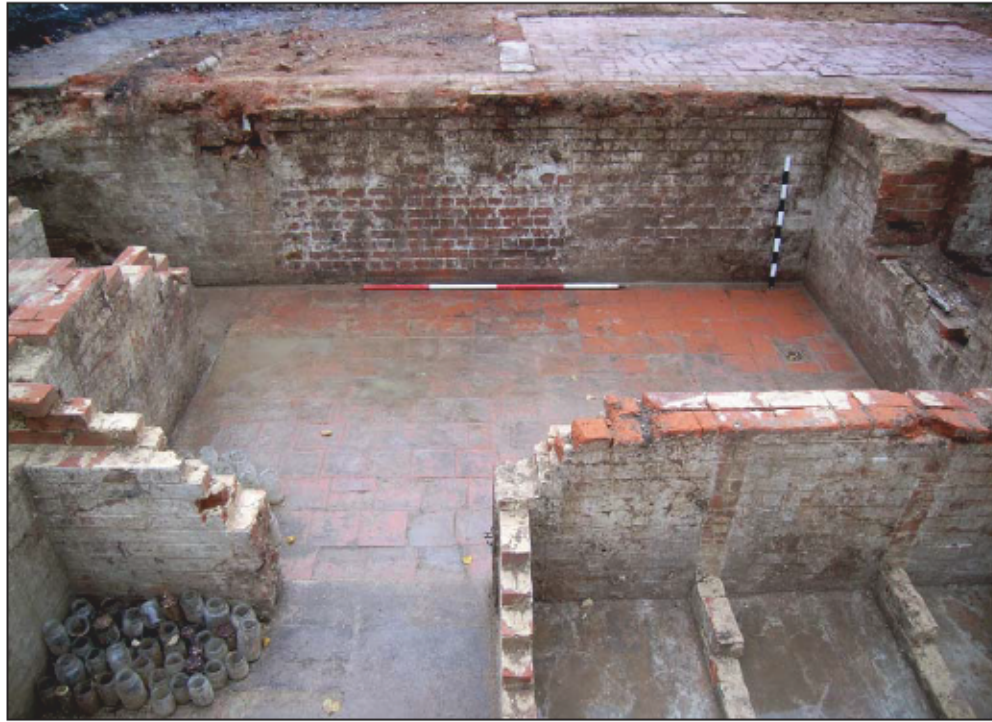
Plate 18: Cellar (Room 1) with preserving jars and shelving partitions to the fore, viewed from the south

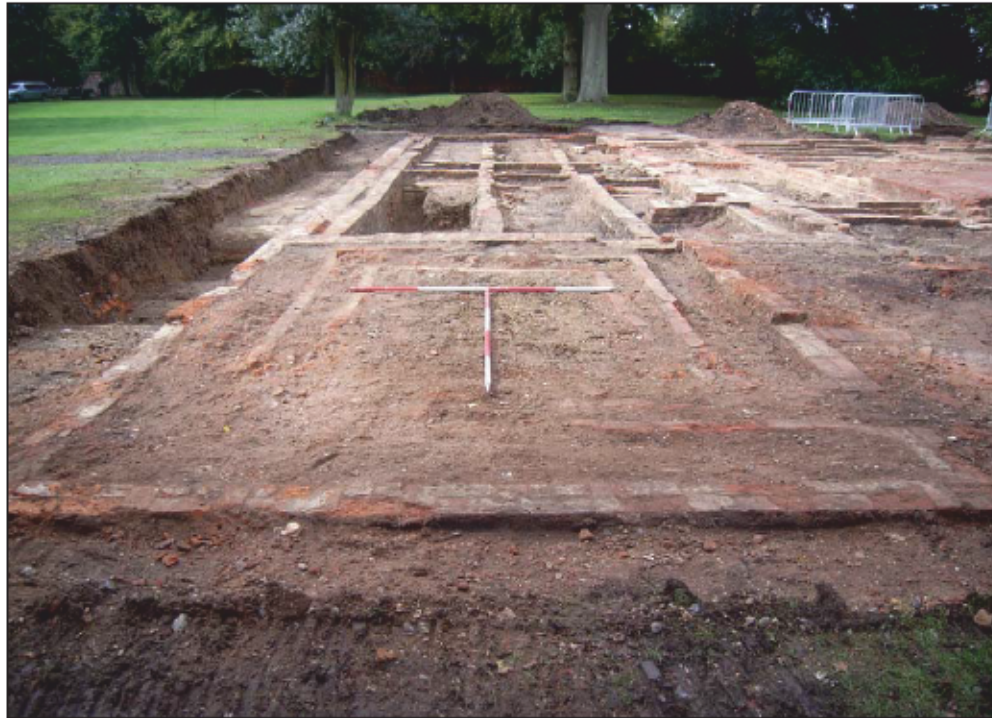
Plate 20: The conservatory (Room 14), viewed from the east

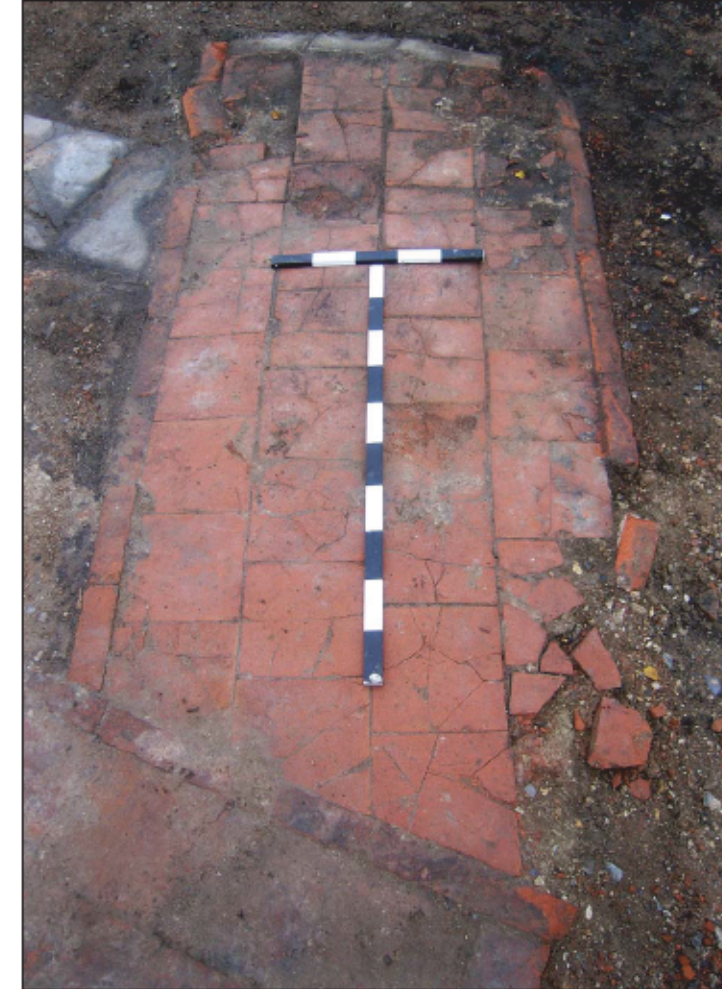
Plate 19: Detail of tiled path allowing access to outbuildings (Rooms 3 and 10), viewed from the southwest
