Kennet Centre, Newbury Berkshire

Archaeological Post-excavation Assessment Report

Report reference: 64342.03

Planning reference – 06/01674/COMIND

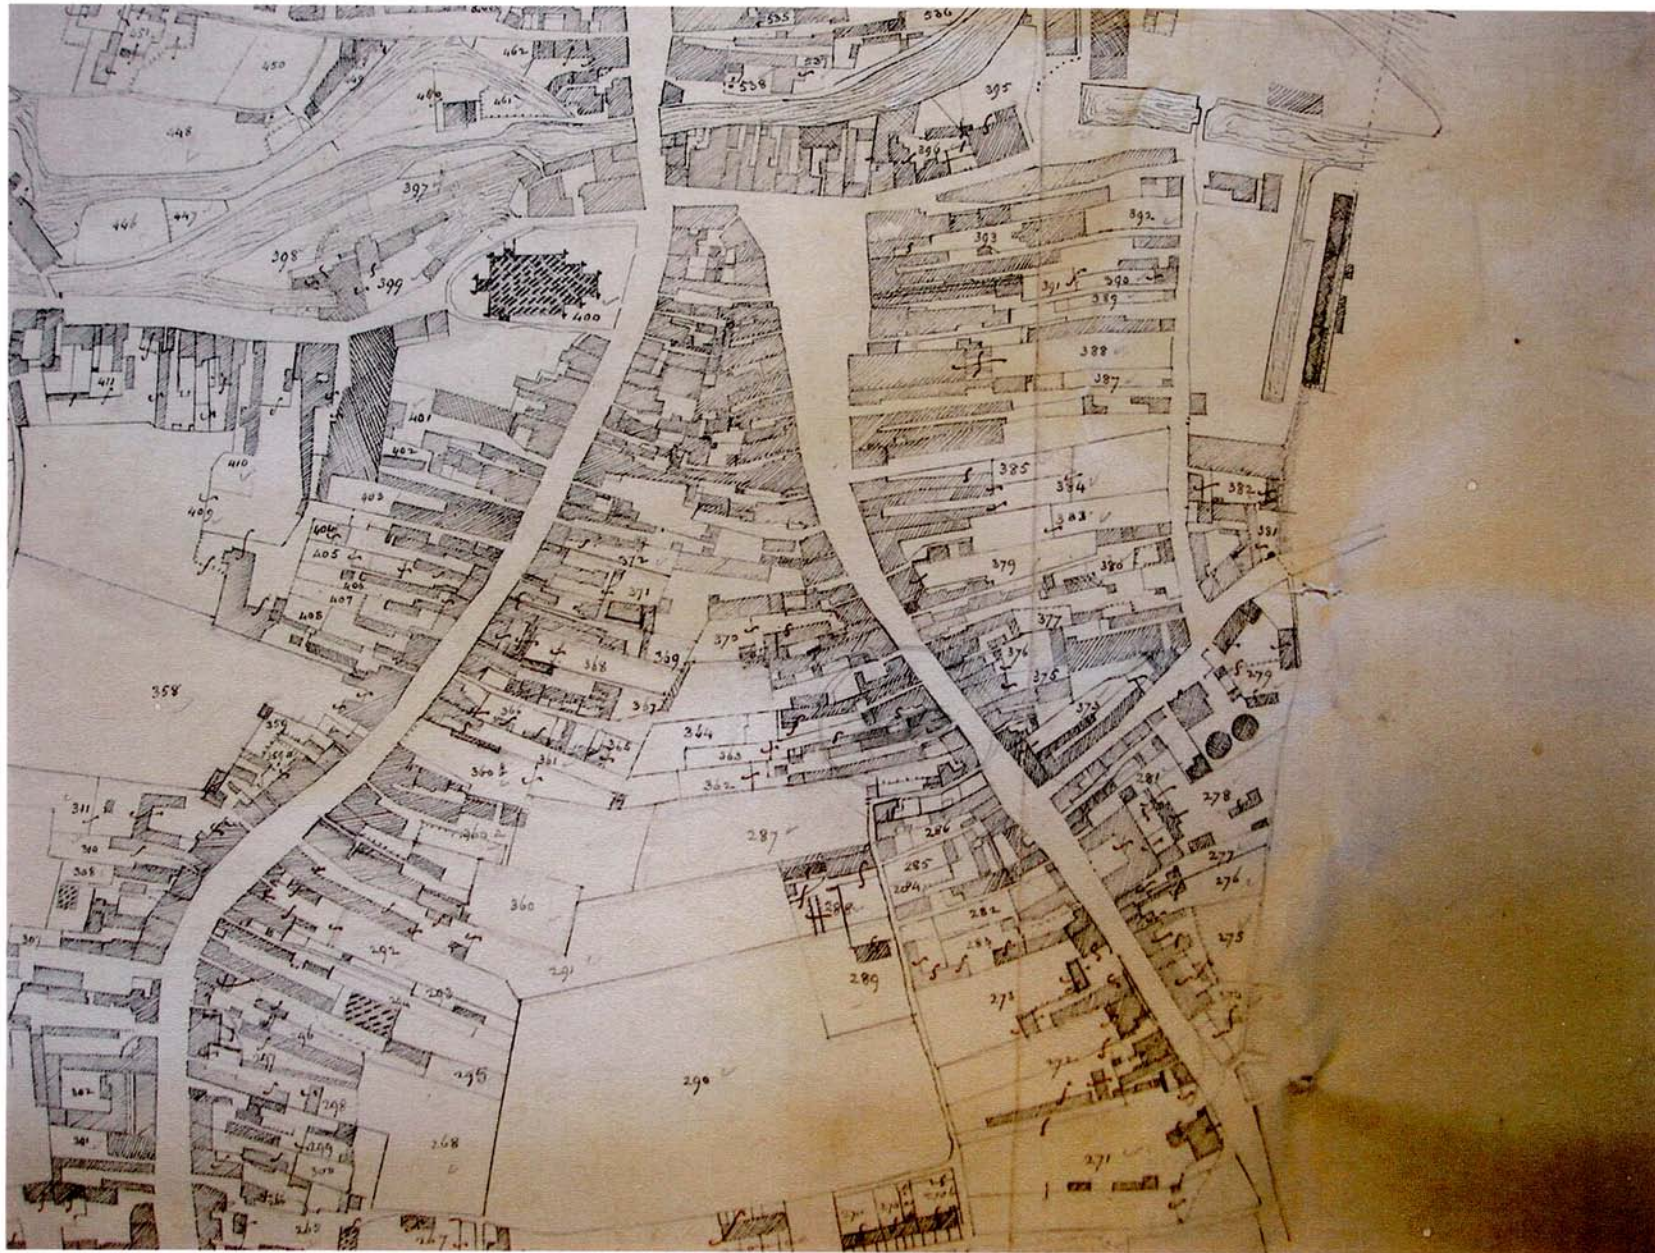
Fig 1 Part of the tithe map of Newbury parish 1839 (from BRO D/D1 89/1)

The Church of St. Bartholomew's P. H. in Cheap Street and a Tenement in Mayer's Lane, containing 13 $\frac{1}{2}$ perches

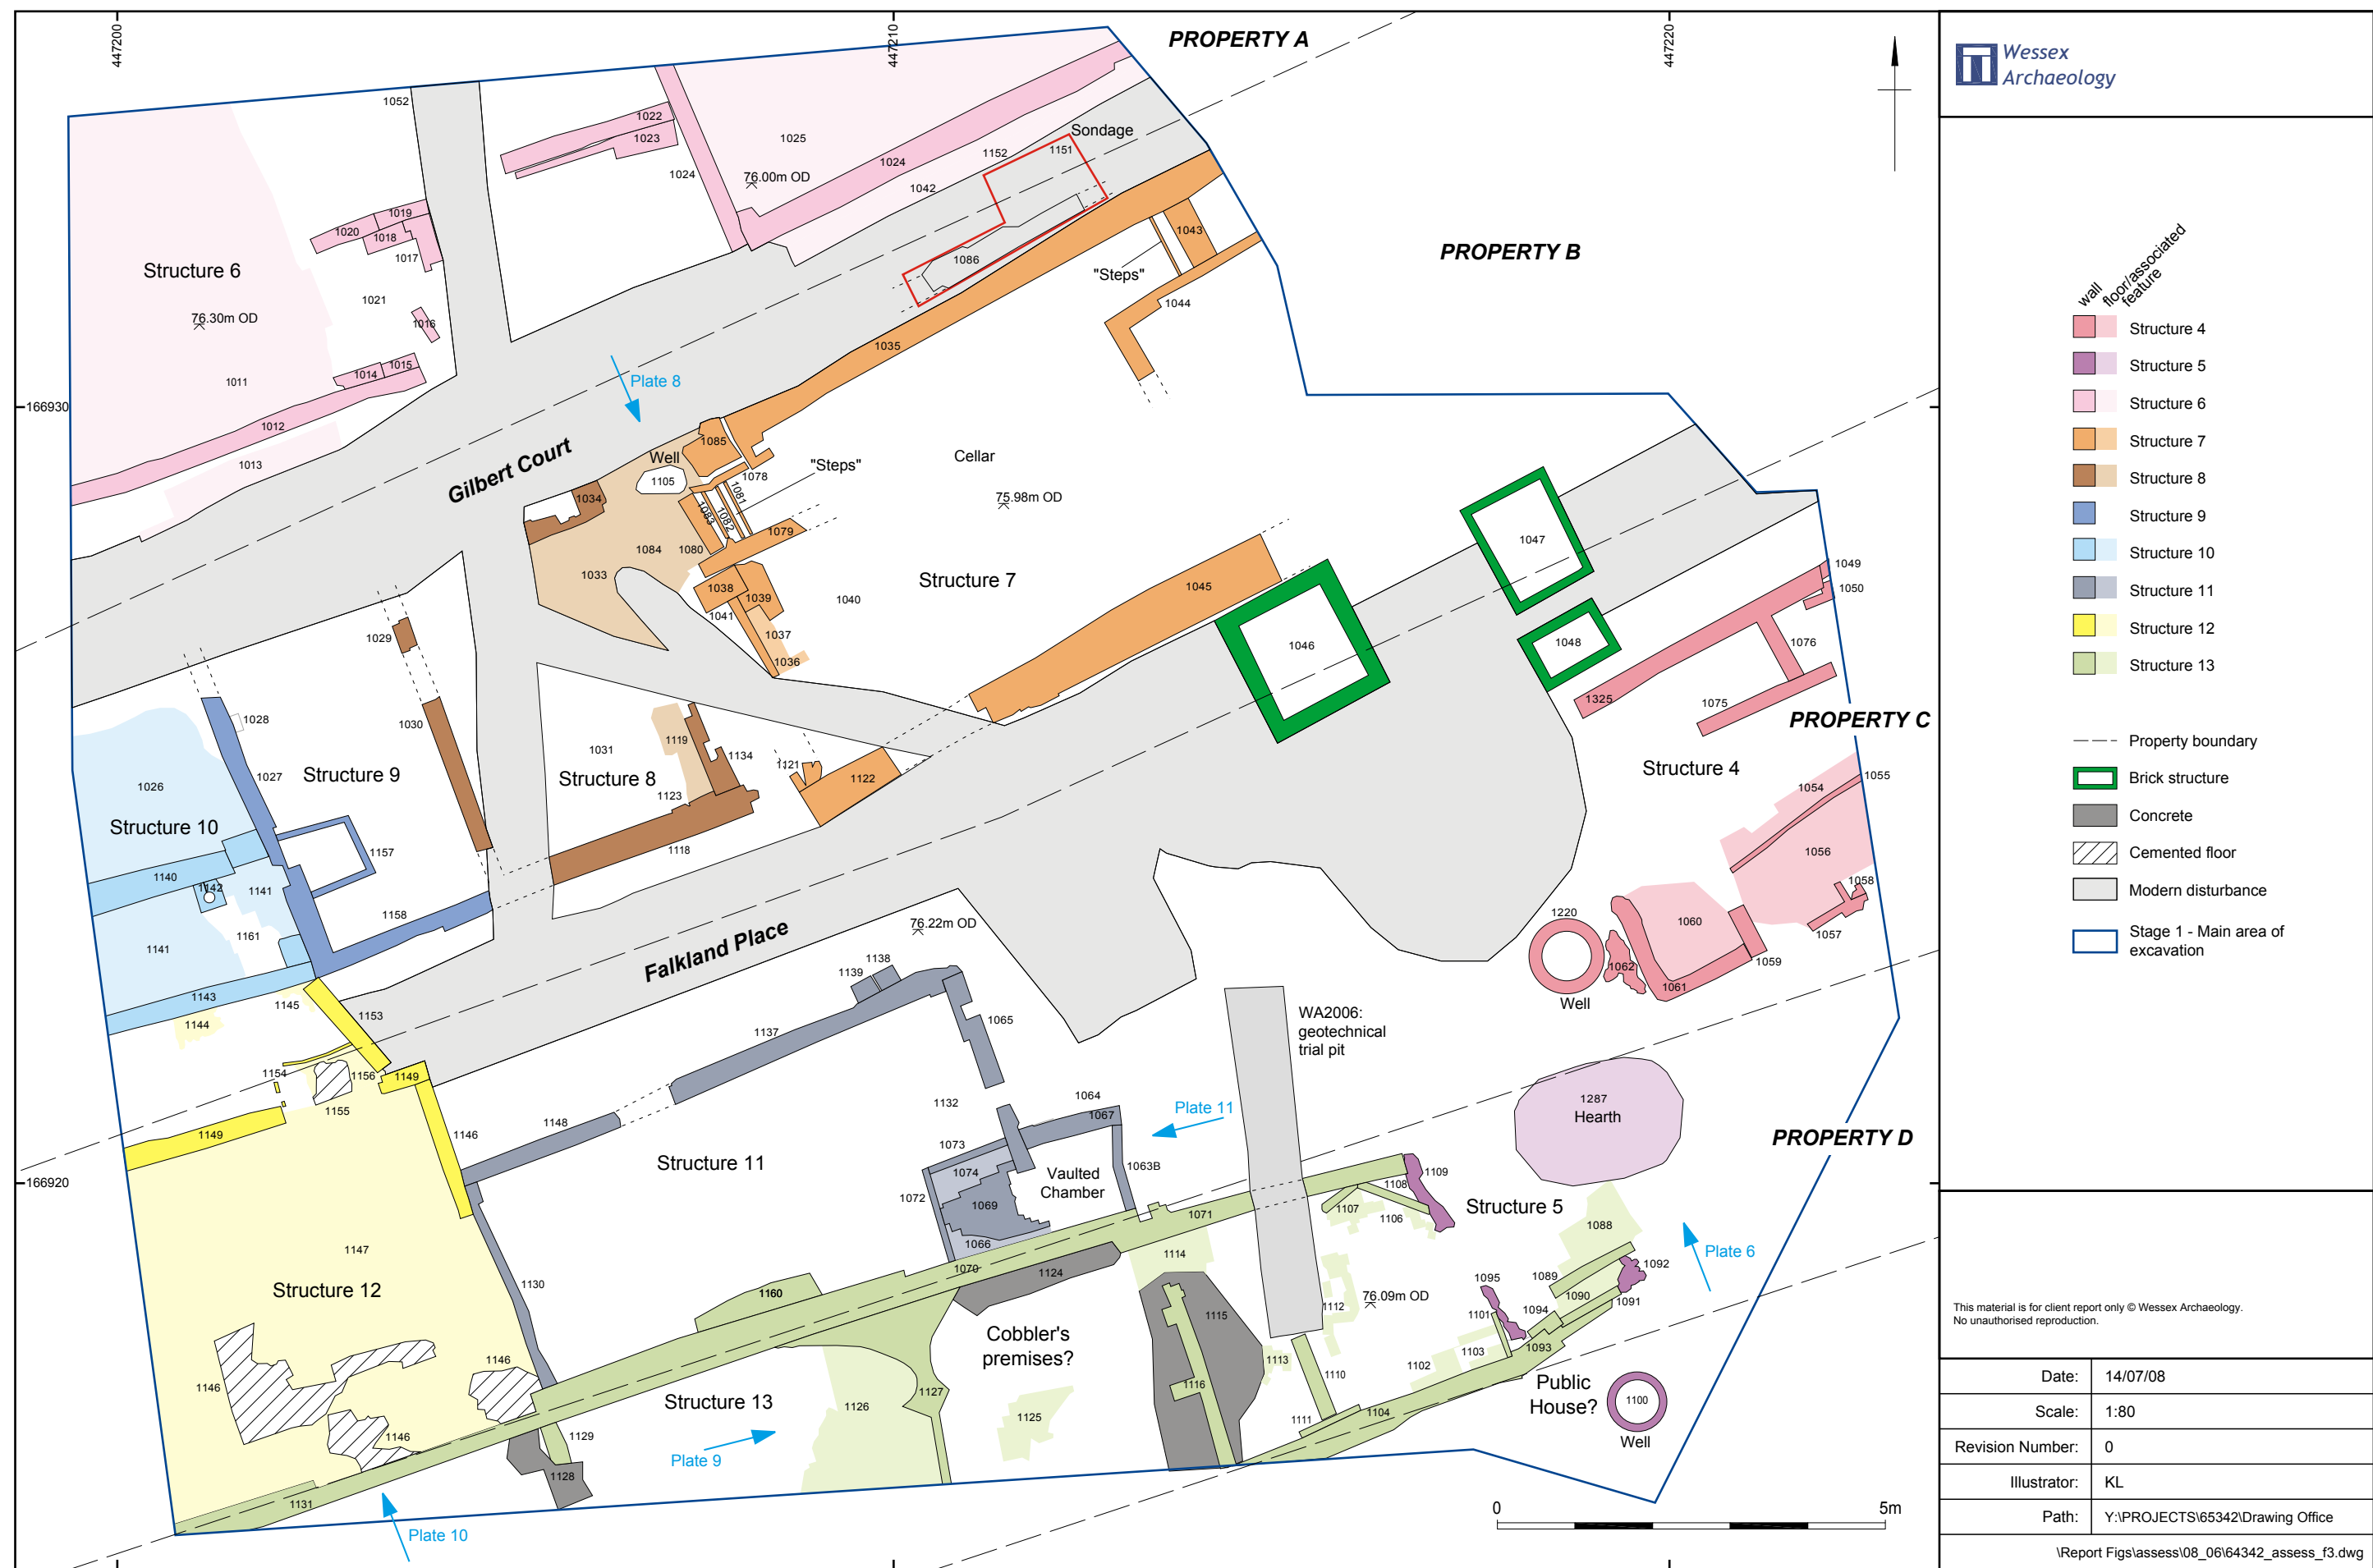
Figure 3

Stage 1 - Main excavation area

- 4.5.10 Beneath the latest phases of construction some elements of earlier buildings could still be identified. Although incorporated within Structure 13 (**Figure 3**), the three fragments of flint and sandstone foundation, which made up Structure 5, remained visible (**1092, 1095** and **1109**). These were on the same alignment as the adjacent Structure 4 and appeared to be of the same construction style, suggesting that they were broadly contemporary.

- 4.6.10 Structure 10, a small toilet building, extended from the southern half of the back wall of Structure 9 in Property B (**Figure 3**). Wall **1027/1158** formed its eastern boundary, the remainder of the structure comprised two parallel and identical walls (**1140**, **1143**) which were constructed 1.25m apart and perpendicular to this. The walls had an initial brick course constructed in header bonding, overlying a concealed foundation which was of a single bricks width. This may indicate that the overlying structure was well built and possibly of English bond construction. The inside of the building was covered with a brick floor (**1141**) within which lay a central drain (**1142**). It is presumed that access to this structure was from the west just beyond the bounds of the excavation area.

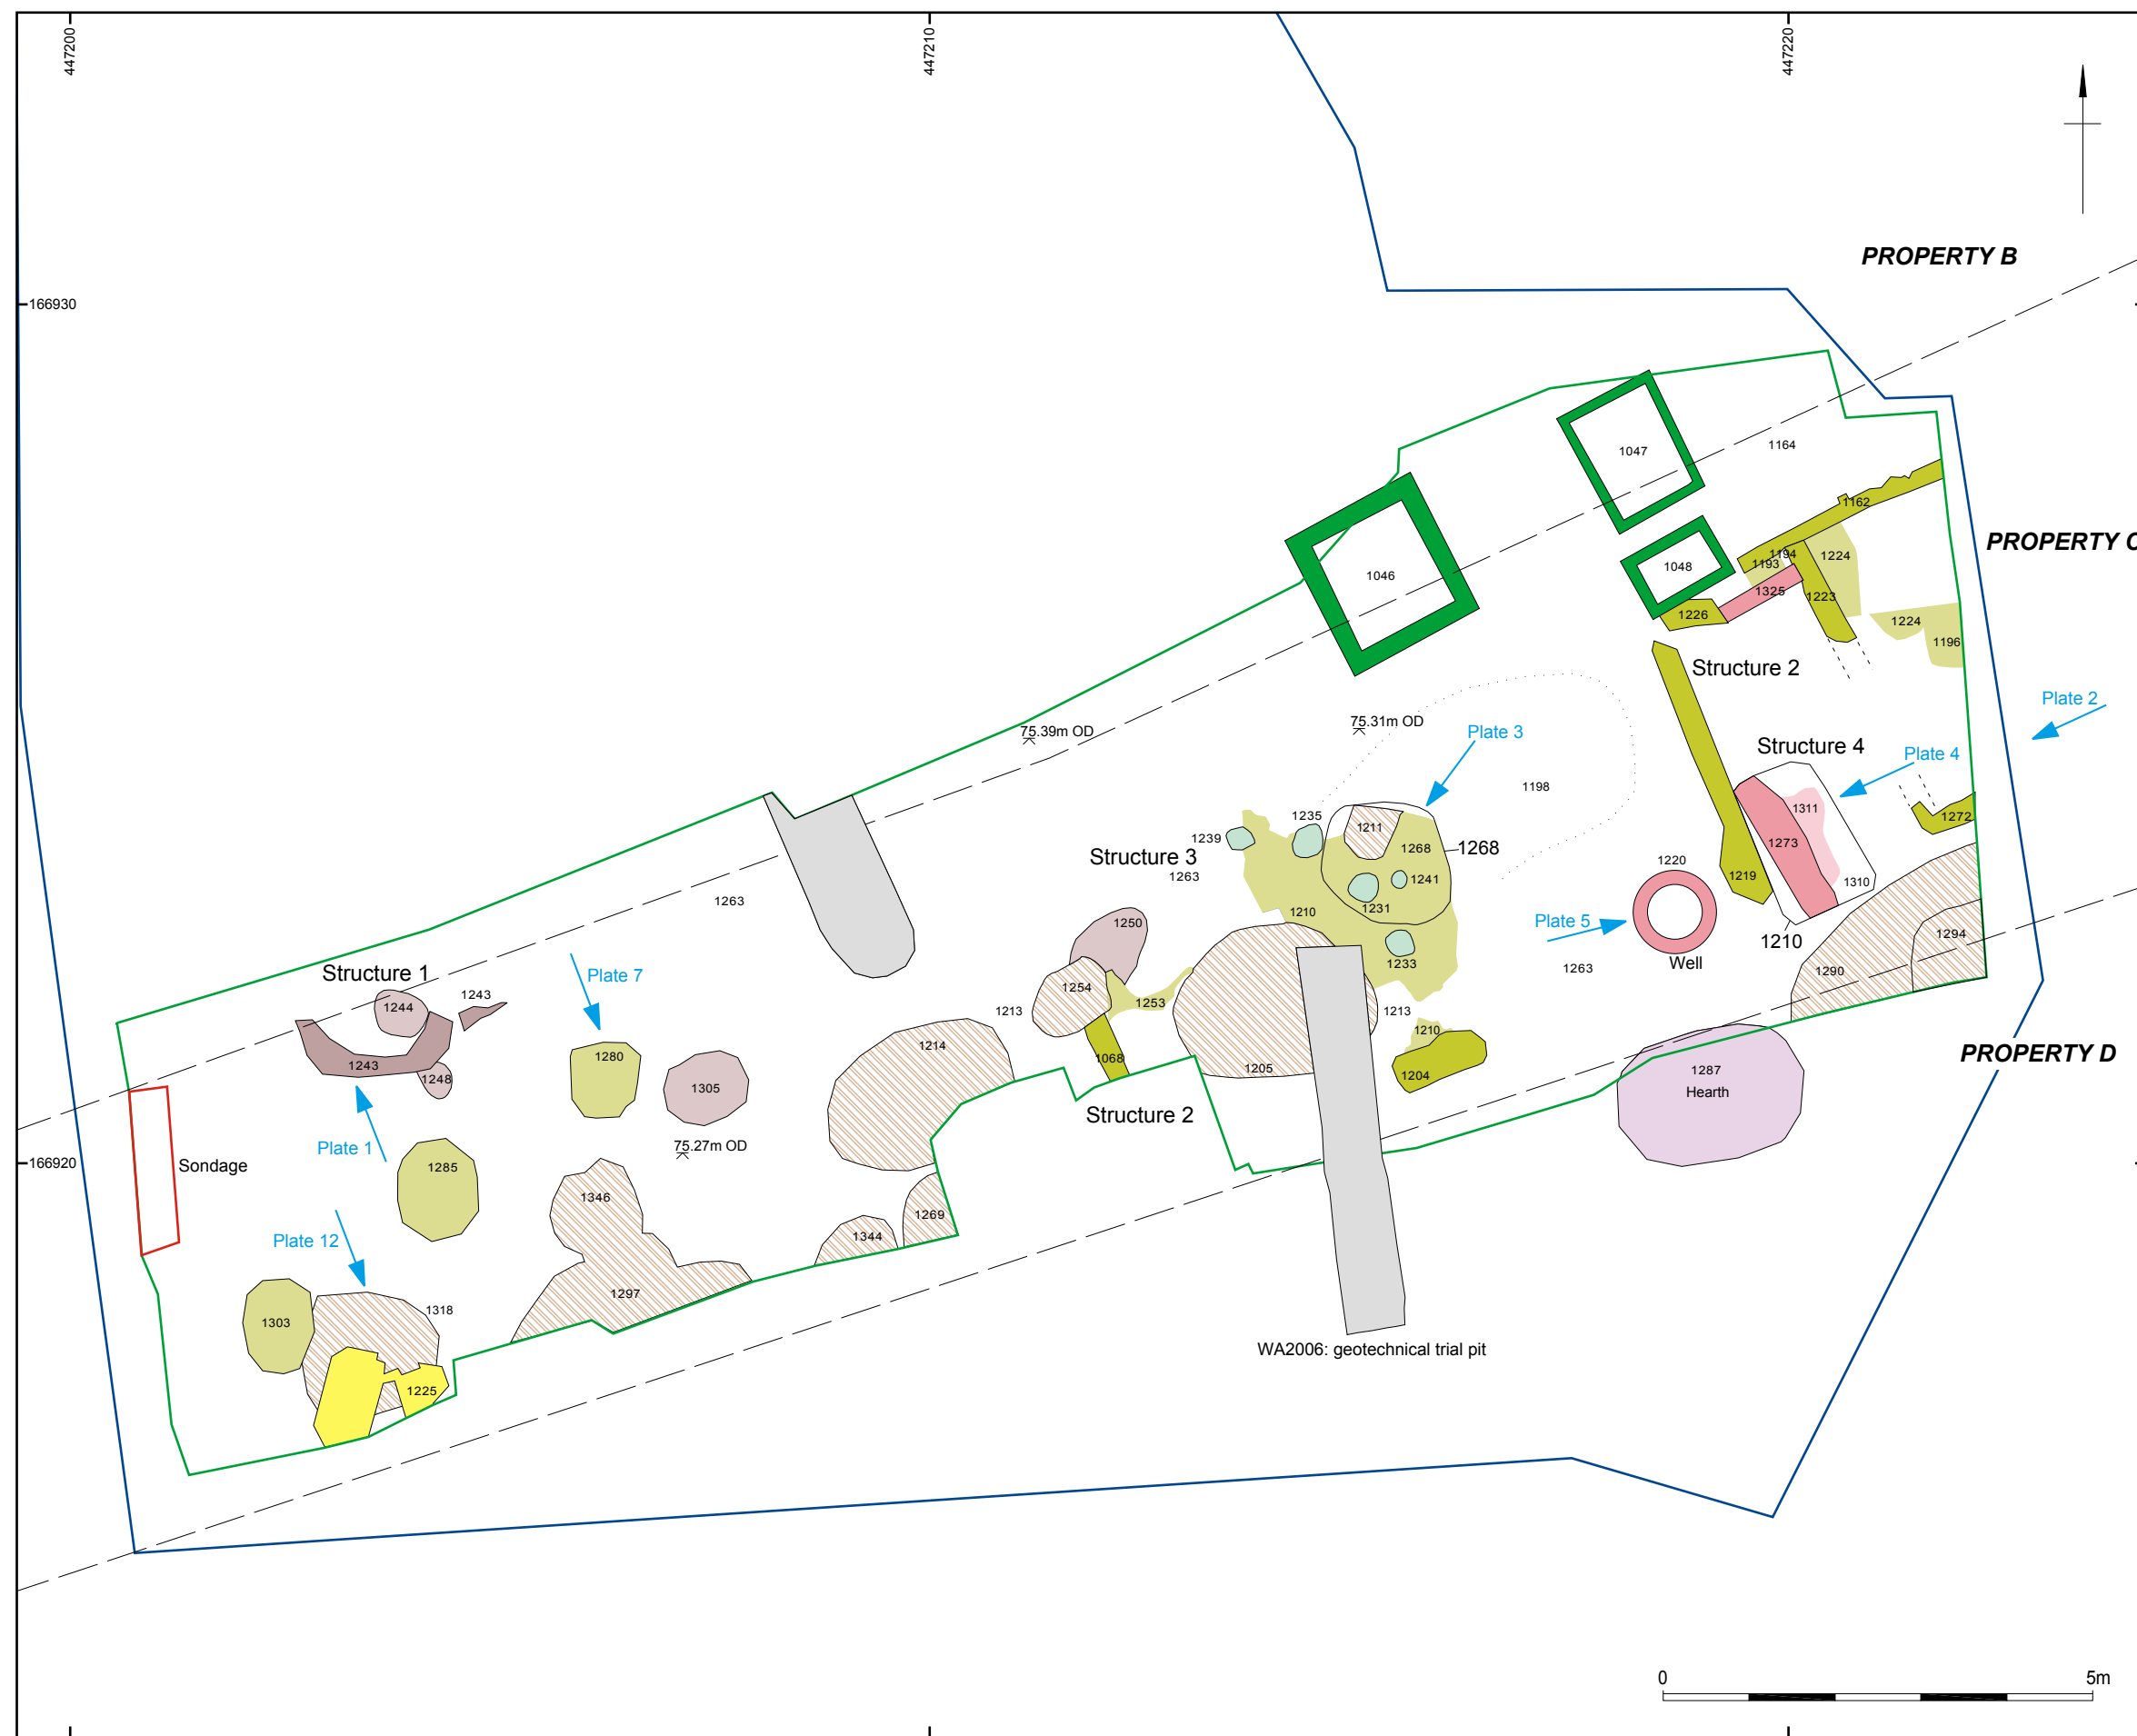
Figure 2

Plan of Stage 2 (deeper excavation area) showing main structural elements

- 4.2 Roman (AD43 - 410)**
- 4.2.1 Although no Roman features were identified from the excavation a single sherd of residual Roman black burnished ware pottery was recovered from the fill of the early post-medieval pit **1280 (Figure 2)**. This is representative of a general low level Roman occupation within the vicinity of the Site.

4.4.4 Two pit features within Property C were identified as stratigraphically earlier than the subsequent building (Structure 2; **Figure 2**). Pit **1268**, situated within the centre of Property C, was a sub-circular, shallow cut containing charcoal rich fills associated with burning and the disposal of hearth material. Pit **1250** was of smaller proportions and contained a single silty clay fill. Both pits contained small quantities of post-medieval pottery.

4.4.6 Structure 2 survived as three islands divided by later truncation and disturbance (**Figure 2**). Six remnant stretches of foundation and wall footings provided the basic footprint of this structure. The rear of the structure was defined by foundation **1068**, the northern boundary by foundation **1162** and the southern boundary by foundation fragments **1204** and **1272** suggesting that the building would have been 4m wide and more than 11.8m long. Associated footings **1219** and **1223** point to internal divisions within the structure.

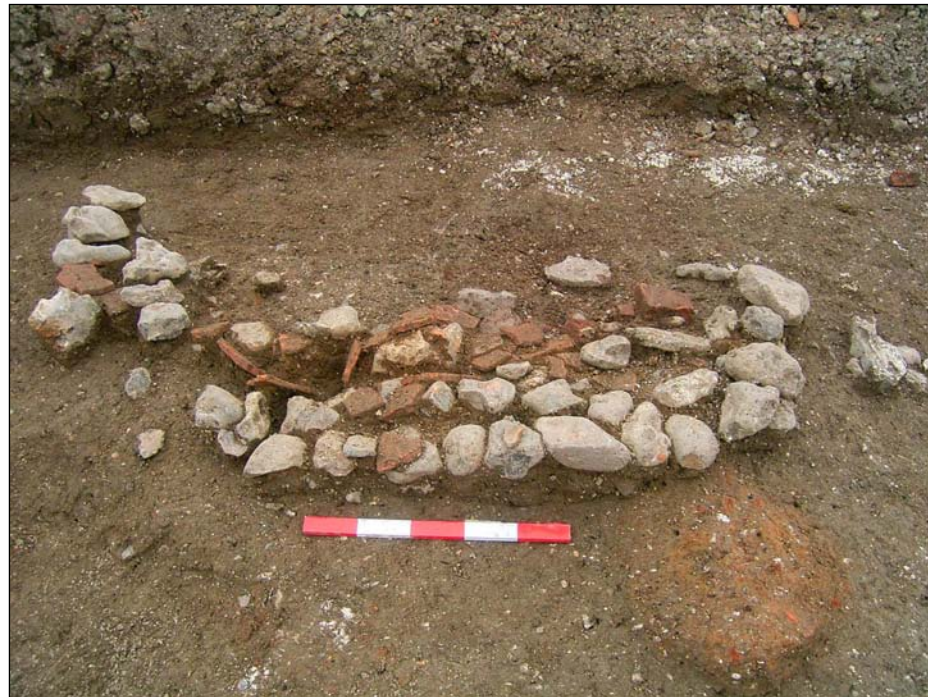
Plate 1: Structure 1, view from south (0.5m scale)

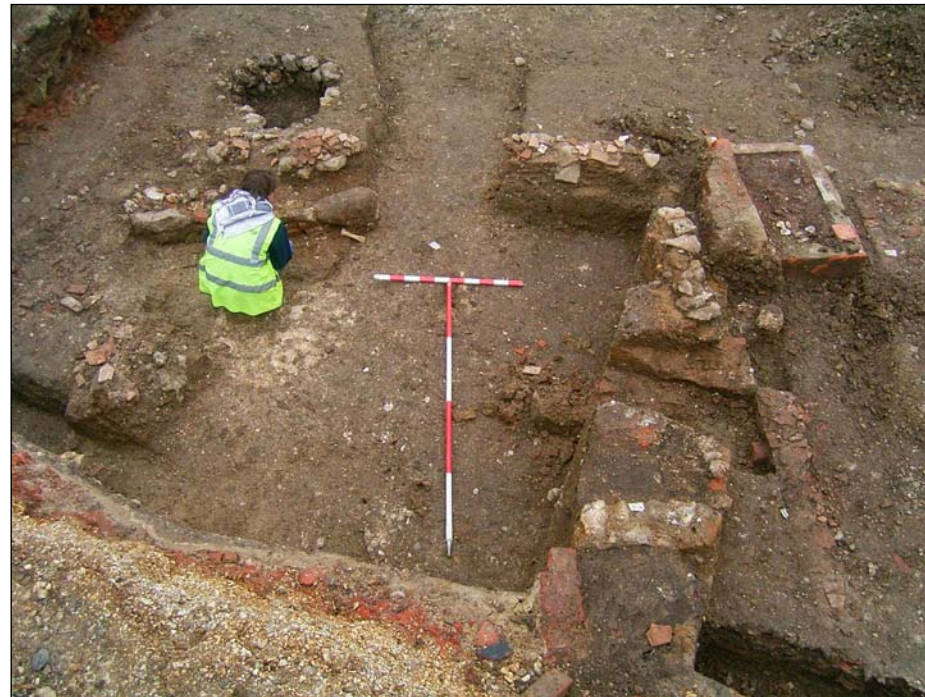
Plate 2: Structure 4, view from east (1x2m and 1x1m scale)

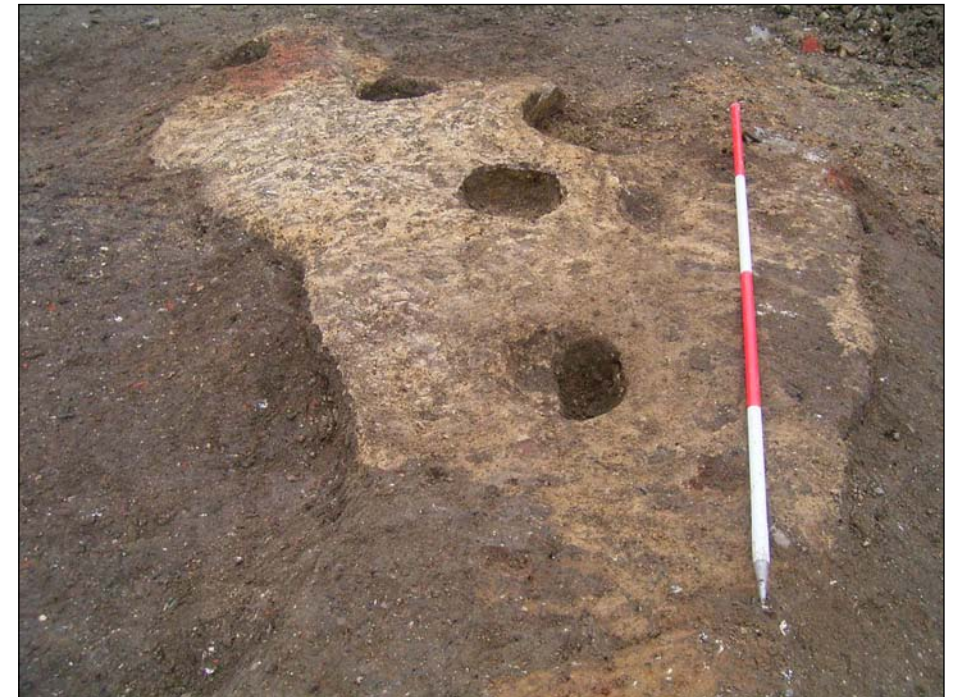
Plate 3: Structure 3, view from south (2m scale)

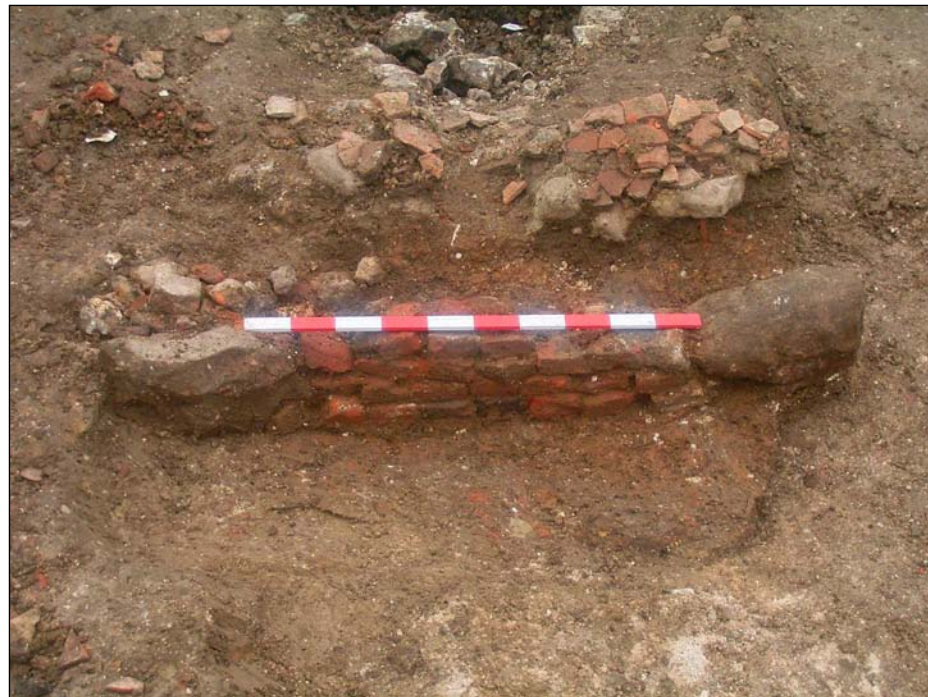
Plate 4: Wall 1273 and Floors 1310/1311 in Structure 4, view from north-northeast (1m scale)

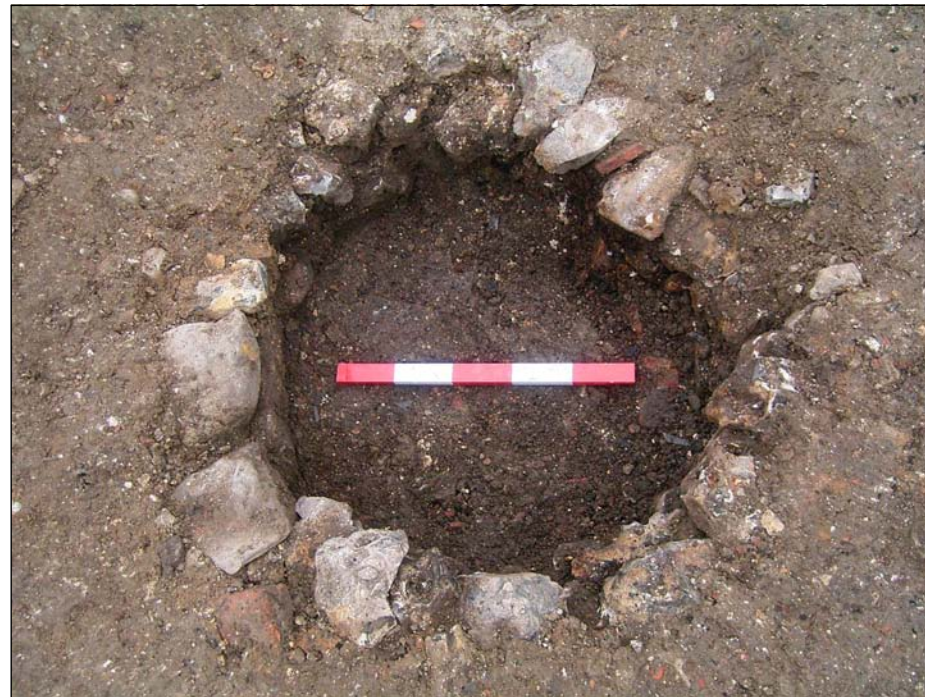
Plate 5: Well 1220, view from west (0.5m scale)

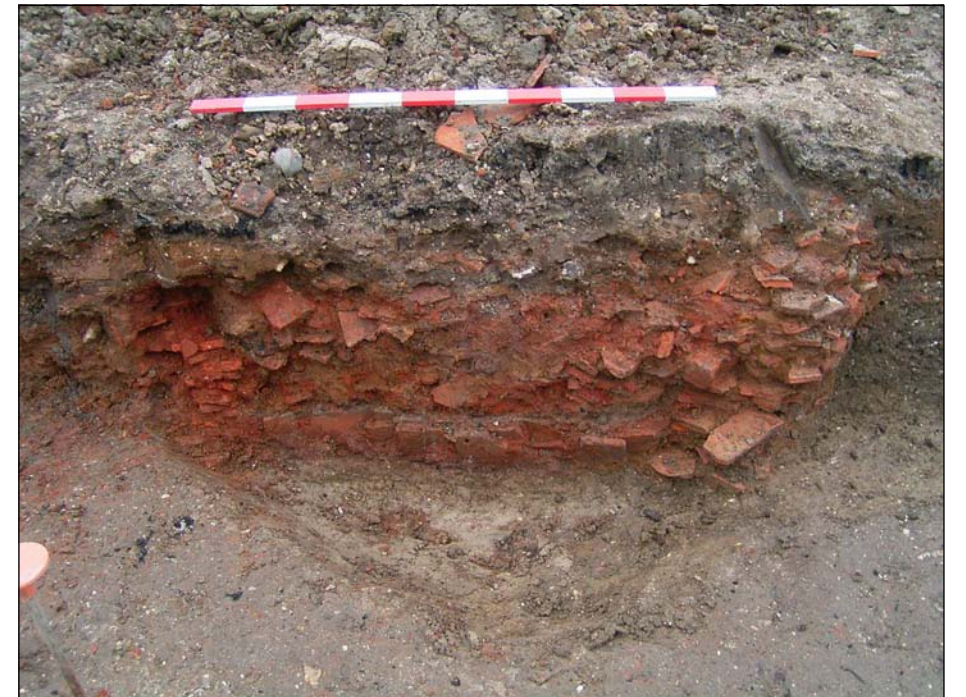
Plate 6: Hearth 1287, view from north (1m scale)

- 4.5.11 On the western side of the structure a hearth (**1287**) was partially exposed in section on the boundary between properties C and D (**Figures 2, 3** and **Figure 5; Plate 6**). Stratigraphically the hearth was contemporary with Structure 5 and was probably situated inside the structure whose western wall was not preserved. The hearth was a sunken feature lined with broken peg tiles laid in horizontal courses to construct its sides and also laid vertically to line its base.

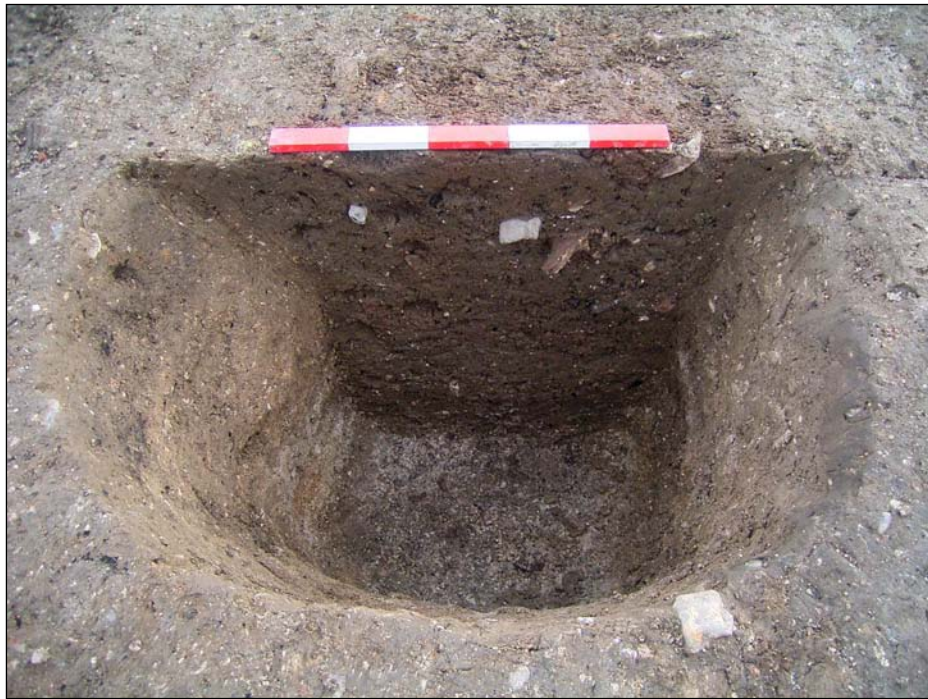
Plate 7: Post-medieval Pit 1280, view from north-northwest (0.5m scale)

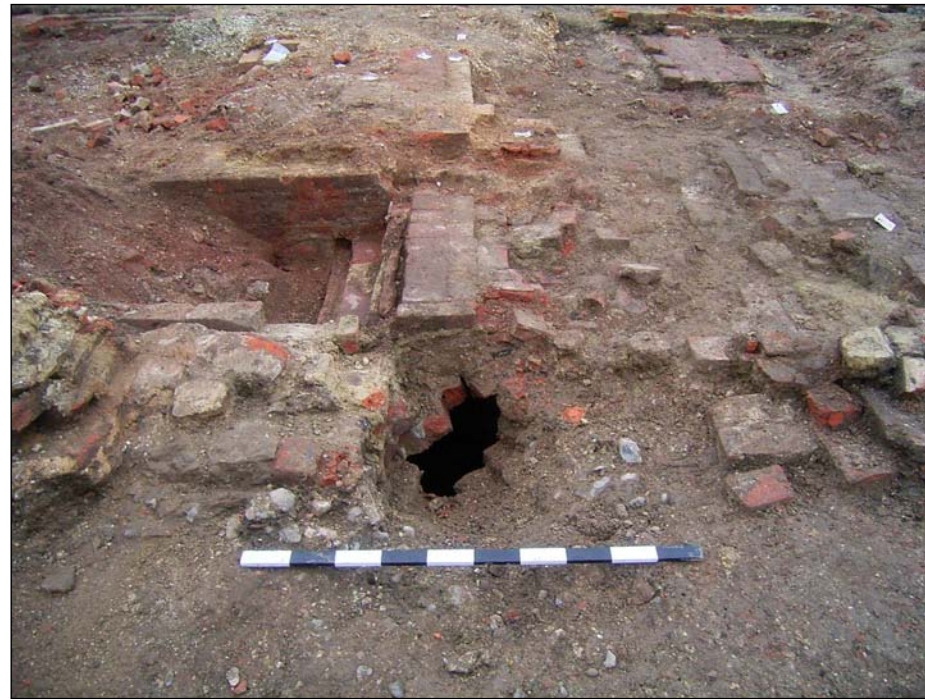
Plate 8: Well 1105 and west entrance into cellar of Structure 7, view from north-northwest (1m scale)

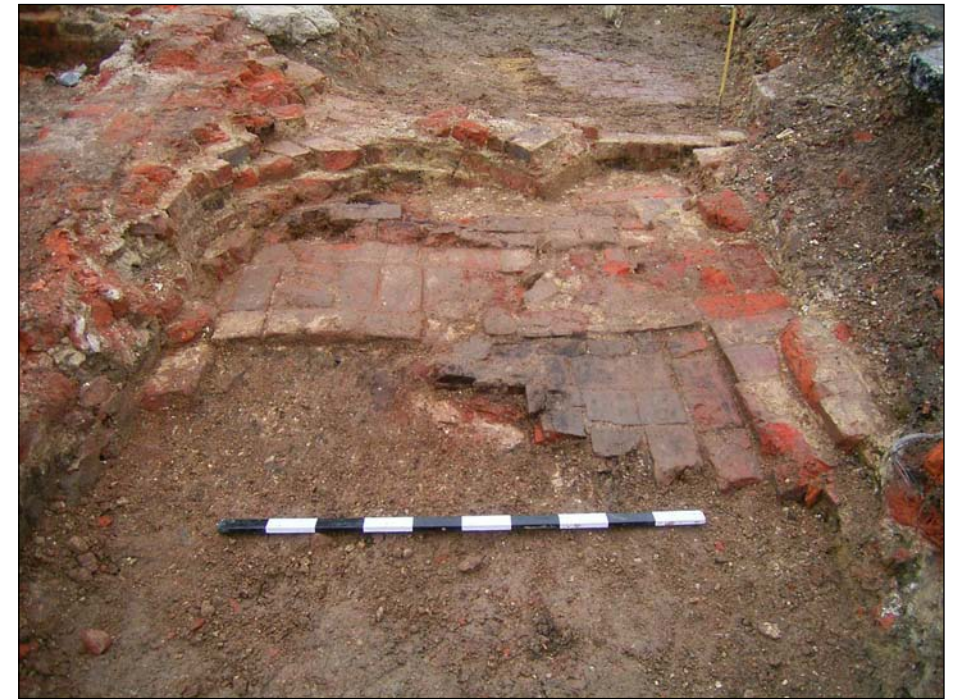
Plate 9: Structure 13, view from north-northwest (1m scale)

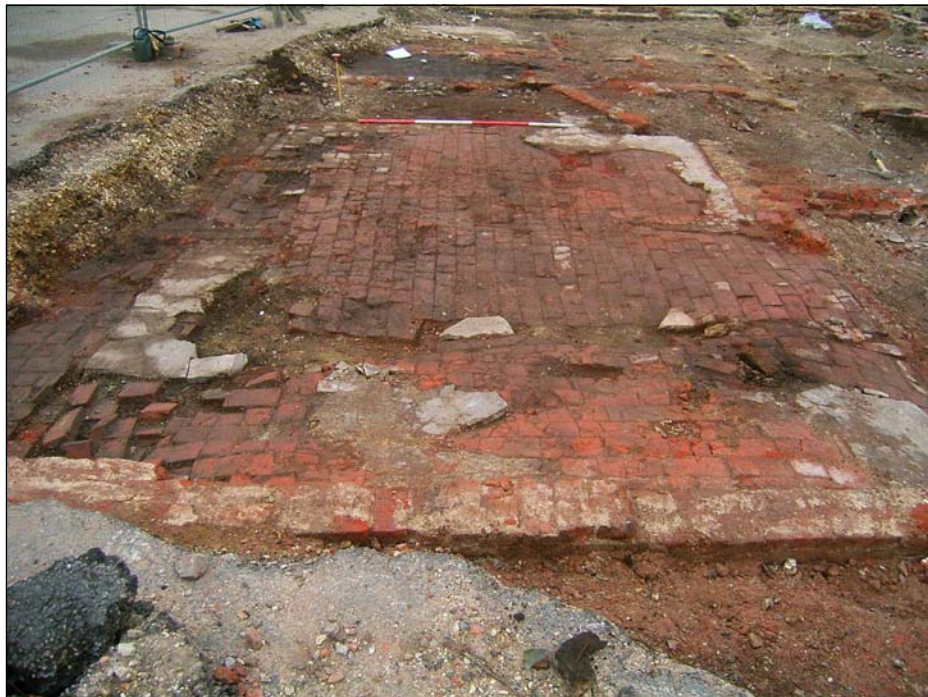
Plate 10: North wall 1131 (Structure 13) in the foreground, view from south-southeast

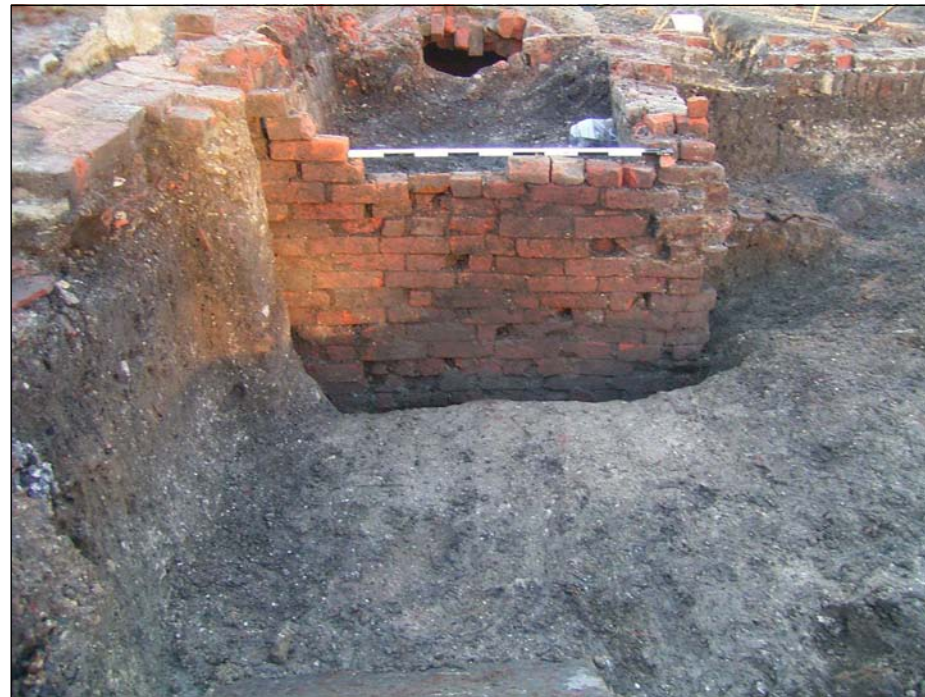
Plate 11: Vaulted chamber in south-east corner of Structure 11, view from east (1m scale)

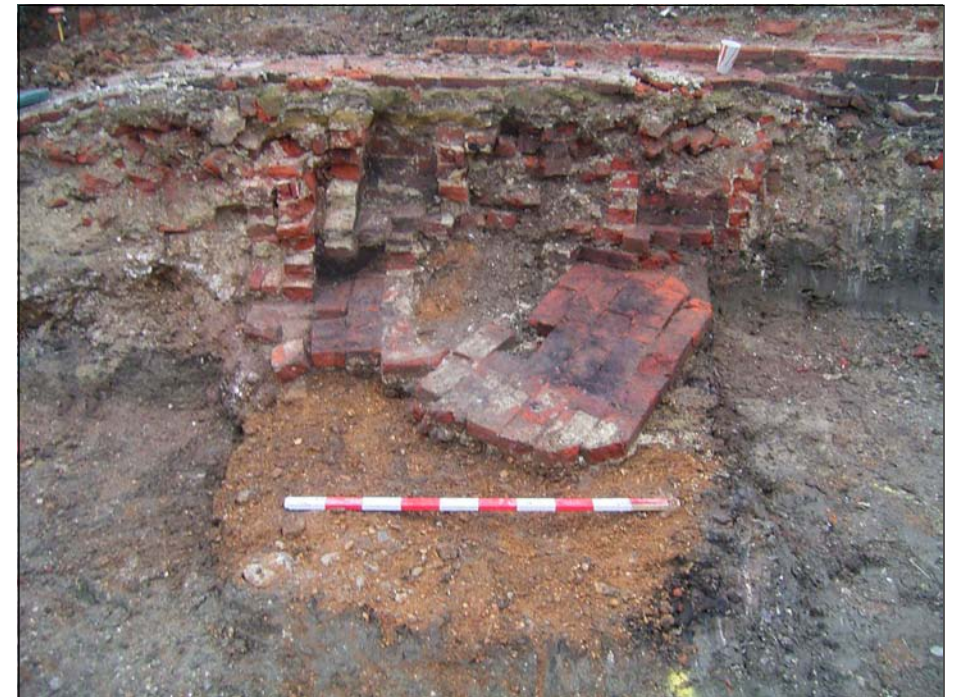
Plate 12: Possible drainage feature in Structure 12, view from north (1m scale)
