# Syon House, Syon Park Hounslow

An Archaeological Evaluation of a Bridgettine Abbey  
and an Assessment of the Results

Ref: 52568.05

October 2003

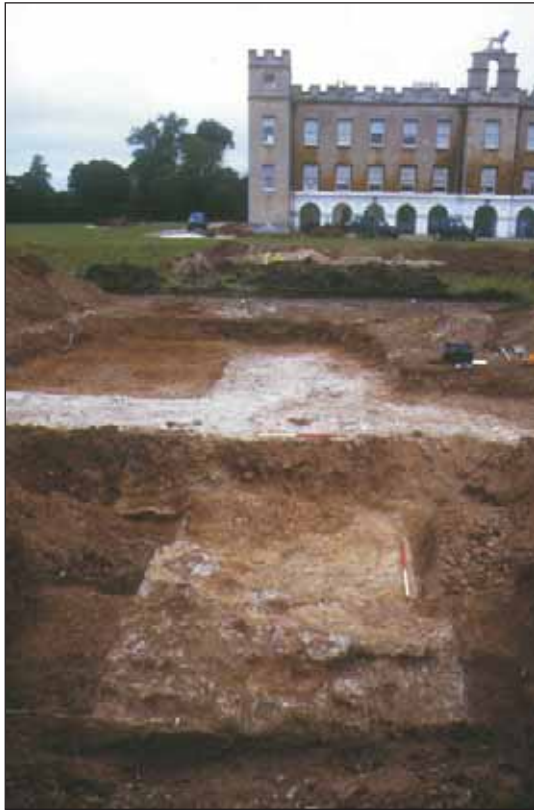
Photo 1: The south-east corner of the abbey church with buttresses to the south and east. Looking west towards Syon House.

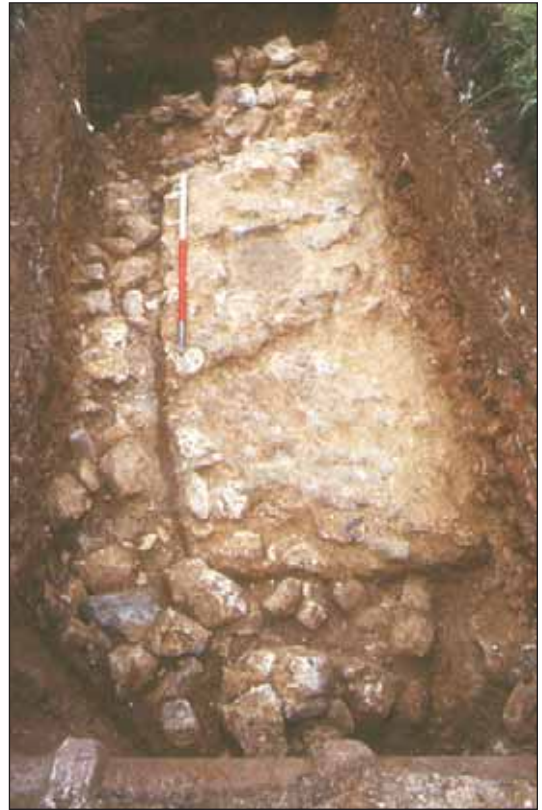
Photo 2: Pier base 149 in Trench 1 looking north.

- 3.4.4 This was not apparently the case in the eastern part of the building. At the centre point of Trench 1, a very large, and not entirely robbed pier base was found (Figure 4, 149; Photo 2). It was located 15 m from the internal face of the north and south walls, and also lay about 14 m east of the two eastern-most pier bases described above. Of great significance was the determination from excavation that it comprised two phases. The first phase consisted of a roughly rectangular, or possibly square, foundation (147) measuring 2.5 m north-south, made of roughly hewn, randomly laid Reigate stone cobbles and chalk fragments set in a hard yellow sandy mortar. Subsequently, a larger, rhomboid or possibly subcircular cut had been made round the pier base to a depth of at least 4.67 m OD (although the feature was not bottomed). This had been backfilled with poorly or un-mortared blocks of Reigate stone, chalk and limestone (149), and effectively extended the width of the base to at least 4.1 m. Between the original base and the later cut could be seen a thin veneer of silty brickearth 0.04 m wide, believed to be undisturbed natural subsoil remaining *in situ*.

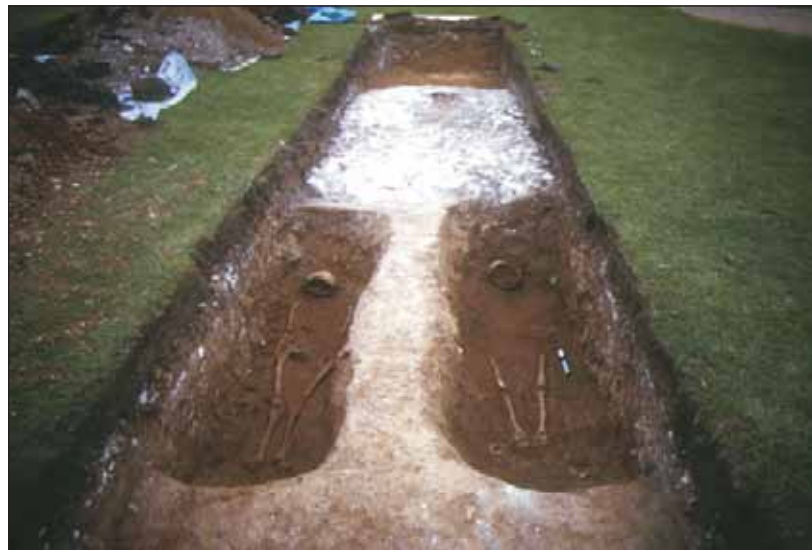
Photo 3: Inhumation graves 708 and 712 in Trench 7, with wall foundation 716 in the background, looking west.

- 3.5.2 Within the passageway formed by the two walls were found two graves (708) and (712) containing poorly preserved human skeletons (Figure 4; Photo 3). The graves were steep-sided and flat-based, and aligned east west. They were identified immediately under the topsoil at c 5.84 m OD, and when excavated proved to be approximately 0.4 m deep. The cuts lay 0.2 m apart. Arranged around each skeleton were a number of iron nails indicating the existence of wooden coffins. The coffins were probably rectangular and measured between 1.65 m and 1.8 m long. No other grave finds were noted.

- 3.5.3 The skeletons were not lifted, but examined by anatomist Dr Alice Roberts. They were both adult, extended and supine, but a significant amount of the bone had decayed away. The skeleton in grave (712) comprised the main bones of both legs, some of the foot bones, and a portion of the skull. The skeleton in grave (708) was similar, but both humeri and one radius, ulna and bones from the hand, as well as part of the pubis, were also present. Both crania were characterised by gracile brow ridges, rounded, high frontal bones and the lack of an occipital external protuberance. One of the skeletons showed small mastoid processes. The pubis fragment from grave (708) was undiagnostic. In the light of these characteristics, it was concluded that there was a greater degree of probability that the burials were female.
