# South Western House, Southampton

Archaeological Evaluation

**Site code SOU 1035**

Report ref. 47999a

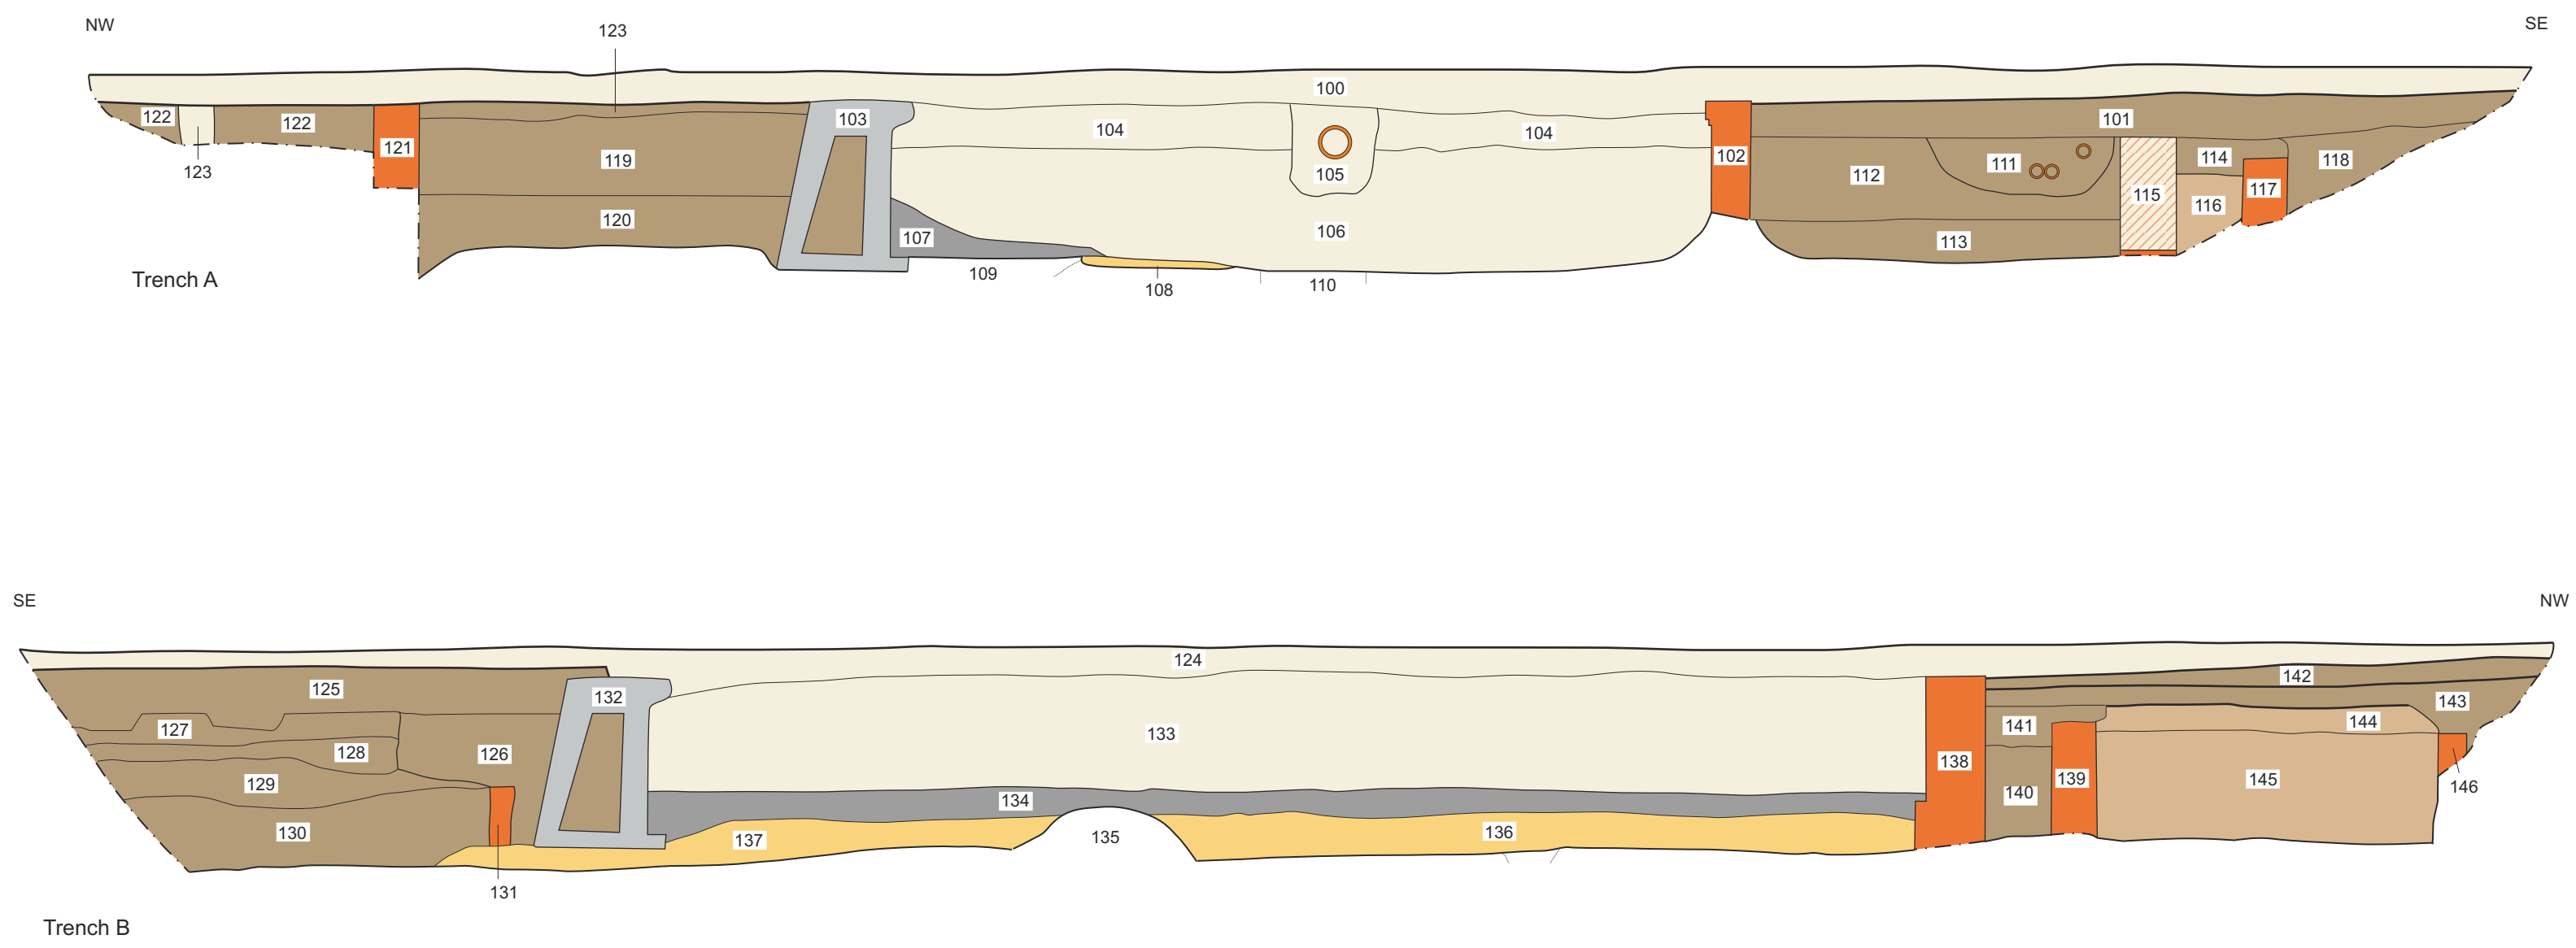
Trench A and B, sections

- 3.2.2. All features encountered appeared to relate to Southampton Terminus Station. The station features could be split into three broad phases of activity (**Figure 3**). The earliest phase consisted of three brick walls and two levelling/infill deposits.

- 3.2.3. At the western end of the trench, wall **121** ran at an angle of approximately 45° to the line of the trench. It was 0.47m wide and stood to a height of 1.35m and was constructed of brick laid in an *English* bond. The eastern face of the wall was slightly concave along its length suggesting that the line of the wall was curved. It was pointed from 0.65m above the surface of the natural. This unpointed element of the wall was covered by deposit **120**, a mixture of sand and gravel layers that was cut away to the east by later structure **103**. The western face of the wall was not seen.

- 3.2.4. At the eastern end of the trench two brick walls **115** and **117** had been partially robbed by cut **114**. Wall **115** was perpendicular to the trench line, 0.47m wide with a 0.10m offset foundation and had been robbed down to the level of its foundations. Wall **117** ran parallel to this, 0.40m to the east. It was 0.47m wide and was visible to a height of 0.50m. Both walls appeared to have been constructed with an *English* bond.

- 3.2.6. At the western end of the trench wall **121** was superseded by concrete structure **103** and a series of associated dumping layers and a surface. Structure **103** was a prefabricated concrete retaining wall consisting of a series of D – shaped frames between vertical concrete shutters. The whole structure survived intact to a height of 1.35m and was founded on a raft of rammed chalk **108**.

- 3.2.13. All the features appeared to relate to Southampton Terminus Station, there were no earlier features or finds. The station features could be split into three broad phases of activity (**Figure 3**). The earliest phase consisted of two brick walls and two levelling/infill deposits.

- 3.2.14. At the western end of the trench, walls **139** and **146** ran perpendicular to the line of the trench, some 2.80m apart. The walls were constructed of brick laid in an *English* bond and were 0.35m wide and stood to a height of 0.90m above the level of the natural. Wall **139** was pointed on its eastern face and wall **146** on its western face. The top surfaces had both been partially robbed.

- 3.2.16. The next phase of activity included three walls, and associated dumps and surfaces, and two drains. At the western end of the trench walls **139** and **146** were superseded by wall **138** and its associated dumps and surfaces. Wall **138** was constructed of brick laid in an *English* bond, it was 0.35m wide with a 0.10m wide offset foundation to the east. It stood to its full height of 1.40m

- 3.2.18. This wall was replaced by concrete structure **132**, which ran perpendicular to the line of the trench. Structure **132** was a prefabricated concrete retaining wall consisting of a series of 'D' shaped frames between vertical concrete shutters. The whole structure survived intact to a height of 1.35m and was founded on a layer of gravel **137**. To the east of **132** dump **126** was sealed by tarmac surface **125** and its associated make-up layer.

- 3.2.19. The gap between concrete structure **132** and wall **138** was 10.60m wide. Two drains ran through this area parallel to the line of the walls dividing the area into three tracks of equal width. These were overlain by track-ballast layer **134**, above a gravel make-up **136**.

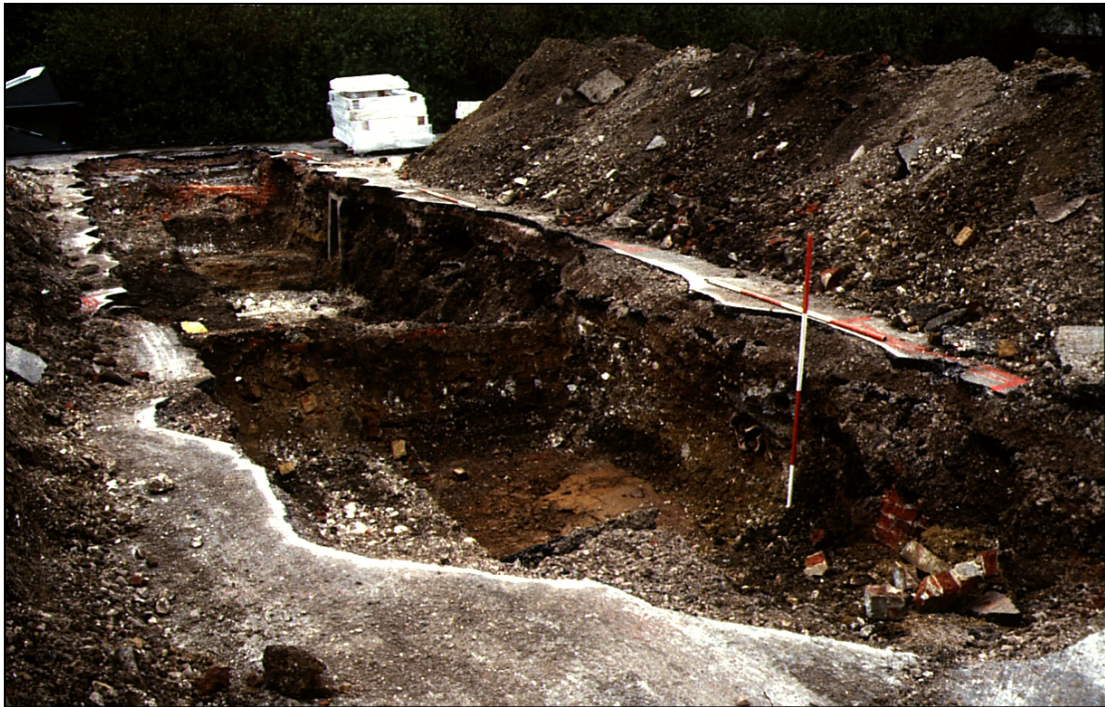
Trench A, looking North

- 3.2.1. Trench A was 19.85m long and up to 1.6m deep (**Plate 1**). It was orientated approximately east – west and targeted on a platform and turn-table from the early station and two platforms from the later station, plus the associated tracks (**Figure 2**).

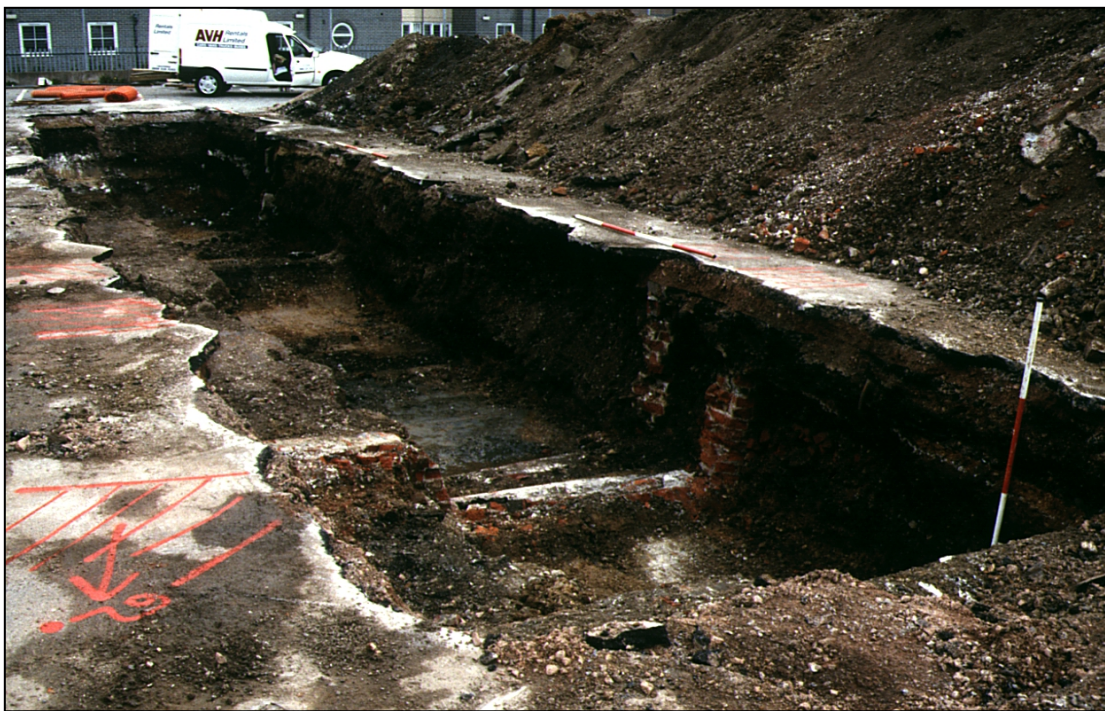
Trench B, looking South

- 3.2.12. Trench B was 20.35m long and up to 1.75m deep (**Plate 2**). It was orientated approximately south-east to north-west and targeted on a platform from the early station and two platforms from the later station plus the associated tracks (**Figure 2**).
