Dun Street, Sheffield, South Yorkshire

Archaeological Strip, Map and Record

Ref: 89950.03
June 2015

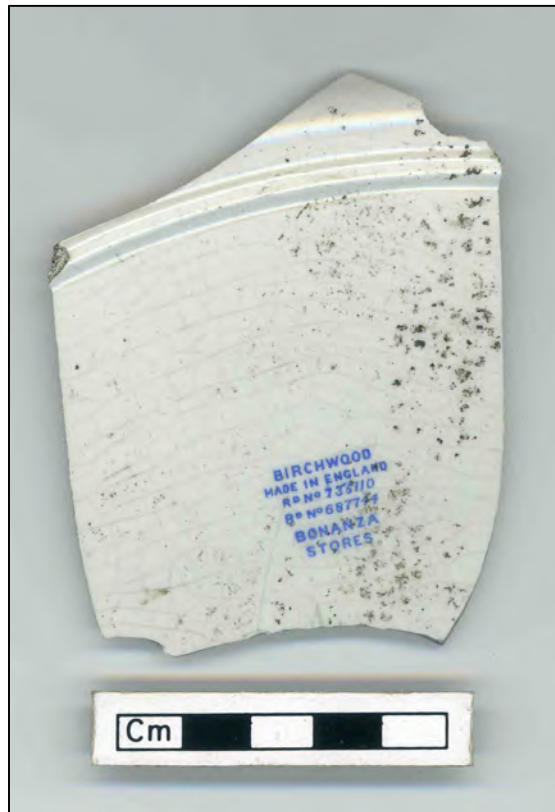
AP Plate 1: Printed maker's mark on a vessel from context WA100

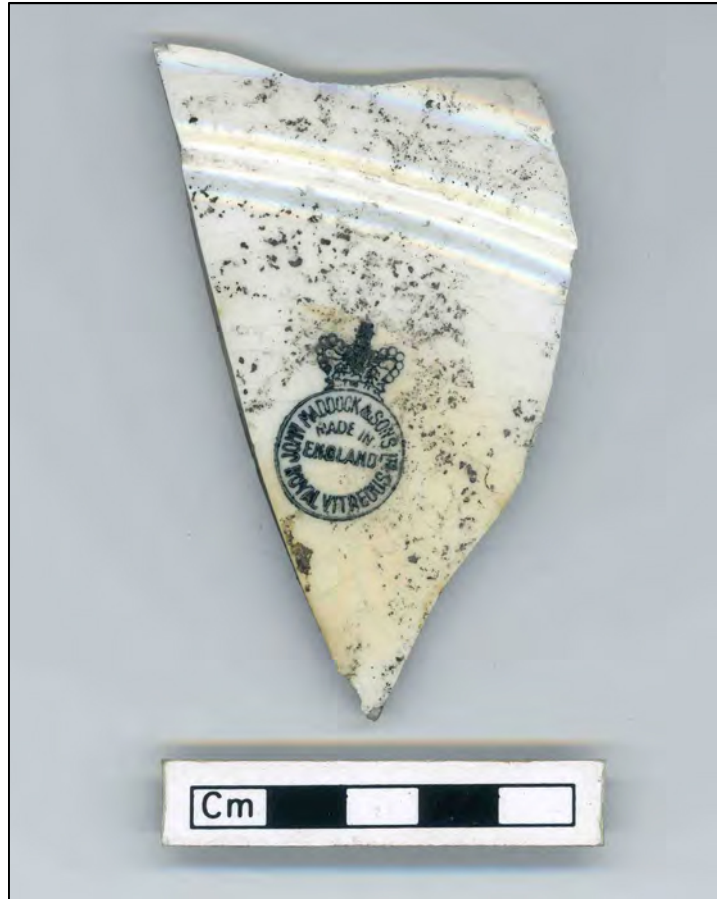
AP Plate 3: Printed maker's mark on a vessel from context WA100

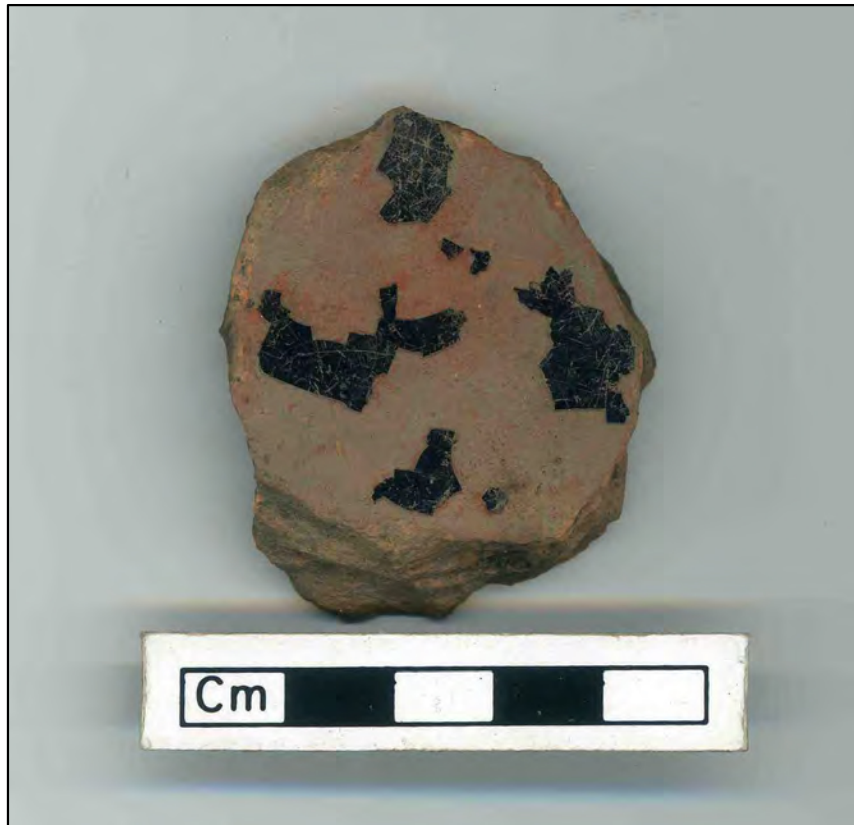
AP Plate 5: Pot disc in Brown Glazed Coarseware (context A188)

- 5.1.12 The pottery from context **A188** consisted of a single sherd of Brown Glazed Coarseware of late 18th or 19th century date. This is of interest less for the type of pottery (which is ubiquitous on sites across Sheffield) than for the fact that it has been reused as a pot disc (**AP Plate 5**, **Appendix I**). Such discs are found on sites of all dates from at least the early/mid 1st millennium BC onwards and are widespread across Europe. They are normally regarded as 'gaming pieces' although the evidence supporting this suggestion is sparse.

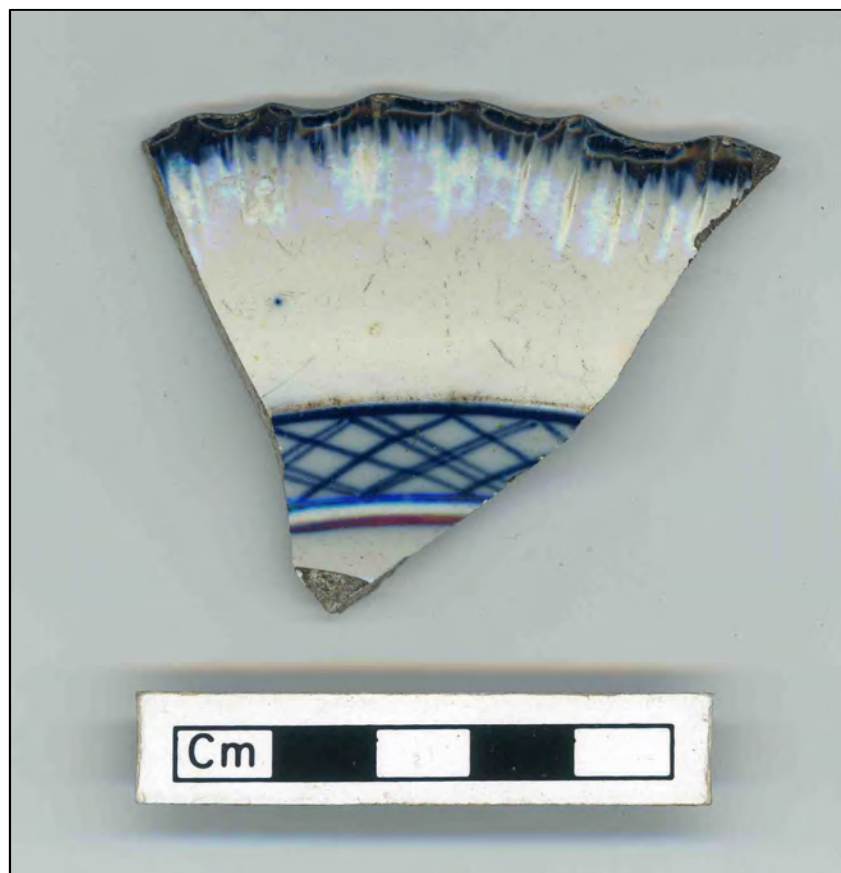
AP Plate 6: Edged ware plate with hand-painted internal decoration (context A109)

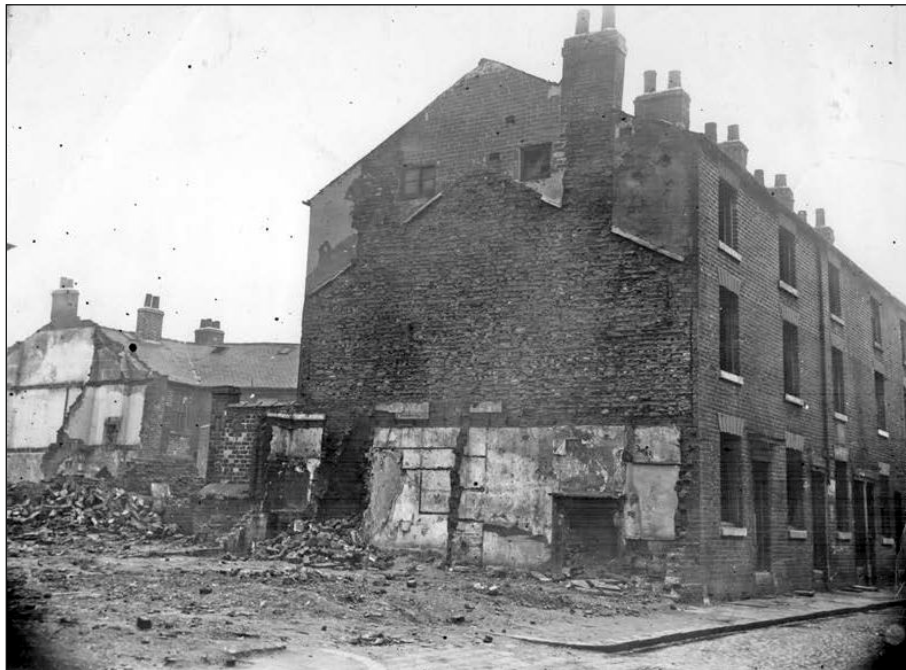
Historic Photo of No 33 Dun Fields showing damage on its western gable indicating the height of the buildings on Site (Picture Sheffield Ref: u00711)
