## South Stoneham House Swaythling, Southampton

Historic Building Record and  
Archaeological Record

Report reference: 78390.01

**August 2011**

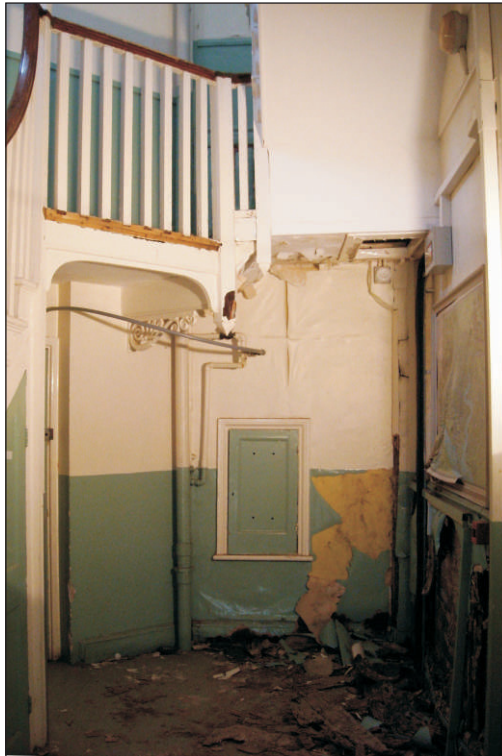
Plate 7: Room RG 07 – North and east walls of the Stairwell prior to remedial works

- 4.1.9 At the southern end of the Stairwell on the ground and first floors the plaster and timber panelling had been removed on the east and north walls due to the dry rot and damp problems. Prior to the remedial works the stairwell was photographed and a detailed drawn record made of the entire staircase and other fixtures and fittings by Stephens Cox Associates Ltd (**Appendix 1, Plate 7**). As elsewhere in the building, the exposed brickwork comprised red brick in English bond with pale lime mortar (**Plate 8**) with the brickwork of the north wall very similar (9" (22.8cm) in length and 2½" (6.3cm) in height) to that on the east wall despite the north wall being a later phase of work. This phasing was demonstrated in the north-eastern corner where the north wall clearly butts up to the east wall.

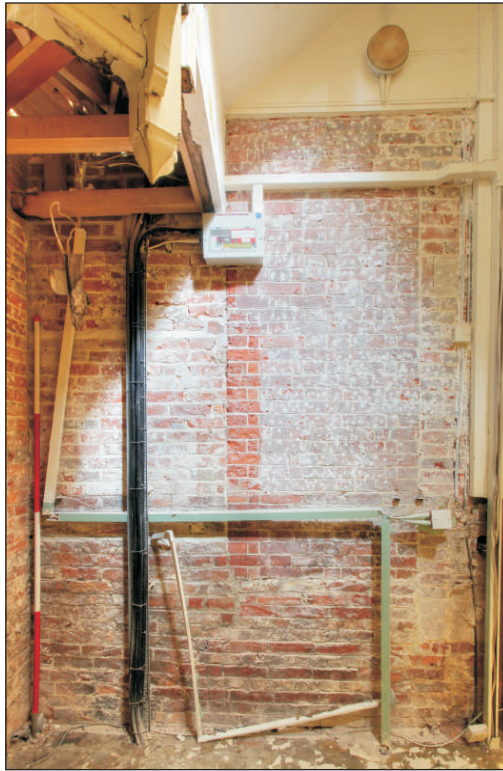
Plate 9: Room RG 07 – Exposed east wall of the Stairwell showing blocked window

- 4.1.10 The plaster removal had exposed fair faced brickwork in addition to a tall blocked window opening on the east wall at ground floor height (**Plate 9**) corresponding to the blocked opening observed on the other side of the wall in RG 08. In addition, following the removal of a small low cupboard on the northern wall (**Plate 10**) a recess measuring 0.99m in height, 0.58m in width and 0.55m in depth was present (**Plate 11**).

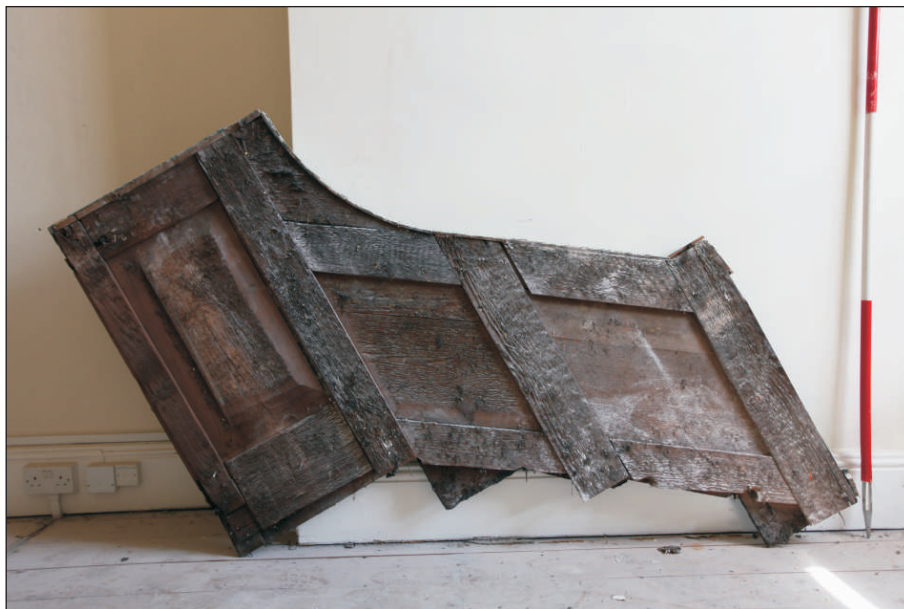
Plate 12: Underside of original panelling showing construction and inverted failed panel

- 4.1.11 Some sections of the original panelling were found to be free of dry rot and will be reinstated along with replacement panels. A removed section present on the first floor was photographed showing the unfinished underside consisting of all softwood construction with a failed raised panel inverted for reuse (**Plate 12**).

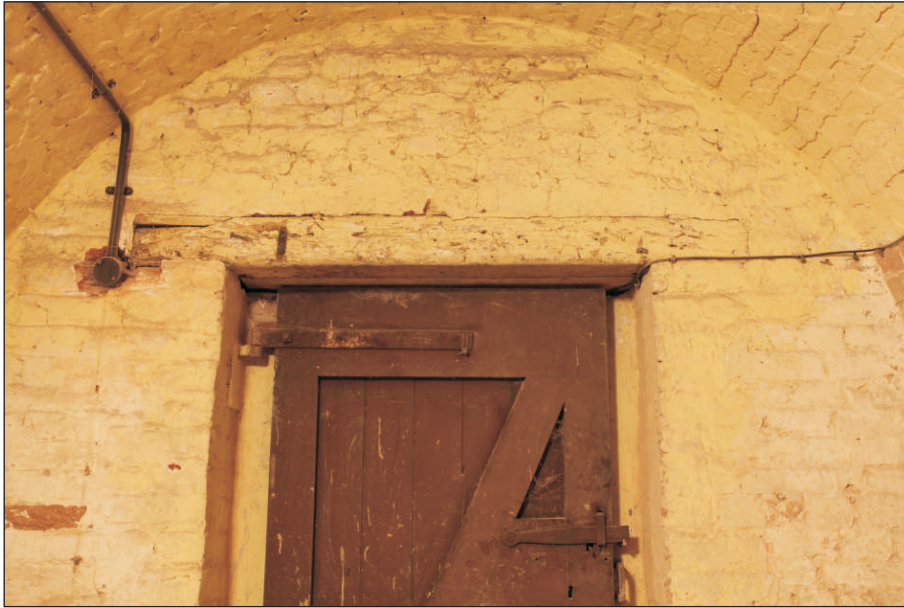
Plate 27: Room RB01 – plain lintel viewed from the south

- 4.2.2 The entrance doorways into each of the rooms were spanned with timber lintels with several revealing signs of reuse comprising doorheads from an earlier building(s). A number of the lintels were obscured by later fittings, electric tracking and pipework which prevented a clear view. All the lintels were made up of three separate pieces of timber which spanned the width of the wall to a width of 0.49m.
- 4.2.3 Of least interest were the lintels found above the entrances into the Storeroom RB 01, Music Room RB 14, Plant Room RB 05 and the Cellar RB 12 (**Figure 5**) which comprised plain timbers measuring approximately 1.2m in width and 0.11m in height (**Plate 27**). These lintels are likely to be original to the building.

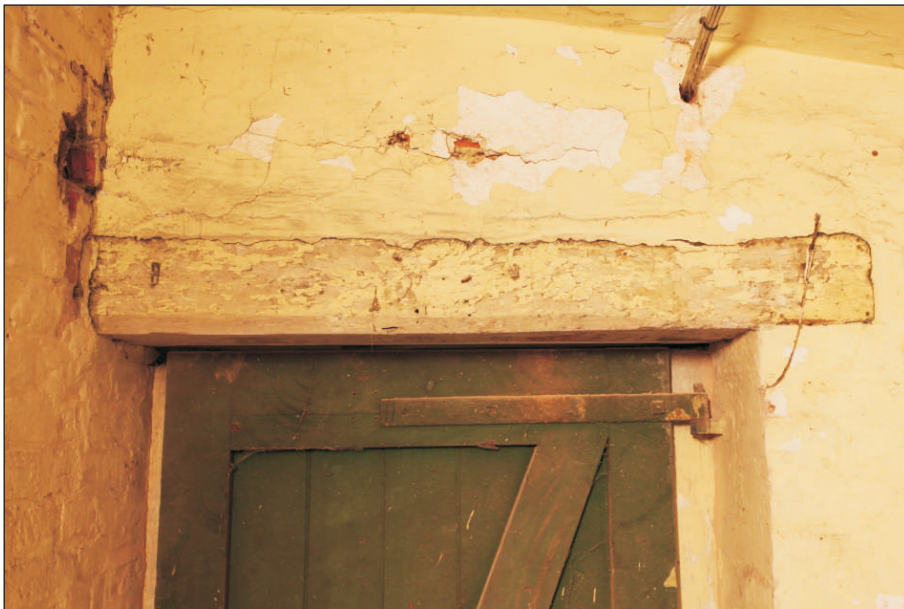
Plate 28: Room RB02 – plain stopped and chamfered timber over entrance

- 4.2.4 Plain stopped and chamfered timber lintels were found above the entrances to Storeroom RB 02 (**Plate 28**), RB 04 (**Plate 29**) (although only on the inner side - the outer timber facing the passage comprising a plain unchamfered piece), and RB 10 (**Plate 30**).

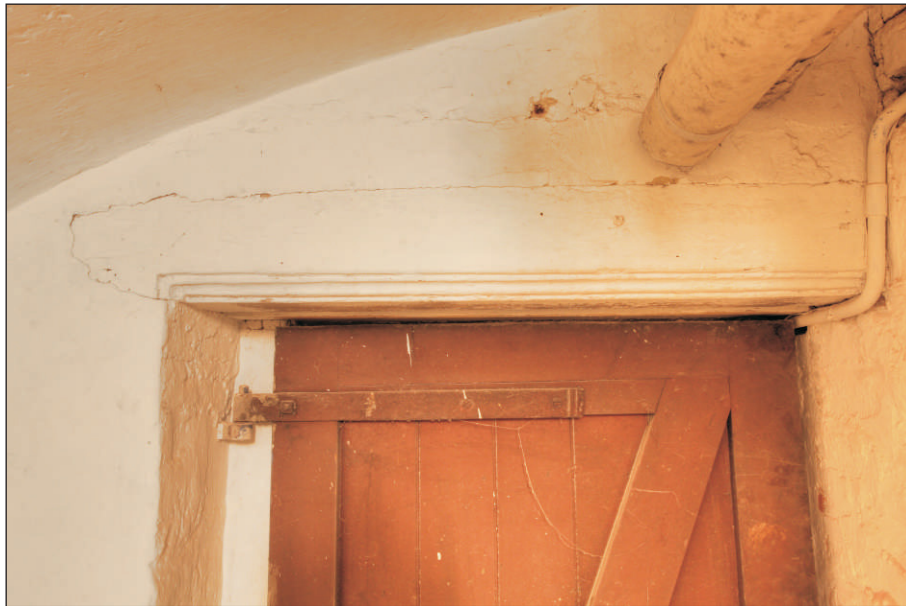
Plate 31: Room RB03 – Reused moulded timber from square-headed doorway

- 4.2.5 The most interesting reused doorheads can be found in the lintels over the entrances into the small Storeroom RB 03 (**Plate 31**) and Oil Storage room RB 09 (**Plate 32**) which comprise square headed moulded doorways with evidence for pegged construction visible on the doorhead over the entrance into Storeroom RB 03. Such doorheads, although sometimes earlier, were prevalent from the mid 16<sup>th</sup> century onwards (Hall 2005, 23).

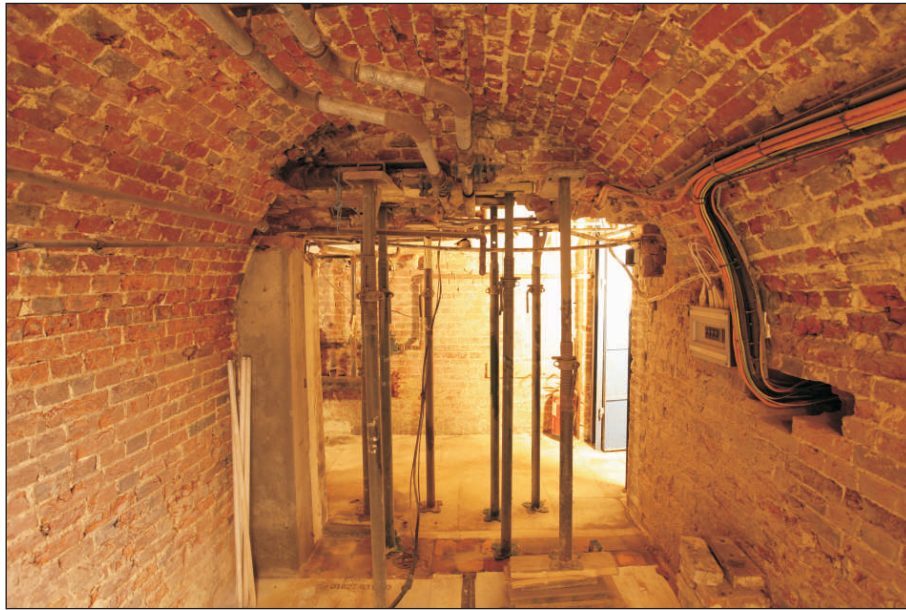
Plate 33: Room RB08 – lintel removed above doorway currently propped

- 4.2.6 The lintel over the entrance into the Bar Store RB 08 had been removed during the recent renovation works due to dry rot (**Plate 33**) with some of the surrounding bricks also removed to facilitate the removal of the timbers (**Plate 34**). Here the weight of the wall was supported by eight adjustable steel props and Strongboys® until the replacement timbers were installed.

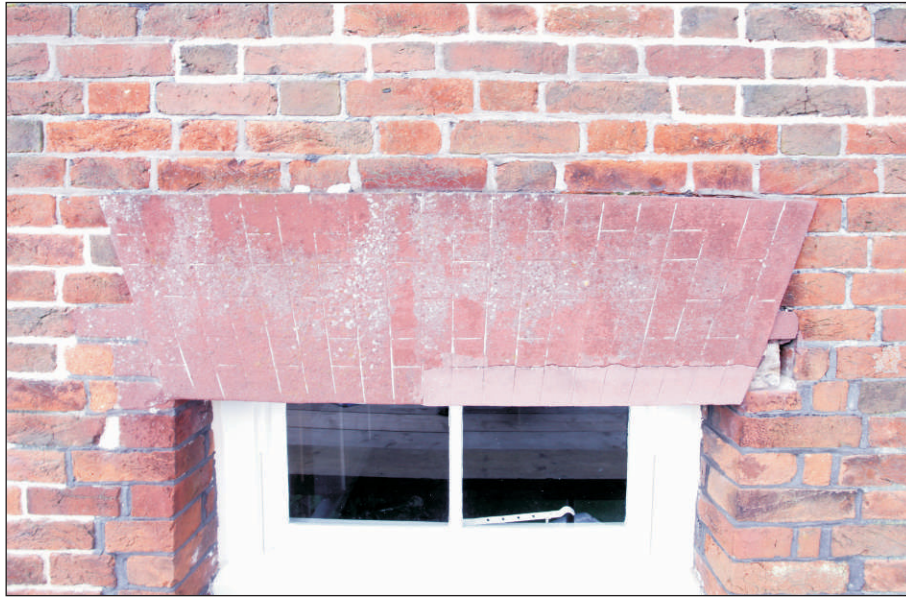
Plate 37: Second floor windows – false cement arch showing later repair

- 4.3.6 Evidence for later patch repairs to the cement brick arches was visible above many of the windows, with colour matched (not entirely successfully) mortar applied to galvanised steel gauze which had been nailed onto the timber lintel beneath. The brickwork concealed behind the cement was mostly in fair condition, although some of the faces of the bricks had deteriorated due to contact with this harder, impermeable material. Following the replacement of the timber lintels (where necessary) the false brick arches will be re-instated using appropriate colour-matched lime mortar.

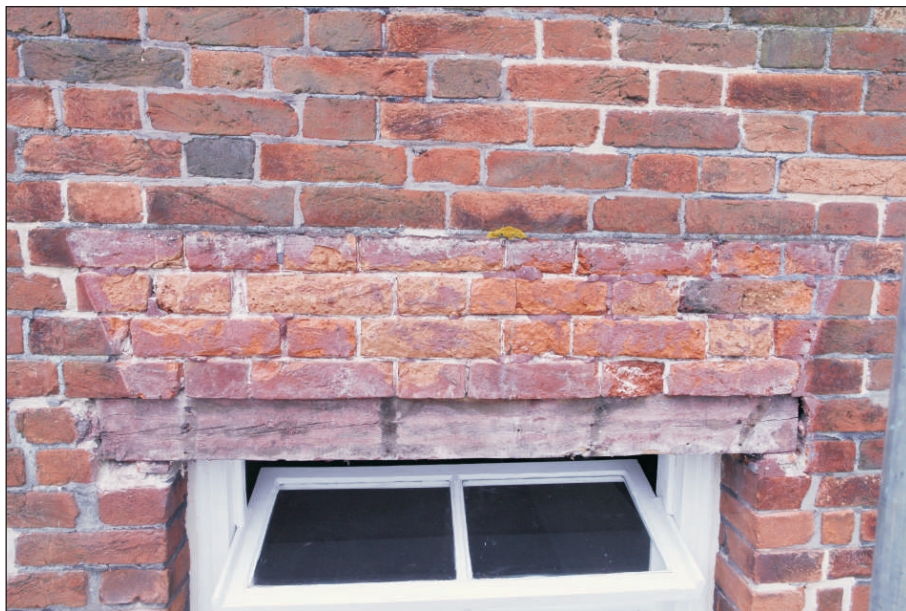
Plate 38: Second floor windows – exposed lintel and brickwork following removal of false cement arch

- 4.3.1 Due to the problems with damp and dry rot within the building it was considered necessary to examine the timber lintels over the seven central windows on the second floor of the front (north) elevation to ensure that they were in sound condition.
