# Round 3 Hornsea Zone, Subzone 1 and Offshore Cable Route

Archaeological Assessment of Geophysical Data

Ref: 87152.01  
April 2013

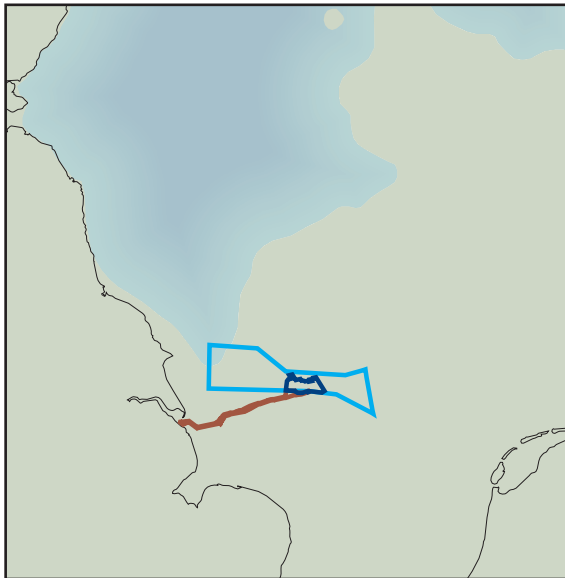
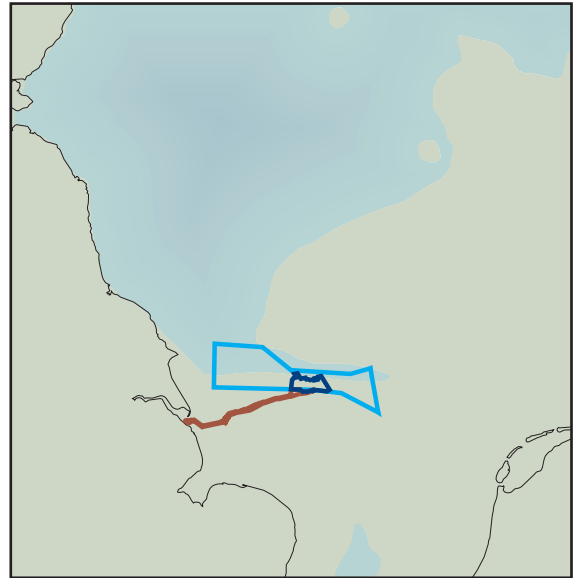
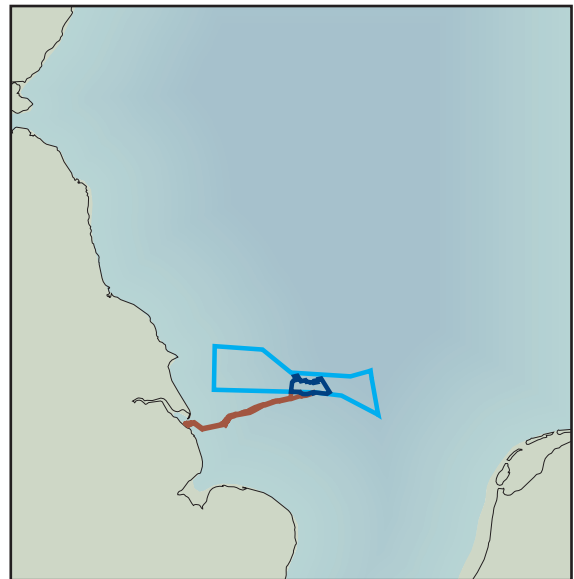
A. 10,000 BP

B. 9000 BP

C. 8000 BP

D. 7000 BP

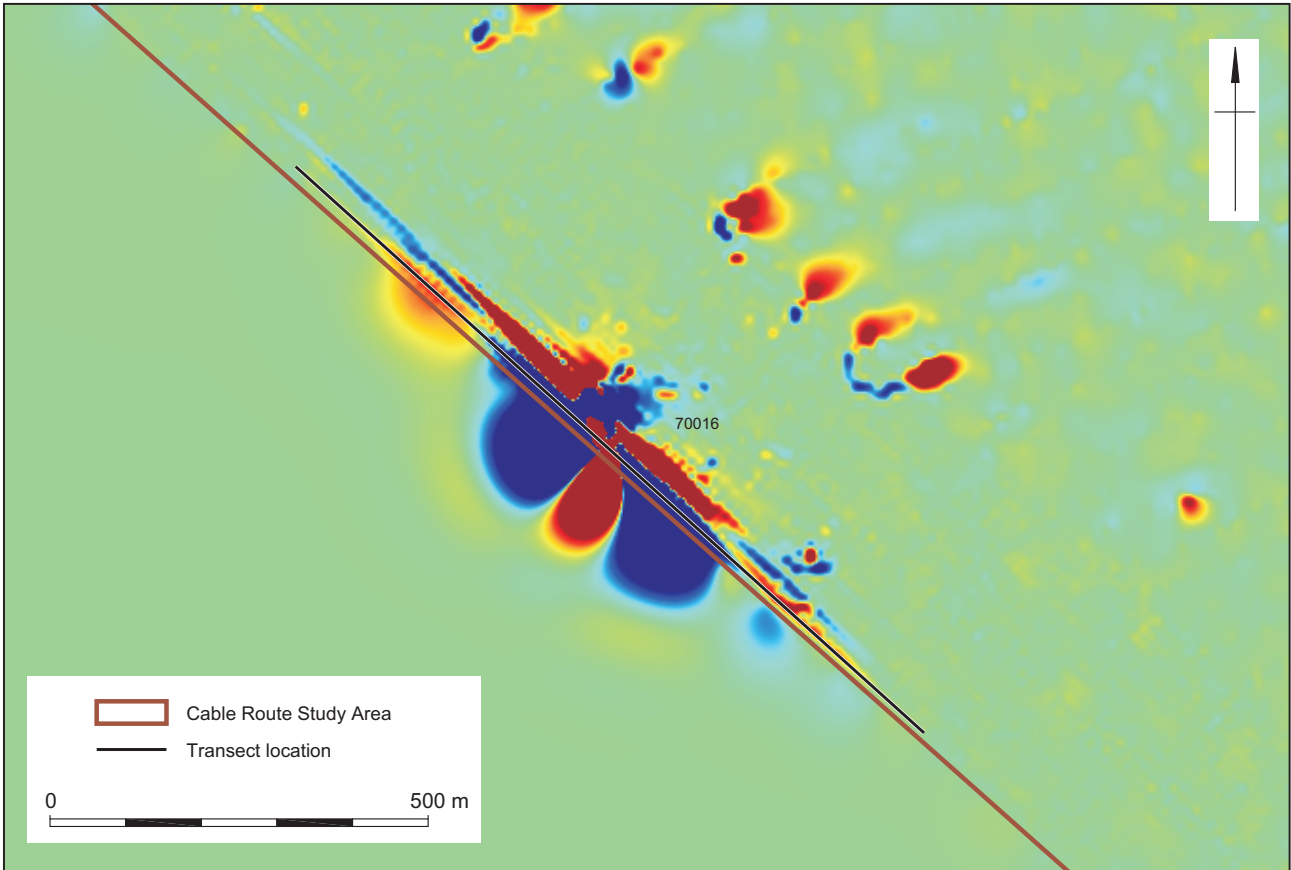
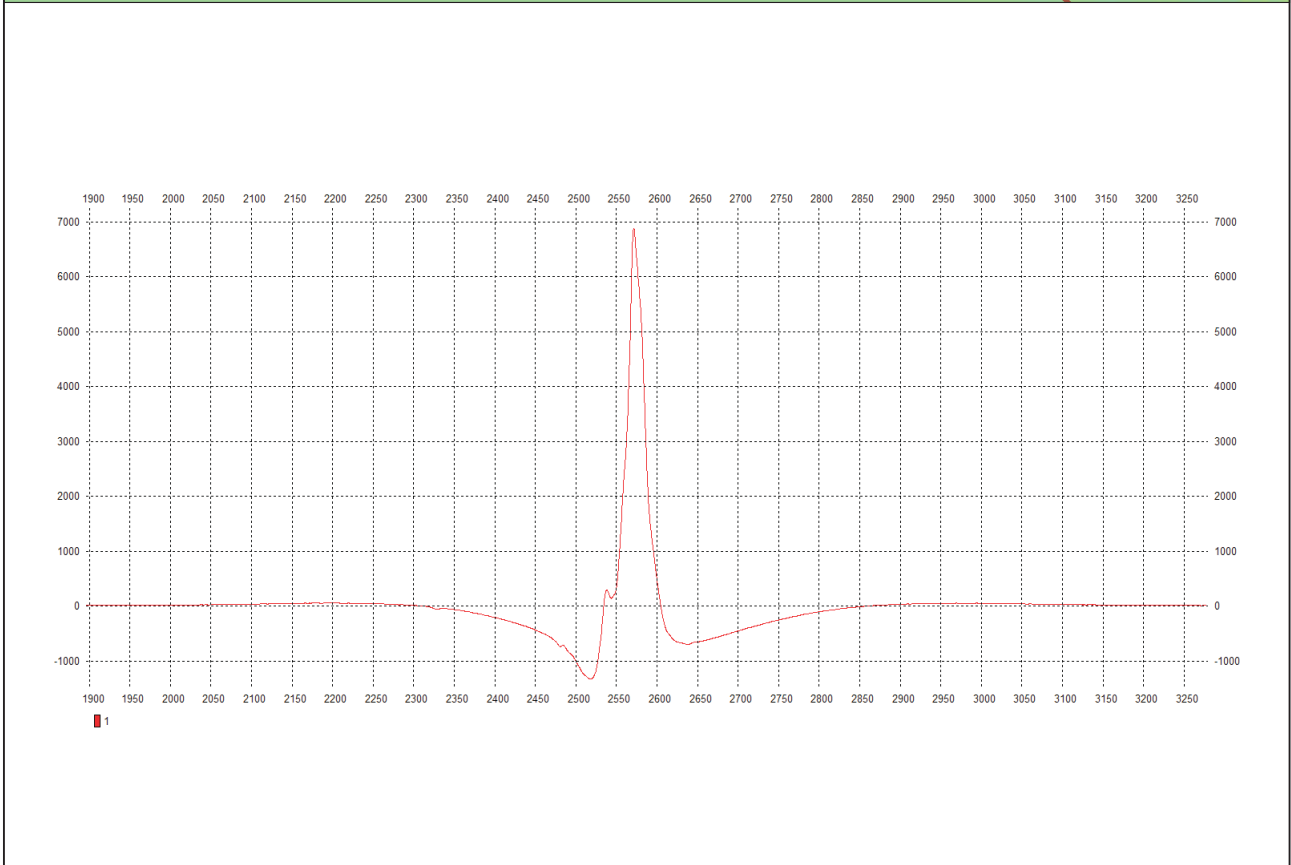
Figure 6

Magnetometer Data Example across Wreck 70016

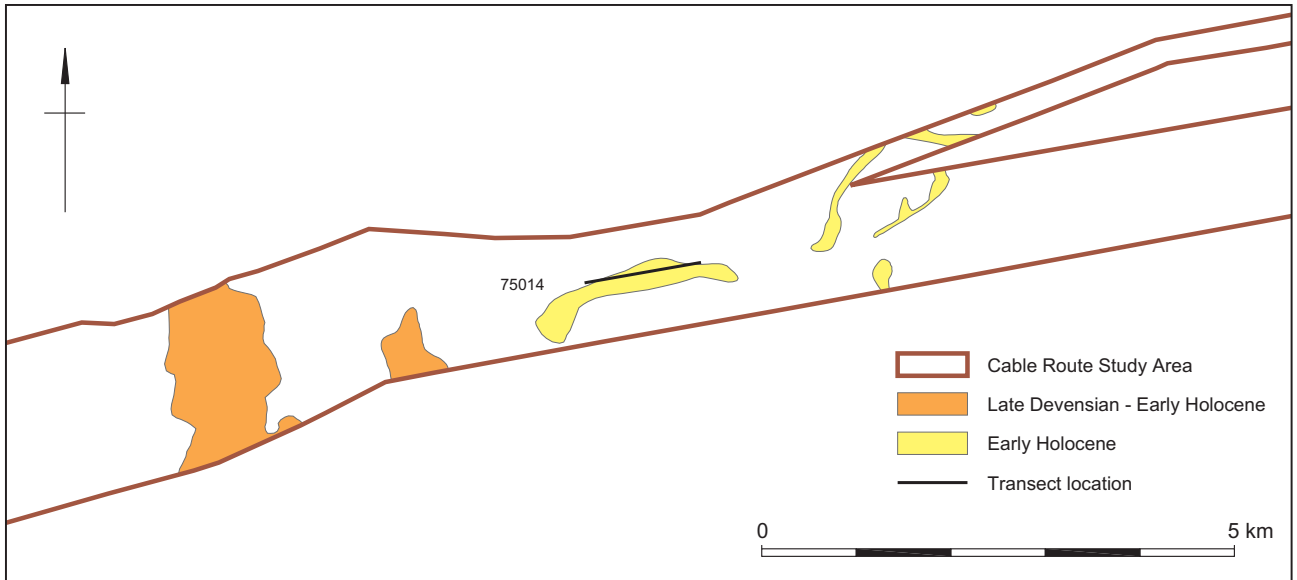
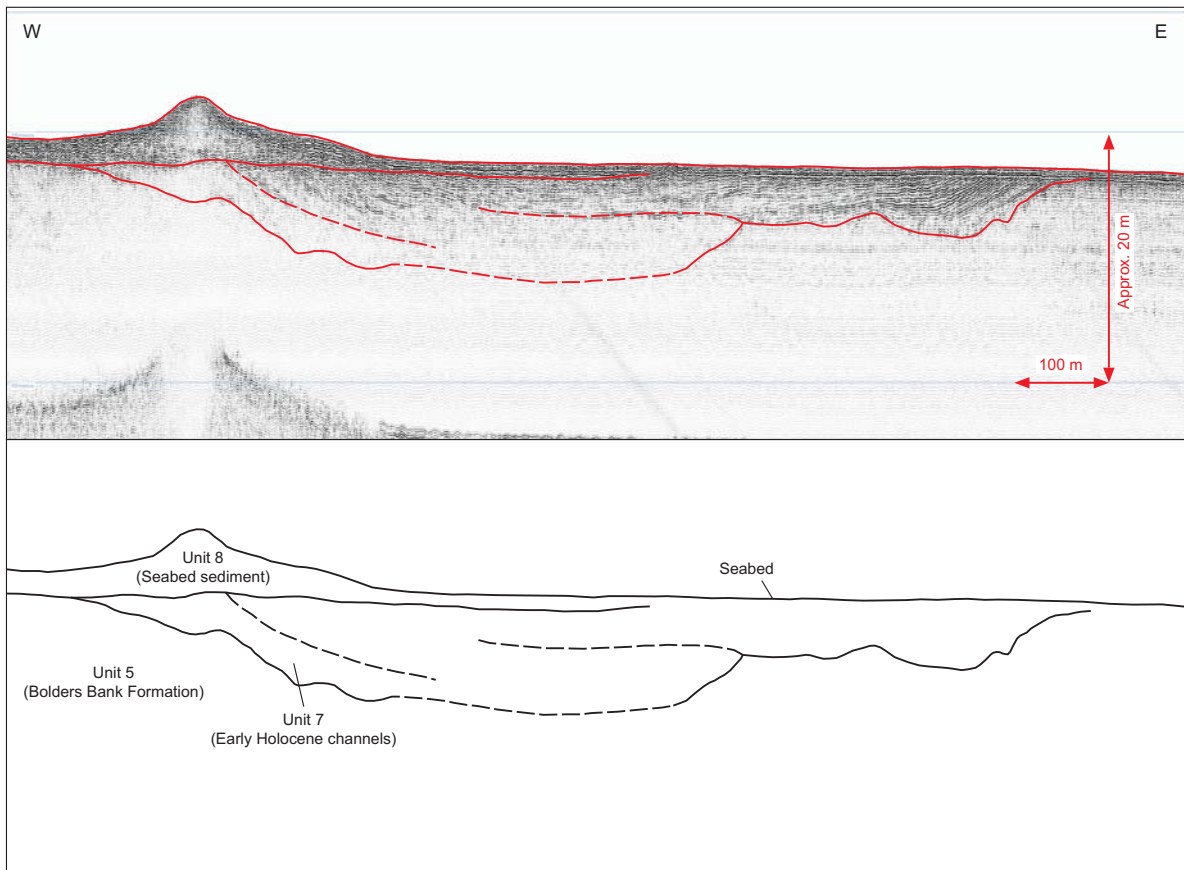
Figure 11

Seismic Data Example of Feature 75014

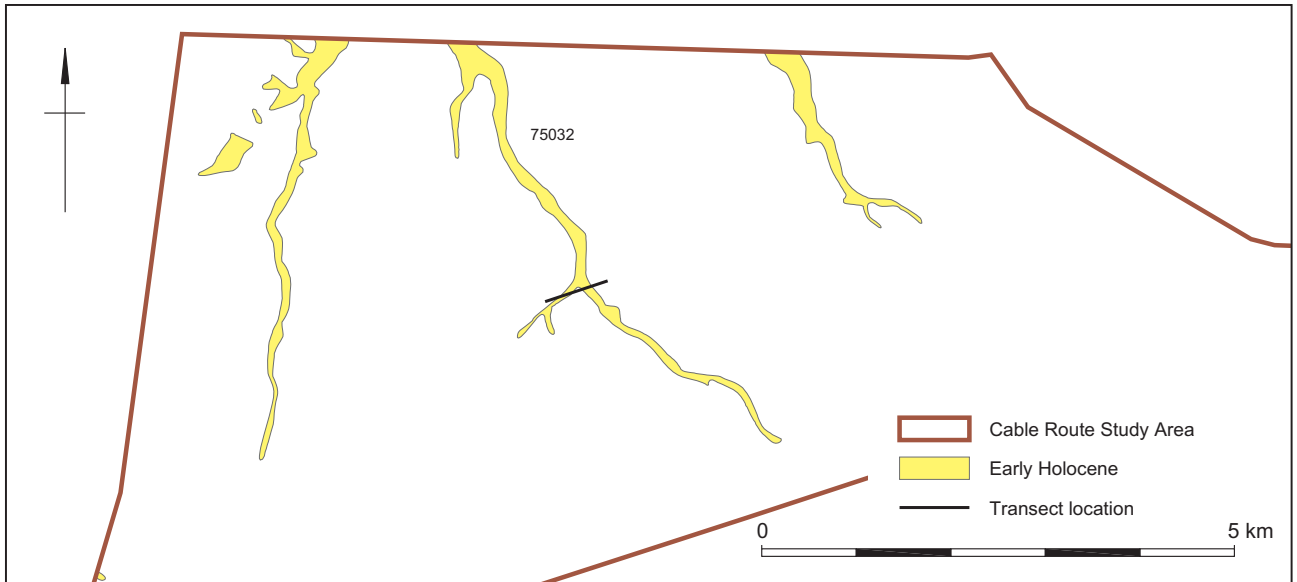
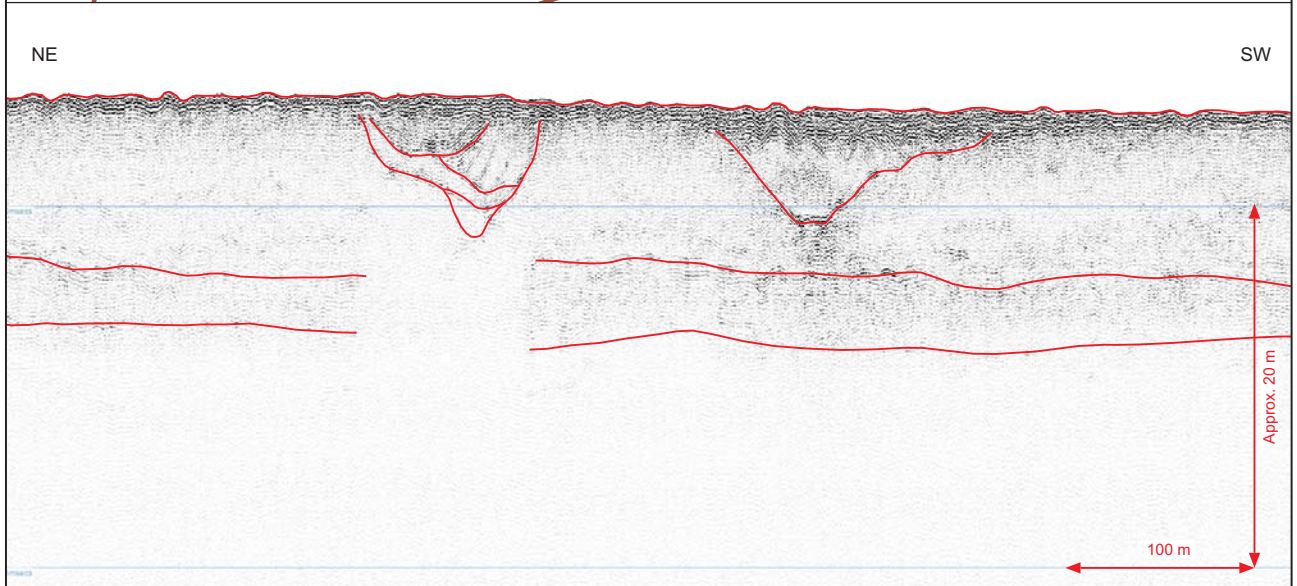
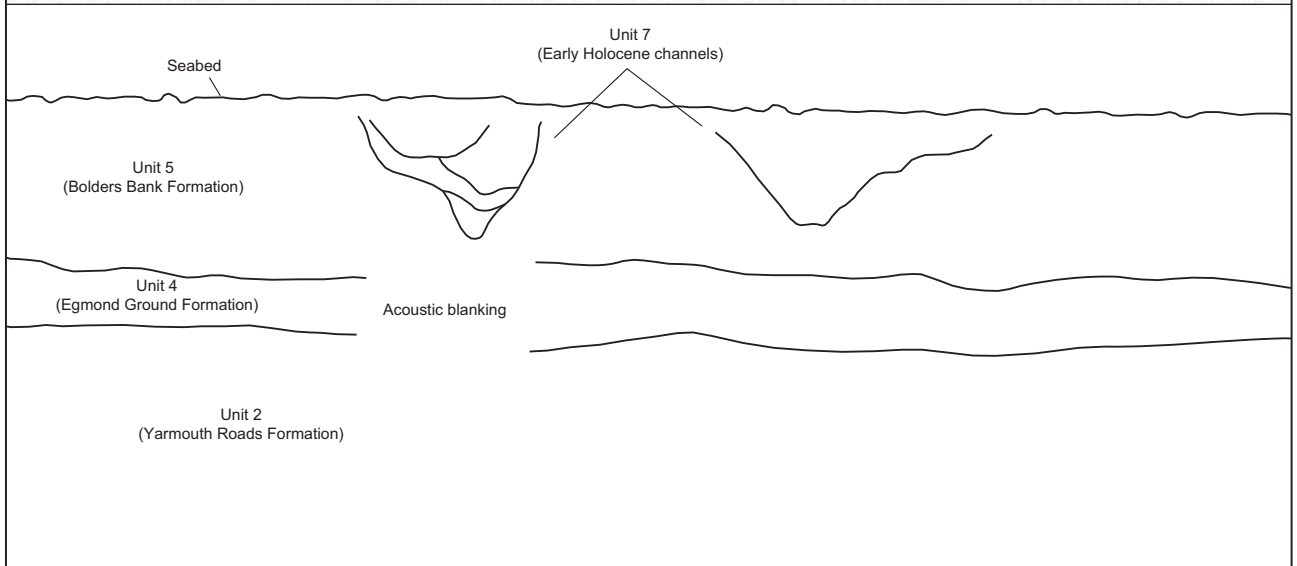
Figure 12

Seismic Data Example of Feature 75032

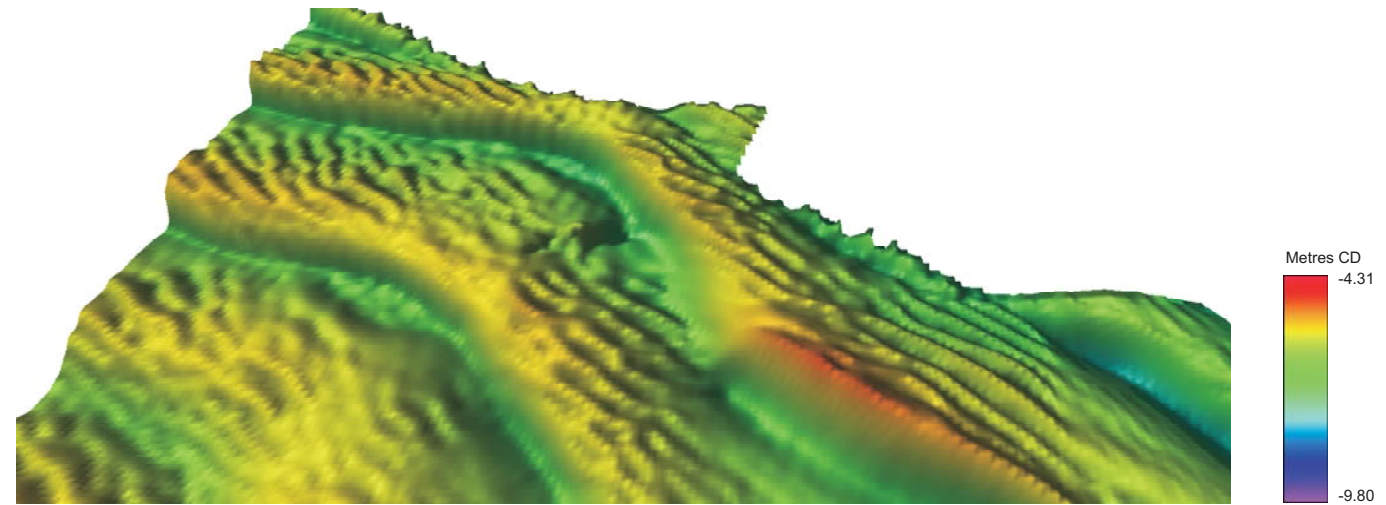
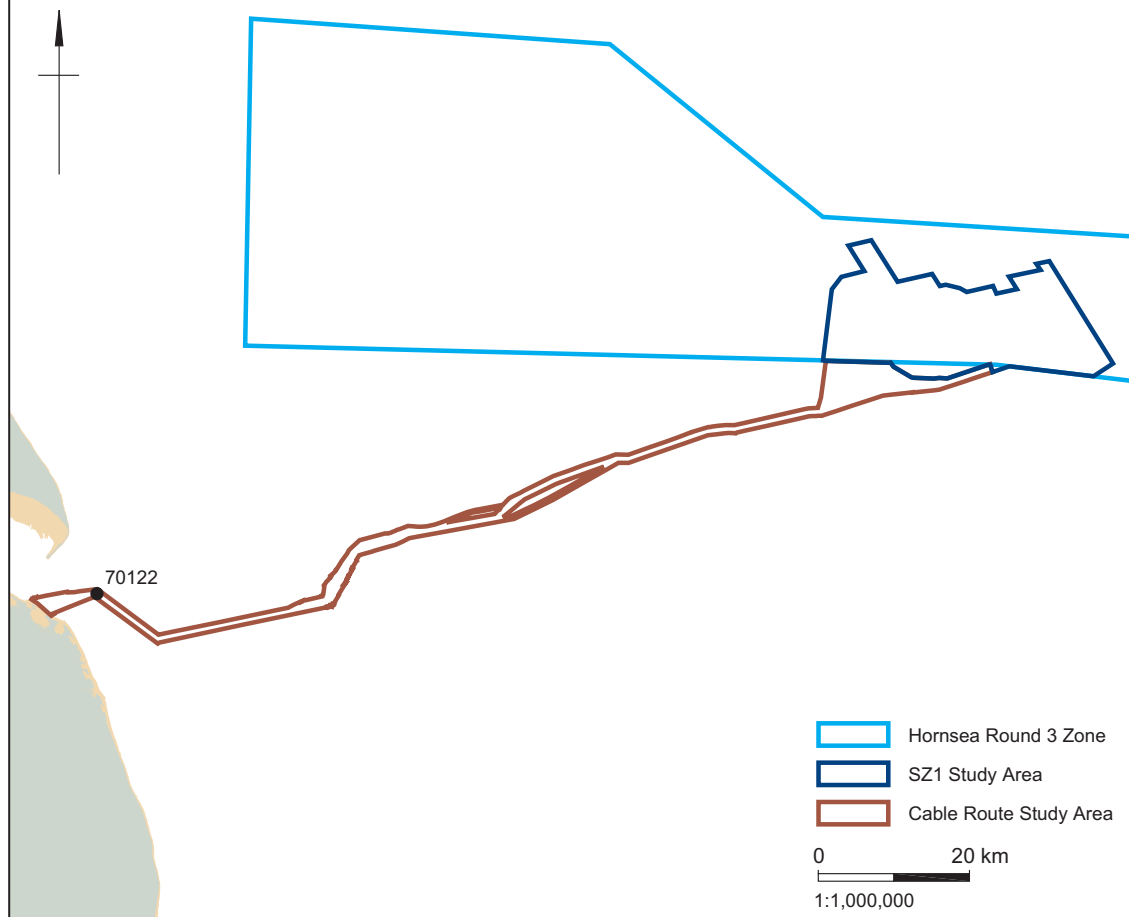
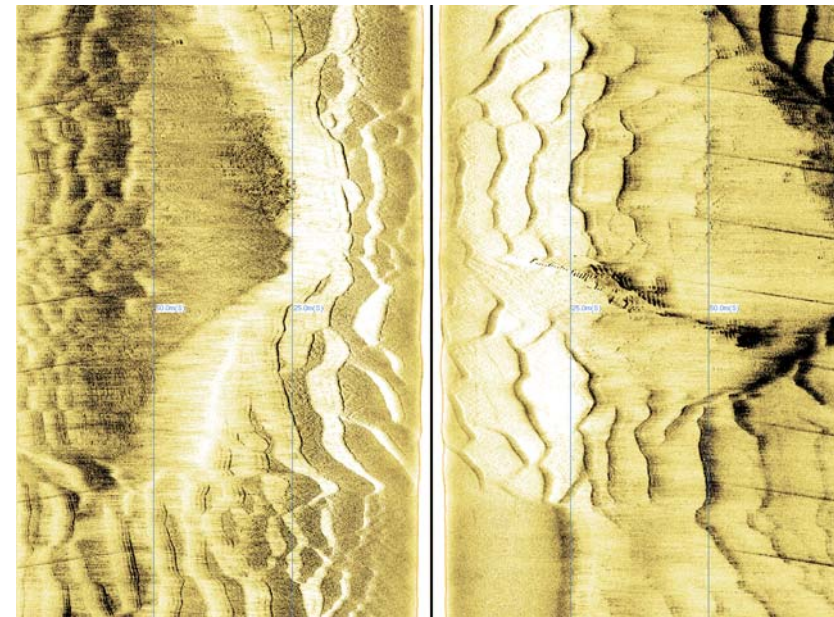
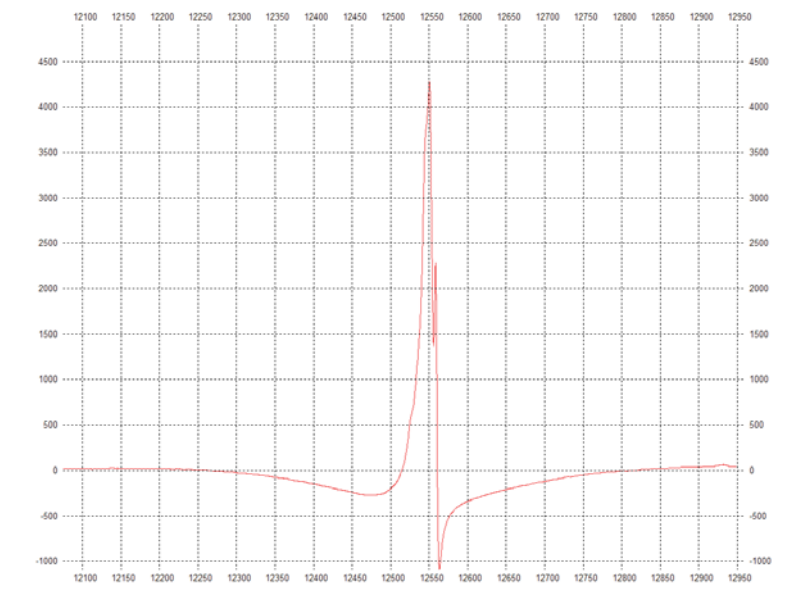
## Wreck 70122 - Unidentified Wreck

<b>Location</b>		315075 E, 5935126 N (UTM31N)	<b>Area</b>	Cable Route
<b>Archaeological Importance</b>		High		
<b>Geophysical survey dimensions and notes</b>		Dimensions: 54.3m x 15.8m x 0.8m. Elongate low mound located in an area of sand waves, orientated NE-SW. Sidescan sonar shows an irregular outline with numerous short, parallel dark reflectors indicating structure. Associated with a very large, distinct magnetic anomaly.		
<b>Build</b>	<b>Type</b>	Unknown		
	<b>Construction</b>	Unknown, but magnetic anomaly suggests steel hull		
	<b>Dimensions</b>	Original dimensions unknown		
	<b>Shipyard</b>	Unknown		
<b>Loss</b>	<b>Cause</b>	Unknown		
<b>Extent of Survival</b>		The wreck is almost completely buried by sand waves, found by multibeam bathymetry data in consecutive years to migrate over time. Difficult to assess due to burial, but the wreck appears at least partially intact with a large coherent structure. Not associated with a known wreck record so potentially previously unrecorded, though could be the <i>Vasco</i> which was not identified at the recorded location approximately 345m NW.

Multibeam image facing North, x10 vertical exaggeration

Sidescan sonar

Magnetometer profile

- 4.2.32 **Unit 8** solely comprises the modern seabed sediment along the Cable Route, and is the most recent identified deposit. It is generally very thin, often less than 1m thick, though in some areas it is thick enough to form sand waves, and has been found by vibrocoring to comprise gravelly sands and sandy gravels (WA 2013). Although not considered of archaeological potential in itself, Unit 8 could potentially cover previously unknown wreck sites in areas where sand waves form, as is the case with wreck **70122 (Sheet 1)**.

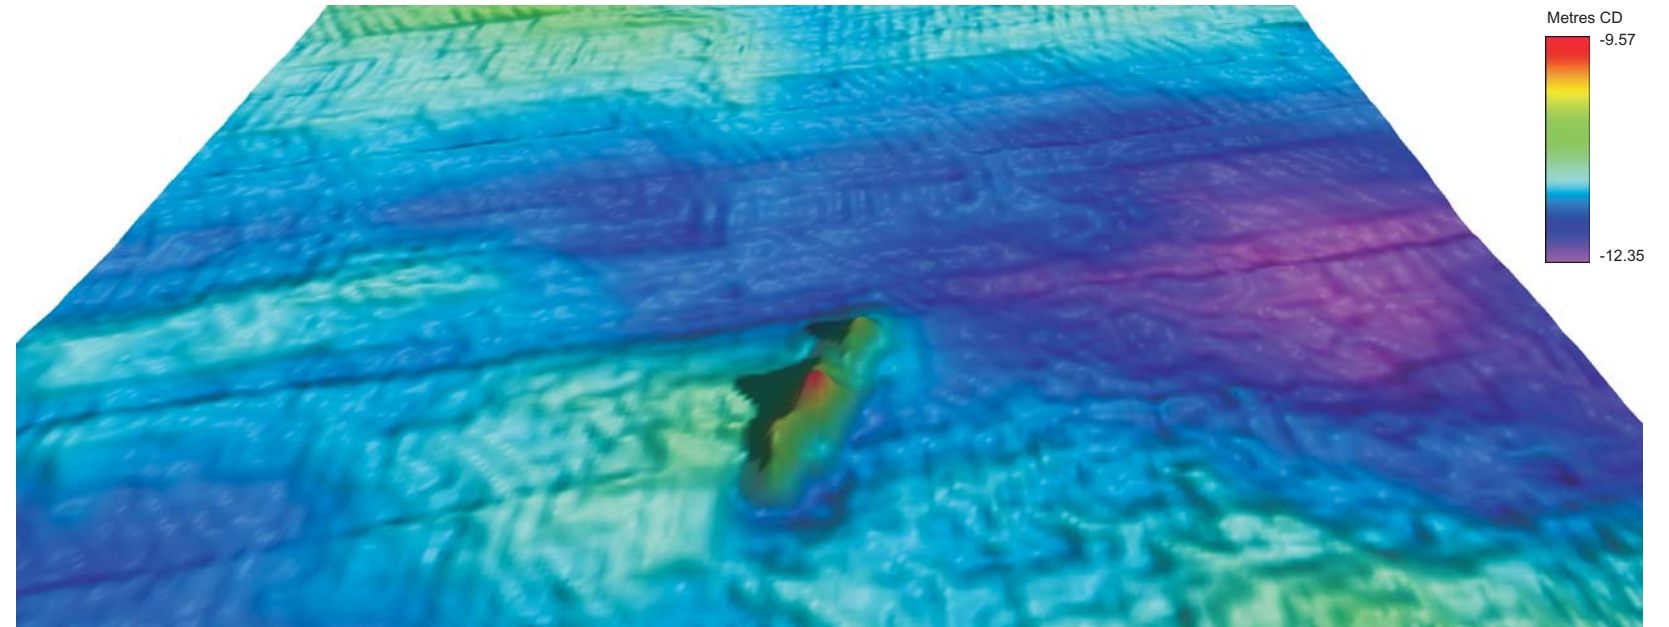
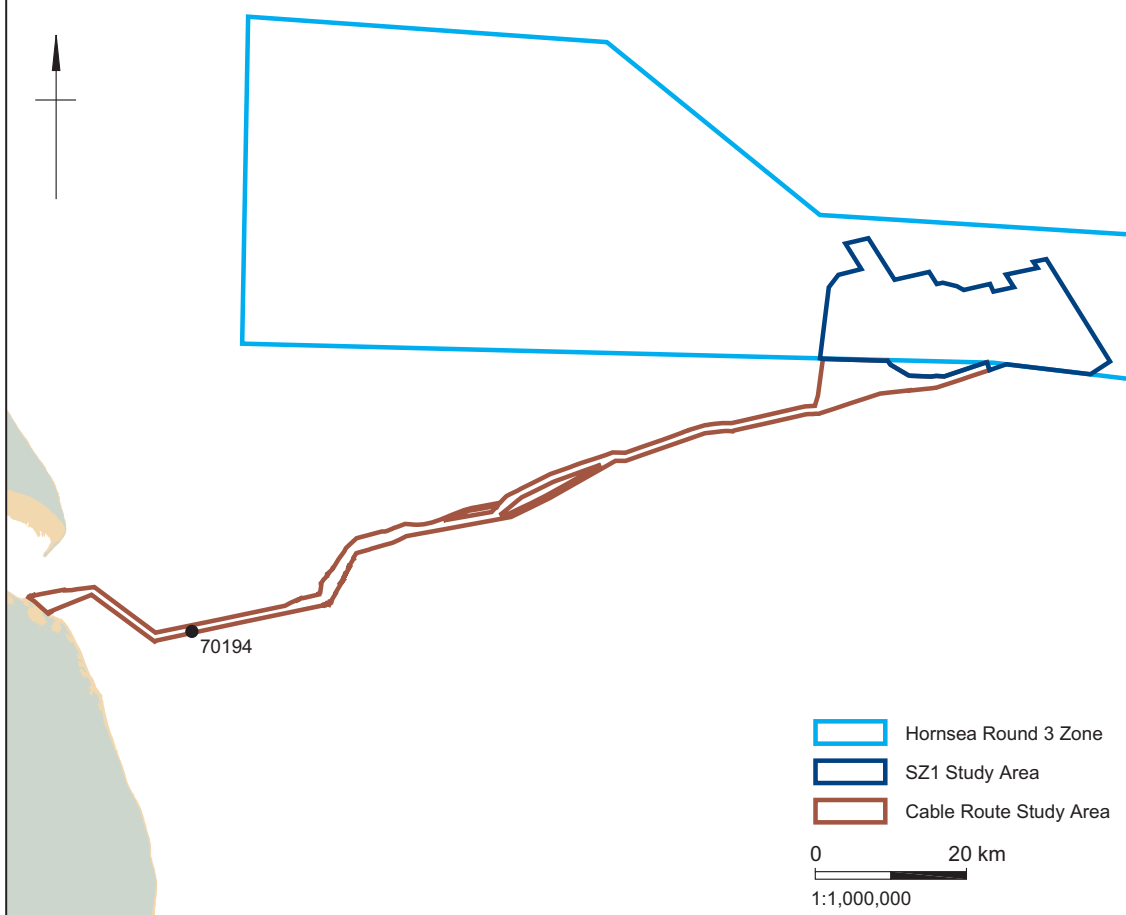
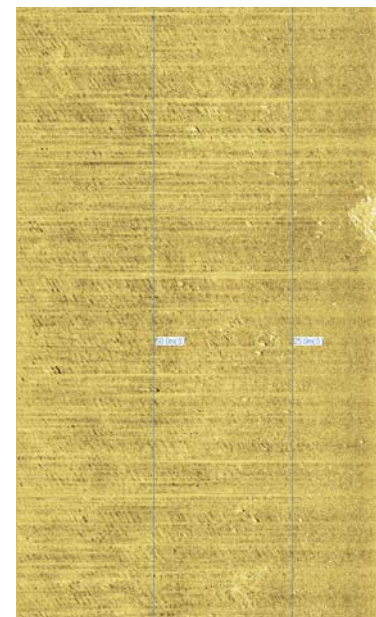
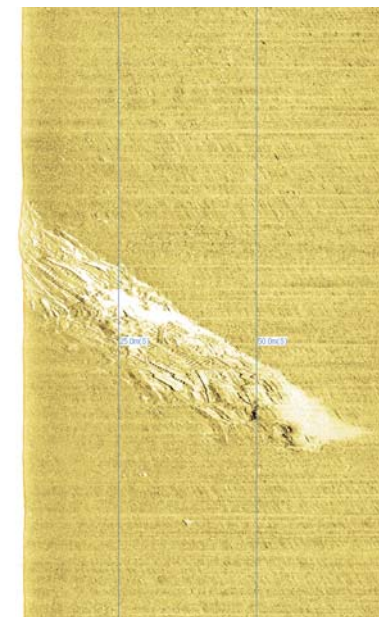
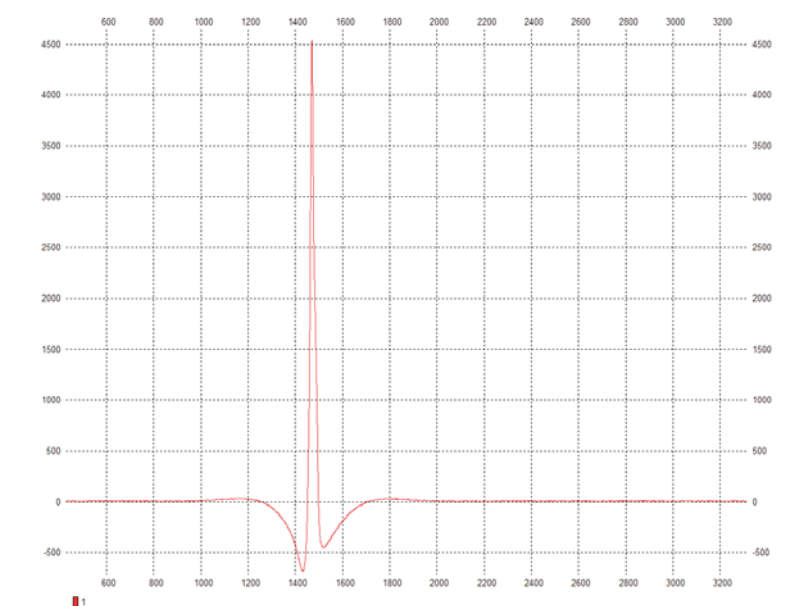
## Wreck 70194 - SS Ravonia

<b>Location</b>		328072 E, 5929813 N (UTM31N)	<b>Area</b>	Cable Route
<b>Archaeological Importance</b>		High		
<b>Geophysical survey dimensions and notes</b>		Dimensions: 109.1m x 42.3m x 2.0m. Distinct, elongate mound orientated approximately NE-SW in an area of generally featureless seabed. Linear reflectors running the length of the wreck and shorter, transverse reflectors suggest structure. Highest part of the wreck is towards the centre. Associated with a very large magnetic anomaly.		
<b>Build</b>	<b>Type</b>	Steam cargo ship		
	<b>Construction</b>	813 grt, steel hull, triple expansion engine		
	<b>Dimensions</b>	56.8m x 9m		
	<b>Shipyard</b>	Williamson R. & Son, Workington		
<b>Loss</b>	<b>Cause</b>	Lost during transit from Sunderland to Cowes following a collision with the HMT trawler <i>Eroicon</i> , 23/09/1944		
<b>Extent of Survival</b>		The wreck appears as a mound of debris rather than a coherent structure, though parallel reflectors suggest that some structure is still visible. Generally featureless seabed suggests it is unlikely to be covered by sand on a regular basis. Recorded as possibly a section of the SS <i>Ravonia</i> , though the measured dimensions are much larger than the original size of this vessel suggesting it could be a different wreck entirely.

Multibeam image facing North, x10 vertical exaggeration

Sidescan sonar

Magnetometer profile

- 4.1.10 Anomaly **70194** is a large, distinct wreck identified by all of the geophysical equipment (**Sheet 2**). The wreck appears as a rectangular mound of debris and, although restricted to a distinct area rather than being dispersed across a large section of the seabed, no identifiable structure is visible suggesting the vessel is badly broken up and degraded. The large magnetic anomaly of 9070nT suggests a significant ferrous component to the debris.

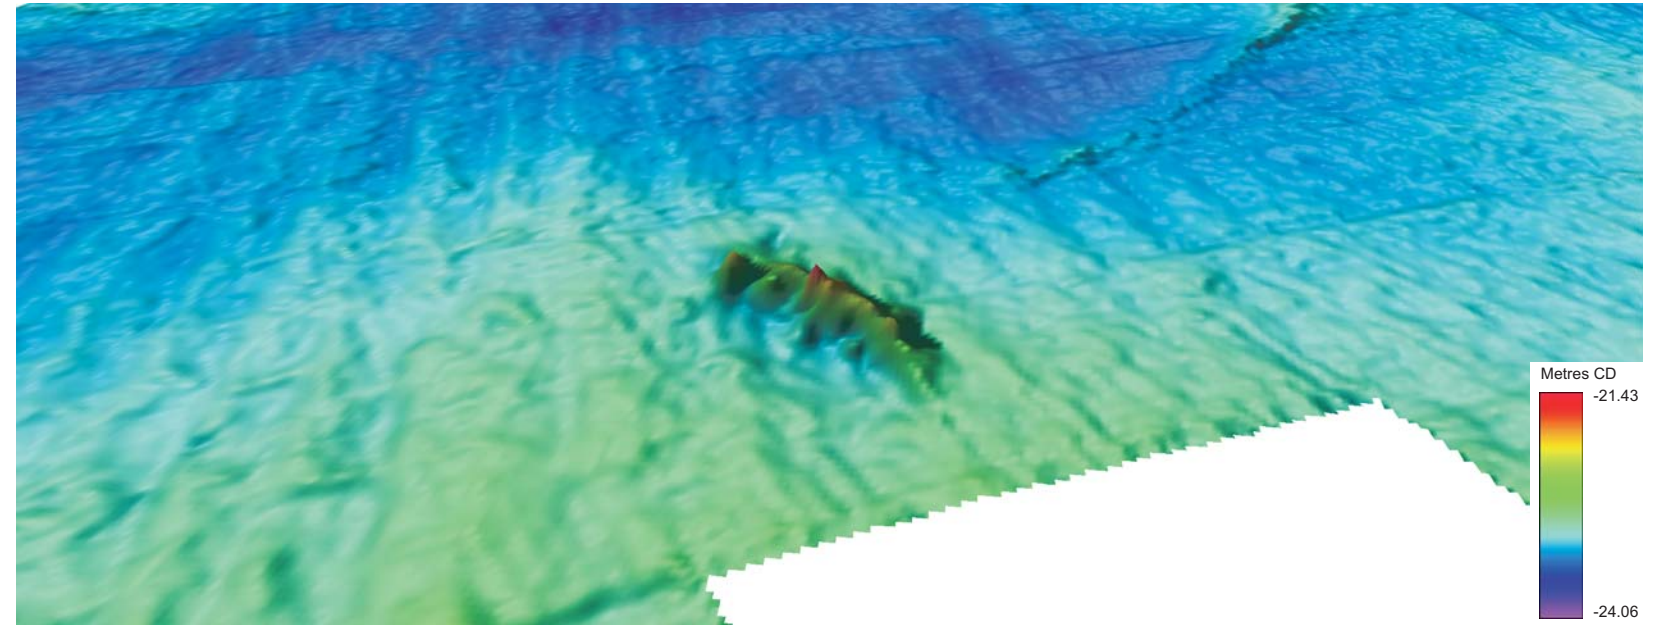
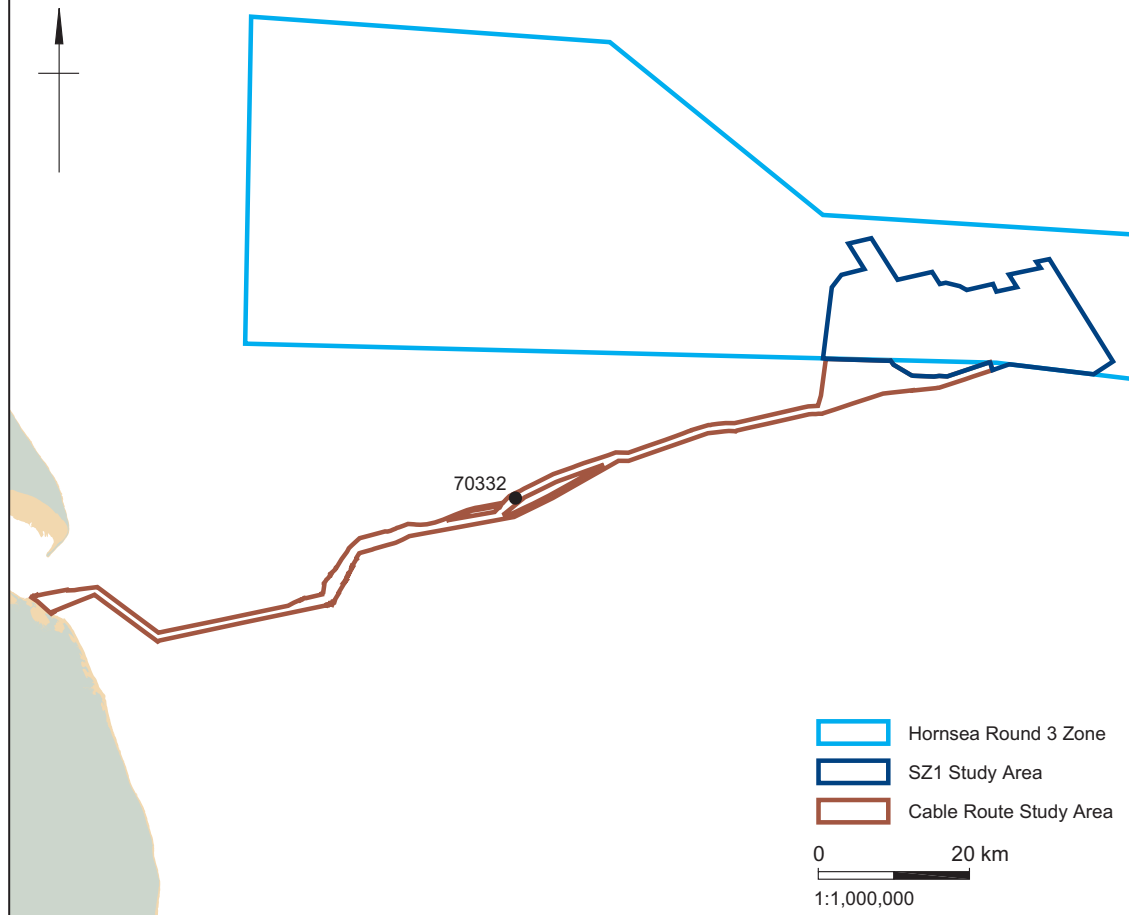
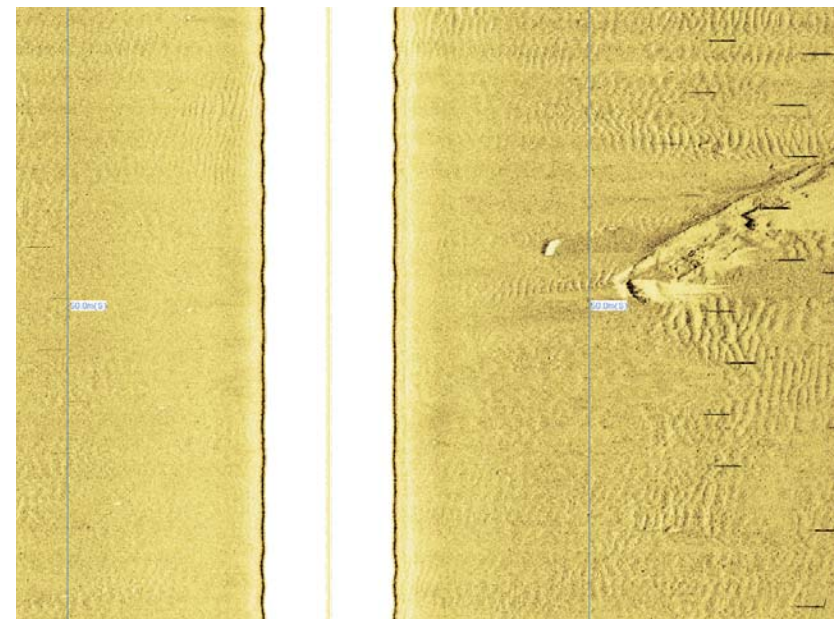
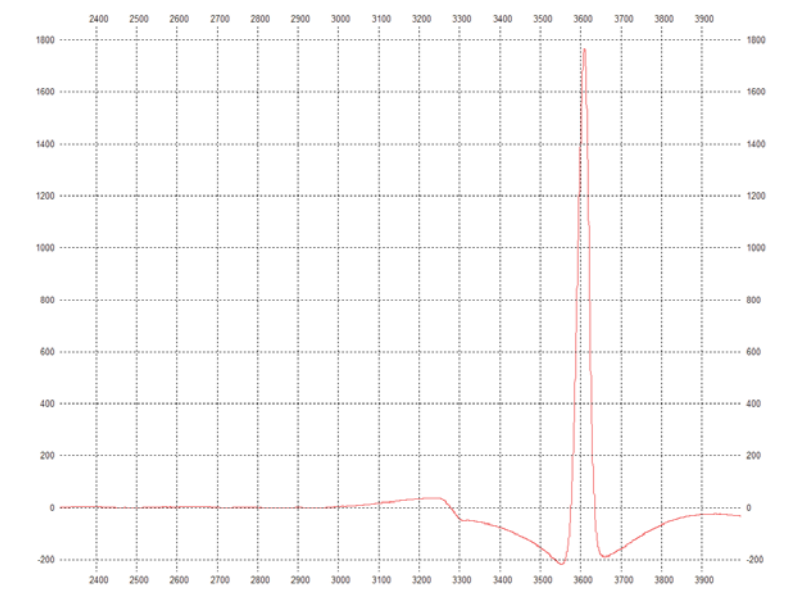
# Wreck 70332 - SS Nieuwland

<b>Location</b>	370438 E, 5947503 N (UTM31N)	<b>Area</b>	Cable Route
<b>Archaeological Importance</b>	High		
<b>Geophysical survey dimensions and notes</b>	imensions: 56.1m x 36.0m x 1.6m. Irregular, slightly curved, elongate mound orientated approximately NW-SE. Area of irregular dark reflectors outlined by long, linear dark reflectors with at least two distinct high points visible on sidescan sonar. One elongate dark reflector visible a short distance from main structure. Associated with a very large magnetic anomaly.		
<b>Build</b>	<b>Type</b>	Steam cargo ship	
	<b>Construction</b>	Unknown, but magnetic anomaly suggests steel hull	
	<b>Dimensions</b>	65.6m x 10.0m	
	<b>Shipyard</b>	Osbourne, Graham & Co. Ltd., North Hylton (Sunderland)	
<b>Loss</b>	<b>Cause</b>	Mined and sunk during transit from Goole to Harlingen, 03/10/1914	
<b>Extent of Survival</b>	General faint vessel outline visible in the geophysical data, the structure appears upright but generally quite badly broken up. The vessel high points could represent remaining coherent structure. Sand ripples in the vicinity indicate it is probably partially buried. One distinct piece of separate debris identified, but no significant debris field.

Multibeam image facing North, x10 vertical exaggeration

Sidescan sonar

Magnetometer profile

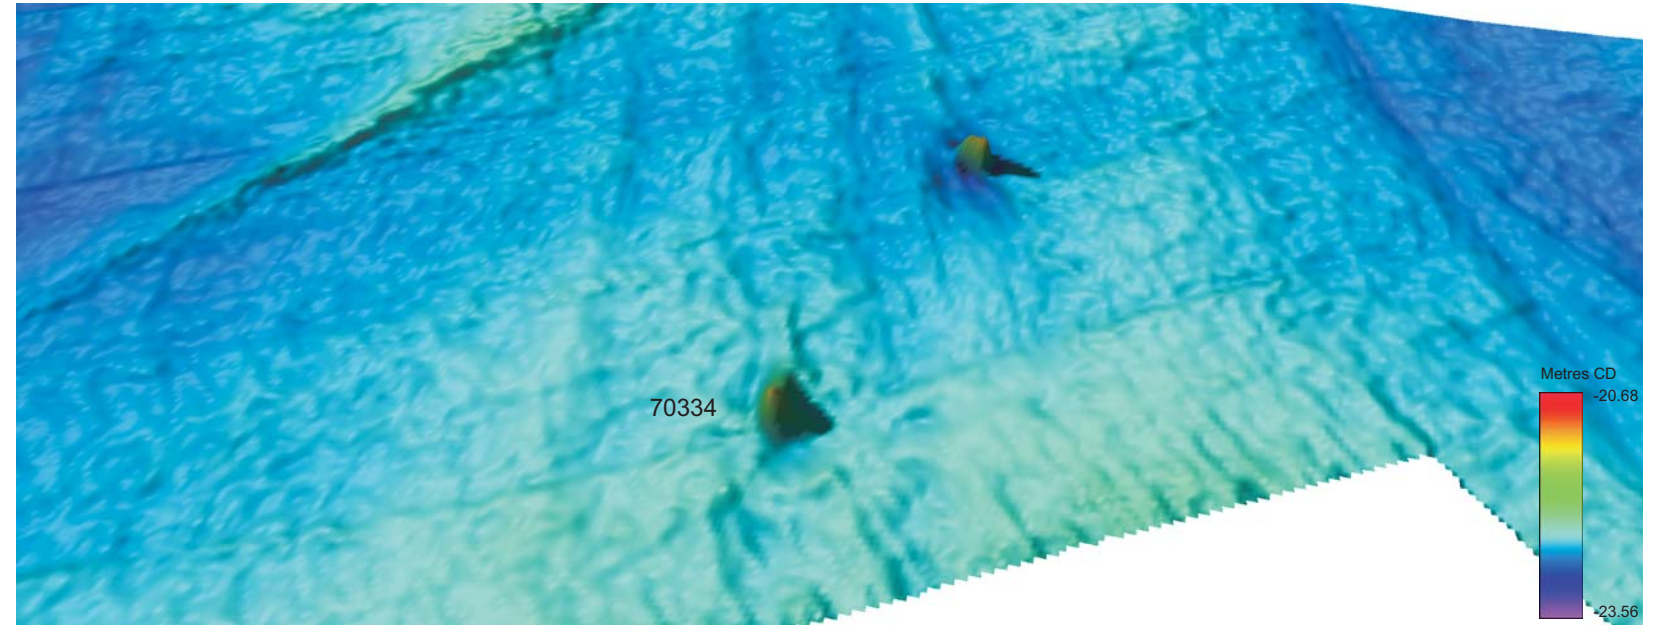
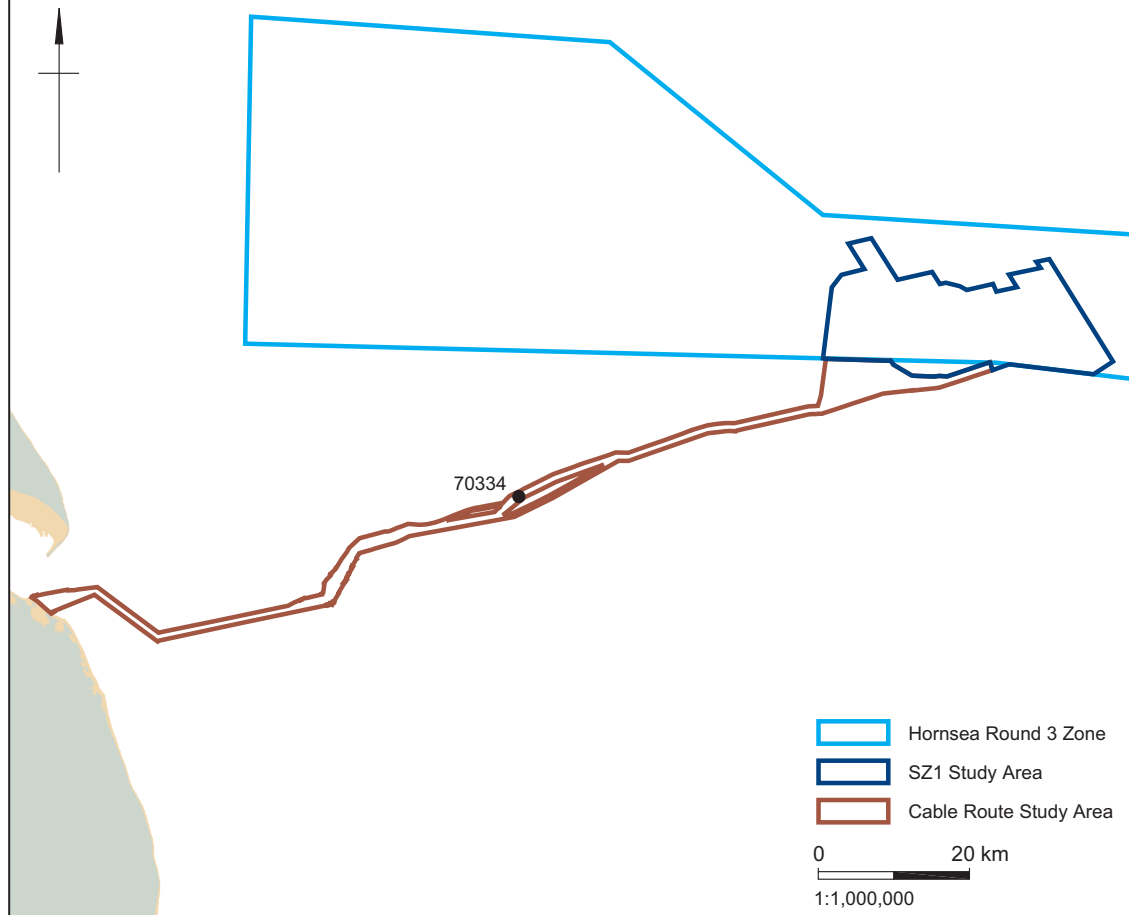
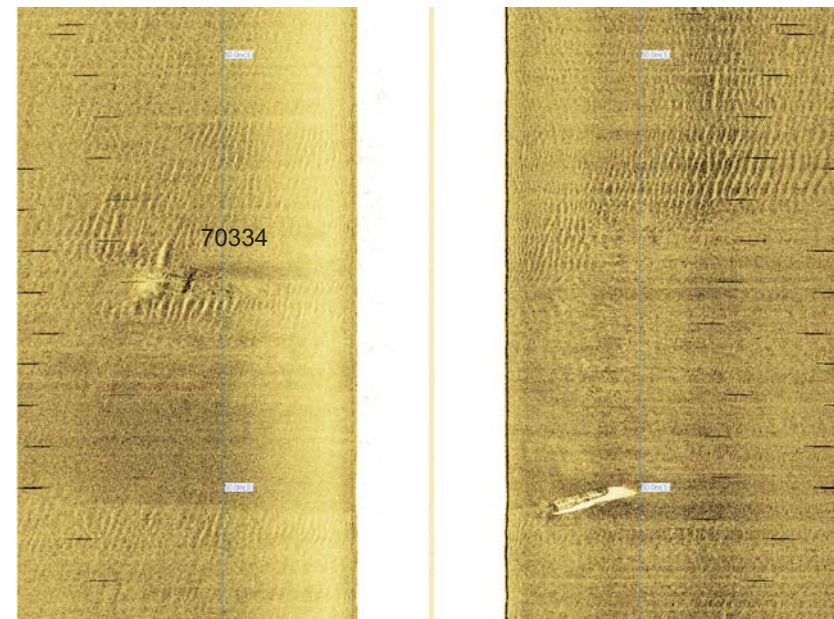
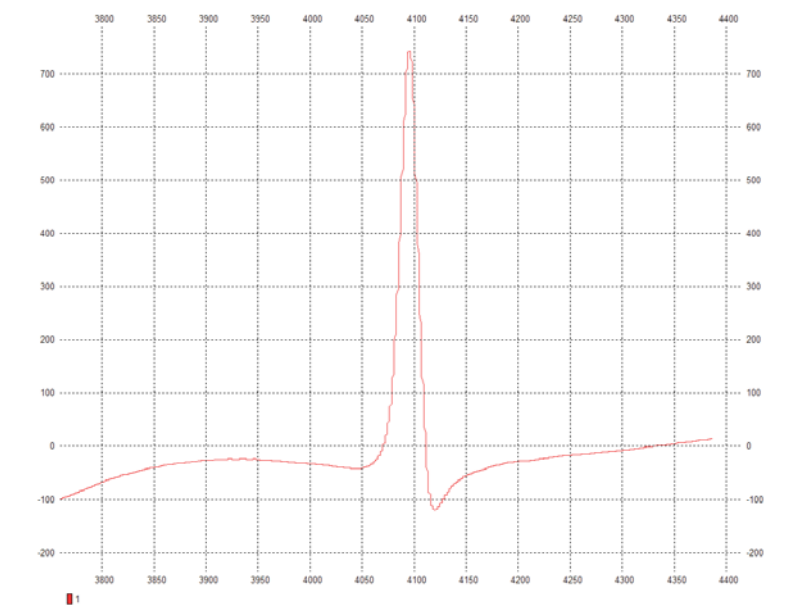
## Wreck 70334 - Unidentified Wreck

<b>Location</b>	370887 E, 5947705 N (UTM31N)	<b>Area</b>	Cable Route
<b>Archaeological Importance</b>	High		
<b>Geophysical survey dimensions and notes</b>	imensions: 33.1m x 14.4m x 2.7m. Small but distinct mound identified by multibeam bathymetry, though wreck is very poorly defined in sidescan sonar. No distinct structure visible, and surrounding sand ripples suggest it is at least partially buried. Associated with a large magnetic anomaly.		
<b>Build</b>	<b>Type</b>	Unknown	
	<b>Construction</b>	Unknown, but magnetic anomaly suggests steel hull	
	<b>Dimensions</b>	Unknown	
	<b>Shipyard</b>	Unknown	
<b>Loss</b>	<b>Cause</b>	Unknown	
<b>Extent of Survival</b>	Structure is very poorly defined, and possibly represents a mound of debris rather than a coherent structure. Large magnetic anomaly suggests significant ferrous debris, and it is likely that the structure is at least partially buried. Not associated with a previously recorded wreck, though it could be part of wreck 70335 located approximately 145m NE.

Multibeam image facing North, x10 vertical exaggeration

Sidescan sonar

Magnetometer profile
