# Round 3 Hornsea Zone, Subzone 1 and Offshore Cable Route

Archaeological Assessment of Geophysical Data

Ref: 87152.01  
April 2013

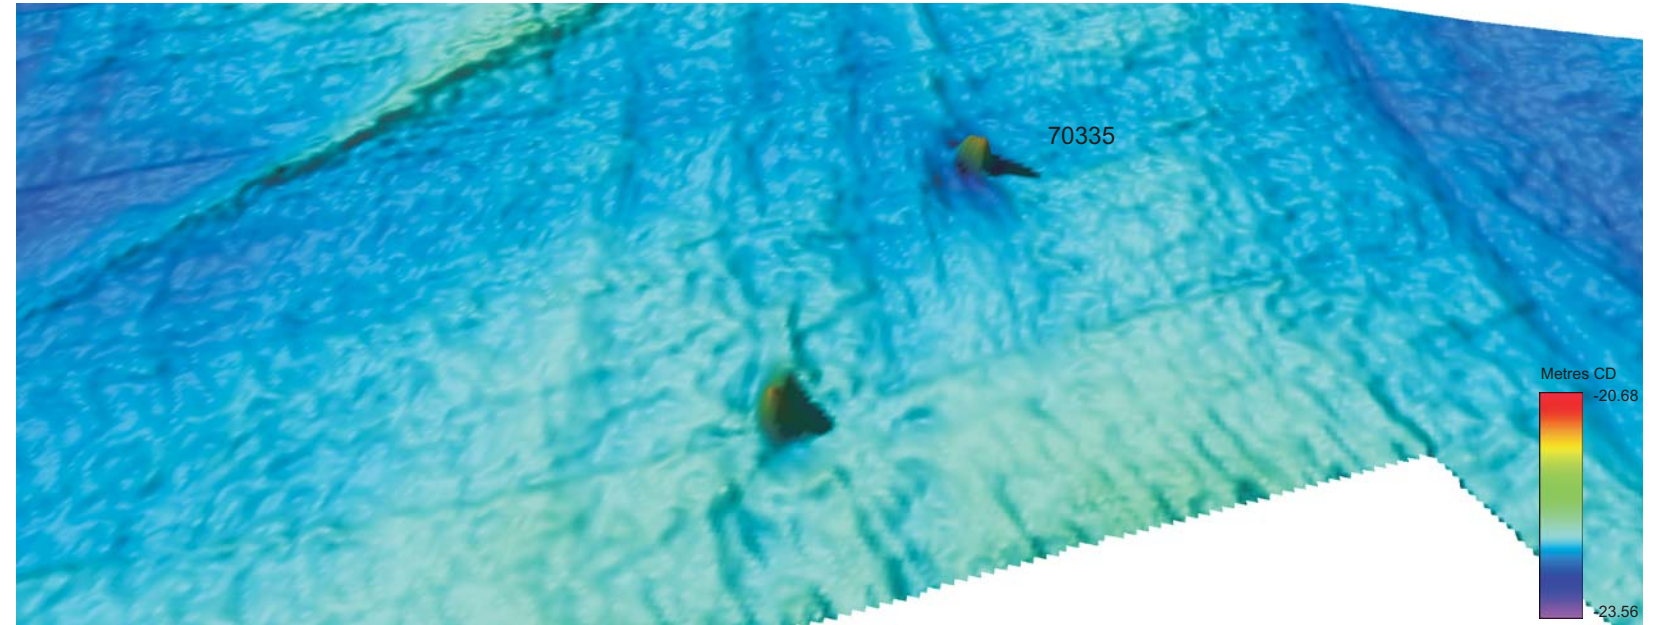
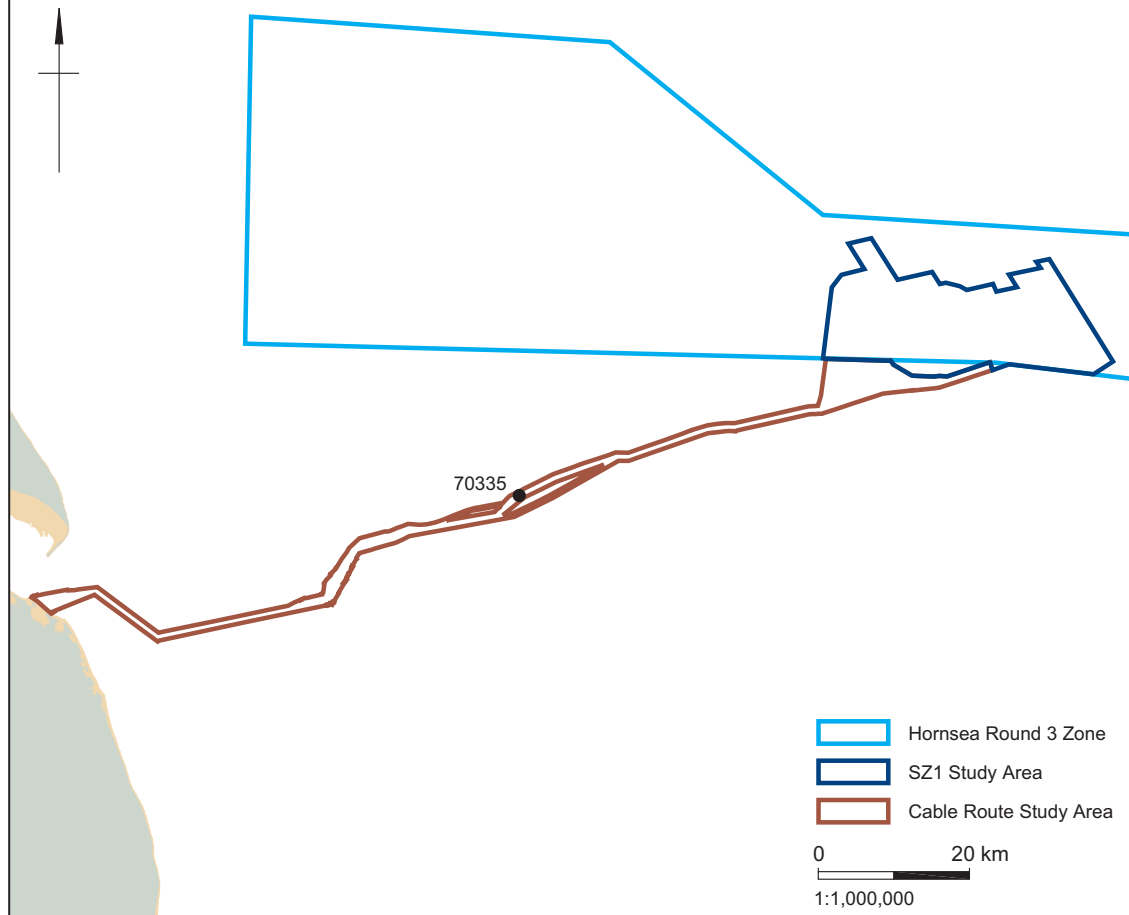
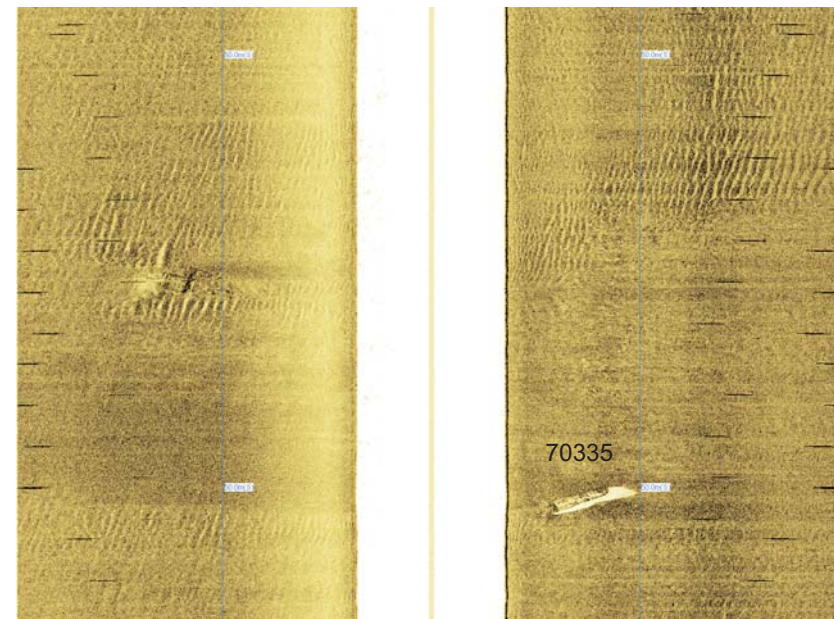
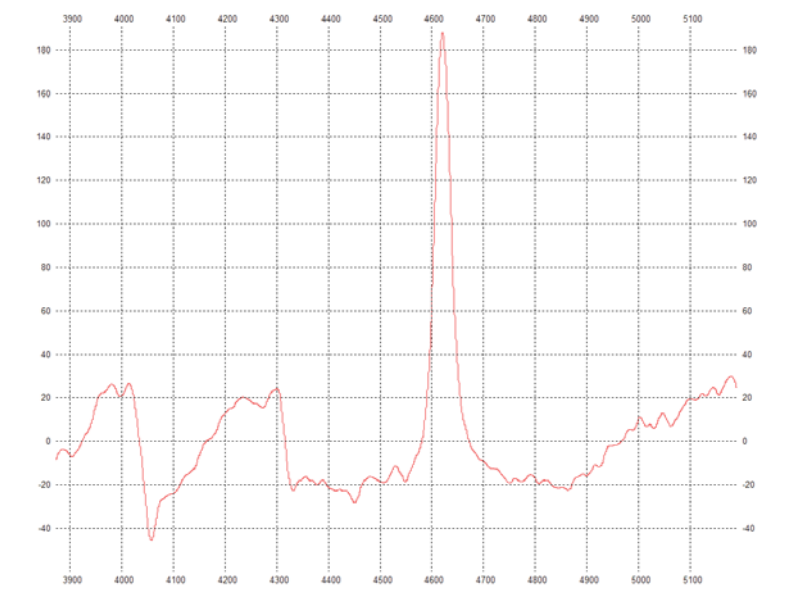
## Wreck 70335 - Unidentified Wreck

<b>Location</b>		370945 E, 5947842 N (UTM31N)	<b>Area</b>	Cable Route
<b>Archaeological Importance</b>		High		
<b>Geophysical survey dimensions and notes</b>		Dimensions: 14.5m x 6.6m x 2.6m. Small mound on multibeam bathymetry data, but distinct wreck on sidescan sonar data with height and possible structure visible. Associated with a large magnetic anomaly.		
<b>Build</b>	<b>Type</b>	Unknown		
	<b>Construction</b>	Unknown, but magnetic anomaly suggests steel hull		
	<b>Dimensions</b>	Unknown		
	<b>Shipyard</b>	Unknown		
<b>Loss</b>	<b>Cause</b>	Unknown		
<b>Extent of Survival</b>		Appears upright and fairly intact with some visible structure. Seabed is generally featureless, so is unlikely to become completely buried. Previously recorded but unidentified, the record states it is possibly only a "portion" of a vessel. Other portion may be anomaly 70334 located 145m SW.

Multibeam image facing North, x10 vertical exaggeration

Sidescan sonar

Magnetometer profile

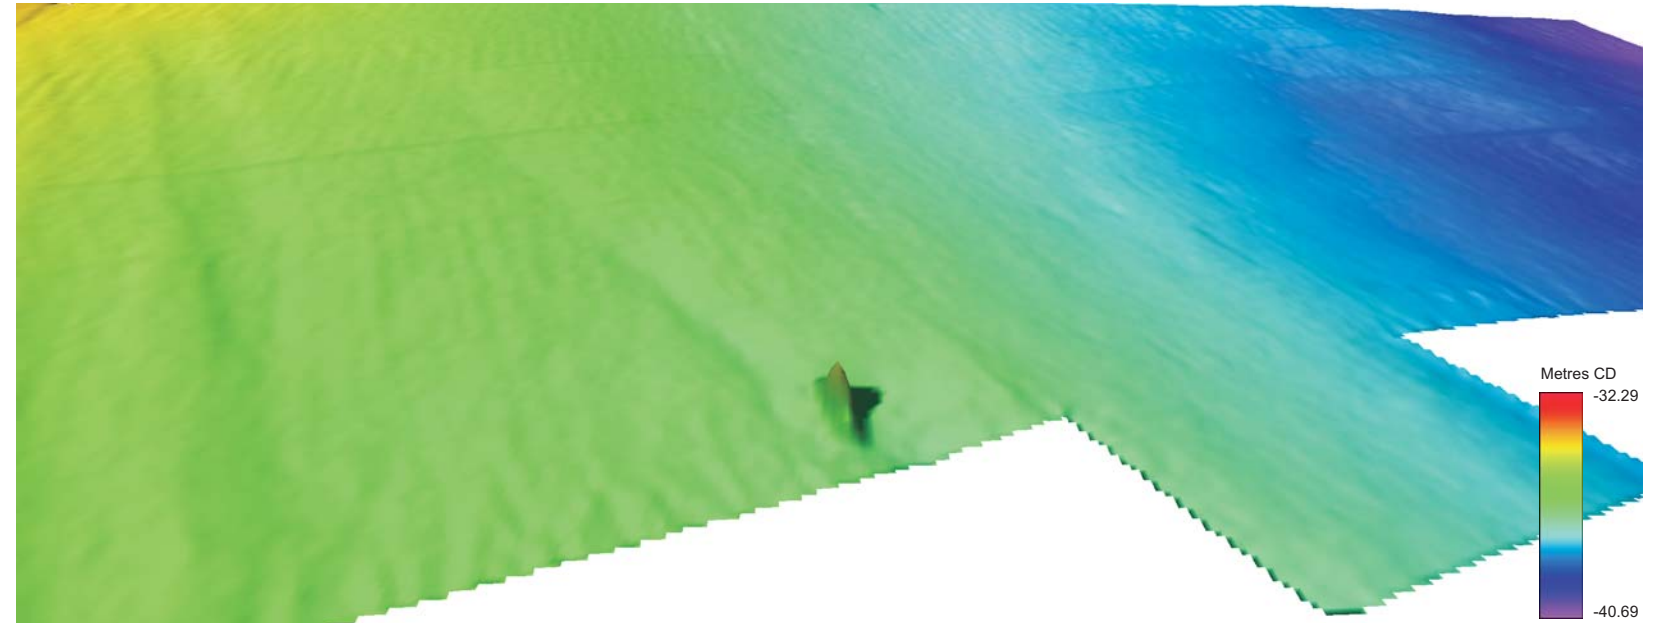
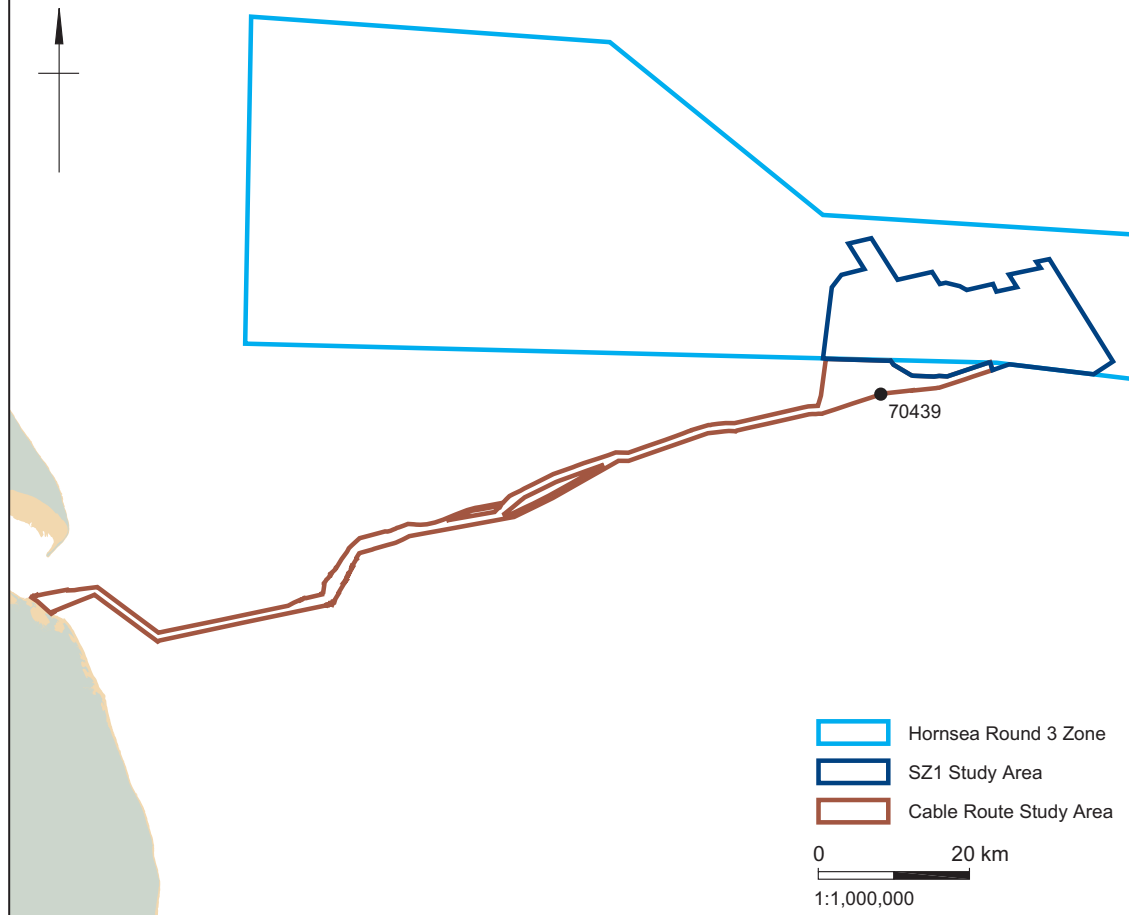
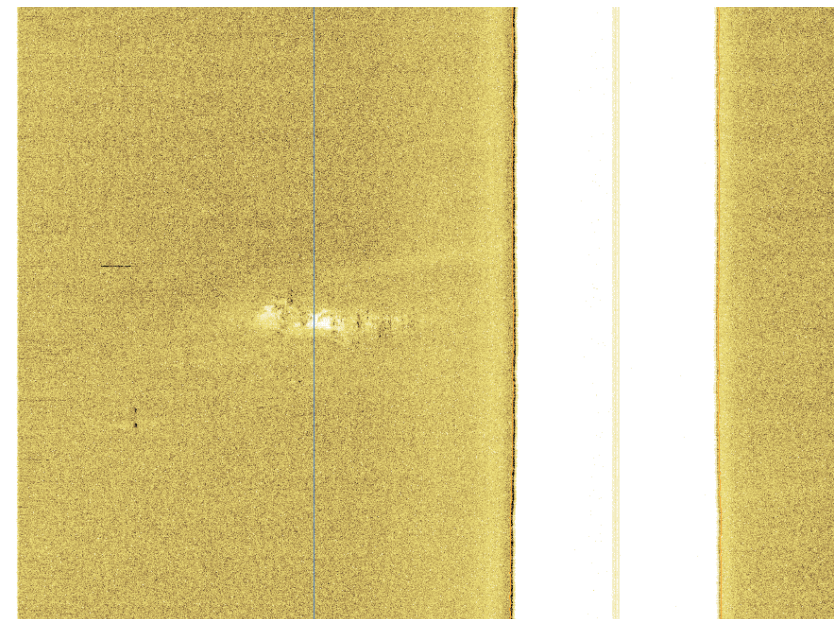
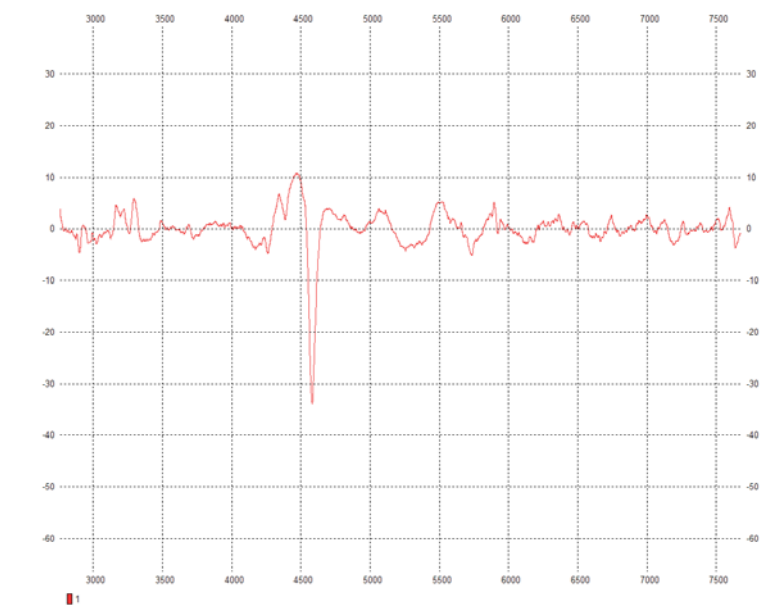
## Wreck 70439 - Unidentified Wreck

<b>Location</b>		418774 E, 5961246 N (UTM31N)	<b>Area</b>	Cable Route
<b>Archaeological Importance</b>		High		
<b>Geophysical survey dimensions and notes</b>		Dimensions: 27.9m x 8.2m x 1.5m. Distinct elongate mound identified by multibeam bathymetry. Very poorly defined by sidescan sonar, appearing as an elongate area of seafloor disturbance and low reflectivity on a generally featureless seabed. Associated with a medium magnetic anomaly.		
<b>Build</b>	<b>Type</b>	Unknown		
	<b>Construction</b>	Unknown, but magnetic anomaly suggests partially steel, partially wooden		
	<b>Dimensions</b>	Unknown		
	<b>Shipyard</b>	Unknown		
<b>Loss</b>	<b>Cause</b>	Unknown		
<b>Extent of Survival</b>		No structure identified by sidescan sonar, and the wreck is likely to be badly broken up and more of a mound of debris than a coherent structure. Magnetic anomaly suggests some ferrous content, but not enough for an entire steel hull so vessel is possibly partially wooden in construction. Located at the position of a recorded but unidentified wreck.

Multibeam image facing North, x10 vertical exaggeration

Sidescan sonar

Magnetometer profile

- 4.1.15 Anomaly **70439** is located at the edge of the area covered by the geophysical data, but was identified by all of the geophysical equipment (**Sheet 6**). The wreck is characterised by an elongate mound in the multibeam bathymetry data, but was only tentatively identified as an area of seafloor disturbance on the sidescan sonar data. The visible mound is unrecognisable as a vessel, and appears badly broken up and possibly mostly buried. An associated magnetic anomaly of 44nT suggests it is partially ferrous in nature. The wreck is approximately 25m ESE of a previously recorded by unnamed wreck, and is interpreted as relating to this record.

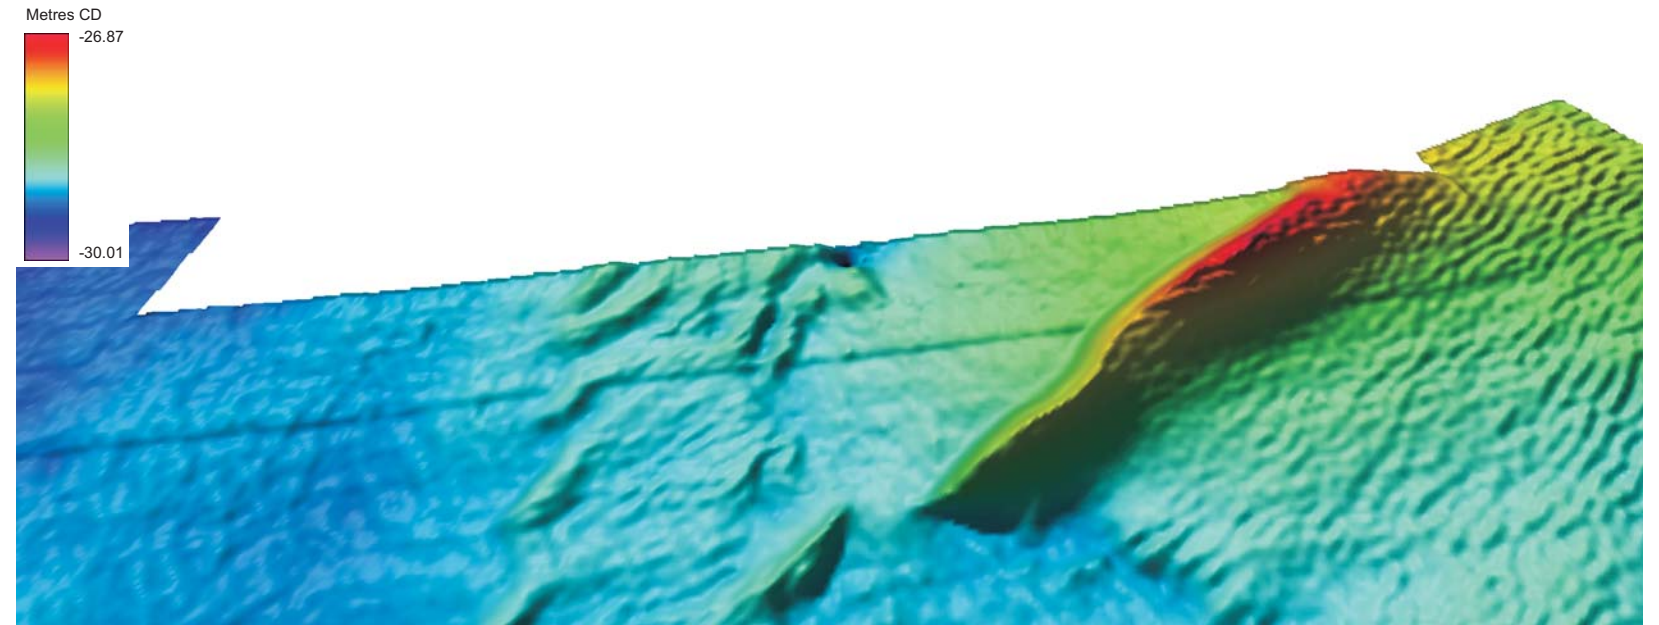
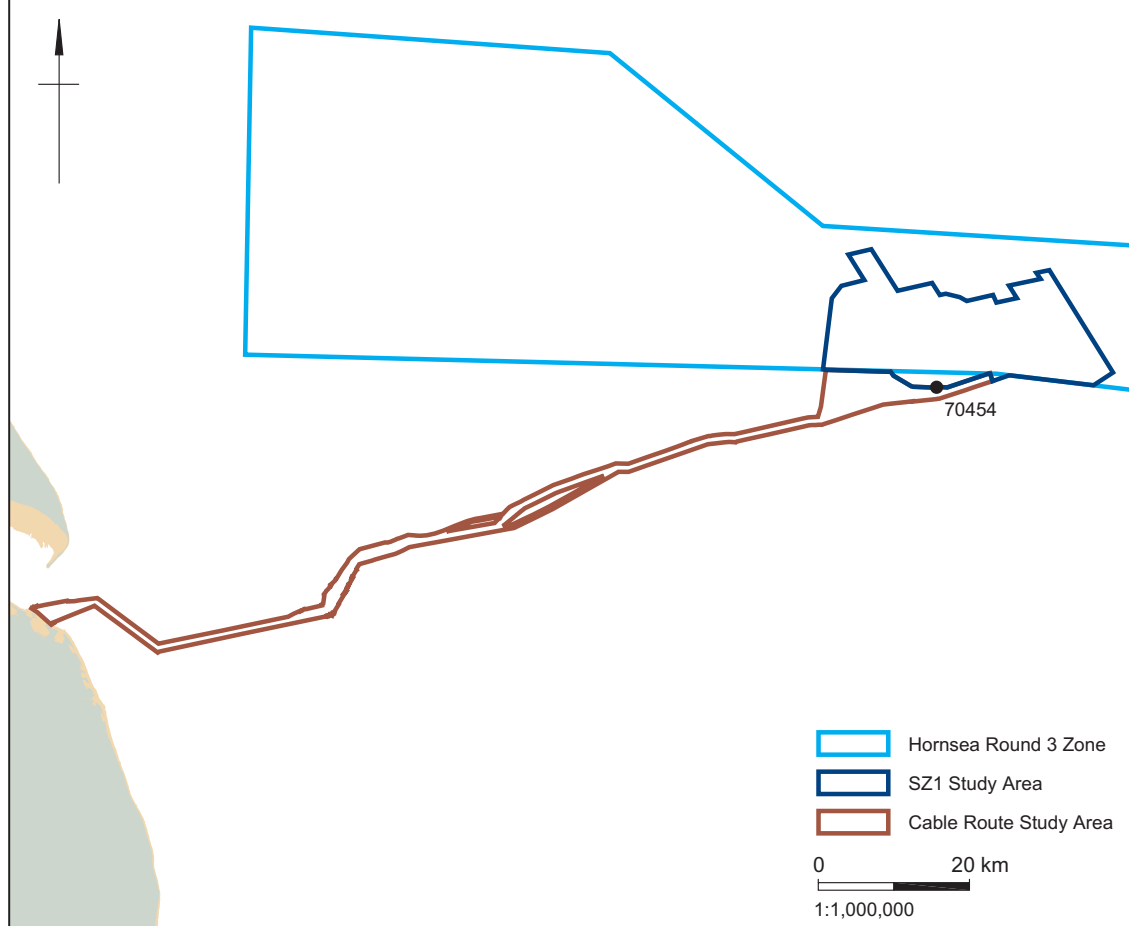
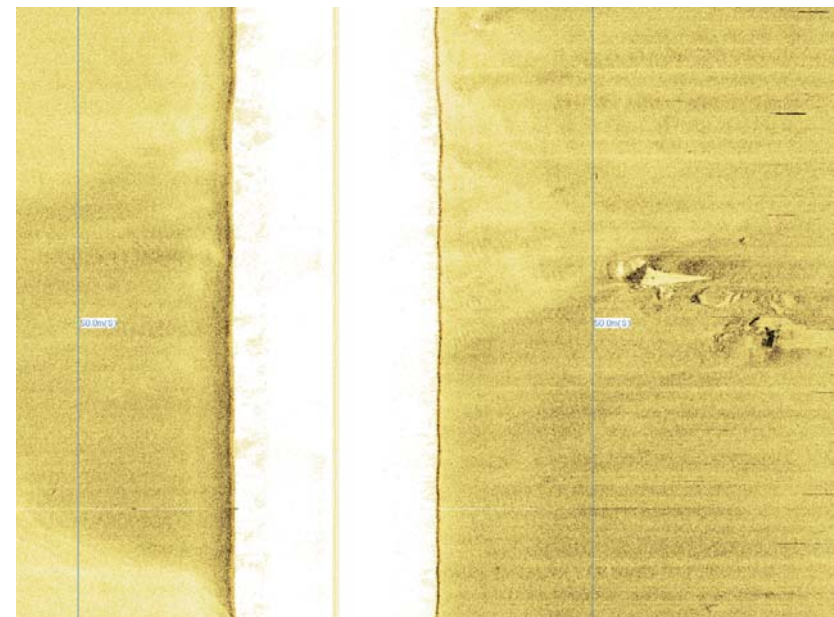
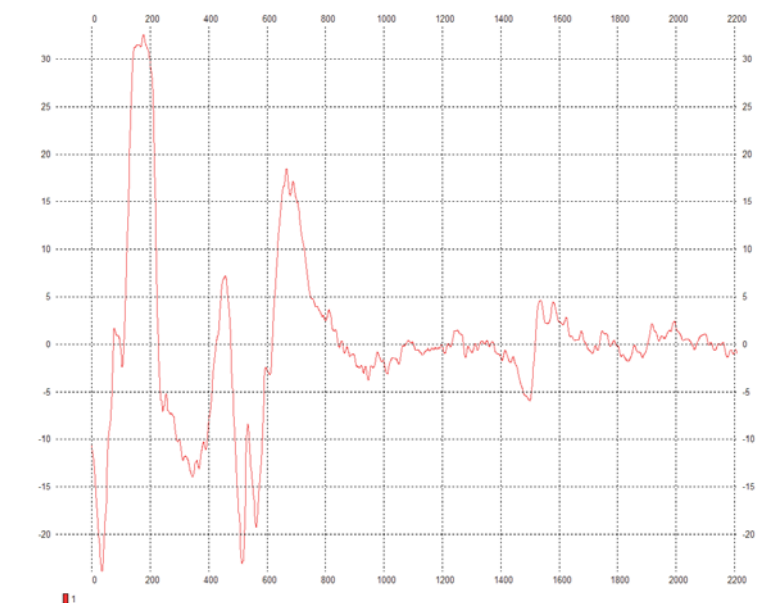
## Wreck 70454 - Unidentified Wreck

<b>Location</b>	426180 E, 5963601 N (UTM31N)	<b>Area</b>	Cable Route
<b>Archaeological Importance</b>	High		
<b>Geophysical survey dimensions and notes</b>	Dimensions: 65.1m x 27.2m x 3.7m. Elongate area of irregular dark reflectors identified by sidescan sonar, with at least two larger and more distinct anomalies with obvious height. Mostly located outside of the coverage of the multibeam bathymetry data, though a possible scour at the southern edge is visible. Possibly associated with a medium magnetic anomaly, but the anomaly is broad, irregular, and located approximately 100m away so this is uncertain.		
<b>Build</b>	<b>Type</b>	Unknown	
	<b>Construction</b>	Unknown	
	<b>Dimensions</b>	Unknown	
	<b>Shipyard</b>	Unknown	
<b>Loss</b>	<b>Cause</b>	Unknown	
<b>Extent of Survival</b>	No distinct coherent structure is visible, and the wreck appears badly broken up and partially buried. The possible magnetic anomaly suggests some ferrous material is present, though this is uncertain. Located at the position of a previously recorded but unnamed wreck.

Multibeam image facing North, x10 vertical exaggeration. Most of wreck located outside of the multibeam bathymetry coverage

Sidescan sonar

Magnetometer profile

- 4.1.16 Finally, anomaly **70454**, again located on the edge of the area covered by geophysical data, was identified by sidescan sonar but only tentatively by the magnetometer and multibeam bathymetry datasets (**Sheet 7**). It also correlates with four anomalies identified by EMU in their provided gazetteer. No coherent wreck structure is visible, but an elongate area of debris is clearly visible within the geophysical data, suggesting the vessel is badly broken up and/or mostly buried. A larger upstanding anomaly marks each end of the wreck, and a small area of associated scour is visible in the multibeam bathymetry data. An associated magnetic anomaly of 41nT suggests the remaining debris is partially ferrous in nature. The wreck is located approximately 20m and 40m NE of the locations of two wrecks recorded in the Seazone database, and is interpreted as relating to both of these records.
