Mousehole Forge Scheduled Ancient Monument 1004804 Sheffield, South Yorkshire

Archaeological Assessment & Building Appraisal

Ref: 101750.01
January 2014

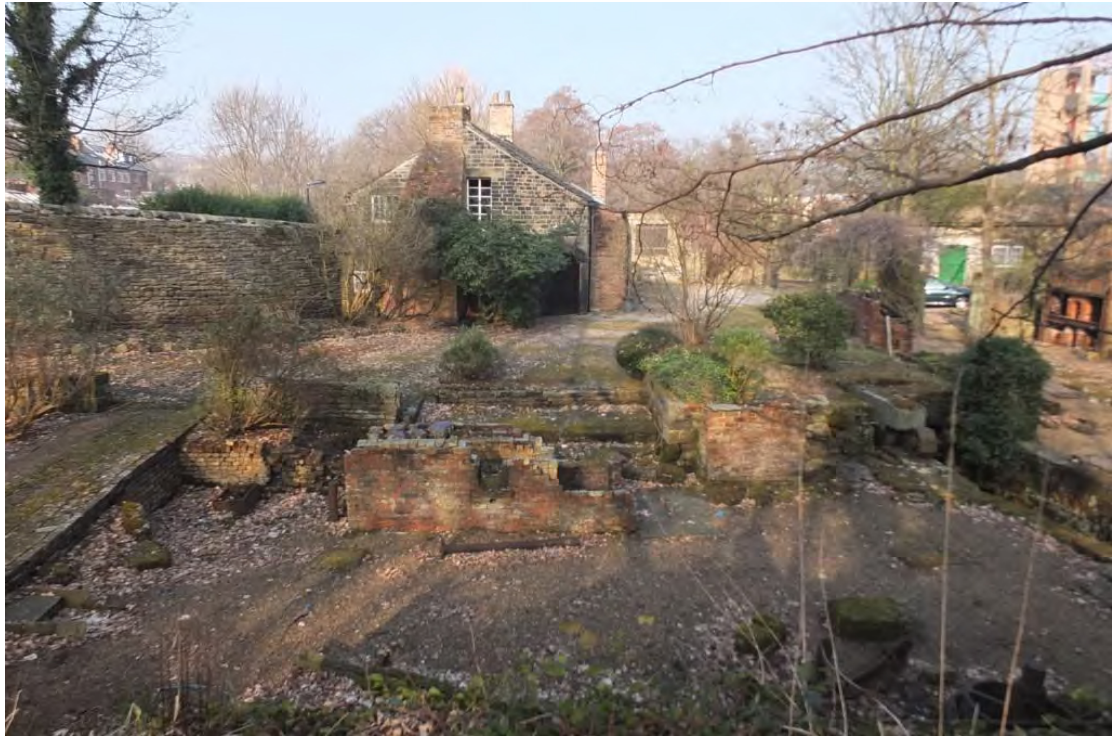
General shot from dam wall, showing ruined forge building(s) with manager's house behind

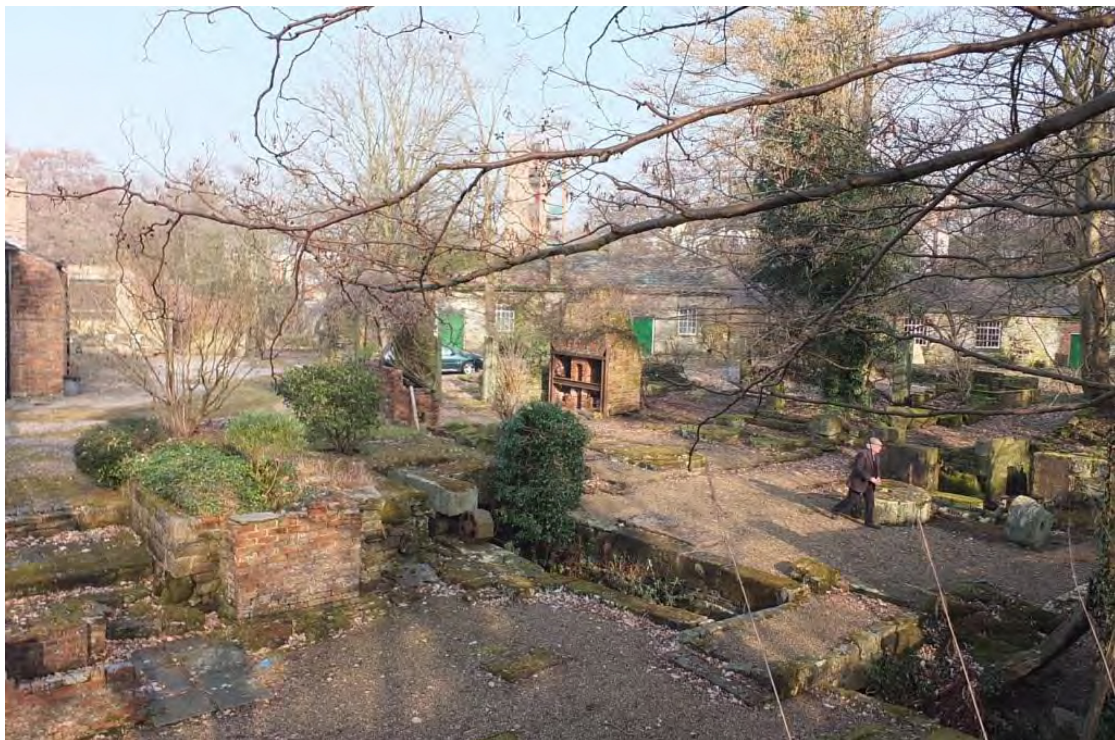
General shot from dam wall, showing ruined forge building(s) with workshop range in background

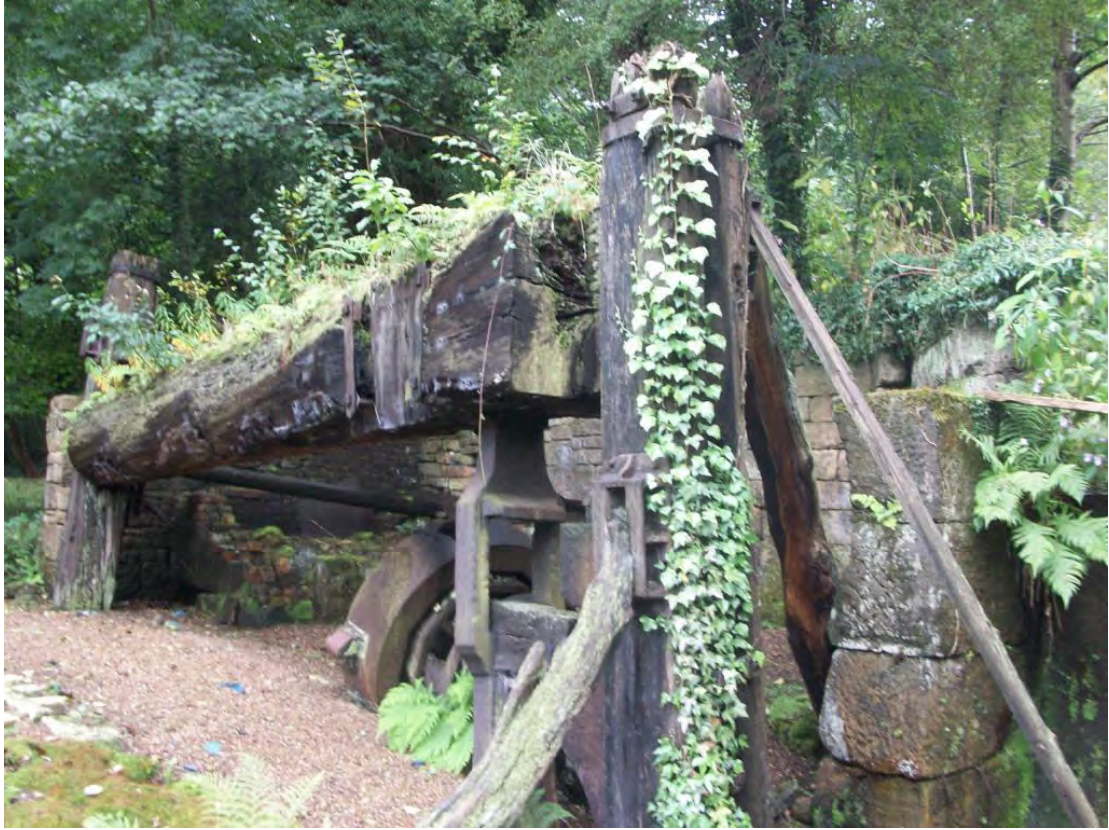
Shot of surviving drop hammer (with dam wall behind)

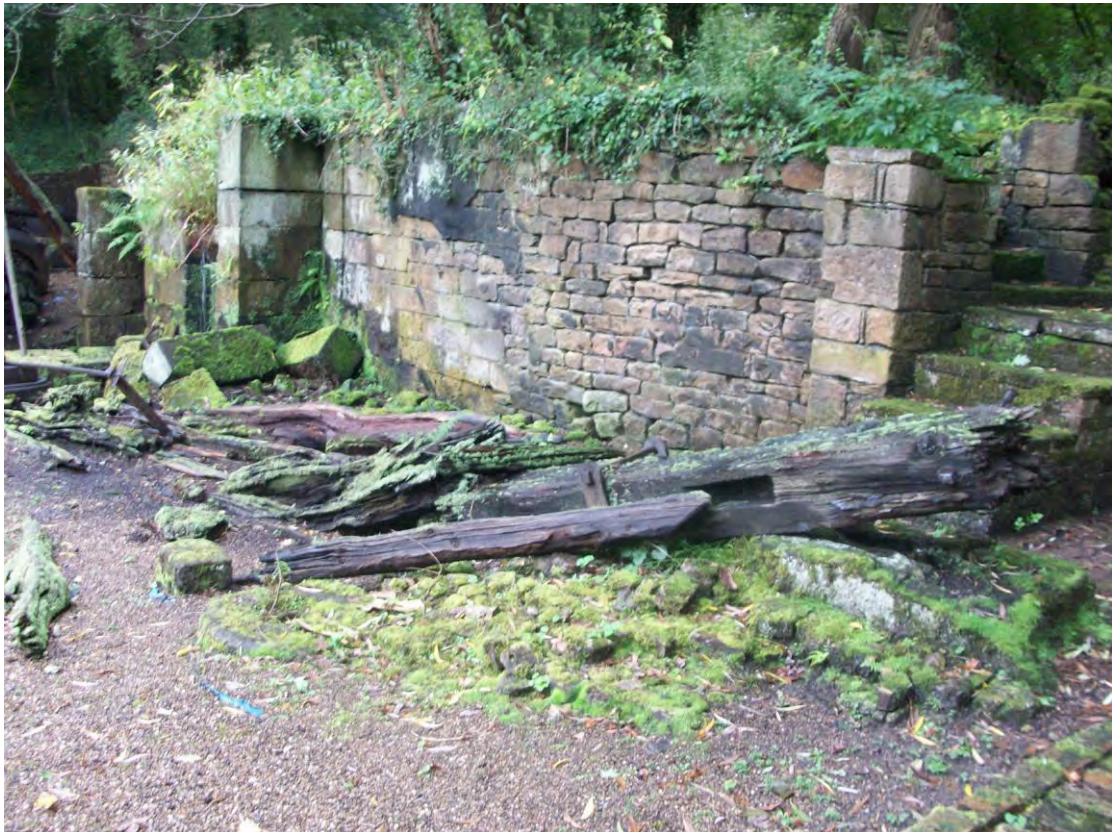
Shot of collapsed drop hammer (with dam wall behind)

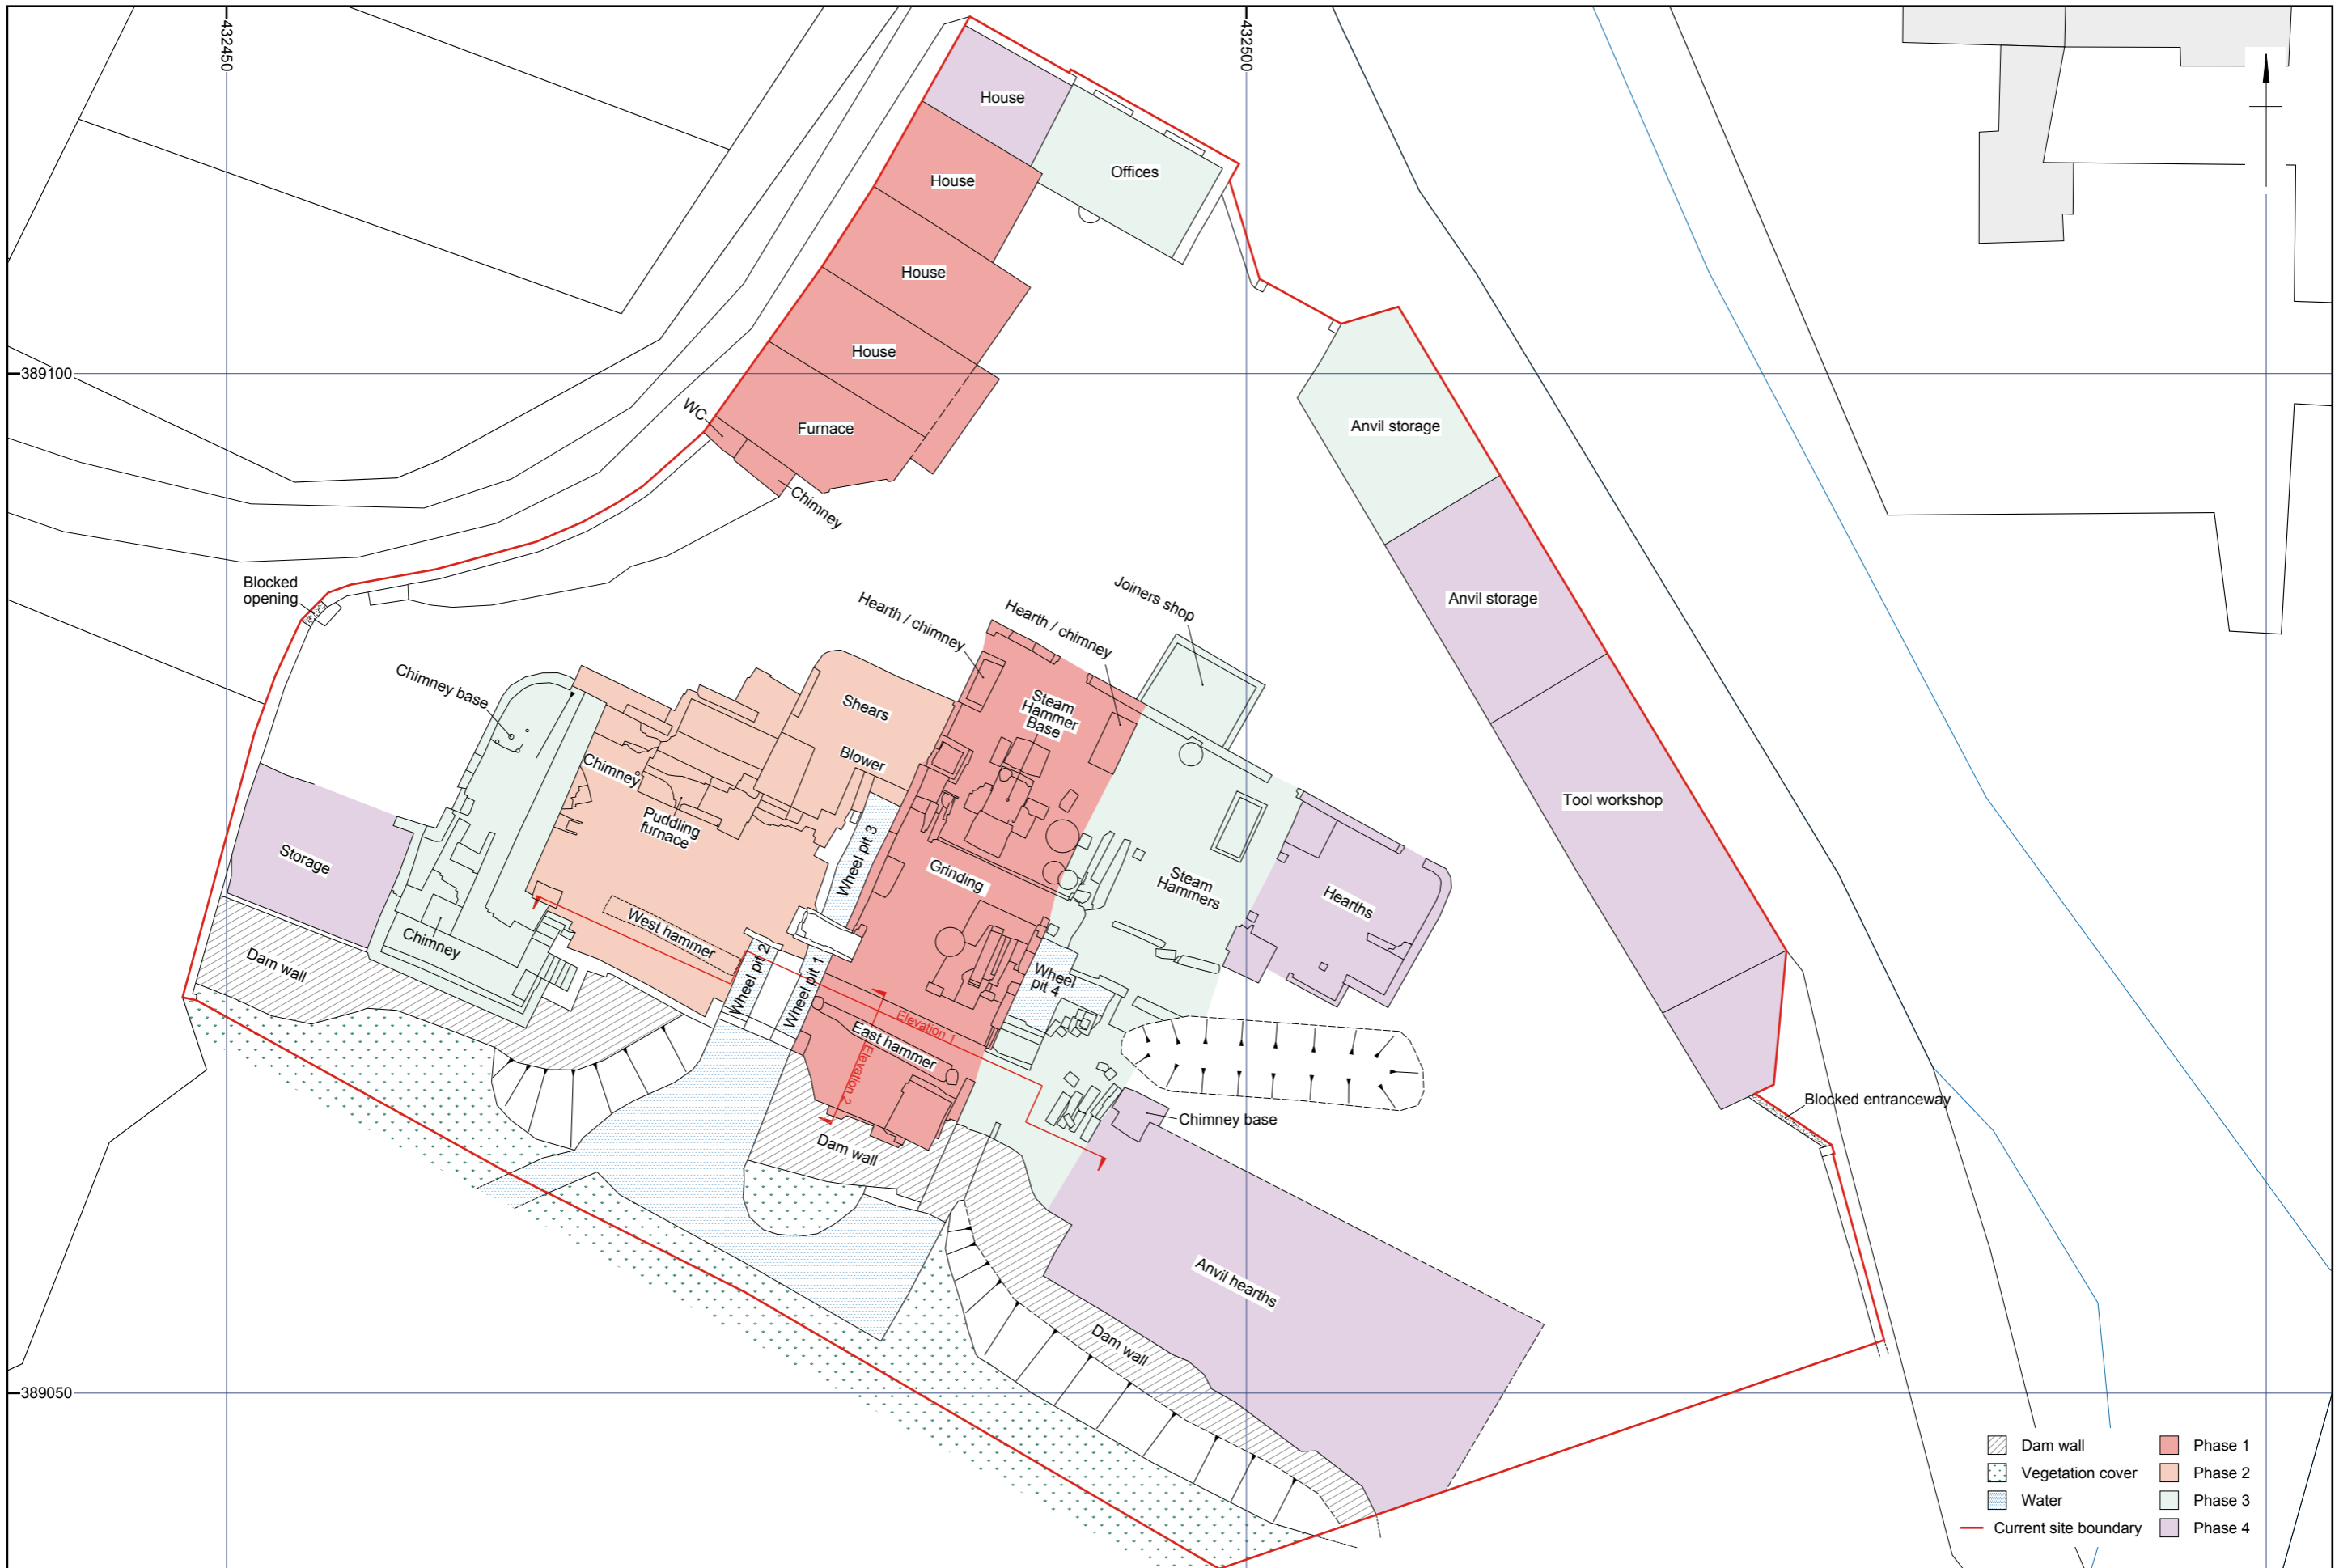
Figure 4

- 4.1.1 The Site survey, which mainly focussed on the remains of the forge buildings, hammer and dam, resulted in a plan of the Site complex (**Figure 4**), and detailed elevation (**Figure 5**) and section (**Figure 6**) of the dam wall and surviving hammer, and a photographic record of the Site (**Plates 5-115**). Each photographic viewpoint can be found on **Figure 7**.

- 5.1.3 The forge complex remains have retained their general layout and once internal features are present, which are indicative of former functions as depicted on **Figure 4**, all of which correspond with those interpretations made by Hatfield in 1991. No features at the Site were observed which contradict previous interpretations. Many features have been lost and there appears to be less survival, certainly above ground, at the southeast side of the Site. This may be due to the former southeast range having been partially demolished between 1923 and 1933, prior to the final closure of the Site.
- 5.1.4 Retained features which are considered to be of most significance include:
- *Surviving east hammer;*
 - *Puddling furnace;*
 - *All wheel pits and associated water management structures;*
 - *Dam wall.*

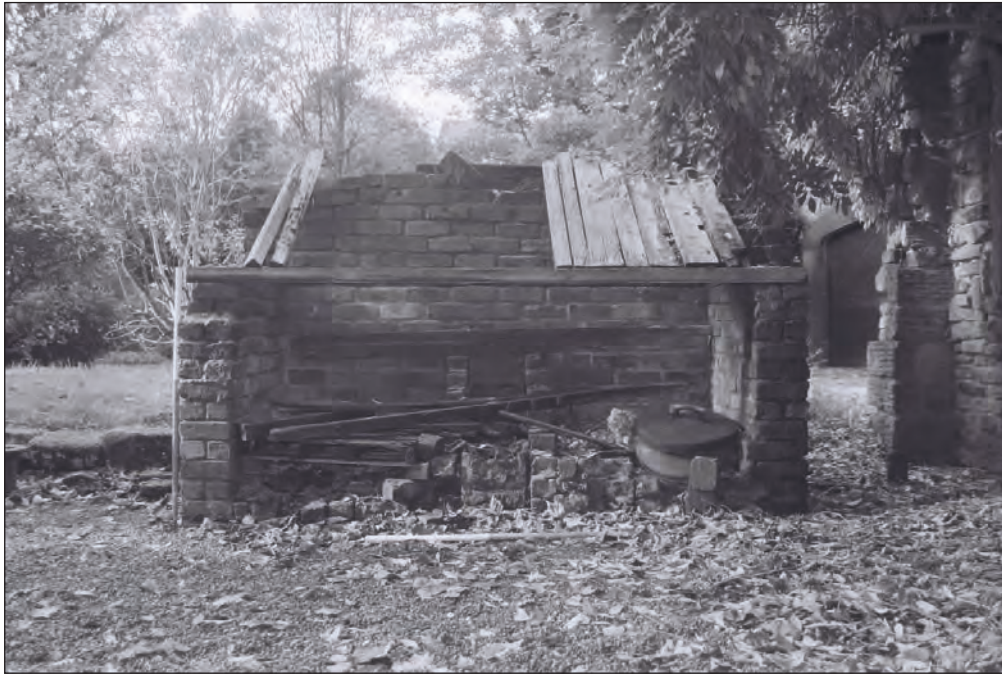
Plate 42: Detail of the remains of the western hearth within the central phase 1 former forge building (Film 8.20)

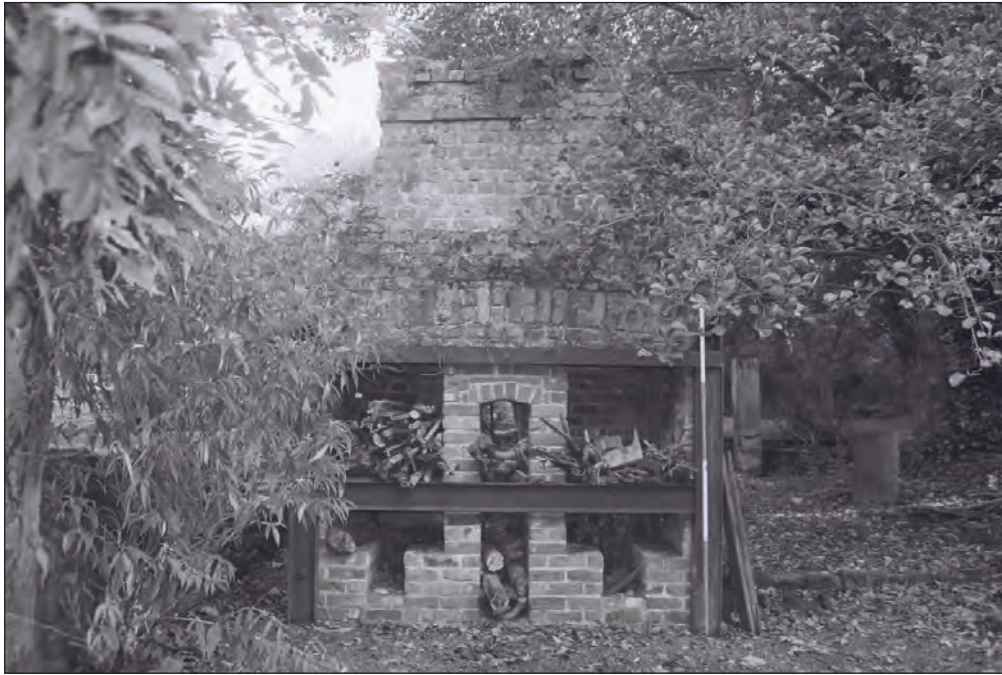
Plate 44: Detail of the remains of the eastern hearth within the central phase 1 former forge building (Film 8.22)

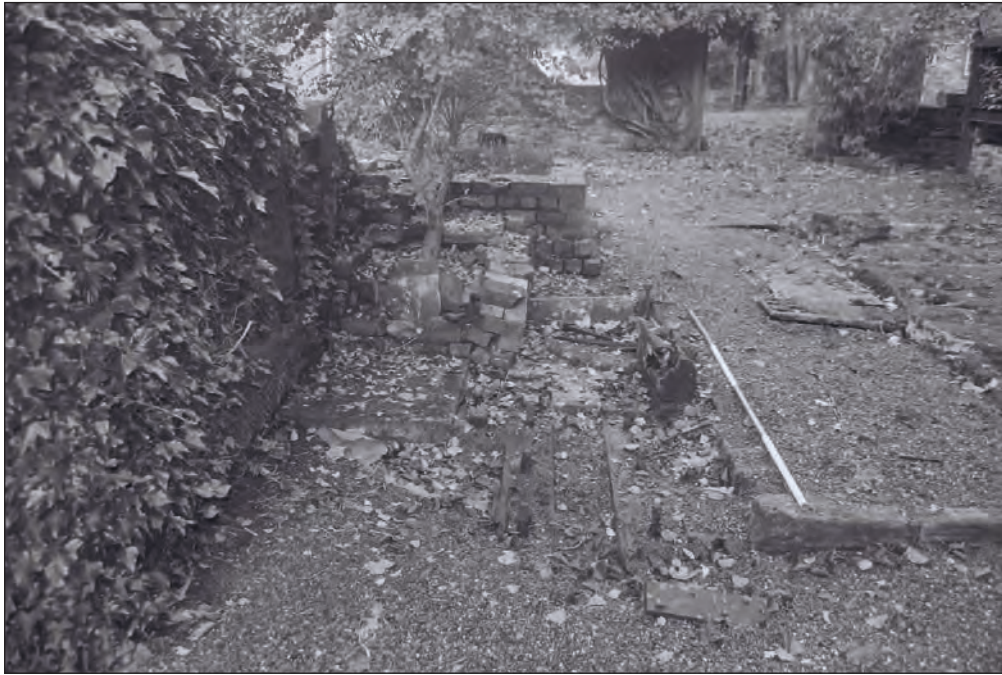
Plate 46: View of remains of structures and machine bases along the western side of the central phase 1 former forge building (Film 8.30)

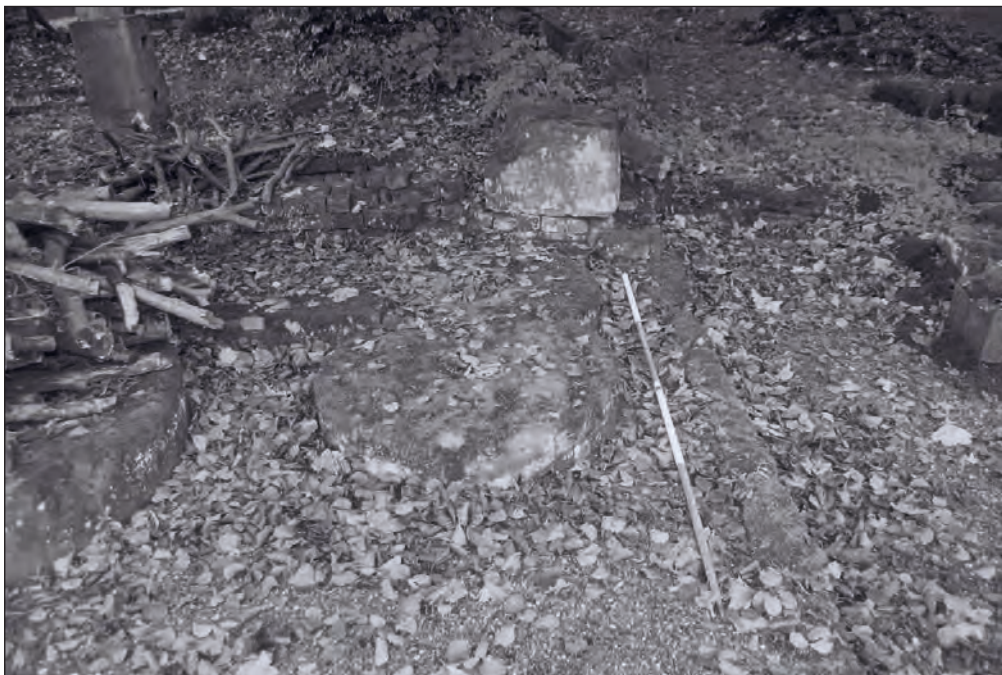
Plate 47: View of remains of structures along the eastern side of the central phase 1 former forge building, showing grinding wheels (Film 8.31)

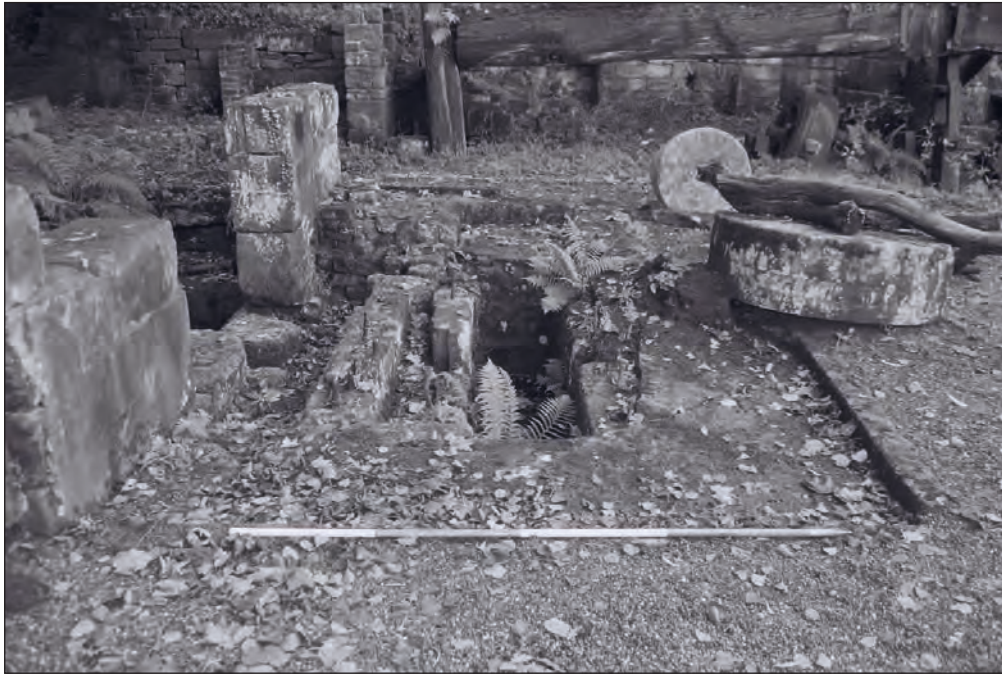
Plate 48: View of remains of structures and machine bases associated with grinding, adjacent to wheel pit, along the south-eastern side of the central phase 1 former forge building (Film 8.33)

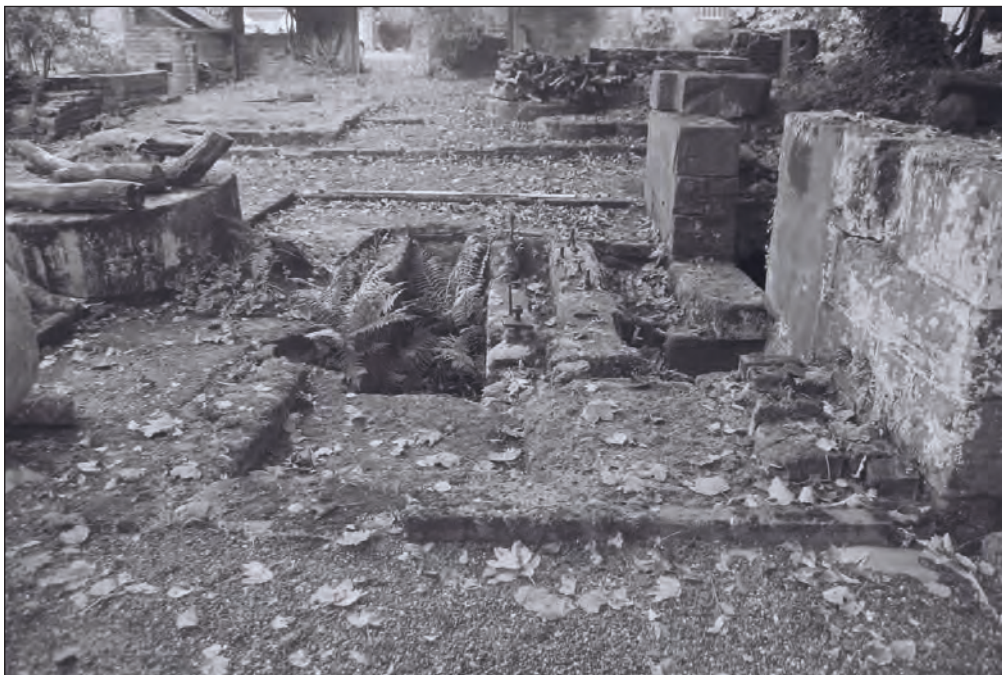
Plate 49: View of remains of structures and machine bases associated with grinding, adjacent to wheel pit 4, along the south-eastern side of the central phase 1 former forge building (Film 8.35)

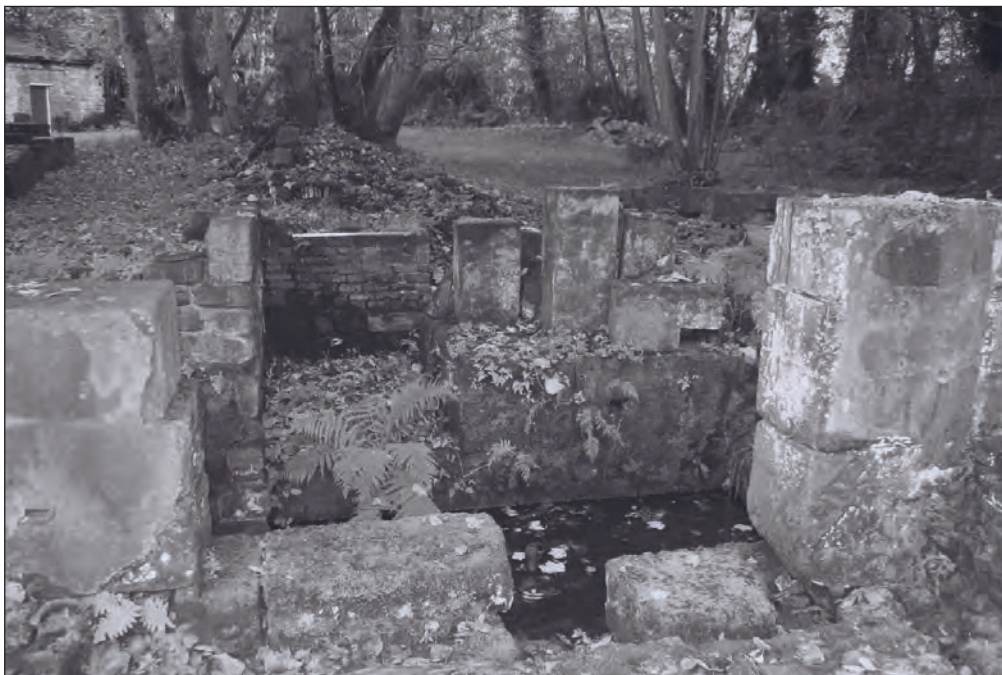
Plate 51: View of remains of wheel pit 4 adjacent to former grinding shop, south-eastern side of the central phase 1 former forge building (Film 9.14)

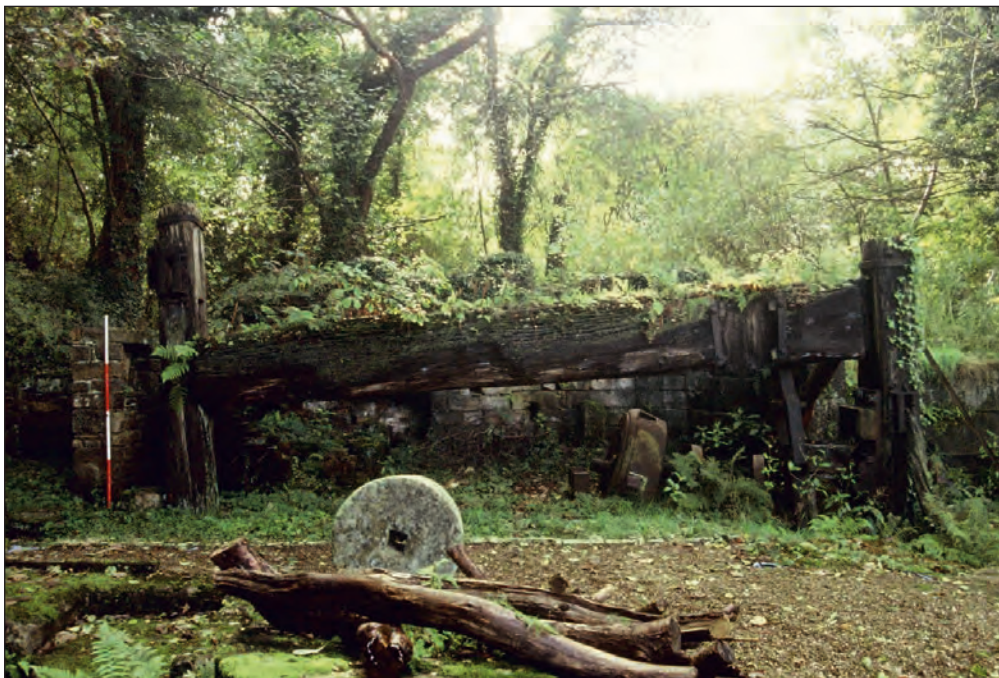
Plate 59: General view of the remaining east helve hammer, south end of the central phase 1 former forge building (Film CS. 21)

- 5.2.2 It is considered that all the remaining above ground elements of the former forge buildings and dam are at risk of further decay from frost and rain penetrating the structures where the core fabric is exposed and where mortar has been eroded. A considered strategy of conservation work, including repointing, would reduce the risk of further decay from this threat. The proposal of a canopy or roof over the east hammer in order to prevent further decay of the hammer is considered to be an essential element of the conservation works needed.

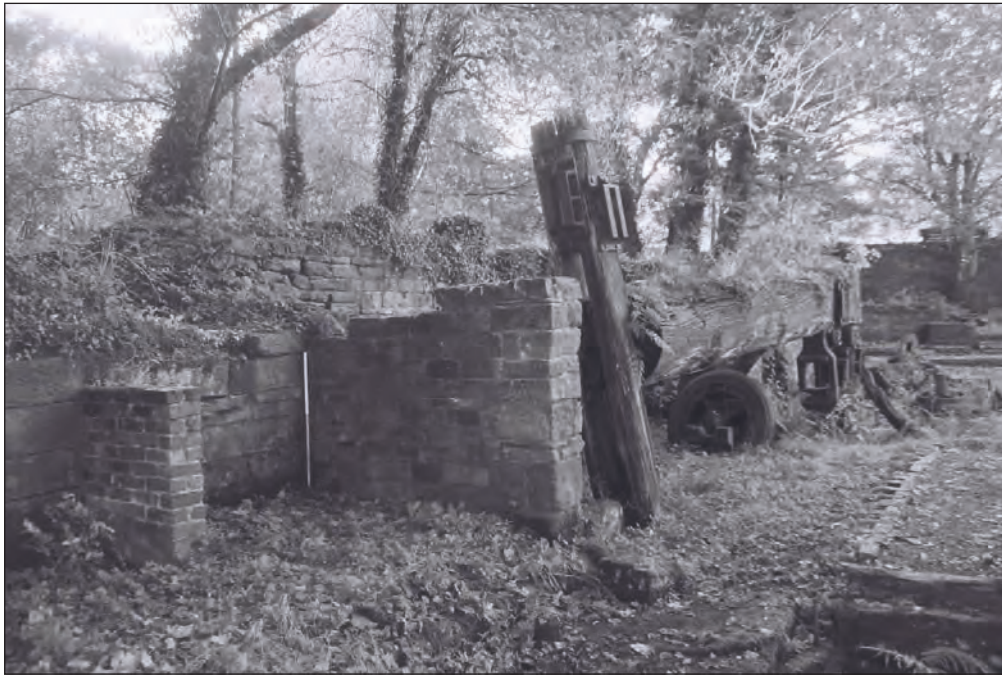
Plate 61: General view of the remaining east helve hammer and dam wall, south end of the central phase 1 former forge building (Film 9.24)

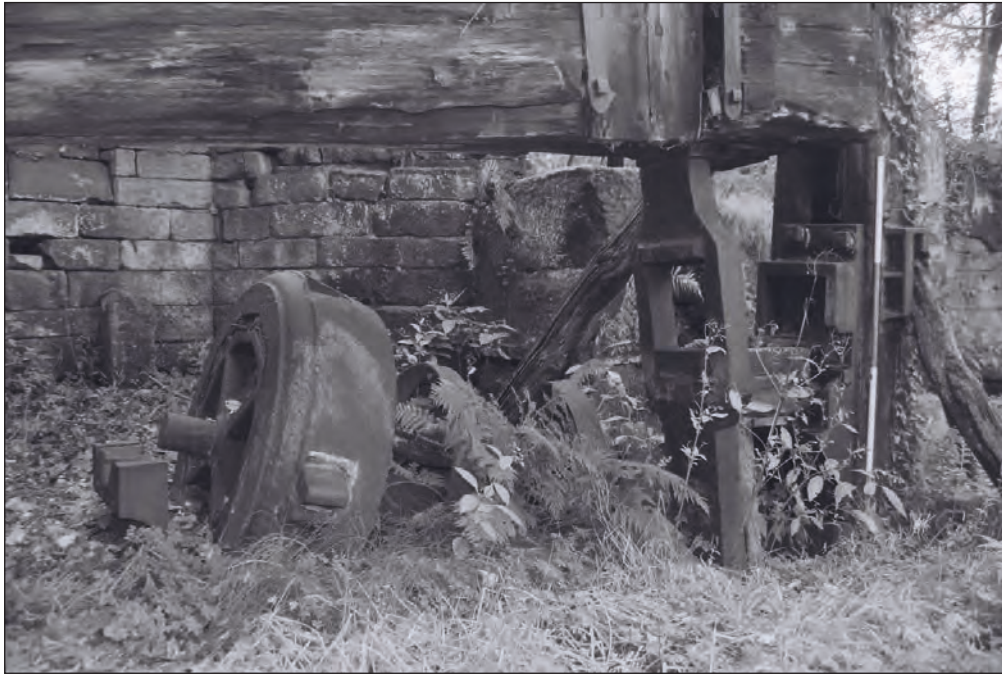
Plate 62: Detail of the west end mechanisms of the east helve hammer, south end of the central phase 1 former forge building (Film 9.6)

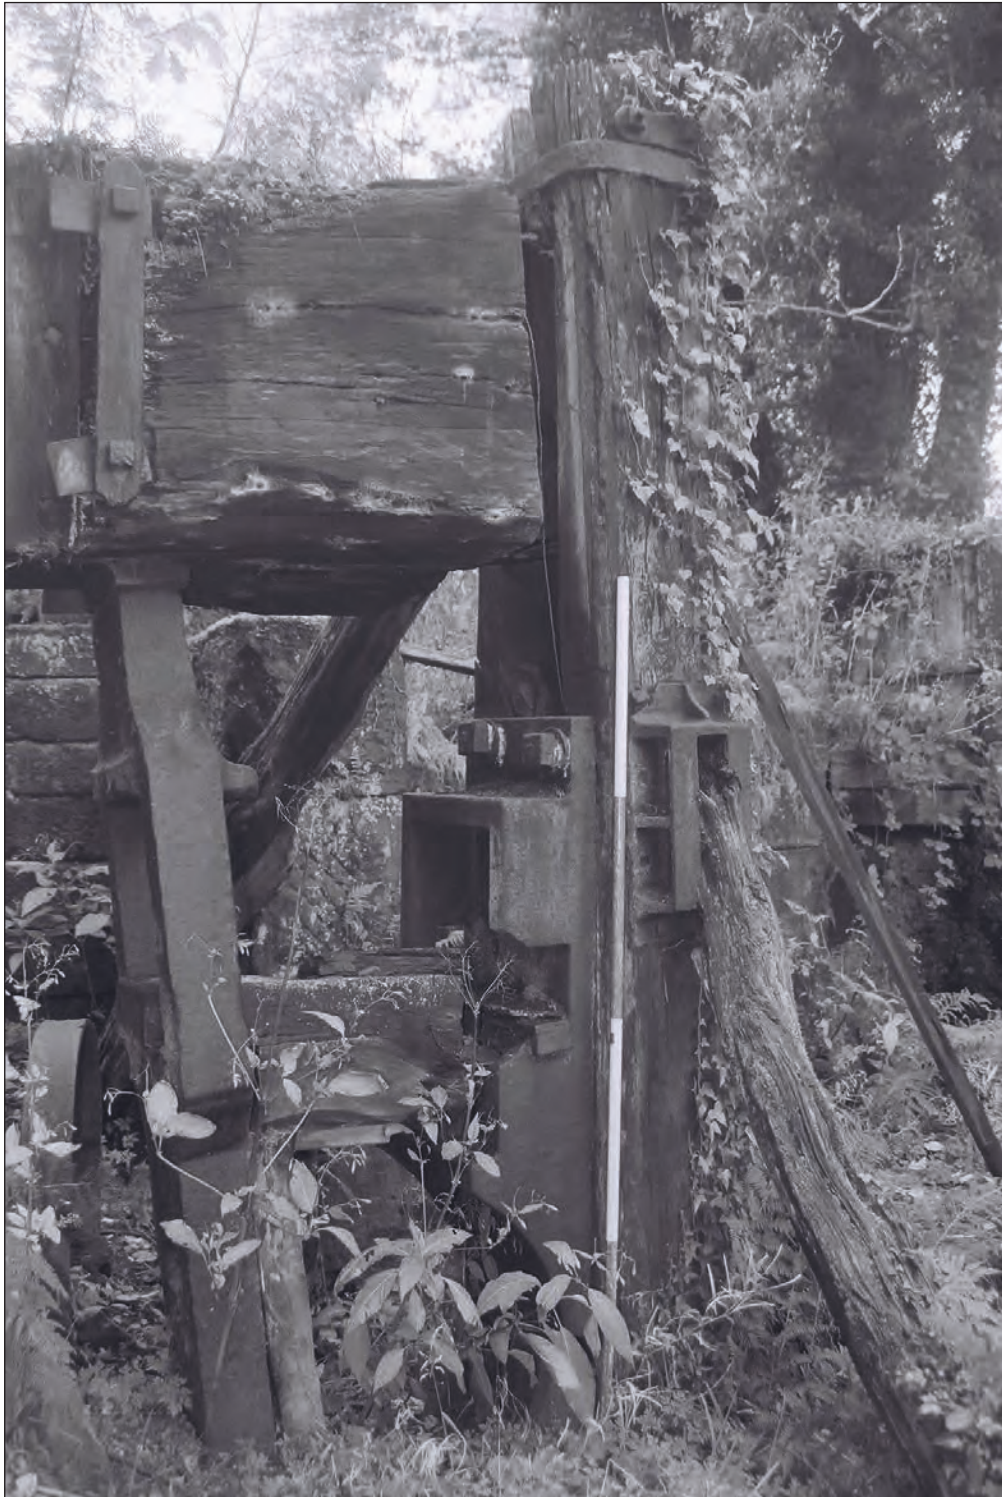
Plate 64: Detail of the west end of the east helve hammer, south end of the central phase 1 former forge building (Film 9.3)

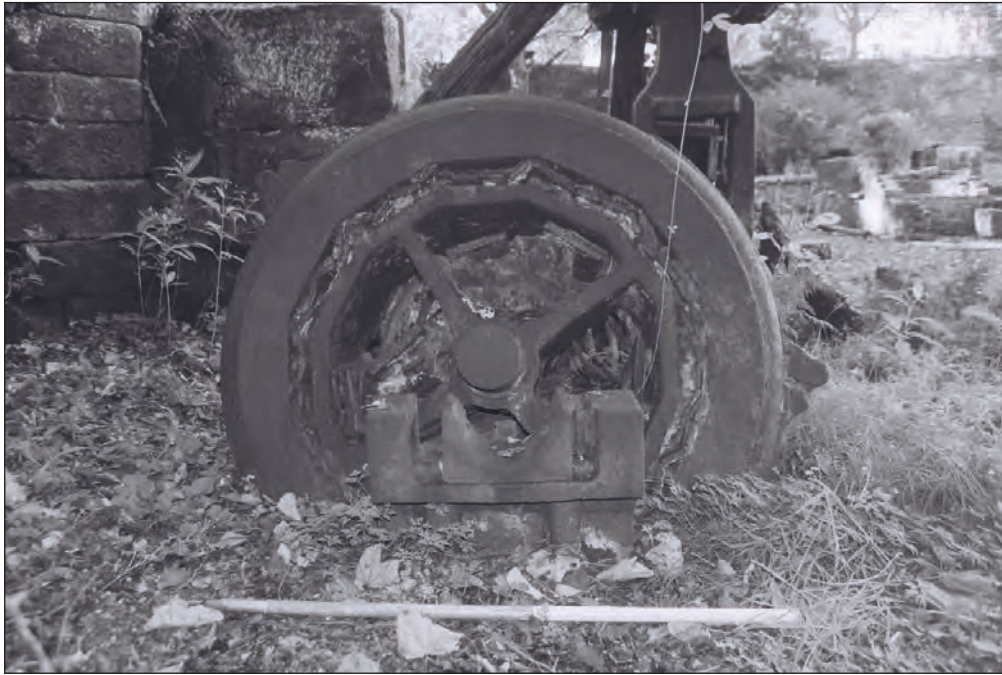
Plate 67: Detail of the cam wheel at the west end of the east helve hammer, south end of the central phase 1 former forge building (Film 9.26)

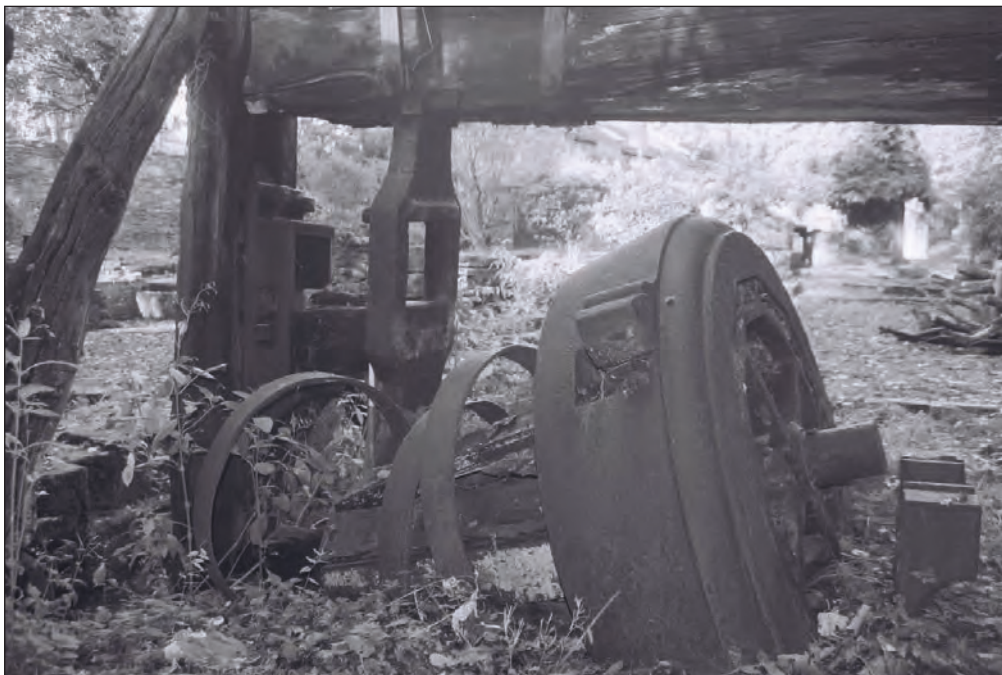
Plate 68: Detail of the cam wheel at the west end of the east helve hammer, south end of the central phase 1 former forge building (Film 9.27)

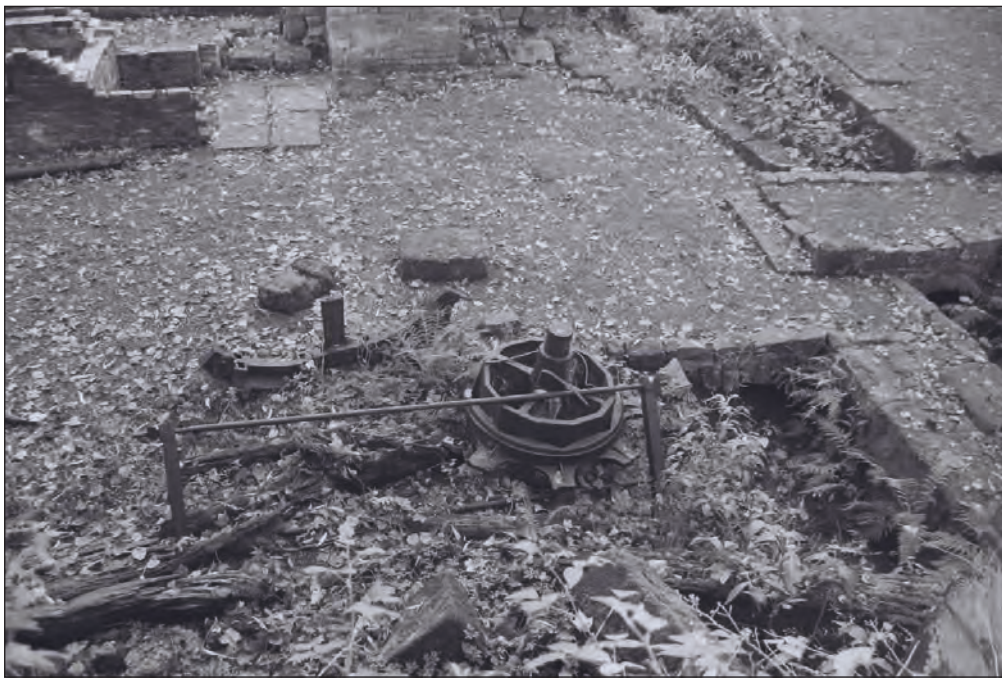
Plate 72: General view of the collapsed west helve hammer from the dam wall at the south end of the phase 2 range (Film 11.12)

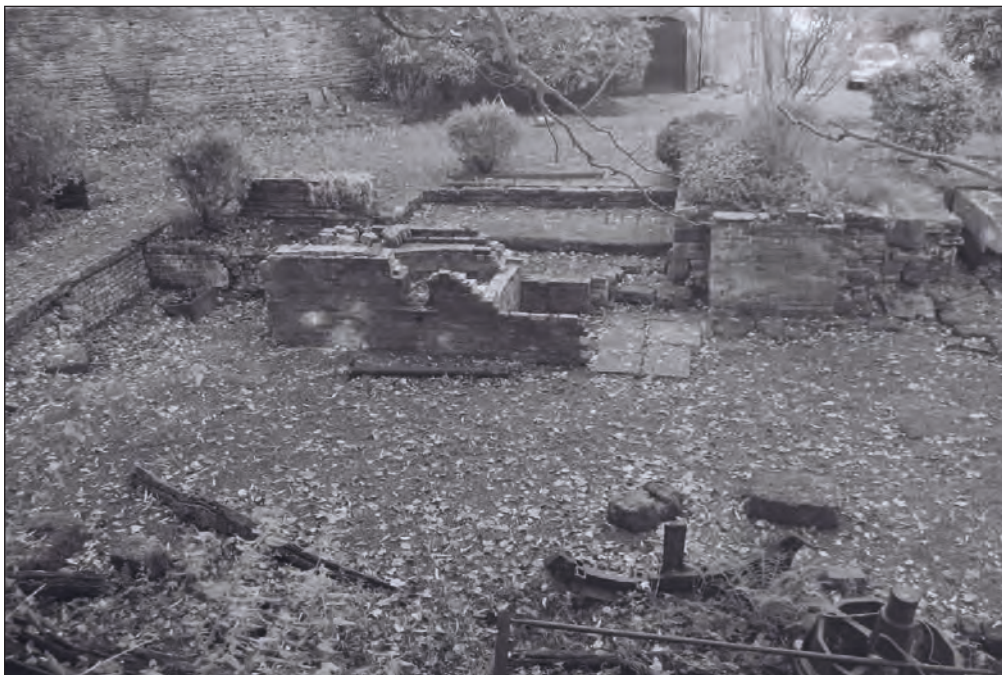
Plate 80: General view of the western phase 2 range from dam wall, showing remains of a puddling furnace (Film 11.11)

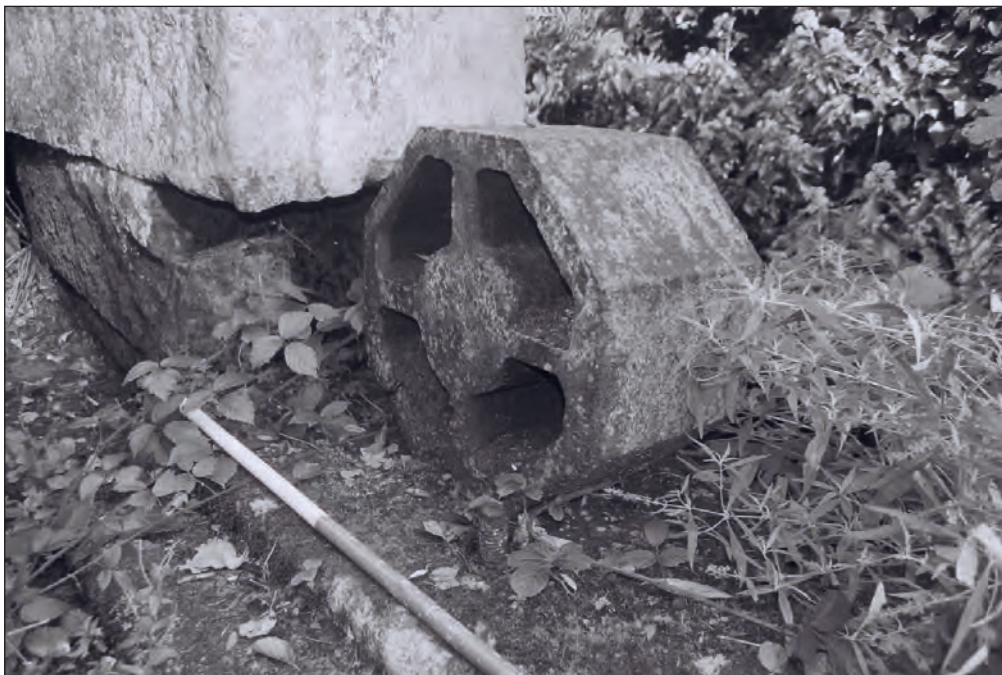
Plate 84: Detail of wheel mechanism remains at the north end of the western phase 2 range (Film 10.8)

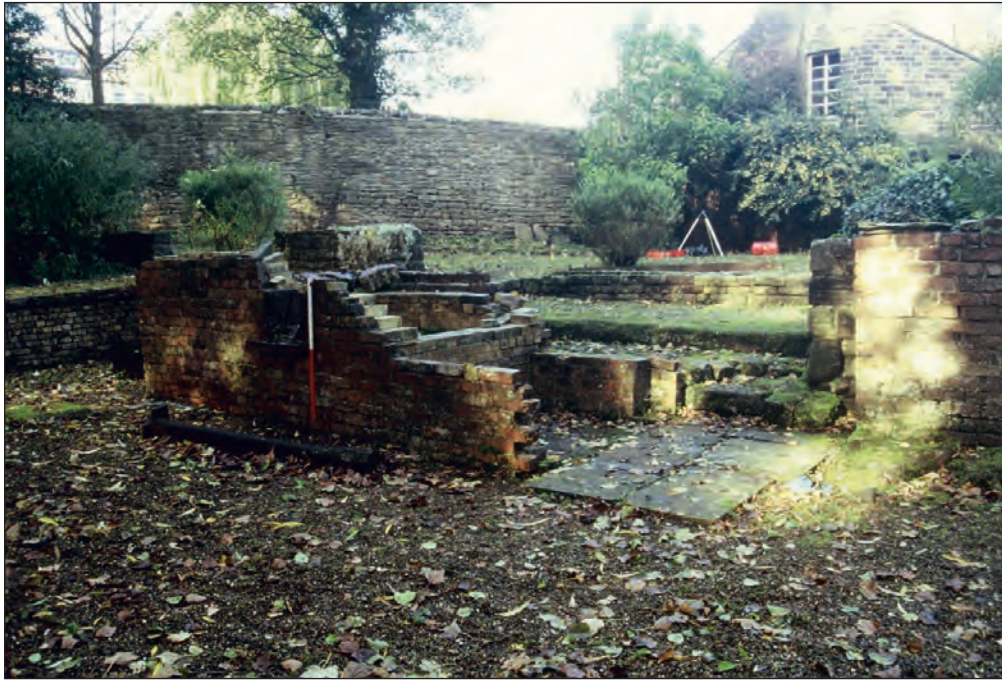
Plate 85: General view of a puddling furnace at north side of the western phase 2 range (Film CS. 13)

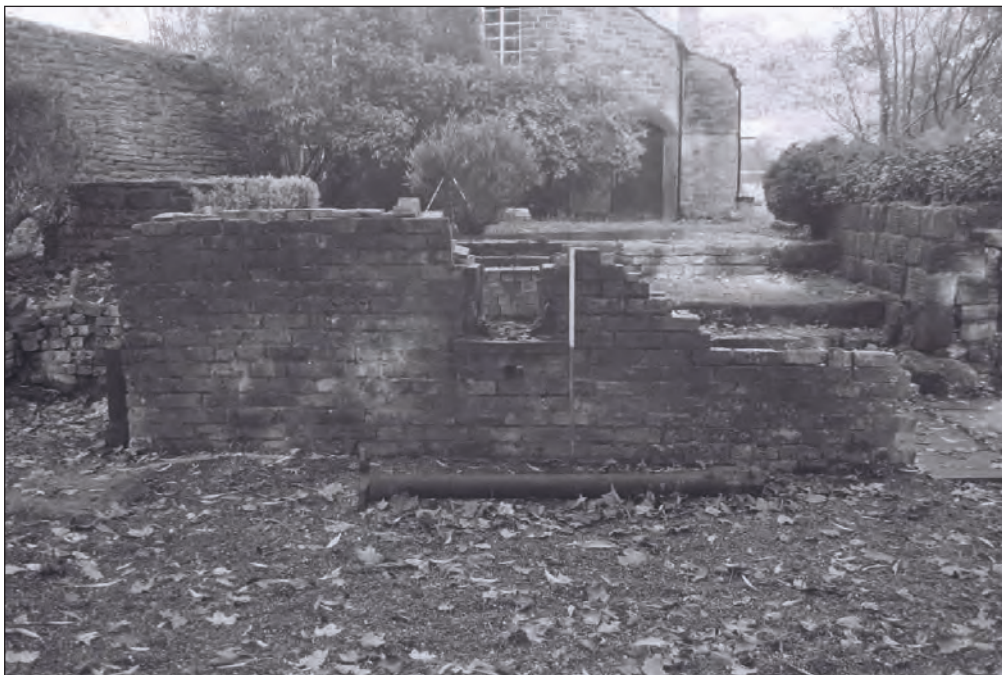
Plate 86: View of the south elevation of the puddling furnace at the north side of the western phase 2 range (Film 10.12)

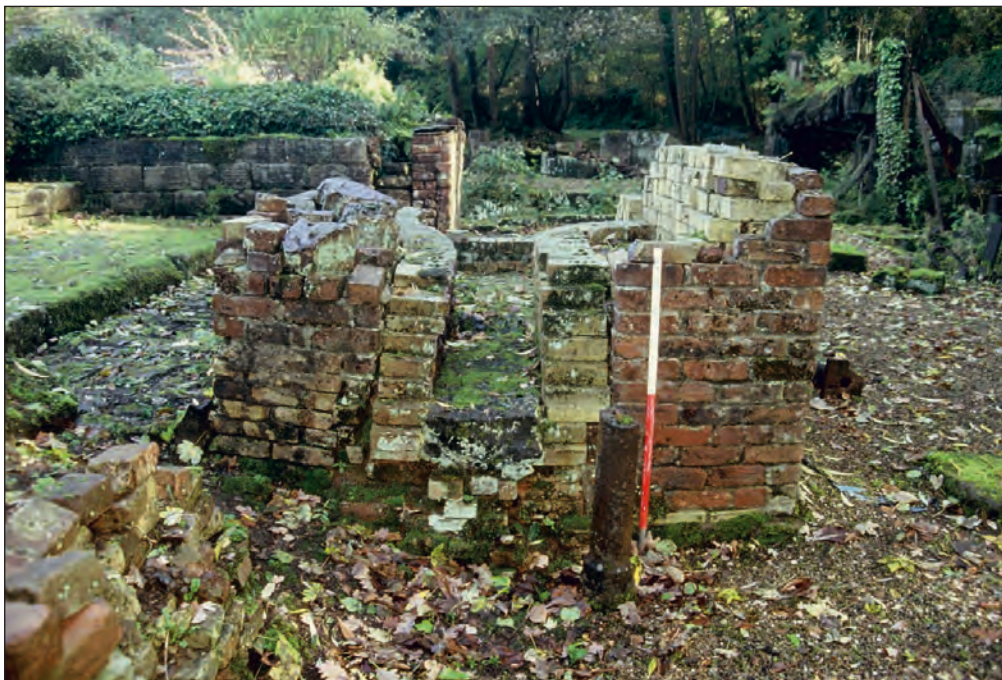
Plate 88: Detail of the northwest elevation/flue of the puddling furnace at the north side of the western phase 2 range (Film CS. 8)

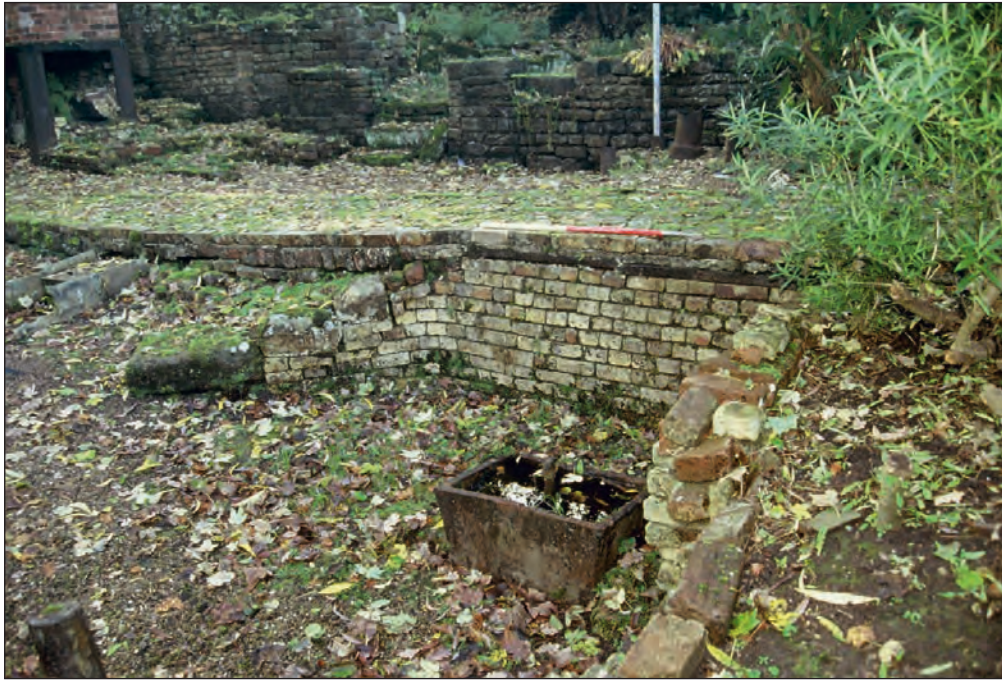
Plate 91: General view of the puddling furnace flue at north side of the western phase 2 range (Film CS. 3)
