Mousehole Forge Scheduled Ancient Monument 1004804 Sheffield, South Yorkshire

Archaeological Assessment & Building Appraisal

Ref: 101750.01
January 2014

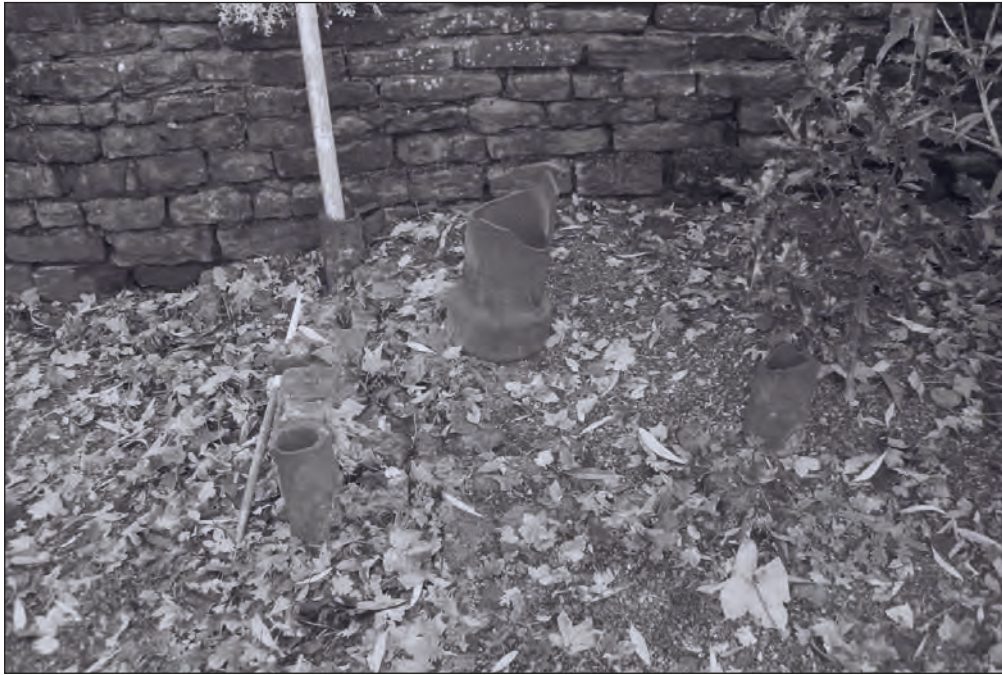
Plate 97: Detail of a former chimney base at the west side of the western phase 3 range (Film 10.31)

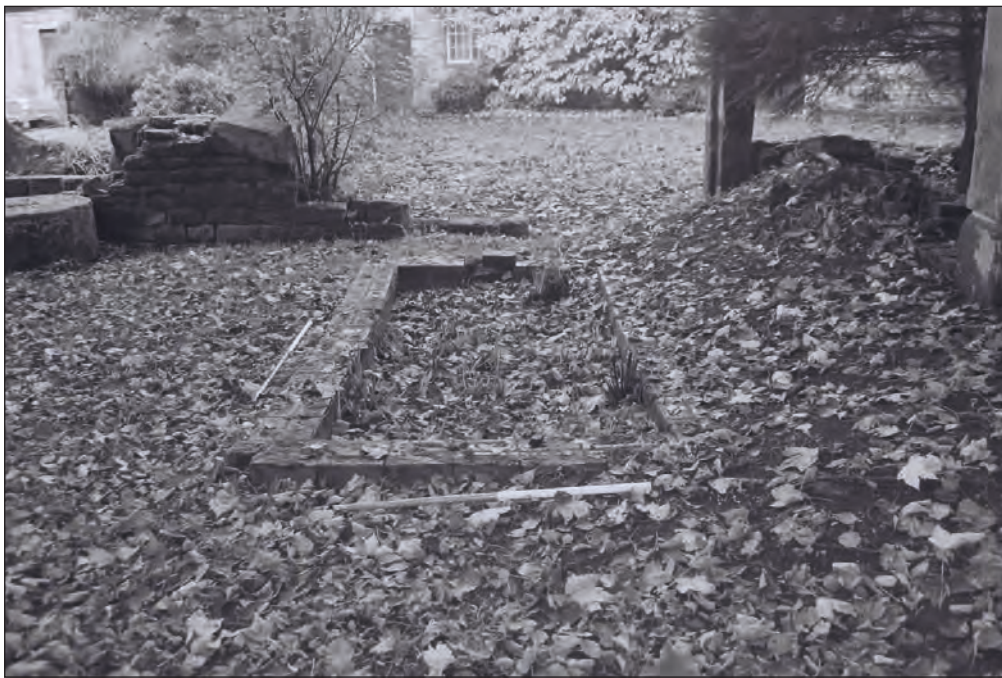
Plate 110: Detail of brick base within eastern phase 3 range (Film 8.13)
