# Duffield Hall, Duffield Derbyshire

Archaeological Strip, Map and Sample  
and Watching Brief Report

Planning Reference: AVA/2013/0835, 0836, 0837, 0838, 0840 & 0843  
Ref: 102101.02  
June 2015

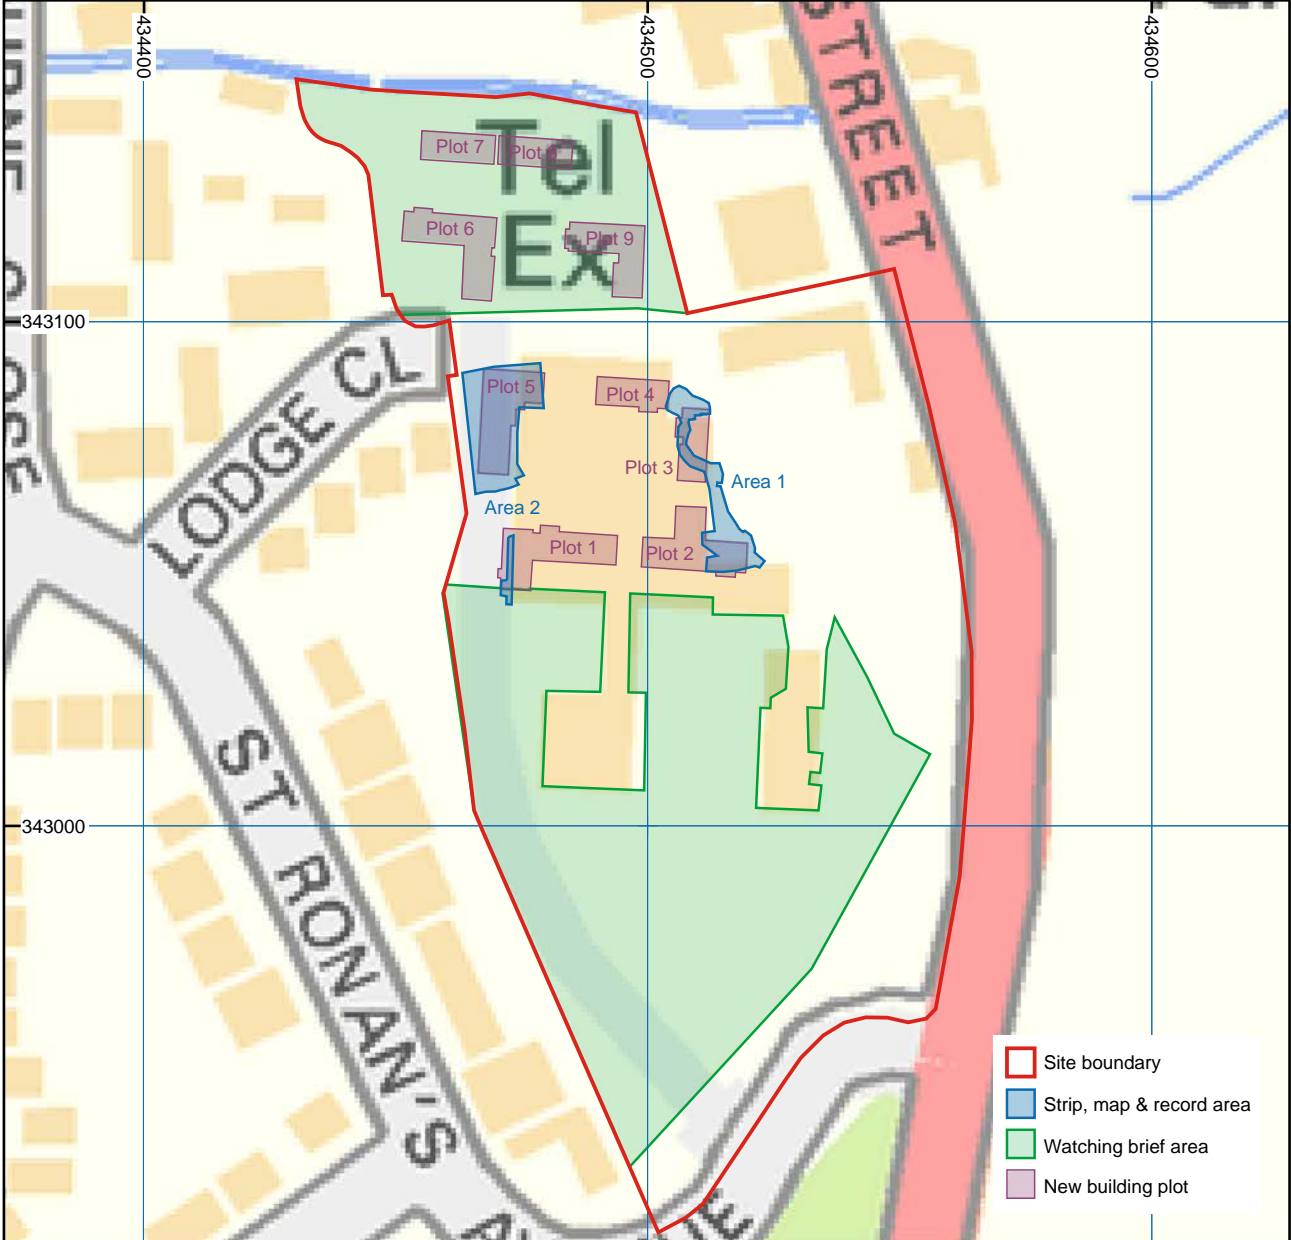
Figure 1

Site location and plan

5.1.2 An archaeological strip, map and sample programme was carried out to the east and west of the former 1970s office building (**Areas 1 and 2, Figures 1, 3, 5**). The areas designated for strip, map and sample had to be reduced in size due to the presence of root protection areas. Two areas, to the north and south of the Site, were monitored and recorded under watching brief conditions.

- 6.4.1 An archaeological watching brief was carried out in designated areas to the north and south of the former 1970s office building (**Figure 1**).
- 6.4.2 The western extent of Plot 1 had originally been positioned within strip, map and sample Area 2, but due to the provision for root protection areas, the western foundation trench of the plot was monitored under the watching brief.

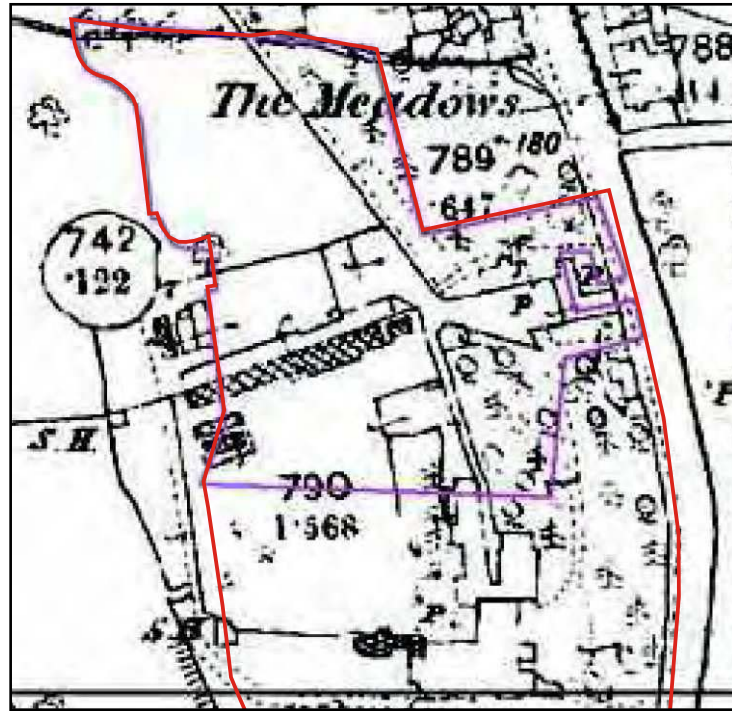
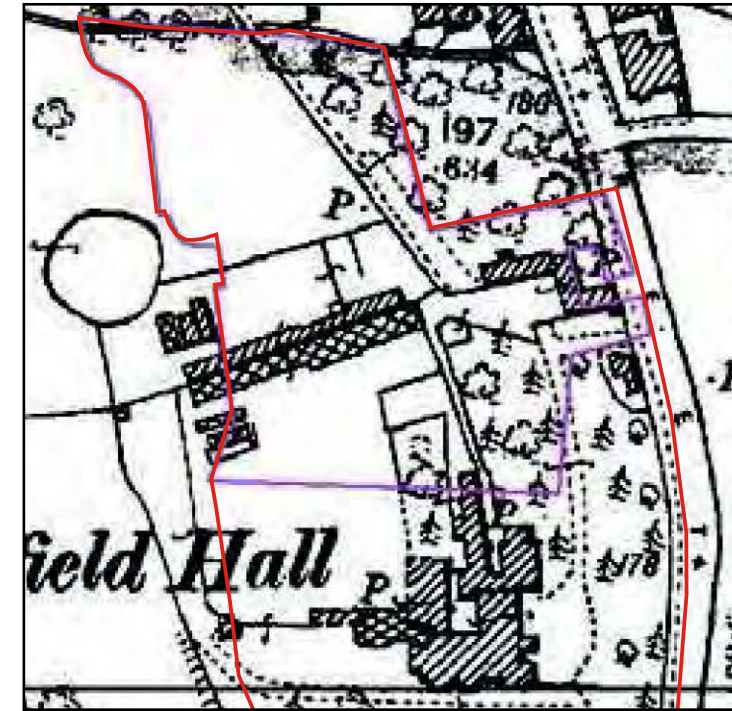
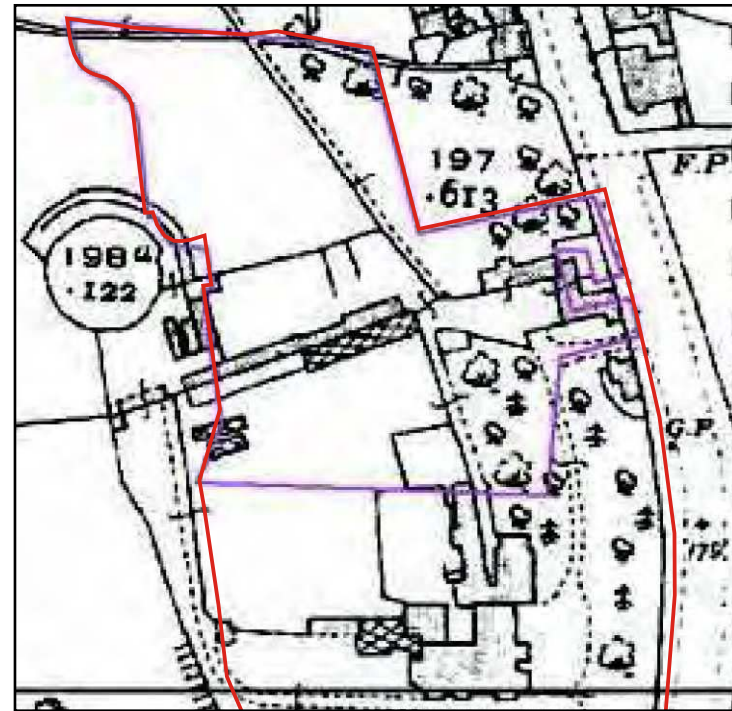
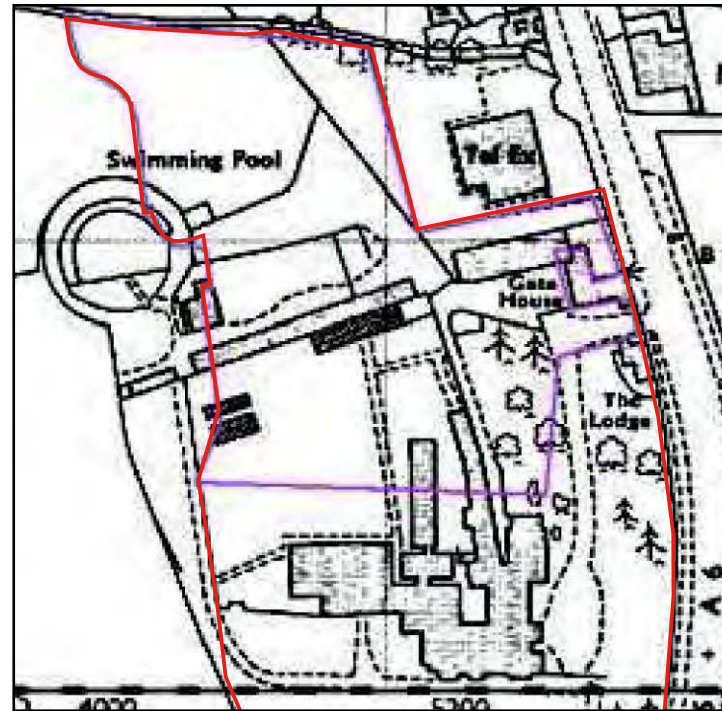
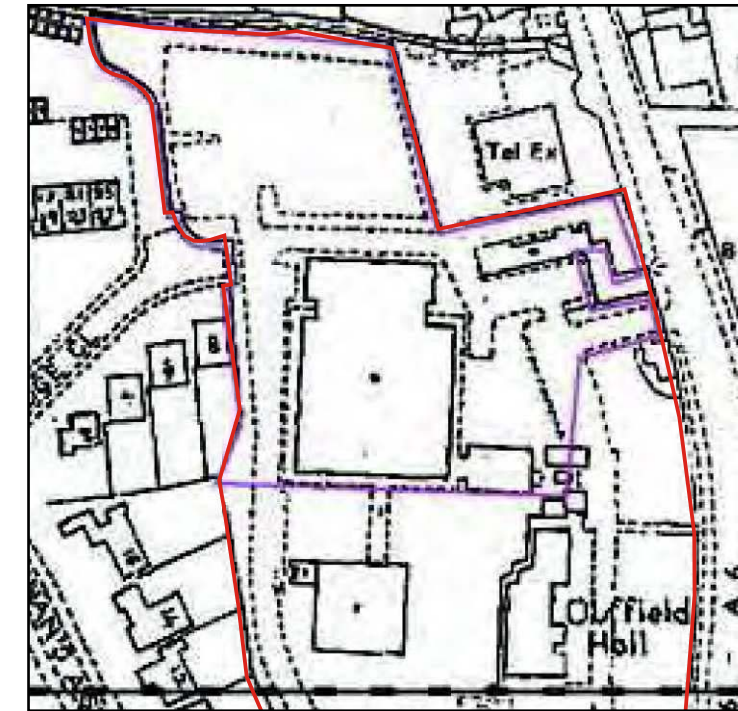
1880 OS Map

1900 OS Map

1938 OS Map

1970 OS Map

1978 OS Map

- 6.3.3 At the north of Area 1, a dry sandstone, 'L'-shaped wall (**1007**) orientated southwest-northeast, returning to the east, was observed at a depth of 0.69m (**Plates 4-5, Figures 3, 4b**). Only a single course of the wall had survived and was truncated by concrete base **1012**. Wall **1007** was laid upon a redeposited natural clay layer (**1016**), above the natural gravels **1021**. The wall (**1007**) corresponds with the eastern end of the glazed outbuilding located to the northwest of the Hall, depicted on the 1880 OS map (**Figure 2**).

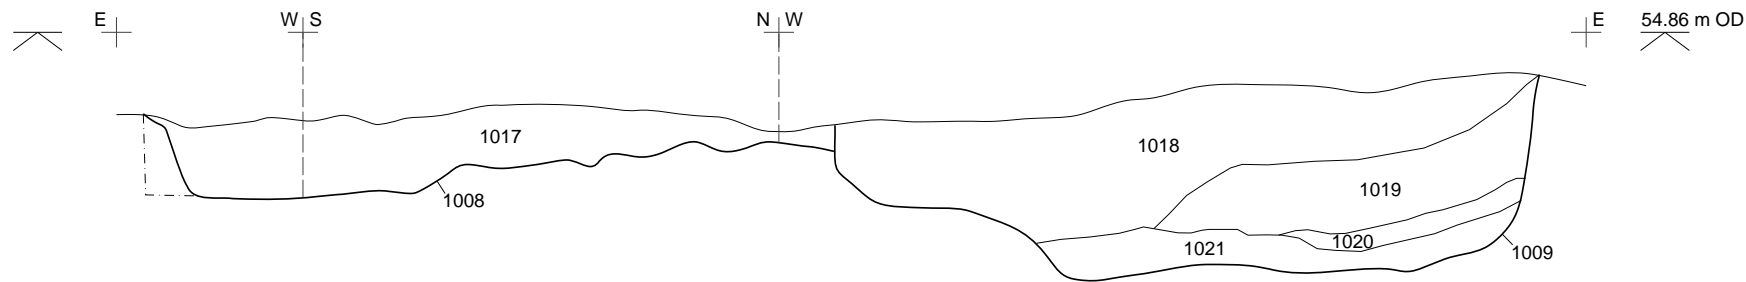
Figure 4a Section through features **1008 & 1009** 1:40

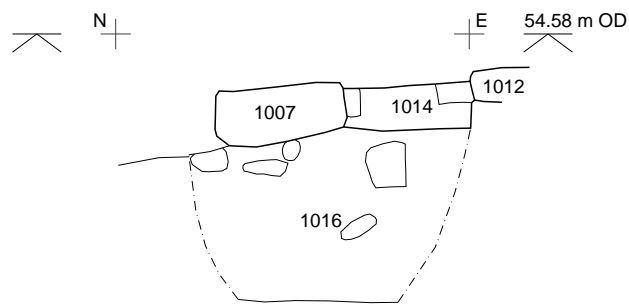
Figure 4b Section through structure **1007 & 1014** 1:20

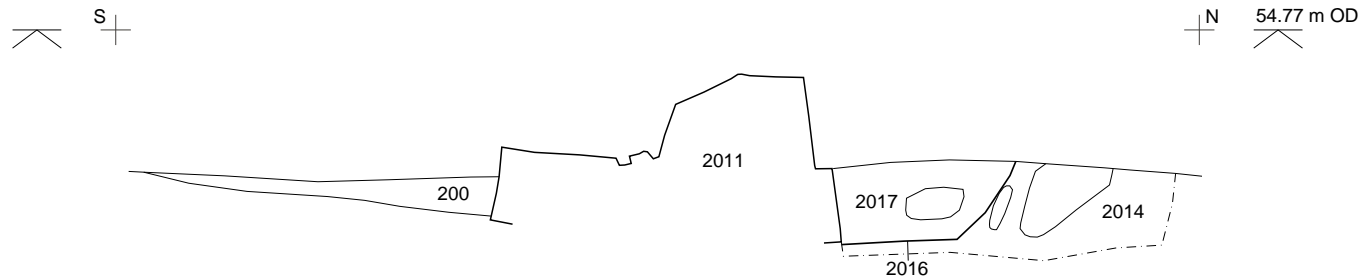
Figure 6a Section through structure **2011** 1:20

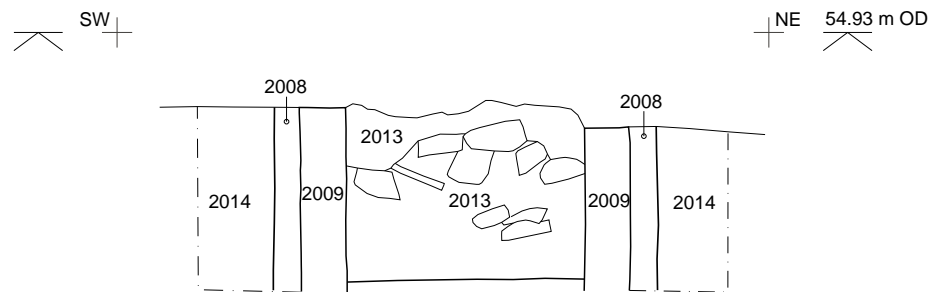
Figure 6b Section through structure **2009** 1:20

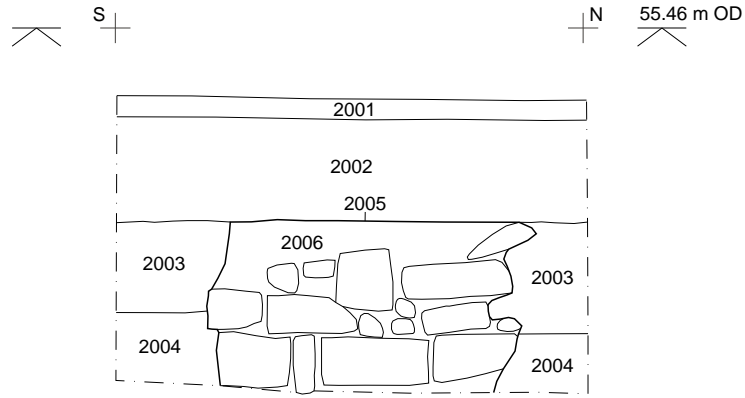
Figure 7a Section through structure **2006** 1:20

- 6.4.3 A layer of tarmac **2001** and hard-core **2002** overlaid natural clay **2003** and gravel **2004**. A sandstone wall (**2006**) was recorded in the east facing section of the western foundation trench of Plot 1 (**Plate 15, Figure 7a**). This wall was cut (**2005**) into the natural (**2003-4**). The wall did not continue across the foundation trench and it was not visible within the west facing section. It would appear that the foundation trench had just clipped the eastern end of the wall which corresponds with the southeast corner of a small outbuilding, first depicted on the 1880 OS map (**Figure 2**). No further archaeology was observed within this area (**Plate 16**).

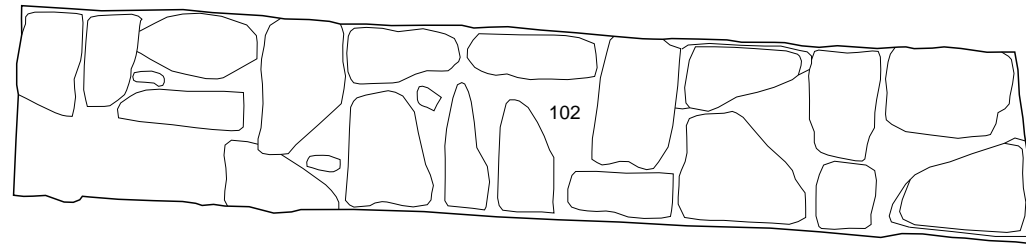
Figure 7b Plan of structure **102** 1:20

- 6.4.4 The monitoring of the groundworks in the area to the south of the Site for the excavation of a new swimming pool and garage, revealed a sandstone foundation wall **102**. This was orientated east-west, 3.38m in length and was related to a small outbuilding attached to the rear of the Hall, depicted on the 1880 OS map (**Plate 14, Figure 7b**). This lay below demolition layer **101**.

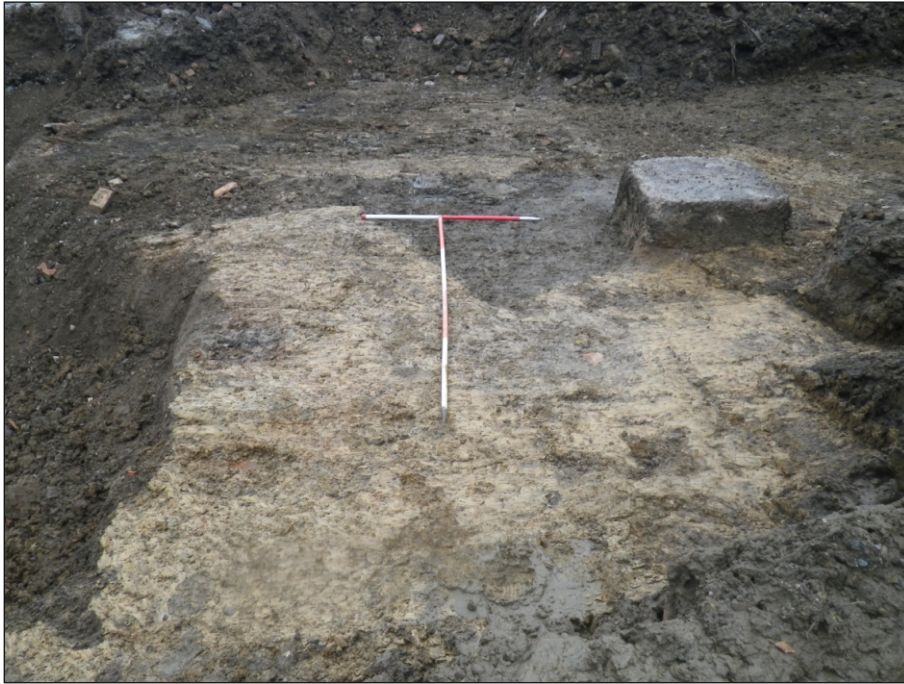
Plate 1: General view of Area 1 showing demolition cut **1003**, concrete stanchion base, cut of pit **1009** and the natural clay **1004**, looking west

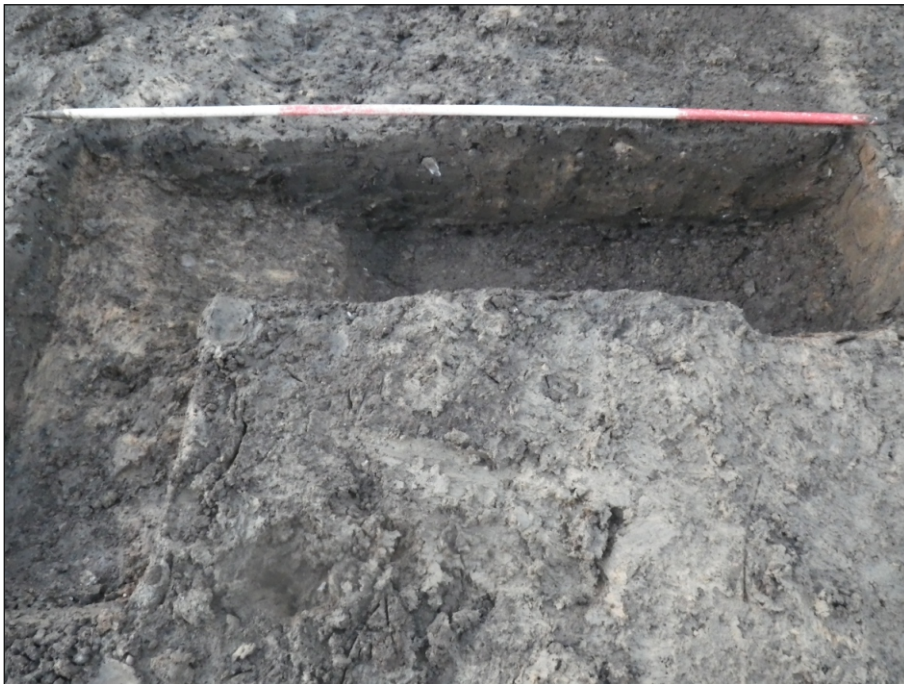
Plate 2: View of pit **1009**, looking north

- 8.2.4 An indeterminate charred grain fragment was observed in the sample from context **1018** within post-medieval pit **1009**. Moderately large numbers of uncharred weed seeds were also noted within this sample and that from post-medieval layer **1017**. These uncharred weed seeds included seeds of bramble, elder, spike-rush (*Eleocharis* sp.) and goosefoot (*Chenopodium* sp.).

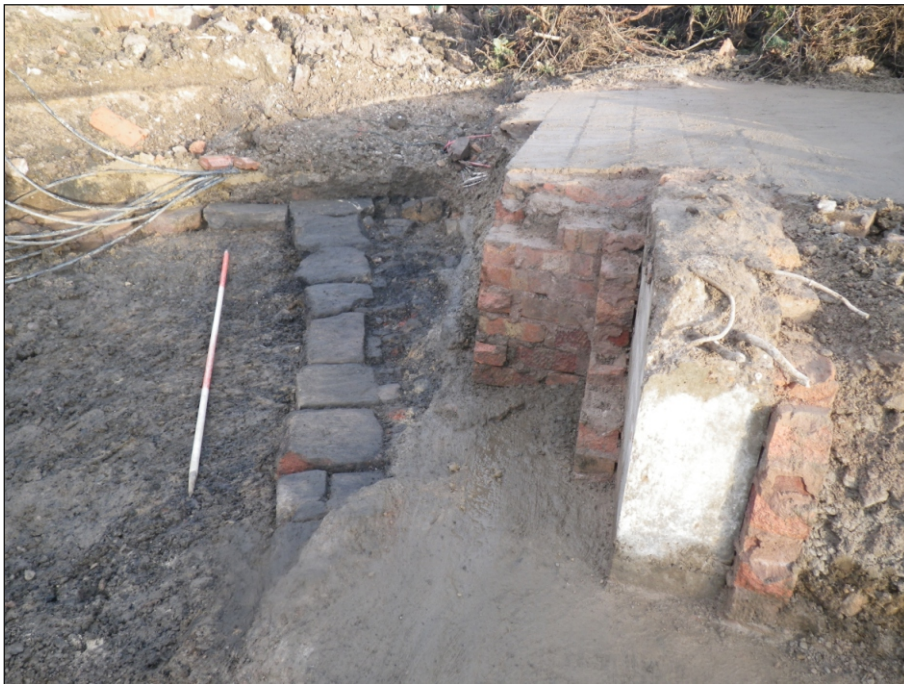
Plate 4: General view of the north of Area 1, looking southeast

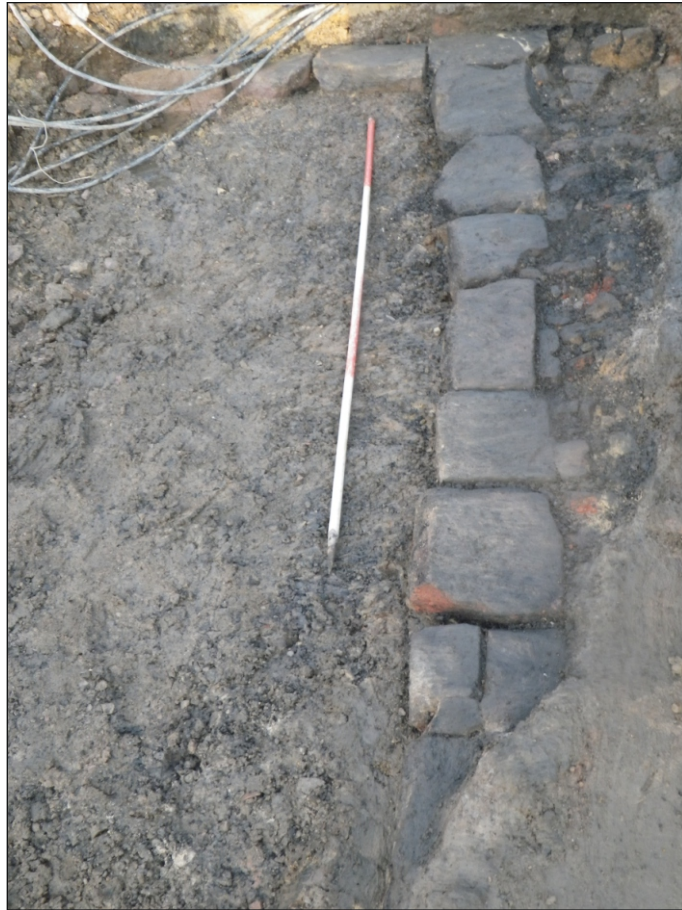
Plate 5: Detail of sandstone wall **1007** in Area 1

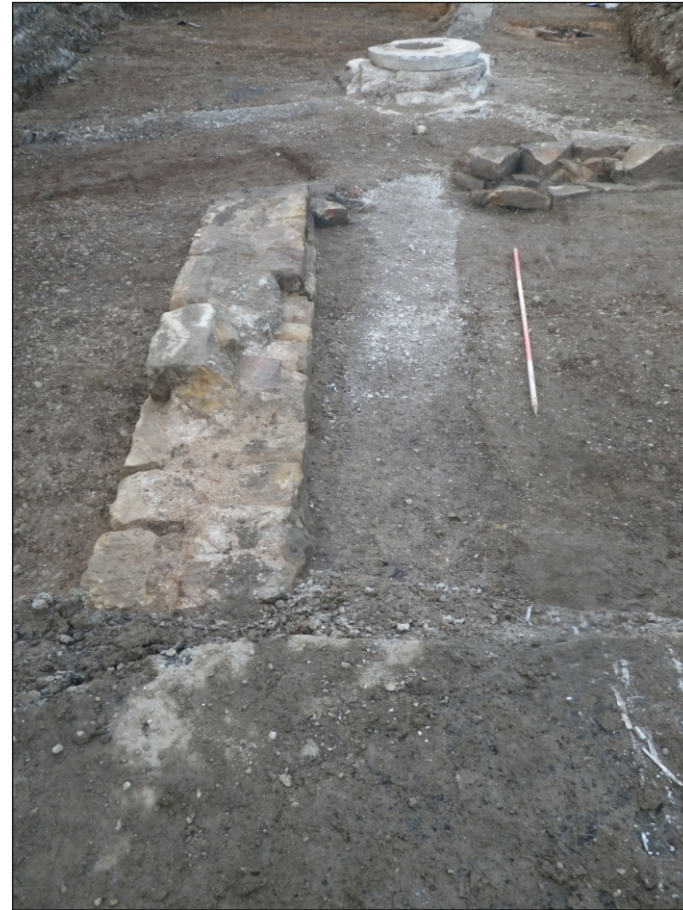
Plate 6: View of wall **2010** adjacent to modern drain cut **2022** which runs to modern manhole **2012** in Area 2

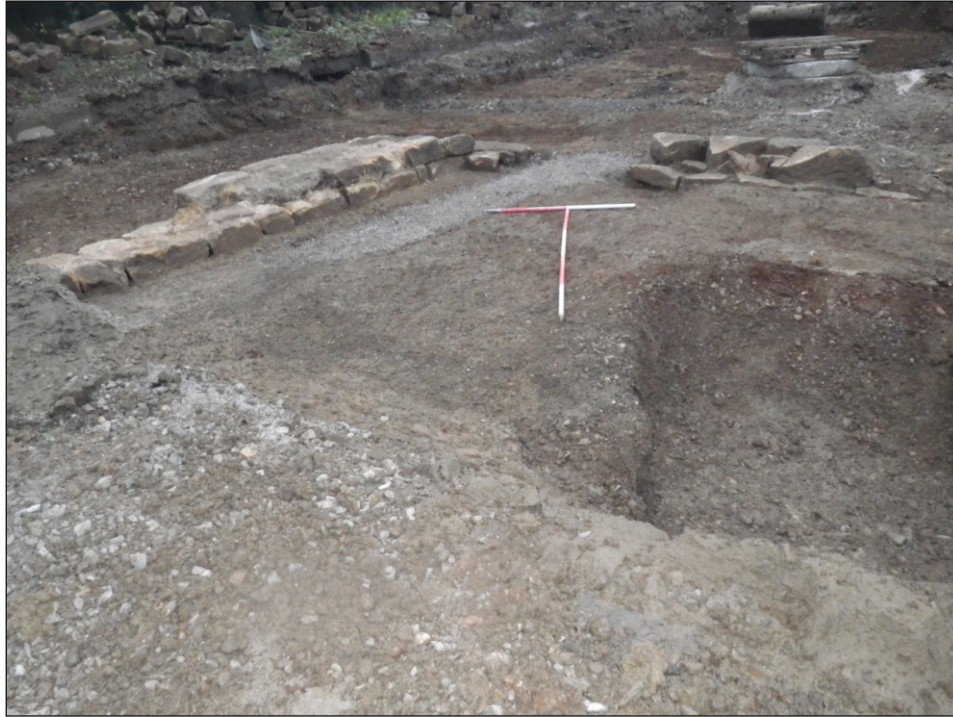
Plate 7: View of sandstone walls **2010** and **2011** in Area 2, looking northwest

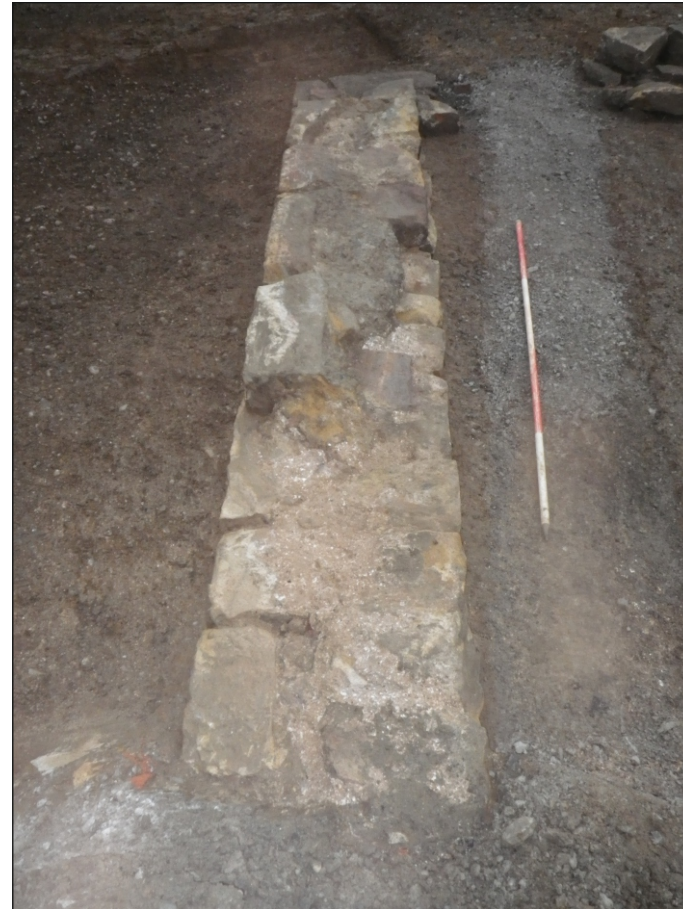
Plate 8: View of sandstone wall **2010**, looking north

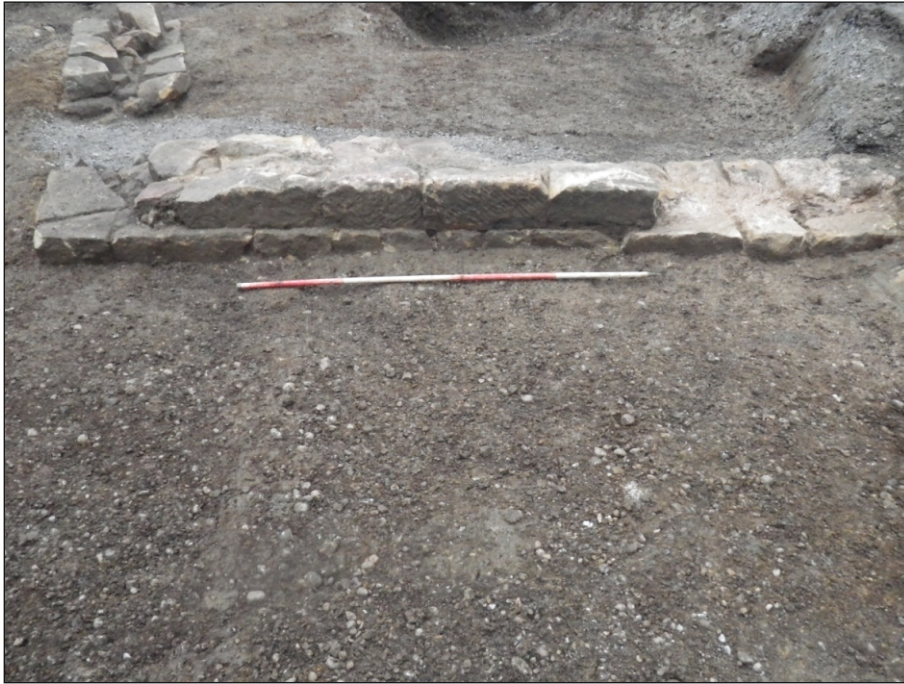
Plate 9: West facing elevation of wall **2010**, showing tooling

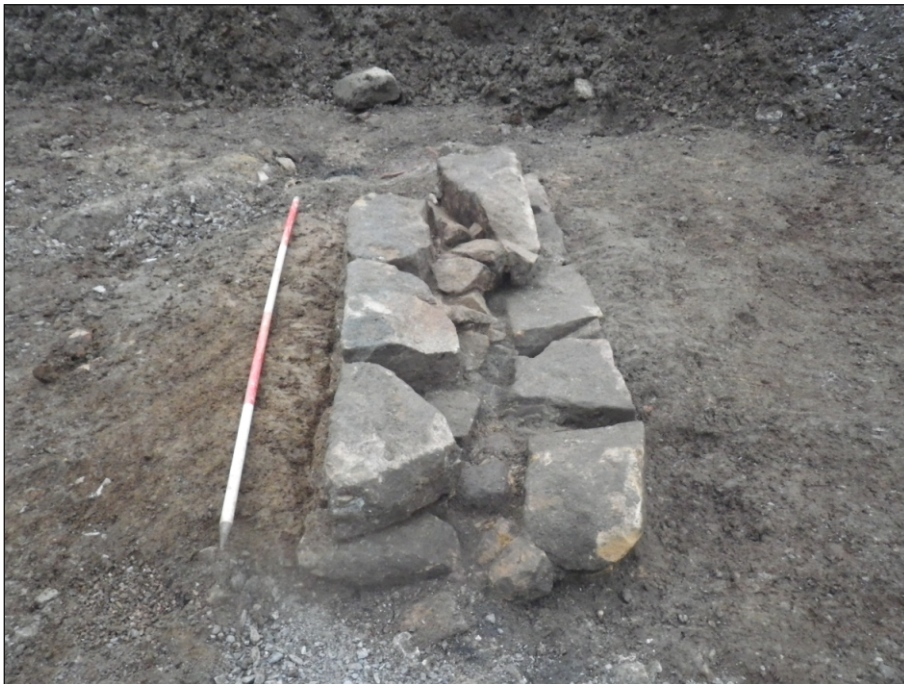
Plate 10: View of wall **2011**, looking east

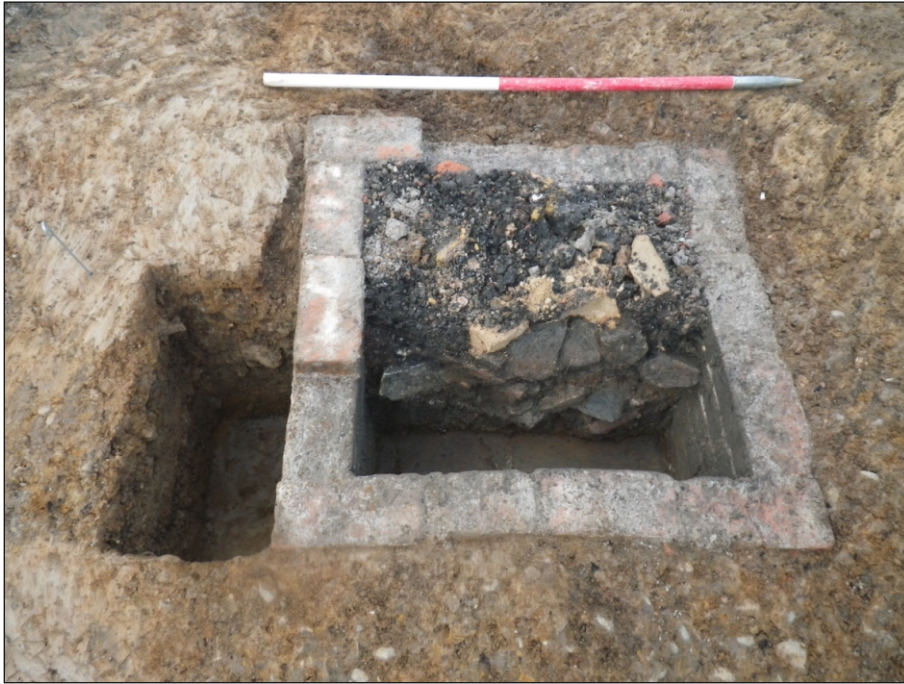
Plate 11: View of **2007**, **2009** with **2013** half sectioned, looking northwest

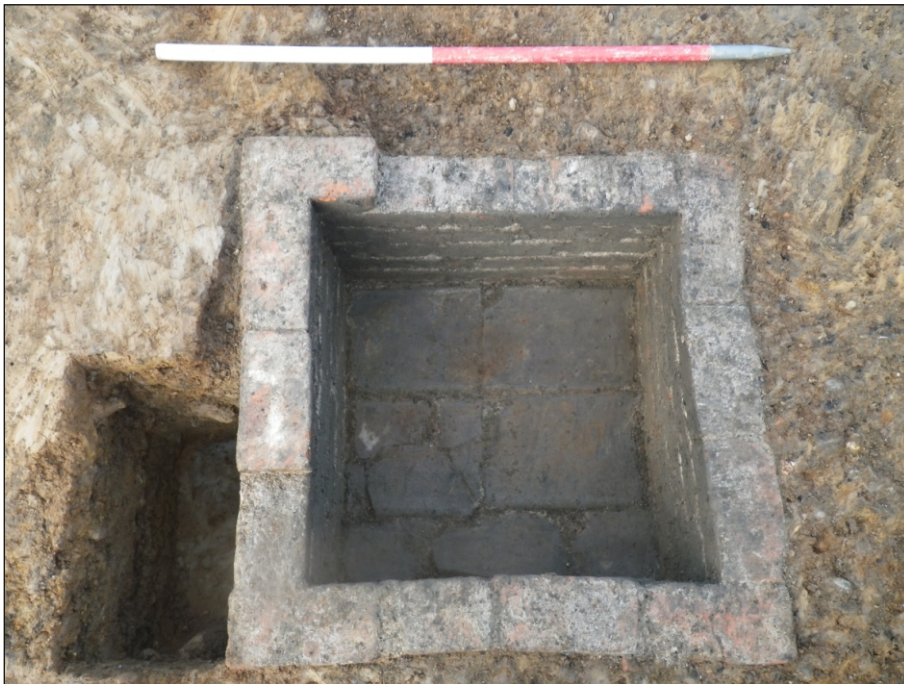
Plate 12: View of redbrick structure **2009** fully excavated, looking northwest

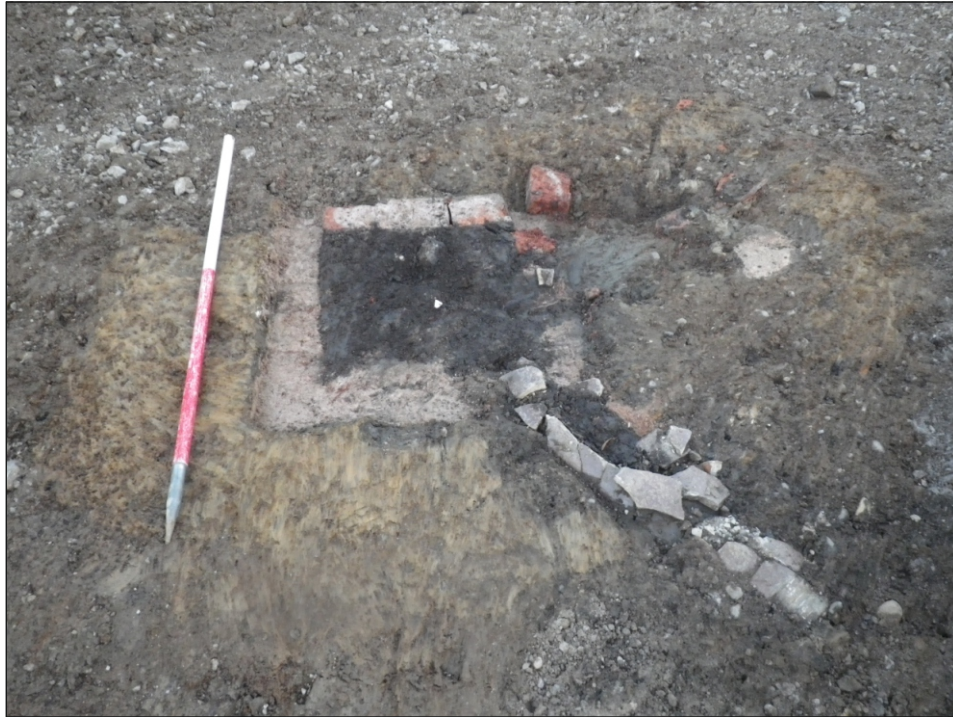
Plate 13: View of redbrick structure **2015** with drains **2032** and **2033**, looking north

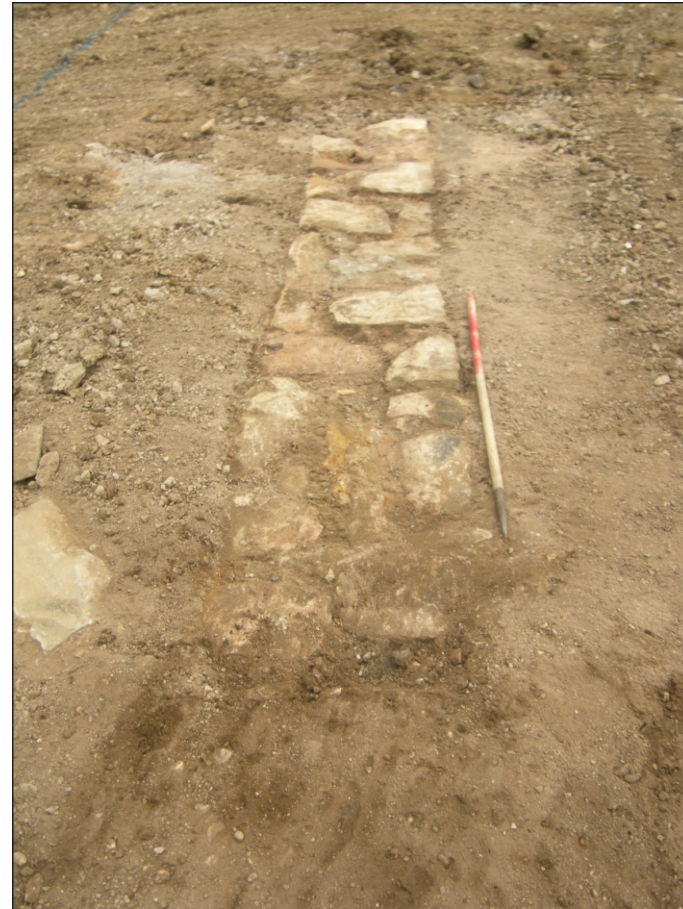
Plate 14: View of sandstone wall **102** exposed in southern area

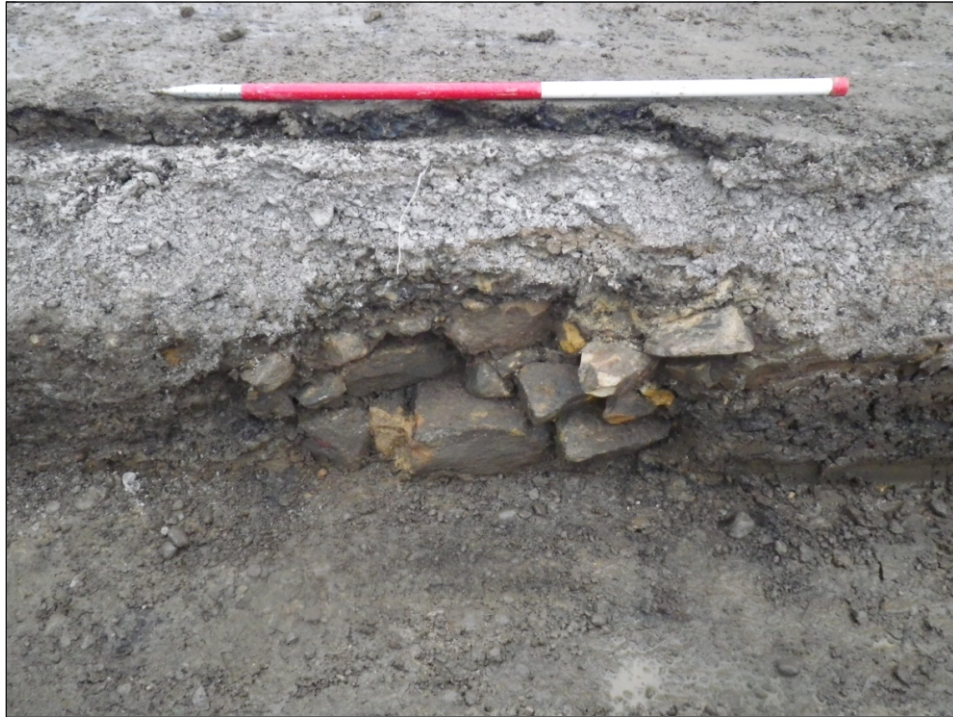
Plate 15: East facing section of Plot 1, showing tarmac **2001**, hard-core **2002**, sandstone wall **2006**, cut **2005**, natural clay **2003** and gravel **2004**

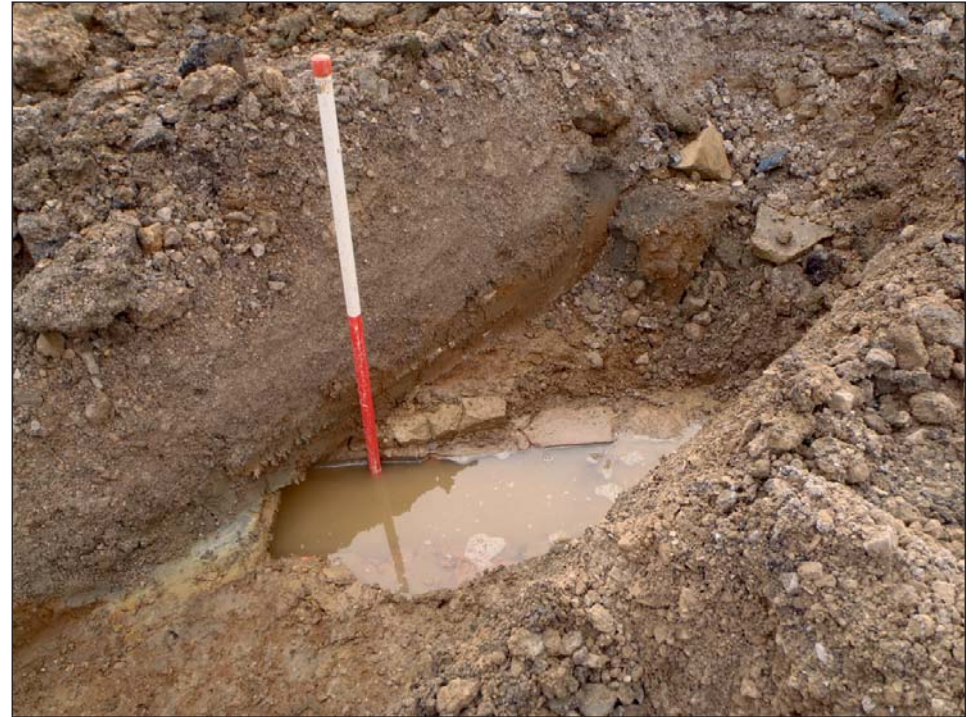
Plate 18: View of culvert **202**, Plot 6, looking southeast

- 6.4.5 This area comprised overburden **200** to a depth of 0.40m and made-ground **201** was encountered below (**Plate 17**). Within the northern foundation trench, a redbrick and sandstone culvert (**202**) was observed that ran northwest-southeast (**Plate 18**). The foundation excavation depth of 0.7m was not sufficient to determine whether the culvert ran across the remainder of the Site or to identify the natural geology in the area. Modern services also ran across the plot.

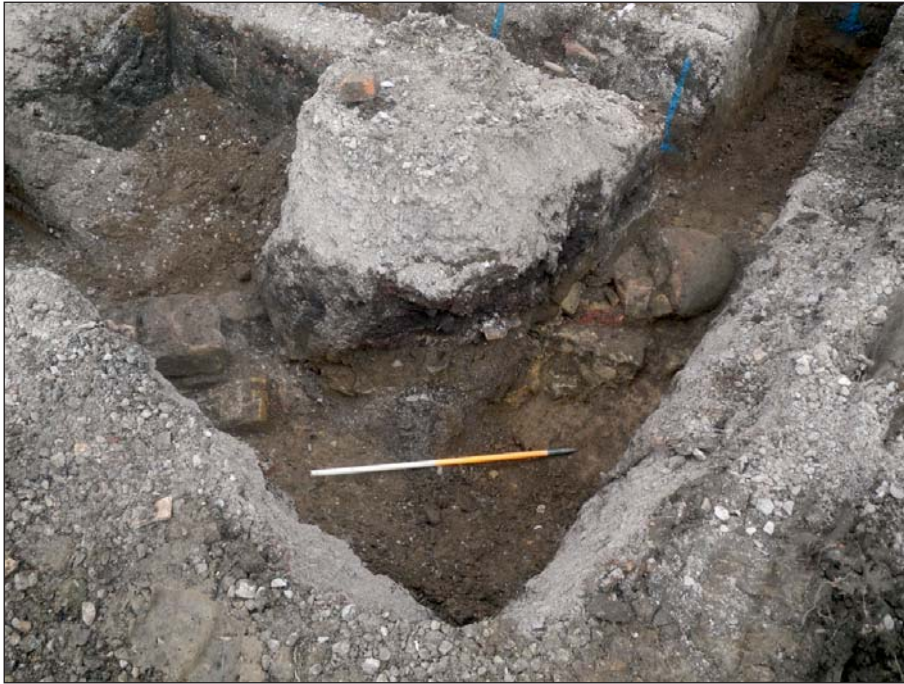
Plate 19: View of drain **806** in Plots 7 and 8, looking northwest

- 6.4.6 The excavation of these plots revealed a drain (**806**) at a depth of 0.7m, running from the southern foundation trench of Plot 8 in a north-easterly direction, through to the eastern trench of the Plot (**Plate 19**). This was constructed of yellow and red sandstone with redbrick patching (**Plates 19, 20**), and cut (**805**) through the natural clay **804** below. This was overlain by made-ground **803**, topsoil **802** and white hard-core **801** respectively which covered the natural deposits within this area (**Plate 21**).

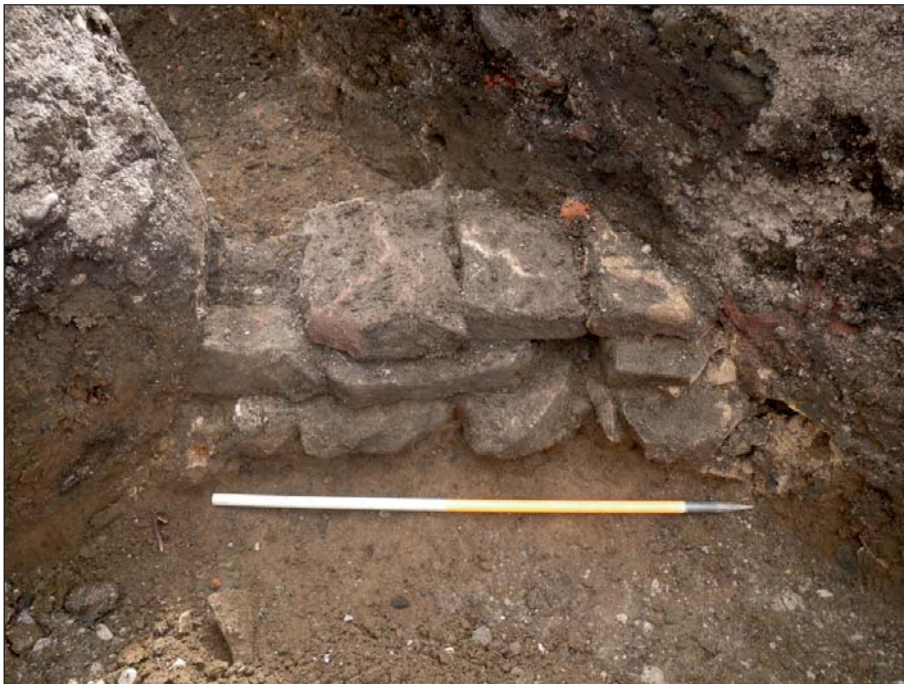
Plate 20: Detail of drain **806** showing fabric, looking east

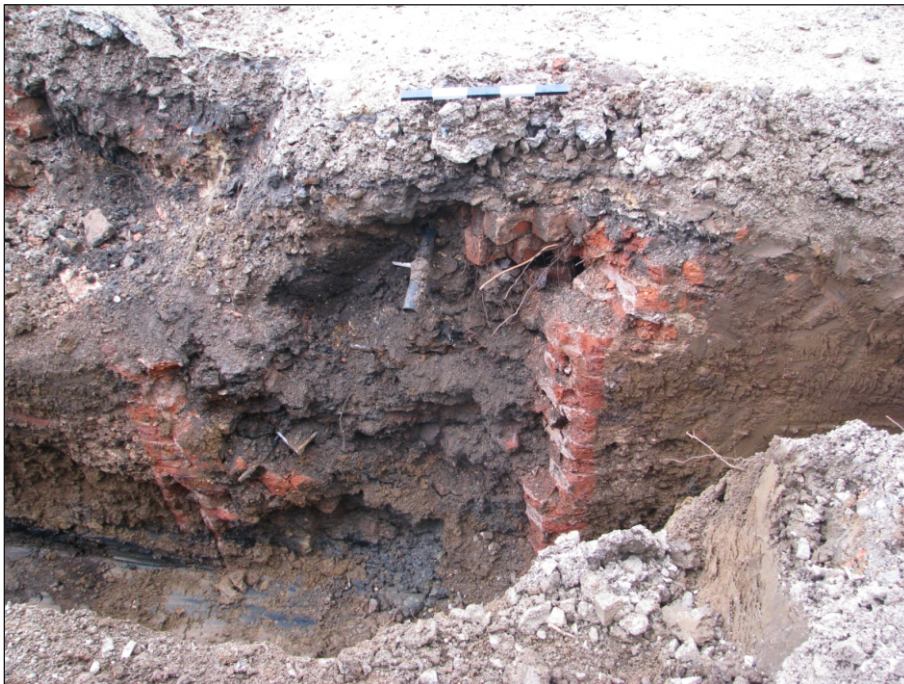
Plate 22: Modern redbrick manhole **903** in the northeast facing section of foundation trench, Plot 9

- 6.4.7 Two layers, topsoil **901** and subsoil **902**, were excavated to a maximum depth of 1.2m. A modern redbrick manhole was truncated by the plot foundation trenches at the east of the area (**Plate 22**). No other features were encountered.
