**GARA ROCK HOTEL
EAST PORTLEMOUTH
SOUTH HAMS
DEVON**

Building Recording

Report reference: 62560.01

20th July 2006

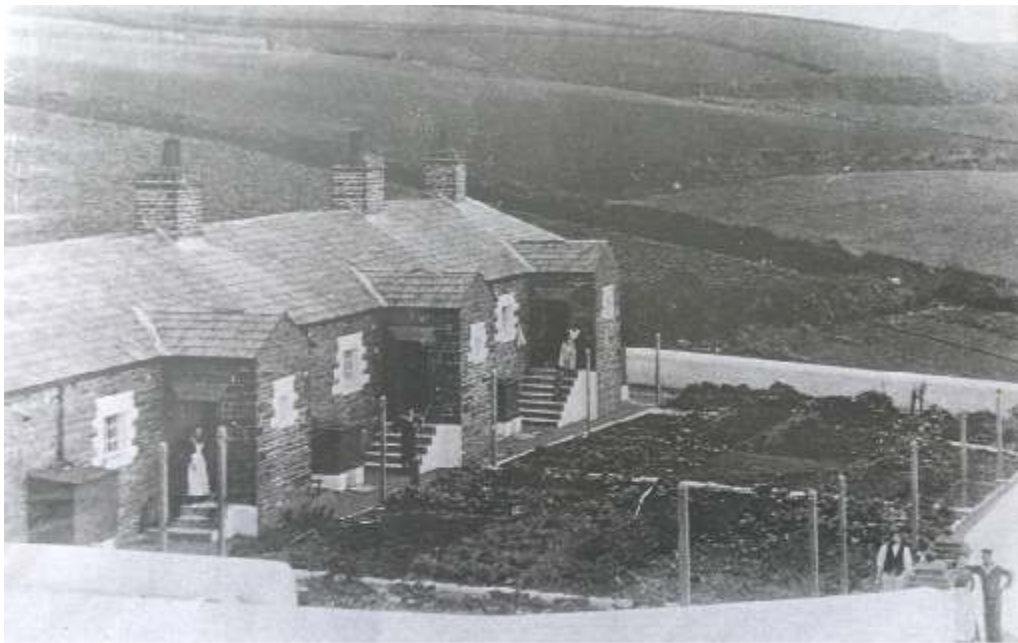
Plate 1. The cottages before 1909

- 3.1.10 A photograph taken before the cottages were sold in 1909 appears to show them much as they were originally built (**Figure 3: Plate 1**). The walls were built from coursed rubble stone with squared stone dressings around the window and door openings. The single pitched roof is covered in slate. Three of the five square stone chimney stacks along the main east-west range are visible. There are rain water tanks between each of the porches. The photograph shows some of the inhabitants of the cottages with two men in what appear to be naval or coast guard uniforms. On the steps of the cottages are women dressed in white pinafores.

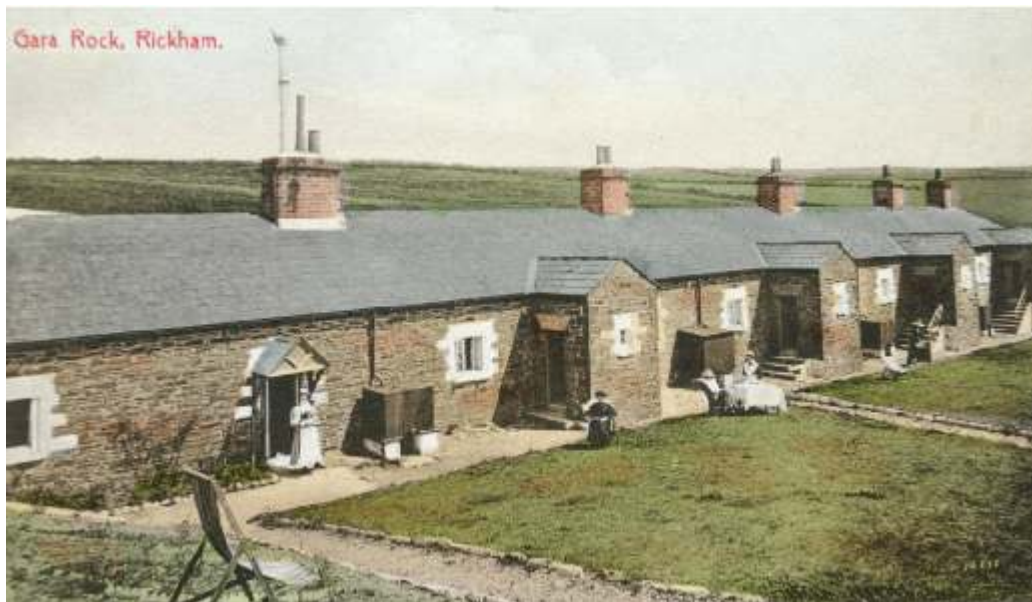
Plate 2. South facing range in 1909 just after the Jordans bought the property

- 3.1.12 A photograph taken just after 1909 when the Jordans bought the property (**Figure 3: Plate 2**) shows the full south facing range. The cottages appear largely as they did in the previous photo but with a change. A small alteration is noted in this photo, the central window at the west end or left hand side of

the photograph has been changed into a doorway with a small wooden porch. It is considered that the area behind this door is the part of the cottages converted into a dining area and lounge. The whitewashed window dressings around the doorway do not reach ground level.

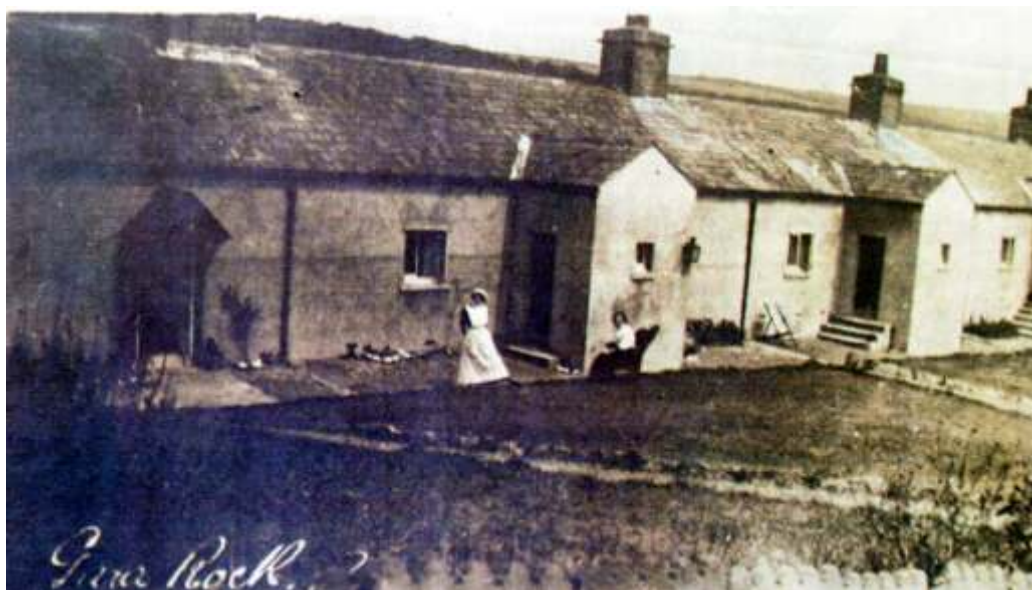
Plate 3. South facing range circa 1919

- 3.1.15 A photograph taken *c.* 1919 (**Figure 3: Plate 3**) shows the front (south) of cottages with the external render applied during this phase of the conversion by the Jordans. A maid and guest are visible on the front lawn.

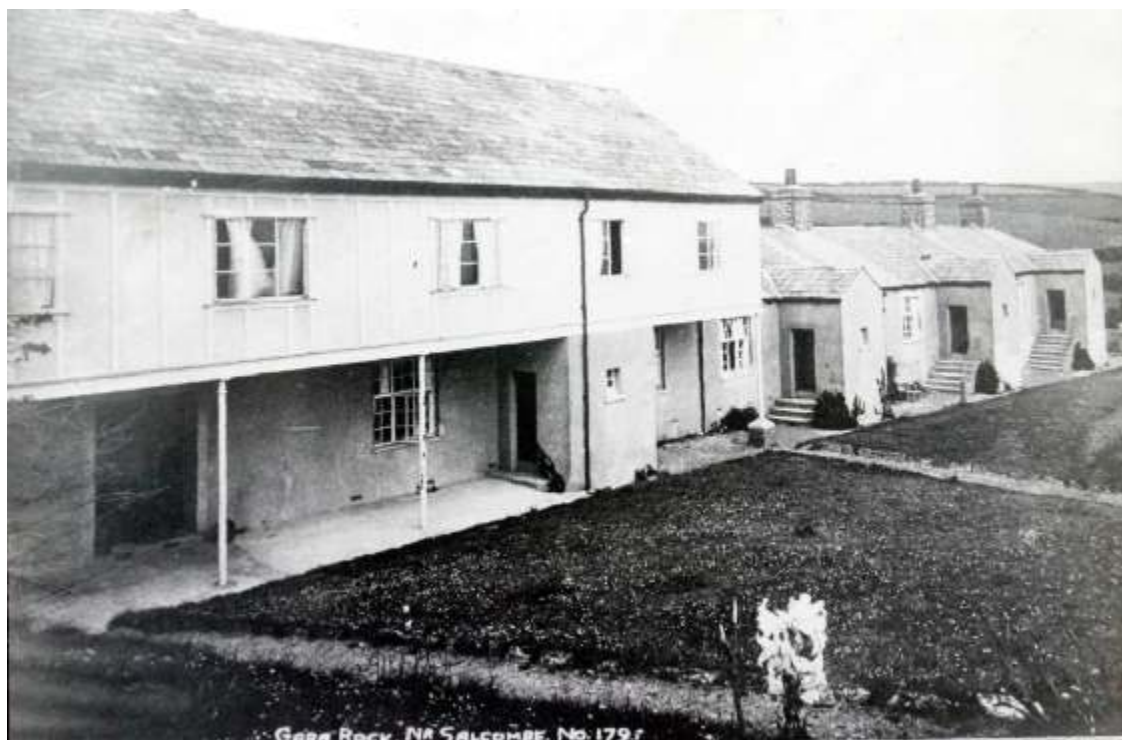
Plate 4. South facing range *circa* 1925 showing second storey

- 3.1.16 A photograph taken approximately 1925 (**Figure 4: Plate 4**) shows the external render and the overhanging second storey added to the west end of the cottages. Three of the original cottages at the east end remain. Metal ‘Crittall’ windows have replaced the earlier casements on the ground floor. The single extant porch, found during the survey, can be seen between two of the iron post supports.

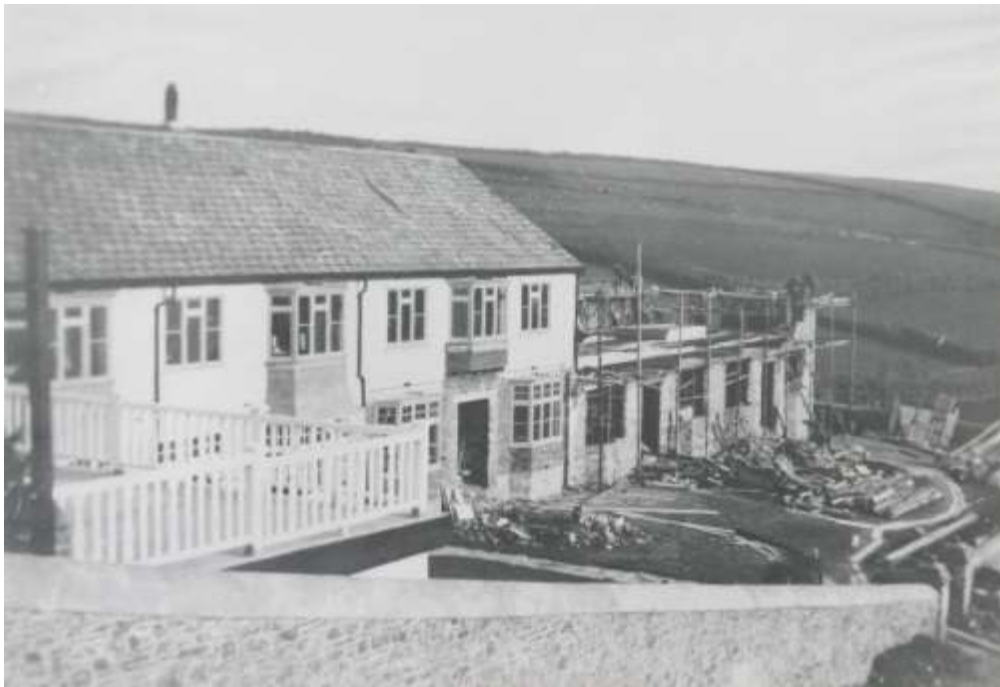
Plate 8. View of the Jordan's alterations *circa* 1925-1939

- 3.1.19 A photograph taken during further refurbishment by the Jordans’ after 1925 and before 1939 (**Figure 6: Plate 8**) shows large scale alteration of the front elevation including new bay windows. The front wall has been brought forward and in line with the front the porches (which were removed). This created the present arrangement with the frontage on one line. The photograph shows the complete removal of the roof and chimneys of the east cottages.

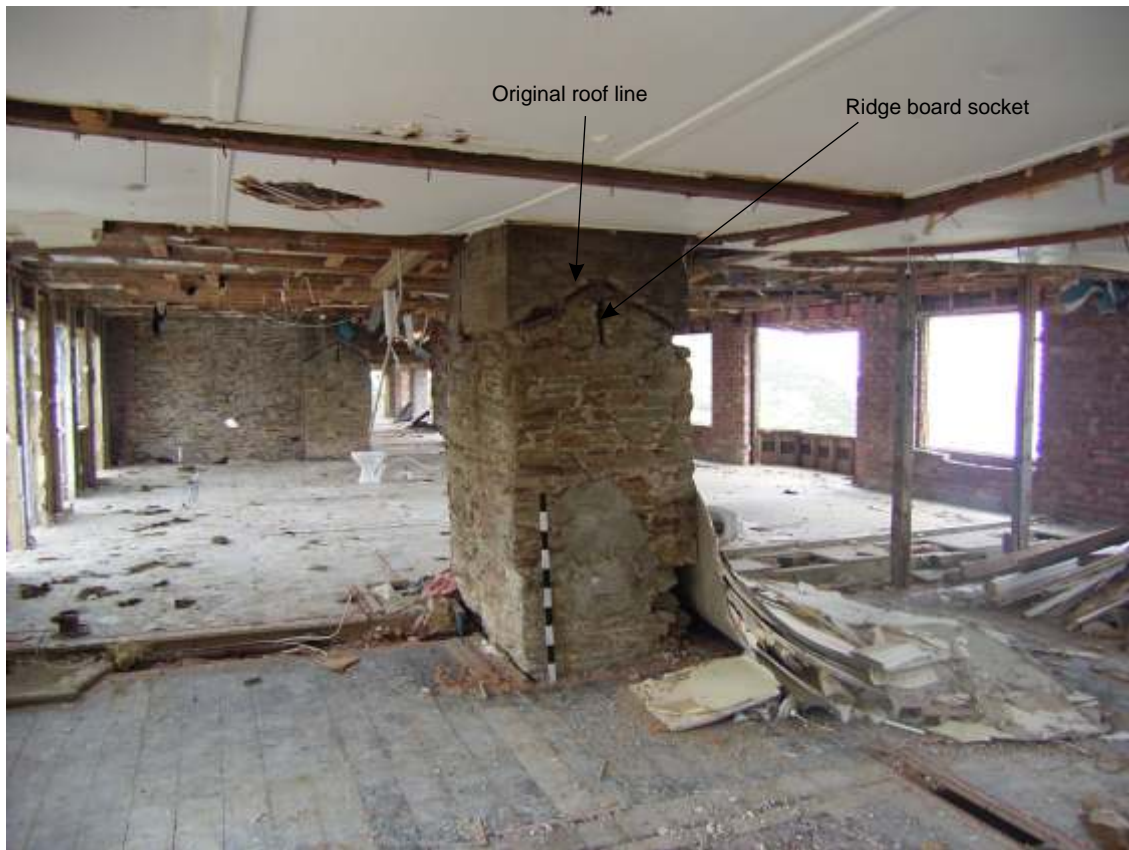
Plate 10. 19th century original chimneys and roof line within first floor space

- 3.2.3 The surviving chimneys show clearly the original roof line (**Figure 8: Plate 10**). Also visible in the east and west faces of the chimneys along the main east-west range was a socket in the masonry for a ridge board which would have supported the common rafters of the earlier roof. The original chimney in the north-west part of the building (**Figure 8: Plate 11**) also shows the original roof line.

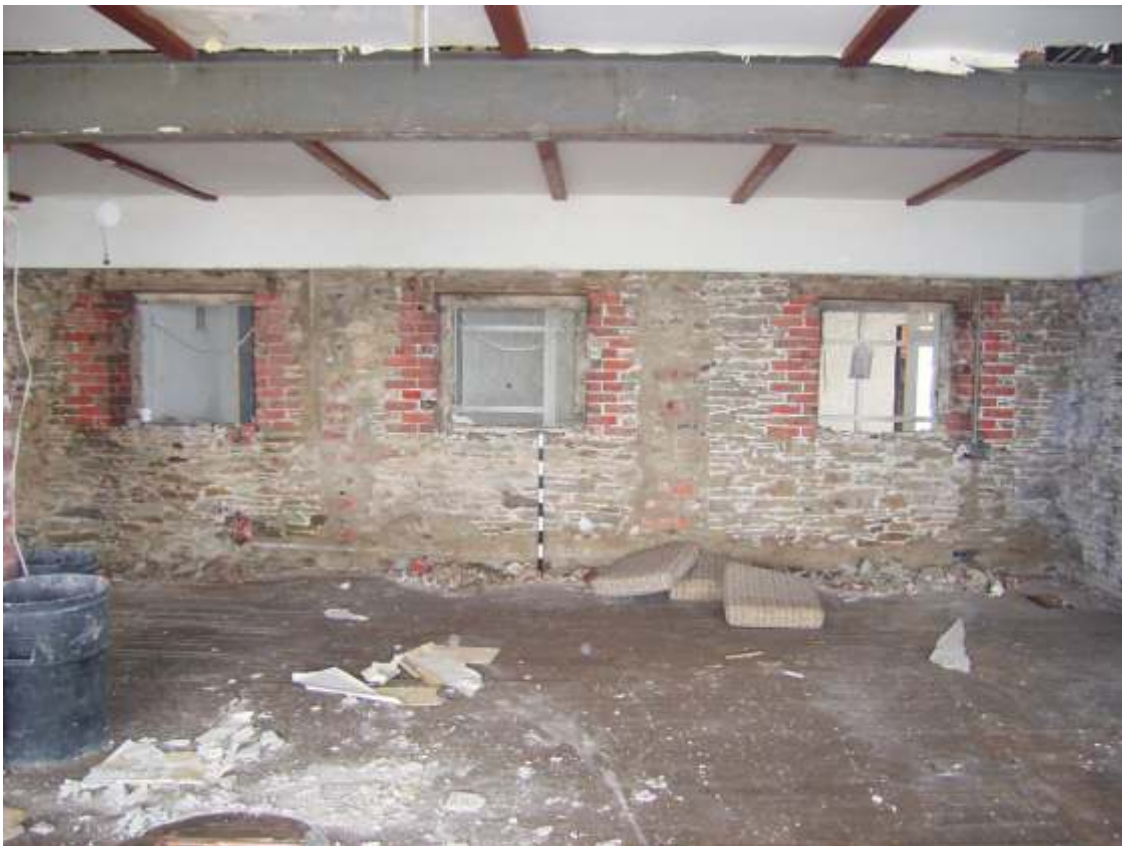
Plate 12. Ground floor lounge showing original window openings and vertical scarring on wall, indicating partitioning

- 3.2.4 On the ground floor, the inside face of the rear wall of the lounge area shows evidence of internal partitioning in the form of vertical wall scars spaced between the surviving original window openings (**Figure 9: Plate 12**). It is likely that this area was originally a store.

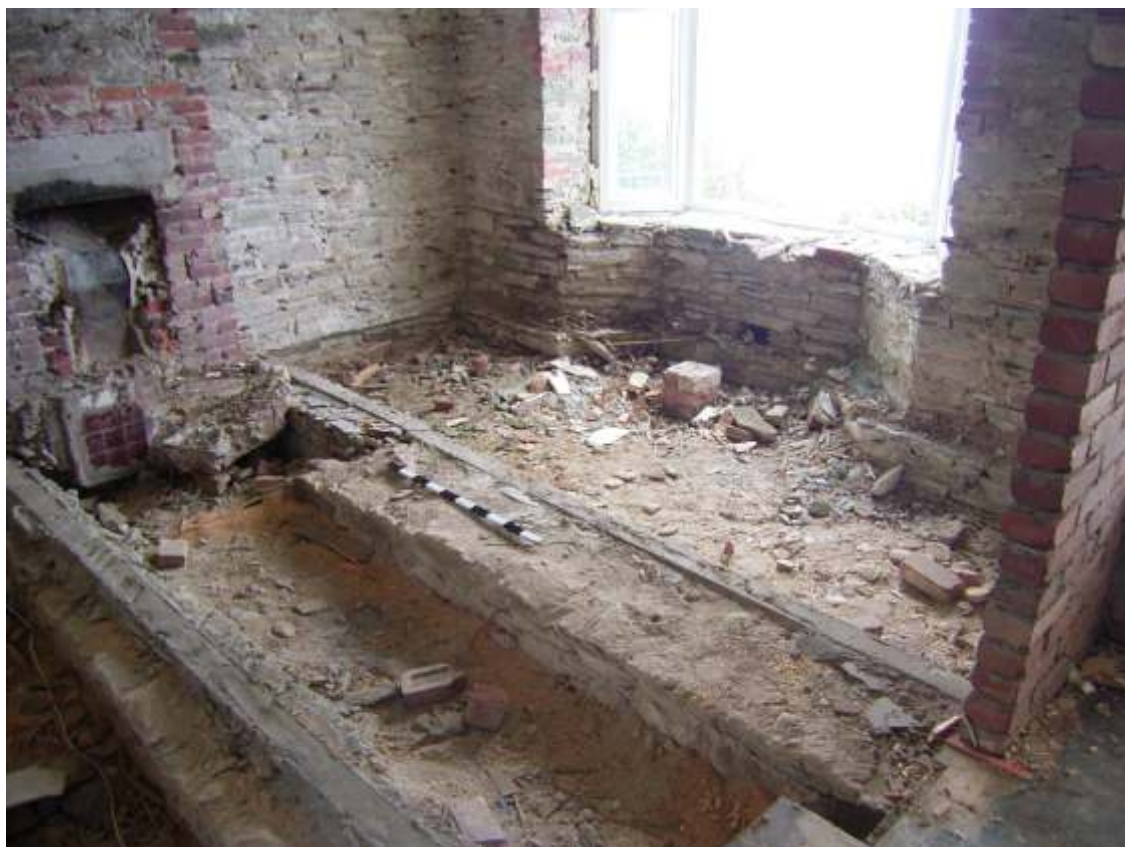
Plate 14. Exposed section of surviving 19th century front south wall foundation at east end of range

- 3.2.6 A section of original 19th century front (south) wall foundation was recorded at the east end of the building after a section of wooden flooring was removed (**Figure 7** and **Figure 10: Plate 14**). The rest of the building still had its floor coverings and **Figure 7** shows the extrapolated line of the original front (south) wall of the cottages.

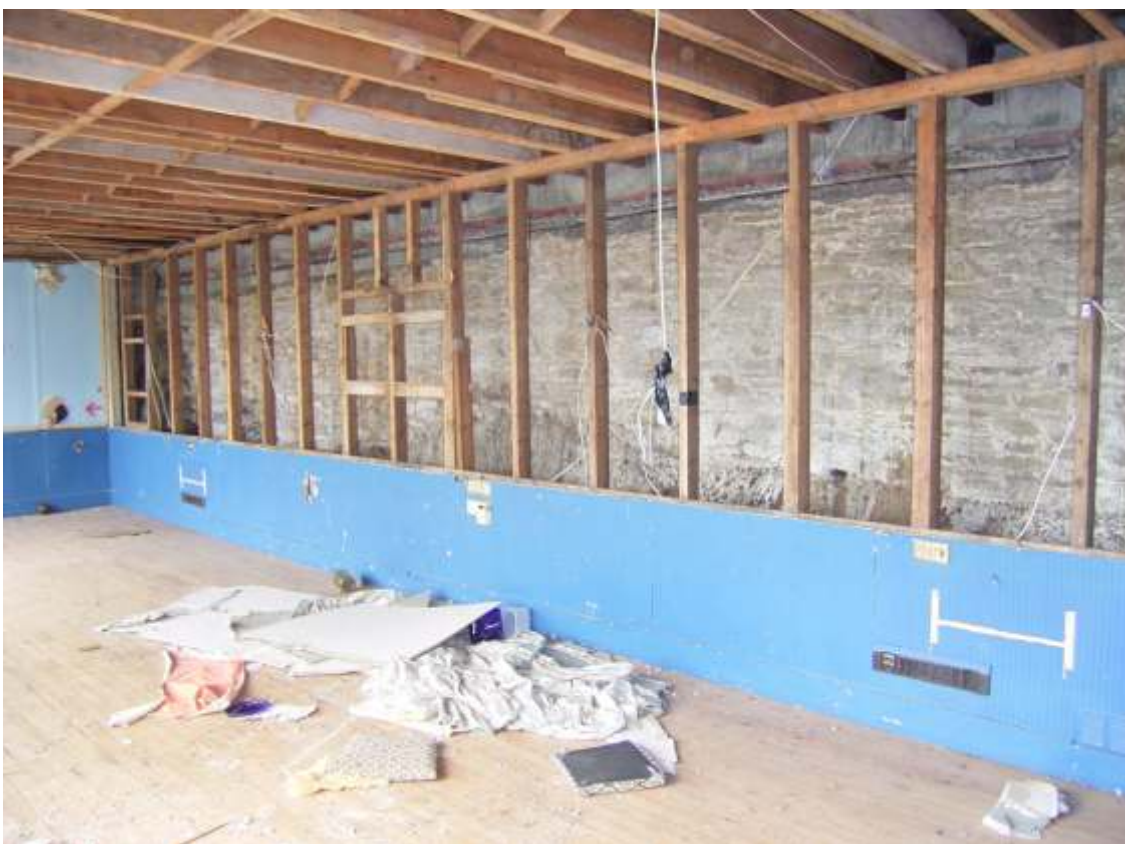
Plate 15. Store boundary wall; 'Great wall of Gara', behind panelling in breakfast room

- 3.2.7 The boundary wall referred to as the ‘Great Wall of Gara’ was noted behind panelling along the west wall of the Breakfast Room (**Figure 7** and **Figure 10: Plate 15**)
