# Salisbury Market Place, Salisbury, Wiltshire

Archaeological Watching Brief Report

Ref: 89120.01  
January 2014

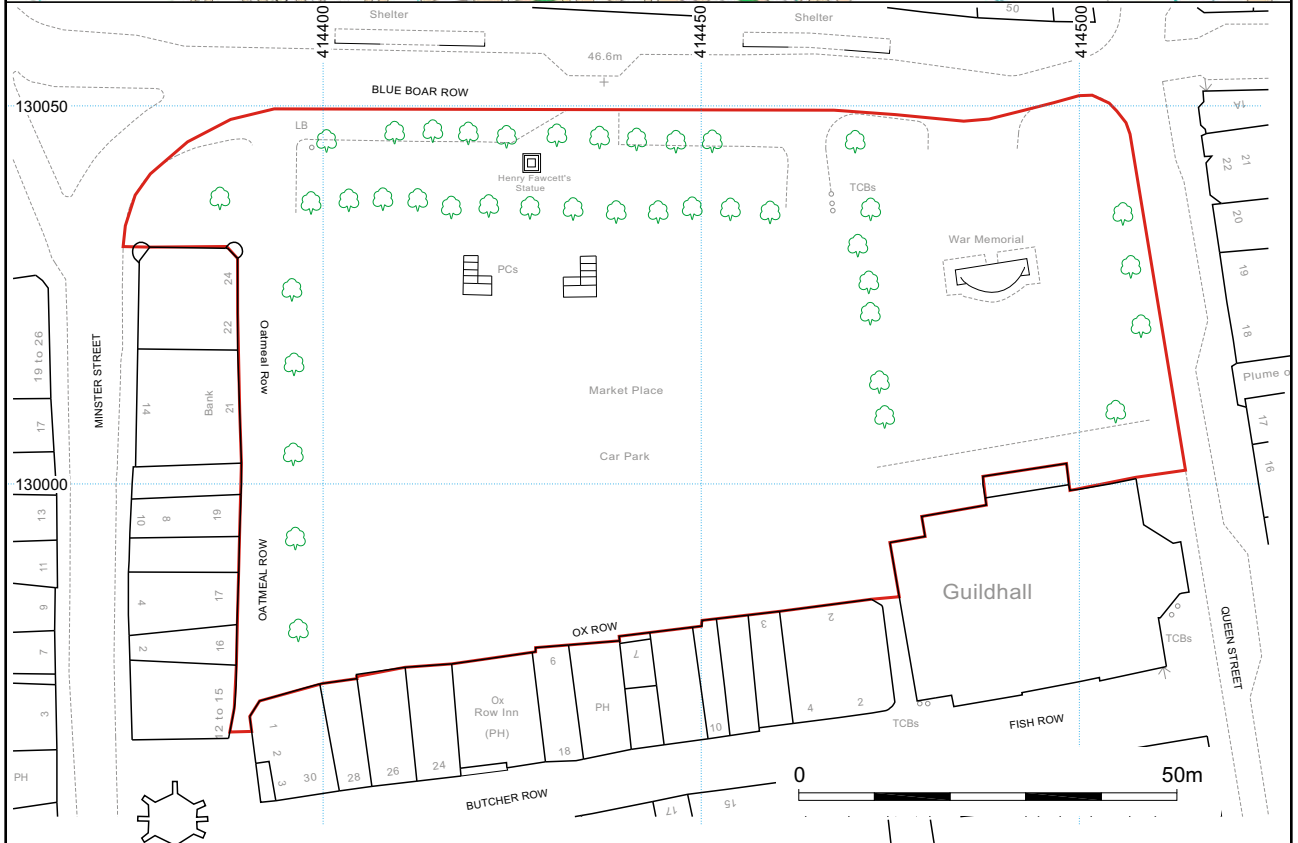
Figure 1

Location of site and observed work.

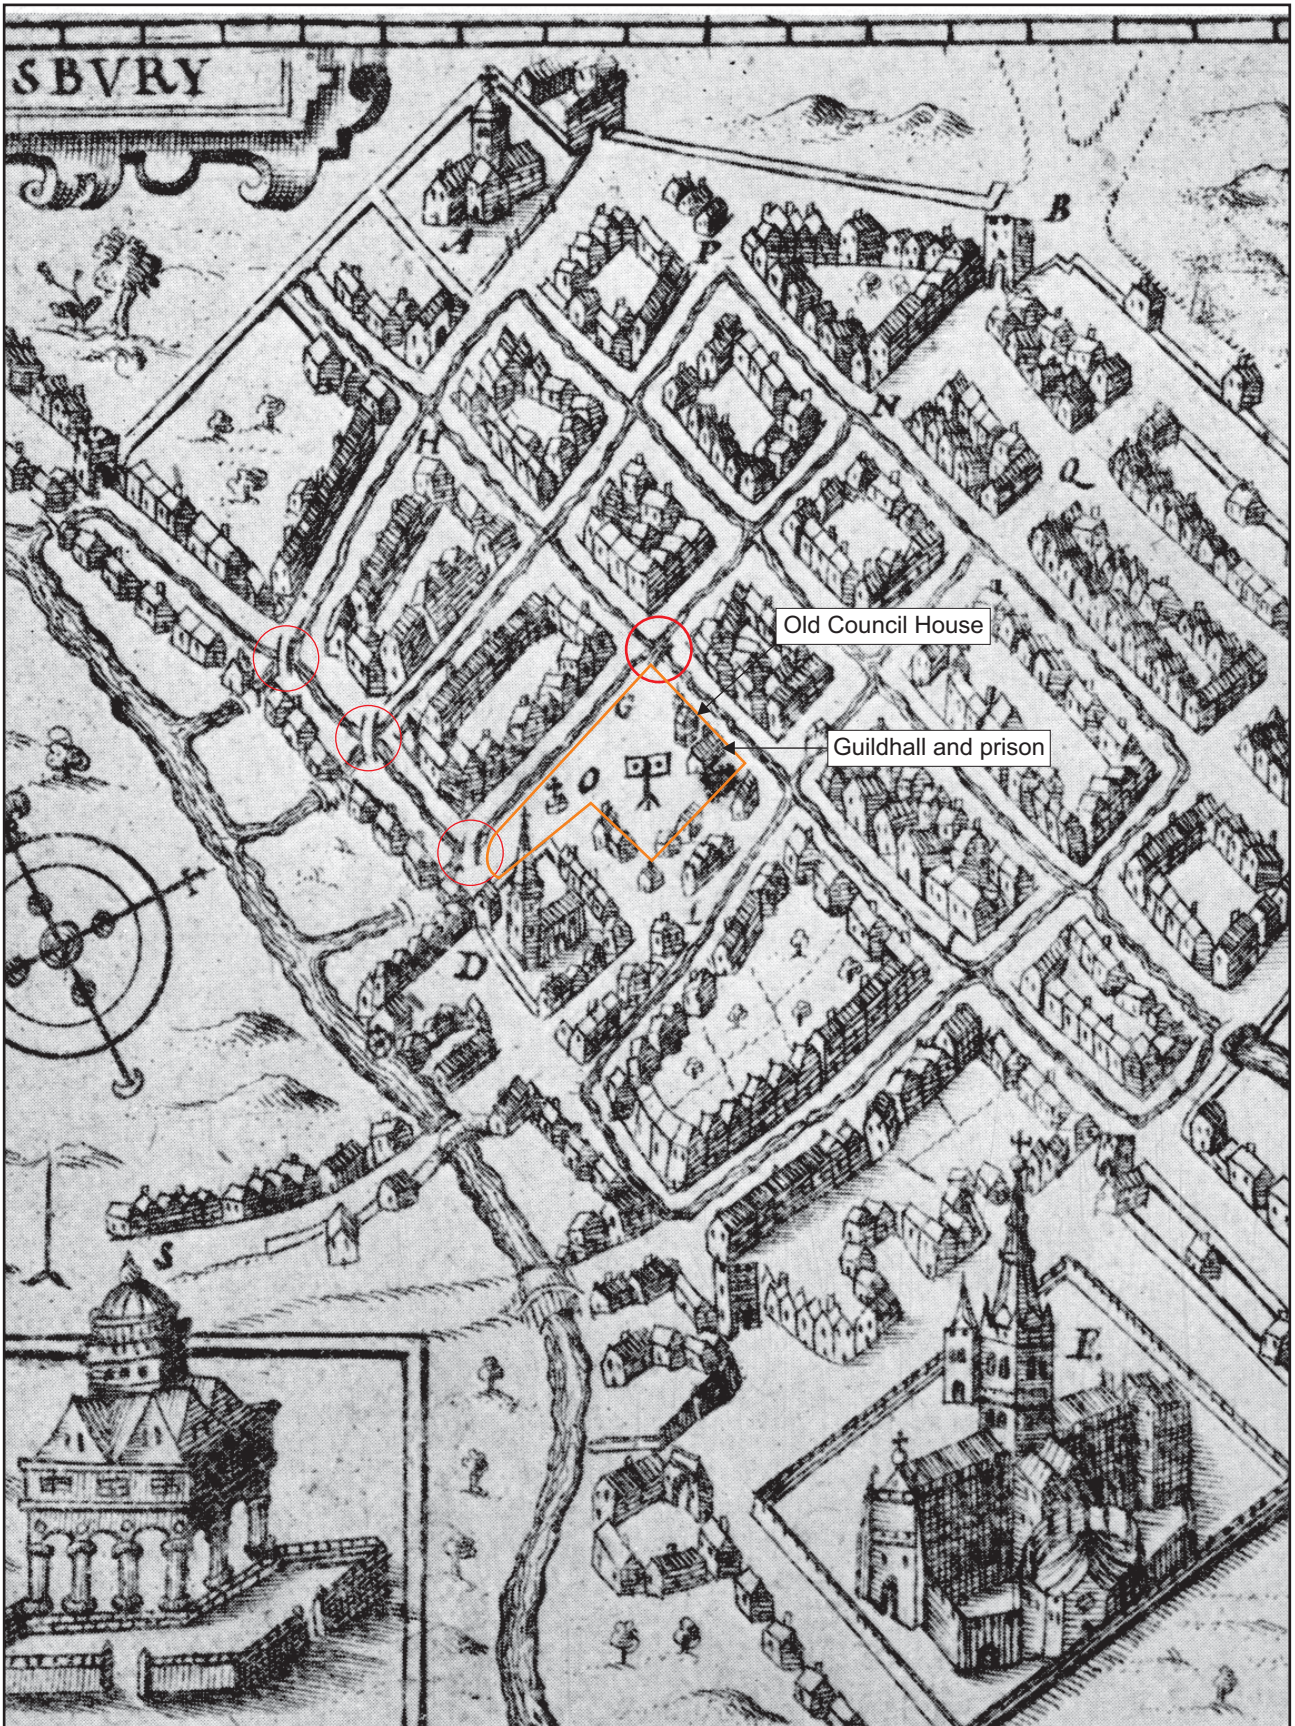
Market place [The Site]

Bridge

- 6.1.1 The generally superficial nature of the development and refurbishment works, coupled with the fact that most of the Site has remained as an open space, in this case the Market Place (with temporary market stalls and booths), has resulted in relatively little archaeological interest being exposed during the watching brief. However, there were two exceptions, both at the eastern end of the Market Place. These included a short length of wall [120] which was likely to have been associated with the Old Council House, built 1580-1584, but subsequently burnt down in 1780. An adjacent brick-lined well [121] of some size and quality may also have been of pre-19th century date, associated with either the existing Guildhall (built 1795) or its medieval predecessor. A further, more substantial stone structure [114] in the north-east corner of the Market Place, partly exposed in a pipe trench, was associated with a substantial dump of demolished building stone and may have been an abutment for a bridge, which is shown on John Speed's map of c. 1600.

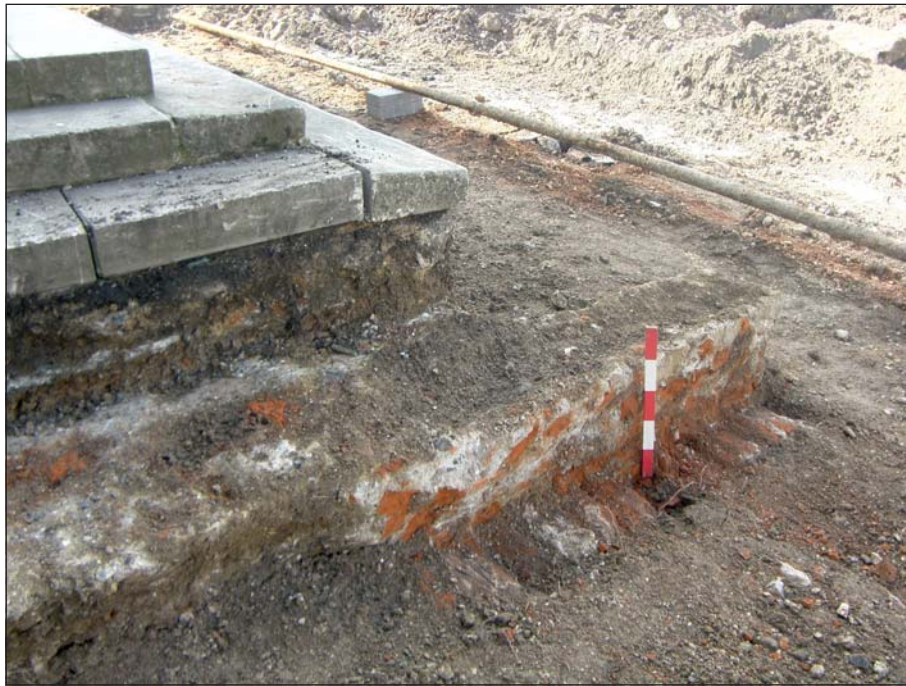
4.2.1 A short length of wall [120] was exposed during ground level reduction at the north-east corner of the existing Guildhall steps (**Plate 1**). Wall [120] was aligned approximately north-south, and at least 3.5m long, 0.7m wide and 0.35m high. It was unfaced and comprised uncoursed bricks and brick fragments, set in a hard creamy white mortar containing broken flint fragments. Part of the wall foundation was also exposed, comprising at least two courses of mortared brick, laid flat at right angles to, and extending slightly beyond, the base of the wall. The bricks in the foundation measured 230 x 115 x 65mm and were unfrogged. It is assumed that this wall, probably a boundary wall (see below), was on the west side of the area it bounded, but no associated surfaces survived. The date of wall [120] is uncertain, but a late post-medieval date is probable, perhaps late 17th or 18th century.

Plate 1: Wall 120, adjacent to Guildhall steps (view from south-east; scale = 0.5m)

- 6.1.4 Wall 120 is thought likely to represent a small, surviving fragment of a boundary wall surrounding the Old Council House, which occupied a site to the north of the former Guildhall and Gaol, itself the site of the existing Guildhall. The location of the Old Council

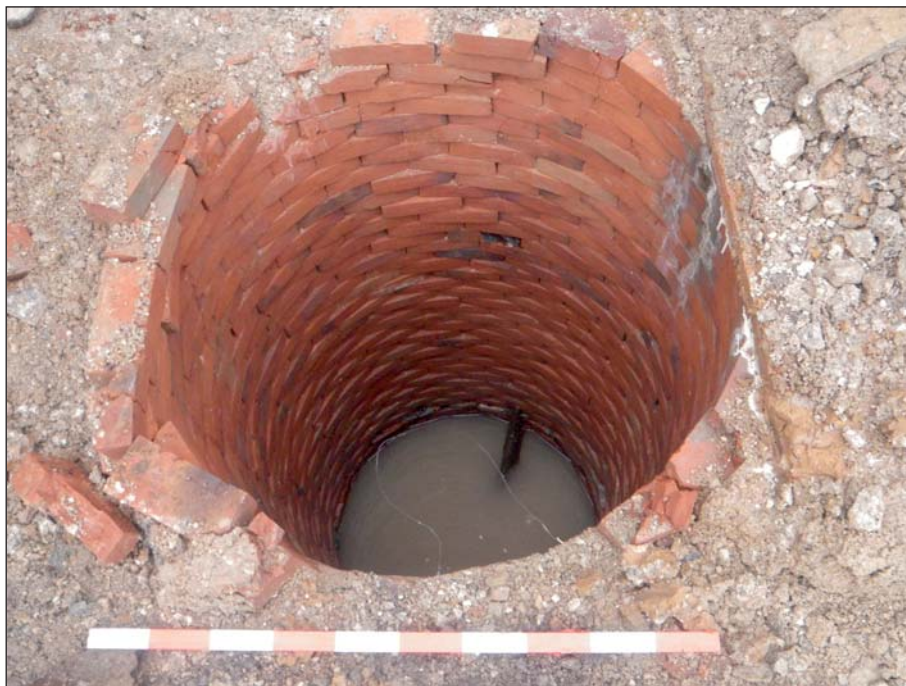
4.2.2 Approximately 2m to the west of the existing Guildhall steps was well [121]. The top had been truncated and capped (with cement), but it was open to a depth of approximately 3m, with the existing water level at c. 2.5m depth (**Plate 2**); it had silted up below this and its full depth was not established. Well [121] was lined with unmortared bricks (38 courses were visible) and had an internal diameter of 0.95m. The unfrogged bricks were of similar dimensions to those used in wall [120], but of better quality and finish, and a late 18th or early 19th century date is likely.

Plate 2: Well 121 (view from east; scale = 1m)

- 6.1.5 The late 18th or early 19th century date of well [121] makes it uncertain as to which building it was associated with. Its high standard of construction using good quality brick (rather than chalk and flint) indicates that it was an important feature. If pre-1780, then it lay within what appears from maps to have been a small, enclosed yard at the rear (north) of the old Guildhall and prison. If post-1780 (or 1795), then it would have lay close to the main entrance to the new Guildhall on the north front, perhaps providing a source of water for the Guildhall, and possibly also for watering horses and other uses elsewhere in the Market Place. The present Guildhall portico was built c. 1889, replacing a former Doric colonnade recessed between the wings on the north front, and thus if this well was of early 19th century date, then it would not have been as close to the then Guildhall entrance as it is to the existing portico/steps today.

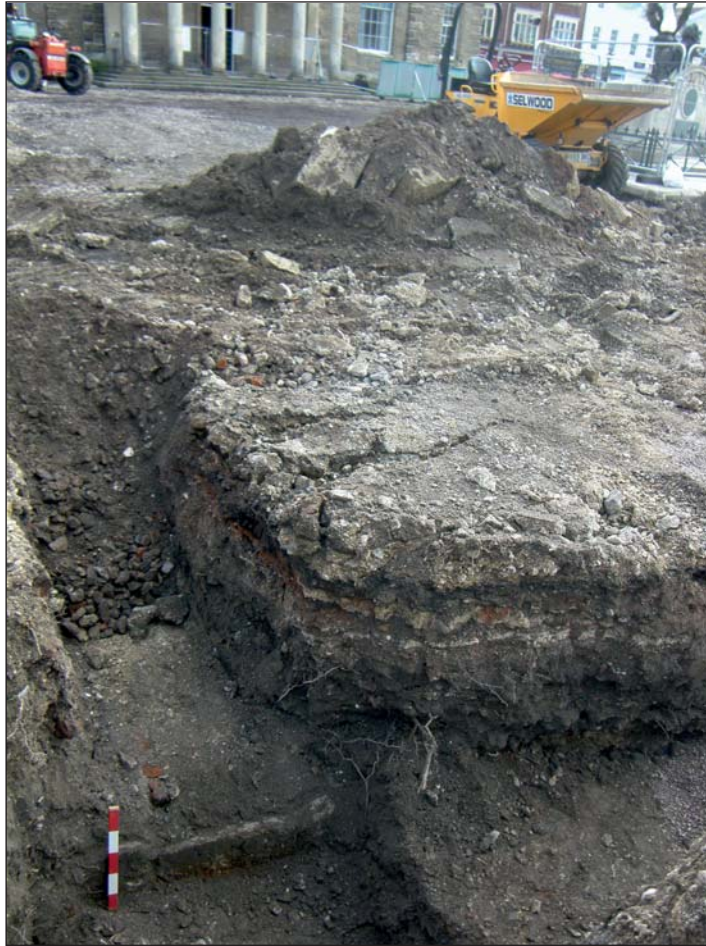
- 4.2.4 An L-shaped pipe trench in the north-east corner of the Site revealed one feature of interest, a stone structure [114] aligned approximately east-west, parallel to Blue Boar Row and close to Queen Street to the east. Structure [114] was exposed in the base of the pipe trench and adjoining inspection chamber pit, crossing these on an oblique alignment (**Plate 3**). A length of approximately 7m of structure [114] was exposed, continuing to the east and west beyond the limits of trenching, but its width could not be ascertained; the north side lay within the trench, revealed within the inspection pit, which showed it to be at least 0.9m wide. The base of the structure was also reached in the bottom of the inspection pit, at a depth of c. 1.5m from the existing ground surface, and it survived to a height of between 0.5 and 0.75m. Although only a small part of structure [114] was visible, it comprised blocks of Chilmark limestone of varying size, apparently regularly coursed with neat, vertical jointing (two courses were seen *in situ*; no mortar was apparent).

- 4.2.5 No clear construction cut for structure [114] was visible and no contemporary surfaces were identified. The area had been disturbed by tree roots, particularly on the south side, but on the north side were deposits of greyish brown and dark greyish brown silty clay loam containing several layers/lenses of crushed brick and mortar. Above the *in-situ* remains of structure [114] was a substantial demolition deposit (113), comprising blocks of Chilmark limestone mixed with pale cream crushed mortar. These blocks, some of them removed in the process of trenching, were of various shapes and sizes (e.g. 0.90 x 0.38 x 0.30m and 1.45 x 0.50 x 0.20m; minimum thickness 0.15m), and are presumed to derive from structure [114]. They included several quoin stones and, though not of high quality ashlar, had clearly been fashioned for use in a substantial structure (**Plate 4**). A pre-19th century date is probable for this worked stone (and associated structure), although it could be somewhat earlier (see below).

Plate 3: Structure 114, exposed in base of pipe trench (view from north; scale = 0.5m)

- 6.1.2 Although no certain medieval features, deposits (including market surfaces) or finds were identified, as was the case with the earlier watching brief on the geotechnical investigations (Oxford Archaeology 2010), stone structure [114] could be of late medieval or early post-medieval date. Very little was seen *in situ*, but this and the associated demolition debris (113) indicates a relatively substantial structure of reasonable quality which, it is suggested, formed part of a bridge abutment which is depicted on John Speed's plan of Salisbury in c. 1600 (Figure 3). He shows at least four bridges at street junctions, crossing the network of watercourses, which supplied water to the city and originally ran along the middle of the streets defining Salisbury's 'chequers'. One of these bridges lay at the north-east corner of the Market Place and crossed a watercourse which flowed along the west side of Queen Street, adjacent to the Market Place. This location matches closely with structure [114] which could represent part of the west abutment of this bridge.

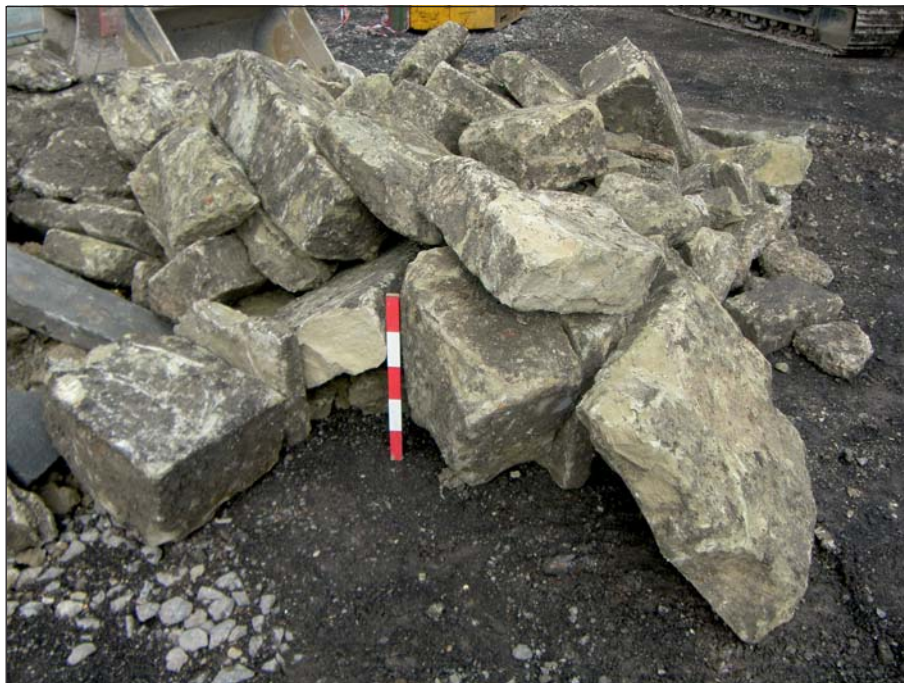
Plate 4: Demolition rubble, probably derived from structure 114
