Doubletree by Hilton Hotel, Hoole Hall, Chester, Cheshire

Archaeological Evaluation
Trial Trenching Report

Ref: 100681.02
September 2013

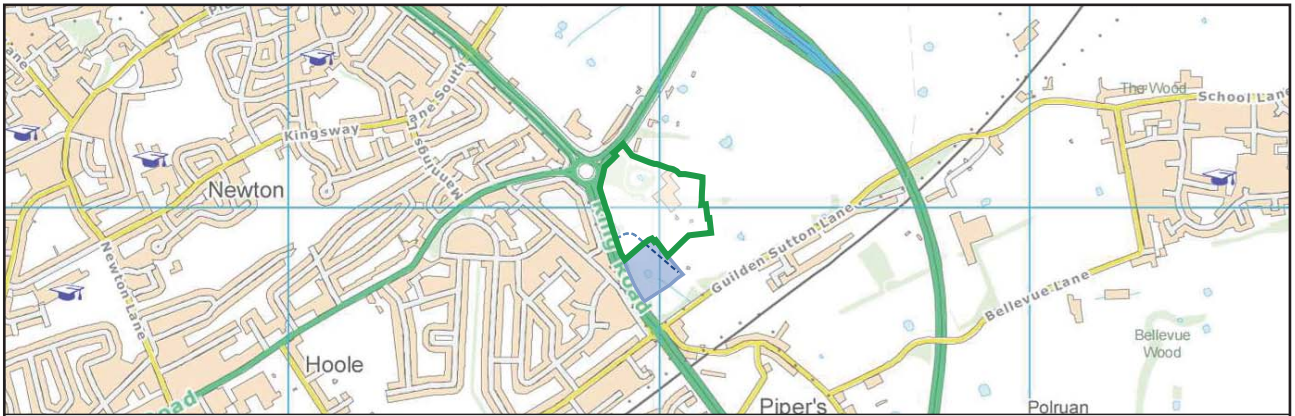
Figure 1

Site location and trench plan on 1899 Ordnance Survey Map

Road and to the south by Guilden Sutton Lane. The land to the east of the Site is made up of open fields. The Site is currently occupied by Hoole Hall and its associated fields, access roads and car parks. The trenches were excavated to the south of the hall in the fields and car park (**Figure 1**). The site is level at approximately 33m OD.

- 4.2.3 **Trench 7** was located in the south of the Site, north of **Trench 6**, to target former buildings associated with Hoole Hall (**Figure 1**). No archaeological features were observed. Natural clay was observed between 0.36m and 0.88m bgl.

These structures are present up until the 1982 map (**Figure 1**). The features appear to survive best under the carpark.

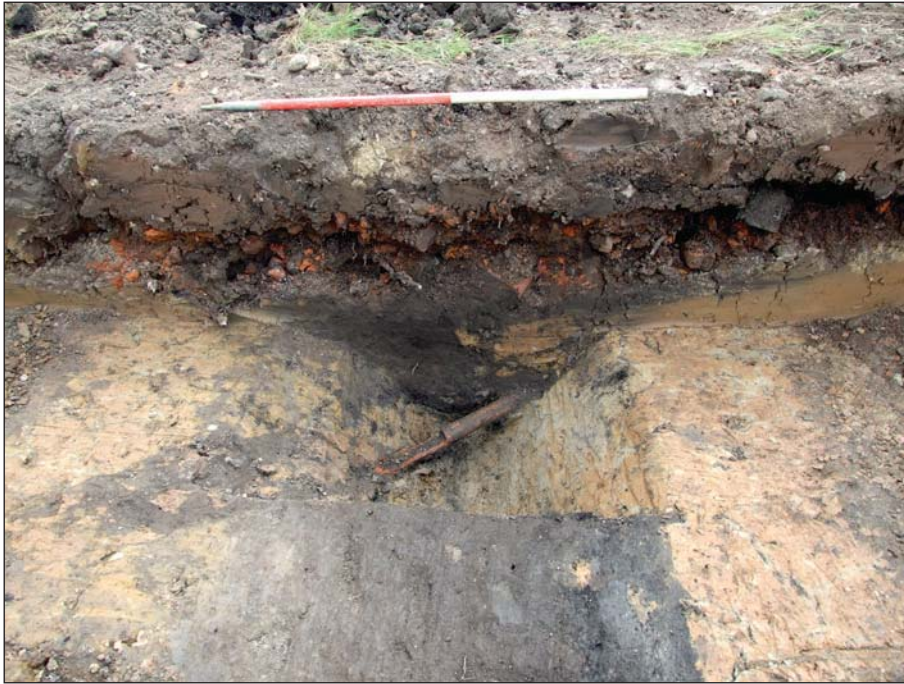
Plate 1: Trench 2, undated ditch truncated by Post-Medieval land drain, looking south

- 4.3.1 **Trench 2** was located to the south of **Trench 1** and was also excavated to target the eastern extent of the Scheduled Monument. The earliest feature identified was an undated ditch (**Plate 1**) towards the western extent of the trench (**Figure 2**). The U-shaped ditch, cut into the natural clay, measured 1.1m in width and 0.48m in depth. The single fill (**205**) of the ditch (**204**) was truncated by a Post-Medieval land drain (**208**). A further land drain was observed to the eastern extent of the trench. The land drains were overlain by subsequent layers of Post-Medieval brick demolition rubble (**210**) and made ground (**202**).

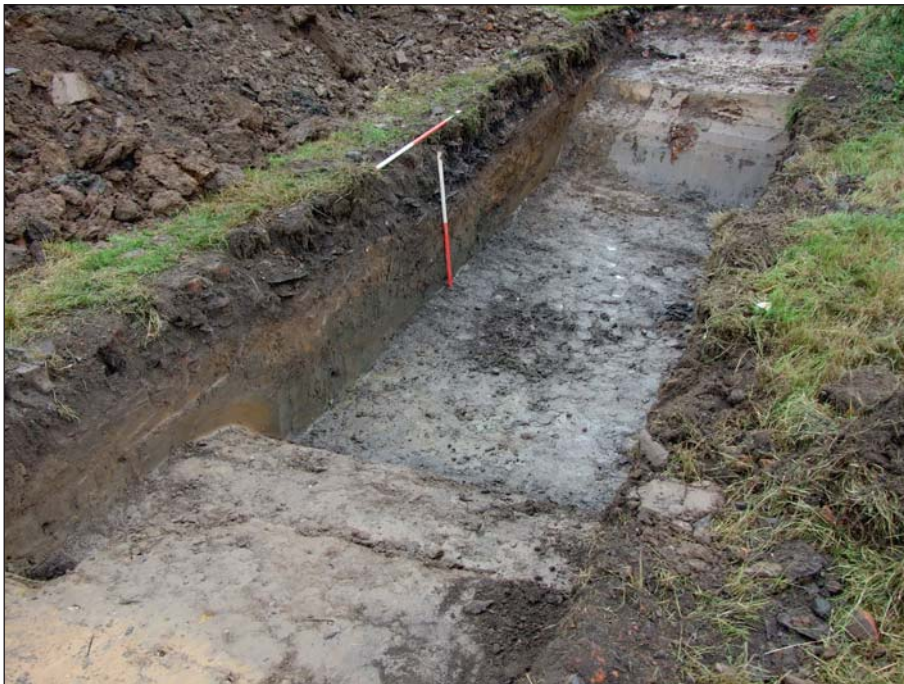
Plate 2: Trench 6, ditch **606** and red brick surface **610**, facing south

- 4.4.1 **Trench 6** was located in the south of the Site to target former buildings associated with Hoole Hall. Natural clay was observed at 0.42m bgl. A red and blue brick surface (**610**)

was identified immediately below ground level at the southern extent of the trench. To the north of the surface was a substantial modern cut (**606**) containing a field drain (**Plate 2**). The cut measured up to 9.5m in width and was excavated to a depth of 1.3m bgl at which point excavation was abandoned. A levelling layer (**607**) sealed the filling of the cut (**608** and **609**).

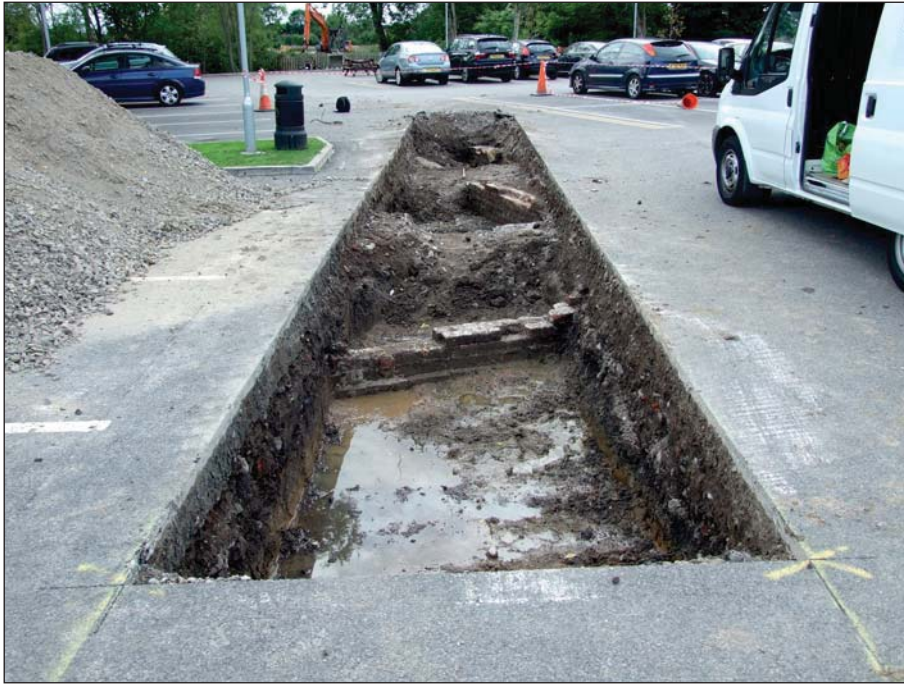
Plate 3: Trench 8, red brick structures, facing west

- 4.4.2 **Trench 8** was located in a car park west of **Trench 7**. Six Post-Medieval red brick walls were identified 1m bgl and located directly below the made ground of the modern car park. Red brick structures **804** and **806** were both two skins wide, three courses deep and orientated northwest to southeast (**Figure 2** and **Plates 3** and **4**). Red brick structures **812** – **815** were all two skins wide and survived to a depth of between four and six courses. These features were orientated southwest to northeast. Walls **812** and **813** form the same wall which is punctuated by a service trench. Walls **814** and **815** are part of the same structure with a 0.8m gap between them. The wall ends were capped with sandstone blocks forming an entrance into the building (**Figure 2**).

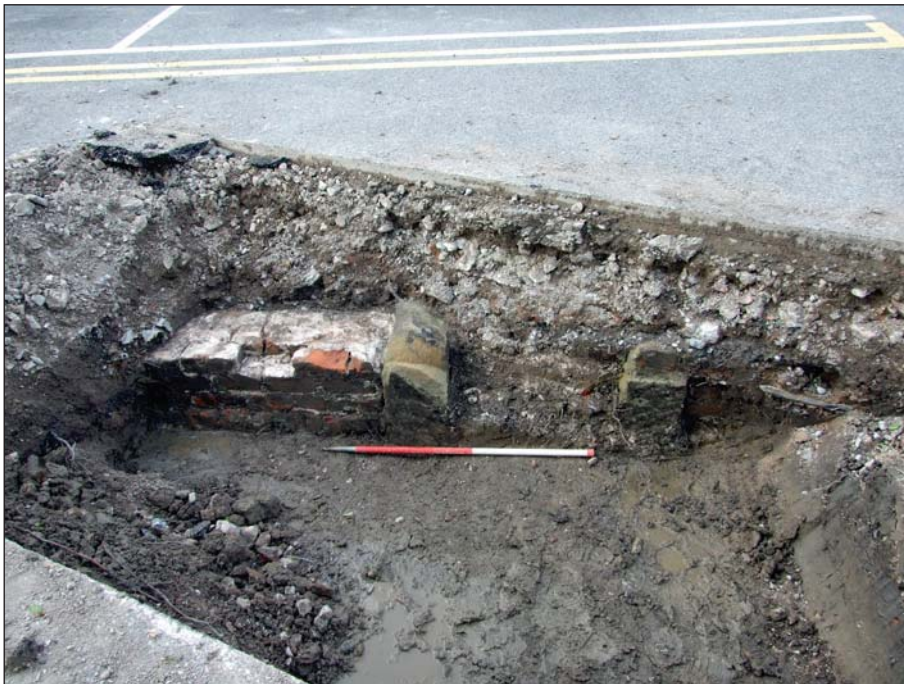
Plate 4: Trench 8, structures **814** and **815** with stone capping, facing north

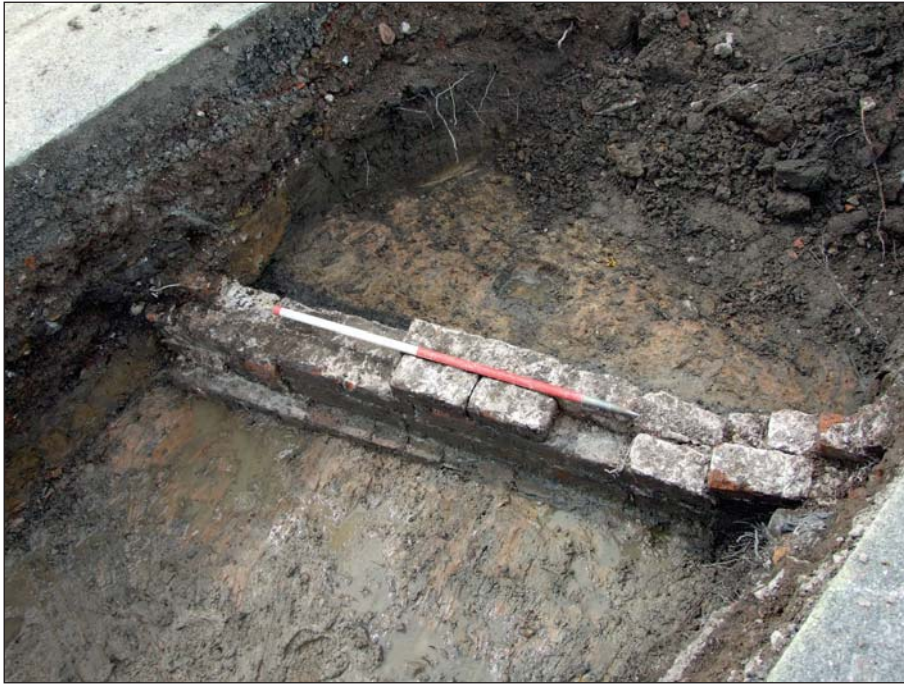
Plate 5: Trench 9, red brick structures **913** and **916**, facing southwest

- 4.4.4 **Trench 9** was located in a car park south of the Hotel and north of **Trench 8**. Three Post-Medieval red brick structures were identified 0.6m bgl and located directly below the made ground of the modern car park. Walls **909**, **913** and **916** were all two skins wide, three courses deep and are orientated northwest to southeast. Wall **913** was aligned with walls **804/806** within **Trench 8** (**Figure 2**) and formed a right angel with **916** (**Plate 5**).

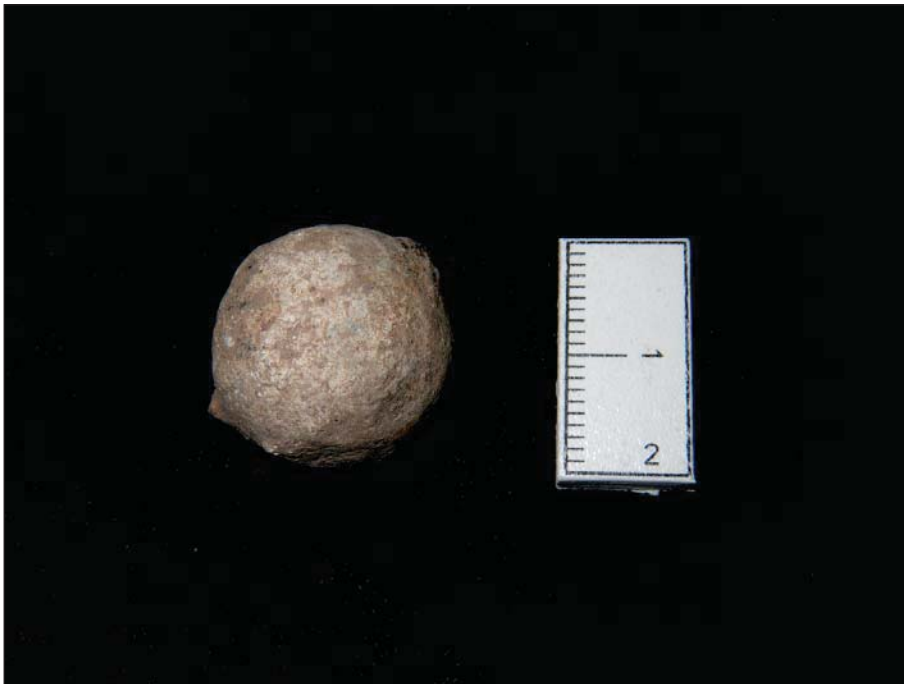
Plate 6: Musket ball recovered by metal detector

from made ground **802** (18th century); two musket balls, of a size consistent with a 17th century date (unstratified in **Trench 3**), and bottle glass (18th century or later).
